**US Army Corps
of Engineers ®**

Site Visit Summary

Name of System: Gary

Name of Segment: Gary North

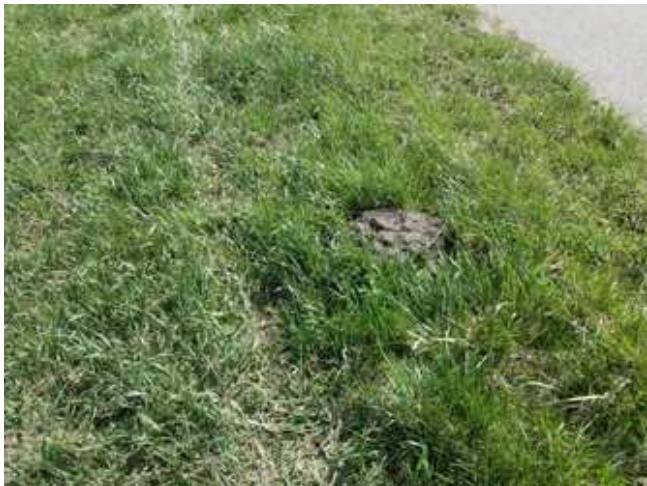
Category:	Levee Embankments	Item:	Animal Control
Observation ID:	2023-0210		
Description:	Animal burrow on landside toe		
Caption:	0210 - No User Rating (Site Visit) - Animal burrow on landside toe		
Lat/Long:	41.56698/-87.35461

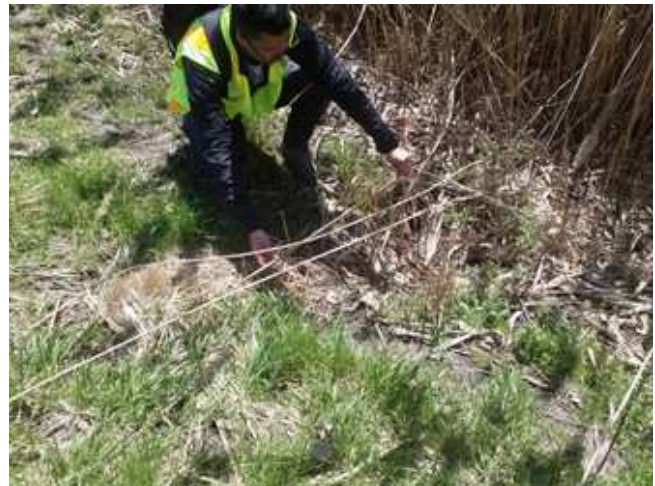
Category:	Levee Embankments	Item:	Animal Control
Observation ID:	2023-0216		
Description:	Animal activity on landside slope		
Caption:	0216 - No User Rating (Site Visit) - Animal activity on landside slope		
Lat/Long:	41.56729/-87.34868

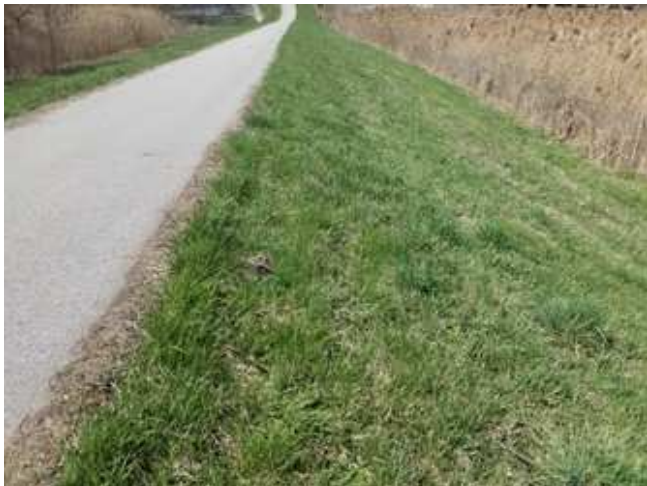
Category:	Levee Embankments	Item:	Animal Control
Observation ID:	2023-0223		
Description:	Typical eight-inch deep animal burrows on riverside toe and slope		
Caption:	No User Rating (Site Visit) - Typical eight-inch deep animal burrows on riverside toe and slope		
Lat/Long:	41.56826/-87.42123

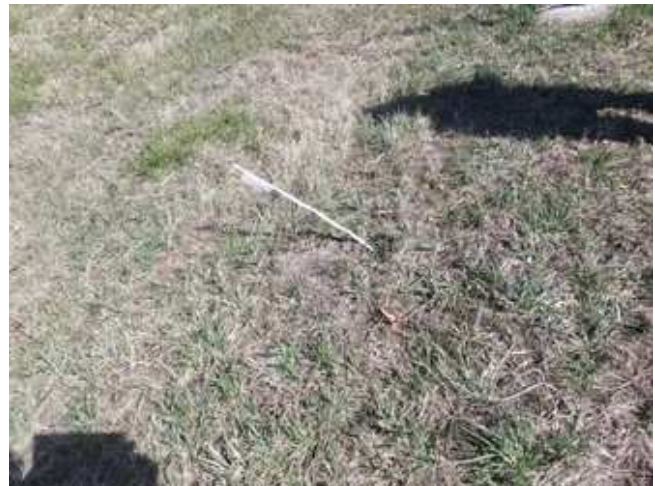
Category:	Levee Embankments	Item:	Animal Control
Observation ID:	2023-0237		
Description:	Animal activity on landside slope		
Caption:	0237 - No User Rating (Site Visit) - Animal activity on landside slope		
Lat/Long:	41.56702/-87.34482

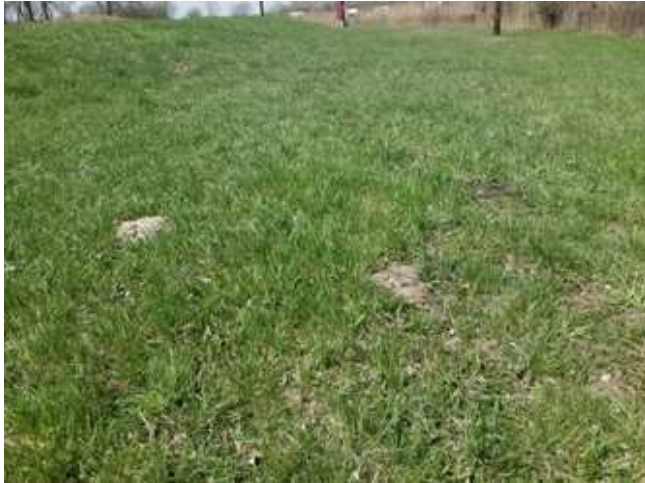
Category:	Levee Embankments	Item:	Animal Control
Observation ID:	2023-0250		
Description:	Animal burrows on landside slope - 8-in deep		
Caption:	0250 - No User Rating (Site Visit) - Animal burrows on landside slope - 8-in deep		
Lat/Long:	41.56706/-87.41923

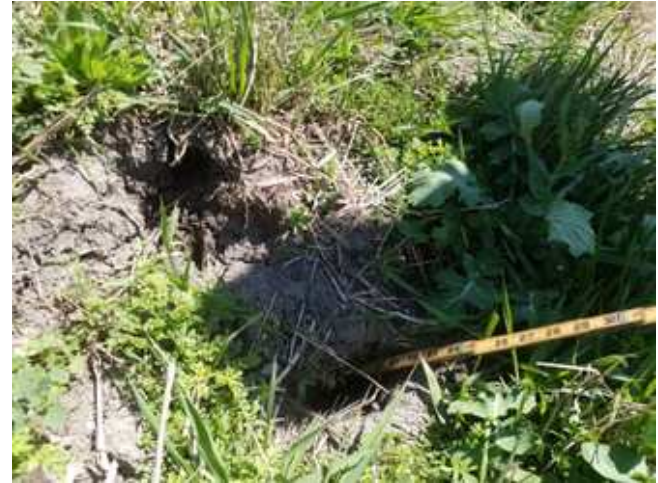
Category:	Levee Embankments	Item:	Animal Control
Observation ID:	2023-0255		
Description:	Typical animal activity on landside toe		
Caption:	0255 - No User Rating (Site Visit) - Typical animal activity on landside toe		
Lat/Long:	41.56667/-87.33982

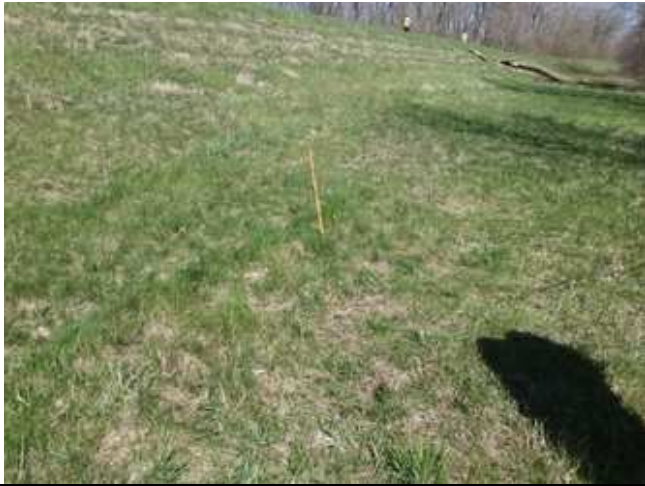
Category:	Levee Embankments	Item:	Animal Control
Observation ID:	2023-0325		
Description:	Animal burrow on riverside slope		
Caption:	0325 - No User Rating (Site Visit) - Animal burrow on riverside slope		
Lat/Long:	41.56218/-87.40945

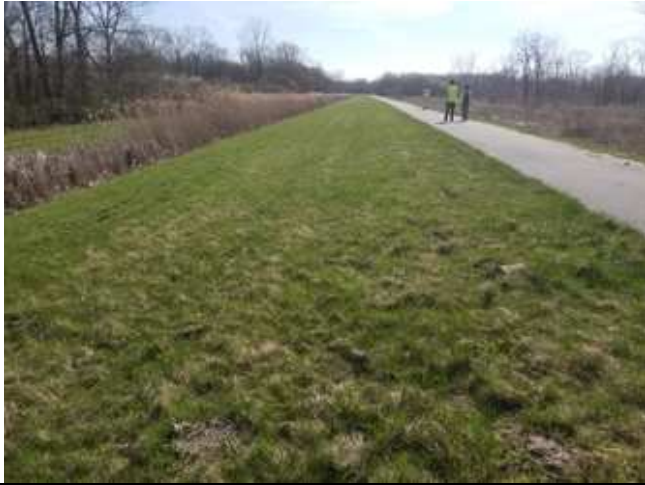
Category:	Levee Embankments	Item:	Animal Control
Observation ID:	2023-0373		
Description:	Animal burrow on riverside toe		
Caption:	0373 - No User Rating (Site Visit) - Animal burrow on riverside toe		
Lat/Long:	41.56085/-87.39740

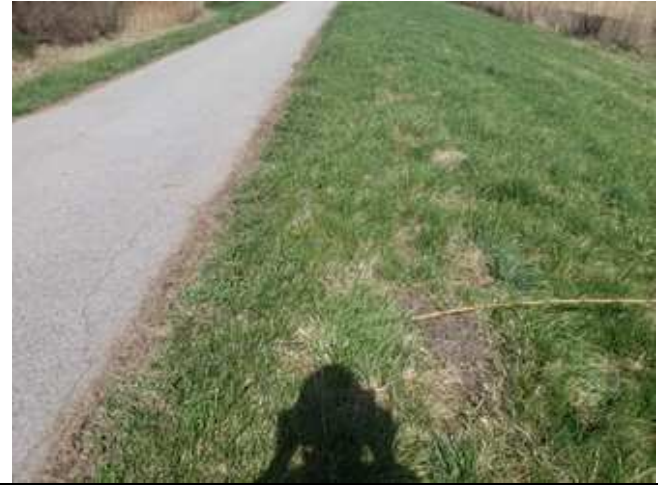
Category:	Levee Embankments	Item:	Animal Control
Observation ID:	2023-0391		
Description:	Typical animal mounds on landside slope		
Caption:	0391 - No User Rating (Site Visit) - Typical animal mounds on landside slope		
Lat/Long:	41.56294/-87.39175

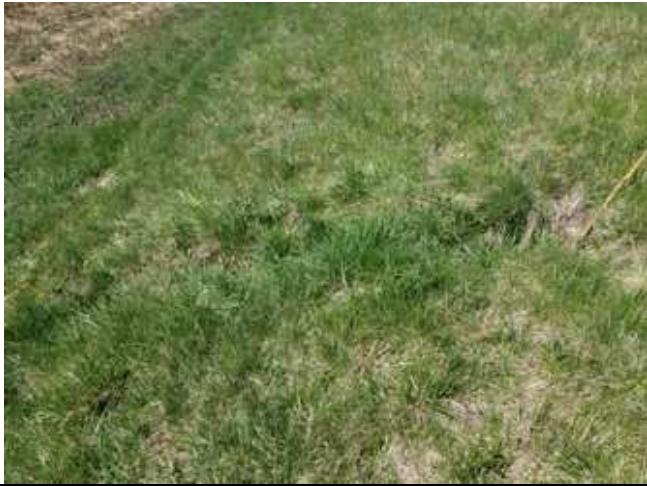
Category:	Levee Embankments	Item:	Animal Control
Observation ID:	2023-0436		
Description:	Animal burrow ~14" deep on landside slope and crown		
Caption:	0436 - No User Rating (Site Visit) - Animal burrow 14-in deep on landside slope and crown		
Lat/Long:	41.56835/-87.35955

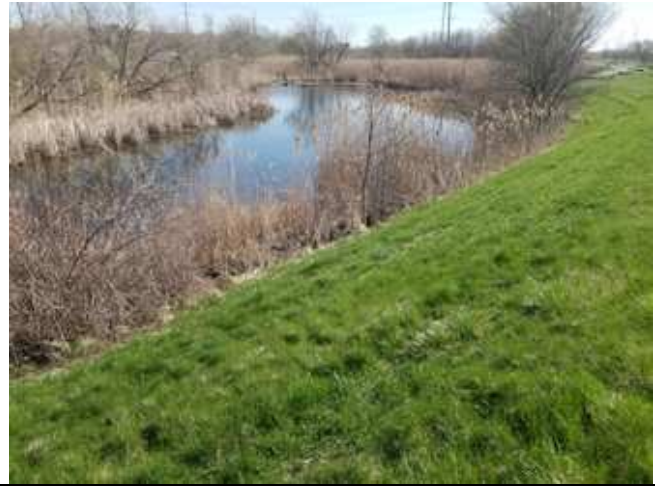
Category:	Levee Embankments	Item:	Animal Control
Observation ID:	2023-0448		
Description:	Three 1.5 ft deep burrows extending 9 ft long on landside slope		
Caption:	0448 - No User Rating (Site Visit) - Three 1.5 ft deep burrows extending 9 ft long on landside slope		
Lat/Long:	41.56748/-87.35096

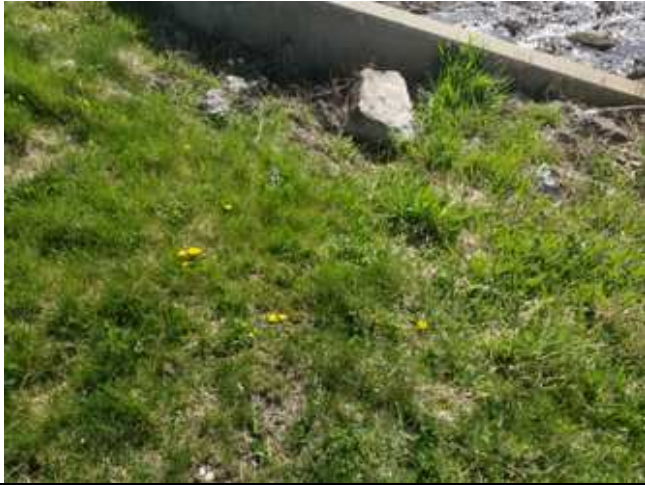
Category:	Levee Embankments	Item:	Riprap Revetments &
Observation ID:	2023-0147		
Description:	Trees and vegetation in riprap along landside toe		
Caption:	0147 - No User Rating (Site Visit) - Trees and vegetation in riprap along landside toe		
Lat/Long:	41.56588/-87.37673

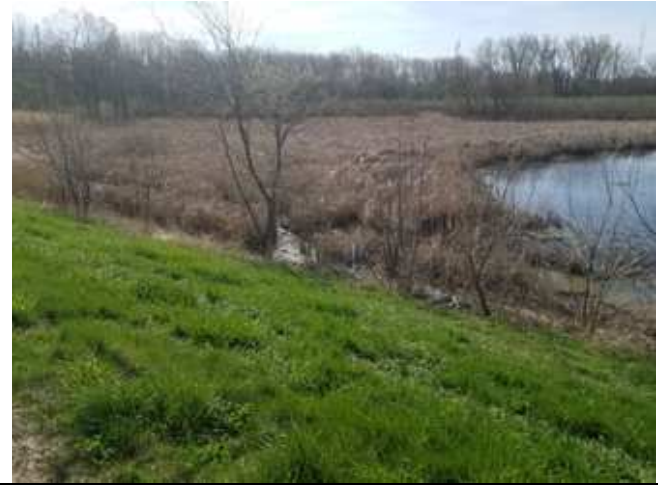
Category:	Levee Embankments	Item:	Riprap Revetments &
Observation ID:	2023-0412		
Description:	Erosion in riprap around gate walls (typical both sides)		
Caption:	0412 - No User Rating (Site Visit) - Erosion in riprap around gate walls (typical both sides)		
Lat/Long:	41.56573/-87.37738

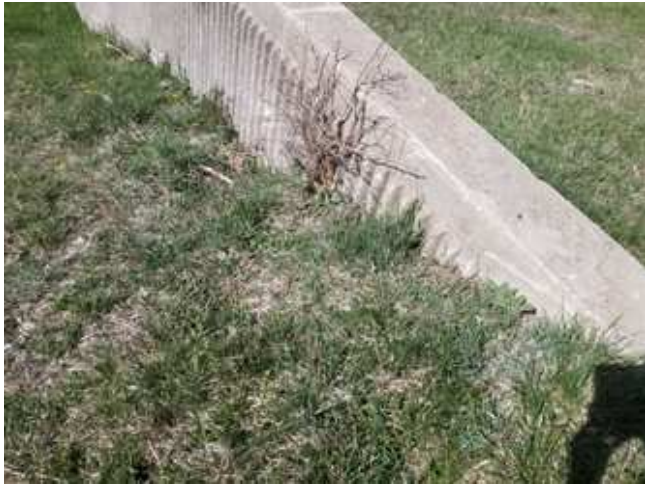
Category:	Floodwalls	Item:	Unwanted Vegetation
Observation ID:	2023-0093		
Description:	Large tree pushing floodwall on landside		
Caption:	0093 - No User Rating (Site Visit) - Large tree pushing floodwall on landside		
Lat/Long:	41.56070/-87.40589

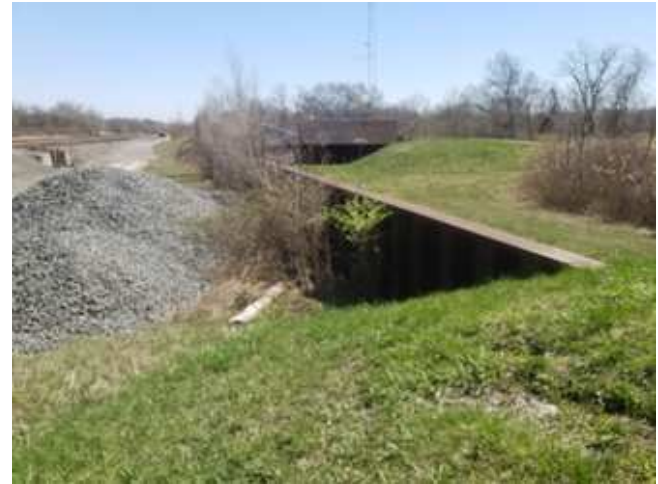
Category:	Floodwalls	Item:	Unwanted Vegetation
Observation ID:	2023-0198		
Description:	Small tree in floodwall on riverside		
Caption:	0198 - No User Rating (Site Visit) - Small tree in floodwall on riverside		
Lat/Long:	41.56711/-87.35725

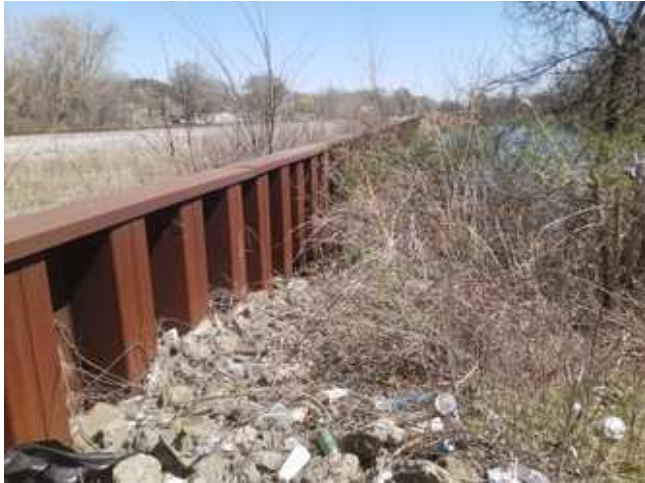
Category:	Floodwalls	Item:	Unwanted Vegetation
Observation ID:	2023-0262		
Description:	Trees along landside wall		
Caption:	0262 - No User Rating (Site Visit) - Trees along landside wall		
Lat/Long:	41.56587/-87.41645

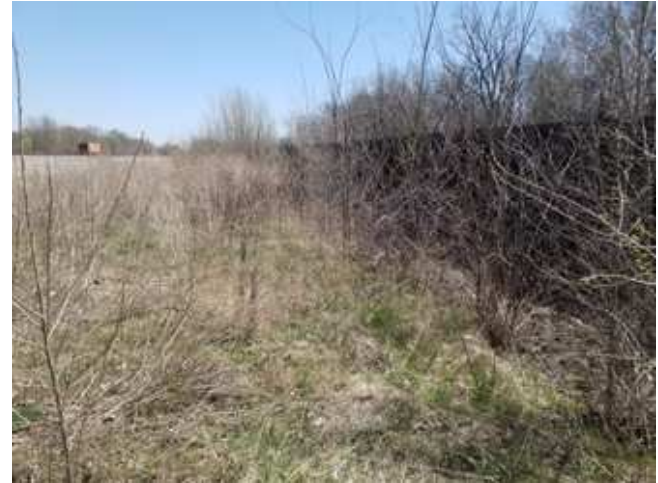
Category:	Floodwalls	Item:	Unwanted Vegetation
Observation ID:	2023-0298		
Description:	Small trees on riverside		
Caption:	0298 - No User Rating (Site Visit) - Small trees on riverside		
Lat/Long:	41.56420/-87.41296

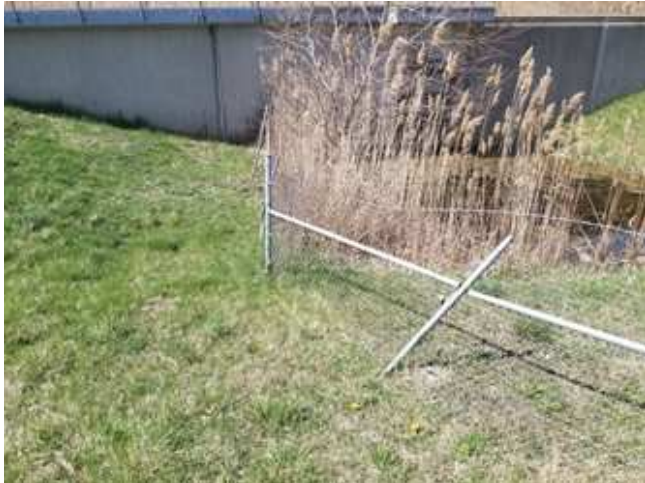
Category:	Floodwalls	Item:	Encroachments
Observation ID:	2023-0195		
Description:	Fence on landside floodwall		
Caption:	0195 - No User Rating (Site Visit) - Fence on landside floodwall		
Lat/Long:	41.56691/-87.35754

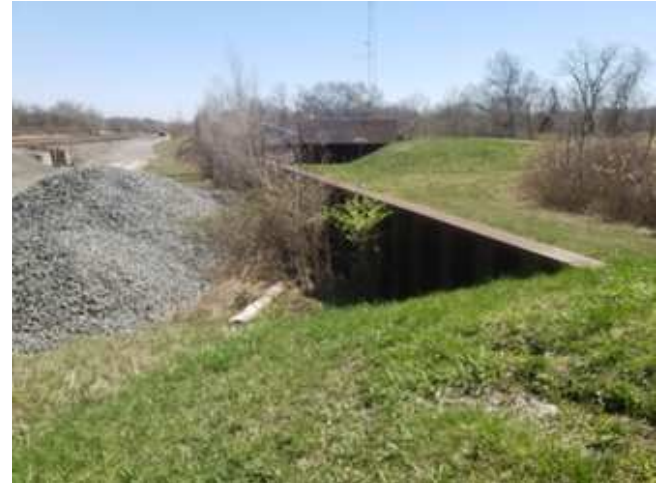
Category:	Floodwalls	Item:	Encroachments
Observation ID:	2023-0265		
Description:	Railroad ballast rock along landside wall		
Caption:	0265 - No User Rating (Site Visit) - Railroad ballast rock along landside wall		
Lat/Long:	41.56574/-87.41616

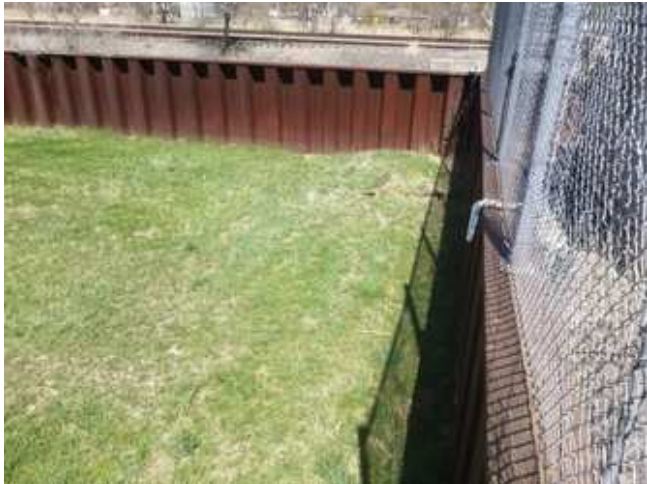
Category:	Floodwalls	Item:	Encroachments
Observation ID:	2023-0271		
Description:	Debris near riverside base		
Caption:	0271 - No User Rating (Site Visit) - Debris near riverside base		
Lat/Long:	41.56522/-87.41600

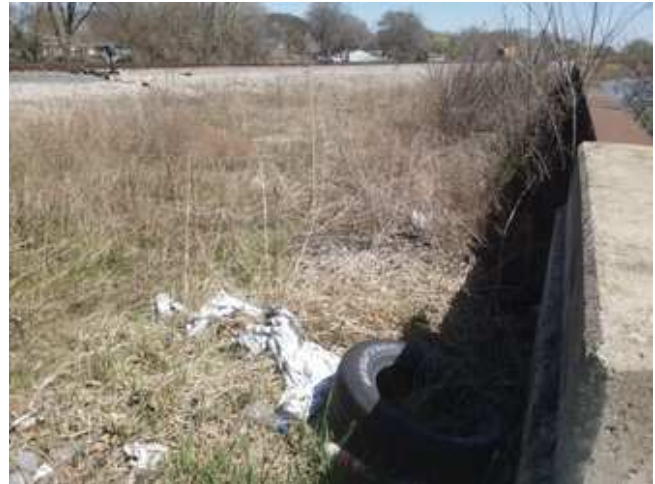
Category:	Floodwalls	Item:	Encroachments
Observation ID:	2023-0295		
Description:	Debris on landside floodwall		
Caption:	0295 - No User Rating (Site Visit) - Debris on landside floodwall		
Lat/Long:	41.56422/-87.41305

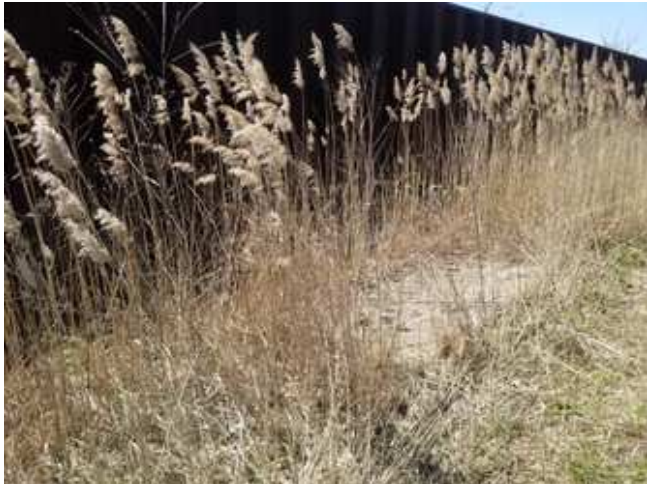
Category:	Floodwalls	Item:	Encroachments
Observation ID:	2023-0316		
Description:	Debris near landside floodwall		
Caption:	0316 - No User Rating (Site Visit) - Debris near landside floodwall		
Lat/Long:	41.56347/-87.41133

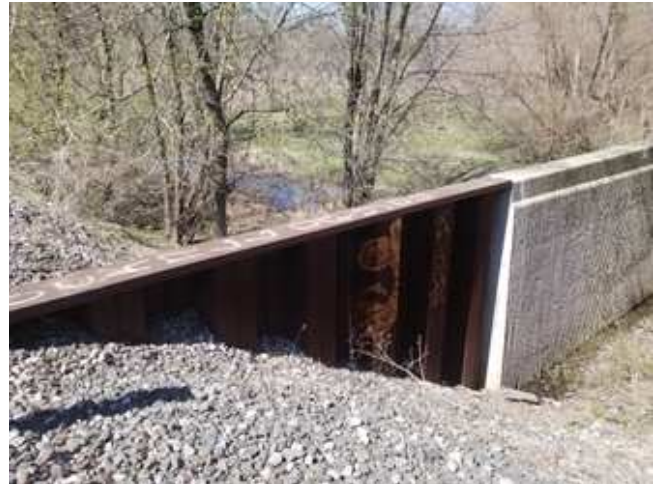
Category:	Floodwalls	Item:	Encroachments
Observation ID:	2023-0343		
Description:	Graffiti on riverside floodwall		
Caption:	0343 - No User Rating (Site Visit) - Graffiti on riverside floodwall		
Lat/Long:	41.56086/-87.40567

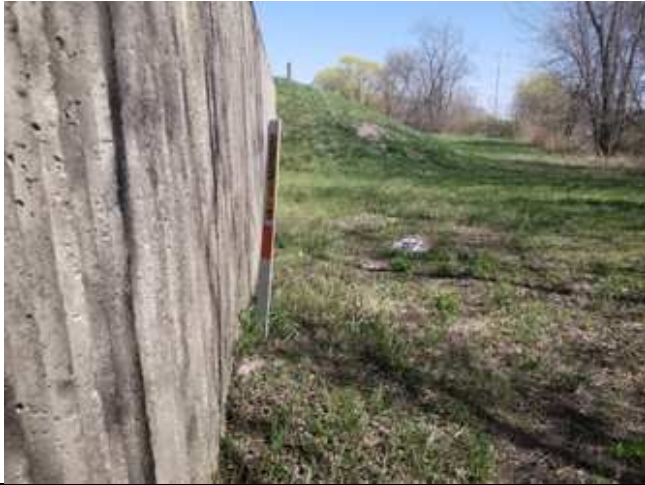
Category:	Floodwalls	Item:	Encroachments
Observation ID:	2023-0346		
Description:	Marker on riverside floodwall		
Caption:	No User Rating (Site Visit) - Marker on riverside floodwall		
Lat/Long:	41.56087/-87.40564

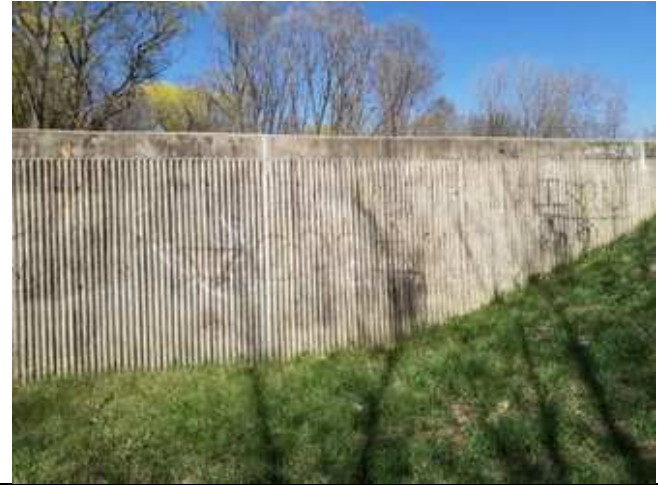
Category:	Floodwalls	Item:	Encroachments
Observation ID:	2023-0349		
Description:	Graffiti on riverside floodwall		
Caption:	0349 - No User Rating (Site Visit) - Graffiti on riverside floodwall		
Lat/Long:	41.56089/-87.40557

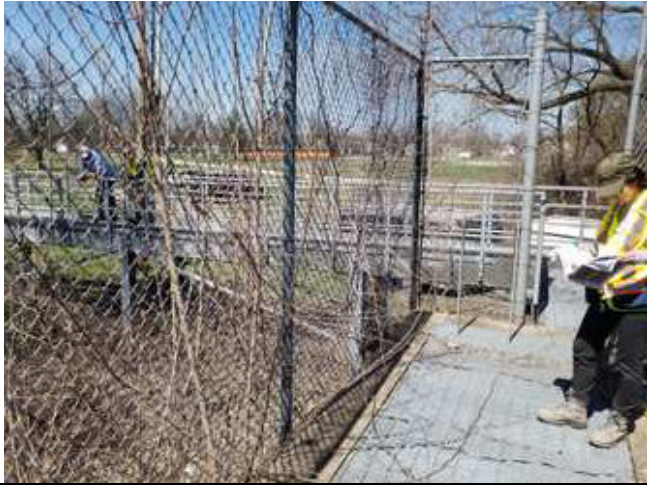
Category:	Interior Drainage System	Item:	Vegetation and Obstr
Observation ID:	2023-0066		
Description:	GN-19: Vegetation encroaching on whole structure		
Caption:	0066 - No User Rating (Site Visit) - GN-19: Vegetation encroaching on whole structure		
Lat/Long:	41.57299/-87.32151

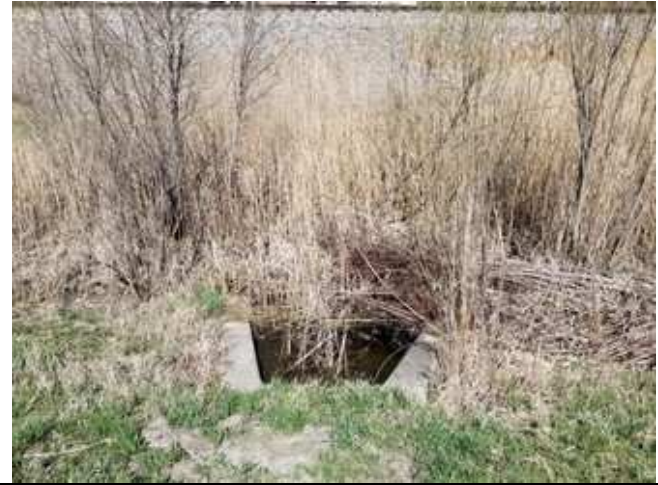
Category:	Interior Drainage System	Item:	Vegetation and Obstr
Observation ID:	2023-0081		
Description:	GN-04: Vegetation in outlet		
Caption:	0081 - No User Rating (Site Visit) - GN-04: Vegetation in outlet		
Lat/Long:	41.56228/-87.40932

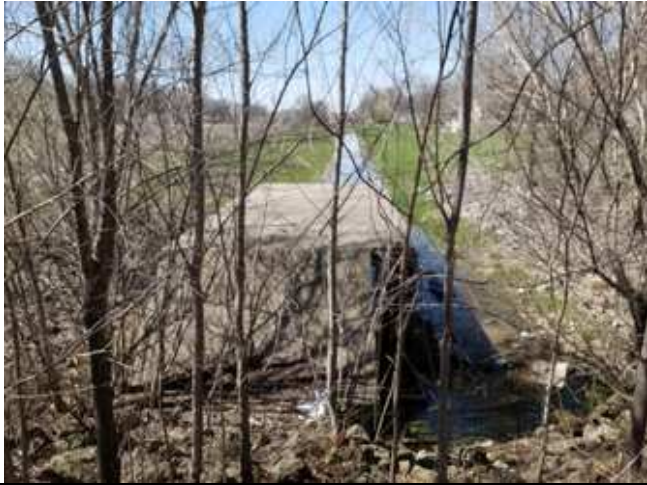
Category:	Interior Drainage System	Item:	Vegetation and Obstr
Observation ID:	2023-0084		
Description:	Ditch looking west		
Caption:	0084 - No User Rating (Site Visit) - Ditch looking west		
Lat/Long:	41.56249/-87.40847

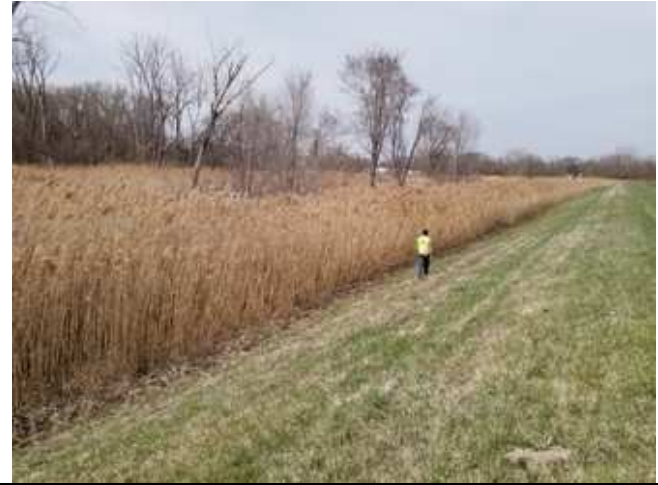
Category:	Interior Drainage System	Item:	Vegetation and Obstr
Observation ID:	2023-0100		
Description:	Tall vegetation in ditch		
Caption:	0100 - No User Rating (Site Visit) - Tall vegetation in ditch		
Lat/Long:	41.57051/-87.32678

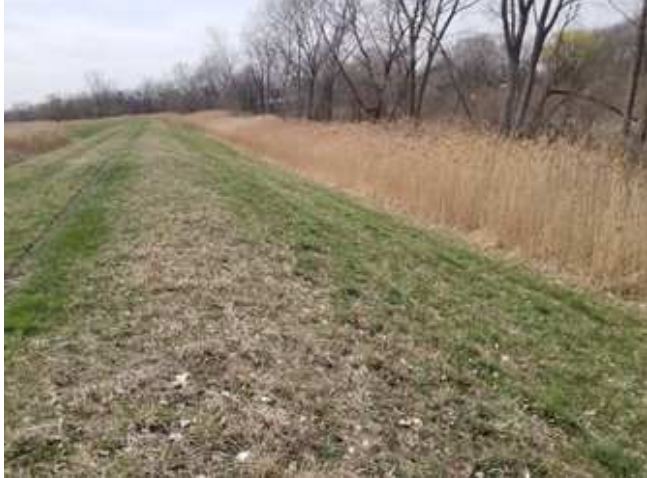
Category:	Interior Drainage System	Item:	Vegetation and Obstr
Observation ID:	2023-0139		
Description:	Tall vegetation in ditch		
Caption:	0139 - No User Rating (Site Visit) - Tall vegetation in ditch		
Lat/Long:	41.57284/-87.32347

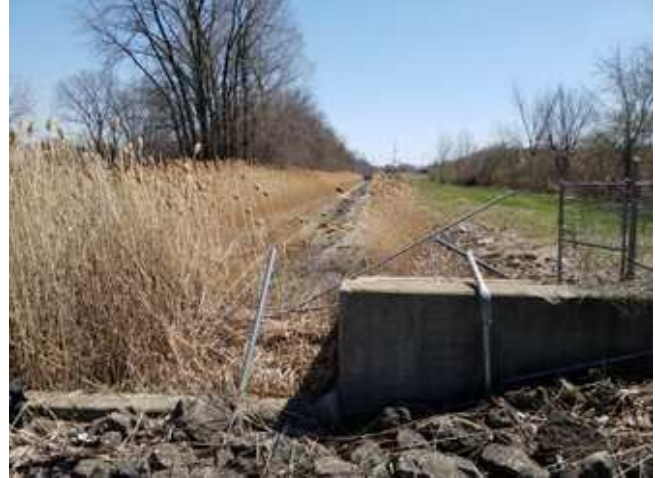
Category:	Interior Drainage System	Item:	Vegetation and Obstr
Observation ID:	2023-0184		
Description:	Ditch looking east		
Caption:	0184 - No User Rating (Site Visit) - Ditch looking east		
Lat/Long:	41.56635/-87.41559

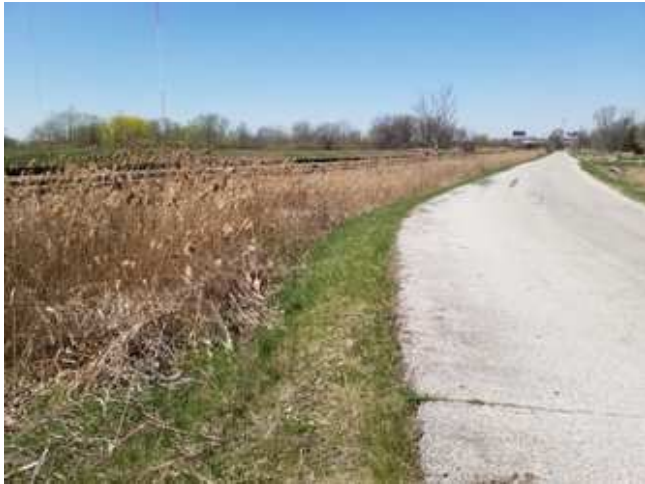
Category:	Interior Drainage System	Item:	Vegetation and Obstr
Observation ID:	2023-0190		
Description:	Ditch looking west. Tree in ditch		
Caption:	0190 - No User Rating (Site Visit) - Ditch looking west. Tree in ditch		
Lat/Long:	41.56639/-87.41613

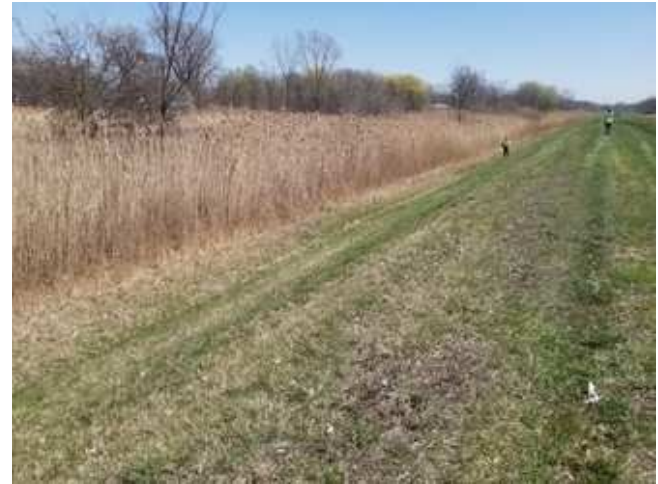
Category:	Interior Drainage System	Item:	Vegetation and Obstr
Observation ID:	2023-0226		
Description:	Vegetation in ditch looking east		
Caption:	0226 - No User Rating (Site Visit) - Vegetation in ditch looking east		
Lat/Long:	41.56809/-87.42090

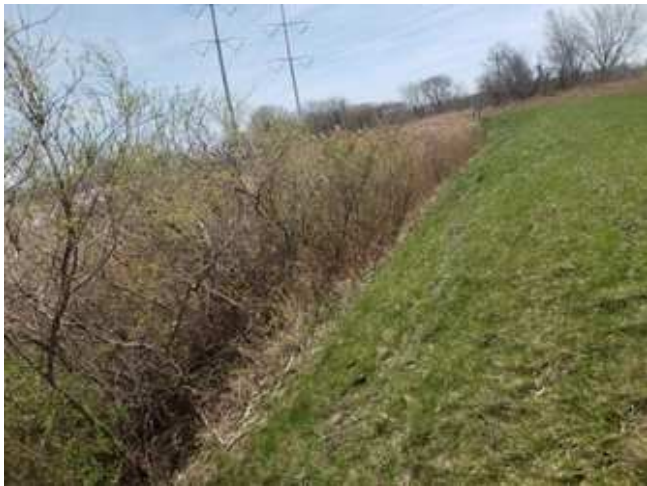
Category:	Interior Drainage System	Item:	Vegetation and Obstr
Observation ID:	2023-0261		
Description:	Phragmites and small trees in landside ditch		
Caption:	0261 - No User Rating (Site Visit) - Phragmites and small trees in landside ditch		
Lat/Long:	41.56579/-87.33858

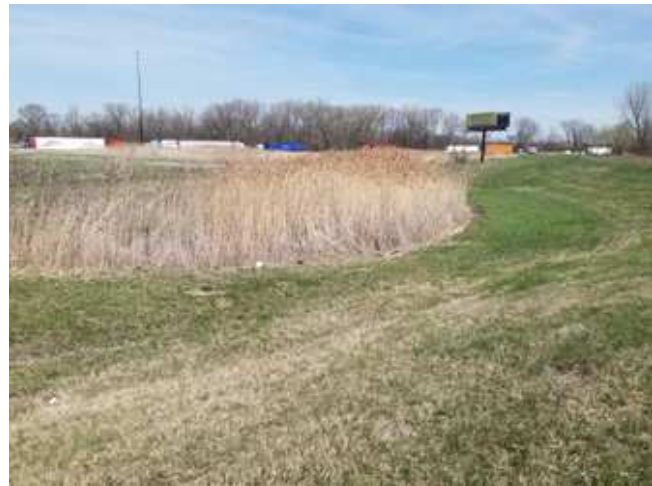
Category:	Interior Drainage System	Item:	Vegetation and Obstr
Observation ID:	2023-0264		
Description:	Phragmites in landside ditch		
Caption:	0264 - No User Rating (Site Visit) - Phragmites in landside ditch		
Lat/Long:	41.56589/-87.33479

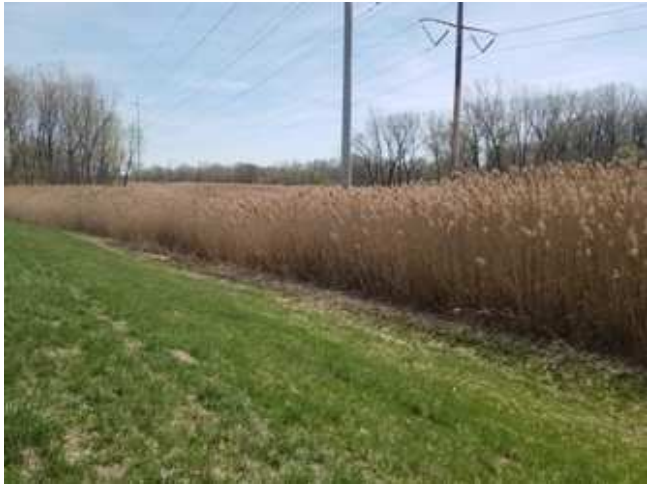
Category:	Interior Drainage System	Item:	Vegetation and Obstr
Observation ID:	2023-0267		
Description:	Vegetation in riverside ditch		
Caption:	0267 - No User Rating (Site Visit) - Vegetation in riverside ditch		
Lat/Long:	41.56558/-87.33427

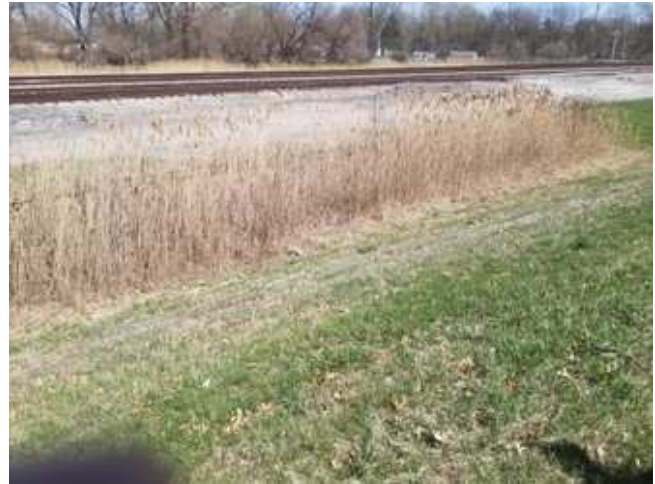
Category:	Interior Drainage System	Item:	Vegetation and Obstr
Observation ID:	2023-0277		
Description:	Vegetation in landside ditch		
Caption:	0277 - No User Rating (Site Visit) - Vegetation in landside ditch		
Lat/Long:	41.56494/-87.41486

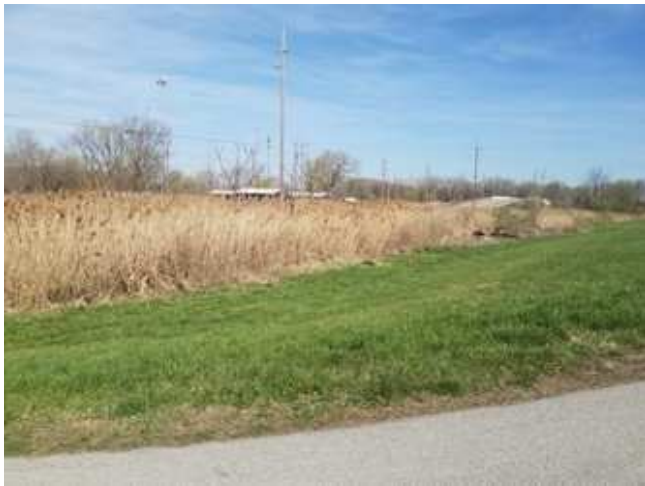
Category:	Interior Drainage System	Item:	Vegetation and Obstr
Observation ID:	2023-0421		
Description:	Small trees and tall vegetation in the ditch		
Caption:	0421 - No User Rating (Site Visit) - Small trees and tall vegetation in the ditch		
Lat/Long:	41.56618/-87.37488

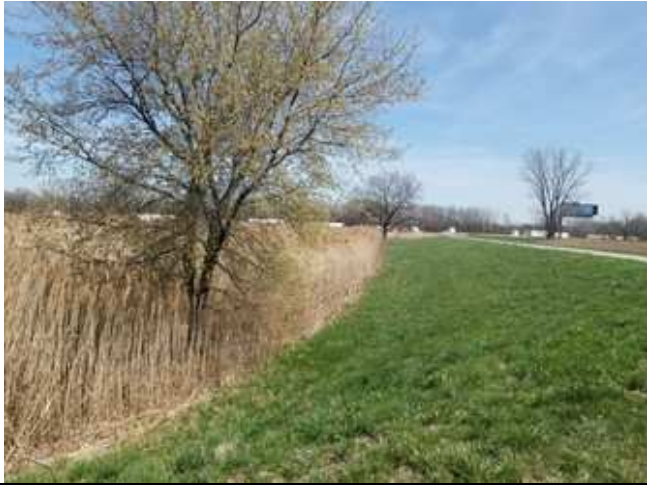
Category:	Interior Drainage System	Item:	Vegetation and Obstr
Observation ID:	2023-0442		
Description:	Phragmites and tree in ditch - looking north		
Caption:	0442 - No User Rating (Site Visit) - Phragmites and tree in ditch - looking north		
Lat/Long:	41.56708/-87.35455

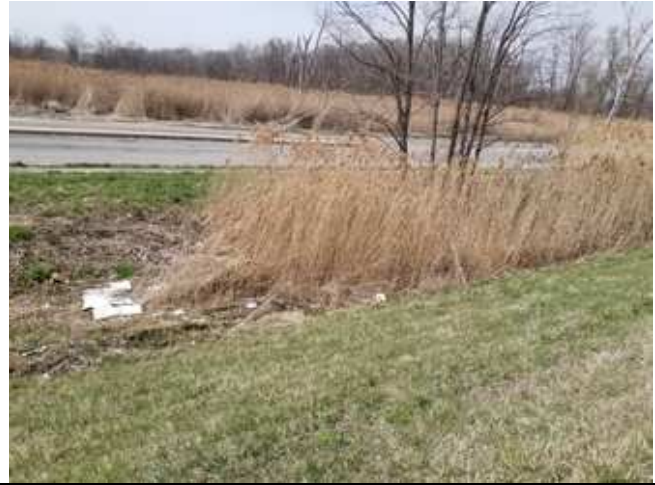
Category:	Interior Drainage System	Item:	Encroachments
Observation ID:	2023-0088		
Description:	Debris in ditch		
Caption:	0088 - No User Rating (Site Visit) - Debris in ditch		
Lat/Long:	41.56950/-87.32670

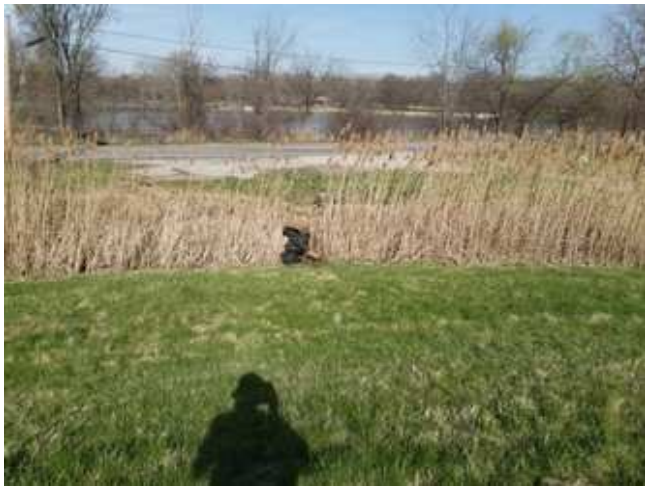
Category:	Interior Drainage System	Item:	Encroachments
Observation ID:	2023-0385		
Description:	Debris in ditch		
Caption:	0385 - No User Rating (Site Visit) - Debris in ditch		
Lat/Long:	41.56255/-87.39338

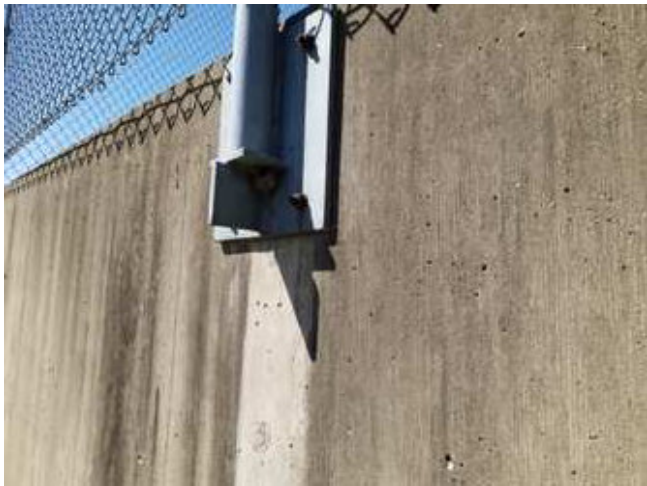
Category:	Interior Drainage System	Item:	Fencing and Gates
Observation ID:	2023-0036		
Description:	GN-14: Wasp nest on bottom of fence		
Caption:	0036 - No User Rating (Site Visit) - GN-14: Wasp nest on bottom of fence		
Lat/Long:	41.56953/-87.32664

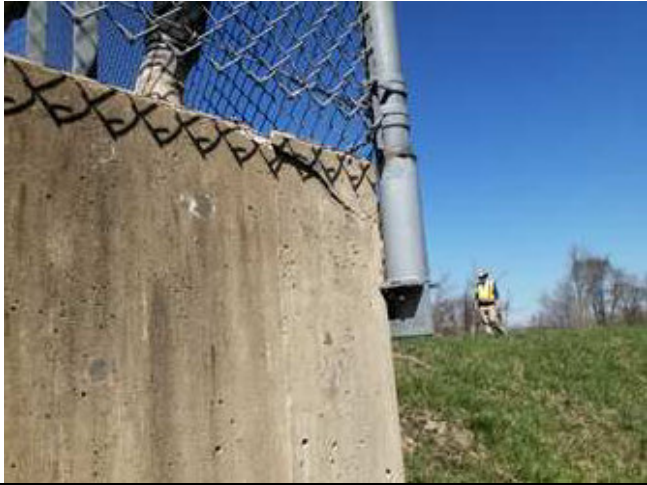
Category:	Interior Drainage System	Item:	Concrete Surfaces (S
Observation ID:	2023-0033		
Description:	GN-14: Delamination of concrete		
Caption:	0033 - No User Rating (Site Visit) - GN-14: Delamination of concrete		
Lat/Long:	41.56950/-87.32676

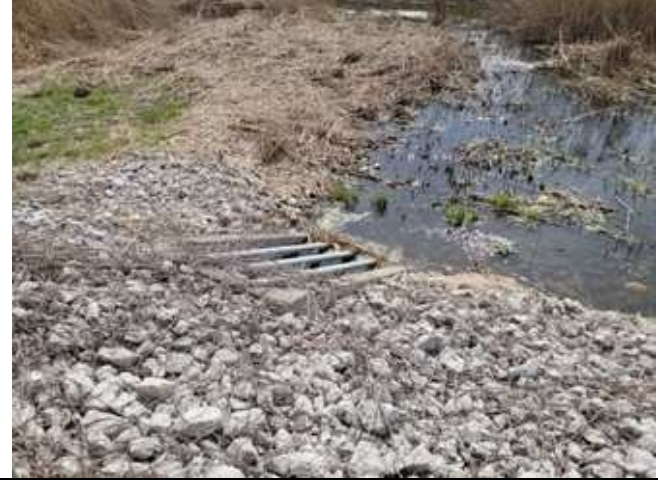
Category:	Interior Drainage System	Item:	Sluice / Slide Gates
Observation ID:	2023-0003		
Description:	GN-20: Some vegetation blocking inlet		
Caption:	No User Rating (Site Visit) - GN-20: Some vegetation blocking inlet		
Lat/Long:	41.56833/-87.31706

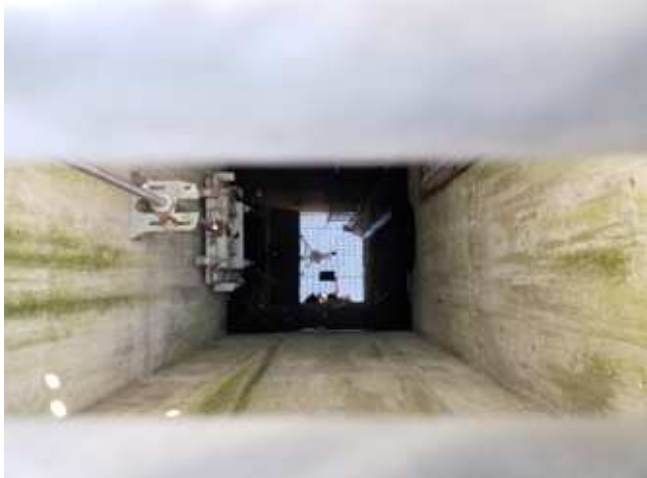
Category:	Interior Drainage System	Item:	Sluice / Slide Gates
Observation ID:	2023-0012		
Description:	GN-15: Gate opened and closed		
Caption:	0012 - No User Rating (Site Visit) - GN-15: Gate opened and closed		
Lat/Long:	41.56683/-87.32549

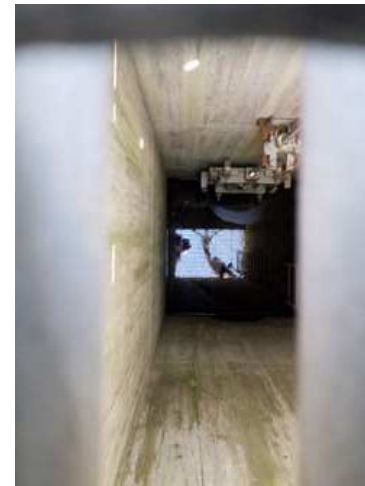
Category:	Interior Drainage System	Item:	Sluice / Slide Gates
Observation ID:	2023-0018		
Description:	GN-18: Gate opened and closed		
Caption:	0018 - No User Rating (Site Visit) - GN-18: Gate opened and closed		
Lat/Long:	41.56682/-87.32500

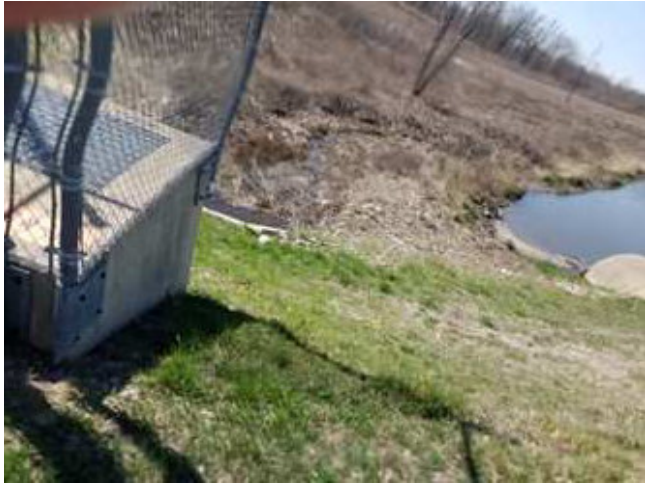
Category:	Interior Drainage System	Item:	Sluice / Slide Gates
Observation ID:	2023-0024		
Description:	GN-18: Vegetation in outlet channel		
Caption:	0024 - No User Rating (Site Visit) - GN-18: Vegetation in outlet channel		
Lat/Long:	41.56688/-87.32501

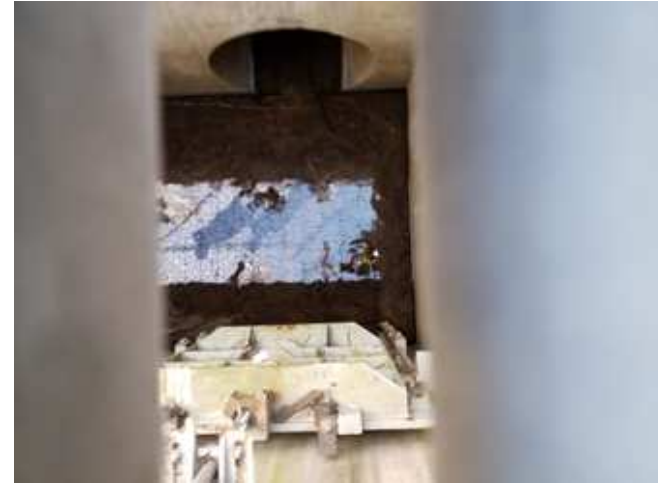
Category:	Interior Drainage System	Item:	Sluice / Slide Gates
Observation ID:	2023-0027		
Description:	GN-14: Sluice gate opened and closed		
Caption:	0027 - No User Rating (Site Visit) - GN-14: Sluice gate opened and closed		
Lat/Long:	41.56956/-87.32667

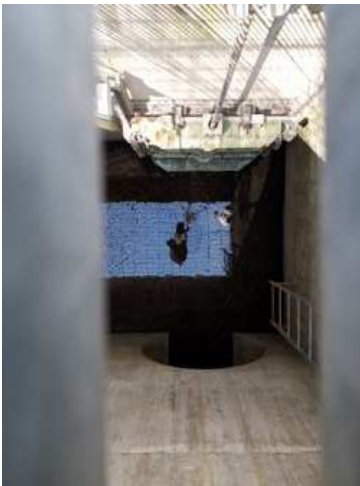
Category:	Interior Drainage System	Item:	Sluice / Slide Gates
Observation ID:	2023-0042		
Description:	GN-14B: Gate opened and closed		
Caption:	0042 - No User Rating (Site Visit) - GN-14B: Gate opened and closed		
Lat/Long:	41.56898/-87.32690

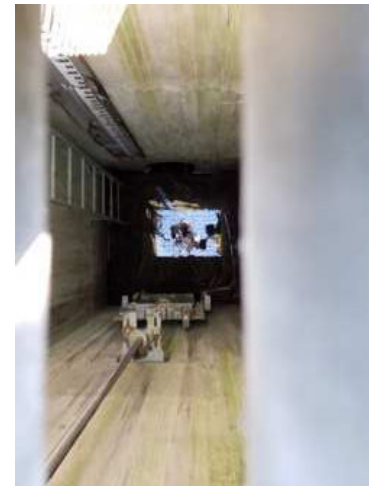
Category:	Interior Drainage System	Item:	Sluice / Slide Gates
Observation ID:	2023-0051		
Description:	GN-16: Gate opened and closed		
Caption:	0051 - No User Rating (Site Visit) - GN-16: Gate opened and closed		
Lat/Long:	41.56799/-87.32543

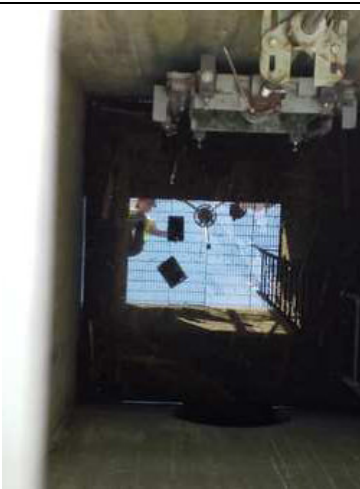
Category:	Interior Drainage System	Item:	Sluice / Slide Gates
Observation ID:	2023-0057		
Description:	GN-17: Gate opened and closed		
Caption:	0057 - No User Rating (Site Visit) - GN-17: Gate opened and closed		
Lat/Long:	41.56793/-87.32506

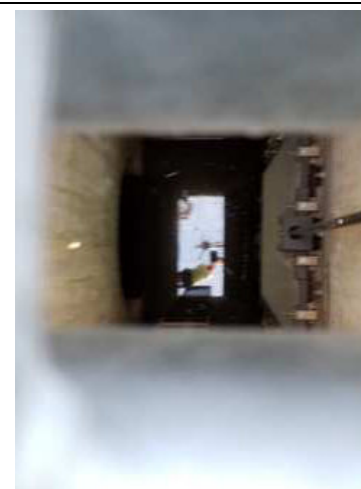
Category:	Interior Drainage System	Item:	Sluice / Slide Gates
Observation ID:	2023-0062		
Description:	GN-03: Gate fully closed. Gate is squeaky and should be greased.		
Caption:	0062 - No User Rating (Site Visit) - GN-03: Gate fully closed. Gate is squeaky and should be greased.		
Lat/Long:	41.56506/-87.41524

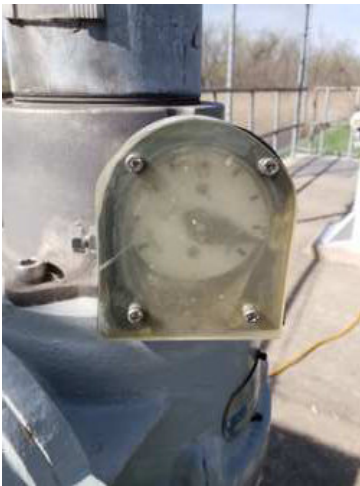
Category:	Interior Drainage System	Item:	Sluice / Slide Gates
Observation ID:	2023-0068		
Description:	GN-08A: Cannot see if gate is fully open but can assume based off shaft. Gauge is not operable		
Caption:	0068_1 - No User Rating (Site Visit) - GN-08A: Gauge is not operable		
Lat/Long:	41.56587/-87.37690

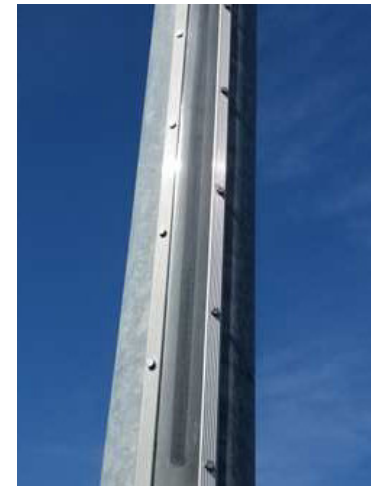
Category:	Interior Drainage System	Item:	Sluice / Slide Gates
Observation ID:	2023-0068		
Description:	GN-08A: Cannot see if gate is fully open but can assume based off shaft. Gauge is not operable		
Caption:	0068_2 - No User Rating (Site Visit) - GN-08A: Cannot see if gate is fully open but can assume based off shaft		
Lat/Long:	41.56587/-87.37690

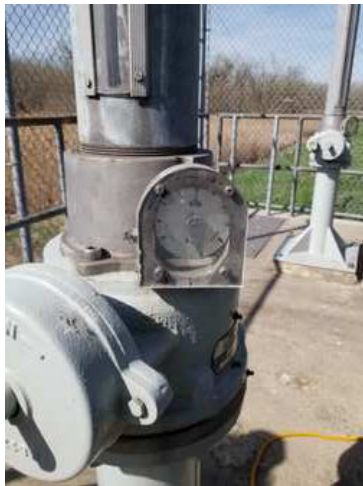
Category:	Interior Drainage System	Item:	Sluice / Slide Gates
Observation ID:	2023-0071		
Description:	GN-08B: Cannot see if gate is fully open but can assume based off shaft. Gauge is not operable		
Caption:	0071_1 - No User Rating (Site Visit) - GN-08B: Gauge is not operable		
Lat/Long:	41.56587/-87.37690

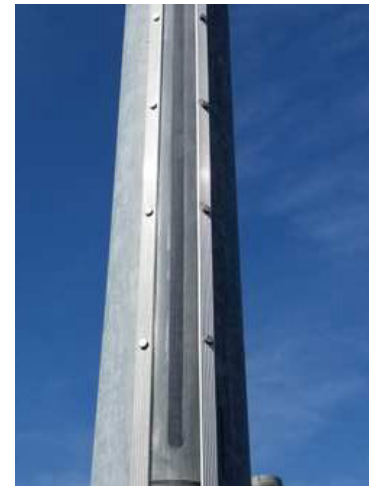
Category:	Interior Drainage System	Item:	Sluice / Slide Gates
Observation ID:	2023-0071		
Description:	GN-08B: Cannot see if gate is fully open but can assume based off shaft. Gauge is not operable		
Caption:	0071_2 - No User Rating (Site Visit) - GN-08B: Cannot see if gate is fully open but can assume based off shaft		
Lat/Long:	41.56587/-87.37690

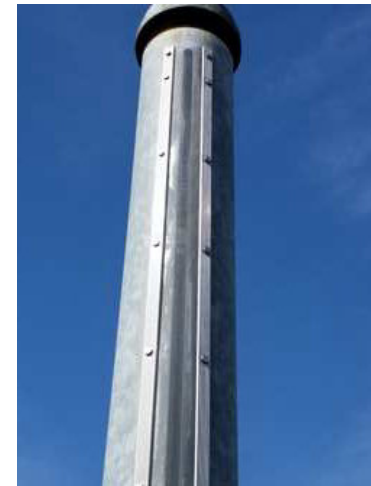
Category:	Interior Drainage System	Item:	Sluice / Slide Gates
Observation ID:	2023-0074		
Description:	GN-08C: Cannot see if gate is fully open but can assume based off shaft. Gauge is not operable		
Caption:	0074_1 - No User Rating (Site Visit) - GN-08C: Gauge is not operable		
Lat/Long:	41.56587/-87.37689

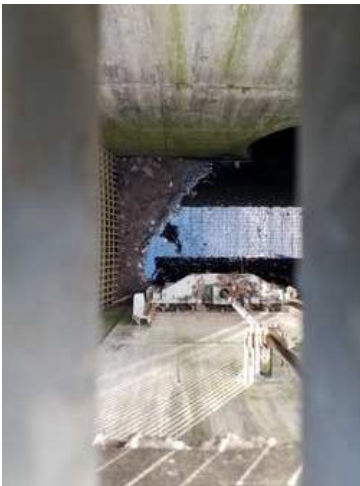
Category:	Interior Drainage System	Item:	Sluice / Slide Gates
Observation ID:	2023-0074		
Description:	GN-08C: Cannot see if gate is fully open but can assume based off shaft. Gauge is not operable		
Caption:	0074_2 - No User Rating (Site Visit) - GN-08C: Cannot see if gate is fully open but can assume based off shaft		
Lat/Long:	41.56587/-87.37689

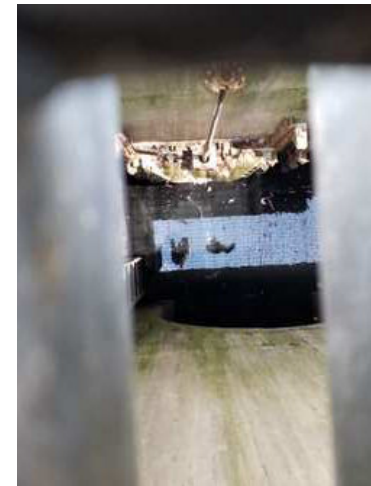
Category:	Interior Drainage System	Item:	Sluice / Slide Gates
Observation ID:	2023-0075		
Description:	GN-19A: Gate opened and closed		
Caption:	0075 - No User Rating (Site Visit) - GN-19A: Gate opened and closed		
Lat/Long:	41.57303/-87.32151

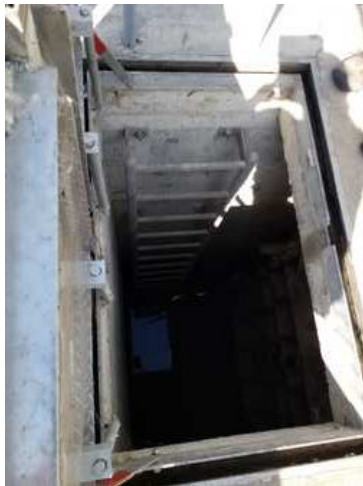
Category:	Interior Drainage System	Item:	Sluice / Slide Gates
Observation ID:	2023-0078		
Description:	GN-19B: Gate opened and closed		
Caption:	0078 - No User Rating (Site Visit) - GN-19B: Gate opened and closed		
Lat/Long:	41.57304/-87.32151

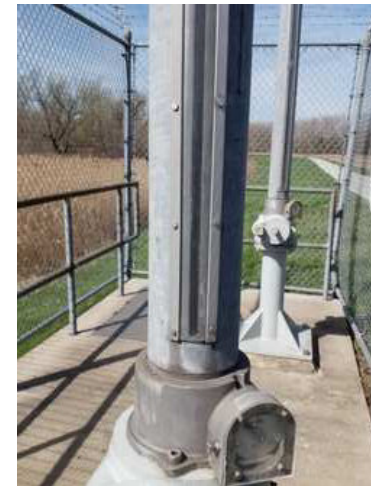
Category:	Interior Drainage System	Item:	Sluice / Slide Gates
Observation ID:	2023-0080		
Description:	GN-08A-C: Gatewell full of silt/sediment.		
Caption:	0080 - No User Rating (Site Visit) - GN-08A-C: Gatewell full of silt/sediment.		
Lat/Long:	41.56584/-87.37717

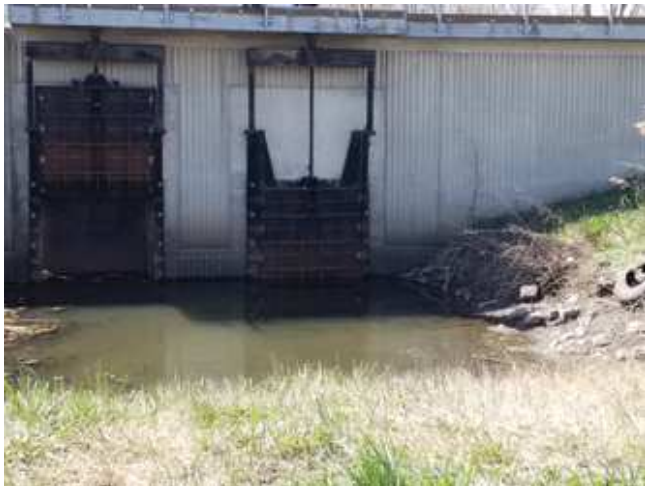
Category:	Interior Drainage System	Item:	Sluice / Slide Gates
Observation ID:	2023-0104		
Description:	GN-09B: Gate opened and closed		
Caption:	0104 - No User Rating (Site Visit) - GN-09B: Gate opened and closed		
Lat/Long:	41.56615/-87.37508

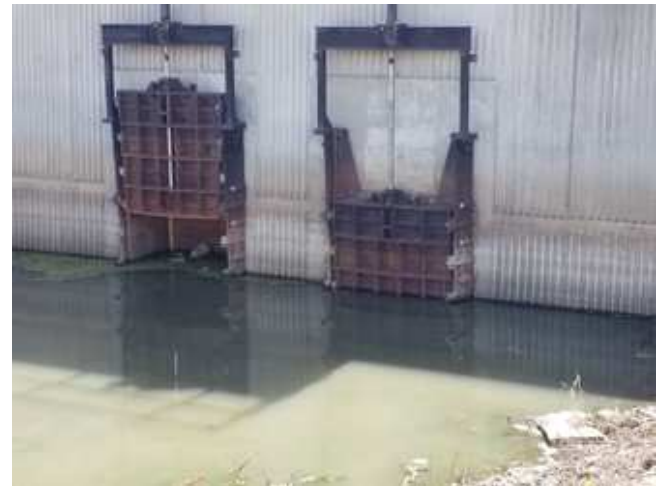
Category:	Interior Drainage System	Item:	Sluice / Slide Gates
Observation ID:	2023-0107		
Description:	GN-09A: Gate opened and closed		
Caption:	0107 - No User Rating (Site Visit) - GN-09A: Gate opened and closed		
Lat/Long:	41.56615/-87.37508

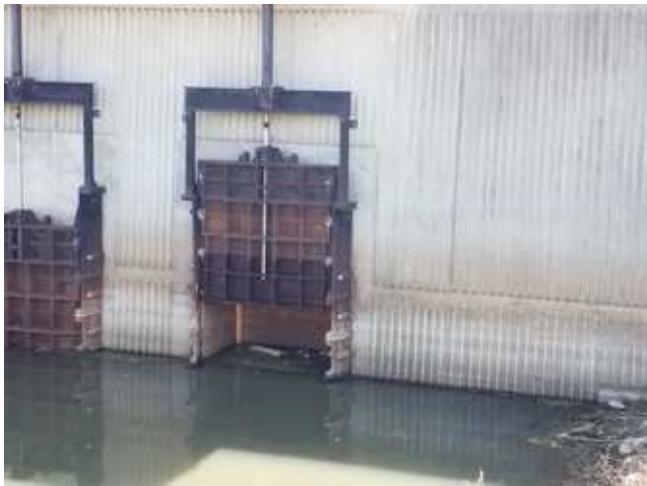
Category:	Interior Drainage System	Item:	Sluice / Slide Gates
Observation ID:	2023-0113		
Description:	GN-10B: Gate fully closed. Was very squeaky and needs to be greased.		
Caption:	0113 - No User Rating (Site Visit) - GN-10B: Gate fully closed. Was very squeaky and needs to be greased.		
Lat/Long:	41.56698/-87.35761
