**US Army Corps
of Engineers ®**

Site Visit Summary

Name of System: Gary

Name of Segment: Gary North

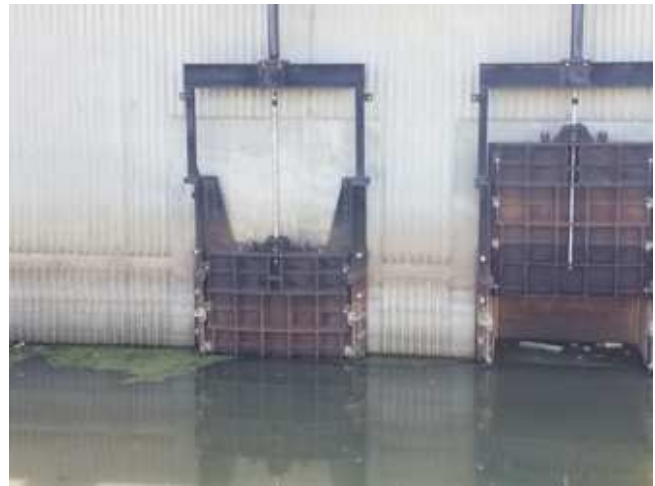
Category:	Interior Drainage System	Item:	Sluice / Slide Gates
Observation ID:	2023-0116		
Description:	GN-10B: Trash in gatewell		
Caption:	0116 - No User Rating (Site Visit) - GN-10B: Trash in gatewell		
Lat/Long:	41.56698/-87.35761

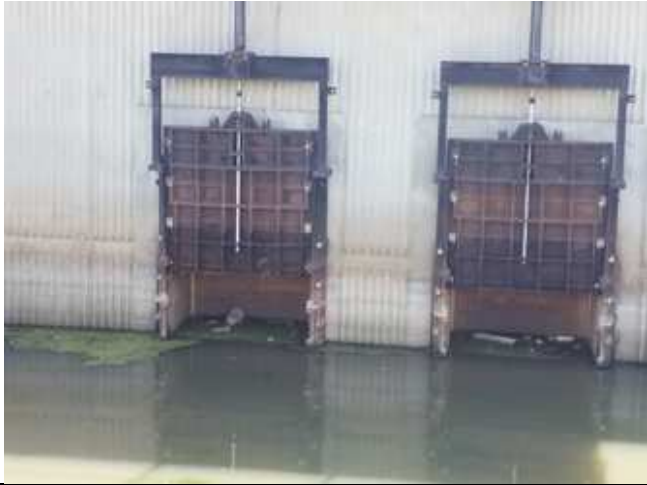
Category:	Interior Drainage System	Item:	Sluice / Slide Gates
Observation ID:	2023-0119		
Description:	GN-10A: Gate fully closed. Gate was very squeaky and skipping		
Caption:	0119 - No User Rating (Site Visit) - GN-10A: Gate fully closed. Gate was very squeaky and skipping		
Lat/Long:	41.56706/-87.35754

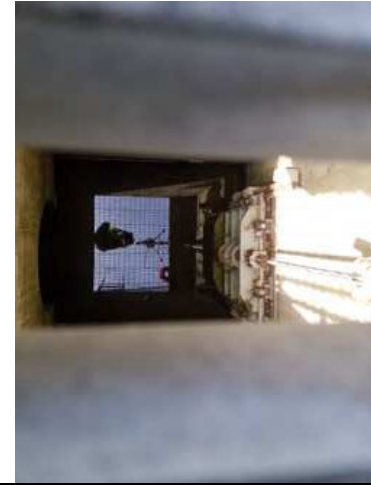
Category:	Interior Drainage System	Item:	Sluice / Slide Gates
Observation ID:	2023-0122		
Description:	GN-10A: Trash in gatewell		
Caption:	0122 - No User Rating (Site Visit) - GN-10A: Trash in gatewell		
Lat/Long:	41.56705/-87.35755

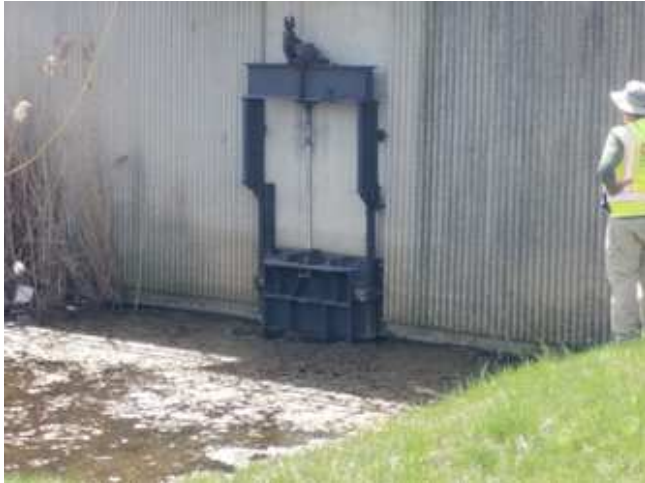
Category:	Interior Drainage System	Item:	Sluice / Slide Gates
Observation ID:	2023-0128		
Description:	GN-12: Gate opened and closed		
Caption:	0128 - No User Rating (Site Visit) - GN-12: Gate opened and closed		
Lat/Long:	41.56681/-87.32760

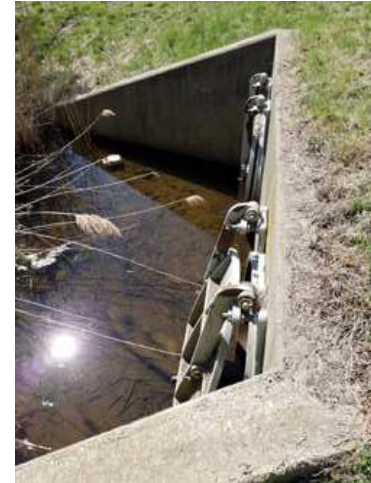
Category:	Interior Drainage System	Item:	Sluice / Slide Gates
Observation ID:	2023-0137		
Description:	GN-11: Gate opened and closed		
Caption:	0137 - No User Rating (Site Visit) - GN-11: Gate opened and closed		
Lat/Long:	41.56720/-87.35465

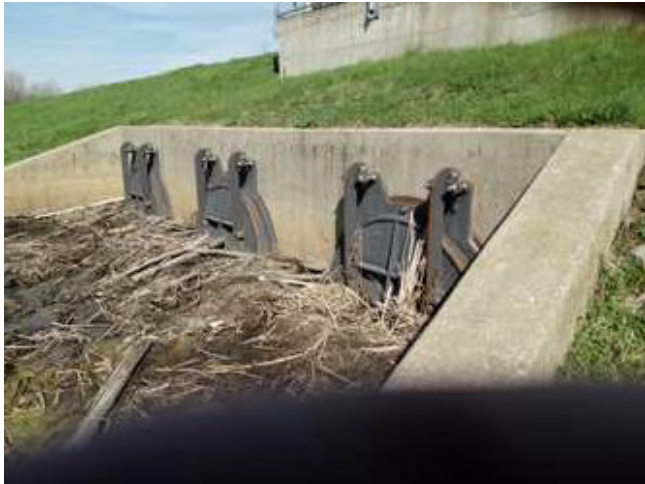
Category:	Interior Drainage System	Item:	Flap Gates/ Flap Val
Observation ID:	2023-0059		
Description:	GN-03: Inlet is in acceptable condition with minimal vegetation		
Caption:	0059 - No User Rating (Site Visit) - GN-03: Inlet is in acceptable condition with minimal vegetation		
Lat/Long:	41.56512/-87.41522

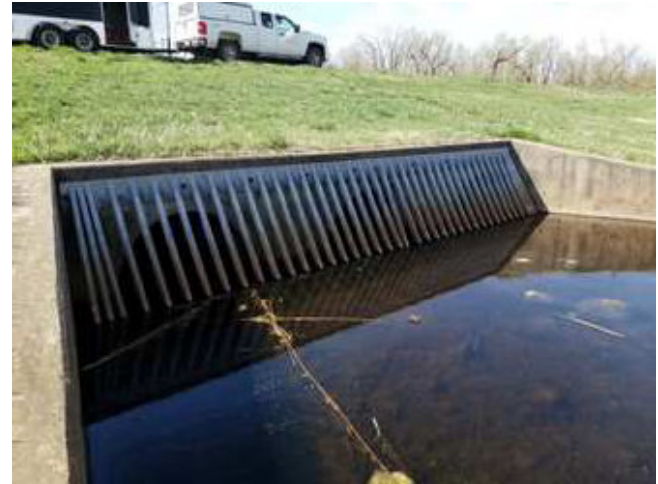
Category:	Interior Drainage System	Item:	Flap Gates/ Flap Val
Observation ID:	2023-0077		
Description:	GN-08A-C: Vegetation/Sediment obstructions at all 3 flap gates. Flap gates won't properly drain		
Caption:	0077 - No User Rating (Site Visit) - GN-08A-C: Vegetation/Sediment obstructions at all 3 flap gates. Flap gates won't properly drain		
Lat/Long:	41.56583/-87.37718

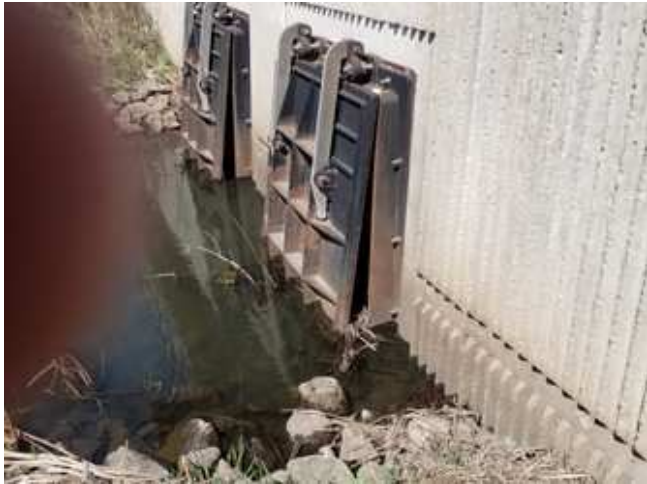
Category:	Interior Drainage System	Item:	Flap Gates/ Flap Val
Observation ID:	2023-0083		
Description:	GN-08A-C: Inlet Structure clear. Cannot properly drain due to obstructions at outlet structure		
Caption:	0083 - No User Rating (Site Visit) - GN-08A-C: Inlet Structure clear. Cannot properly drain due to obstructions at outlet structure		
Lat/Long:	41.56585/-87.37710

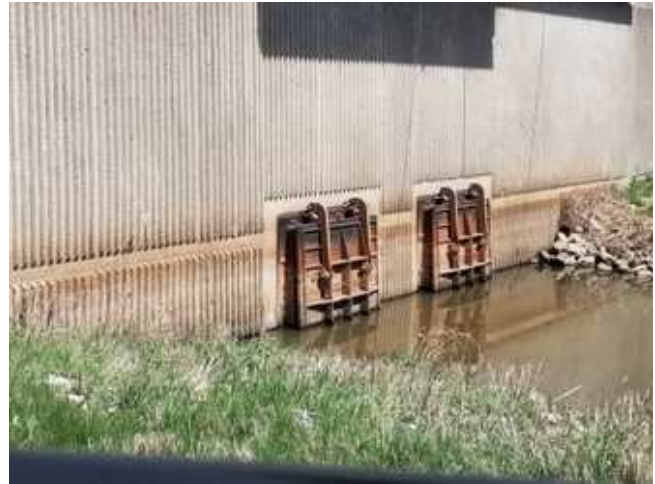
Category:	Interior Drainage System	Item:	Flap Gates/ Flap Val
Observation ID:		2023-0095	
Description:	GN-09A-B: Flap Gates stuck open. Vegetation/ sediment obstructions		
Caption:	0095_1 - No User Rating (Site Visit) - GN-09A-B: Flap Gates stuck open. Vegetation/ sediment obstructions		
Lat/Long:	41.56606/-87.37479

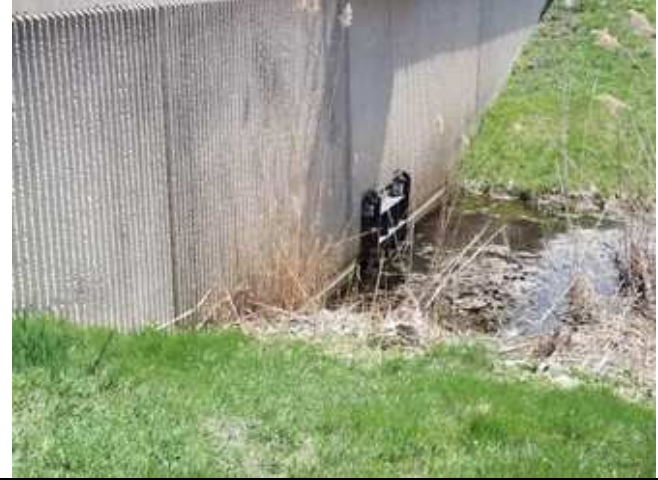
Category:	Interior Drainage System	Item:	Flap Gates/ Flap Val
Observation ID:	2023-0131		
Description:	GN-12: Flap gate in acceptable condition		
Caption:	0131 - No User Rating (Site Visit) - GN-12: Flap gate in acceptable condition		
Lat/Long:	41.56687/-87.32779

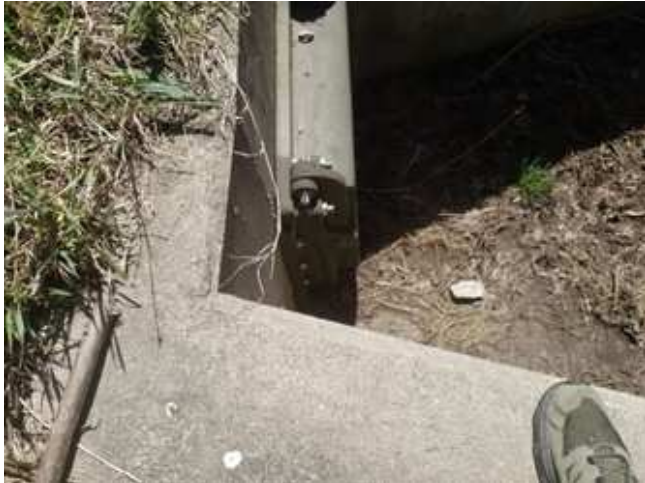
Category:	Interior Drainage System	Item:	Flap Gates/ Flap Val
Observation ID:	2023-0134		
Description:	GN-11: Flap gate has vegetation obstructions but is closed		
Caption:	0134 - No User Rating (Site Visit) - GN-11: Flap gate has vegetation obstructions but is closed		
Lat/Long:	41.56720/-87.35466

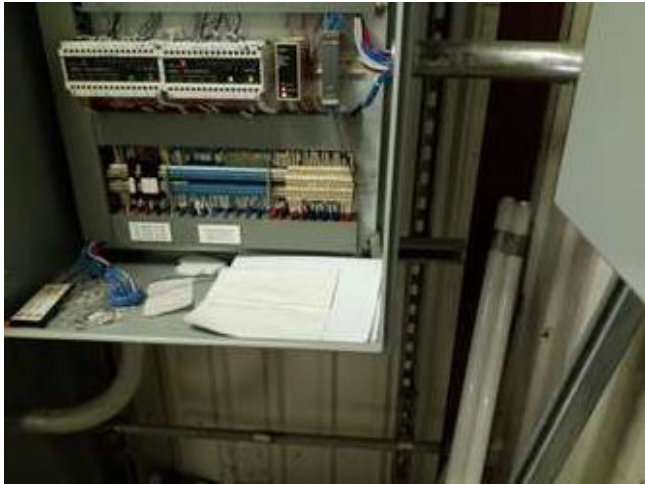
Category:	Pump Stations	Item:	Pump Station Operati
Observation ID:	2023-0008		
Description:	PS-IW: Operations manual not onsite. Found in office.		
Caption:	0008 - No User Rating (Site Visit) - PS-IW: Operations manual not onsite. Found in office.		
Lat/Long:	41.57300/-87.32151

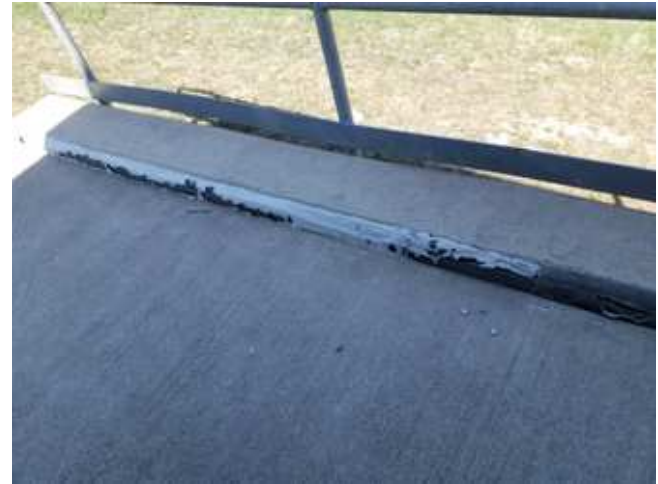
Category:	Pump Stations	Item:	Plant Building
Observation ID:	2023-0044		
Description:	PS-BR: Settlement on generator pad.		
Caption:	0044 - No User Rating (Site Visit) - PS-BR: Settlement on generator pad.		
Lat/Long:	41.56095/-87.40231

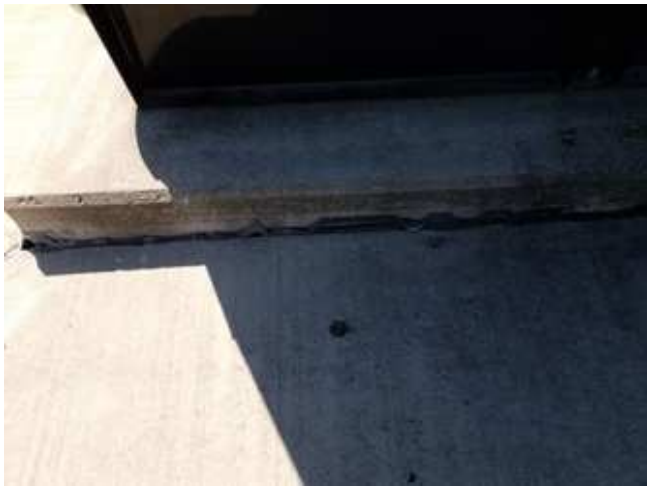
Category:	Pump Stations	Item:	Plant Building
Observation ID:	2023-0044		
Description:	PS-BR: Settlement on generator pad.		
Caption:	0044_2 - No User Rating (Site Visit) - PS-BR: Settlement on generator pad.		
Lat/Long:	41.56095/-87.40231

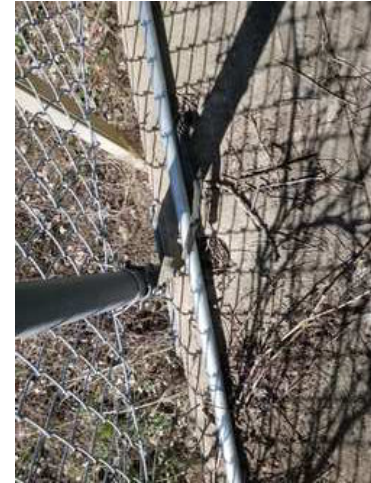
Category:	Pump Stations	Item:	Fencing and Gates
Observation ID:	2023-0002		
Description:	PS-IW: Vegetation growing along fencing		
Caption:	0002 - No User Rating (Site Visit) - PS-IW: Vegetation growing along fencing		
Lat/Long:	41.57301/-87.32154

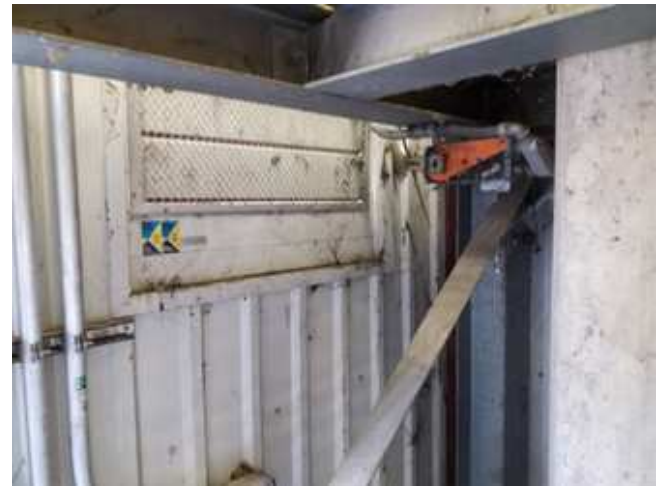
Category:	Pump Stations	Item:	Pumps
Observation ID:	2023-0029		
Description:	PS-BR: Sump pump out of service due to overheating		
Caption:	0029 - No User Rating (Site Visit) - PS-BR: Sump pump out of service due to overheating		
Lat/Long:	41.56083/-87.40220
