## Site Visit Summary

Name of System: Gary

Name of Segment: Gary South

Date of Site Visit: 04/11/2023 - 04/12/2023

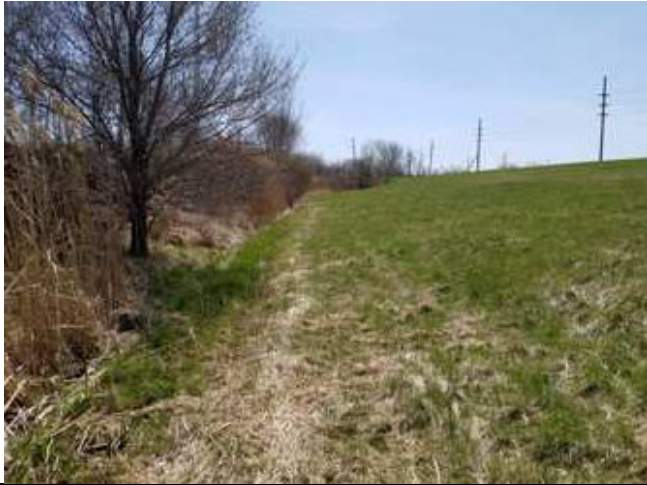
Category:	Levee Embankments	Item:	Unwanted Vegetation
Observation ID:	2023-0031		
Description:	Small trees and woody debris on the landside toe.		
Caption:	0031 - No User Rating (Site Visit) - Small trees and woody debris on the landside toe.		
Lat/Long:	41.55654/-87.37473

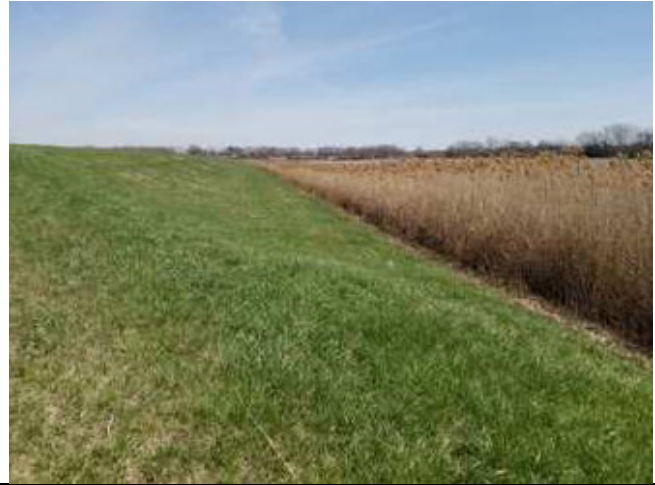
Category:	Levee Embankments	Item:	Unwanted Vegetation
Observation ID:	2023-0037		
Description:	Some vegetation and large tree on the ditch along the landside toe.		
Caption:	0037 - No User Rating (Site Visit) - Some vegetation and large tree on the ditch along the landside toe.		
Lat/Long:	41.55689/-87.37468

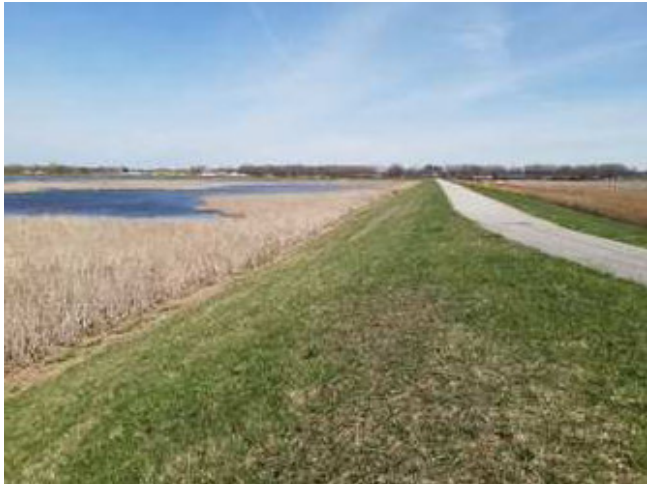
Category:	Levee Embankments	Item:	Unwanted Vegetation
Observation ID:	2023-0067		
Description:	Some vegetation on the ditch along the landside toe.		
Caption:	0067 - No User Rating (Site Visit) - Some vegetation on the ditch along the landside toe.		
Lat/Long:	41.55877/-87.36653

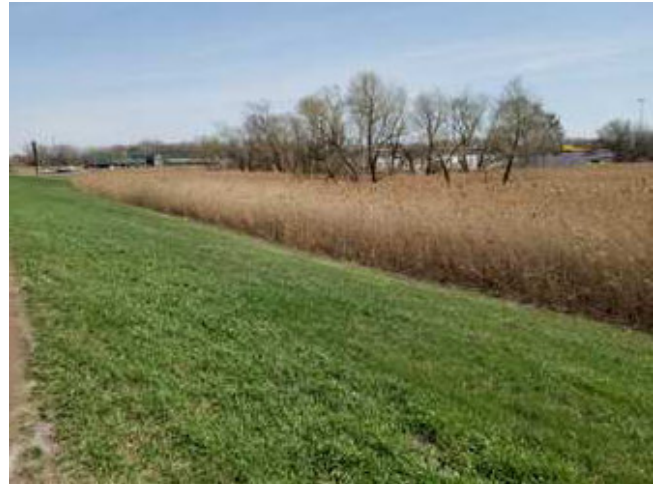
Category:	Levee Embankments	Item:	Unwanted Vegetation
Observation ID:	2023-0070		
Description:	Vegetation along the riverside toe.		
Caption:	0070 - No User Rating (Site Visit) - Vegetation along the riverside toe.		
Lat/Long:	41.55906/-87.36629

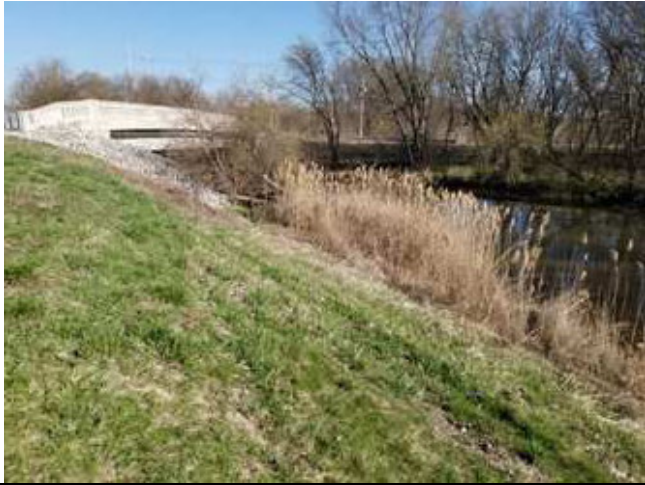
Category:	Levee Embankments	Item:	Unwanted Vegetation
Observation ID:	2023-0091		
Description:	Vegetation on the ditch along the landside toe.		
Caption:	0091 - No User Rating (Site Visit) - Vegetation on the ditch along the landside toe.		
Lat/Long:	41.56465/-87.35861

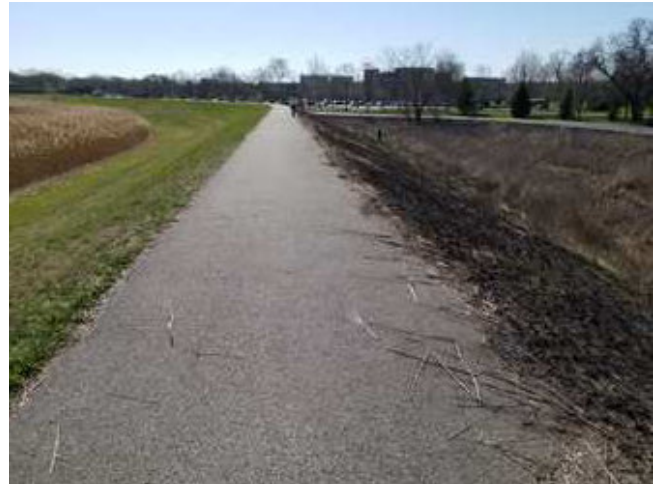
Category:	Levee Embankments	Item:	Unwanted Vegetation
Observation ID:	2023-0148		
Description:	Vegetation along the riverside toe.		
Caption:	0148 - No User Rating (Site Visit) - Vegetation along the riverside toe.		
Lat/Long:	41.56028/-87.34350

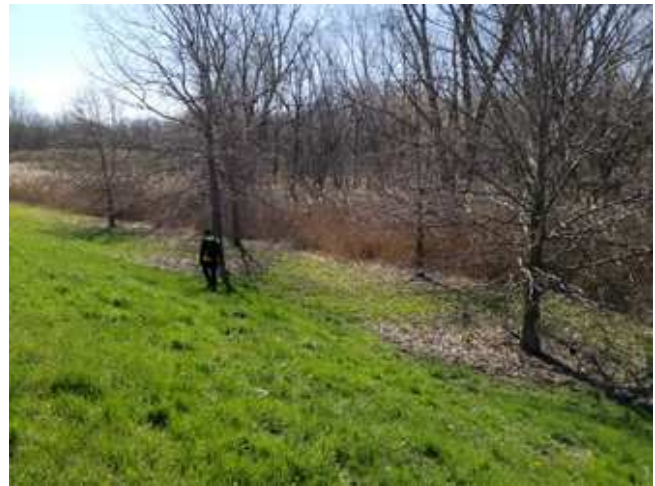
Category:	Levee Embankments	Item:	Unwanted Vegetation
Observation ID:	2023-0163		
Description:	Small tree on the riverside toe.		
Caption:	0163 - No User Rating (Site Visit) - Small tree on the riverside toe.		
Lat/Long:	41.55910/-87.33962

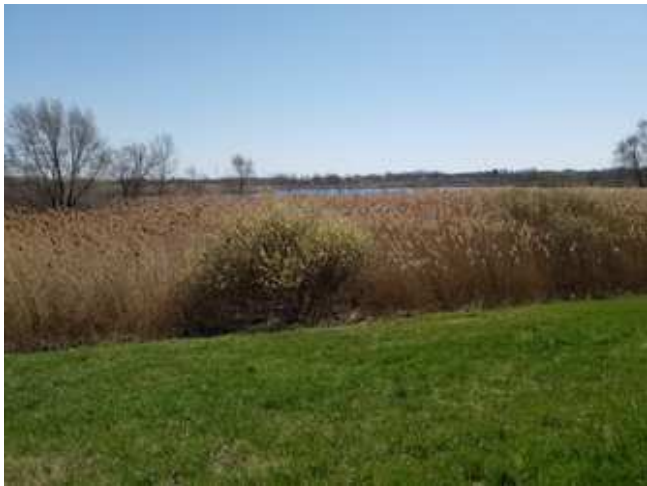
Category:	Levee Embankments	Item:	Unwanted Vegetation
Observation ID:	2023-0199		
Description:	Trees encroaching the landside toe clearance.		
Caption:	0199 - No User Rating (Site Visit) - Trees encroaching the landside toe clearance.		
Lat/Long:	41.56070/-87.33607

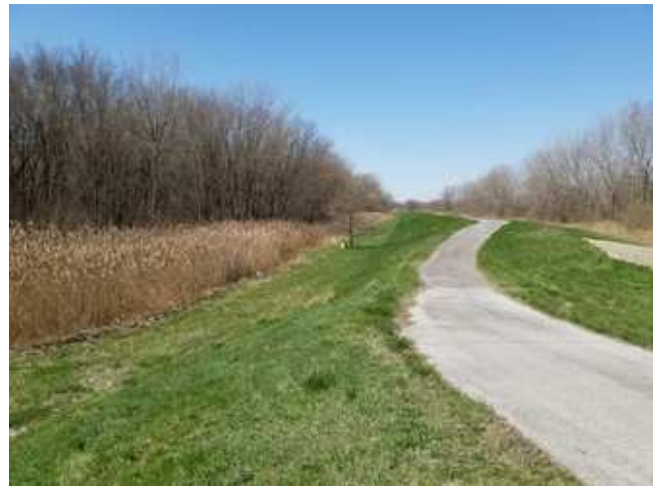
Category:	Levee Embankments	Item:	Unwanted Vegetation
Observation ID:	2023-0280		
Description:	Tree, bush and phragmites encroaching the landside toe clearance.		
Caption:	0280 - No User Rating (Site Visit) - Tree, bush and phragmites encroaching the landside toe clearance.		
Lat/Long:	41.56458/-87.31921

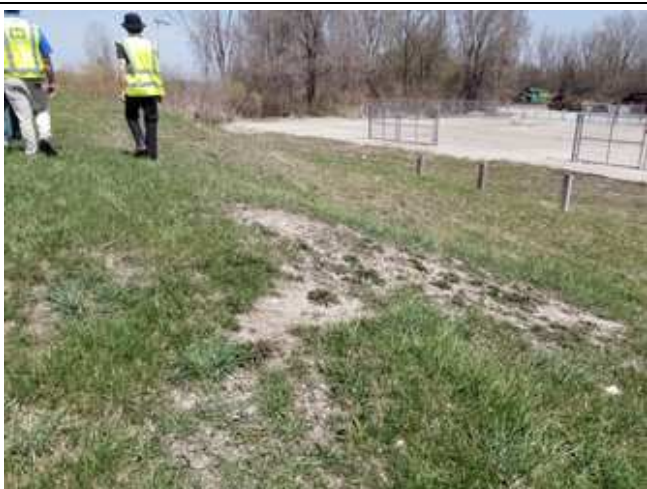
Category:	Levee Embankments	Item:	Sod Cover
Observation ID:	2023-0022		
Description:	Poor sod cover on the riverside slope.		
Caption:	0022 - No User Rating (Site Visit) - Poor sod cover on the riverside slope.		
Lat/Long:	41.55525/-87.37458

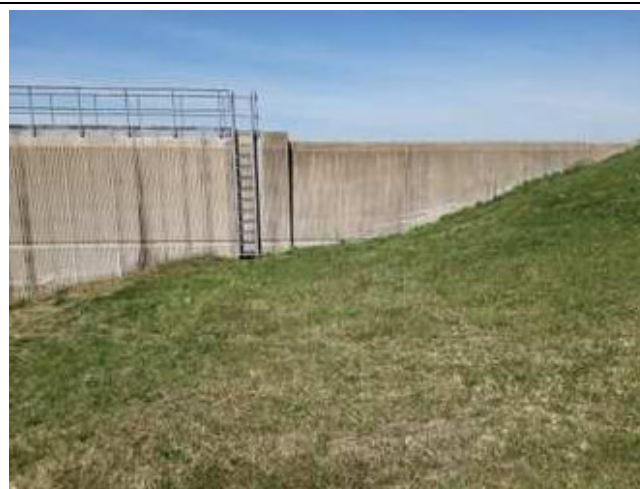
Category:	Levee Embankments	Item:	Sod Cover
Observation ID:	2023-0025		
Description:	Poor sod cover on the landside slope.		
Caption:	0025 - No User Rating (Site Visit) - Poor sod cover on the landside slope.		
Lat/Long:	41.55563/-87.37479

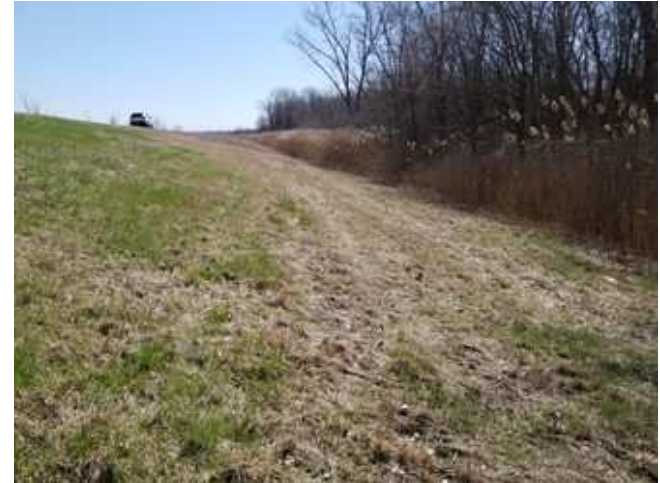
Category:	Levee Embankments	Item:	Sod Cover
Observation ID:	2023-0205		
Description:	Poor sod cover on the riverside slope.		
Caption:	0205 - No User Rating (Site Visit) - Poor sod cover on the riverside slope.		
Lat/Long:	41.56073/-87.33284

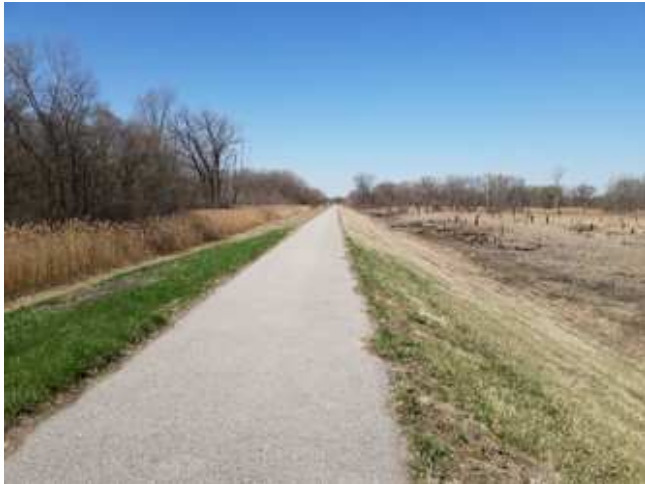
Category:	Levee Embankments	Item:	Sod Cover
Observation ID:	2023-0226		
Description:	Poor sod cover on the landside and riverside slopes.		
Caption:	0226_1 - No User Rating (Site Visit) - Poor sod cover on the landside and riverside slopes.		
Lat/Long:	41.56063/-87.32632

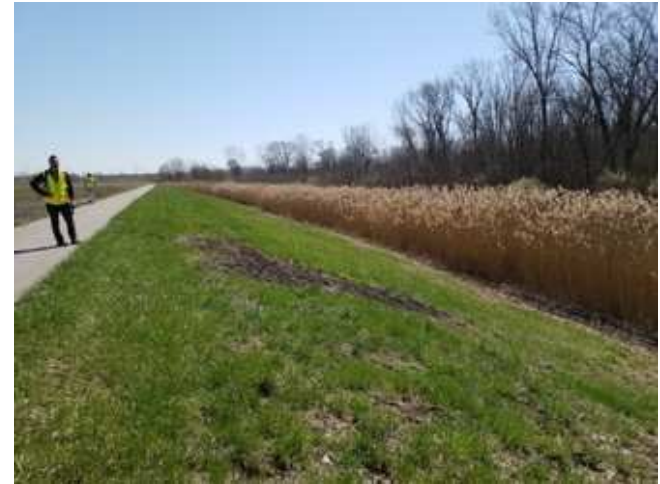
Category:	Levee Embankments	Item:	Sod Cover
Observation ID:	2023-0226		
Description:	Poor sod cover on the landside and riverside slopes.		
Caption:	0226_2 - No User Rating (Site Visit) - Poor sod cover on the landside and riverside slopes.		
Lat/Long:	41.56063/-87.32632

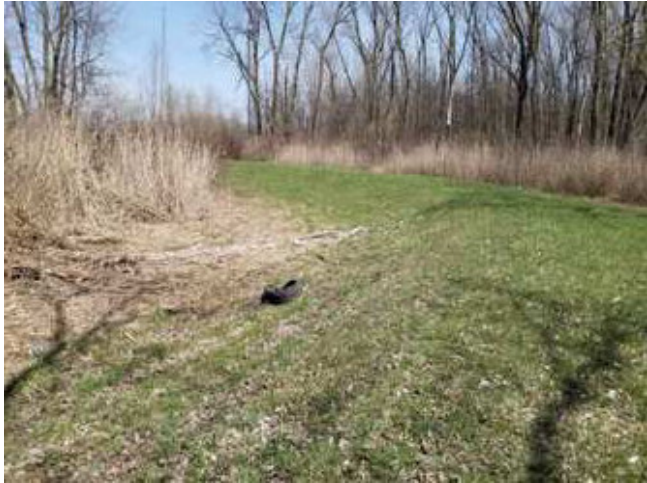
Category:	Levee Embankments	Item:	Sod Cover
Observation ID:	2023-0250		
Description:	Poor sod cover on the landside slopes.		
Caption:	0250 - No User Rating (Site Visit) - Poor sod cover on the landside slopes.		
Lat/Long:	41.56063/-87.32146

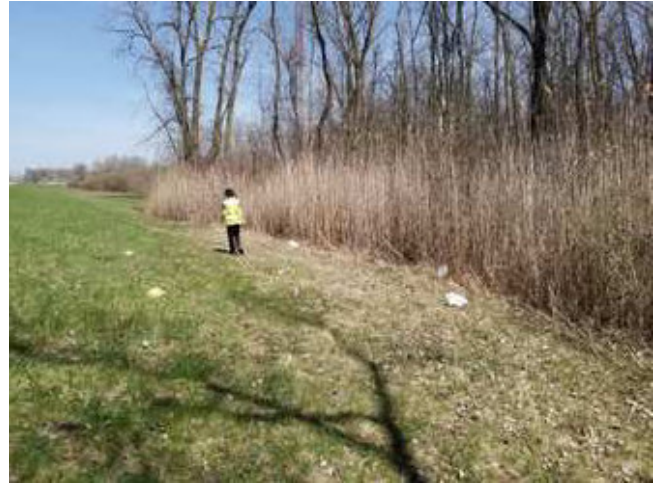
Category:	Levee Embankments	Item:	Encroachments
Observation ID:	2023-0001		
Description:	Tire and wooden debris on the riverside.		
Caption:	0001 - No User Rating (Site Visit) - Tire and wooden debris on the riverside.		
Lat/Long:	41.55252/-87.37490

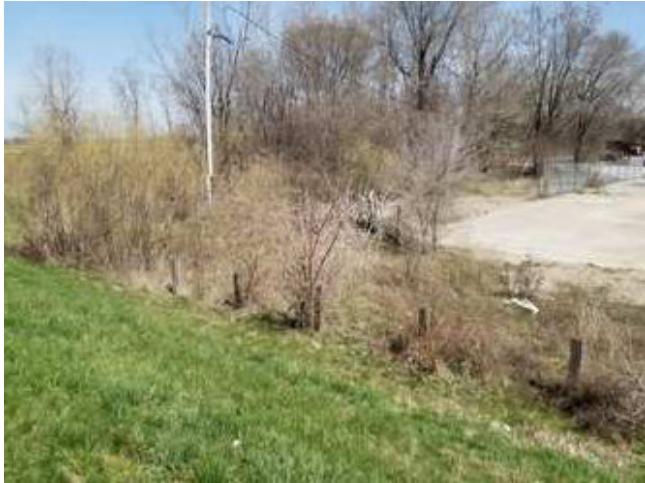
Category:	Levee Embankments	Item:	Encroachments
Observation ID:	2023-0004		
Description:	Trash and other debris on the landside.		
Caption:	0004 - No User Rating (Site Visit) - Trash and other debris on the landside.		
Lat/Long:	41.55254/-87.37475

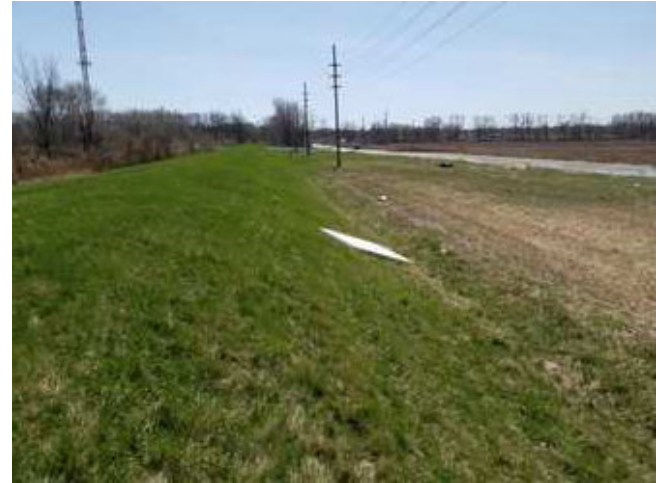
Category:	Levee Embankments	Item:	Encroachments
Observation ID:	2023-0028		
Description:	Encroachment		
Caption:	0028 - No User Rating (Site Visit) - Concrete posts, trees and some vegetation encroaching the landside toe.		
Lat/Long:	41.55576/-87.37479

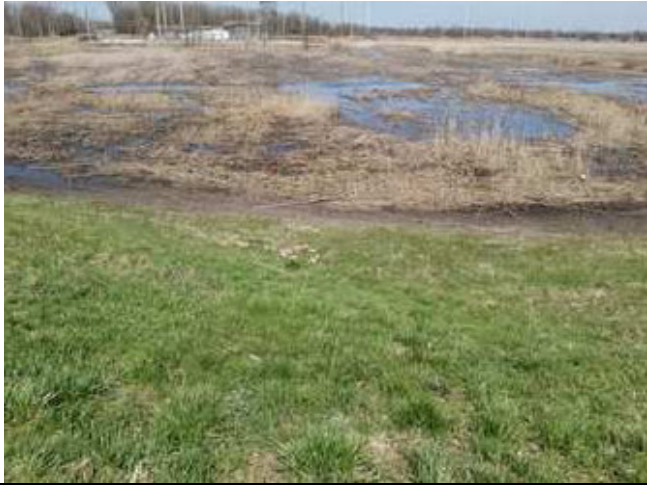
Category:	Levee Embankments	Item:	Encroachments
Observation ID:	2023-0040		
Description:	Mattress on the riverside slope.		
Caption:	0040 - No User Rating (Site Visit) - Mattress on the riverside slope.		
Lat/Long:	41.55689/-87.37479

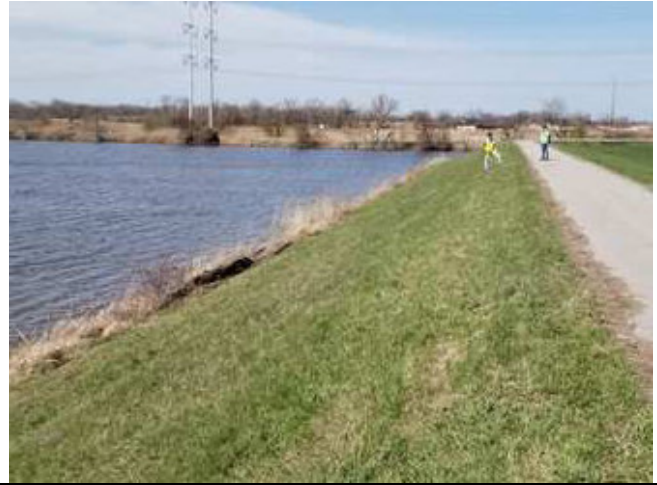
Category:	Levee Embankments	Item:	Encroachments
Observation ID:	2023-0049		
Description:	Wooden debris on the riverside toe.		
Caption:	0049 - No User Rating (Site Visit) - Wooden debris on the riverside toe.		
Lat/Long:	41.55890/-87.37448

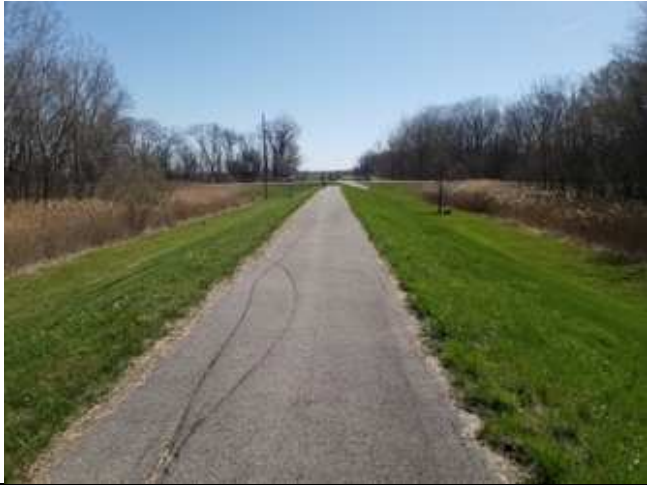
Category:	Levee Embankments	Item:	Encroachments
Observation ID:	2023-0085		
Description:	Wooden debris on the riverside toe.		
Caption:	0085 - No User Rating (Site Visit) - Wooden debris on the riverside toe.		
Lat/Long:	41.56376/-87.35934

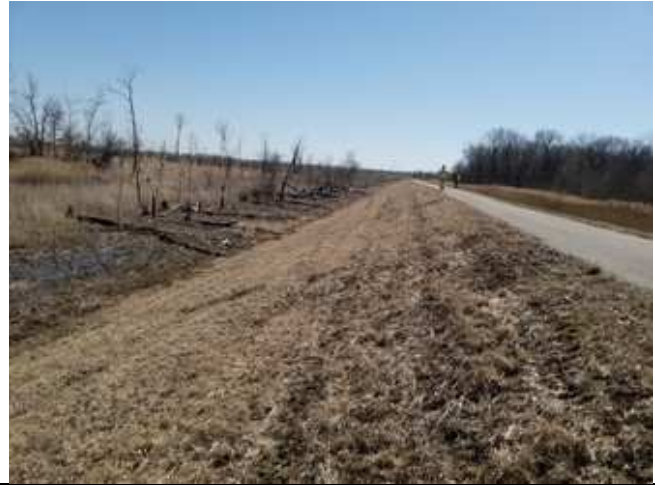
Category:	Levee Embankments	Item:	Encroachments
Observation ID:	2023-0211		
Description:	Some debris on the landside and riverside. Tree in photo is acceptable (part of design plan).		
Caption:	0211 - No User Rating (Site Visit) - Some debris on the landside and riverside. Tree in photo is acceptable (part of design plan).		
Lat/Long:	41.56075/-87.32782

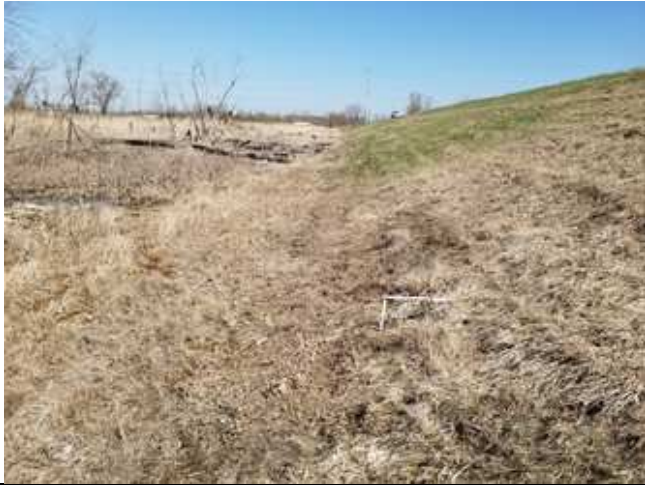
Category:	Levee Embankments	Item:	Encroachments
Observation ID:	2023-0232		
Description:	Tree log encroaching on the riverside toe.		
Caption:	0232 - No User Rating (Site Visit) - Tree log encroaching on the riverside toe.		
Lat/Long:	41.56067/-87.32556

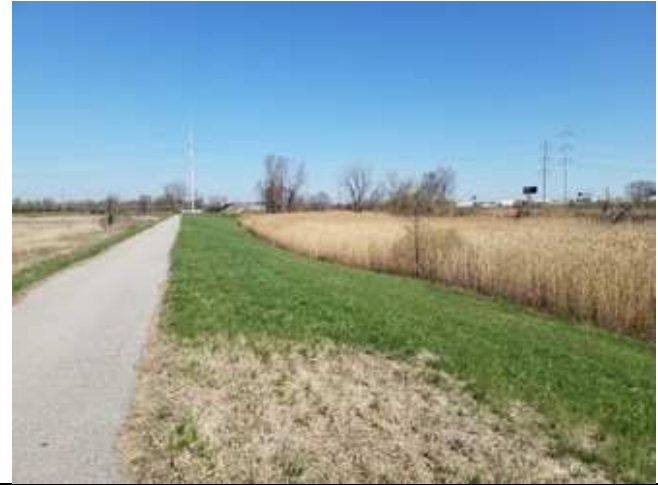
Category:	Levee Embankments	Item:	Encroachments
Observation ID:	2023-0262		
Description:	Tree log encroaching on the riverside toe.		
Caption:	0262 - No User Rating (Site Visit) - Tree log encroaching on the riverside toe.		
Lat/Long:	41.56186/-87.31934

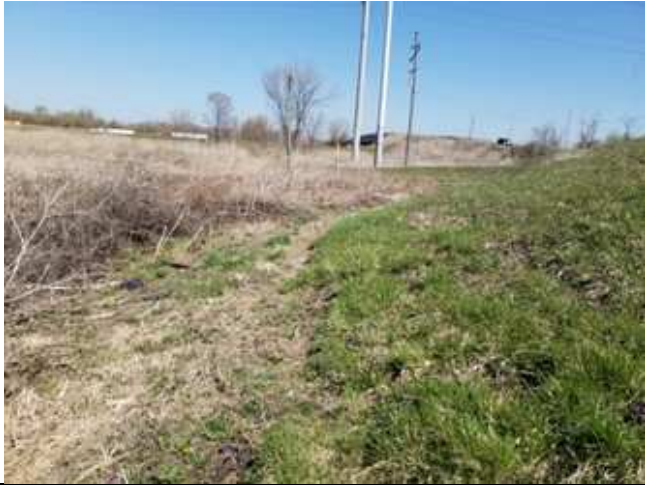
Category:	Levee Embankments	Item:	Encroachments
Observation ID:	2023-0271		
Description:	Tree log encroaching on the riverside toe.		
Caption:	0271 - No User Rating (Site Visit) - Tree log encroaching on the riverside toe.		
Lat/Long:	41.56357/-87.31906

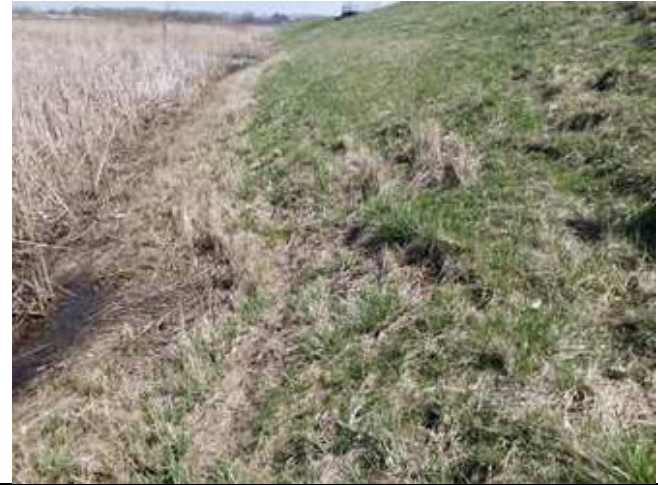
Category:	Levee Embankments	Item:	Encroachments
Observation ID:	2023-0283		
Description:	Debris and some vegetation encroaching the riverside toe clearance.		
Caption:	0283 - No User Rating (Site Visit) - Debris and some vegetation encroaching the riverside toe clearance.		
Lat/Long:	41.56518/-87.31932

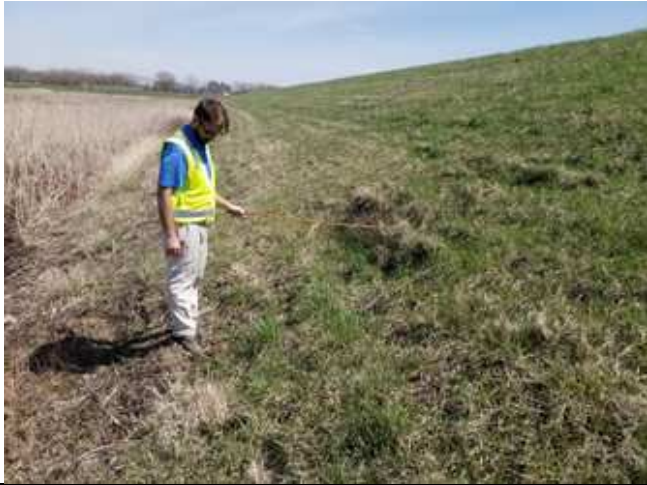
Category:	Levee Embankments	Item:	Erosion/ Bank Caving
Observation ID:	2023-0061		
Description:	Erosion at the toe on the north of berm located 1000 feet north of the Village Shopping Center.		
Caption:	0061 - No User Rating (Site Visit) - Erosion at the toe on the north of berm located 1000 feet north of the Village Shopping Center.		
Lat/Long:	41.55900/-87.36764

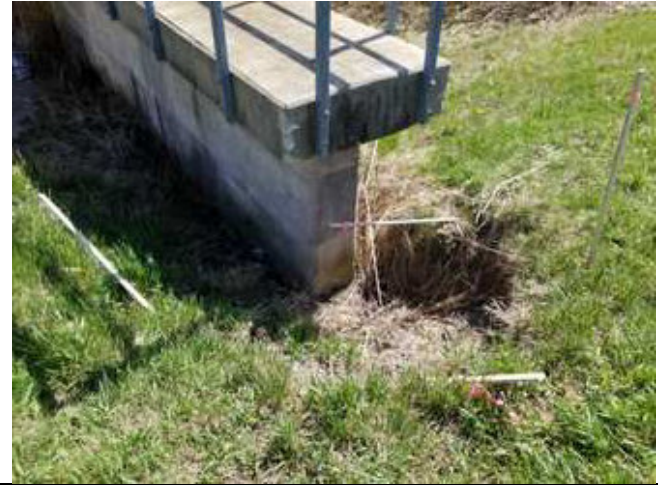
Category:	Levee Embankments	Item:	Erosion/ Bank Caving
Observation ID:	2023-0073		
Description:	Erosion on the riverside toe located 2000 feet west of Grant St.		
Caption:	0073 - No User Rating (Site Visit) - Erosion on the riverside toe located 2000 feet west of Grant St.		
Lat/Long:	41.55897/-87.36316

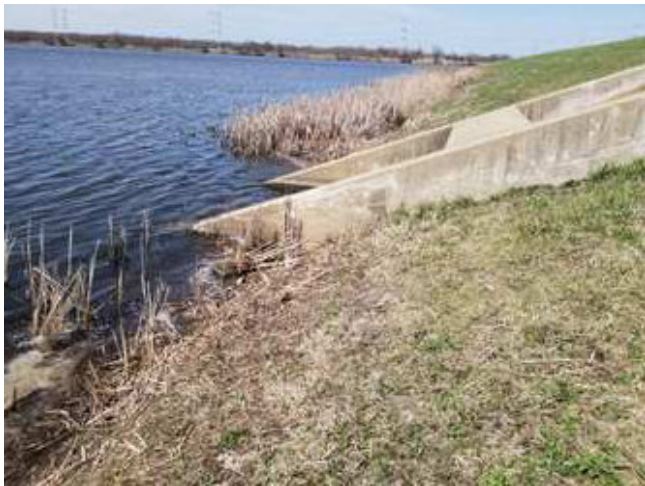
Category:	Levee Embankments	Item:	Erosion/ Bank Caving
Observation ID:	2023-0076		
Description:	Erosion around the well wall located about 650 feet west of Grant Street.		
Caption:	0076 - No User Rating (Site Visit) - Erosion around the well wall located about 650 feet west of Grant Street.		
Lat/Long:	41.55886/-87.35923

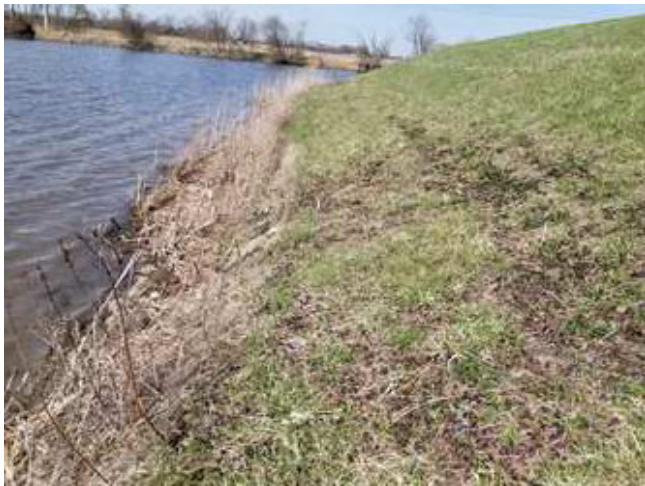
Category:	Levee Embankments	Item:	Erosion/ Bank Caving
Observation ID:	2023-0082		
Description:	Caving along the riverside toe located south of the Little Cal river (parallel to Grant Street).		
Caption:	0082 - No User Rating (Site Visit) - Caving along the riverside toe located south of the Little Cal river (parallel to Grant Street).		
Lat/Long:	41.56122/-87.35943

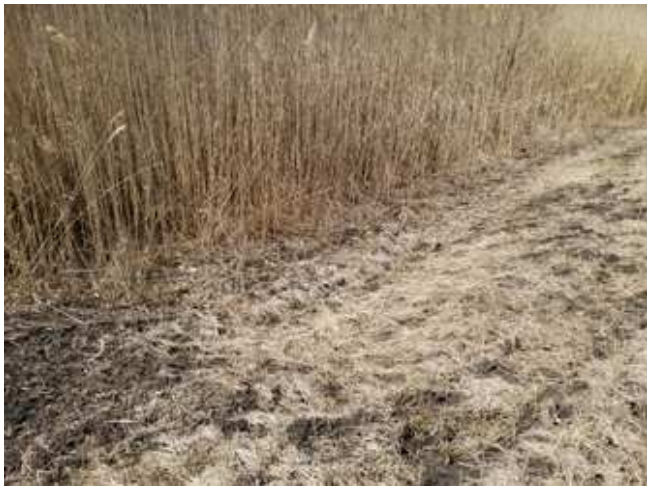
Category:	Levee Embankments	Item:	Erosion/ Bank Caving
Observation ID:	2023-0229		
Description:	Erosion of about 8-inch deep x 8-ft long x 5-ft wide located on the landside toe east of Georgia Street.		
Caption:	0229 - No User Rating (Site Visit) - Erosion of about 8-inch deep x 8-ft long x 5-ft wide located on the landside toe east of Georgia Street.		
Lat/Long:	41.56055/-87.32591

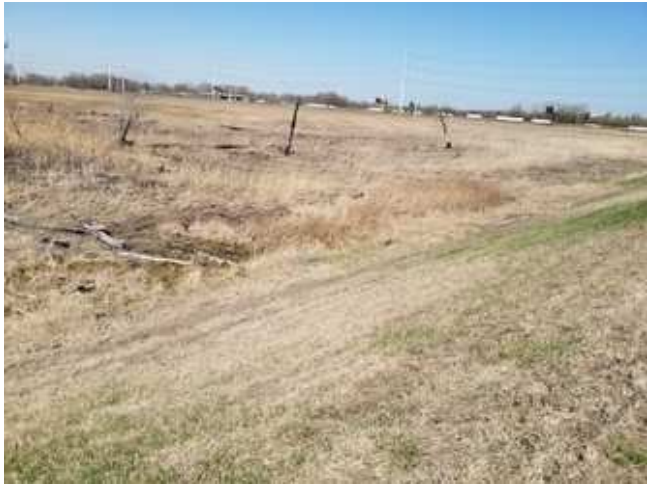
Category:	Levee Embankments	Item:	Erosion/ Bank Caving
Observation ID:	2023-0259		
Description:	Slope/bank erosion on the riverside slope west of Martin Luther King Drive.		
Caption:	0259 - No User Rating (Site Visit) - Slope/bank erosion on the riverside slope west of Martin Luther King Drive.		
Lat/Long:	41.56186/-87.31935

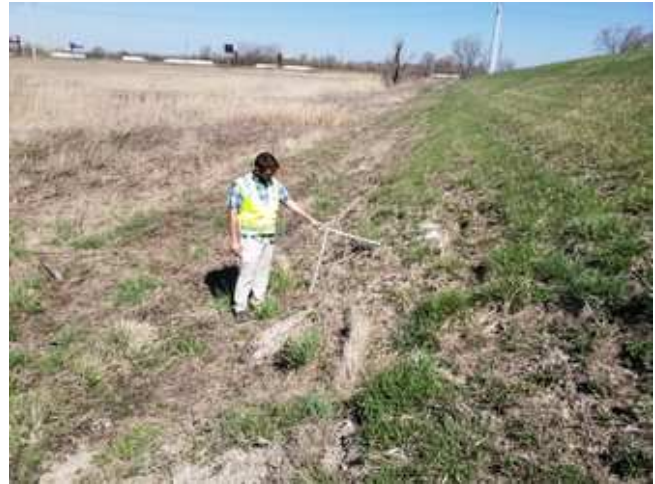
Category:	Levee Embankments	Item:	Erosion/ Bank Caving
Observation ID:	2023-0265		
Description:	Slope/bank erosion on the riverside slope west of Martin Luther King Drive.		
Caption:	0265 - No User Rating (Site Visit) - Slope/bank erosion on the riverside slope west of Martin Luther King Drive.		
Lat/Long:	41.56291/-87.31905

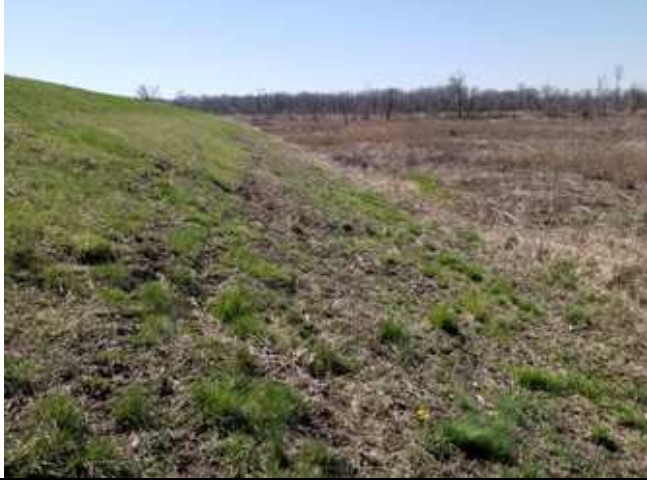
Category:	Levee Embankments	Item:	Erosion/ Bank Caving
Observation ID:	2023-0274		
Description:	Erosion on the riverside toe west of Martin Luther King Drive.		
Caption:	0274 - No User Rating (Site Visit) - Erosion on the riverside toe west of Martin Luther King Drive.		
Lat/Long:	41.56373/-87.31921

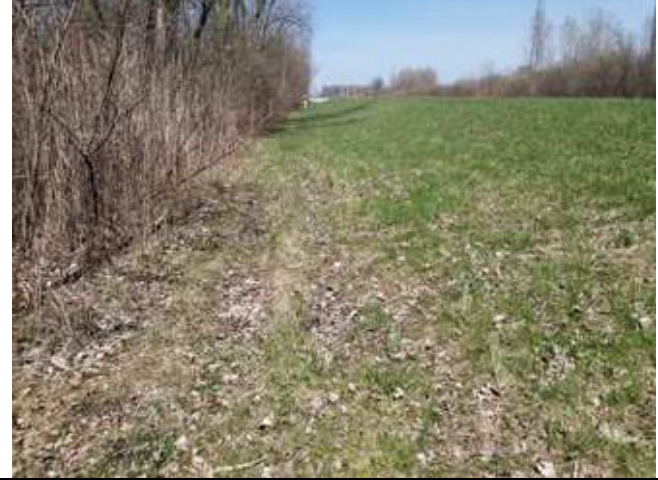
Category:	Levee Embankments	Item:	Erosion/ Bank Caving
Observation ID:	2023-0277		
Description:	Erosion on the riverside toe west of Martin Luther King Drive.		
Caption:	0277 - No User Rating (Site Visit) - Erosion on the riverside toe west of Martin Luther King Drive.		
Lat/Long:	41.56456/-87.31931

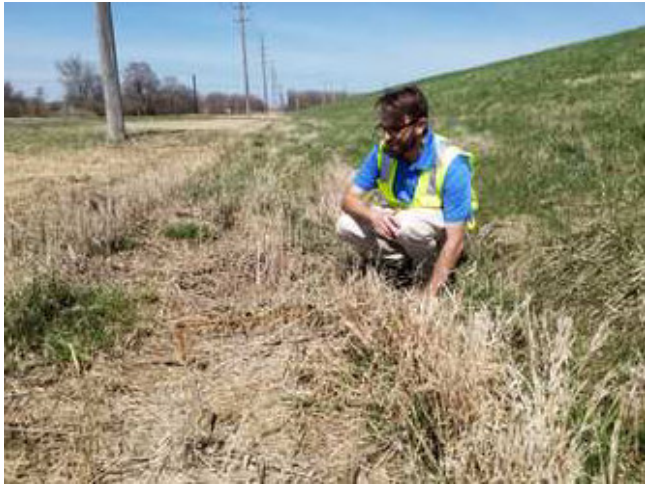
Category:	Levee Embankments	Item:	Depressions/ Rutting
Observation ID:	2023-0007		
Description:	Rutting about 4 inches deep on the riverside located NW of Norfolk Southern RR and Chase Street.		
Caption:	0007 - No User Rating (Site Visit) - Rutting about 4 inches deep on the riverside located NW of Norfolk Southern RR and Chase Street.		
Lat/Long:	41.55275/-87.37481

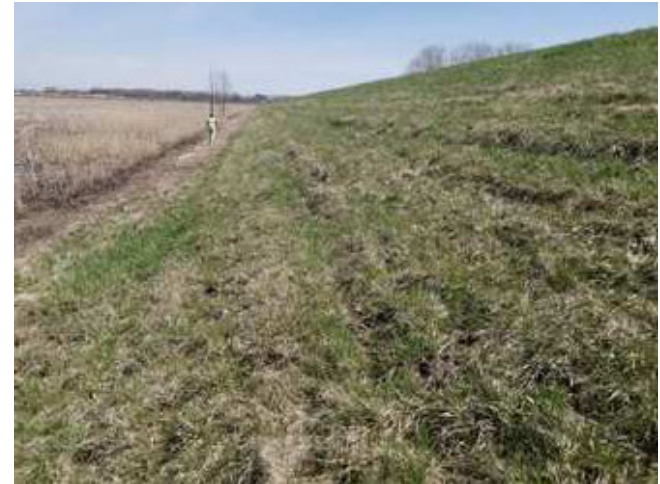
Category:	Levee Embankments	Item:	Depressions/ Rutting
Observation ID:	2023-0043		
Description:	Depression on the riverside toe located 600 feet NE of Chase and W. 35 Street intersection.		
Caption:	0043 - No User Rating (Site Visit) - Depression on the riverside toe located 600 feet NE of Chase and W. 35 Street intersection.		
Lat/Long:	41.55714/-87.37492

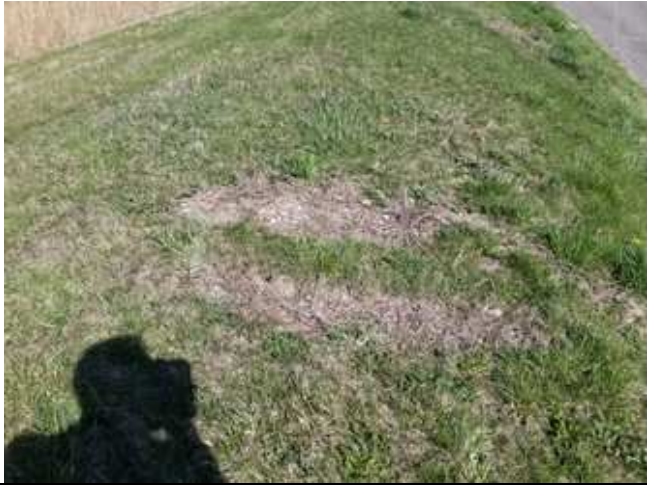
Category:	Levee Embankments	Item:	Depressions/ Rutting
Observation ID:	2023-0055		
Description:	Depression along the riverside slope located north of the Village Shopping Center.		
Caption:	0055 - No User Rating (Site Visit) - Depression along the riverside slope located north of the Village Shopping Center.		
Lat/Long:	41.55898/-87.37073

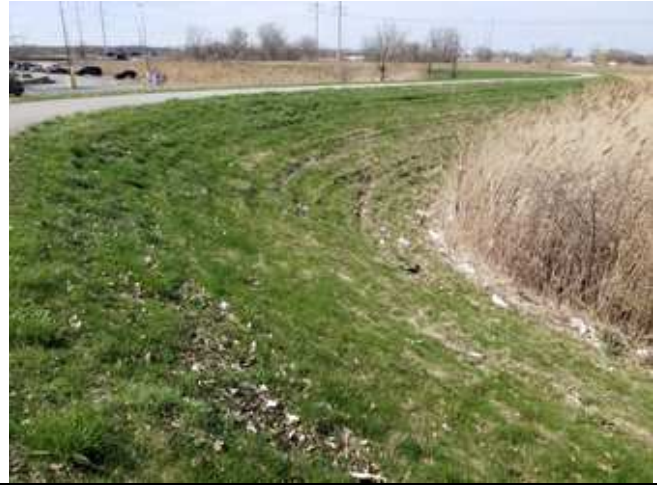
Category:	Levee Embankments	Item:	Depressions/ Rutting
Observation ID:	2023-0106		
Description:	Some ruts over the levee crown on the SE of Little Cal river and Grant Street.		
Caption:	0106 - No User Rating (Site Visit) - Some ruts over the levee crown on the SE of Little Cal river and Grant Street.		
Lat/Long:	41.56466/-87.35462

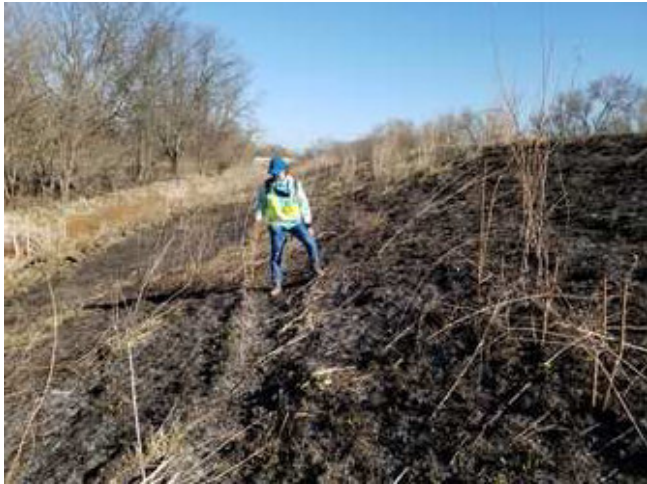
Category:	Levee Embankments	Item:	Depressions/ Rutting
Observation ID:	2023-0112		
Description:	Some ruts over the riverside toe and slope on the SE of Little Cal river and Grant Street.		
Caption:	0112 - No User Rating (Site Visit) - Some ruts over the riverside toe and slope on the SE of Little Cal river and Grant Street.		
Lat/Long:	41.56381/-87.35335

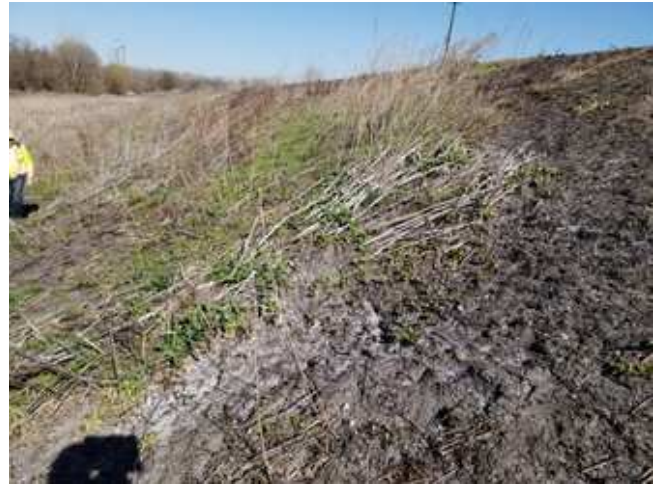
Category:	Levee Embankments	Item:	Depressions/ Rutting
Observation ID:	2023-0133		
Description:	Some ruts over the landside slope on the north of Gleason Park.		
Caption:	0133 - No User Rating (Site Visit) - Some ruts over the landside slope on the north of Gleason Park.		
Lat/Long:	41.56115/-87.34487

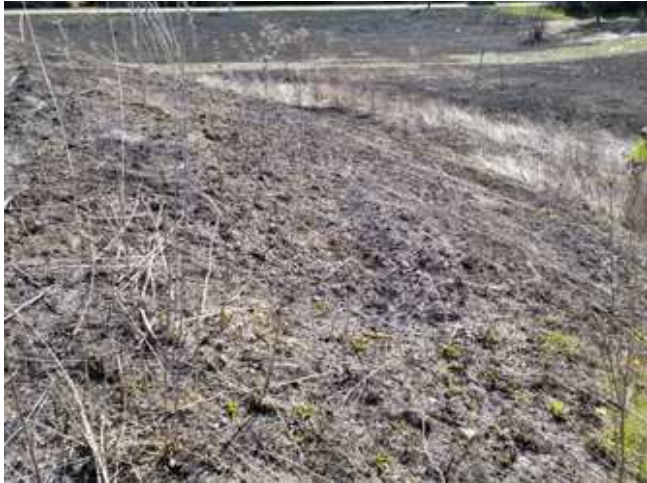
Category:	Levee Embankments	Item:	Depressions/ Rutting
Observation ID:	2023-0157		
Description:	Depression on the landside slope of about 12-inch wide and 3-inch deep located at north of Jefferson Street and W. 33rd Avenue.		
Caption:	0157 - No User Rating (Site Visit) - Depression on the landside slope of about 12-inch wide and 3-inch deep located at north of Jefferson Street and W. 33rd Avenue.		
Lat/Long:	41.55947/-87.34118

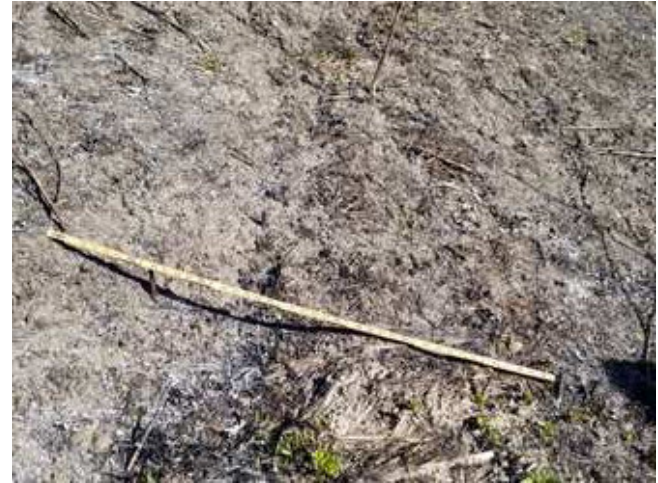
Category:	Levee Embankments	Item:	Depressions/ Rutting
Observation ID:	2023-0169		
Description:	Depression on the landside slope of about 24-inch wide and 3-inch deep located at NW of Broadway Street and W. 33rd Avenue.		
Caption:	0169 - No User Rating (Site Visit) - Depression on the landside slope of about 24-inch wide and 3-inch deep located at NW of Broadway Street and W. 33rd Avenue.		
Lat/Long:	41.55906/-87.33759

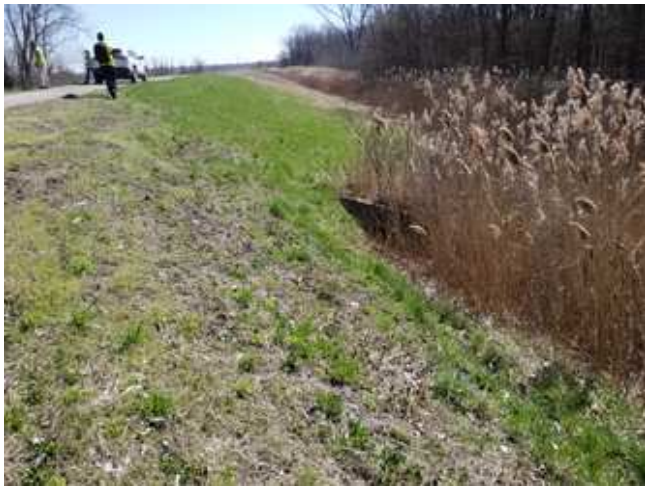
Category:	Levee Embankments	Item:	Depressions/ Rutting
Observation ID:	2023-0172		
Description:	Depression on the landside slope of about 30-inch wide and 3-inch deep located at NW of Broadway Street and W. 33rd Avenue.		
Caption:	0172 - No User Rating (Site Visit) - Depression on the landside slope of about 30-inch wide and 3-inch deep located at NW of Broadway Street and W. 33rd Avenue.		
Lat/Long:	41.55917/-87.33744

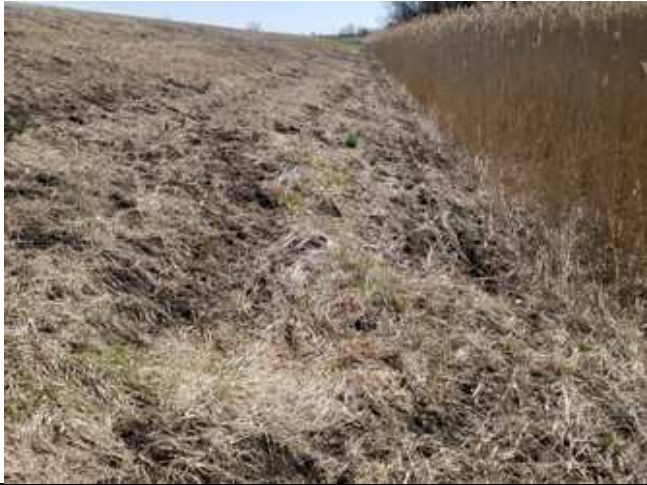
Category:	Levee Embankments	Item:	Depressions/ Rutting
Observation ID:	2023-0235		
Description:	Some ruts along the riverside slope located 500 feet east of Georgia Street.		
Caption:	0235 - No User Rating (Site Visit) - Some ruts along the riverside slope located 500 feet east of Georgia Street.		
Lat/Long:	41.56068/-87.32559

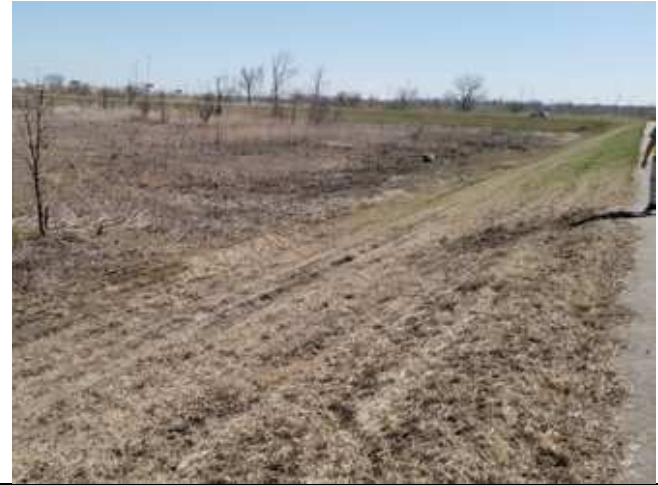
Category:	Levee Embankments	Item:	Depressions/ Rutting
Observation ID:	2023-0244		
Description:	Depression on the landside toe of about 6-inch diameter and 8-inch deep located 600 feet east of Georgia Street.		
Caption:	0244 - No User Rating (Site Visit) - Depression on the landside toe of about 6-inch diameter and 8-inch deep located 600 feet east of Georgia Street.		
Lat/Long:	41.56055/-87.32352

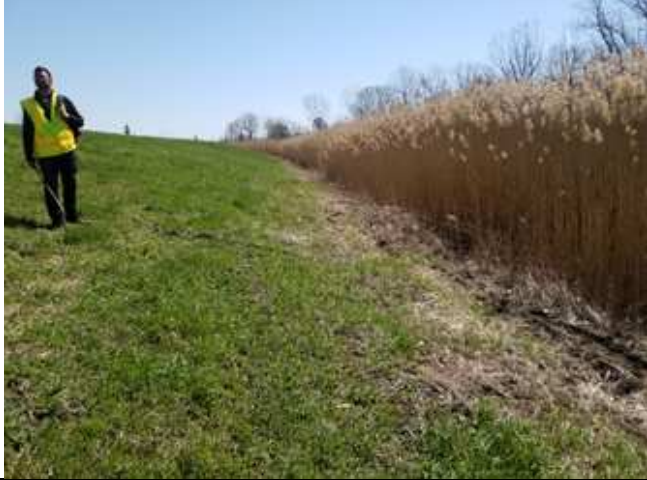
Category:	Levee Embankments	Item:	Depressions/ Rutting
Observation ID:	2023-0247		
Description:	Depression on the riverside slope about 600 feet west of Martin Luther King Drive.		
Caption:	0247 - No User Rating (Site Visit) - Depression on the riverside slope about 600 feet west of Martin Luther King Drive.		
Lat/Long:	41.56066/-87.32172

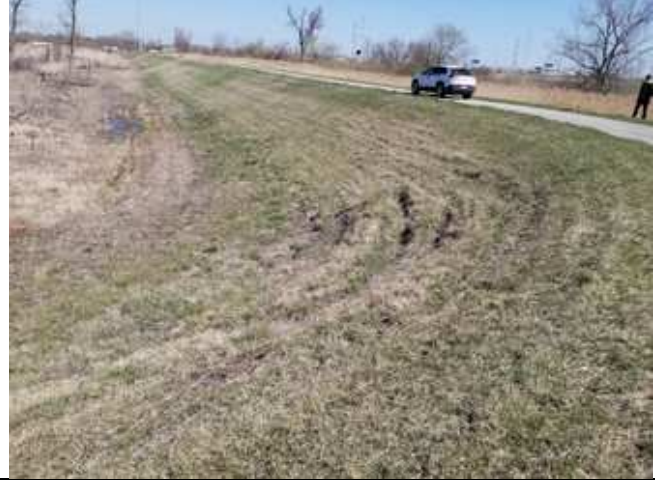
Category:	Levee Embankments	Item:	Depressions/ Rutting
Observation ID:	2023-0253		
Description:	Depression and some rutting on the landside toe about 600 feet west of Martin Luther King Drive.		
Caption:	0253 - No User Rating (Site Visit) - Depression and some rutting on the landside toe about 600 feet west of Martin Luther King Drive.		
Lat/Long:	41.56059/-87.32082

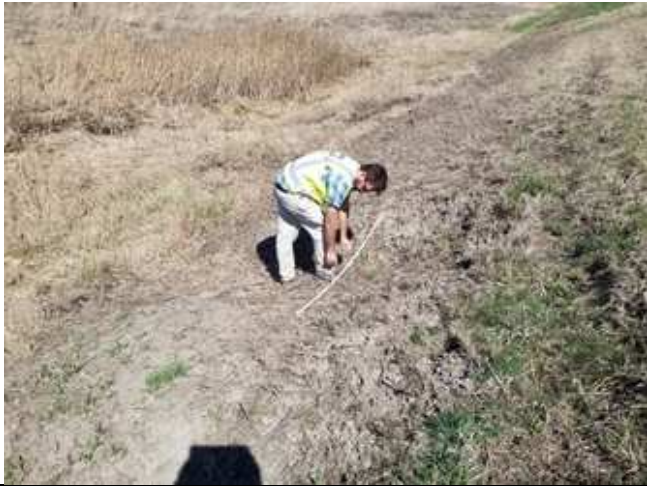
Category:	Levee Embankments	Item:	Depressions/ Rutting
Observation ID:	2023-0256		
Description:	Some rutting on the riverside slope about 300 feet west of Martin Luther King Drive.		
Caption:	0256 - No User Rating (Site Visit) - Some rutting on the riverside slope about 300 feet west of Martin Luther King Drive.		
Lat/Long:	41.56072/-87.31938

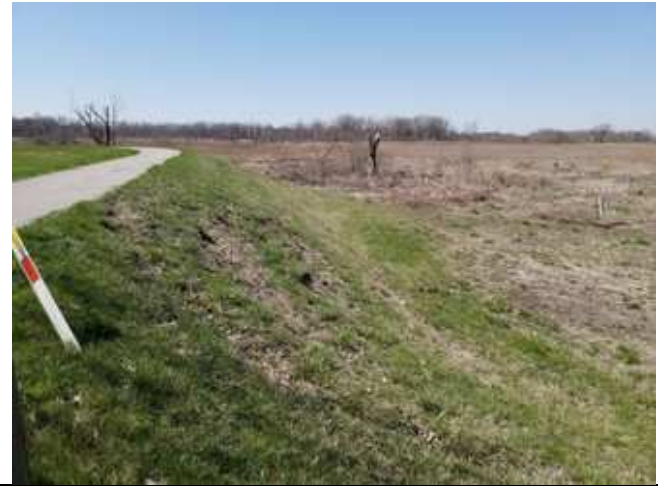
Category:	Levee Embankments	Item:	Depressions/ Rutting
Observation ID:	2023-0268		
Description:	Depression on the riverside toe of about 6-inch wide x 12-ft long x 5-inch deep located 600 feet east of Martin Luther King Drive.		
Caption:	0268 - No User Rating (Site Visit) - Depression on the riverside toe of about 6-inch wide x 12-ft long x 5-inch deep located 600 feet east of Martin Luther King Drive.		
Lat/Long:	41.56296/-87.31926

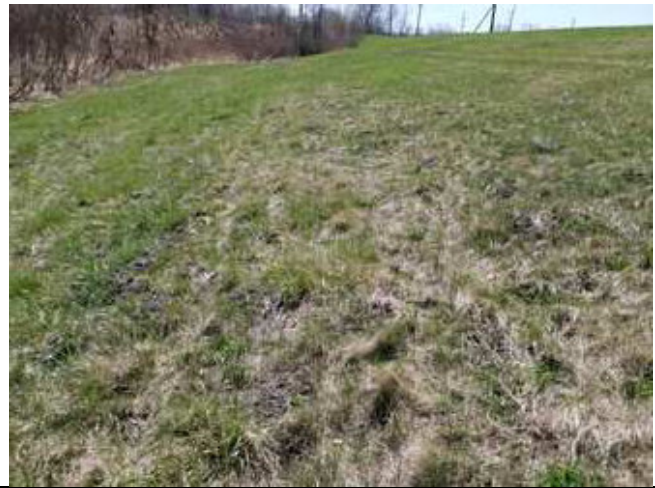
Category:	Levee Embankments	Item:	Animal Control
Observation ID:	2023-0016		
Description:	Animal burrow activity on the landside slope located SE of Chase Street and W. 35th Avenue.		
Caption:	0016 - No User Rating (Site Visit) - Animal burrow activity on the landside slope located SE of Chase Street and W. 35th Avenue.		
Lat/Long:	41.55469/-87.37475

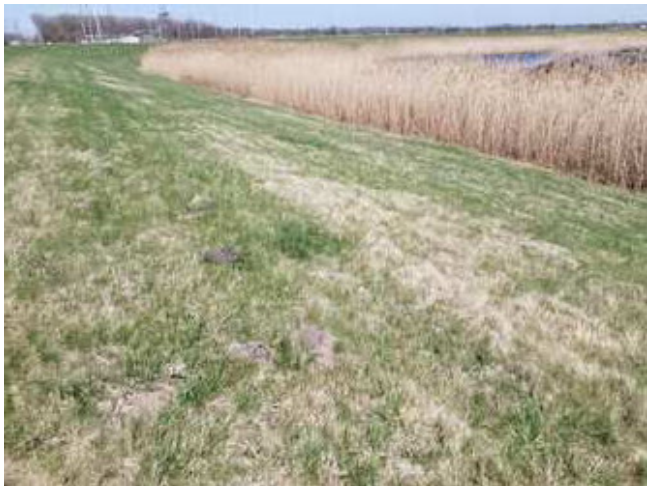
Category:	Levee Embankments	Item:	Animal Control
Observation ID:	2023-0034		
Description:	Animal burrow activity on the landside slope located NE of Chase Street and W. 35th Avenue.		
Caption:	0034 - No User Rating (Site Visit) - Animal burrow activity on the landside slope located NE of Chase Street and W. 35th Avenue.		
Lat/Long:	41.55658/-87.37457

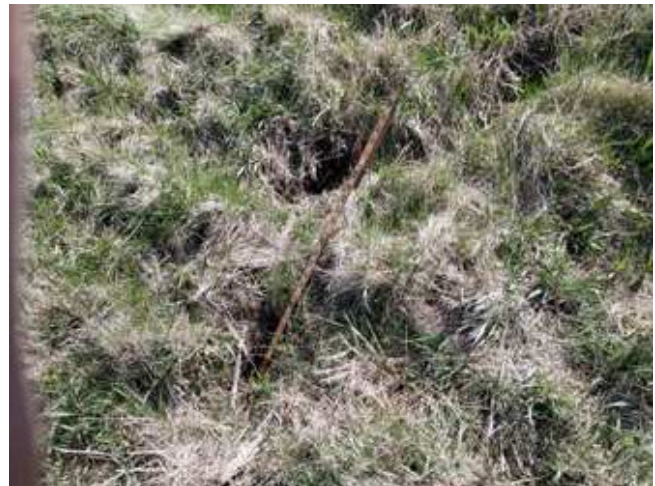
Category:	Levee Embankments	Item:	Animal Control
Observation ID:	2023-0046		
Description:	Animal burrow activity on the landside slope located 150 feet east of Chase Street.		
Caption:	0046 - No User Rating (Site Visit) - Animal burrow activity on the landside slope located 150 feet east of Chase Street.		
Lat/Long:	41.55777/-87.37474

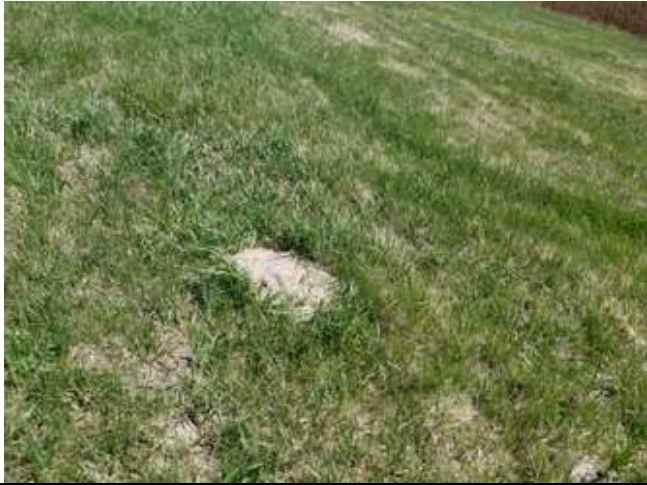
Category:	Levee Embankments	Item:	Animal Control
Observation ID:	2023-0052		
Description:	Animal burrow activity on the riverside slope located 1000 feet east of Chase Street.		
Caption:	0052 - No User Rating (Site Visit) - Animal burrow activity on the riverside slope located 1000 feet east of Chase Street.		
Lat/Long:	41.55889/-87.37085

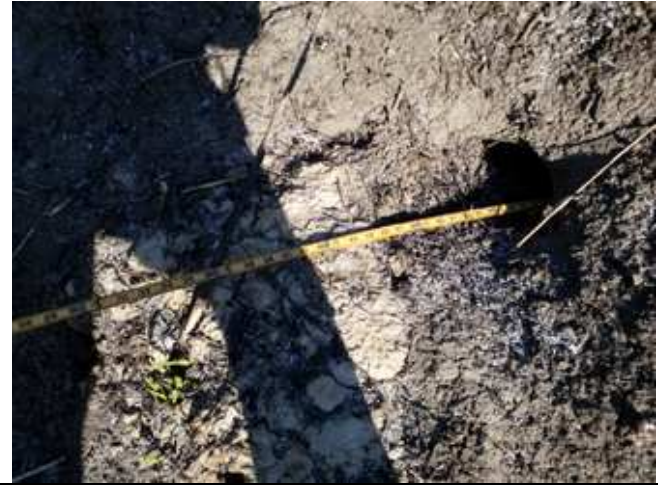
Category:	Levee Embankments	Item:	Animal Control
Observation ID:	2023-0058		
Description:	Animal burrow activity on the landside slope located north of the Village Shopping Center.		
Caption:	0058 - No User Rating (Site Visit) - Animal burrow activity on the landside slope located north of the Village Shopping Center.		
Lat/Long:	41.55890/-87.36891

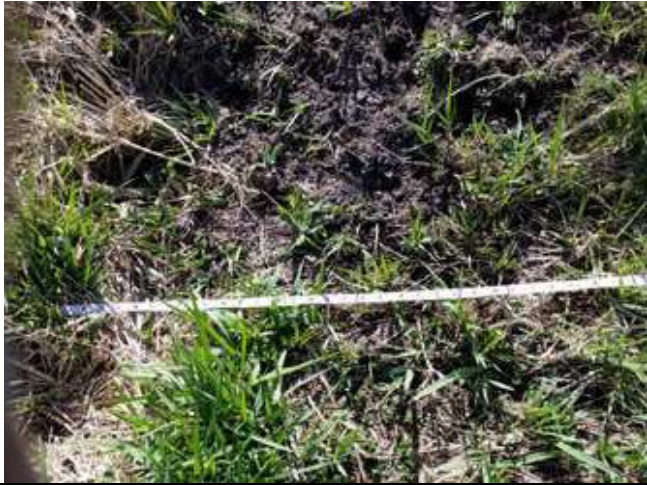
Category:	Levee Embankments	Item:	Animal Control
Observation ID:	2023-0145		
Description:	Animal burrow activity on the landside slope about 6 to 12 inches deep located SE of North Gleason Park, parallel to Jefferson Street.		
Caption:	0145 - No User Rating (Site Visit) - Animal burrow activity on the landside slope about 6 to 12 inches deep located SE of North Gleason Park, parallel to Jefferson Street.		
Lat/Long:	41.55925/-87.34091
