## Site Visit Summary

Name of System: Gary

Name of Segment: Gary South

Date of Site Visit: 04/11/2023 - 04/12/2023

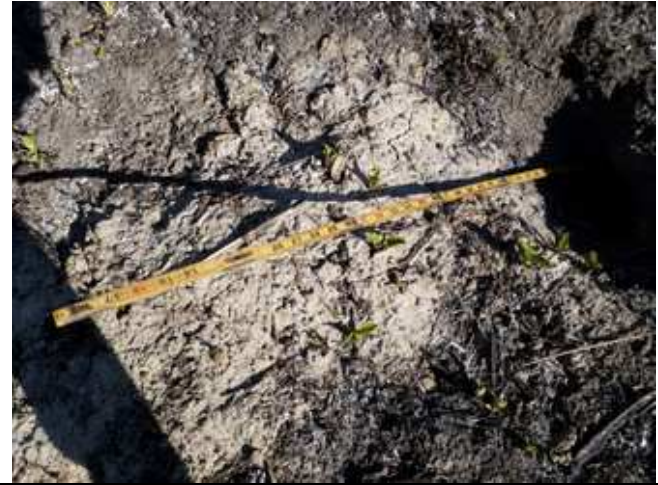
Category:	Levee Embankments	Item:	Animal Control
Observation ID:	2023-0151		
Description:	Animal burrow activity on the riverside slope about 6 inches deep located SE of North Gleason Park, parallel to Jefferson Street.		
Caption:	0151 - No User Rating (Site Visit) - Animal burrow activity on the riverside slope about 6 inches deep located SE of North Gleason Park, parallel to Jefferson Street.		
Lat/Long:	41.56040/-87.34288

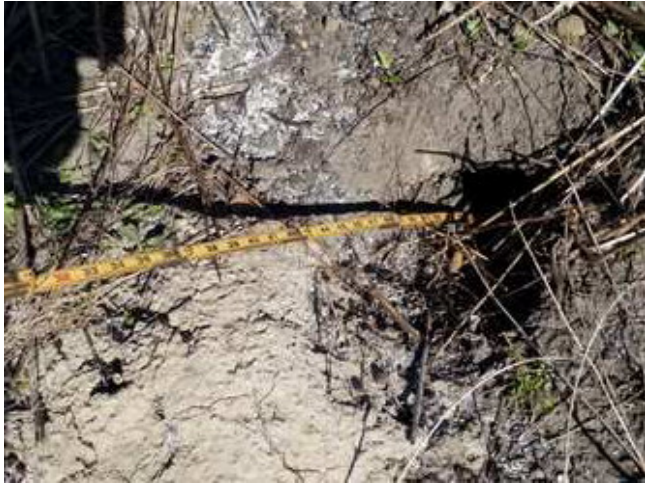
Category:	Levee Embankments	Item:	Animal Control
Observation ID:	2023-0154		
Description:	Animal burrow activity on the landside slope about 30 inches deep located SE of North Gleason Park, parallel to Jefferson Street.		
Caption:	0154 - No User Rating (Site Visit) - Animal burrow activity on the landside slope about 30 inches deep located SE of North Gleason Park, parallel to Jefferson Street.		
Lat/Long:	41.55989/-87.34218

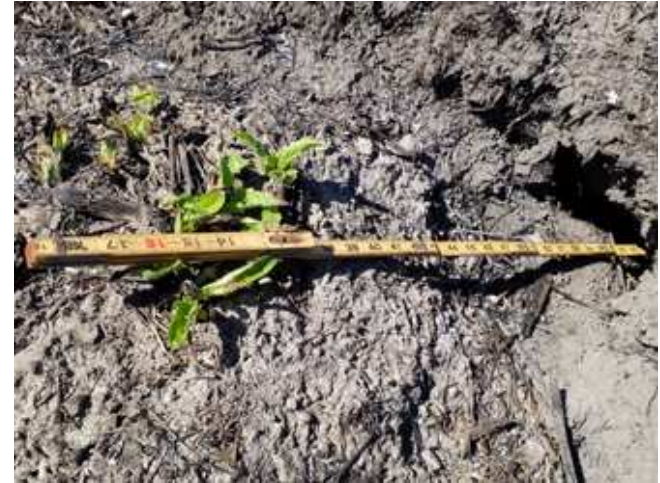
Category:	Levee Embankments	Item:	Animal Control
Observation ID:	2023-0166		
Description:	Animal burrow activity on the landside slope about 20 inches deep located NW of Broadway and W. 33rd Avenue, parallel to Jefferson Street.		
Caption:	0166 - No User Rating (Site Visit) - Animal burrow activity on the landside slope about 20 inches deep located NW of Broadway and W. 33rd Avenue, parallel to Jefferson Street.		
Lat/Long:	41.55898/-87.33928

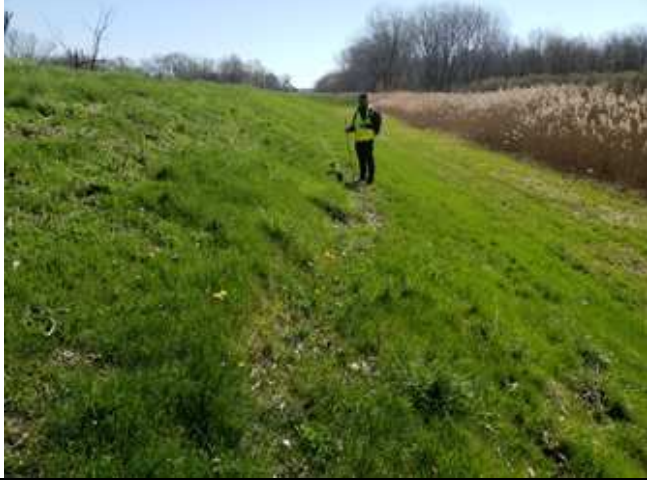
Category:	Levee Embankments	Item:	Animal Control
Observation ID:	2023-0175		
Description:	Animal burrow activity on the landside slope about 35 inches deep located near NW of Broadway and W. 33rd Avenue.		
Caption:	0175 - No User Rating (Site Visit) - Animal burrow activity on the landside slope about 35 inches deep located near NW of Broadway and W. 33rd Avenue.		
Lat/Long:	41.55936/-87.33740

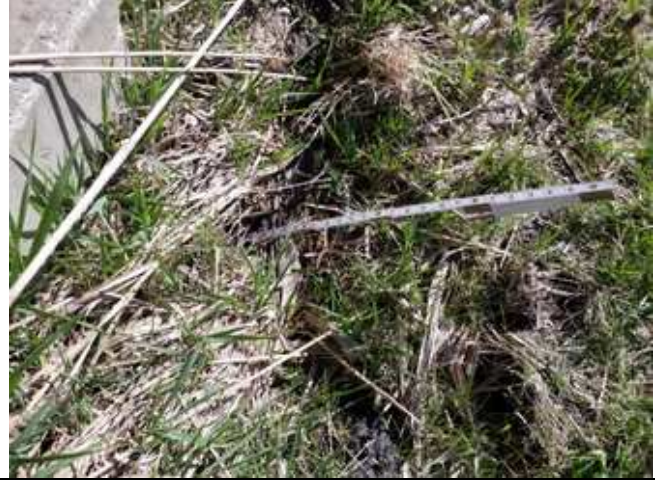
Category:	Levee Embankments	Item:	Animal Control
Observation ID:	2023-0202		
Description:	Animal burrow activity on the riverside toe about 17 inches deep located near SE of Broadway and Little Cal River.		
Caption:	0202_1 - No User Rating (Site Visit) - Animal burrow activity on the riverside toe about 17 inches deep located near SE of Broadway and Little Cal River.		
Lat/Long:	41.56074/-87.33357

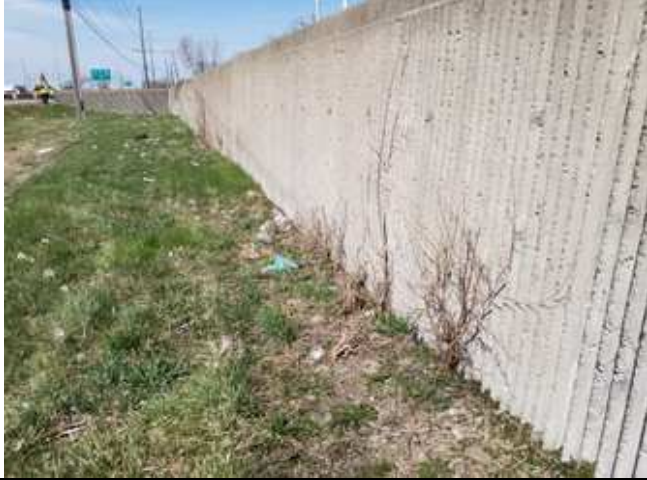
Category:	Levee Embankments	Item:	Animal Control
Observation ID:	2023-0202		
Description:	Animal burrow activity on the riverside toe about 17 inches deep located near SE of Broadway and Little Cal River.		
Caption:	0202_2 - No User Rating (Site Visit) - Animal burrow activity on the riverside toe about 17 inches deep located near SE of Broadway and Little Cal River.		
Lat/Long:	41.56074/-87.33357

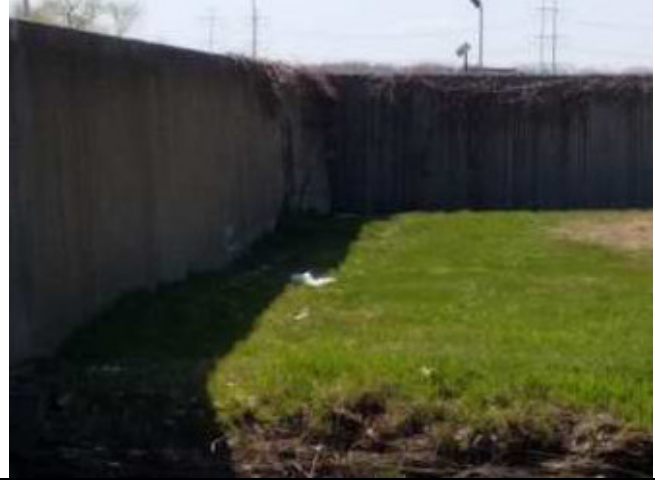
Category:	Floodwalls	Item:	Unwanted Vegetation
Observation ID:	2023-0100		
Description:	Small trees on the landside ground line/base located near Grant Street.		
Caption:	0100 - No User Rating (Site Visit) - Small trees on the landside ground line/base located near Grant Street.		
Lat/Long:	41.56468/-87.35579

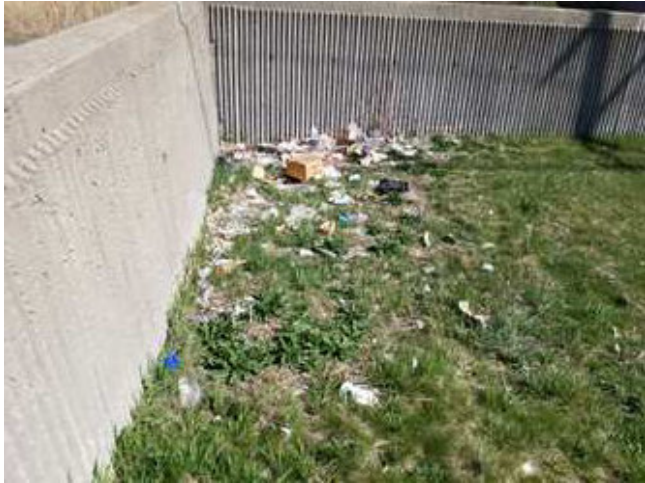
Category:	Floodwalls	Item:	Unwanted Vegetation
Observation ID:	2023-0103		
Description:	Vegetation on the riverside floodwall near Grant Street.		
Caption:	0103 - No User Rating (Site Visit) - Vegetation on the riverside floodwall near Grant Street.		
Lat/Long:	41.56472/-87.35492

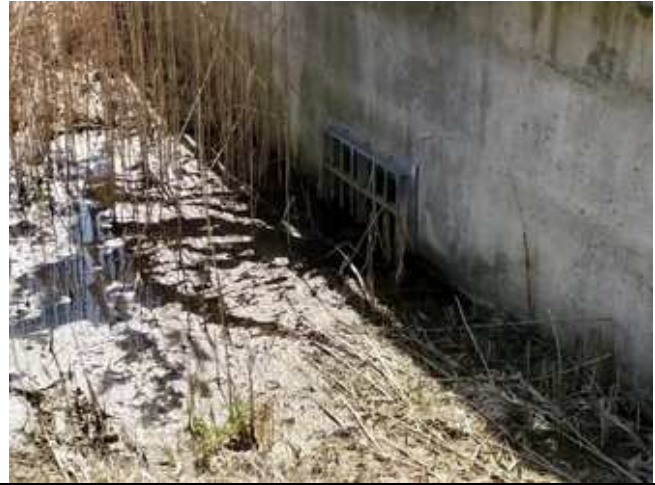
Category:	Interior Drainage System	Item:	Vegetation and Obstr
Observation ID:	2023-0033		
Description:	GS-3: Some debris at the SW gate in the ditch.		
Caption:	0033 - No User Rating (Site Visit) - GS-3: Some debris at the SW gate in the ditch.		
Lat/Long:	41.55883/-87.35925

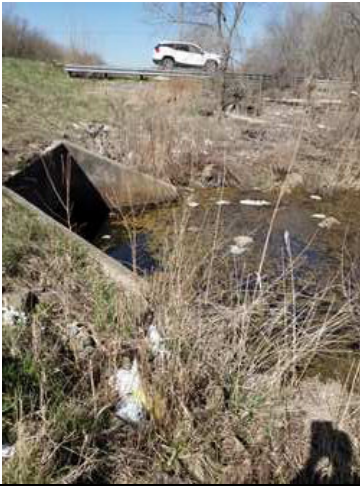
Category:	Interior Drainage System	Item:	Vegetation and Obstr
Observation ID:	2023-0118		
Description:	Vegetation in ditches located east of Grant Street.		
Caption:	0118 - No User Rating (Site Visit) - Vegetation in ditches located east of Grant Street.		
Lat/Long:	41.56375/-87.35264

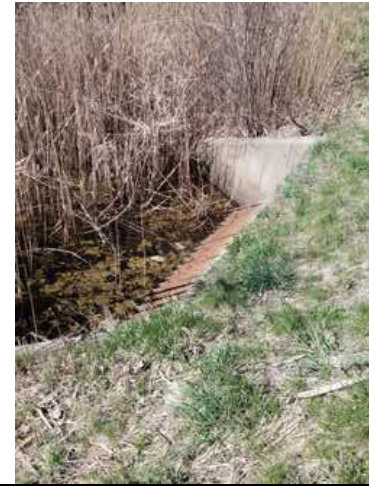
Category:	Interior Drainage System	Item:	Vegetation and Obstr
Observation ID:	2023-0126		
Description:	Debris and obstructions at GS-16 inlet near Georgia Street.		
Caption:	0126 - No User Rating (Site Visit) - Debris and obstructions at GS-16 inlet near Georgia Street.		
Lat/Long:	41.56076/-87.32659

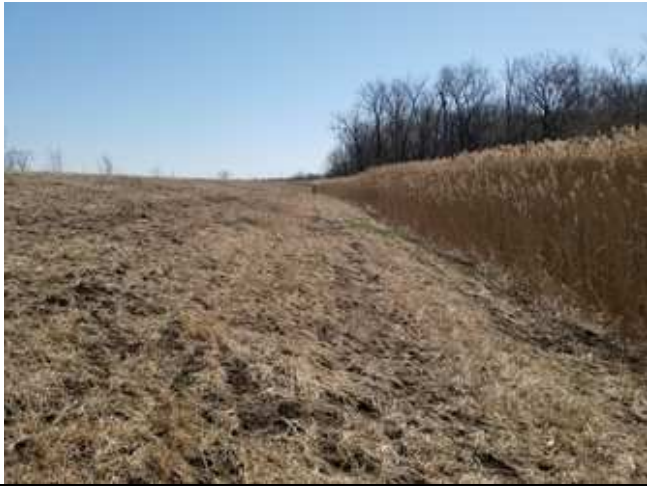
Category:	Interior Drainage System	Item:	Vegetation and Obstr
Observation ID:	2023-0132		
Description:	Some vegetation at GS-16 inlet near Georgia Street.		
Caption:	0132 - No User Rating (Site Visit) - Some vegetation at GS-16 inlet near Georgia Street.		
Lat/Long:	41.56077/-87.32666

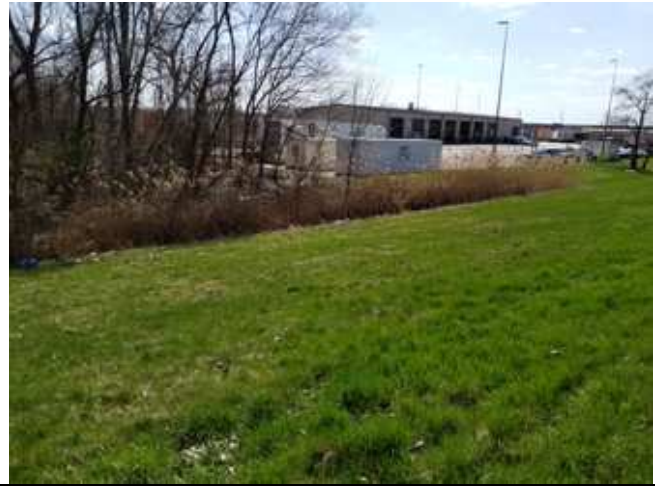
Category:	Interior Drainage System	Item:	Vegetation and Obstr
Observation ID:	2023-0241		
Description:	Phragmites encroachment that extends around levee bend, located east of Georgia Street.		
Caption:	0241 - No User Rating (Site Visit) - Phragmites encroachment that extends around levee bend, located east of Georgia Street.		
Lat/Long:	41.56060/-87.32452

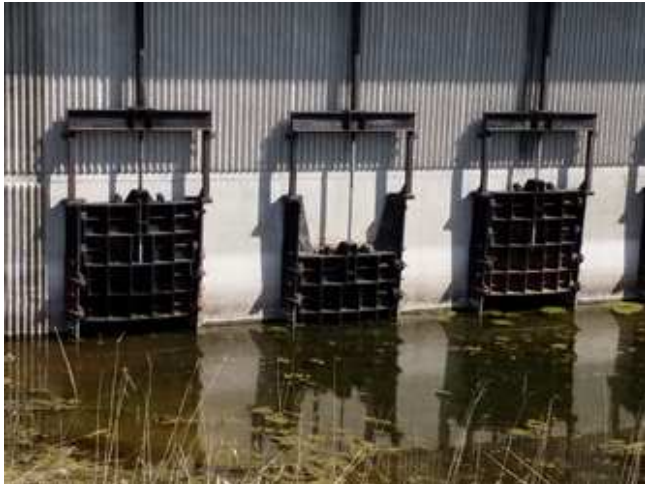
Category:	Interior Drainage System	Item:	Sluice / Slide Gates
Observation ID:	2023-0021		
Description:	GS-2a: gate closed completely.		
Caption:	0021 - No User Rating (Site Visit) - GS-2a: gate closed completely.		
Lat/Long:	41.55879/-87.36691

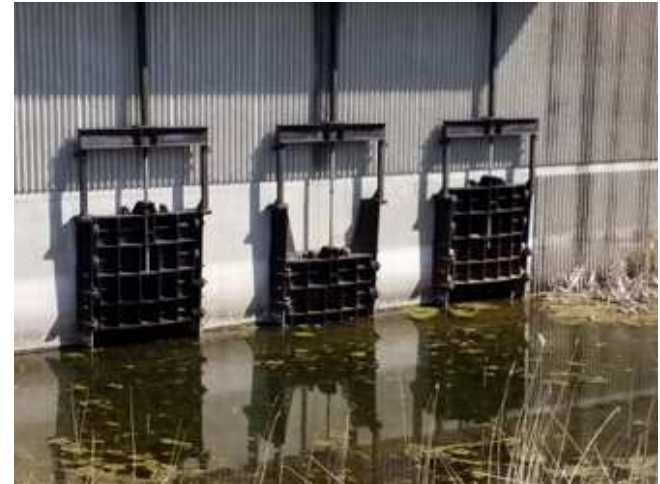
Category:	Interior Drainage System	Item:	Sluice / Slide Gates
Observation ID:	2023-0024		
Description:	GS-2b: gate was squeaky when closed fully.		
Caption:	0024 - No User Rating (Site Visit) - GS-2b: gate was squeaky when closed fully.		
Lat/Long:	41.55881/-87.36689

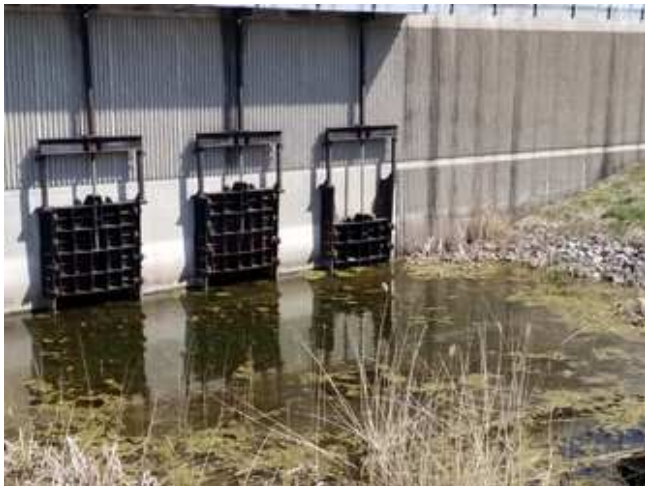
Category:	Interior Drainage System	Item:	Sluice / Slide Gates
Observation ID:	2023-0027		
Description:	GS-2c: gate was squeaky when closed fully.		
Caption:	0027 - No User Rating (Site Visit) - GS-2c: gate was squeaky when closed fully.		
Lat/Long:	41.55879/-87.36690

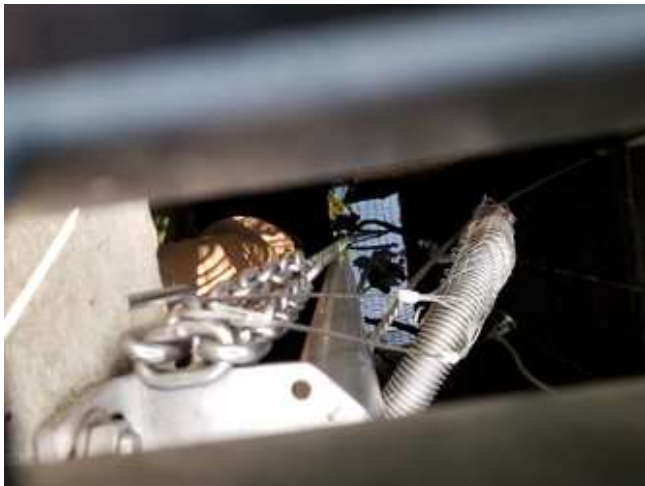
Category:	Interior Drainage System	Item:	Sluice / Slide Gates
Observation ID:	2023-0042		
Description:	GS-3: closed completely.		
Caption:	0042 - No User Rating (Site Visit) - GS-3: closed completely.		
Lat/Long:	41.55894/-87.35974

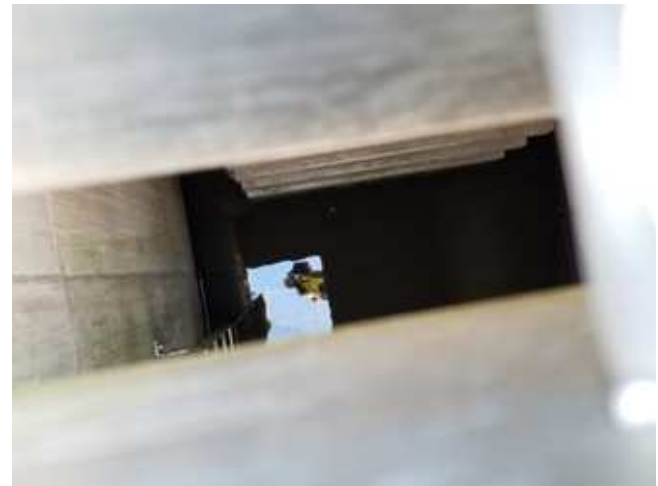
Category:	Interior Drainage System	Item:	Sluice / Slide Gates
Observation ID:	2023-0102		
Description:	GS-12b: upstream gate missing dial.		
Caption:	0102 - No User Rating (Site Visit) - GS-12b: upstream gate missing dial.		
Lat/Long:	41.56069/-87.33604

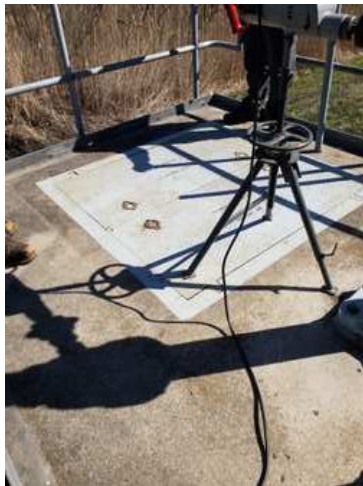
Category:	Interior Drainage System	Item:	Sluice / Slide Gates
Observation ID:	2023-0114		
Description:	GS-14: Gate opened and closed completely.		
Caption:	0114 - No User Rating (Site Visit) - GS-14: Gate opened and closed completely.		
Lat/Long:	41.56066/-87.33360

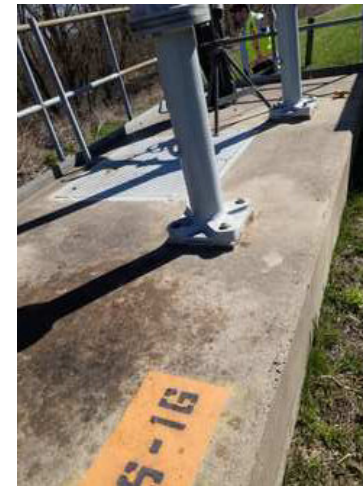
Category:	Interior Drainage System	Item:	Sluice / Slide Gates
Observation ID:	2023-0117		
Description:	GS-15: gate was working, but were not able to see the sluice gate if fully open. Also, team couldn't lift the hatch since it was too heavy.		
Caption:	0117 - No User Rating (Site Visit) - GS-15: gate was working, but were not able to see the sluice gate if fully open. Also, team couldn't lift the hatch since it was too heavy.		
Lat/Long:	41.56060/-87.33307

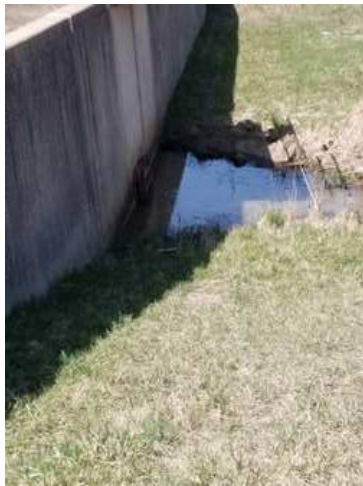
Category:	Interior Drainage System	Item:	Sluice / Slide Gates
Observation ID:	2023-0123		
Description:	GS-16: gate was working, but the steel plate too heavy to lift to see if gates opened.		
Caption:	0123 - No User Rating (Site Visit) - GS-16: gate was working, but the steel plate too heavy to lift to see if gates opened.		
Lat/Long:	41.56068/-87.32693

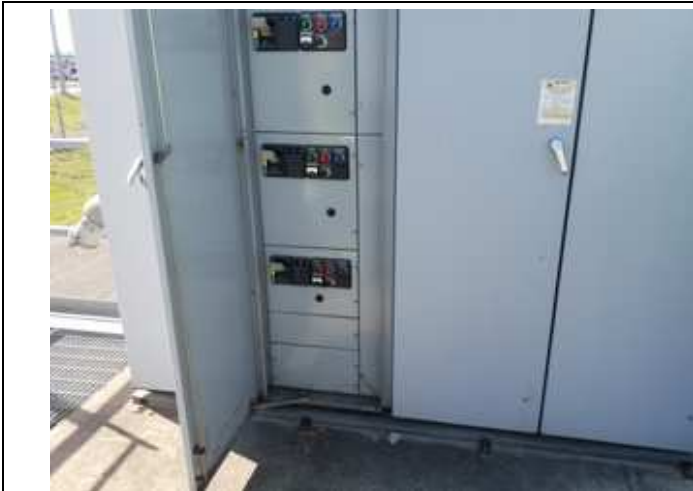
Category:	Pump Stations	Item:	Pump Station Operati
Observation ID:	2023-0002		
Description:	PS-GE: no operations manual on site, but located at central office.		
Caption:	0002 - No User Rating (Site Visit) - PS-GE: no operations manual on site, but located at central office.		
Lat/Long:	41.56468/-87.35518

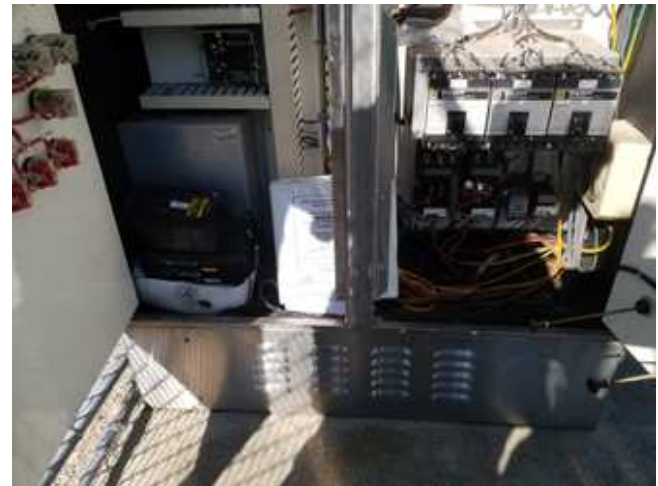
Category:	Pump Stations	Item:	Pump Station Operati
Observation ID:	2023-0023		
Description:	PS-GW: no operations manual on site, but located at the central office.		
Caption:	0023 - No User Rating (Site Visit) - PS-GW: no operations manual on site, but located at the central office.		
Lat/Long:	41.56467/-87.35656

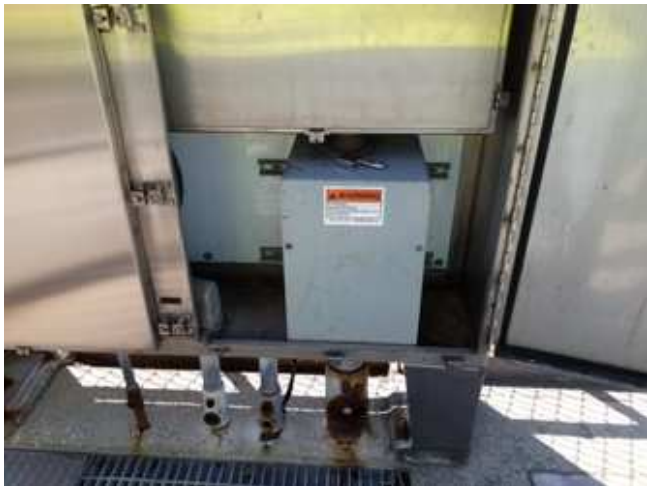
Category:	Pump Stations	Item:	Pump Station Operati
Observation ID:	2023-0032		
Description:	PS-CL: operations manual present on site.		
Caption:	0032 - No User Rating (Site Visit) - PS-CL: operations manual present on site.		
Lat/Long:	41.56055/-87.35910

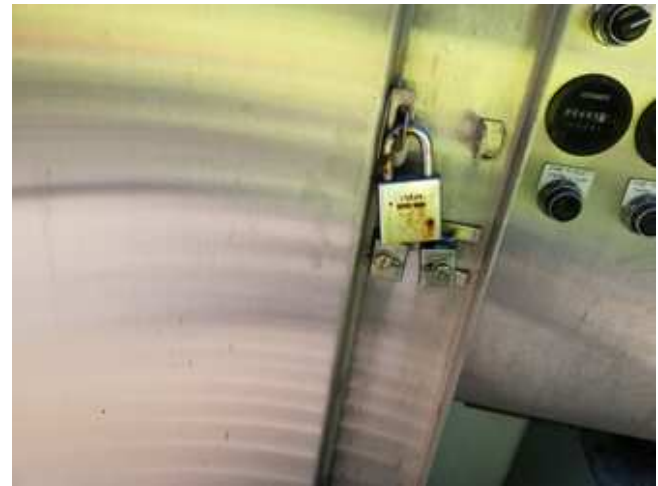
Category:	Pump Stations	Item:	Pump Station Operati
Observation ID:	2023-0050		
Description:	PS-BW: operations manuals not present on site, but located at the central office.		
Caption:	0050 - No User Rating (Site Visit) - PS-BW: operations manuals not present on site, but located at the central office.		
Lat/Long:	41.56074/-87.33605

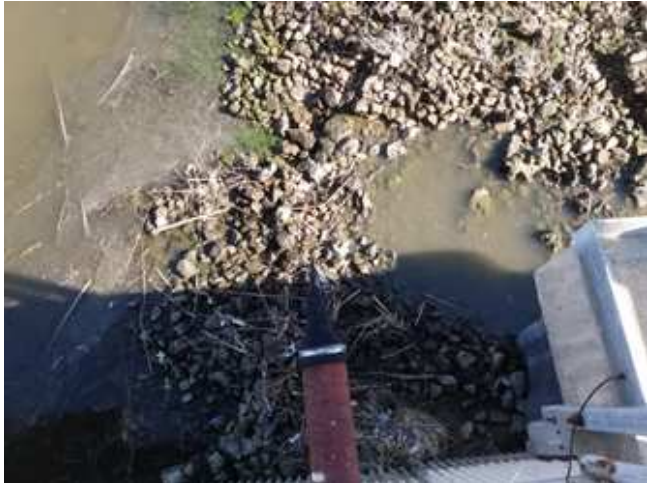
Category:	Pump Stations	Item:	Plant Building
Observation ID:	2023-0014		
Description:	PS-GW: Minimal cracks in concrete wall facing.		
Caption:	0014_2 - No User Rating (Site Visit) - PS-GW: Minimal cracks in concrete wall facing.		
Lat/Long:	41.56466/-87.35655

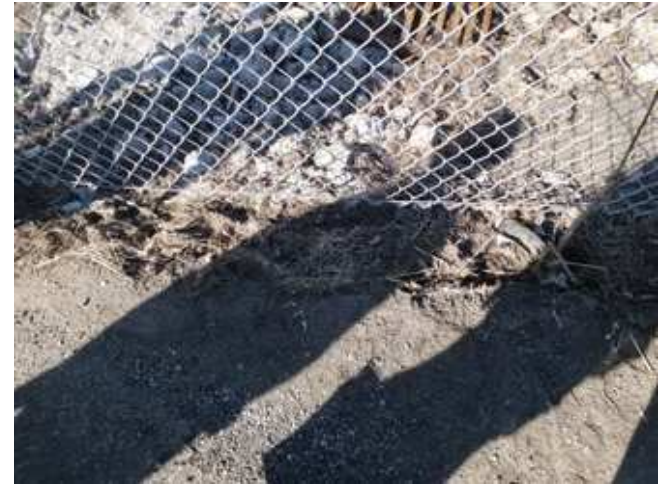
Category:	Pump Stations	Item:	Fencing and Gates
Observation ID:	2023-0008		
Description:	PS-GW: Fence post has been repaired/replaced.		
Caption:	0008 - No User Rating (Site Visit) - PS-GW: Fence post has been repaired/replaced.		
Lat/Long:	41.56449/-87.35656

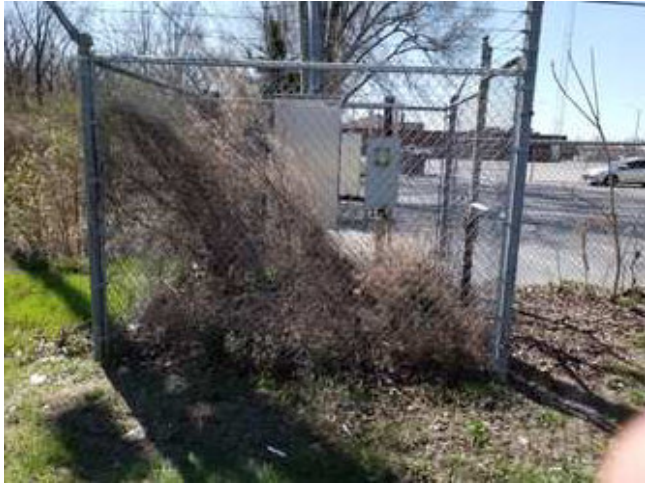
Category:	Pump Stations	Item:	Fencing and Gates
Observation ID:	2023-0026		
Description:	PS-GW: Animal burrows under wire fence.		
Caption:	0026 - No User Rating (Site Visit) - PS-GW: Animal burrows under wire fence.		
Lat/Long:	41.56440/-87.35648

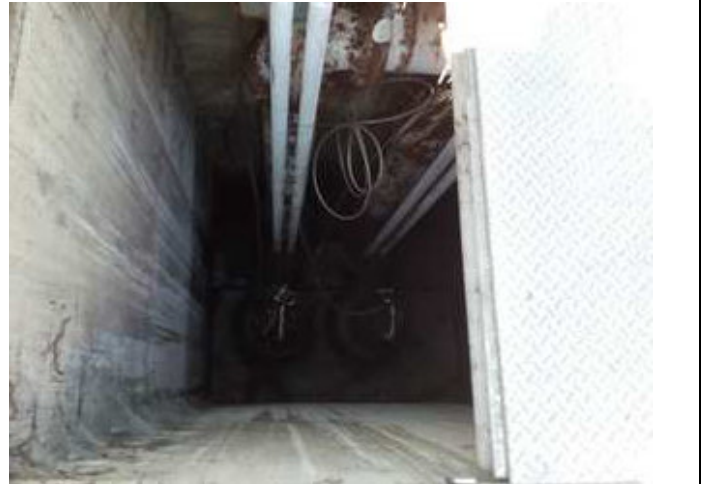
Category:	Pump Stations	Item:	Pumps
Observation ID:	2023-0017		
Description:	PS-GW: Missing nut and bolt on top of pump assembly.		
Caption:	0017 - No User Rating (Site Visit) - PS-GW: Missing nut and bolt on top of pump assembly.		
Lat/Long:	41.56466/-87.35650

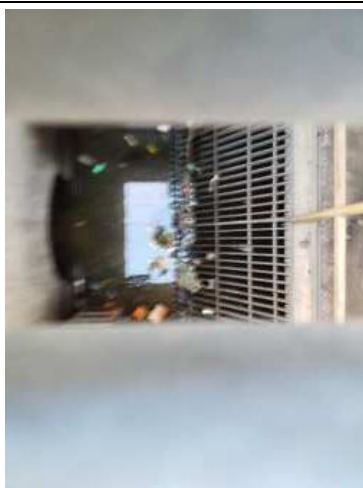
Category:	Pump Stations	Item:	Pumps
Observation ID:	2023-0056		
Description:	PS-BW: Pump intake chamber is empty and dry. Pumps were not operated.		
Caption:	0056 - No User Rating (Site Visit) - PS-BW: Pump intake chamber is empty and dry. Pumps were not operated.		
Lat/Long:	41.56070/-87.33607

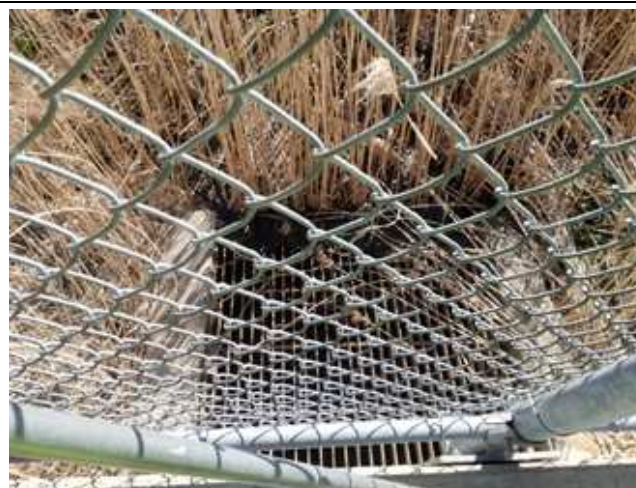
Category:	Pump Stations	Item:	Non-Mechanical Trash
Observation ID:	2023-0011		
Description:	PS-GW: Some trash and debris build up on trash rake.		
Caption:	0011 - No User Rating (Site Visit) - PS-GW: Some trash and debris build up on trash rake.		
Lat/Long:	41.56459/-87.35656

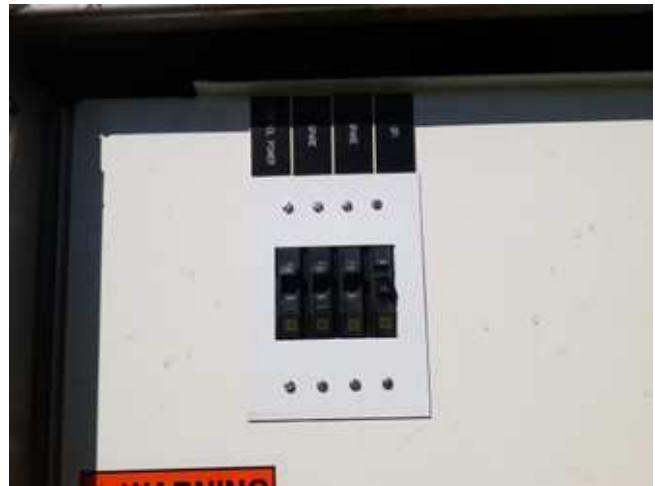
Category:	Pump Stations	Item:	Electrical Systems
Observation ID:	2023-0038		
Description:	PS-CL: Broken Button.		
Caption:	0038 - No User Rating (Site Visit) - PS-CL: Broken Button.		
Lat/Long:	41.56057/-87.35905

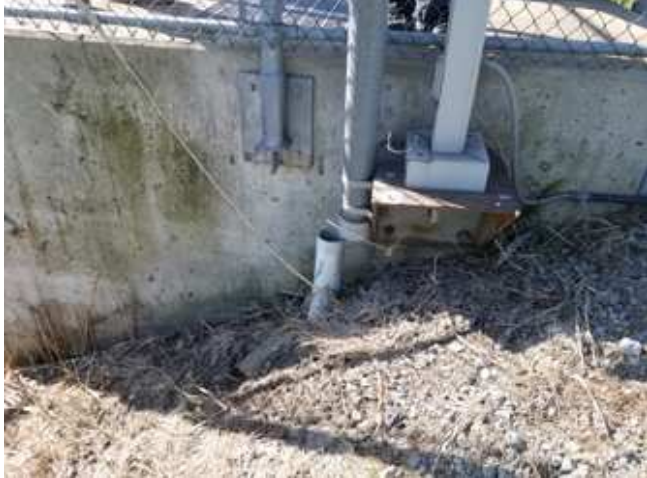
Category:	Pump Stations	Item:	Electrical Systems
Observation ID:	2023-0044		
Description:	PS-CL: GFI is actually a camera.		
Caption:	0044 - No User Rating (Site Visit) - PS-CL: GFI is actually a camera.		
Lat/Long:	41.56057/-87.35909
