**US Army Corps
of Engineers®**

Levee Inspection Report

Name of System: Hammond Forest Ave

Date(s) of Inspection: 07/06/2020 - 07/08/2020

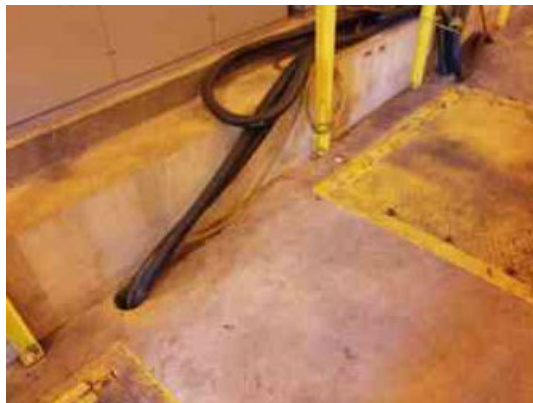
Inspect ID: 2020-0019 **Title:** 2604000010_CELRC_2020_A_0017_1_20200707T135958.jpg **Rated Item:** 13. Power Source **Caption:** Acceptable - PS-SH: Submersible pumps have non-removable power cables. Cannot be placed in conduit.

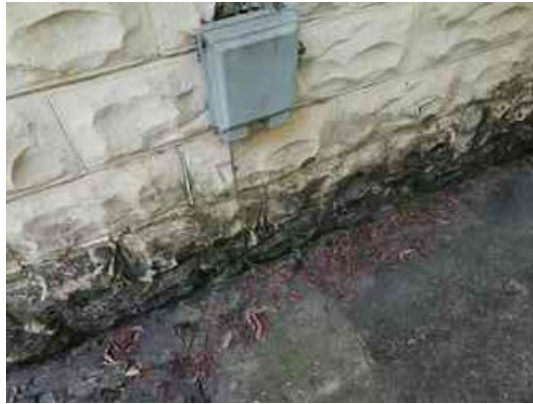
Inspect ID: 2020-0031 **Title:** 2604000010_CELRC_2020_A_0031_1_20200707T155558.jpg **Rated Item:** 14. Electrical Systems **Caption:** Minimally Acceptable - PS-FA: Grounding wire loose.

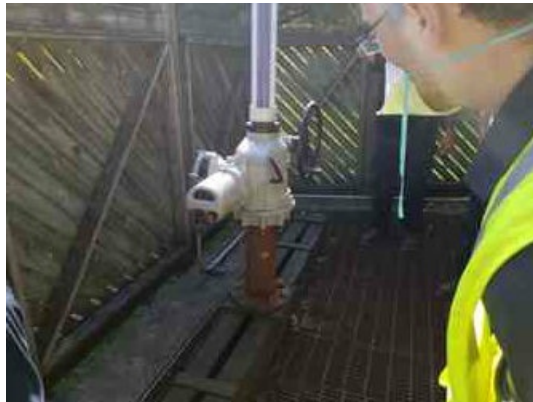
Inspect ID: 2020-0001 **Title:** 2604000010_CELRC_2020_A_0001_1_20200707T134240.jpg **Rated Item:** 18. Sluice/ Slide Gates **Caption:** Acceptable - PS-SH: Influent sluice gate is now in operation.
