Levee Inspection Report

Name of System: Hammond

Name of Segment: Hammond

Date(s) of Inspection: 07/07/2020 - 07/08/2020

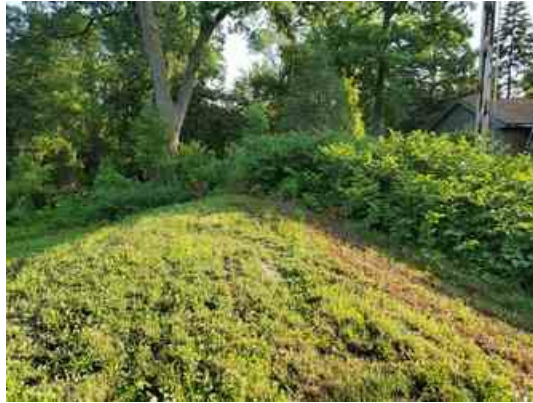
Inspect ID: 2020-0003 **Title:** 2604000008_CELRC_2020_A_0003_1_20200707T121341.jpg **Rated Item:** 1. Unwanted Vegetation Growth **Caption:** Minimally Acceptable - Tall vegetation on crest and slopes.

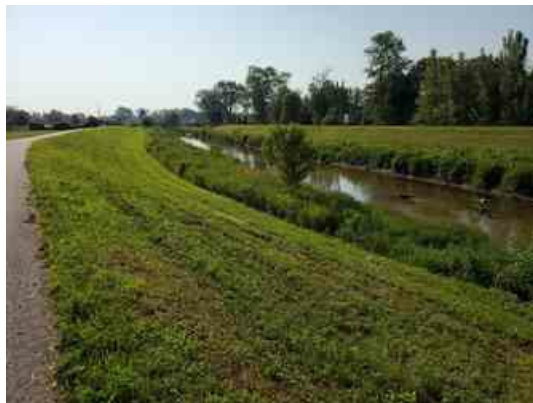
Inspect ID: 2020-0075 **Title:** 2604000008_CELRC_2020_A_0075_1_20200707T134115.jpg **Rated Item:** 1. Unwanted Vegetation Growth **Caption:** Minimally Acceptable - Trees on riverside toe.

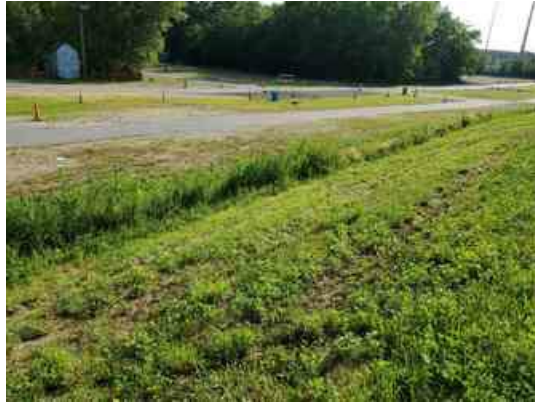
Inspect ID: 2020-0078 **Title:** 2604000008_CELRC_2020_A_0078_1_20200707T134212.jpg **Rated Item:** 1. Unwanted Vegetation Growth **Caption:** Minimally Acceptable - Tall vegetation on landside toe.

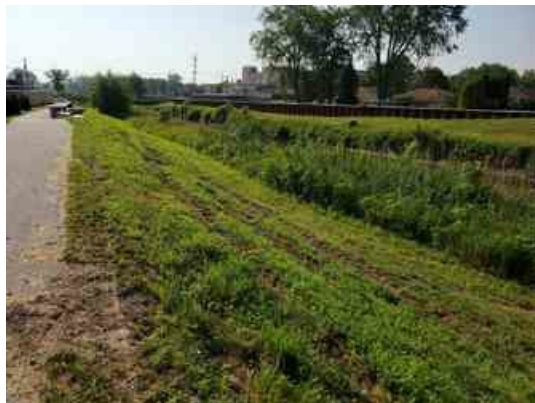
Inspect ID: 2020-0084 **Title:** 2604000008_CELRC_2020_A_0084_1_20200707T134551.jpg **Rated Item:** 1. Unwanted Vegetation Growth **Caption:** Minimally Acceptable - Tall vegetation on riverside toe.

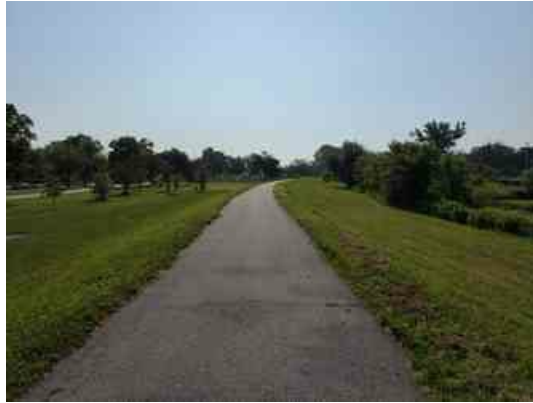
Inspect ID: 2020-0099 **Title:** 2604000008_CELRC_2020_A_0099_1_20200707T135423.jpg **Rated Item:** 1. Unwanted Vegetation Growth **Caption:** Acceptable - Acceptable vegetation on slopes.

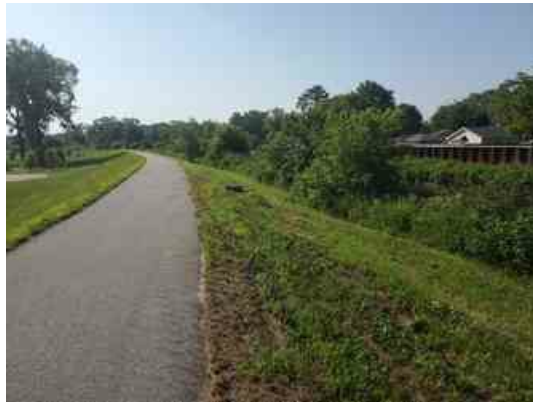
Inspect ID: 2020-0105 **Title:** 2604000008_CELRC_2020_A_0105_1_20200707T140557.jpg **Rated Item:** 1. Unwanted Vegetation Growth **Caption:** Minimally Acceptable - Tall vegetation and trees on riverside toe.

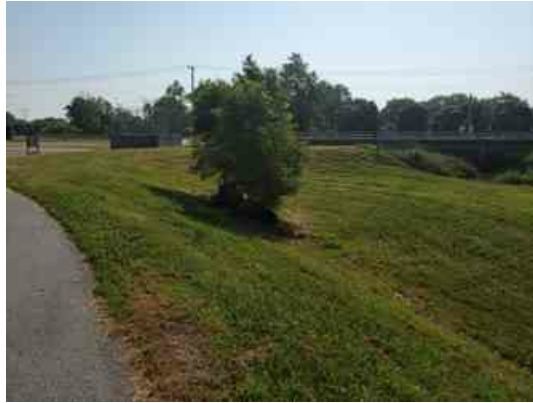
Inspect ID: 2020-0117 **Title:** 2604000008_CELRC_2020_A_0117_1_20200707T141502.jpg **Rated Item:** 1. Unwanted Vegetation Growth **Caption:** Minimally Acceptable - Tall trees on riverside slope.

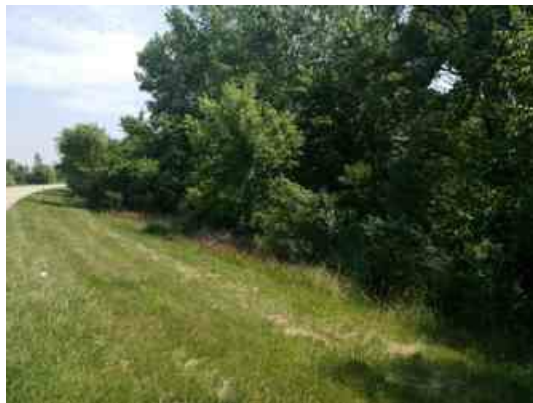
Inspect ID: 2020-0119 **Title:** 2604000008_CELRC_2020_A_2020-0119_1_20200708T160615.jpg **Rated Item:** 1. Unwanted Vegetation Growth **Caption:** Minimally Acceptable - Trees on riverside slope.

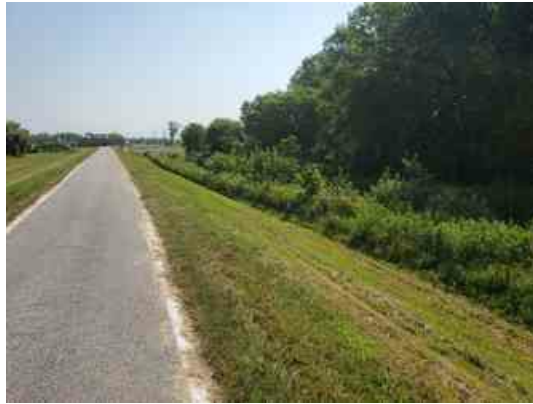
Inspect ID: 2020-0219 **Title:** 2604000008_CELRC_2020_A_0219_1_20200707T145457.jpg **Rated Item:** 1. Unwanted Vegetation Growth **Caption:** Minimally Acceptable - Tall vegetation on riverside toe.

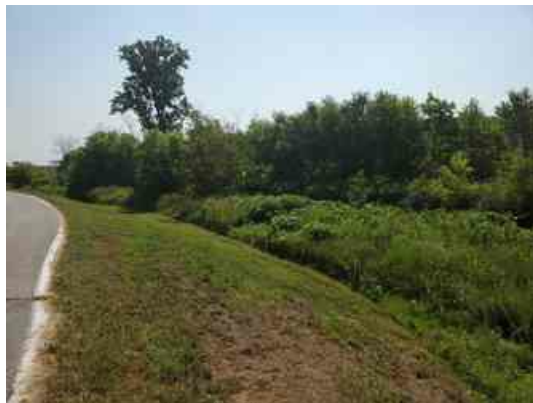
Inspect ID: 2020-0228 **Title:** 2604000008_CELRC_2020_A_0228_1_20200707T150524.jpg **Rated Item:** 1. Unwanted Vegetation Growth **Caption:** Minimally Acceptable - Tall vegetation and trees on landside toe.

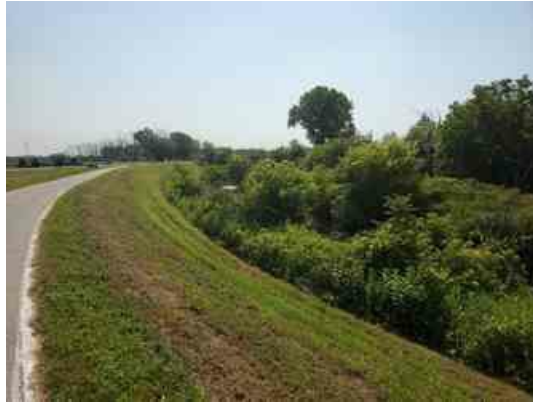
Inspect ID: 2020-0237 **Title:** 2604000008_CELRC_2020_A_0237_1_20200707T150922.jpg **Rated Item:** 1. Unwanted Vegetation Growth **Caption:** Minimally Acceptable - Tall vegetation and trees on riverside toe.

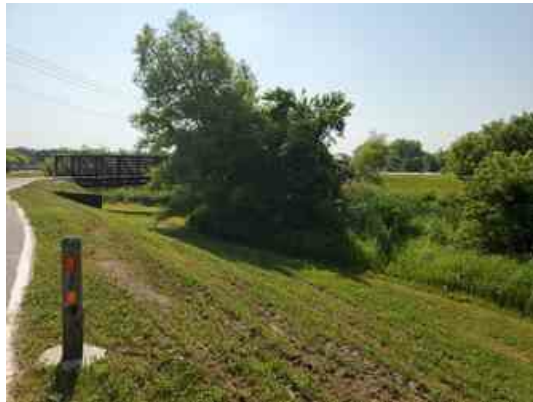
Inspect ID: 2020-0240 **Title:** 2604000008_CELRC_2020_A_0240_1_20200707T151336.jpg **Rated Item:** 1. Unwanted Vegetation Growth **Caption:** Minimally Acceptable - Trees on riverside toe.

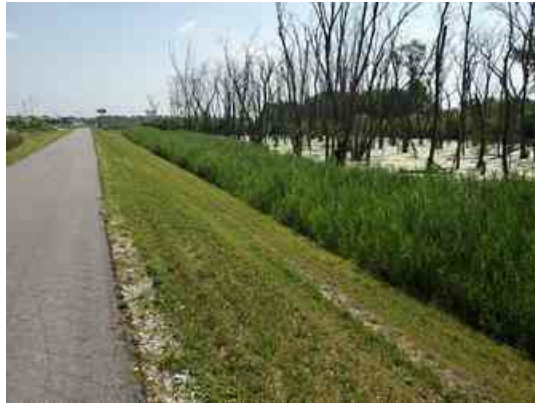
Inspect ID: 2020-0261 **Title:** 2604000008_CELRC_2020_A_0261_1_20200707T153521.jpg **Rated Item:** 1. Unwanted Vegetation Growth **Caption:** Minimally Acceptable - Tall vegetation on riverside toe.

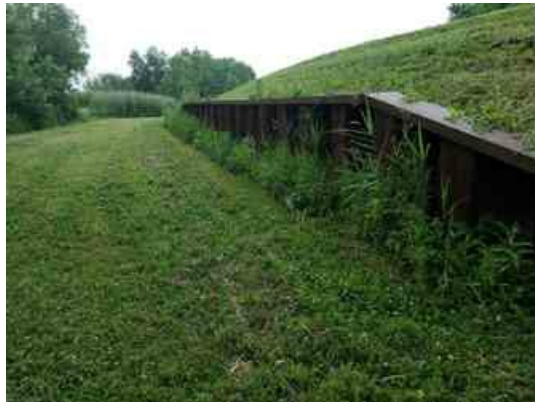
Inspect ID: 2020-0294 **Title:** 2604000008_CELRC_2020_A_0294_1_20200707T155619.jpg **Rated Item:** 1. Unwanted Vegetation Growth **Caption:** Minimally Acceptable - Small vegetation along sheetpile retaining wall.

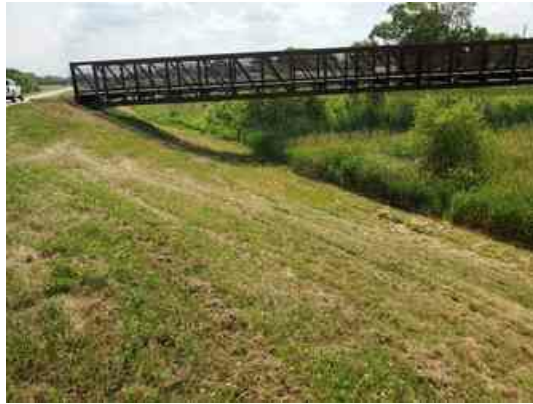
Inspect ID: 2020-0306 **Title:** 2604000008_CELRC_2020_A_0306_1_20200707T161419.jpg **Rated Item:** 1. Unwanted Vegetation Growth **Caption:** Minimally Acceptable - Tall vegetation on riverside toe.

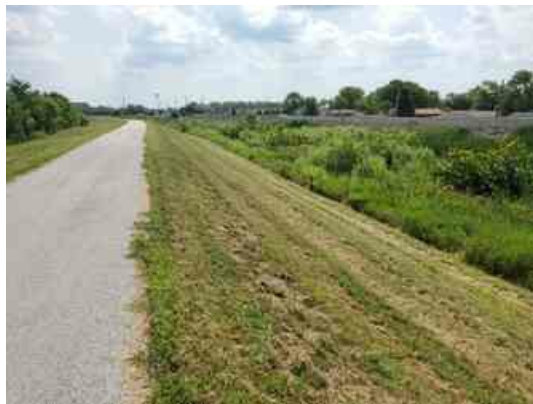
Inspect ID: 2020-0309 **Title:** 2604000008_CELRC_2020_A_0309_1_20200707T161548.jpg **Rated Item:** 1. Unwanted Vegetation Growth **Caption:** Minimally Acceptable - Tall vegetation and trees on riverside toe.

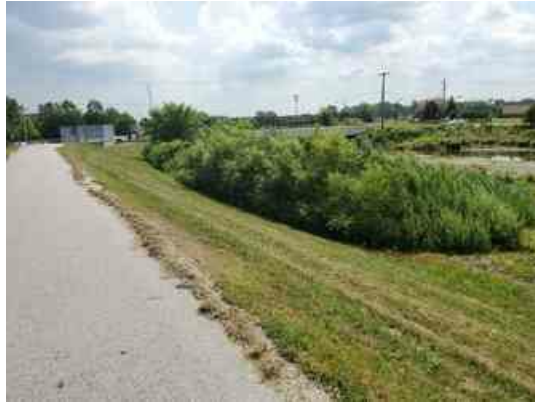
Inspect ID: 2020-0321 **Title:** 2604000008_CELRC_2020_A_0321_1_20200707T162152.jpg **Rated Item:** 1. Unwanted Vegetation Growth **Caption:** Minimally Acceptable - Trees on riverside toe.

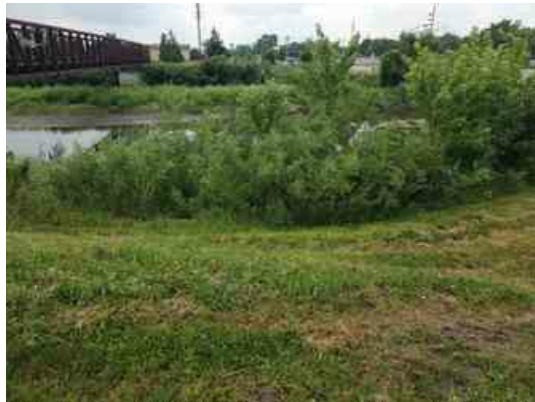
Inspect ID: 2020-0330 **Title:** 2604000008_CELRC_2020_A_0330_1_20200707T171945.jpg **Rated Item:** 1. Unwanted Vegetation Growth **Caption:** Minimally Acceptable - Tall vegetation and trees on riverside toe.

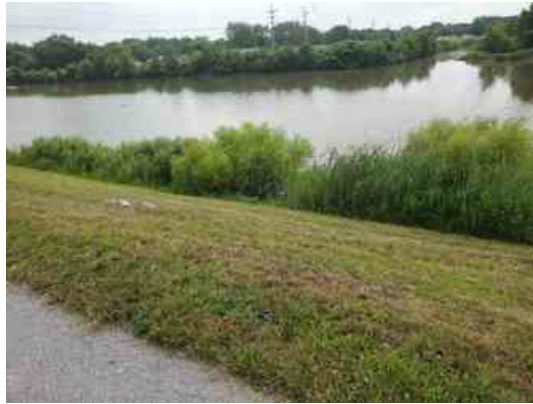
Inspect ID: 2020-0366 **Title:** 2604000008_CELRC_2020_A_0366_1_20200707T174412.jpg **Rated Item:** 1. Unwanted Vegetation Growth **Caption:** Minimally Acceptable - Tall vegetation on riverside toe.

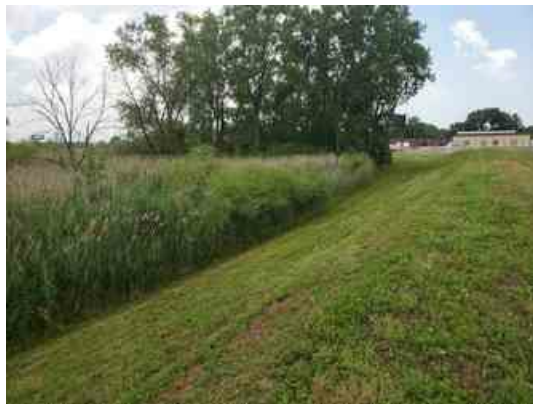
Inspect ID: 2020-0369 **Title:** 2604000008_CELRC_2020_A_0369_1_20200707T174638.jpg **Rated Item:** 1. Unwanted Vegetation Growth **Caption:** Minimally Acceptable - Tall vegetation and trees on landside toe.

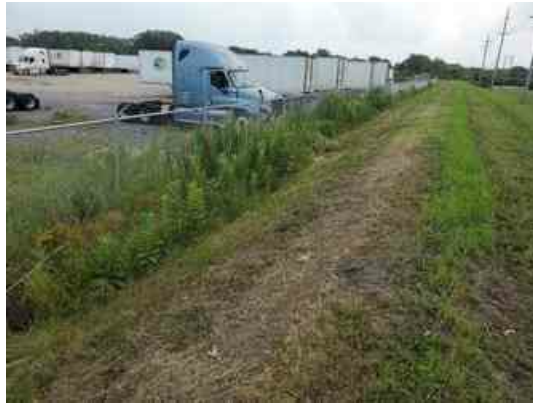
Inspect ID: 2020-0381 **Title:** 2604000008_CELRC_2020_A_0381_1_20200707T175413.jpg **Rated Item:** 1. Unwanted Vegetation Growth **Caption:** Minimally Acceptable - Tall vegetation on landside toe.

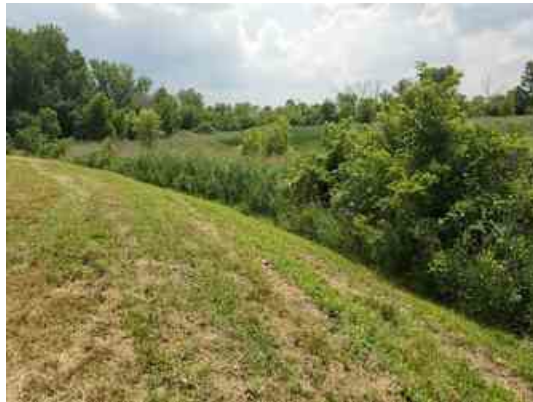
Inspect ID: 2020-0432 **Title:** 2604000008_CELRC_2020_A_0432_1_20200707T182016.jpg **Rated Item:** 1. Unwanted Vegetation Growth **Caption:** Minimally Acceptable - Trees on riverside slope.

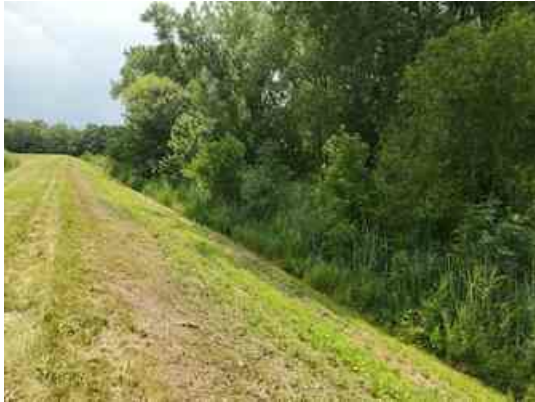
Inspect ID: 2020-0438 Title: 2604000008_CELRC_2020_A_0438_1_20200707T182148.jpg Rated Item: 1. Unwanted Vegetation Growth Caption: Minimally Acceptable - Trees on riverside toe.

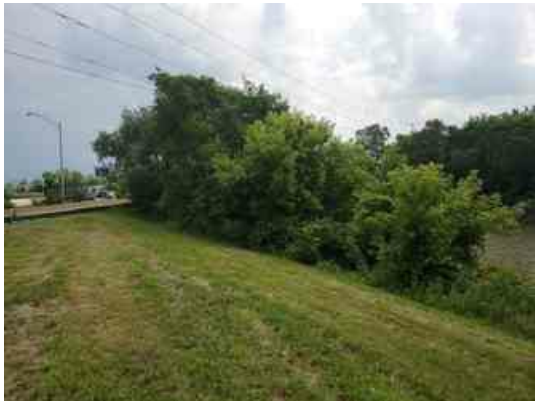
Inspect ID: 2020-0471 Title: 2604000008_CELRC_2020_A_0471_1_20200707T184649.jpg Rated Item: 1. Unwanted Vegetation Growth Caption: Minimally Acceptable - Large trees and tall vegetation on slope.

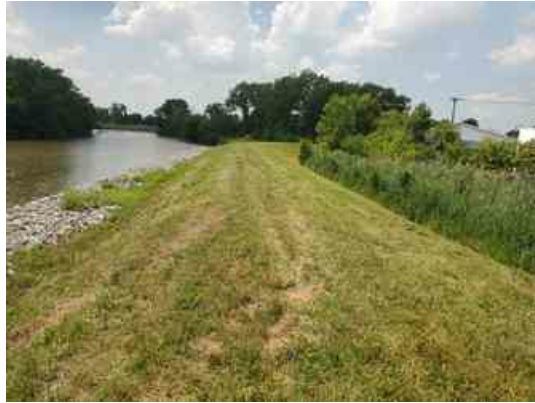
Inspect ID: 2020-0450 **Title:** 2604000008_CELRC_2020_A_0450_1_20200707T182637.jpg **Rated Item:** 2. Sod Cover **Caption:** Acceptable - Good sod cover.

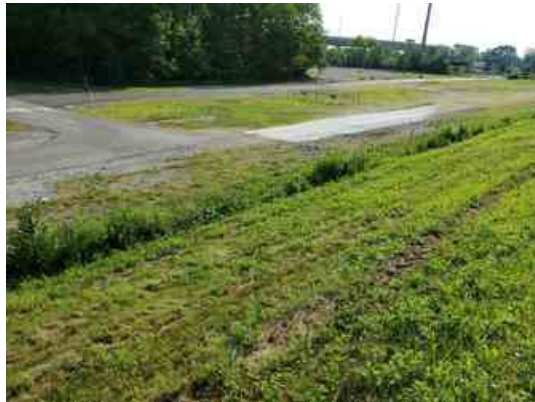
Inspect ID: 2020-0081 **Title:** 2604000008_CELRC_2020_A_0081_1_20200707T134312.jpg **Rated Item:** 3. Encroachments **Caption:** Minimally Acceptable - Posts and rope along the landside toe.

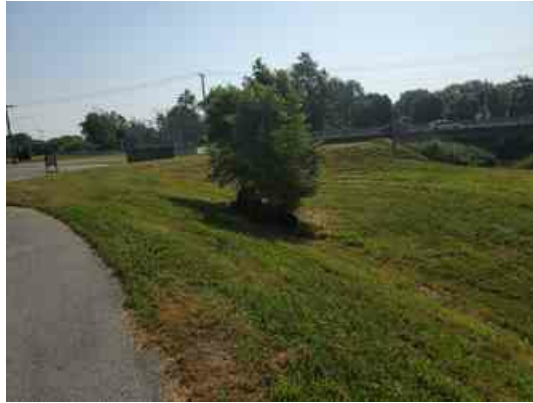
Inspect ID: 2020-0114 **Title:** 2604000008_CELRC_2020_A_0114_1_20200707T141433.jpg **Rated Item:** 3. Encroachments **Caption:** Minimally Acceptable - Large logs on riverside slope. Prevented mowing and allowed trees to grow.

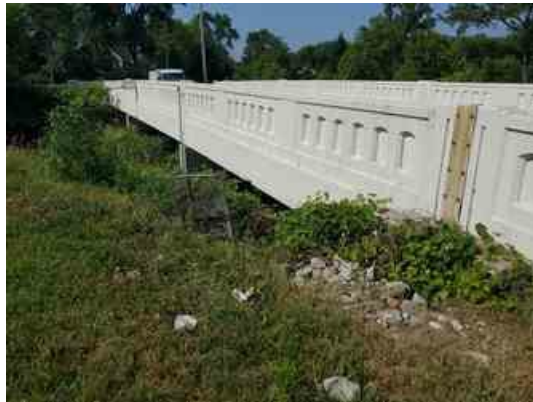
Inspect ID: 2020-0204 **Title:** 2604000008_CELRC_2020_A_0204_1_20200707T144751.jpg **Rated Item:** 3. Encroachments **Caption:** Minimally Acceptable - Shopping cart on riverside slope.

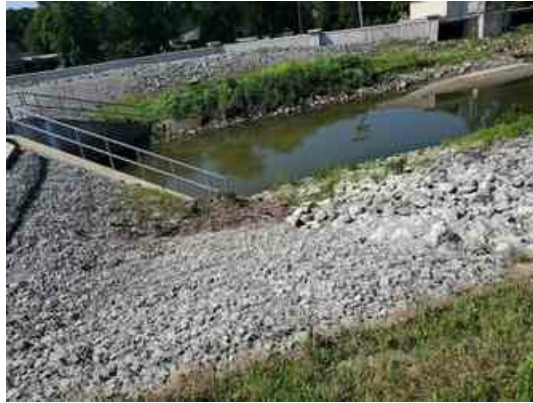
Inspect ID: 2020-0207 **Title:** 2604000008_CELRC_2020_A_0207_1_20200707T144946.jpg **Rated Item:** 3. Encroachments **Caption:** Minimally Acceptable - Woody debris on riverside slope.

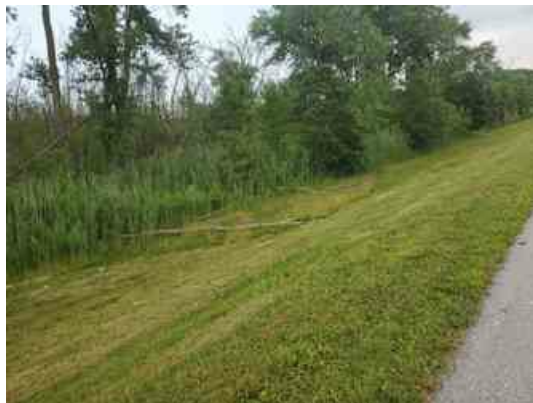
Inspect ID: 2020-0354 **Title:** 2604000008_CELRC_2020_A_0354_1_20200707T173721.jpg **Rated Item:** 3. Encroachments **Caption:** Minimally Acceptable - Downed trees on landside toe.

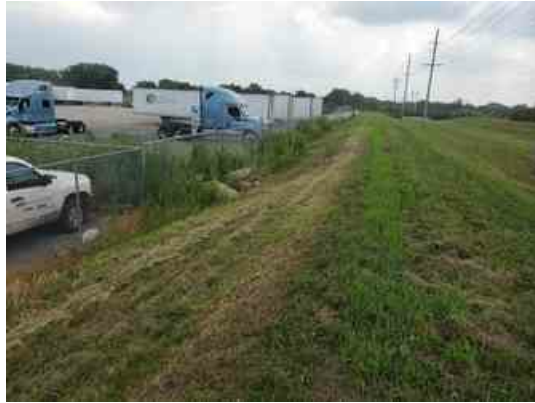
Inspect ID: 2020-0378 **Title:** 2604000008_CELRC_2020_A_0378_1_20200707T175330.jpg **Rated Item:** 3. Encroachments **Caption:** Minimally Acceptable - Concrete debris on landside toe.

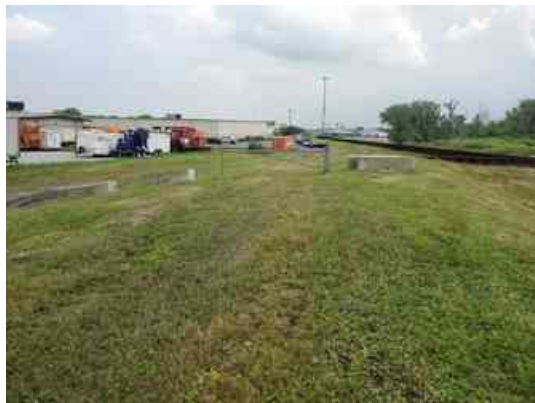
Inspect ID: 2020-0399 **Title:** 2604000008_CELRC_2020_A_0399_1_20200707T180214.jpg **Rated Item:** 3. Encroachments **Caption:** Minimally Acceptable - Concrete blocks across levee.

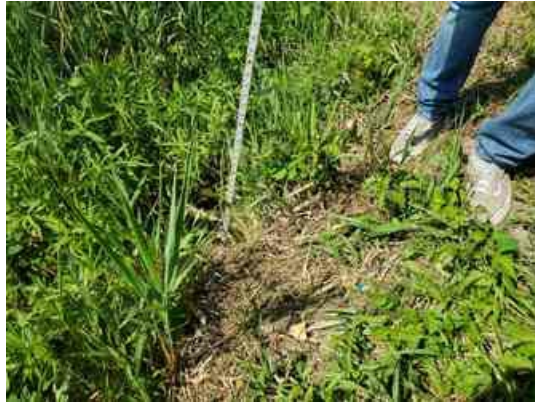
Inspect ID: 2020-0249 **Title:** 2604000008_CELRC_2020_A_0249_1_20200707T151715.jpg **Rated Item:** 6. Erosion/ Bank Caving **Caption:** Minimally Acceptable - 1 ft scarp on riverside toe.

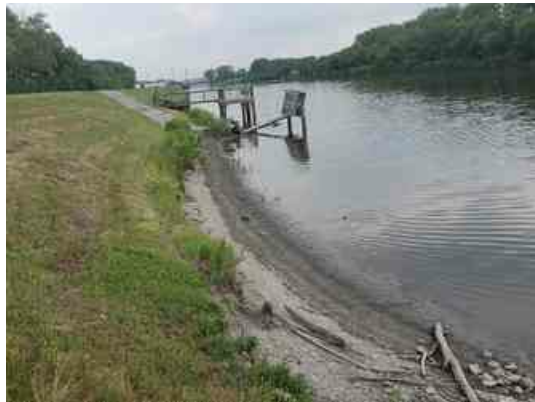
Inspect ID: 2020-0348 **Title:** 2604000008_CELRC_2020_A_0348_1_20200707T173401.jpg **Rated Item:** 6. Erosion/ Bank Caving **Caption:** Minimally Acceptable - Erosion at toe.

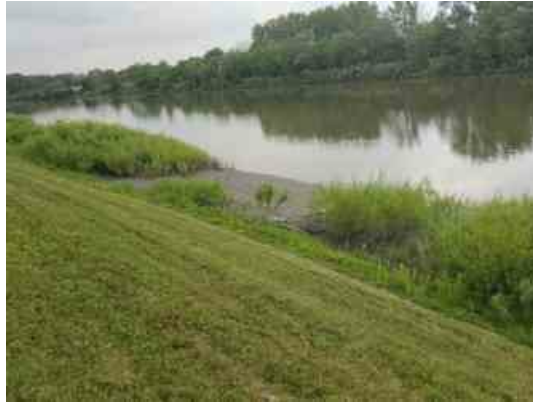
Inspect ID: 2020-0357 **Title:** 2604000008_CELRC_2020_A_0357_1_20200707T173824.jpg **Rated Item:** 6. Erosion/ Bank Caving **Caption:** Minimally Acceptable - Erosion at toe.

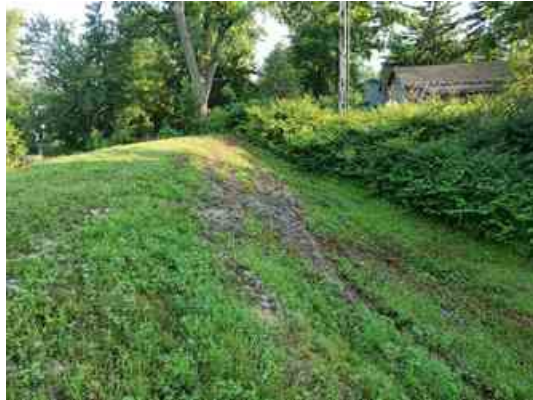
Inspect ID: 2020-0009 **Title:** 2604000008_CELRC_2020_A_0009_1_20200707T121531.jpg **Rated Item:** 8. Depressions/ Rutting **Caption:** Minimally Acceptable - Rutting on landside slope.

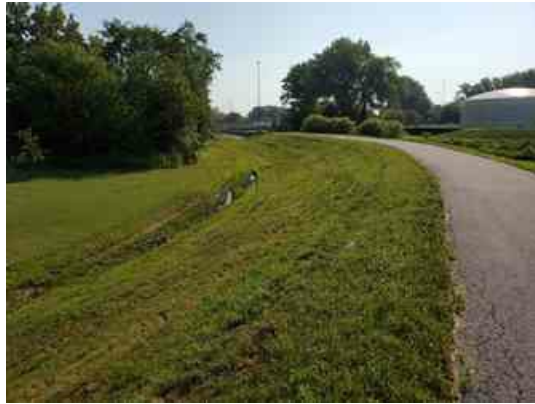
Inspect ID: 2020-0030 **Title:** 2604000008_CELRC_2020_A_0030_1_20200707T132543.jpg **Rated Item:** 8. Depressions/ Rutting **Caption:** Minimally Acceptable - Rutting on landside toe.

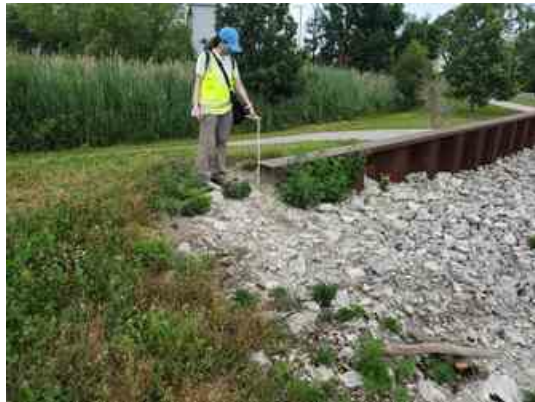
Inspect ID: 2020-0345 **Title:** 2604000008_CELRC_2020_A_0345_1_20200707T172629.jpg **Rated Item:** 8. Depressions/ Rutting **Caption:** Minimally Acceptable - Levee eroded at transition.

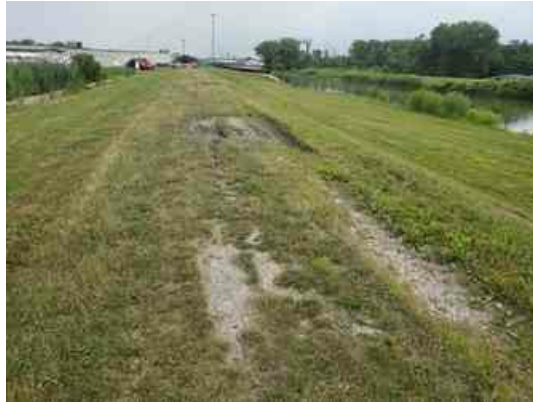
Inspect ID: 2020-0390 **Title:** 2604000008_CELRC_2020_A_0390_1_20200707T175809.jpg **Rated Item:** 8. Depressions/ Rutting **Caption:** Minimally Acceptable - Deep ruts on crest.

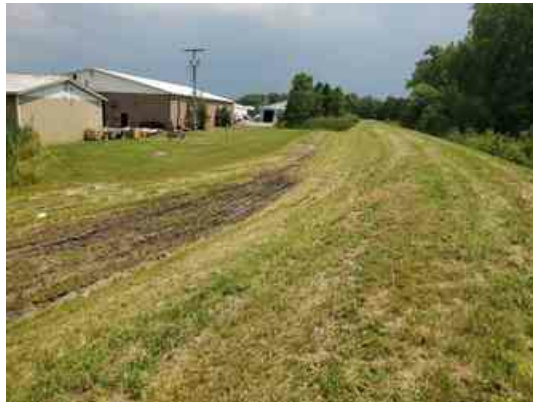
Inspect ID: 2020-0435 **Title:** 2604000008_CELRC_2020_A_0435_1_20200707T182041.jpg **Rated Item:** 8. Depressions/ Rutting **Caption:** Minimally Acceptable - Rutting on landside toe.

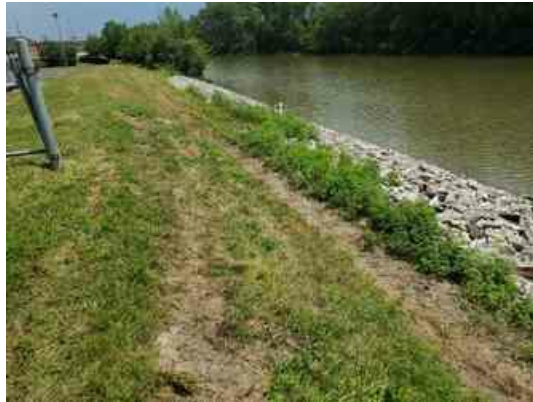
Inspect ID: 2020-0447 **Title:** 2604000008_CELRC_2020_A_0447_1_20200707T182607.jpg **Rated Item:** 8. Depressions/ Rutting **Caption:** Minimally Acceptable - Rut on riverside slope.

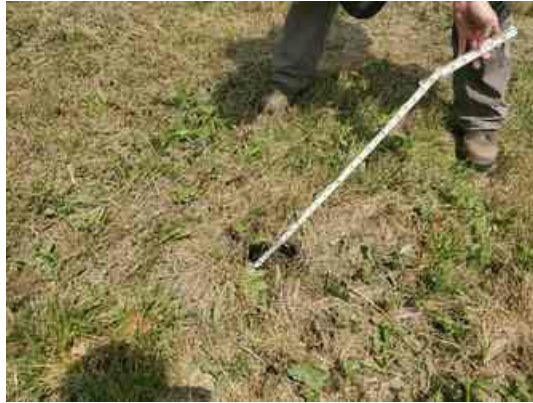
Inspect ID: 2020-0468 **Title:** 2604000008_CELRC_2020_A_0468_1_20200707T184551.jpg **Rated Item:** 10. Animal Control **Caption:** Minimally Acceptable - Three burrows on crest, two feet deep.

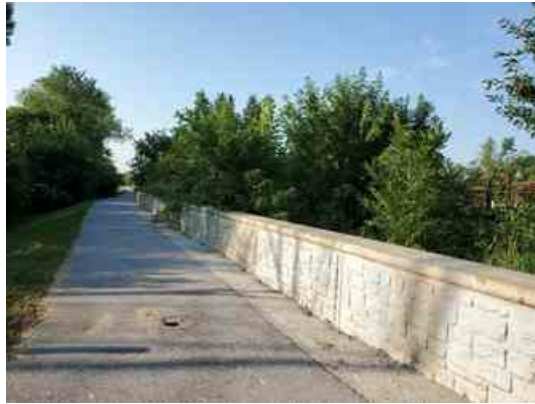
Inspect ID: 2020-0012 **Title:** 2604000008_CELRC_2020_A_0012_1_20200707T121951.jpg **Rated Item:** 1. Unwanted Vegetation Growth **Caption:** Minimally Acceptable - Trees on riverside.

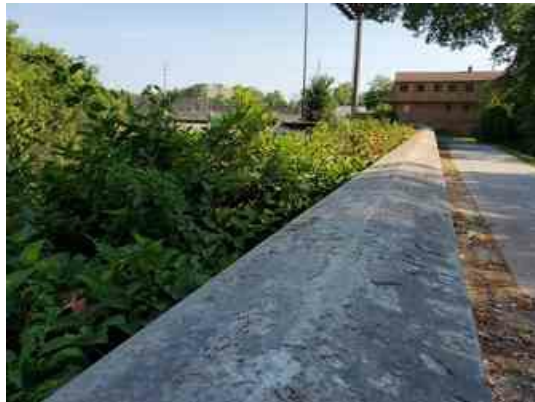
Inspect ID: 2020-0054 **Title:** 2604000008_CELRC_2020_A_0054_1_20200707T133634.jpg **Rated Item:** 1. Unwanted Vegetation Growth **Caption:** Minimally Acceptable - Tall vegetation on riverside.

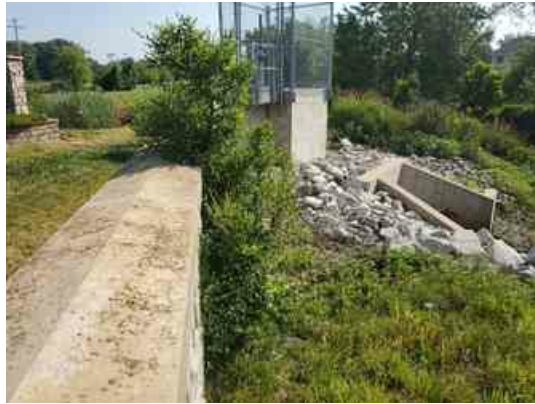
Inspect ID: 2020-0120 **Title:** 2604000008_CELRC_2020_A_0120_1_20200707T141712.jpg **Rated Item:** 1. Unwanted Vegetation Growth **Caption:** Minimally Acceptable - Tree on riverside.

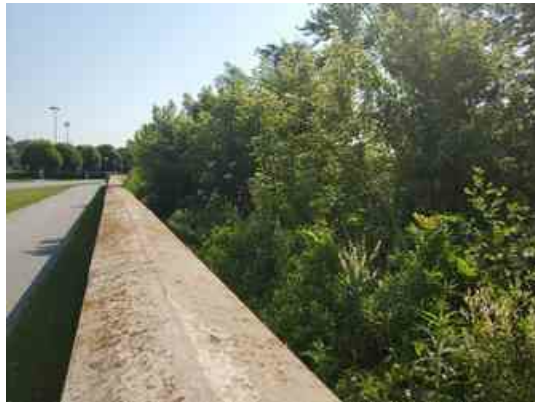
Inspect ID: 2020-0129 **Title:** 2604000008_CELRC_2020_A_0129_1_20200707T142019.jpg **Rated Item:** 1. Unwanted Vegetation Growth **Caption:** Minimally Acceptable - Trees on riverside.

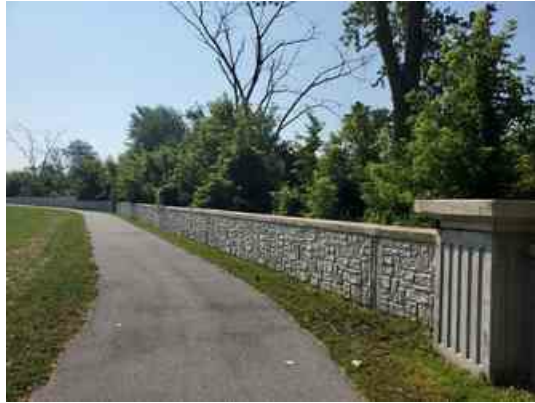
Inspect ID: 2020-0150 **Title:** 2604000008_CELRC_2020_A_0150_1_20200707T142725.jpg **Rated Item:** 1. Unwanted Vegetation Growth **Caption:** Minimally Acceptable - Trees on riverside.

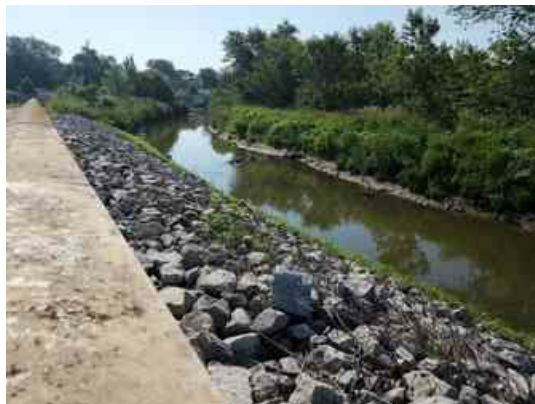
Inspect ID: 2020-0153 **Title:** 2604000008_CELRC_2020_A_0153_1_20200707T142946.jpg **Rated Item:** 1. Unwanted Vegetation Growth **Caption:** Minimally Acceptable - Small trees in riprap.

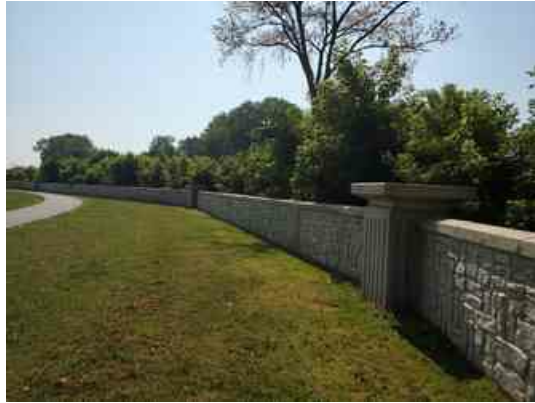
Inspect ID: 2020-0177 **Title:** 2604000008_CELRC_2020_A_0177_1_20200707T143731.jpg **Rated Item:** 1. Unwanted Vegetation Growth **Caption:** Minimally Acceptable - Trees on riverside.

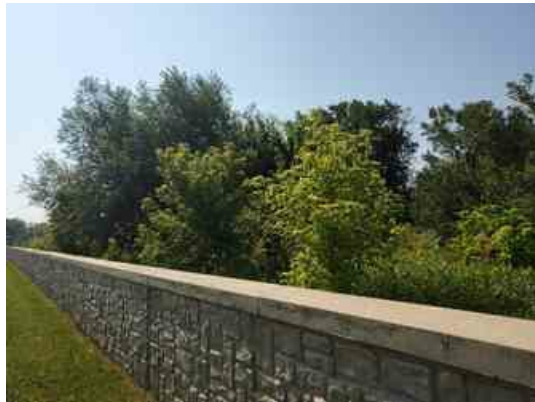
Inspect ID: 2020-0189 **Title:** 2604000008_CELRC_2020_A_0189_1_20200707T144152.jpg **Rated Item:** 1. Unwanted Vegetation Growth **Caption:** Minimally Acceptable - Trees on riverside.

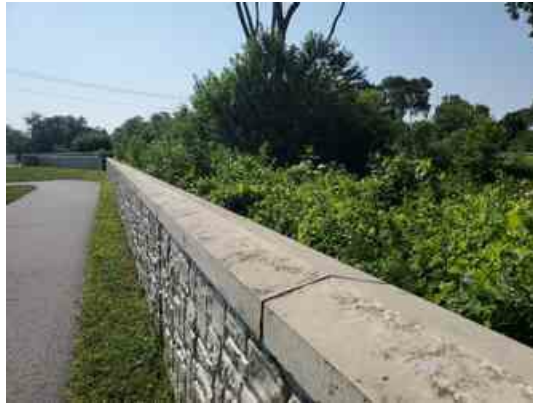
Inspect ID: 2020-0198 **Title:** 2604000008_CELRC_2020_A_0198_1_20200707T144533.jpg **Rated Item:** 1. Unwanted Vegetation Growth **Caption:** Minimally Acceptable - Trees on riverside.

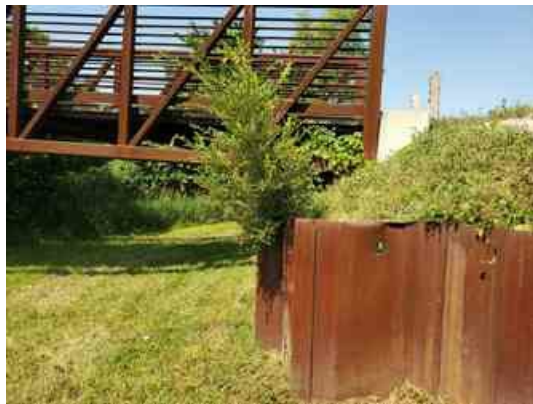
Inspect ID: 2020-0243 **Title:** 2604000008_CELRC_2020_A_0243_1_20200707T151444.jpg **Rated Item:** 1. Unwanted Vegetation Growth **Caption:** Minimally Acceptable - Tree on landside.

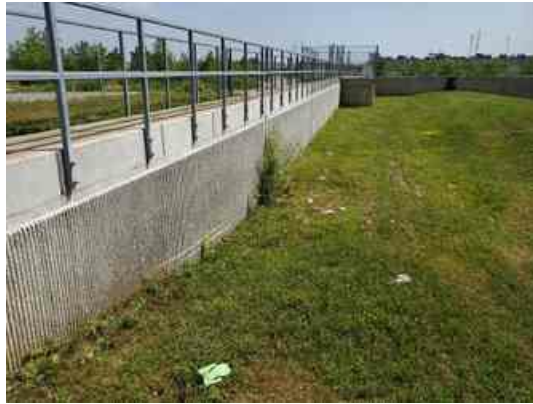
Inspect ID: 2020-0273 **Title:** 2604000008_CELRC_2020_A_0273_1_20200707T154503.jpg **Rated Item:** 1. Unwanted Vegetation Growth **Caption:** Minimally Acceptable - Small tree on riverside.

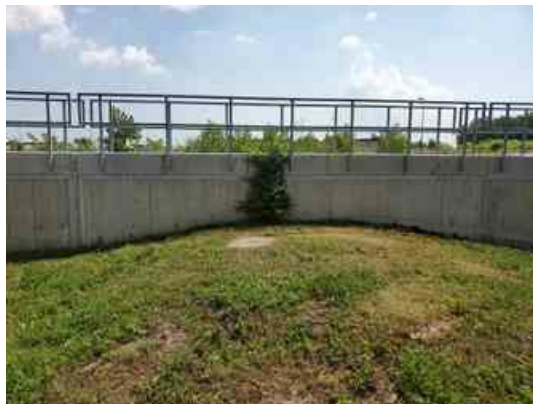
Inspect ID: 2020-0276 **Title:** 2604000008_CELRC_2020_A_0276_1_20200707T154558.jpg **Rated Item:** 1. Unwanted Vegetation Growth **Caption:** Minimally Acceptable - Tree on riverside.

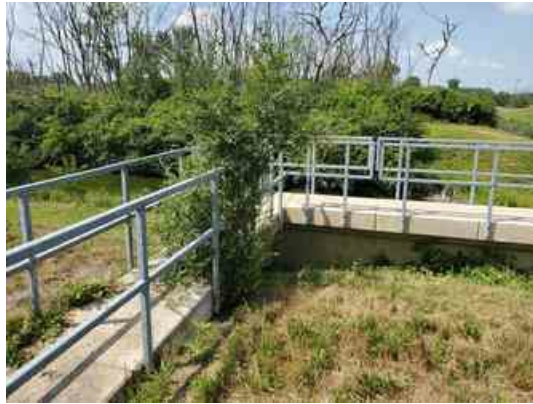
Inspect ID: 2020-0282 **Title:** 2604000008_CELRC_2020_A_0282_1_20200707T154753.jpg **Rated Item:** 1. Unwanted Vegetation Growth **Caption:** Minimally Acceptable - Tree on landside.

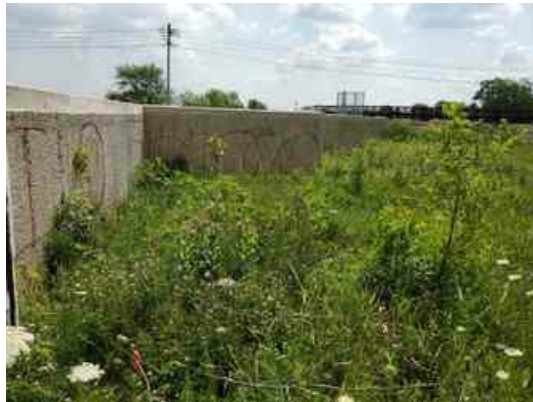
Inspect ID: 2020-0300 **Title:** 2604000008_CELRC_2020_A_0300_1_20200707T160325.jpg **Rated Item:** 1. Unwanted Vegetation Growth **Caption:** Minimally Acceptable - Tall vegetation on riverside.

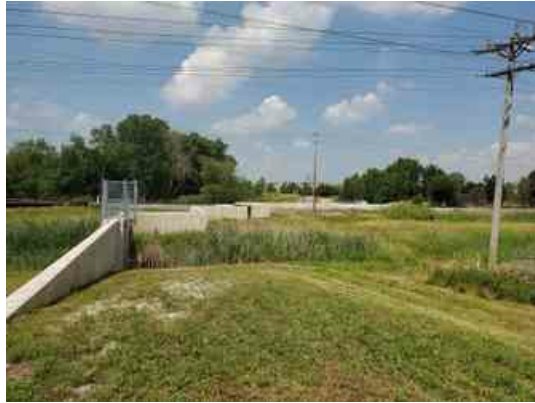
Inspect ID: 2020-0303 **Title:** 2604000008_CELRC_2020_A_0303_1_20200707T161227.jpg **Rated Item:** 1. Unwanted Vegetation Growth **Caption:** Minimally Acceptable - Tall vegetation on landside.

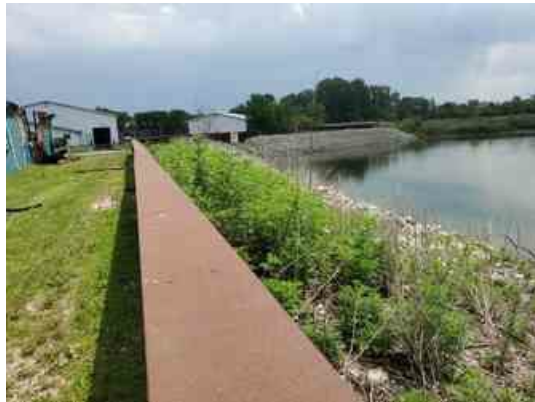
Inspect ID: 2020-0420 **Title:** 2604000008_CELRC_2020_A_0420_1_20200707T181507.jpg **Rated Item:** 1. Unwanted Vegetation Growth **Caption:** Minimally Acceptable - Tall vegetation on riverside.

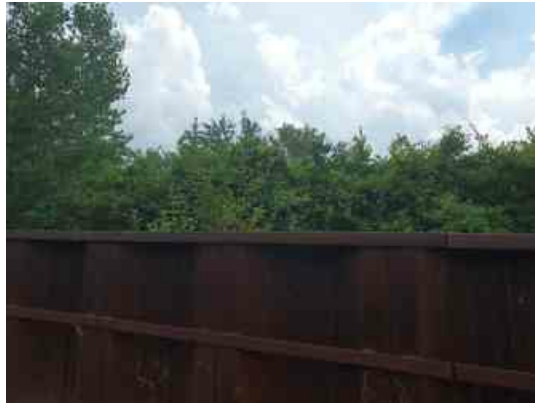
Inspect ID: 2020-0456 **Title:** 2604000008_CELRC_2020_A_0456_1_20200707T183001.jpg **Rated Item:** 1. Unwanted Vegetation Growth **Caption:** Minimally Acceptable - Small tree on riverside.

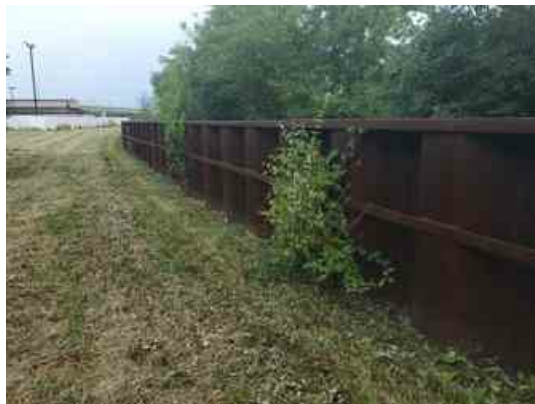
Inspect ID: 2020-0462 **Title:** 2604000008_CELRC_2020_A_0462_1_20200707T183419.jpg **Rated Item:** 1. Unwanted Vegetation Growth **Caption:** Minimally Acceptable - Trees on landside.

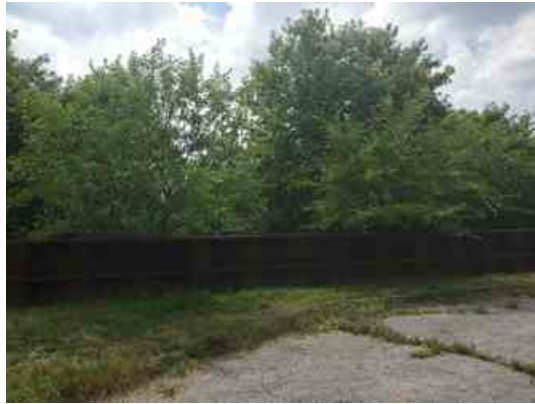
Inspect ID: 2020-0465 **Title:** 2604000008_CELRC_2020_A_0465_1_20200707T184239.jpg **Rated Item:** 1. Unwanted Vegetation Growth **Caption:** Minimally Acceptable - Tall trees on riverside.

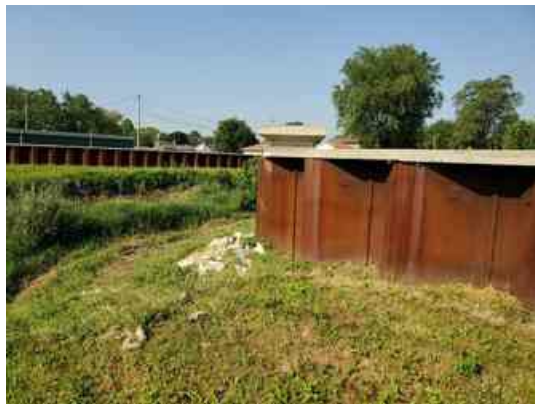
Inspect ID: 2020-0093 **Title:** 2604000008_CELRC_2020_A_0093_1_20200707T135014.jpg **Rated Item:** 2. Encroachments **Caption:** Minimally Acceptable - Sandbags on riverside.

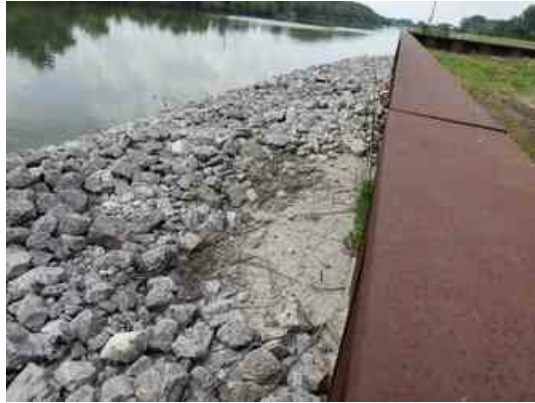
Inspect ID: 2020-0402 **Title:** 2604000008_CELRC_2020_A_0402_1_20200707T180426.jpg **Rated Item:** 2. Encroachments **Caption:** Minimally Acceptable - Riprap moved on riverside.

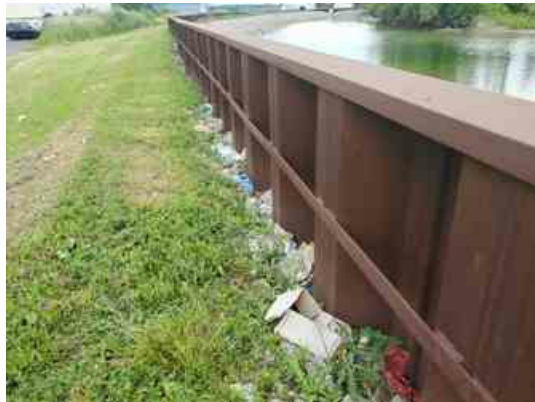
Inspect ID: 2020-0411 **Title:** 2604000008_CELRC_2020_A_0411_1_20200707T181001.jpg **Rated Item:** 2. Encroachments **Caption:** Minimally Acceptable - Debris on landside.

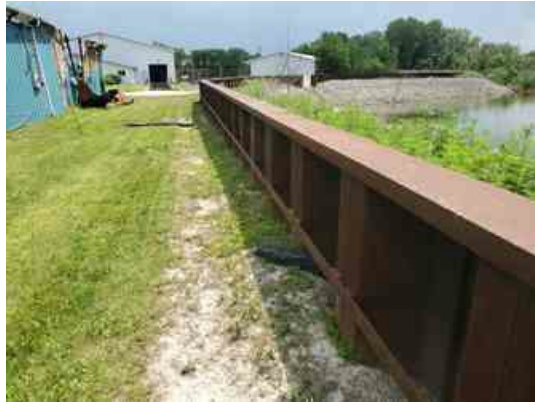
Inspect ID: 2020-0423 **Title:** 2604000008_CELRC_2020_A_0423_1_20200707T181544.jpg **Rated Item:** 2. Encroachments **Caption:** Minimally Acceptable - Debris on landside.

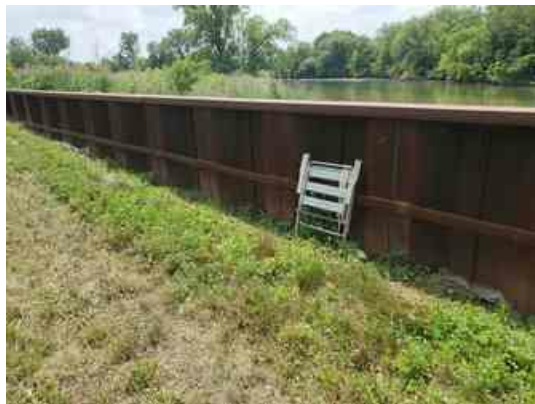
Inspect ID: 2020-0429 **Title:** 2604000008_CELRC_2020_A_0429_1_20200707T181916.jpg **Rated Item:** 2. Encroachments **Caption:** Minimally Acceptable - Debris on landside.

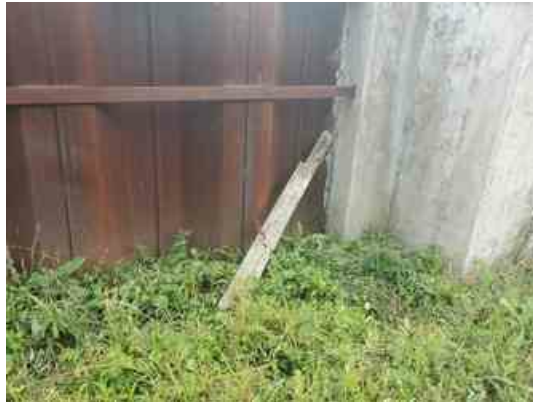
Inspect ID: 2020-0459 **Title:** 2604000008_CELRC_2020_A_0459_1_20200707T183333.jpg **Rated Item:** 2. Encroachments **Caption:** Minimally Acceptable - Debris on landside.

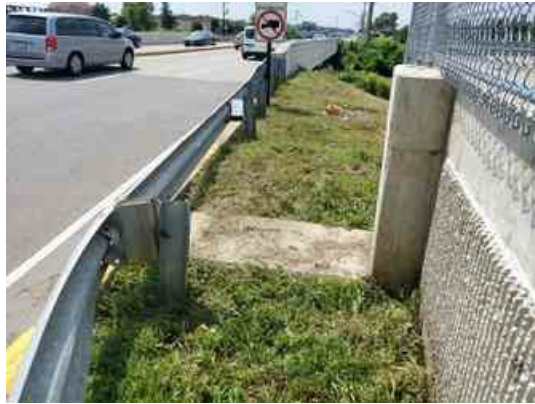
Inspect ID: 2020-0324 **Title:** 2604000008_CELRC_2020_A_0324_1_20200707T162359.jpg **Rated Item:** 3. Closure Structures (Stop Log Closures and Gates) (A or U only) **Caption:** Acceptable - Guardrail blocking west sill at Kennedy. Last exercise performed in 2016. Perform next exercise in 2021.

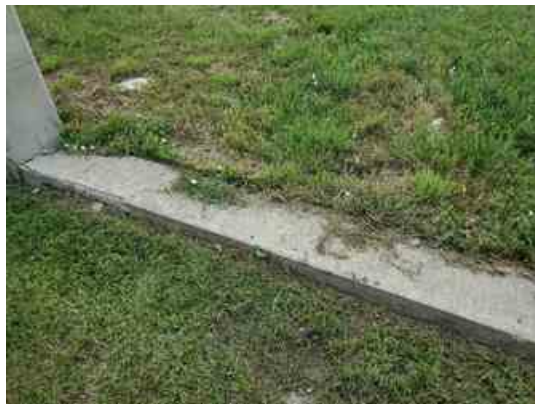
Inspect ID: 2020-0327 **Title:** 2604000008_CELRC_2020_A_0327_1_20200707T171846.jpg **Rated Item:** 3. Closure Structures (Stop Log Closures and Gates) (A or U only) **Caption:** Acceptable - Vegetation on east sill at Kennedy.

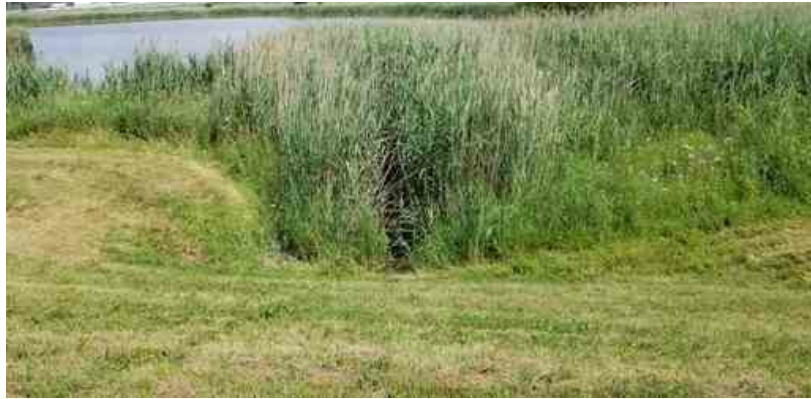
Inspect ID: 2020-0017 **Title:** 2604000008_CELRC_2020_A_0017_1_20200904T153810.jpg **Rated Item:** 1. Vegetation and Obstructions **Caption:** Minimally Acceptable - HA-23: Vegetation at inlet.

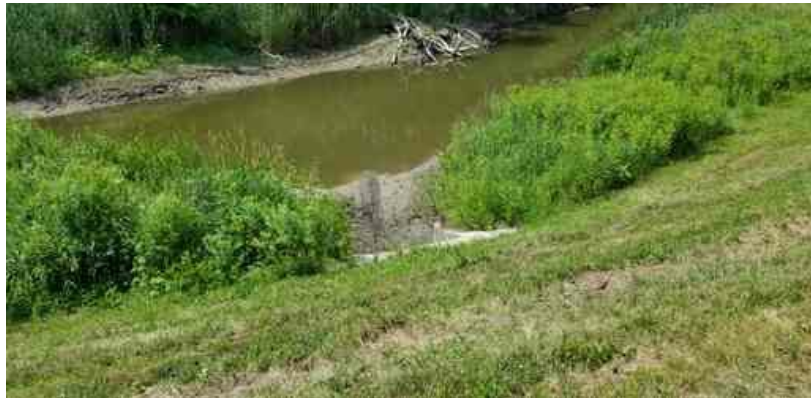
Inspect ID: 2020-0020 **Title:** 2604000008_CELRC_2020_A_0020_1_20200904T153939.jpg **Rated Item:** 1. Vegetation and Obstructions **Caption:** Minimally Acceptable - HA-23: Outlet silted in.

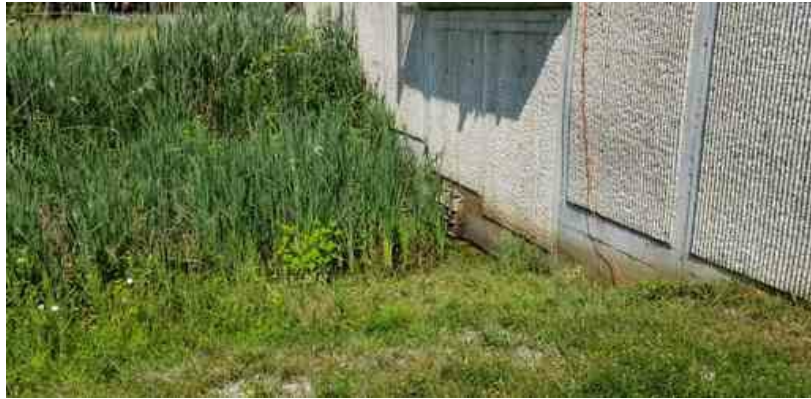
Inspect ID: 2020-0023 **Title:** 2604000008_CELRC_2020_A_0023_1_20200904T154338.jpg **Rated Item:** 1. Vegetation and Obstructions **Caption:** Minimally Acceptable - HA-24: Vegetation on downstream side.

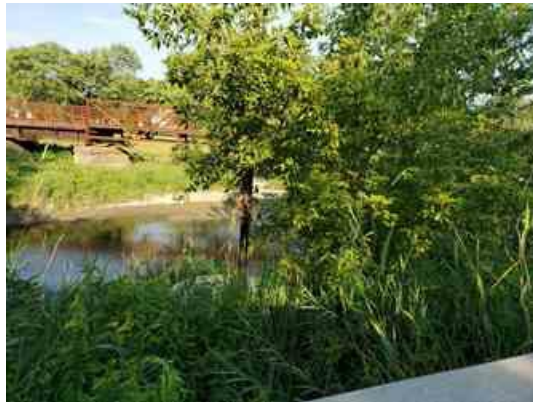
Inspect ID: 2020-0024 **Title:** 2604000008_CELRC_2020_A_0024_1_20200707T123226.jpg **Rated Item:** 1. Vegetation and Obstructions **Caption:** Minimally Acceptable - HA-3: Tall vegetation around structure.

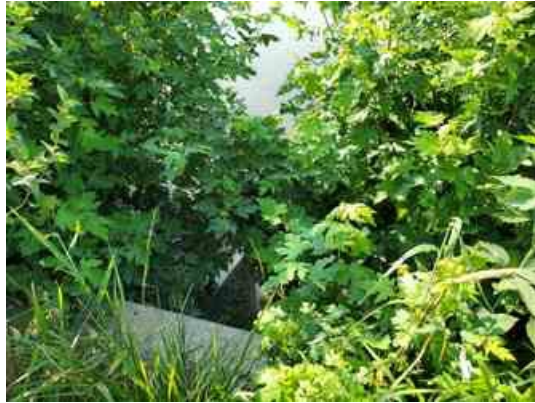
Inspect ID: 2020-0033 **Title:** 2604000008_CELRC_2020_A_0033_1_20200707T132815.jpg **Rated Item:** 1. Vegetation and Obstructions **Caption:** Minimally Acceptable - HA-5: Tall vegetation around outlet.

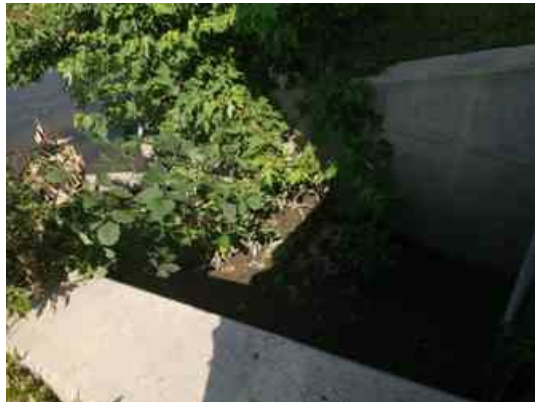
Inspect ID: 2020-0038 **Title:** 2604000008_CELRC_2020_A_0038_1_20200707T144832.jpg **Rated Item:** 1. Vegetation and Obstructions **Caption:** Minimally Acceptable - HA-9: Logs and debris built up at outlet.

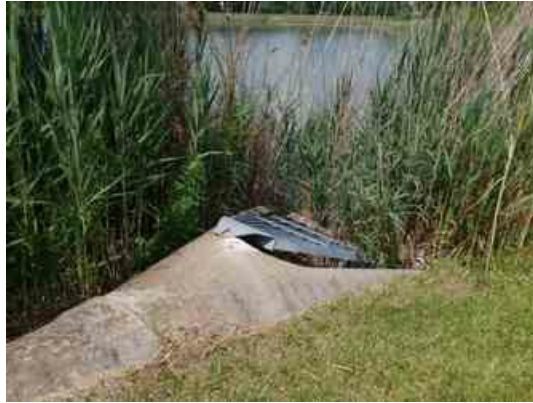
Inspect ID: 2020-0089 **Title:** 2604000008_CELRC_2020_A_0089_2_20200707T163454.jpg **Rated Item:** 1. Vegetation and Obstructions **Caption:** Minimally Acceptable - HA-17: Vegetation at inlet.

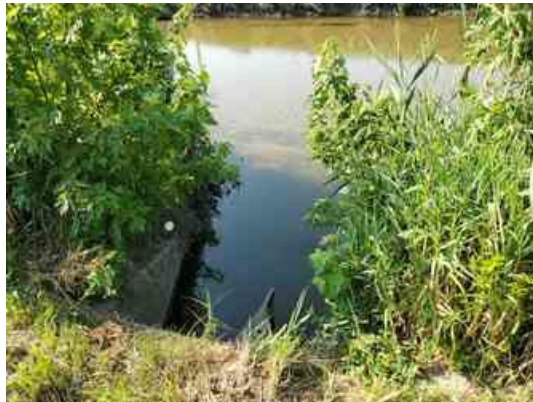
Inspect ID: 2020-0096 **Title:** 2604000008_CELRC_2020_A_0096_1_20200707T135118.jpg **Rated Item:** 1. Vegetation and Obstructions **Caption:** Minimally Acceptable - HA-7: Tall vegetation by outlet.

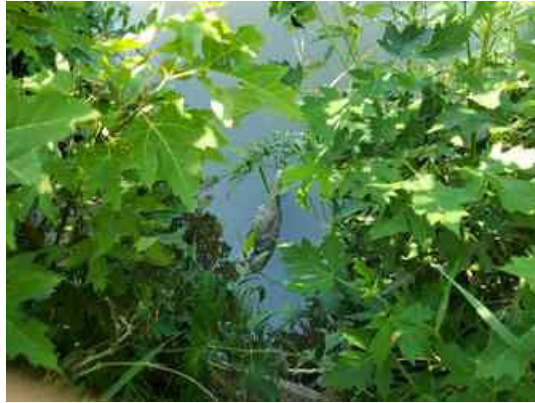
Inspect ID: 2020-0102 **Title:** 2604000008_CELRC_2020_A_0102_1_20200707T135939.jpg **Rated Item:** 1. Vegetation and Obstructions **Caption:** Minimally Acceptable - HA-9: Tall vegetation around outlet.

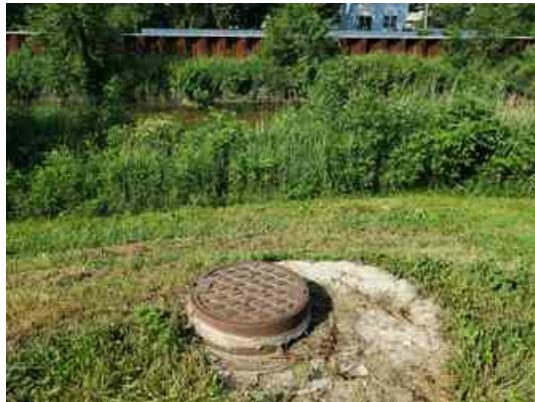
Inspect ID: 2020-0108 **Title:** 2604000008_CELRC_2020_A_0108_2_20200707T140713.jpg **Rated Item:** 1. Vegetation and Obstructions **Caption:** Minimally Acceptable - HA-11: Tall vegetation around outlet.

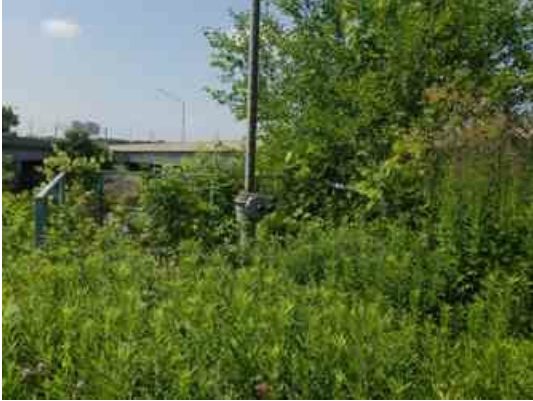
<p>Inspect ID: 2020-0110 Title: 2604000008_CELRC_2020_A_0110_1_20200708T155957.jpg Rated Item: 1. Vegetation and Obstructions Caption: Minimally Acceptable - HA-38: Trees and tall vegetation around gatewell.</p>

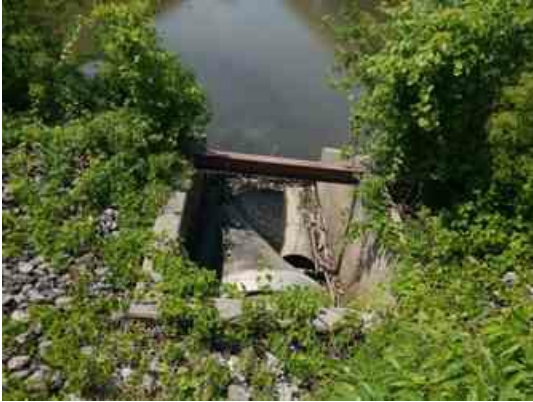
<p>Inspect ID: 2020-0113 Title: 2604000008_CELRC_2020_A_0113_1_20200708T160121.jpg Rated Item: 1. Vegetation and Obstructions Caption: Minimally Acceptable - HA-38: Trees around outlet.</p>

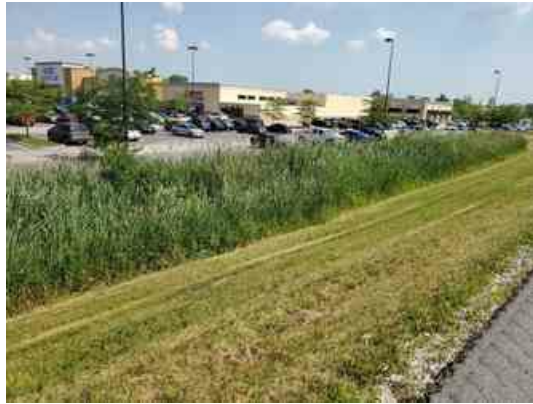
Inspect ID: 2020-0264 **Title:** 2604000008_CELRC_2020_A_0264_1_20200707T153627.jpg **Rated Item:** 1. Vegetation and Obstructions **Caption:** Minimally Acceptable - Tall vegetation in ditch.

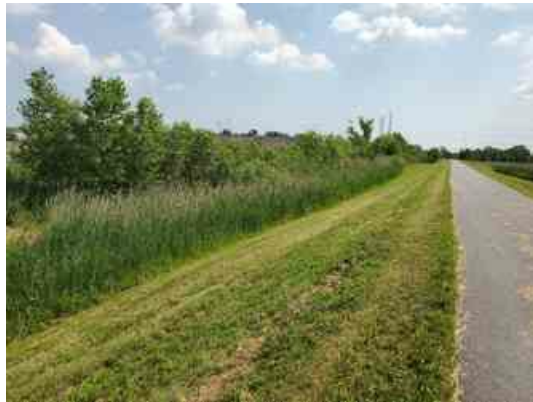
Inspect ID: 2020-0285 **Title:** 2604000008_CELRC_2020_A_0285_1_20200707T154956.jpg **Rated Item:** 1. Vegetation and Obstructions **Caption:** Minimally Acceptable - Vegetation and trees in ditch.
