Levee Inspection Report

Name of System: Hammond

Name of Segment: Hammond

Date(s) of Inspection: 07/07/2020 - 07/08/2020

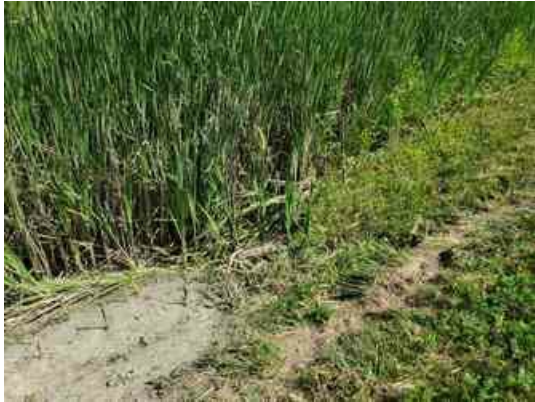
<p>Inspect ID: 2020-0288 Title: 2604000008_CELRC_2020_A_0288_1_20200707T155042.jpg Rated Item: 1. Vegetation and Obstructions Caption: Minimally Acceptable - HA-22: Vegetation at inlet.</p>

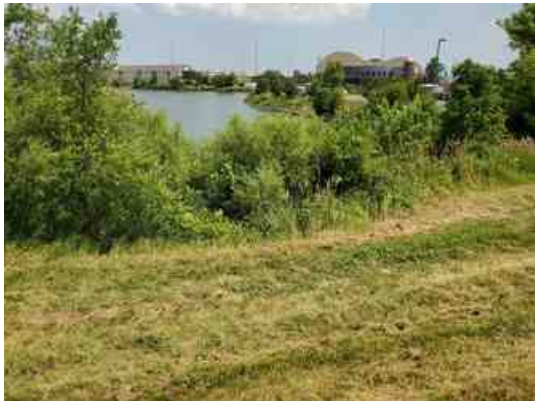
<p>Inspect ID: 2020-0312 Title: 2604000008_CELRC_2020_A_0312_1_20200707T161815.jpg Rated Item: 1. Vegetation and Obstructions Caption: Minimally Acceptable - HA-24: Vegetation at inlet.</p>

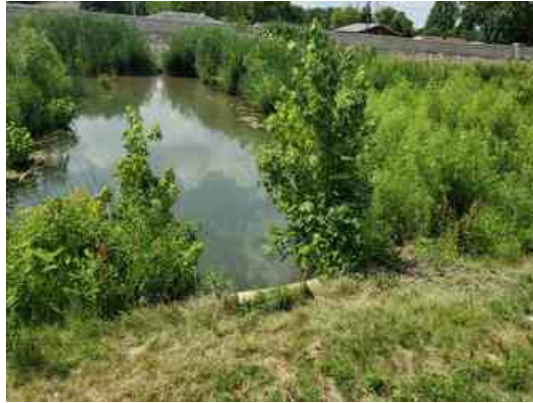
Inspect ID: 2020-0318 **Title:** 2604000008_CELRC_2020_A_0318_1_20200707T161932.jpg **Rated Item:** 1. Vegetation and Obstructions **Caption:** Minimally Acceptable - HA-24: Vegetation at outlet.

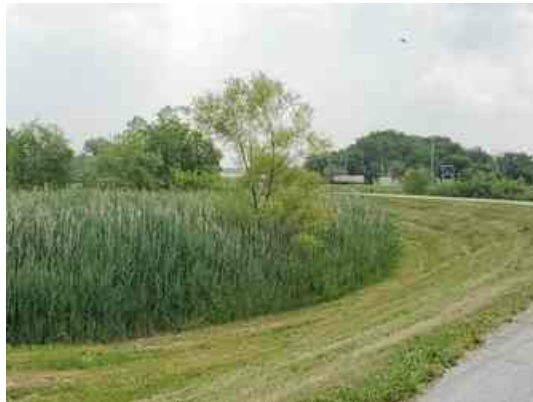
Inspect ID: 2020-0336 **Title:** 2604000008_CELRC_2020_A_0336_1_20200707T172123.jpg **Rated Item:** 1. Vegetation and Obstructions **Caption:** Minimally Acceptable - Tall vegetation and tree in ditch.

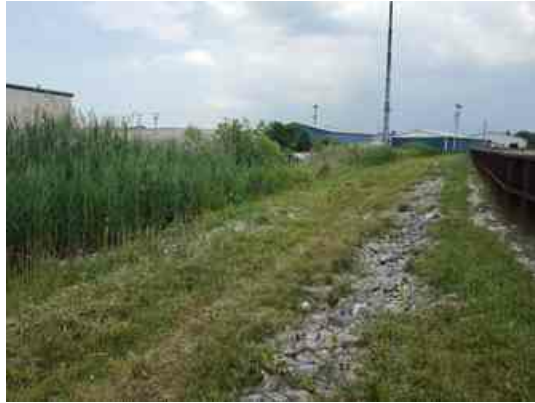
Inspect ID: 2020-0417 **Title:** 2604000008_CELRC_2020_A_0417_1_20200707T181309.jpg **Rated Item:** 1. Vegetation and Obstructions **Caption:** Minimally Acceptable - Trees in ditch.

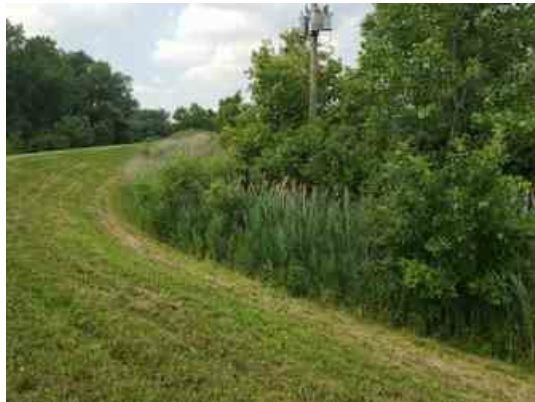
Inspect ID: 2020-0444 **Title:** 2604000008_CELRC_2020_A_0444_1_20200707T182446.jpg **Rated Item:** 1. Vegetation and Obstructions **Caption:** Minimally Acceptable - Trees in ditch

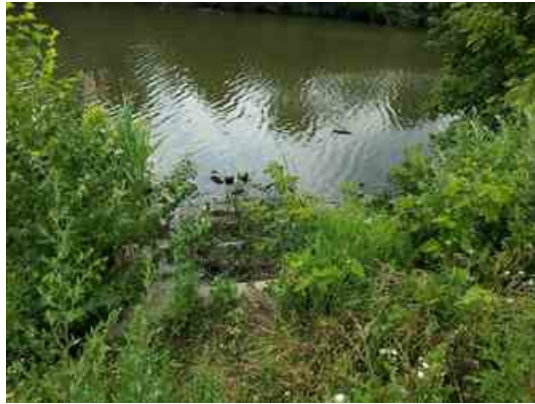
Inspect ID: 2020-0477 **Title:** 2604000008_CELRC_2020_A_0477_1_20200707T184846.jpg **Rated Item:** 1. Vegetation and Obstructions **Caption:** Minimally Acceptable - HA-36: Vegetation at outlet.

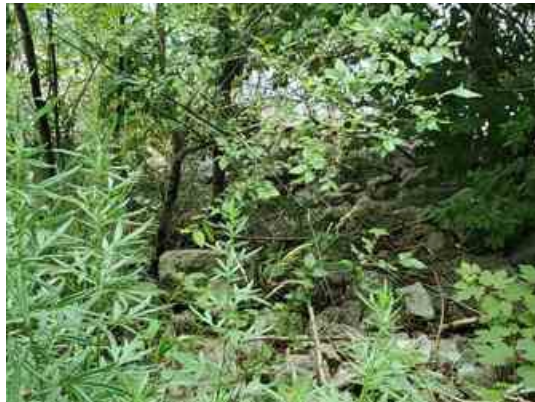
Inspect ID: 2020-0480 **Title:** 2604000008_CELRC_2020_A_0480_1_20200707T185128.jpg **Rated Item:** 1. Vegetation and Obstructions **Caption:** Minimally Acceptable - HA-37: Vegetation around pipe.

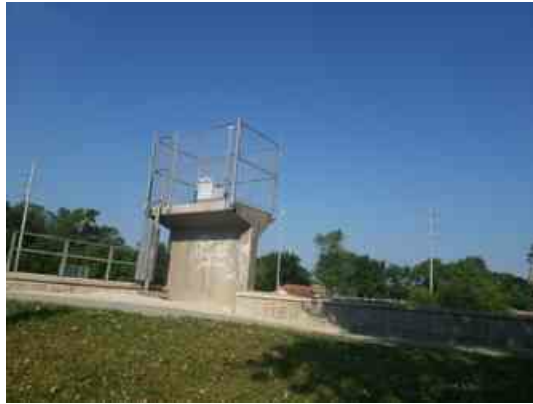
Inspect ID: 2020-0002 **Title:** 2604000008_CELRC_2020_A_0002_1_20200707T132520.jpg **Rated Item:** 2. Encroachments **Caption:** Minimally Acceptable - HA 4: Graffiti on structure.

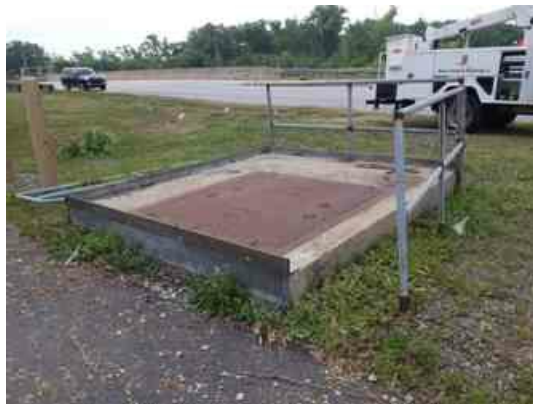
Inspect ID: 2020-0107 **Title:** 2604000008_CELRC_2020_A_0107_1_20200707T181546.jpg **Rated Item:** 4. Fencing and Gates **Caption:** Minimally Acceptable - HA 20: Rails not attached.

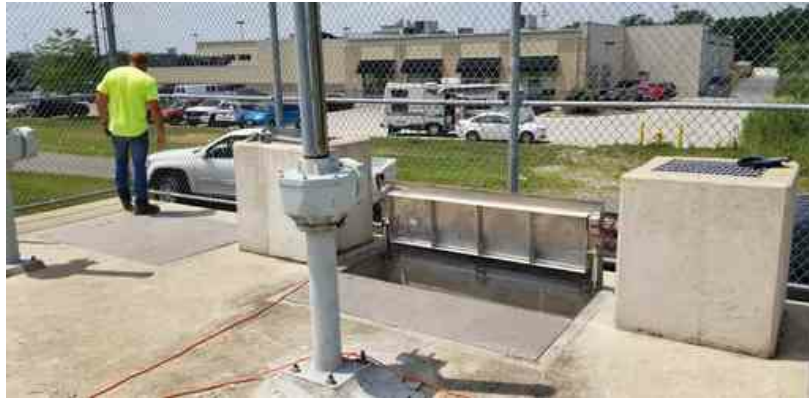
Inspect ID: 2020-0008 **Title:** 2604000008_CELRC_2020_A_0008_1_20200904T152918.jpg **Rated Item:** 10. Sluice/ Slide Gates **Caption:** Minimally Acceptable - HA-22b: Only works in low gear.

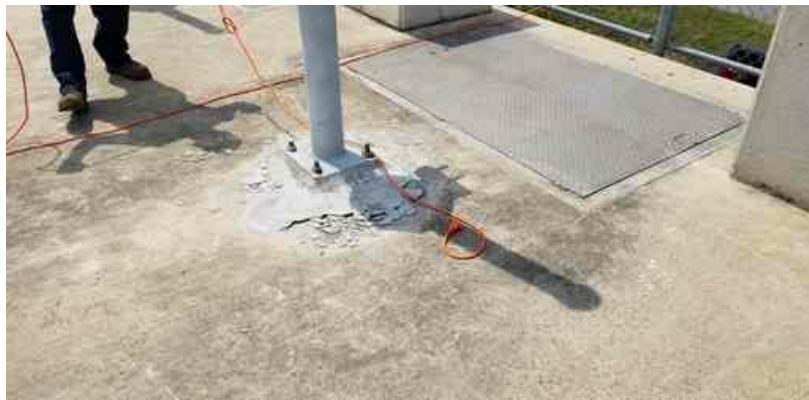
Inspect ID: 2020-0011 **Title:** 2604000008_CELRC_2020_A_0011_1_20200904T153118.jpg **Rated Item:** 10. Sluice/ Slide Gates **Caption:** Minimally Acceptable - HA-22b: Base grout for pedestal is falling apart.

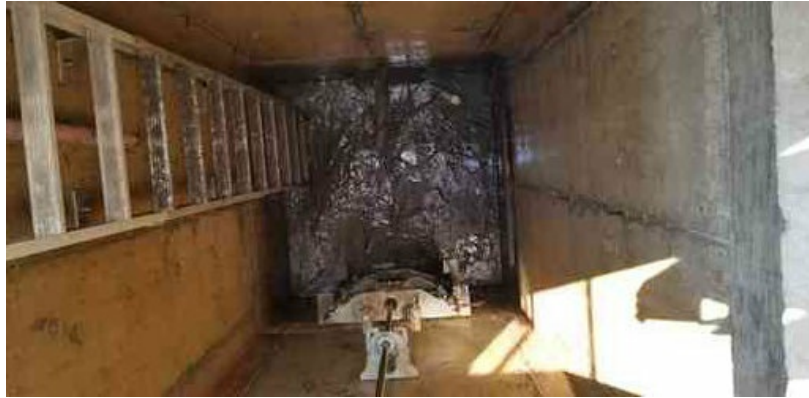
Inspect ID: 2020-0014 **Title:** 2604000008_CELRC_2020_A_0014_1_20200904T153541.jpg **Rated Item:** 10. Sluice/ Slide Gates **Caption:** Minimally Acceptable - HA-23: Silt inside.

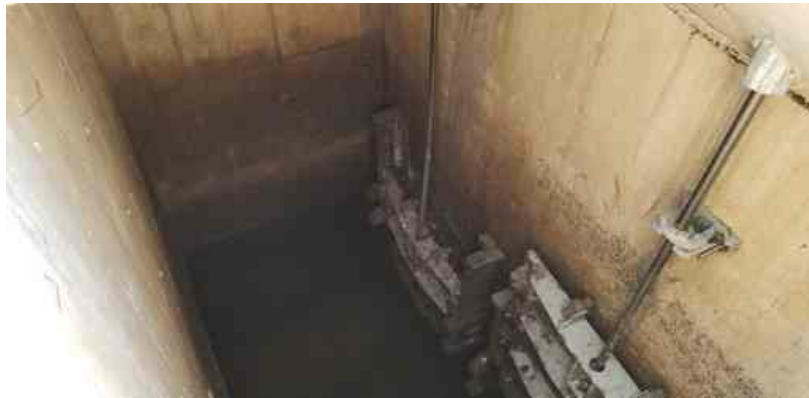
Inspect ID: 2020-0026 **Title:** 2604000008_CELRC_2020_A_0026_1_20200904T155310.jpg **Rated Item:** 10. Sluice/ Slide Gates **Caption:** Minimally Acceptable - HA-27a: Silt inside.

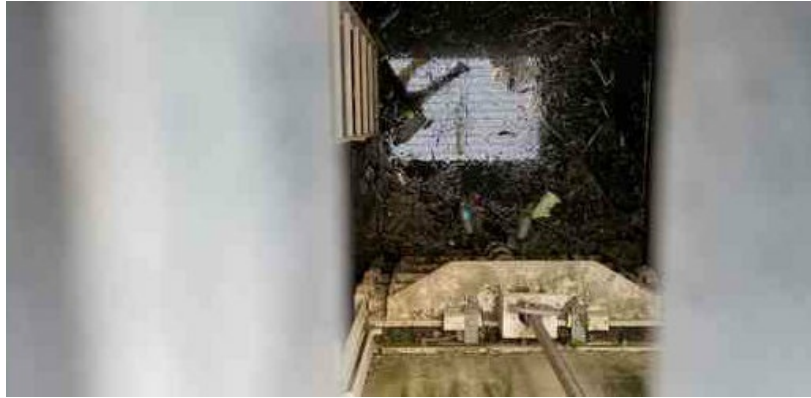
Inspect ID: 2020-0041 **Title:** 2604000008_CELRC_2020_A_0041_1_20200904T182928.jpg **Rated Item:** 10. Sluice/ Slide Gates **Caption:** Minimally Acceptable - HA-28: Debris in gatewell.

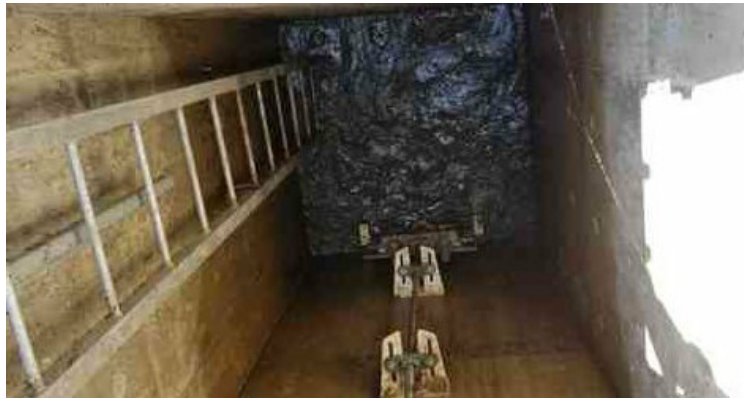
Inspect ID: 2020-0047 **Title:** 2604000008_CELRC_2020_A_0047_1_20200904T183459.jpg **Rated Item:** 10. Sluice/ Slide Gates **Caption:** Minimally Acceptable - HA-30: Silt in gatewell.

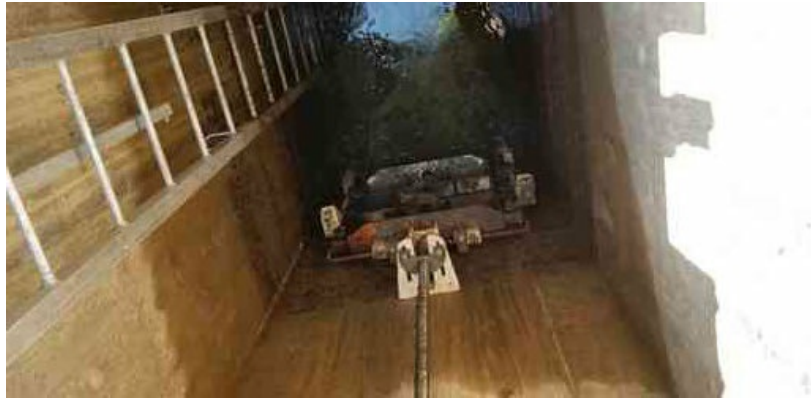
Inspect ID: 2020-0050 **Title:** 2604000008_CELRC_2020_A_0050_1_20200904T183844.jpg **Rated Item:** 10. Sluice/ Slide Gates **Caption:** Minimally Acceptable - HA-31: Silt in gatewell.

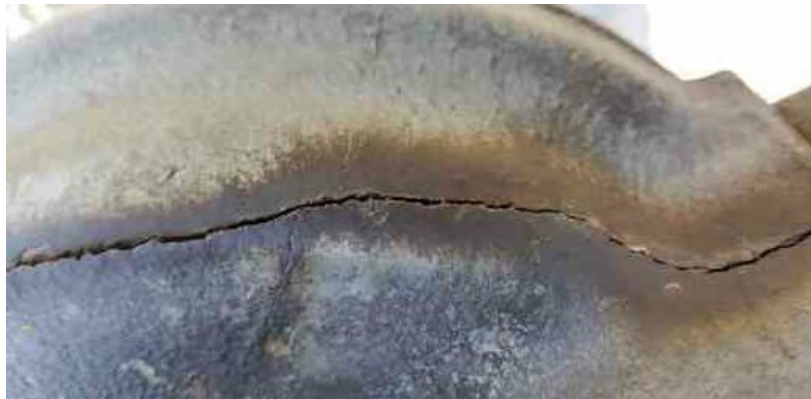
Inspect ID: 2020-0077 **Title:** 2604000008_CELRC_2020_A_0077_1_20200904T190137.jpg **Rated Item:** 10. Sluice/ Slide Gates **Caption:** Minimally Acceptable - HA-35: Gear housing is splitting. Possible due to trapped water freezing.

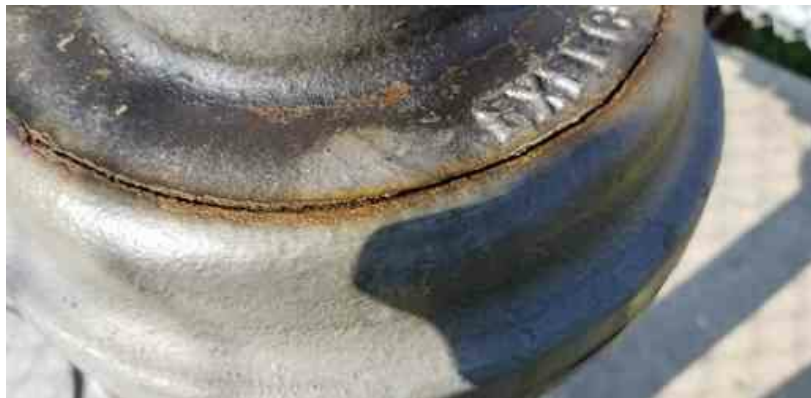
Inspect ID: 2020-0077 **Title:** 2604000008_CELRC_2020_A_0077_2_20200904T190153.jpg **Rated Item:** 10. Sluice/ Slide Gates **Caption:** Minimally Acceptable - HA-35: Gear housing is splitting. Possible due to trapped water freezing.

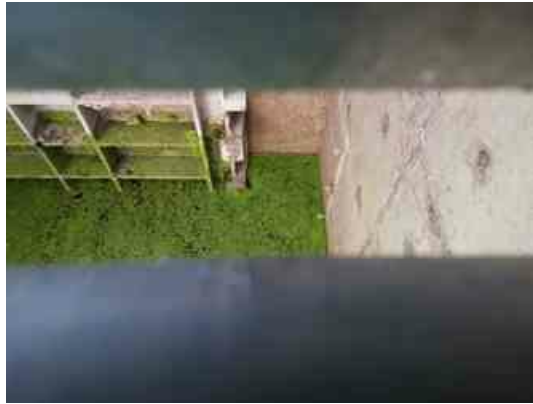
Inspect ID: 2020-0083 **Title:** 2604000008_CELRC_2020_A_0083_1_20200707T161912.jpg **Rated Item:** 10. Sluice/ Slide Gates **Caption:** Minimally Acceptable - HA-16: Sluice gate has some debris.

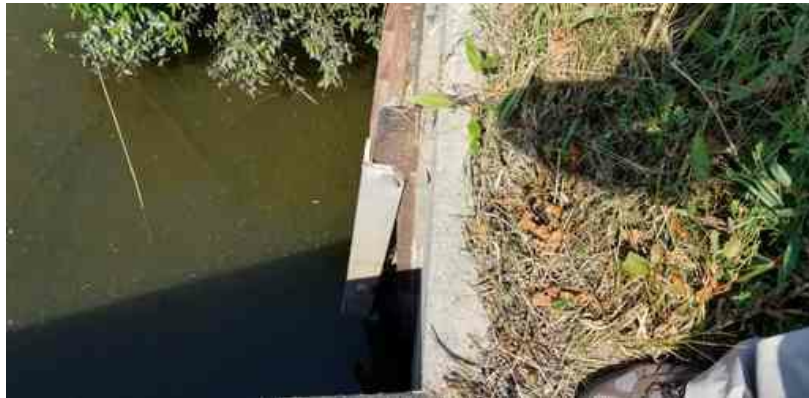
Inspect ID: 2020-0032 **Title:** 2604000008_CELRC_2020_A_0032_1_20200904T185811.jpg **Rated Item:** 11. Flap Gates/ Flap Valves/ Pinch Valves **Caption:** Minimally Acceptable - HA-26: Flap gate stuck open.

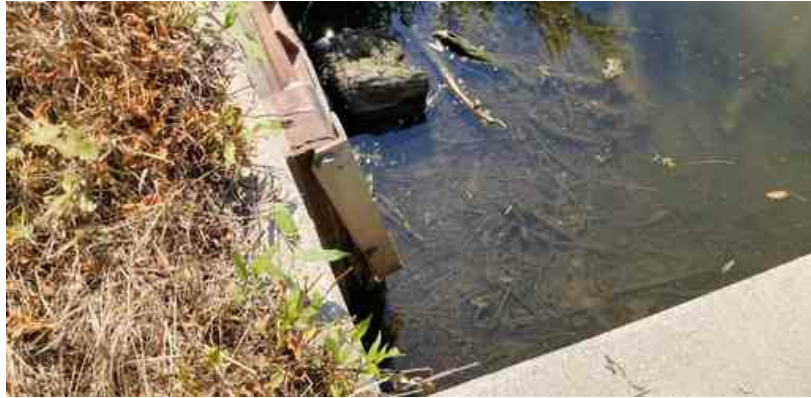
Inspect ID: 2020-0035 **Title:** 2604000008_CELRC_2020_A_0035_1_20200904T182415.jpg **Rated Item:** 11. Flap Gates/ Flap Valves/ Pinch Valves **Caption:** Minimally Acceptable - HA-27: Flap gate stuck open.

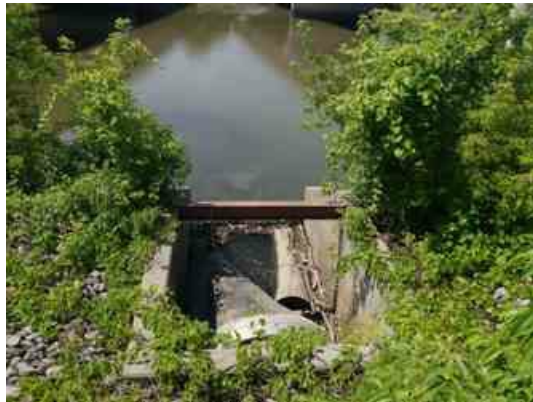
Inspect ID: 2020-0116 **Title:** 2604000008_CELRC_2020_A_0116_1_20200708T160155.jpg **Rated Item:** 11. Flap Gates/ Flap Valves/ Pinch Valves **Caption:** Minimally Acceptable - HA-38: Hole in valve, water flowing.

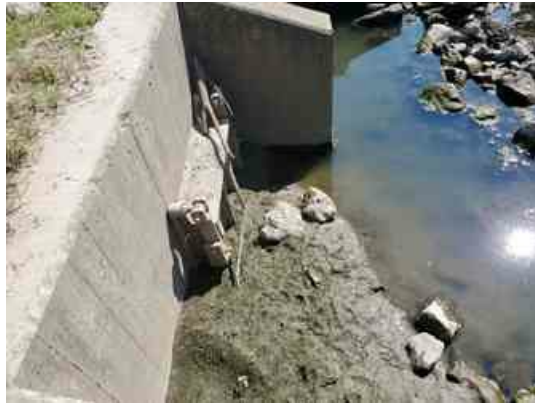
Inspect ID: 2020-0222 **Title:** 2604000008_CELRC_2020_A_0222_1_20200707T145821.jpg **Rated**
Item: 11. Flap Gates/ Flap Valves/ Pinch Valves **Caption:** Minimally
Acceptable - HA-17: West flap gate blocked with silt.

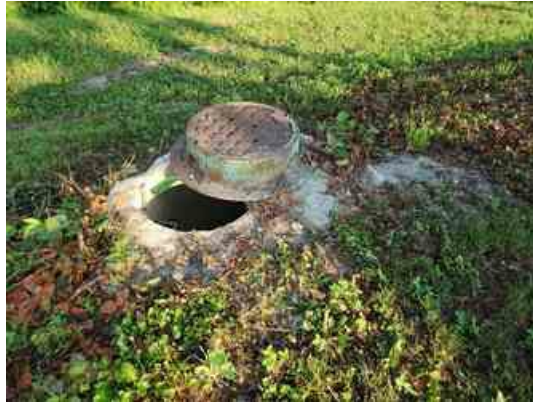
Inspect ID: 2020-0006 **Title:** 2604000008_CELRC_2020_A_0006_1_20200707T121439.jpg **Rated Item:** 13. Other Metallic Items **Caption:** Minimally Acceptable - HA-1: Manhole open.

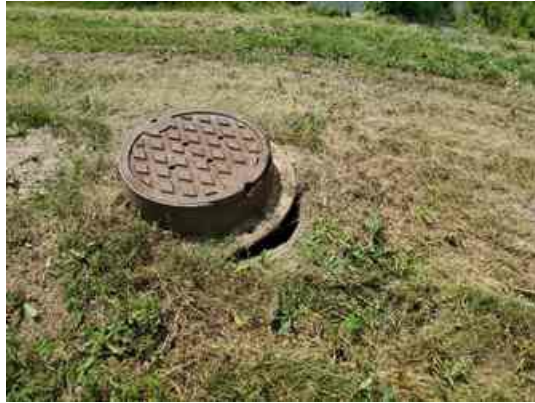
Inspect ID: 2020-0315 **Title:** 2604000008_CELRC_2020_A_0315_1_20200707T161852.jpg **Rated Item:** 13. Other Metallic Items **Caption:** Minimally Acceptable - HA-24: Manhole cover not on.

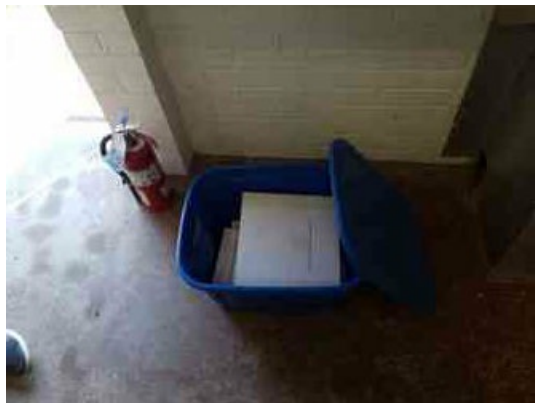
Inspect ID: 2020-0001 **Title:** 2604000008_CELRC_2020_A_0001_1_20200706T163338.jpg **Rated Item:** 2. Pump Station Operations and Maintenance Equipment Manuals **Caption:** Acceptable - PS-TA: Operation manuals present.

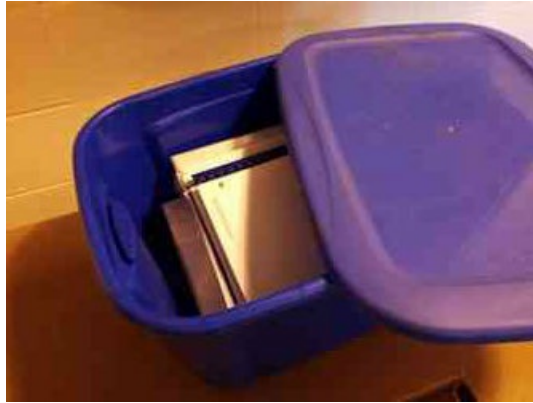
Inspect ID: 2020-0016 **Title:** 2604000008_CELRC_2020_A_0016_1_20200706T164616.jpg **Rated Item:** 2. Pump Station Operations and Maintenance Equipment Manuals
Caption: Acceptable - PS-WA: Manuals present.

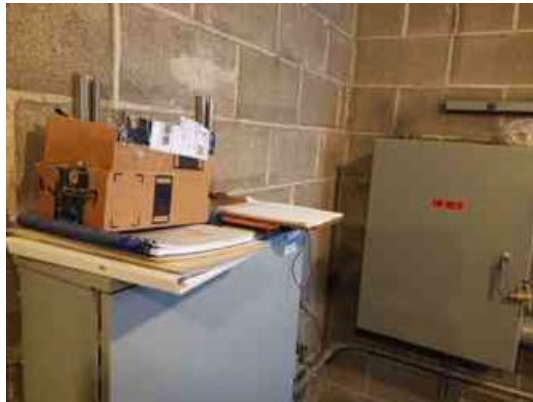
Inspect ID: 2020-0043 **Title:** 2604000008_CELRC_2020_A_0043_1_20200706T170949.jpg **Rated Item:** 2. Pump Station Operations and Maintenance Equipment Manuals
Caption: Acceptable - PS-FA: Manuals present.

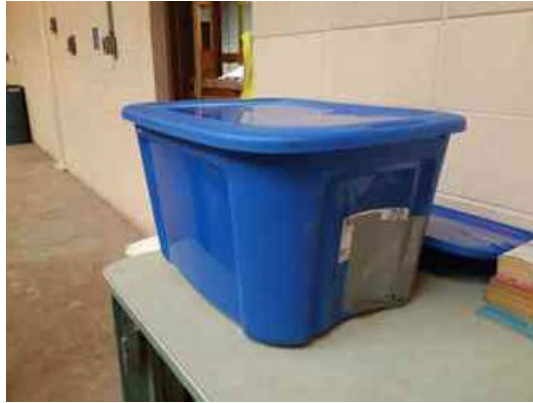
Inspect ID: 2020-0064 **Title:**
2604000008_CELRC_2020_A_0064_2_20200706T172335.jpg **Rated**
Item: 2. Pump Station Operations and Maintenance Equipment Manuals
Caption: Acceptable - PS-HV: Operation manuals present.

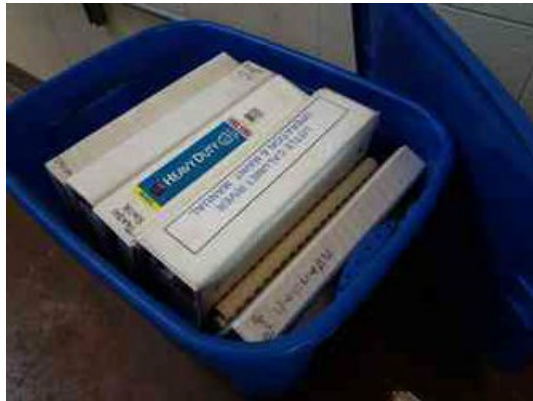
Inspect ID: 2020-0097 **Title:**
2604000008_CELRC_2020_A_0097_1_20200707T130814.jpg **Rated**
Item: 2. Pump Station Operations and Maintenance Equipment Manuals
Caption: Acceptable - PS-JA: Operation manuals present.

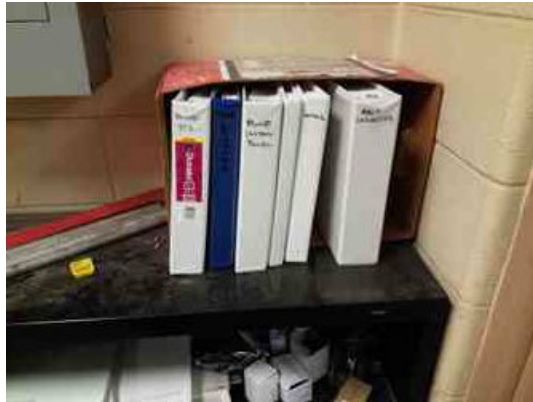
Inspect ID: 2020-0151 **Title:**
2604000008_CELRC_2020_A_0151_1_20200707T141716.jpg **Rated**
Item: 2. Pump Station Operations and Maintenance Equipment Manuals
Caption: Acceptable - PS-SS: Operation manuals present.

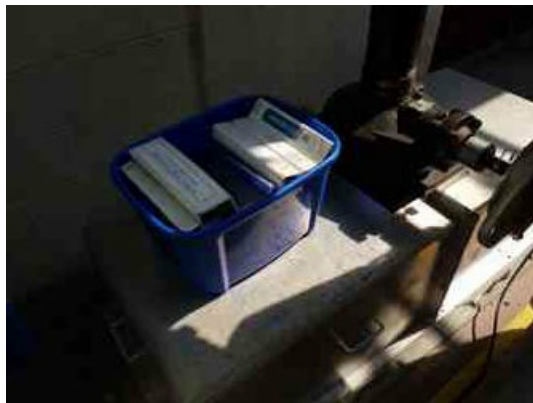
Inspect ID: 2020-0199 **Title:**
2604000008_CELRC_2020_A_0199_1_20200707T145028.jpg **Rated**
Item: 2. Pump Station Operations and Maintenance Equipment Manuals
Caption: Acceptable - PS-IN: Operation manuals present.

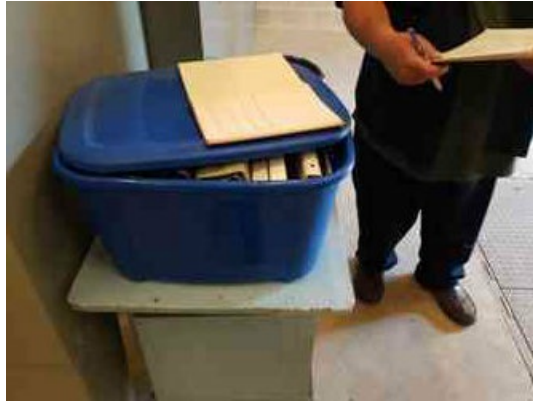
Inspect ID: 2020-0217 **Title:** 2604000008_CELRC_2020_A_0217_1_20200707T150935.jpg **Rated Item:** 2. Pump Station Operations and Maintenance Equipment Manuals **Caption:** Acceptable - PS-CA: Operation manuals present.

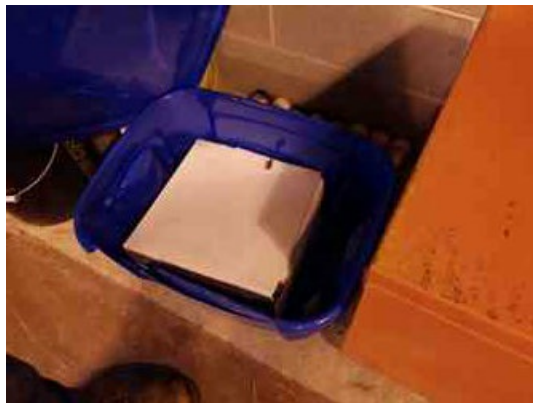
Inspect ID: 2020-0232 **Title:** 2604000008_CELRC_2020_A_0232_1_20200707T152604.jpg **Rated Item:** 2. Pump Station Operations and Maintenance Equipment Manuals **Caption:** Acceptable - PS-SK: Operation manuals present.

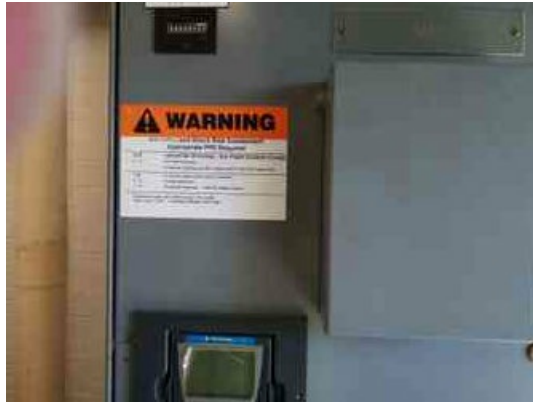
Inspect ID: 2020-0007 **Title:** 2604000008_CELRC_2020_A_0007_1_20200706T163509.jpg **Rated Item:** 3. Safety Compliance **Caption:** Acceptable - PS-TA: Arc flash warning labels added.

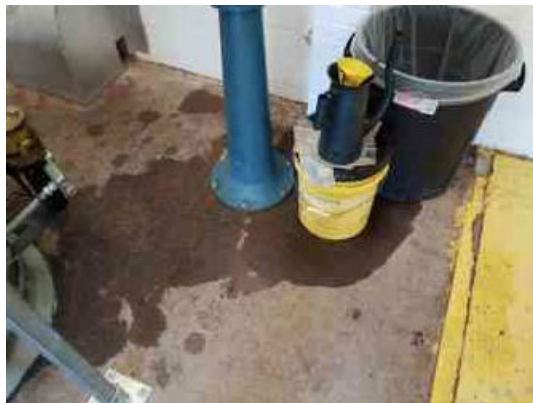
Inspect ID: 2020-0010 **Title:** 2604000008_CELRC_2020_A_0010_1_20200706T163620.jpg **Rated Item:** 3. Safety Compliance **Caption:** Minimally Acceptable - PS-TA: Fluid spillage.

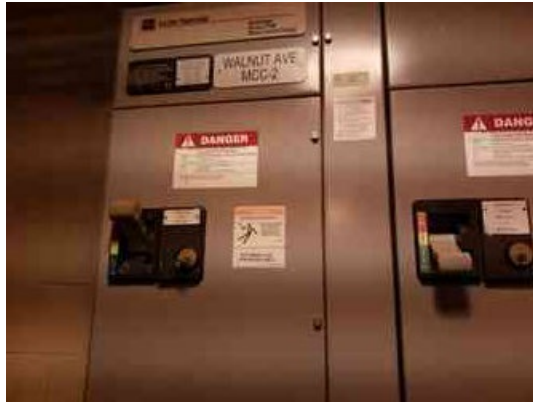
Inspect ID: 2020-0019 **Title:** 2604000008_CELRC_2020_A_0019_1_20200706T164726.jpg **Rated Item:** 3. Safety Compliance **Caption:** Minimally Acceptable - PS-WA: Needs updated arc flash warning label.

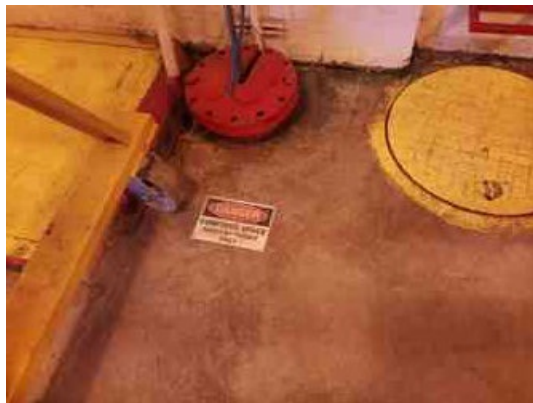
Inspect ID: 2020-0022 **Title:** 2604000008_CELRC_2020_A_0022_1_20200706T164743.jpg **Rated Item:** 3. Safety Compliance **Caption:** Acceptable - PS-WA: Confined space label added.

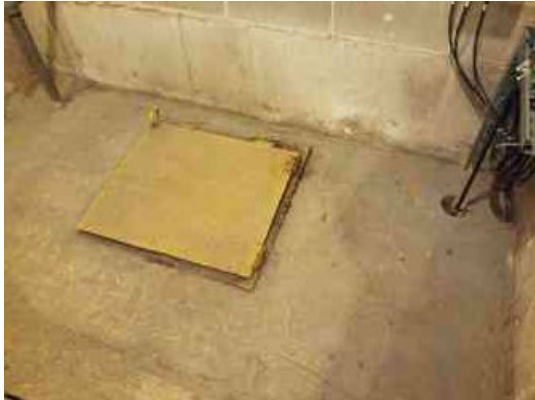
<p>Inspect ID: 2020-0037 Title: 2604000008_CELRC_2020_A_0037_1_20200706T170825.jpg Rated Item: 3. Safety Compliance Caption: Minimally Acceptable - PS-KA: Needs confined space warning label.</p>

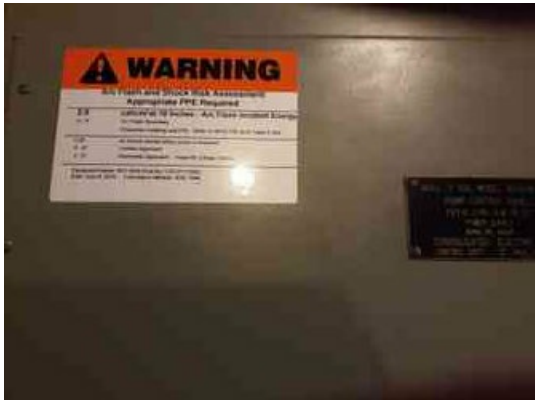
<p>Inspect ID: 2020-0046 Title: 2604000008_CELRC_2020_A_0046_1_20200706T171034.jpg Rated Item: 3. Safety Compliance Caption: Acceptable - PS-KA: Arc flash warning label added.</p>

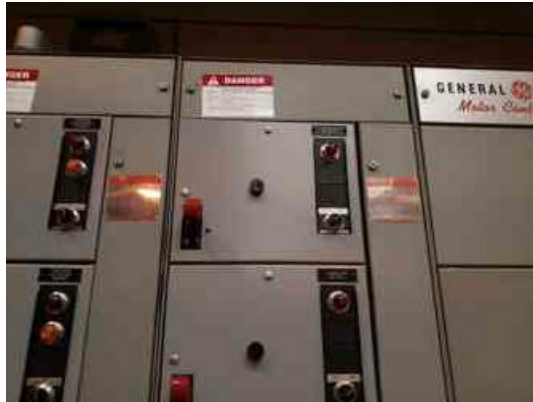
Inspect ID: 2020-0067 **Title:** 2604000008_CELRC_2020_A_0067_1_20200706T172416.jpg **Rated Item:** 3. Safety Compliance **Caption:** Minimally Acceptable - PS-HV: Arc flash warning label possibly out of date.

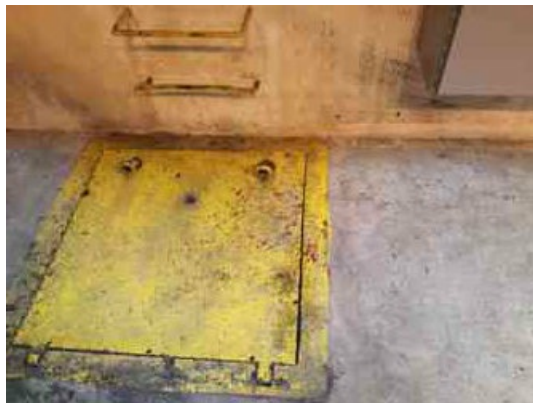
Inspect ID: 2020-0076 **Title:** 2604000008_CELRC_2020_A_0076_1_20200706T172838.jpg **Rated Item:** 3. Safety Compliance **Caption:** Minimally Acceptable - PS-HV: Needs confined space warning label.

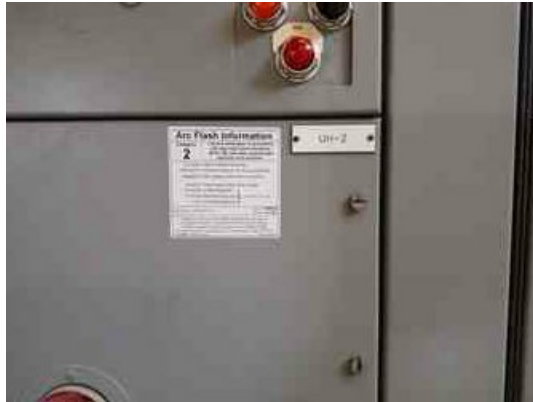
Inspect ID: 2020-0100 **Title:** 2604000008_CELRC_2020_A_0100_1_20200707T130910.jpg **Rated Item:** 3. Safety Compliance **Caption:** Minimally Acceptable - PS-JA: Arc flash warning label needs updating.

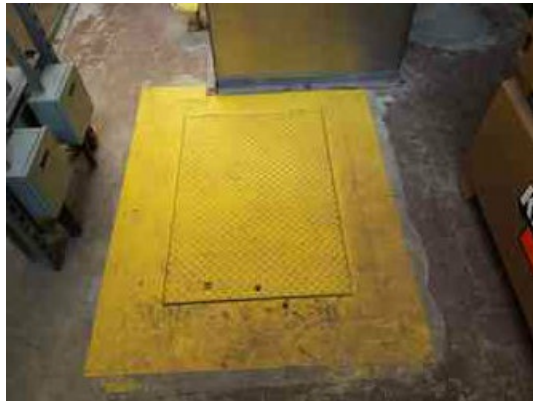
Inspect ID: 2020-0130 **Title:** 2604000008_CELRC_2020_A_0130_1_20200707T132448.jpg **Rated Item:** 3. Safety Compliance **Caption:** Minimally Acceptable - PS-JA: Needs confined space warning label.

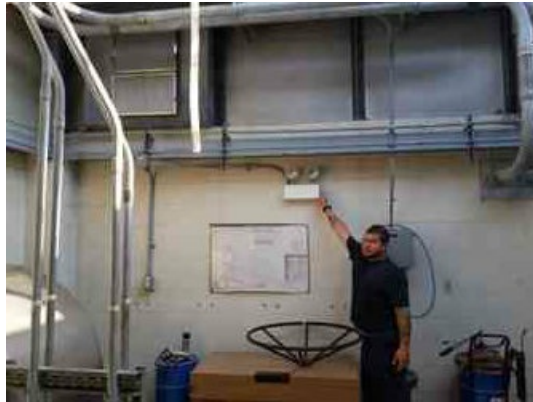
Inspect ID: 2020-0136 **Title:** 2604000008_CELRC_2020_A_0136_1_20200707T132619.jpg **Rated Item:** 3. Safety Compliance **Caption:** Minimally Acceptable - PS-JA: Safety lights do not work.

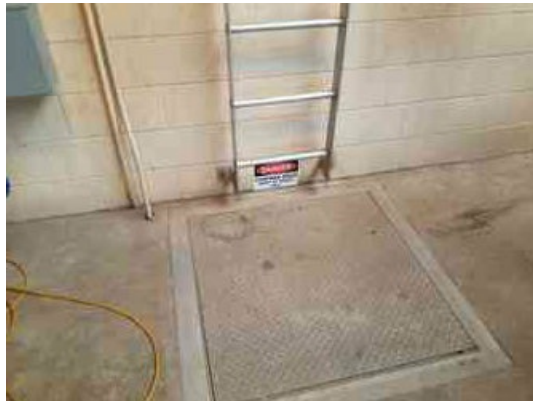
Inspect ID: 2020-0142 **Title:** 2604000008_CELRC_2020_A_0142_1_20200707T141335.jpg **Rated Item:** 3. Safety Compliance **Caption:** Acceptable - PS-SS: Confined space warning label added.

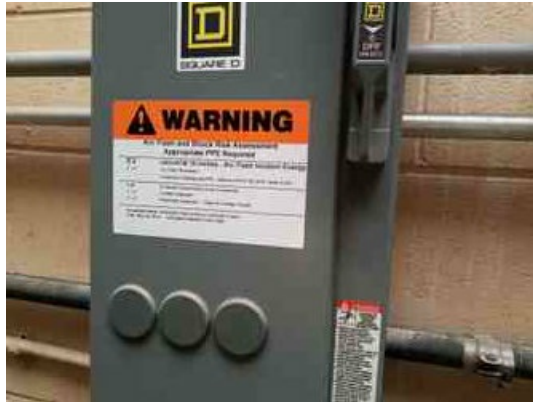
Inspect ID: 2020-0145 **Title:** 2604000008_CELRC_2020_A_0145_1_20200707T141413.jpg **Rated Item:** 3. Safety Compliance **Caption:** Acceptable - PS-SS: Arc flash warning label added.

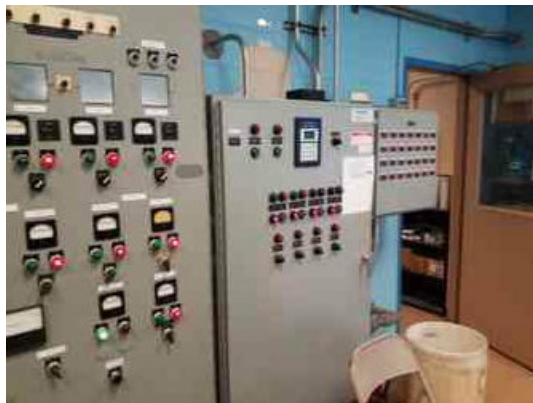
Inspect ID: 2020-0148 **Title:** 2604000008_CELRC_2020_A_0148_1_20200707T141556.jpg **Rated Item:** 3. Safety Compliance **Caption:** Minimally Acceptable - PS-SS: Need arc flash warning labels in electrical room.

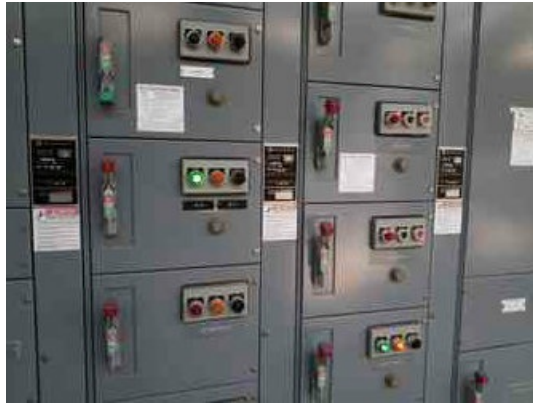
Inspect ID: 2020-0184 **Title:** 2604000008_CELRC_2020_A_0184_1_20200707T144447.jpg **Rated Item:** 3. Safety Compliance **Caption:** Minimally Acceptable - PS-IN: Update arc flash warning labels.

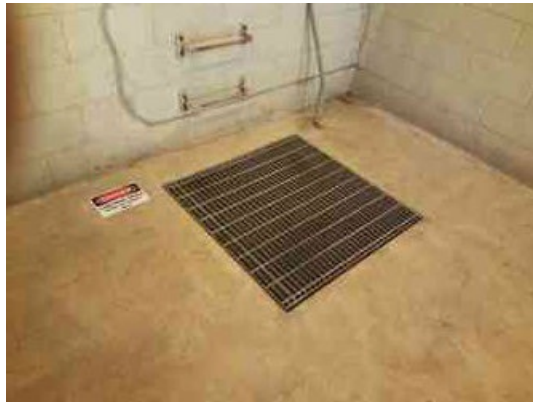
Inspect ID: 2020-0187 **Title:** 2604000008_CELRC_2020_A_0187_1_20200707T144551.jpg **Rated Item:** 3. Safety Compliance **Caption:** Acceptable - PS-IN: Confined space warning label added.

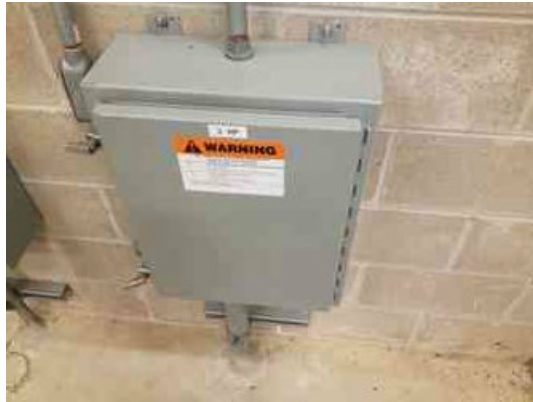
Inspect ID: 2020-0220 **Title:** 2604000008_CELRC_2020_A_0220_1_20200707T151313.jpg **Rated Item:** 3. Safety Compliance **Caption:** Acceptable - PS-CA: Arc flash warning label added.

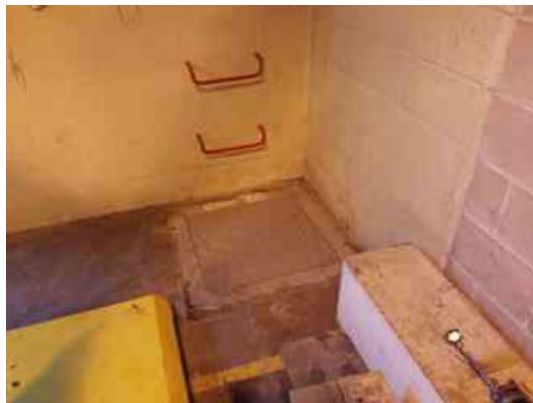
Inspect ID: 2020-0229 **Title:** 2604000008_CELRC_2020_A_0229_1_20200707T152535.jpg **Rated Item:** 3. Safety Compliance **Caption:** Minimally Acceptable - PS-SK: Need confined space warning label.

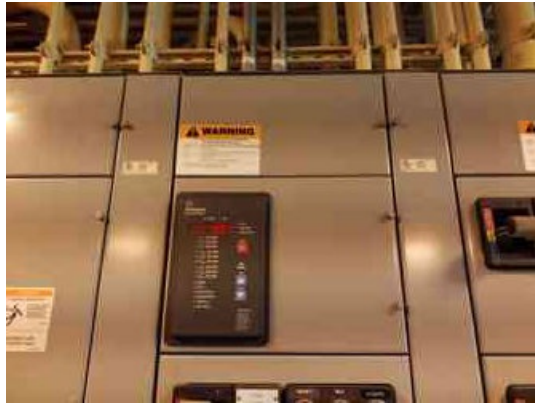
Inspect ID: 2020-0241 **Title:** 2604000008_CELRC_2020_A_0241_1_20200707T152841.jpg **Rated Item:** 3. Safety Compliance **Caption:** Acceptable - PS-SK: Arc flash warning label added.

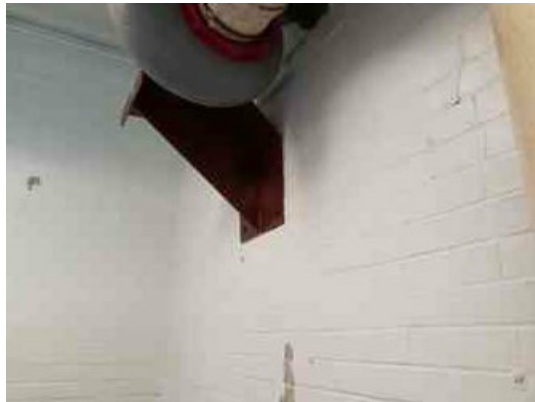
Inspect ID: 2020-0004 **Title:** 2604000008_CELRC_2020_A_0004_1_20200706T163423.jpg **Rated Item:** 5. Plant Building **Caption:** Minimally Acceptable - PS-TA: Bracket is falling off wall.

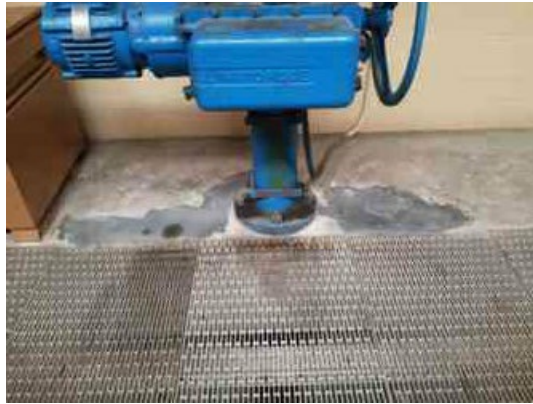
Inspect ID: 2020-0073 **Title:** 2604000008_CELRC_2020_A_0073_1_20200706T172707.jpg **Rated Item:** 5. Plant Building **Caption:** Acceptable - PS-HV: Concrete around pipe fixed.

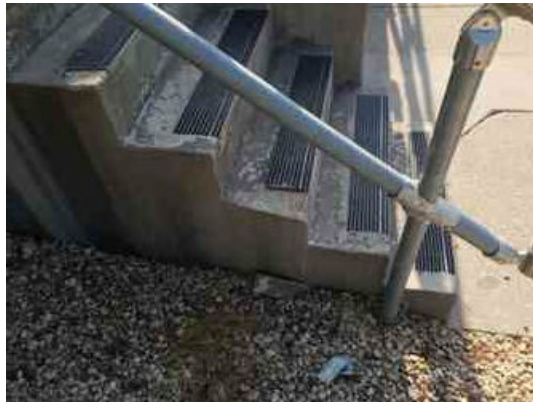
Inspect ID: 2020-0103 **Title:** 2604000008_CELRC_2020_A_0103_1_20200707T131030.jpg **Rated Item:** 5. Plant Building **Caption:** Minimally Acceptable - PS-JA: Exterior stairs are spalling and toe board has come loose.

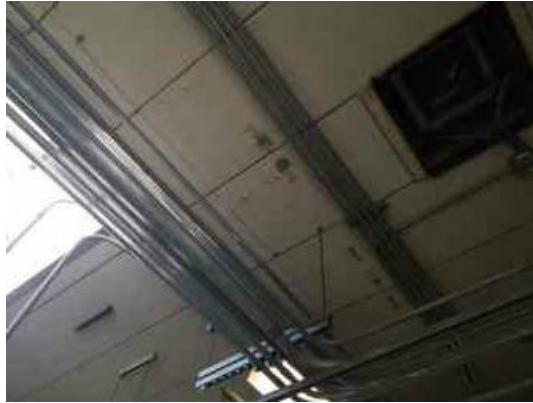
Inspect ID: 2020-0106 **Title:** 2604000008_CELRC_2020_A_0106_1_20200707T131157.jpg **Rated Item:** 5. Plant Building **Caption:** Minimally Acceptable - PS-JA: Peeling paint on ceiling.

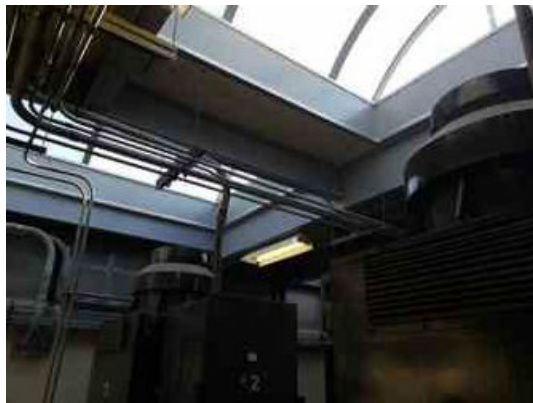
Inspect ID: 2020-0109 **Title:** 2604000008_CELRC_2020_A_0109_1_20200707T131240.jpg **Rated Item:** 5. Plant Building **Caption:** Acceptable - PS-JA: Beams were cleaned and painted.

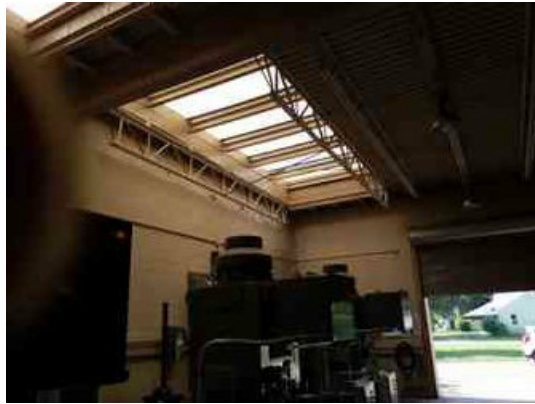
Inspect ID: 2020-0163 **Title:** 2604000008_CELRC_2020_A_0163_1_20200707T142132.jpg **Rated Item:** 5. Plant Building **Caption:** Minimally Acceptable - PS-SS: Paint peeling on wall.

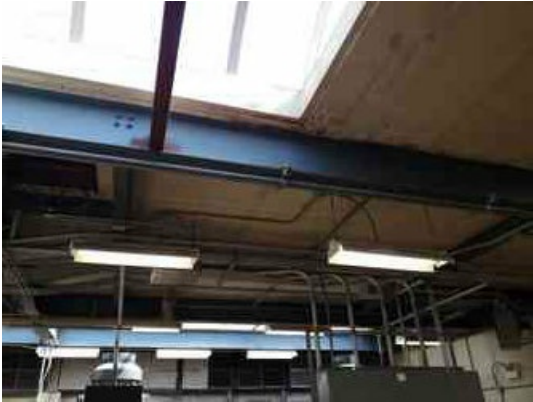
Inspect ID: 2020-0193 Title: 2604000008_CELRC_2020_A_0193_1_20200707T144848.jpg Rated Item: 5. Plant Building Caption: Minimally Acceptable - PS-IN: Corrosion around skylight.

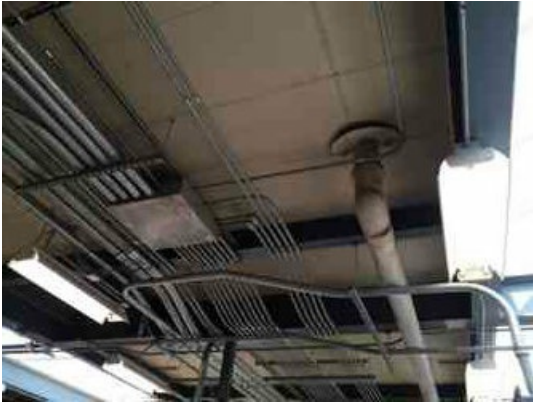
Inspect ID: 2020-0196 Title: 2604000008_CELRC_2020_A_0196_1_20200707T144941.jpg Rated Item: 5. Plant Building Caption: Minimally Acceptable - PS-IN: Cover coming off pipe.

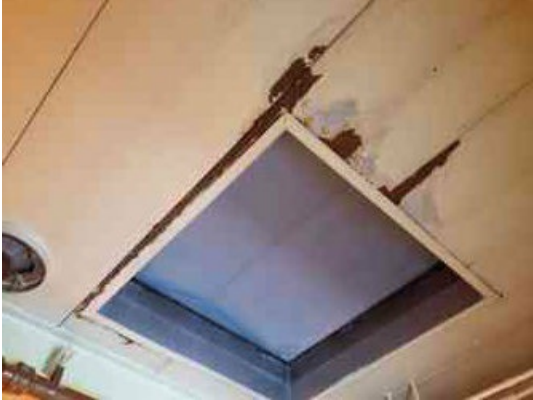
<p>Inspect ID: 2020-0250 Title: 2604000008_CELRC_2020_A_0250_1_20200707T153206.jpg Rated Item: 5. Plant Building Caption: Minimally Acceptable - PS-SK: Corrosion around ceiling hatch.</p>

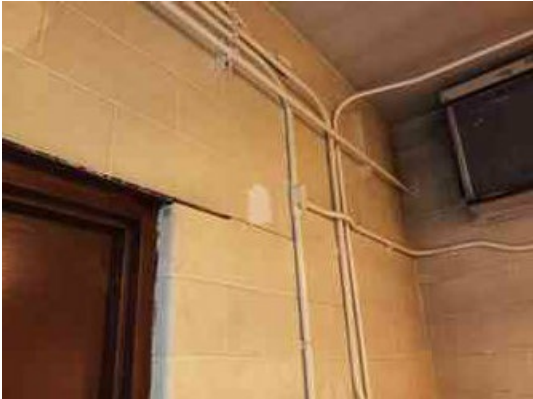
<p>Inspect ID: 2020-0253 Title: 2604000008_CELRC_2020_A_0253_1_20200707T153241.jpg Rated Item: 5. Plant Building Caption: Minimally Acceptable - PS-SK: Crack and corrosion around door.</p>

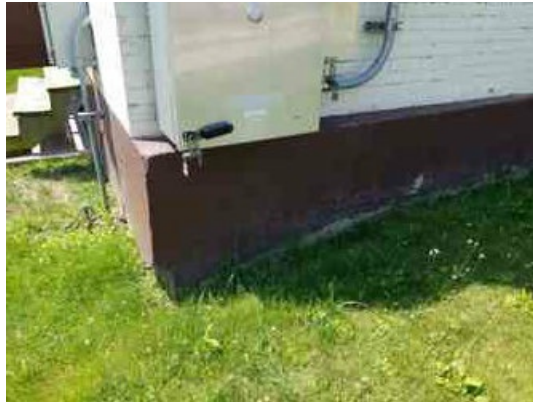
Inspect ID: 2020-0262 **Title:** 2604000008_CELRC_2020_A_0262_1_20200707T155012.jpg **Rated Item:** 5. Plant Building **Caption:** Minimally Acceptable - PS-TA: Foundation split.

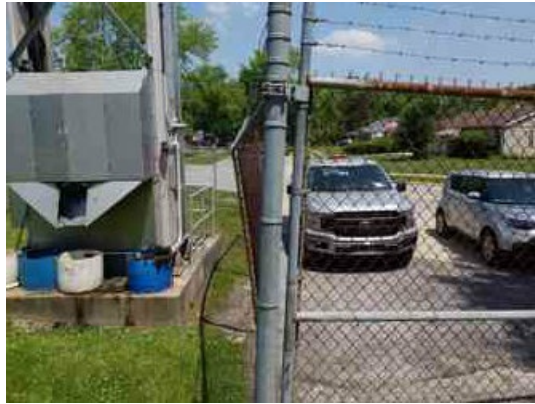
Inspect ID: 2020-0034 **Title:** 2604000008_CELRC_2020_A_0034_1_20200706T165712.jpg **Rated Item:** 6. Fencing and Gates **Caption:** Minimally Acceptable - PS-WA: Fence is falling over.

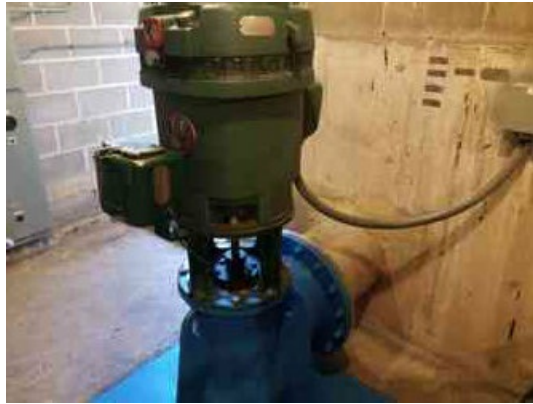
Inspect ID: 2020-0040 **Title:** 2604000008_CELRC_2020_A_0040_1_20200706T170906.jpg **Rated Item:** 7. Pumps **Caption:** Acceptable - PS-KA: Pump 1 in service .

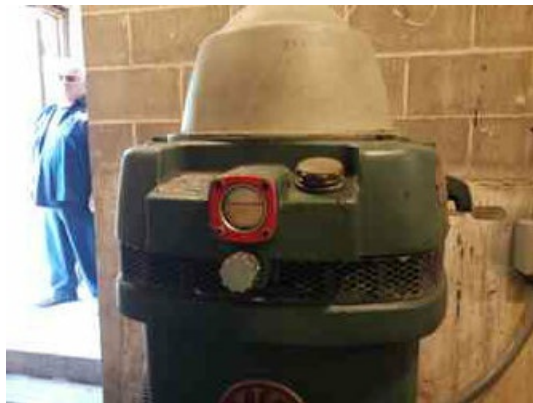
Inspect ID: 2020-0052 **Title:** 2604000008_CELRC_2020_A_0052_1_20200706T171234.jpg **Rated Item:** 7. Pumps **Caption:** Minimally Acceptable - PS-KA: Pump 2 oil indicator cracked.

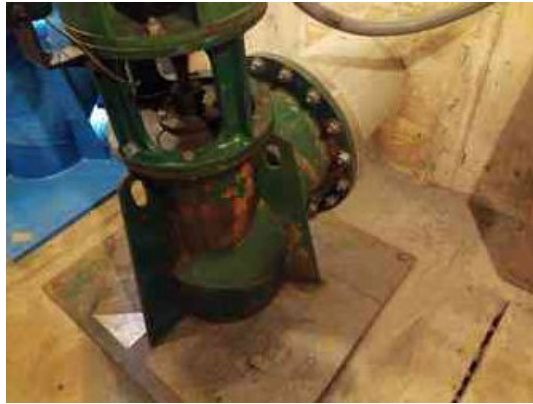
Inspect ID: 2020-0055 **Title:** 2604000008_CELRC_2020_A_0055_1_20200706T171314.jpg **Rated Item:** 7. Pumps **Caption:** Minimally Acceptable - PS-KA: Pump 1 has excessive corrosion.

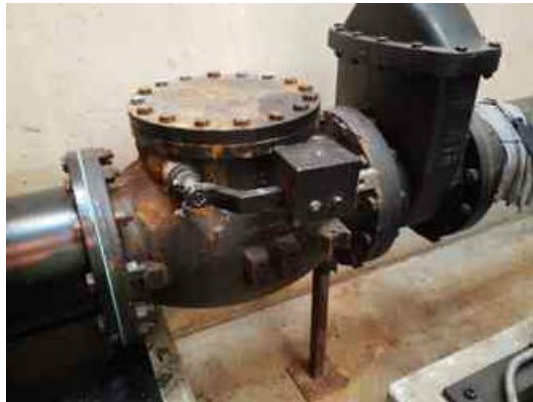
Inspect ID: 2020-0079 **Title:** 2604000008_CELRC_2020_A_0079_1_20200706T172923.jpg **Rated Item:** 7. Pumps **Caption:** Minimally Acceptable - PS-HV: DWP has excessive corrosion.

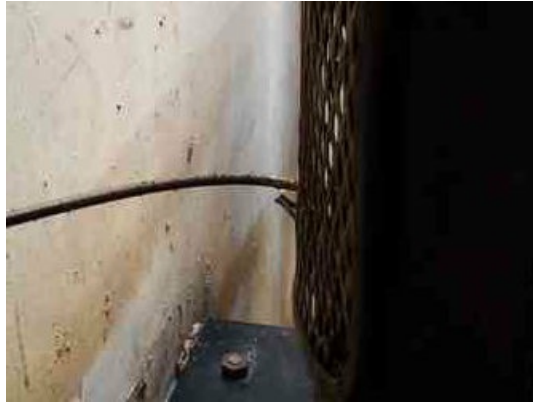
Inspect ID: 2020-0082 **Title:** 2604000008_CELRC_2020_A_0082_1_20200706T173011.jpg **Rated Item:** 7. Pumps **Caption:** Minimally Acceptable - PS-HV: DWP has small active oil leak.

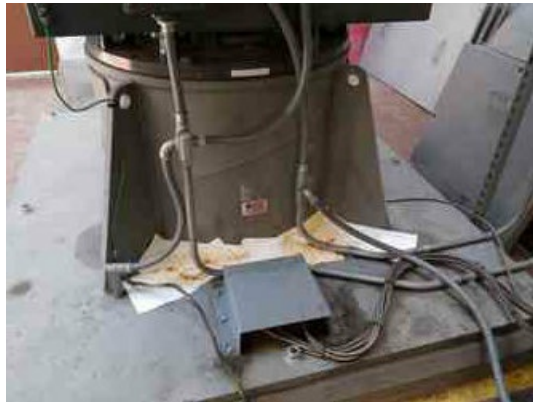
Inspect ID: 2020-0211 **Title:** 2604000008_CELRC_2020_A_0211_1_20200707T145617.jpg **Rated Item:** 7. Pumps **Caption:** Minimally Acceptable - PS-IN: SWP 1 has leak.

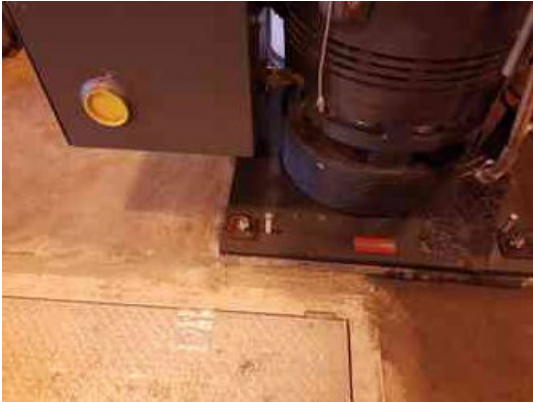
<p>Inspect ID: 2020-0238 Title: 2604000008_CELRC_2020_A_0238_1_20200707T152749.jpg Rated Item: 7. Pumps Caption: Minimally Acceptable - PS-SK: SWP 1 has liquid pooling under the control box.</p>

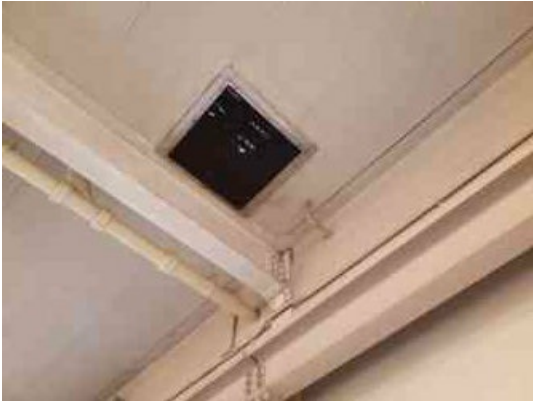
<p>Inspect ID: 2020-0094 Title: 2604000008_CELRC_2020_A_0094_1_20200706T173607.jpg Rated Item: 8. Motors, Engines, Fans, Gear Reducers, Back Stop Devices, etc. Caption: Minimally Acceptable - PS-HV: Ceiling fan screens need cleaning.</p>

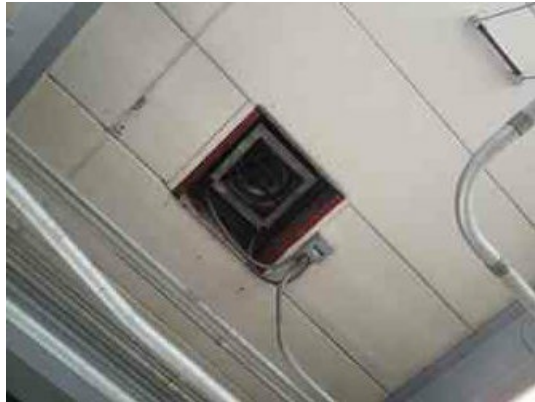
Inspect ID: 2020-0118 **Title:** 2604000008_CELRC_2020_A_0118_1_20200707T131919.jpg **Rated Item:** 8. Motors, Engines, Fans, Gear Reducers, Back Stop Devices, etc. **Caption:** Acceptable - PS-JA: Exhaust fan 1 and 2 were working.

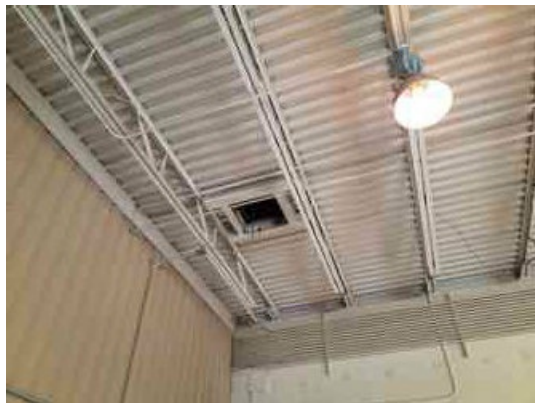
Inspect ID: 2020-0169 **Title:** 2604000008_CELRC_2020_A_0169_1_20200707T142625.jpg **Rated Item:** 8. Motors, Engines, Fans, Gear Reducers, Back Stop Devices, etc. **Caption:** Minimally Acceptable - PS-SS: Motorized dampener EF-1 does not open during operation.

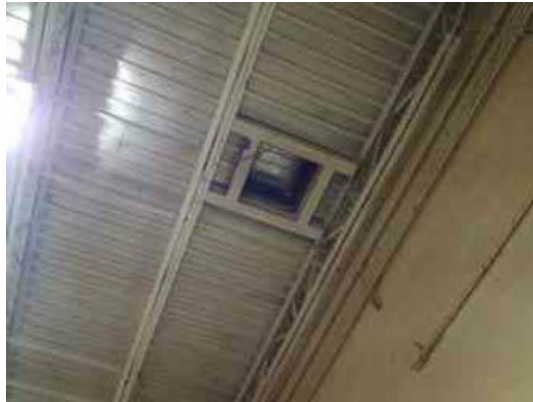
Inspect ID: 2020-0172 **Title:** 2604000008_CELRC_2020_A_0172_1_20200707T142727.jpg **Rated Item:** 8. Motors, Engines, Fans, Gear Reducers, Back Stop Devices, etc. **Caption:** Minimally Acceptable - PS-SS: Motorized dampener EF-2 does not open during operation.

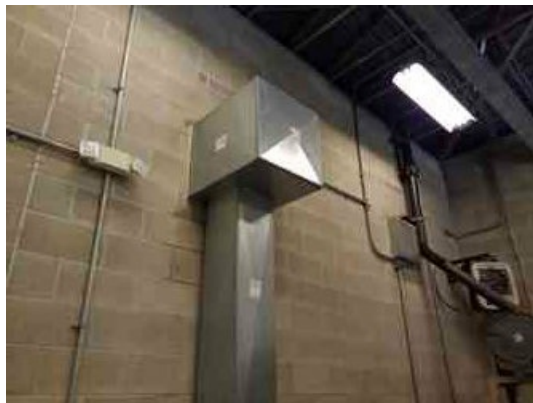
Inspect ID: 2020-0223 **Title:** 2604000008_CELRC_2020_A_0223_1_20200707T151355.jpg **Rated Item:** 8. Motors, Engines, Fans, Gear Reducers, Back Stop Devices, etc. **Caption:** Minimally Acceptable - PS-CA: Exhaust fan inoperable.

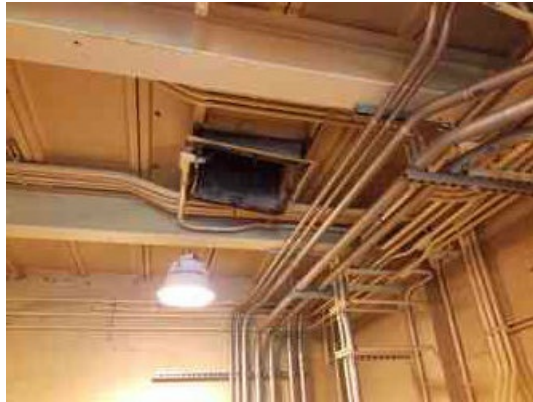
Inspect ID: 2020-0244 **Title:** 2604000008_CELRC_2020_A_0244_1_20200707T153008.jpg **Rated Item:** 8. Motors, Engines, Fans, Gear Reducers, Back Stop Devices, etc. **Caption:** Minimally Acceptable - PS-SK: EF-1 housing is not supported in the ceiling.

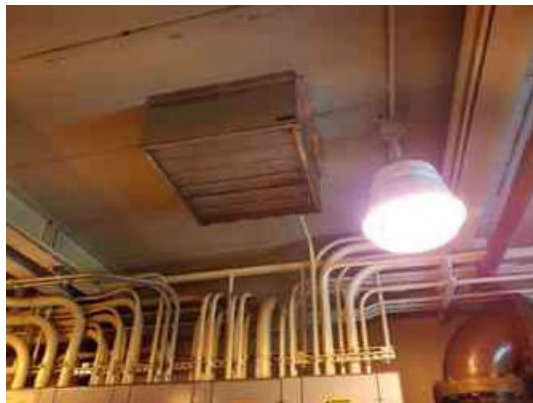
Inspect ID: 2020-0247 **Title:** 2604000008_CELRC_2020_A_0247_1_20200707T153106.jpg **Rated Item:** 8. Motors, Engines, Fans, Gear Reducers, Back Stop Devices, etc. **Caption:** Minimally Acceptable - PS-SK: EF-2 is inoperable.
