Levee Inspection Report

Name of System: Hammond

Name of Segment: Hammond

Date(s) of Inspection: 07/07/2020 - 07/08/2020

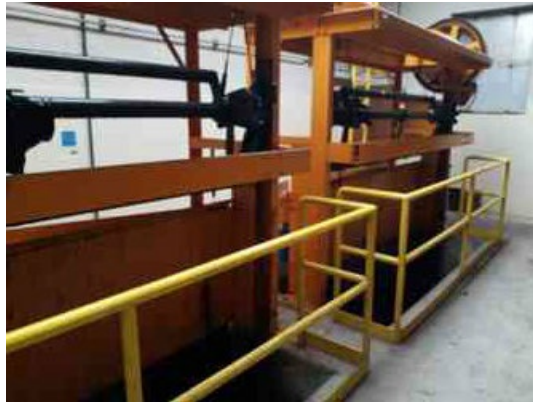
Inspect ID: 2020-0070 **Title:** 2604000008_CELRC_2020_A_0070_1_20200706T172616.jpg **Rated Item:** 10. Mechanical Operating Trash Rakes **Caption:** Acceptable - PS-HV: Alarm problem fixed. Rakes look good.

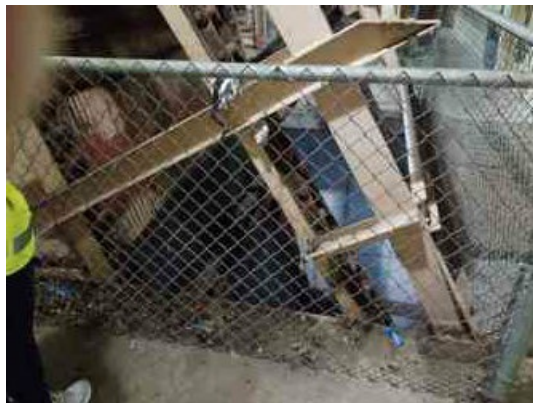
Inspect ID: 2020-0154 **Title:** 2604000008_CELRC_2020_A_0154_1_20200707T141825.jpg **Rated Item:** 10. Mechanical Operating Trash Rakes **Caption:** Minimally Acceptable - PS-SS: Makes a high pitched squealing when in operation.

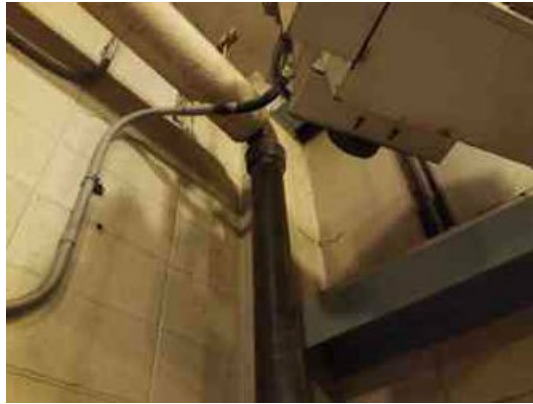
Inspect ID: 2020-0127 **Title:** 2604000008_CELRC_2020_A_0127_1_20200707T132328.jpg **Rated Item:** 16. Enclosures, Panels, Conduit and Ducts **Caption:** Minimally Acceptable - PS-JA: Elbow is heavily corroded.

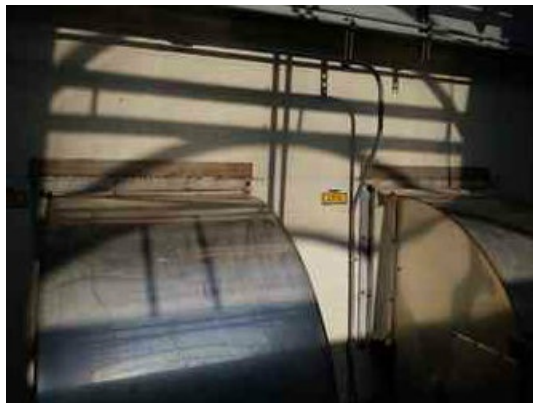
Inspect ID: 2020-0133 **Title:** 2604000008_CELRC_2020_A_0133_1_20200707T132553.jpg **Rated Item:** 16. Enclosures, Panels, Conduit and Ducts **Caption:** Minimally Acceptable - PS-JA: Rusting of shroud. Needs cleaning.

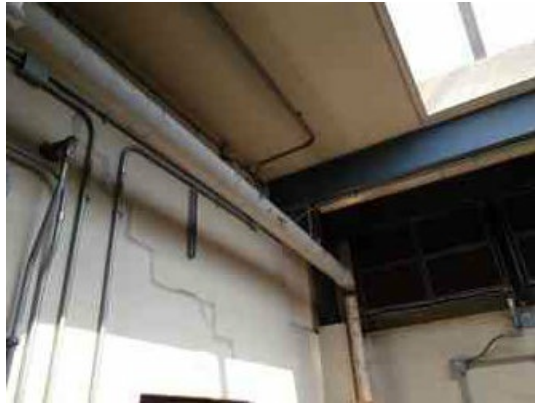
Inspect ID: 2020-0202 **Title:** 2604000008_CELRC_2020_A_0202_1_20200707T145109.jpg **Rated Item:** 16. Enclosures, Panels, Conduit and Ducts **Caption:** Minimally Acceptable - PS-IN: Insulation coming off pipe.

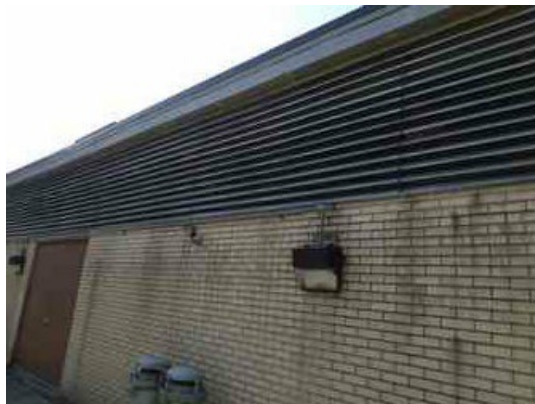
Inspect ID: 2020-0214 **Title:** 2604000008_CELRC_2020_A_0214_1_20200707T145727.jpg **Rated Item:** 16. Enclosures, Panels, Conduit and Ducts **Caption:** Minimally Acceptable - PS-IN: Nest in vent.

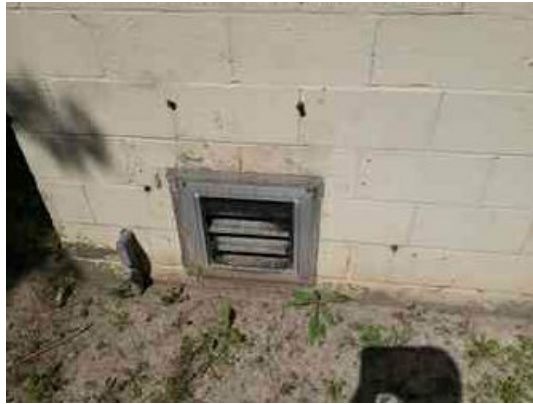
Inspect ID: 2020-0256 **Title:** 2604000008_CELRC_2020_A_0256_1_20200707T153422.jpg **Rated Item:** 16. Enclosures, Panels, Conduit and Ducts **Caption:** Minimally Acceptable - PS-SK: Broken screen.

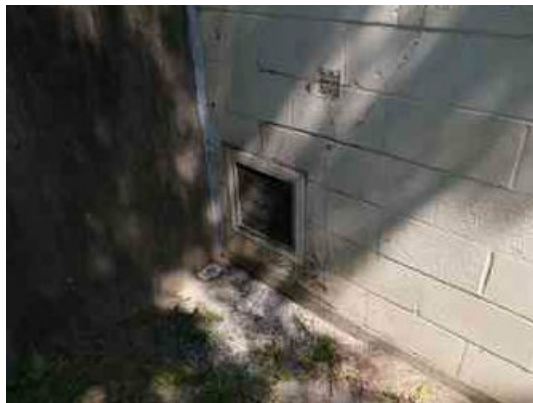
Inspect ID: 2020-0259 **Title:** 2604000008_CELRC_2020_A_0259_1_20200707T153500.jpg **Rated Item:** 16. Enclosures, Panels, Conduit and Ducts **Caption:** Minimally Acceptable - PS-SK: Clean screen.

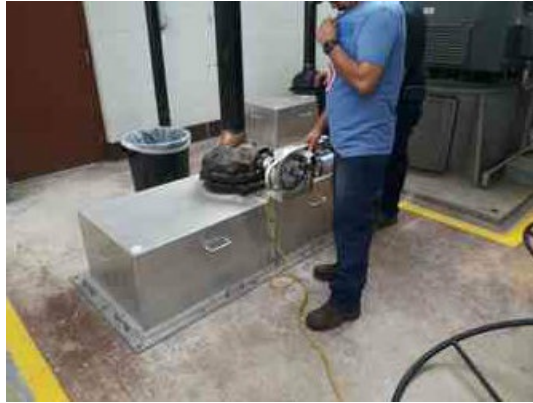
Inspect ID: 2020-0112 **Title:** 2604000008_CELRC_2020_A_0112_1_20200707T131309.jpg **Rated Item:** 18. Sluice/ Slide Gates **Caption:** Acceptable - PS-JA: Valve was operated successfully.

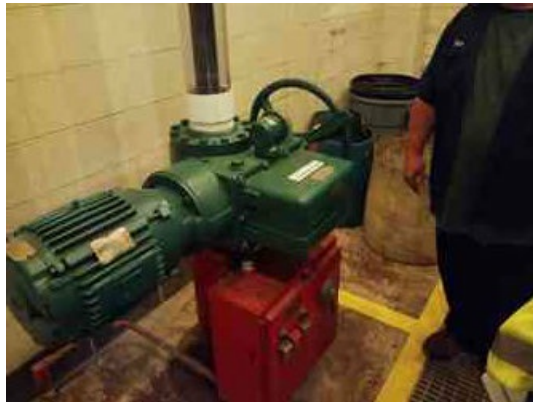
Inspect ID: 2020-0124 **Title:** 2604000008_CELRC_2020_A_0124_1_20200707T132217.jpg **Rated Item:** 18. Sluice/ Slide Gates **Caption:** Acceptable - PS-JA: Sluice gate is in operation.

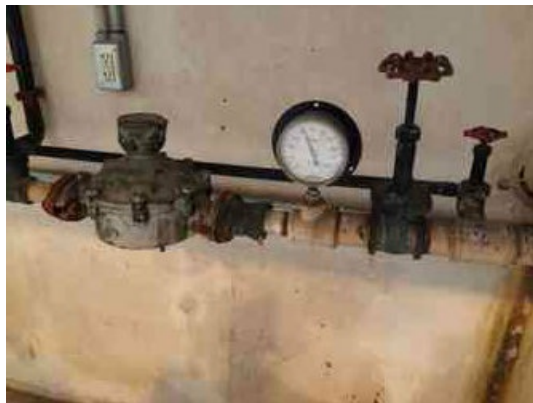
Inspect ID: 2020-0085 **Title:** 2604000008_CELRC_2020_A_0085_1_20200706T173104.jpg **Rated Item:** 21. Other Metallic Items (Equipment, Ladders, Platform Anchors, etc) **Caption:** Minimally Acceptable - PS-HV: Excessive corrosion.

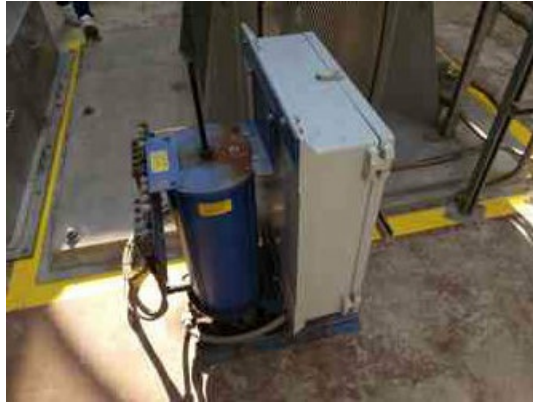
Inspect ID: 2020-0139 **Title:** 2604000008_CELRC_2020_A_0139_1_20200707T133317.jpg **Rated Item:** 21. Other Metallic Items (Equipment, Ladders, Platform Anchors, etc) **Caption:** Minimally Acceptable - PS-JA: Rusting on top of oil reservoir. Needs cleaning.
