**US Army Corps
of Engineers®**

Levee Inspection Report

Name of System: Highland

Date(s) of Inspection: 07/14/2020 - 07/14/2020

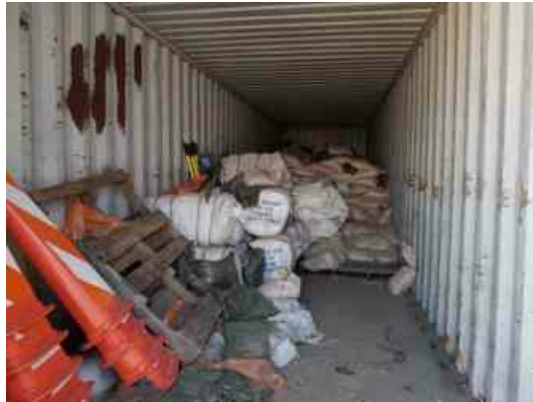
Inspect ID: 2020-0113 **Title:** 2604000007_CELRC_2020_A_0113_1_20200714T155531.jpg **Rated Item:** 2. Emergency Supplies and Equipment (A or M only) **Caption:** Acceptable - Highland storage containers with sandbags.

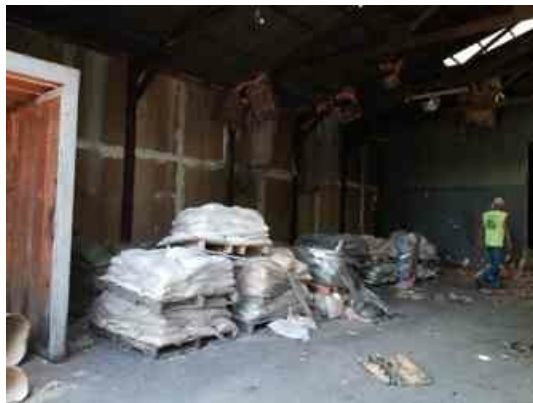
Inspect ID: 2020-0116 **Title:** 2604000007_CELRC_2020_A_0116_1_20200714T160248.jpg **Rated Item:** 2. Emergency Supplies and Equipment (A or M only) **Caption:** Acceptable - Highland storage of sandbags.

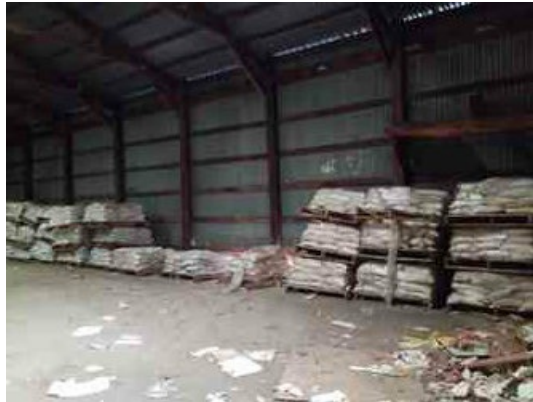
Inspect ID: 2020-0116 **Title:** 2604000007_CELRC_2020_A_0116_2_20200714T160306.jpg **Rated Item:** 2. Emergency Supplies and Equipment (A or M only) **Caption:** Acceptable - Highland storage of sandbags

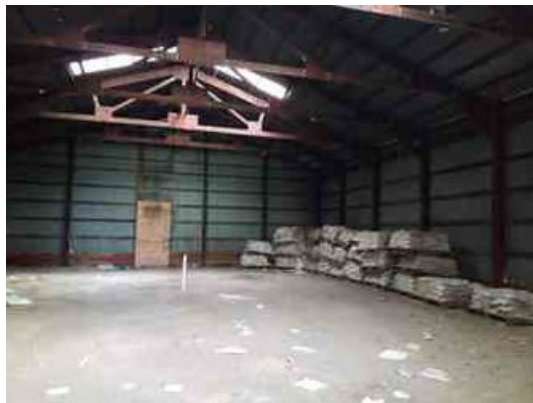
Inspect ID: 2020-0116 **Title:** 2604000007_CELRC_2020_A_0116_3_20200714T160322.jpg **Rated Item:** 2. Emergency Supplies and Equipment (A or M only) **Caption:** Acceptable - Highland storage of sandbags

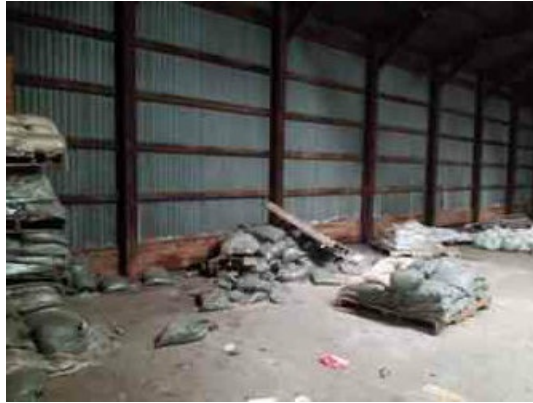
Inspect ID: 2020-0116 **Title:** 2604000007_CELRC_2020_A_0116_4_20200714T160329.jpg **Rated Item:** 2. Emergency Supplies and Equipment (A or M only) **Caption:** Acceptable - Highland storage of sandbags

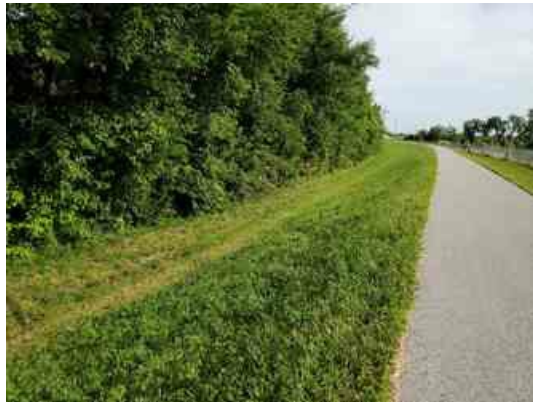
Inspect ID: 2020-0027 **Title:** 2604000007_CELRC_2020_A_0027_1_20200714T132646.jpg **Rated Item:** 1. Unwanted Vegetation Growth **Caption:** Minimally Acceptable - Trees near riverside toe.

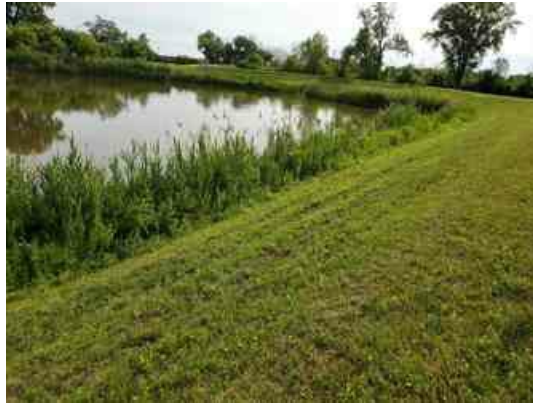
Inspect ID: 2020-0084 **Title:** 2604000007_CELRC_2020_A_2020-0084_1_20200714T134950.jpg **Rated Item:** 1. Unwanted Vegetation Growth **Caption:** Minimally Acceptable - Tall vegetation along riverside toe.

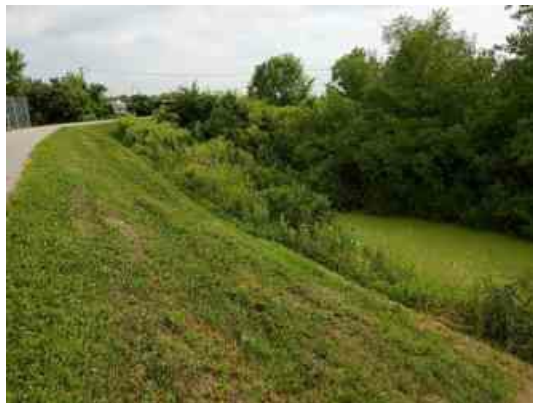
Inspect ID: 2020-0096 **Title:** 2604000007_CELRC_2020_A_0096_1_20200714T135504.jpg **Rated Item:** 1. Unwanted Vegetation Growth **Caption:** Minimally Acceptable - Tall vegetation on landside slope.

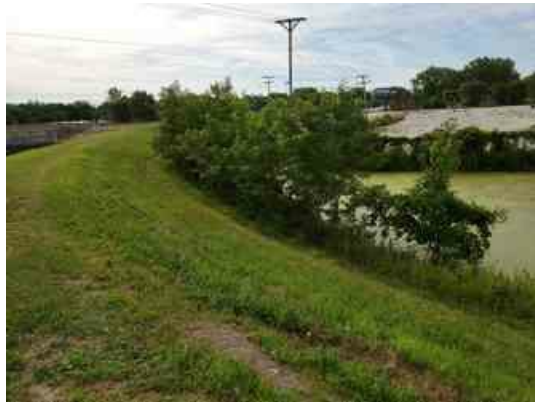
Inspect ID: 2020-0102 **Title:** 2604000007_CELRC_2020_A_0102_1_20200714T135721.jpg **Rated Item:** 1. Unwanted Vegetation Growth **Caption:** Minimally Acceptable - Trees

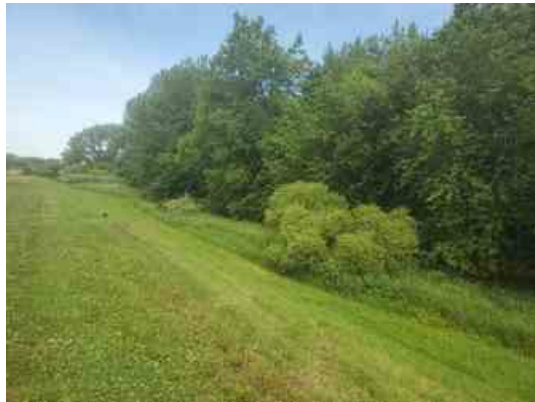
Inspect ID: 2020-0141 **Title:** 2604000007_CELRC_2020_A_0141_1_20200714T144044.jpg **Rated Item:** 1. Unwanted Vegetation Growth **Caption:** Minimally Acceptable - Tree on riverside slope.

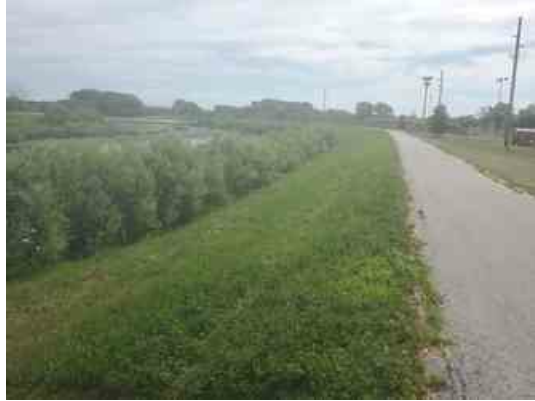
Inspect ID: 2020-0189 **Title:** 2604000007_CELRC_2020_A_0189_1_20200714T151335.jpg **Rated Item:** 1. Unwanted Vegetation Growth **Caption:** Minimally Acceptable - Tall vegetation on riverside toe.

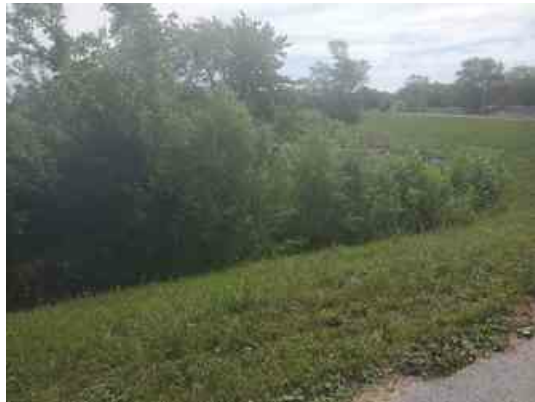
Inspect ID: 2020-0213 **Title:** 2604000007_CELRC_2020_A_0213_1_20200714T153224.jpg **Rated Item:** 1. Unwanted Vegetation Growth **Caption:** Minimally Acceptable - Tall vegetation and trees on riverside toe.

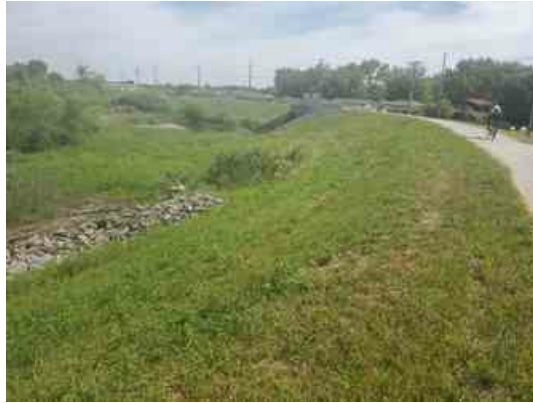
Inspect ID: 2020-0231 **Title:** 2604000007_CELRC_2020_A_0231_1_20200714T154016.jpg **Rated Item:** 1. Unwanted Vegetation Growth **Caption:** Minimally Acceptable - Tall vegetation on riverside toe.

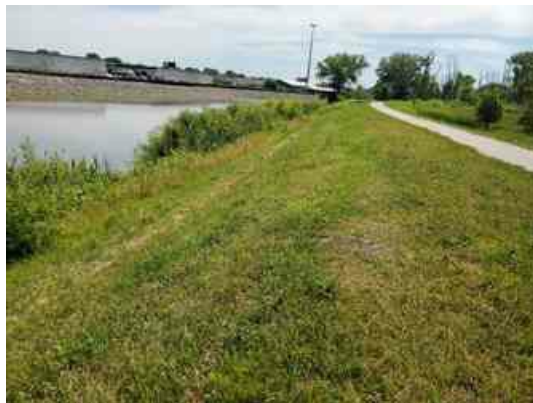
Inspect ID: 2020-0255 **Title:** 2604000007_CELRC_2020_A_0255_1_20200714T155328.jpg **Rated Item:** 1. Unwanted Vegetation Growth **Caption:** Minimally Acceptable - Tall vegetation on riverside toe.

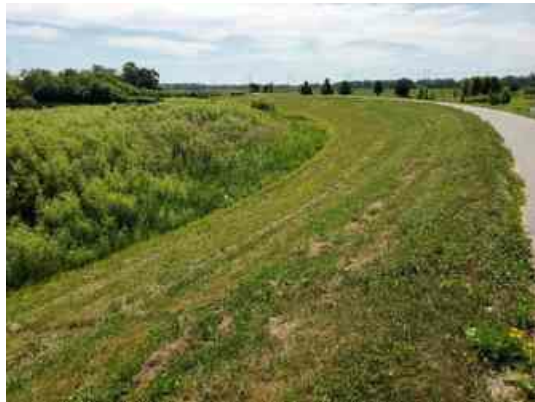
Inspect ID: 2020-0276 **Title:** 2604000007_CELRC_2020_A_0276_1_20200714T160141.jpg **Rated Item:** 1. Unwanted Vegetation Growth **Caption:** Minimally Acceptable - Tall vegetation on riverside toe.

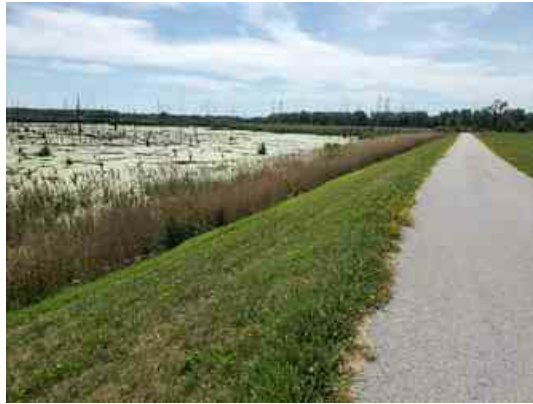
Inspect ID: 2020-0294 **Title:** 2604000007_CELRC_2020_A_0294_1_20200714T161327.jpg **Rated Item:** 1. Unwanted Vegetation Growth **Caption:** Minimally Acceptable - Small trees on riverside toe.

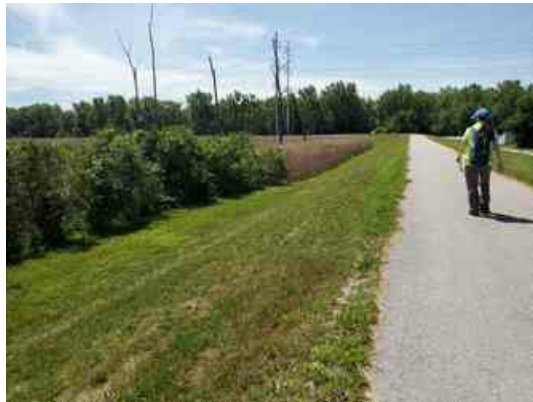
Inspect ID: 2020-0303 **Title:** 2604000007_CELRC_2020_A_0303_1_20200714T162104.jpg **Rated Item:** 1. Unwanted Vegetation Growth **Caption:** Minimally Acceptable - Trees near riverside toe.

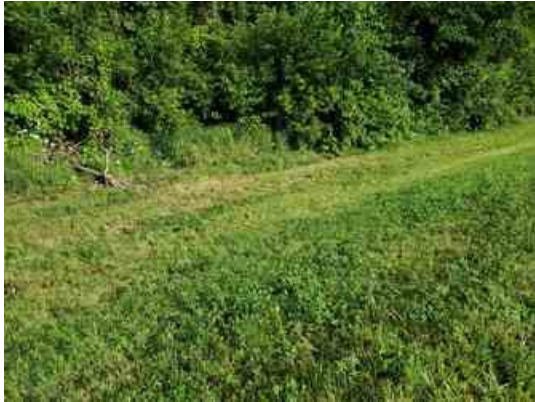
Inspect ID: 2020-0024 Title: 2604000007_CELRC_2020_A_0024_1_20200714T132620.jpg Rated Item: 3. Encroachments Caption: Minimally Acceptable - Downed tree on riverside toe.

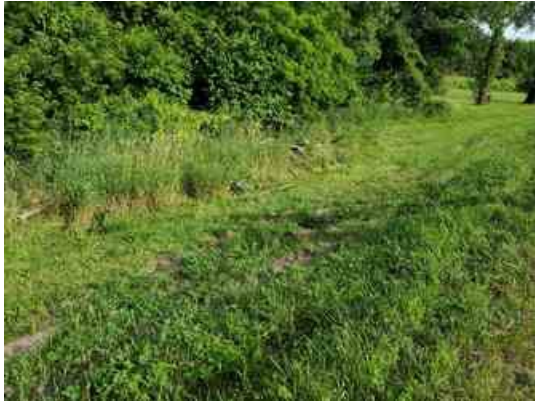
Inspect ID: 2020-0060 Title: 2604000007_CELRC_2020_A_0060_1_20200714T133728.jpg Rated Item: 3. Encroachments Caption: Minimally Acceptable - Logs on riverside toe causing tall vegetation growth.

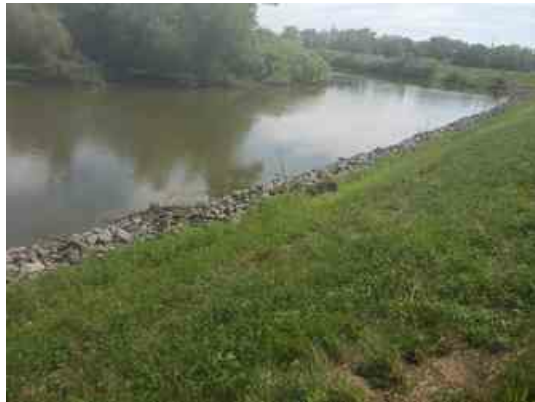
Inspect ID: 2020-0222 **Title:** 2604000007_CELRC_2020_A_0222_1_20200714T153539.jpg **Rated Item:** 3. Encroachments **Caption:** Minimally Acceptable - Downed trees on riprap.

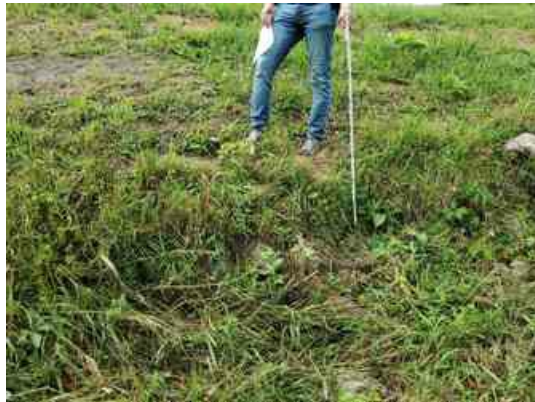
Inspect ID: 2020-0132 **Title:** 2604000007_CELRC_2020_A_0132_1_20200714T143300.jpg **Rated Item:** 6. Erosion/ Bank Caving **Caption:** Minimally Acceptable - 1 foot drop on riverside slope.

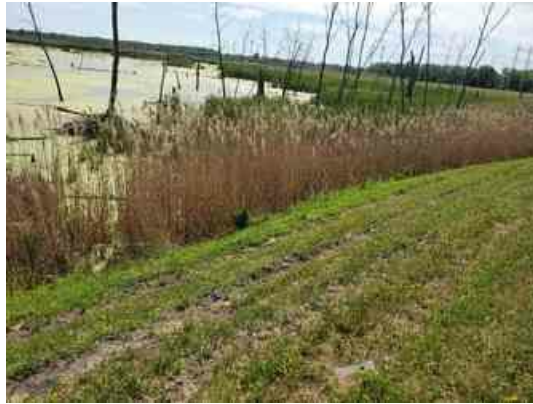
Inspect ID: 2020-0297 **Title:** 2604000007_CELRC_2020_A_0297_2_20200714T161719.jpg **Rated Item:** 6. Erosion/ Bank Caving **Caption:** Minimally Acceptable - Erosion along riverside toe.

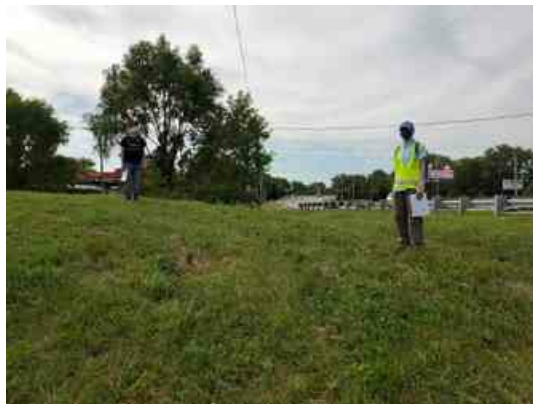
Inspect ID: 2020-0123 **Title:** 2604000007_CELRC_2020_A_0123_2_20200714T142313.jpg **Rated Item:** 7. Settlement **Caption:** Acceptable - Low spot on the crest. As-constructed.

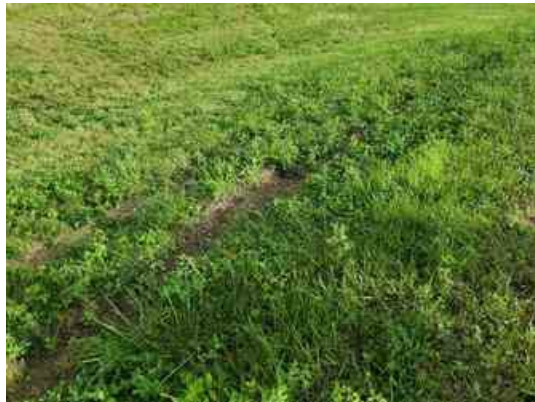
Inspect ID: 2020-0066 **Title:** 2604000007_CELRC_2020_A_0066_1_20200714T133905.jpg **Rated Item:** 8. Depressions/ Rutting **Caption:** Minimally Acceptable - Rutting on riverside slope.

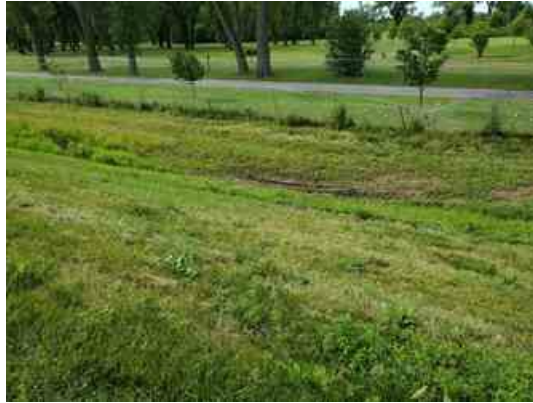
Inspect ID: 2020-0075 **Title:** 2604000007_CELRC_2020_A_0075_1_20200714T134359.jpg **Rated Item:** 8. Depressions/ Rutting **Caption:** Minimally Acceptable - Deep rut in ditch.

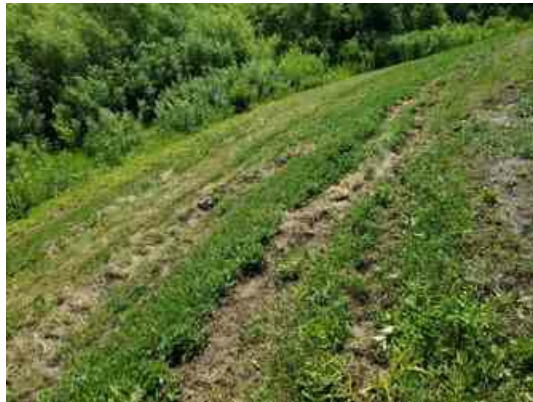
Inspect ID: 2020-0264 **Title:** 2604000007_CELRC_2020_A_0264_1_20200714T155557.jpg **Rated Item:** 8. Depressions/ Rutting **Caption:** Minimally Acceptable - Rutting on the riverside slope.

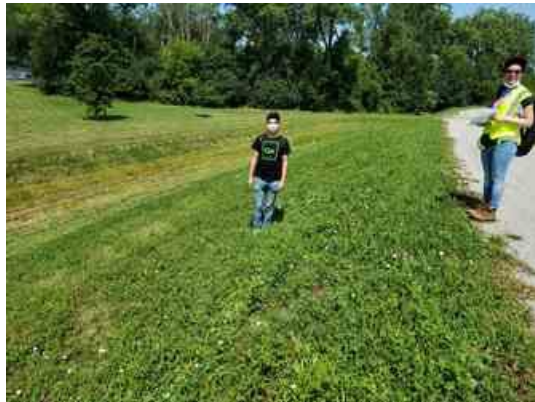
Inspect ID: 2020-0282 **Title:** 2604000007_CELRC_2020_A_0282_1_20200714T160303.jpg **Rated Item:** 8. Depressions/ Rutting **Caption:** Minimally Acceptable - Depression on upper half of landside slope.

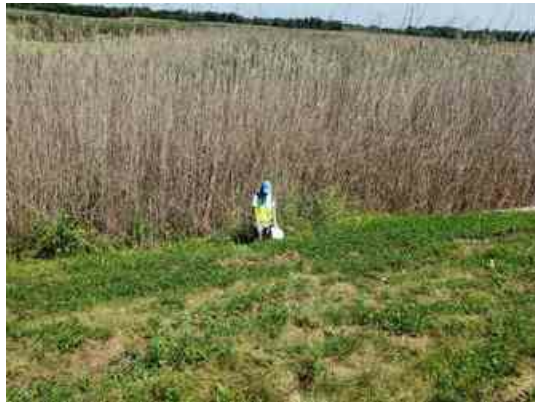
Inspect ID: 2020-0333 **Title:** 2604000007_CELRC_2020_A_0333_1_20200714T164232.jpg **Rated Item:** 10. Animal Control **Caption:** Minimally Acceptable - Collapsed burrows on riverside toe.

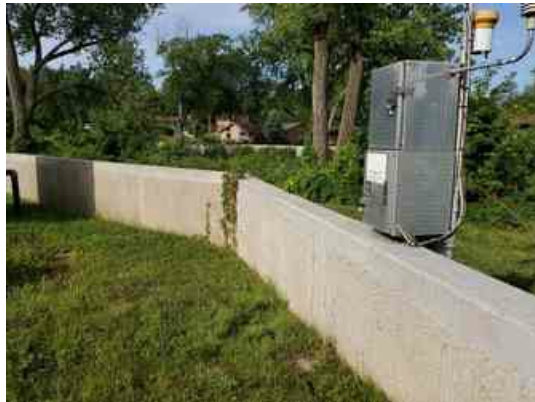
Inspect ID: 2020-0015 **Title:** 2604000007_CELRC_2020_A_0015_1_20200714T131900.jpg **Rated Item:** 1. Unwanted Vegetation Growth **Caption:** Minimally Acceptable - Vines on landside.

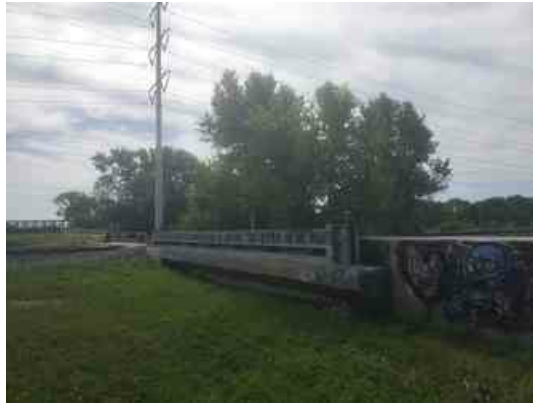
Inspect ID: 2020-0156 **Title:** 2604000007_CELRC_2020_A_2020-0156_1_20200714T145100.jpg **Rated Item:** 1. Unwanted Vegetation Growth **Caption:** Minimally Acceptable - Trees on landside.

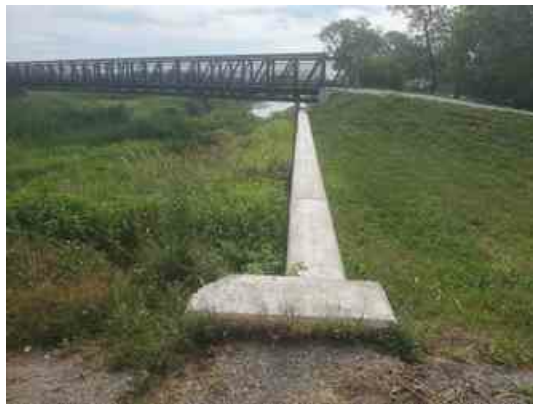
Inspect ID: 2020-0168 **Title:** 2604000007_CELRC_2020_A_0168_1_20200714T145717.jpg **Rated Item:** 1. Unwanted Vegetation Growth **Caption:** Minimally Acceptable - Small trees on riverside.

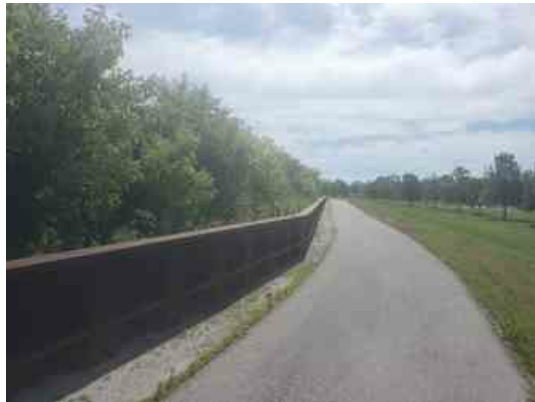
Inspect ID: 2020-0204 **Title:** 2604000007_CELRC_2020_A_0204_1_20200714T152554.jpg **Rated Item:** 1. Unwanted Vegetation Growth **Caption:** Minimally Acceptable - Tall trees on riverside.

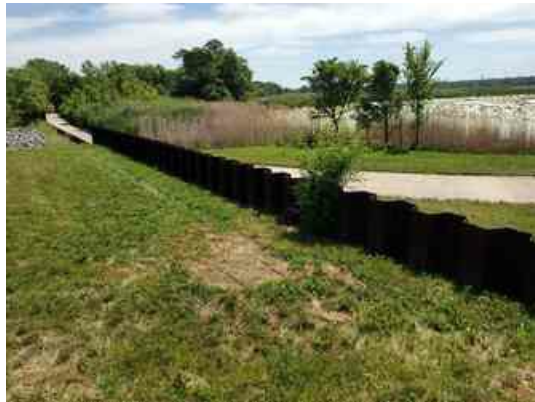
Inspect ID: 2020-0288 **Title:** 2604000007_CELRC_2020_A_0288_1_20200714T160602.jpg **Rated Item:** 1. Unwanted Vegetation Growth **Caption:** Minimally Acceptable - Trees along weir.

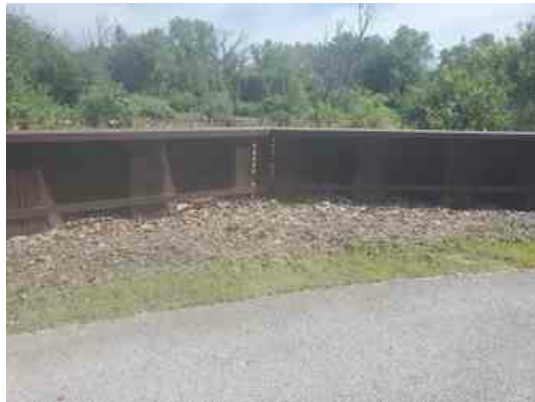
Inspect ID: 2020-0207 **Title:** 2604000007_CELRC_2020_A_0207_1_20200714T152905.jpg **Rated Item:** 2. Encroachments **Caption:** Minimally Acceptable - Dumped yard clippings on landside.

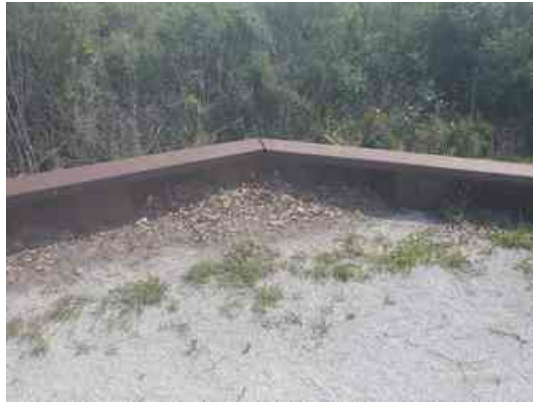
Inspect ID: 2020-0210 **Title:** 2604000007_CELRC_2020_A_0210_1_20200714T153142.jpg **Rated Item:** 2. Encroachments **Caption:** Minimally Acceptable - Dumped yard clippings on landside.

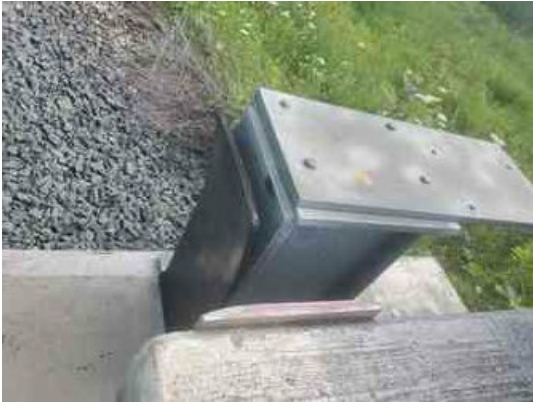
<p>Inspect ID: 2020-0162 Title: 2604000007_CELRC_2020_A_0162_2_20200714T145446.jpg Rated Item: 3. Closure Structures (Stop Log Closures and Gates) (A or U only) Caption: Acceptable - Rubber stop peeling. Last exercise performed in 2013. Exercise overdue.</p>

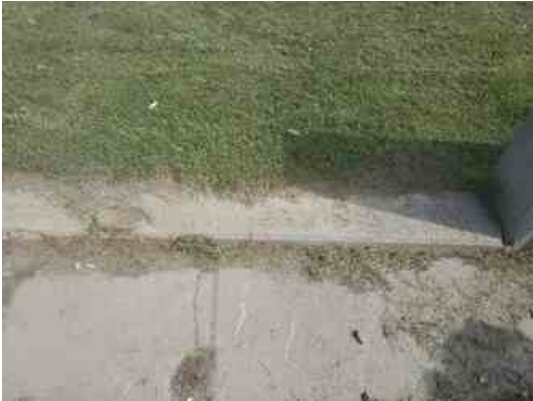
<p>Inspect ID: 2020-0183 Title: 2604000007_CELRC_2020_A_0183_1_20200714T151127.jpg Rated Item: 3. Closure Structures (Stop Log Closures and Gates) (A or U only) Caption: Acceptable - Grass growing over sill at Kennedy. Last exercise performed in 2016. Next exercise due in 2021.</p>

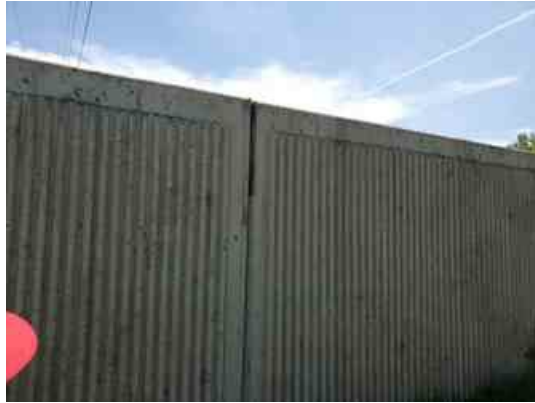
Inspect ID: 2020-0366 **Title:** 2604000007_CELRC_2020_A_0366_1_20200714T165332.jpg **Rated Item:** 7. Monolith Joints **Caption:** Minimally Acceptable - Exposed water stop on landside.

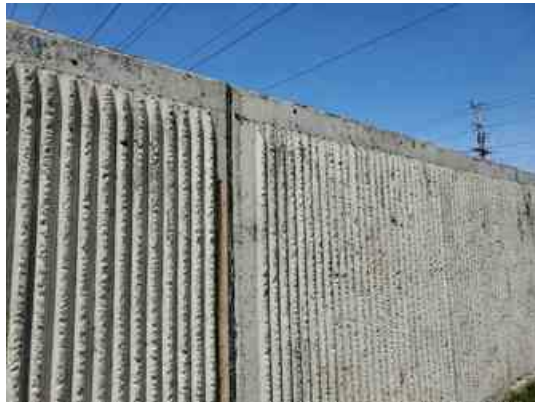
Inspect ID: 2020-0369 **Title:** 2604000007_CELRC_2020_A_0369_1_20200714T165452.jpg **Rated Item:** 7. Monolith Joints **Caption:** Minimally Acceptable - Exposed water stop on riverside.

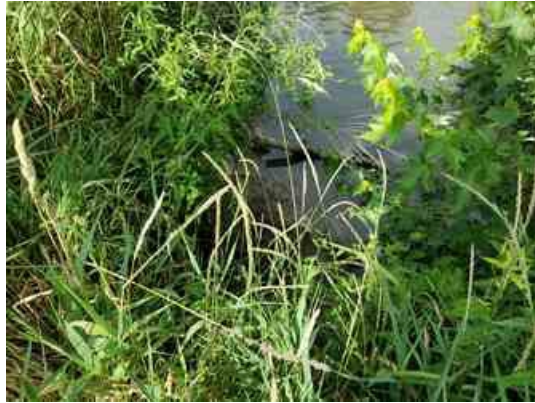
Inspect ID: 2020-0018 **Title:** 2604000007_CELRC_2020_A_0018_1_20200714T132104.jpg **Rated Item:** 1. Vegetation and Obstructions **Caption:** Minimally Acceptable - HI-2: Silt at outlet.

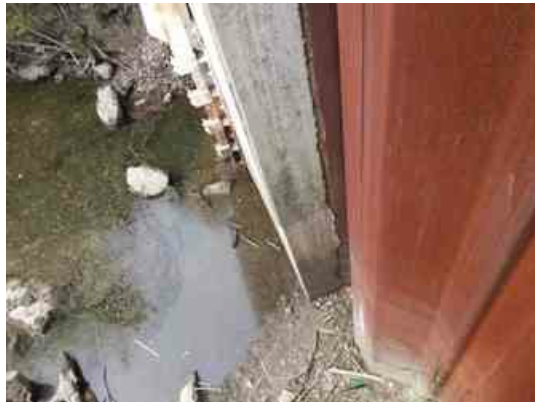
Inspect ID: 2020-0038 **Title:** 2604000007_CELRC_2020_A_0038_1_20200714T142121.jpg **Rated Item:** 1. Vegetation and Obstructions **Caption:** Minimally Acceptable - HI-6: Debris at outlet.

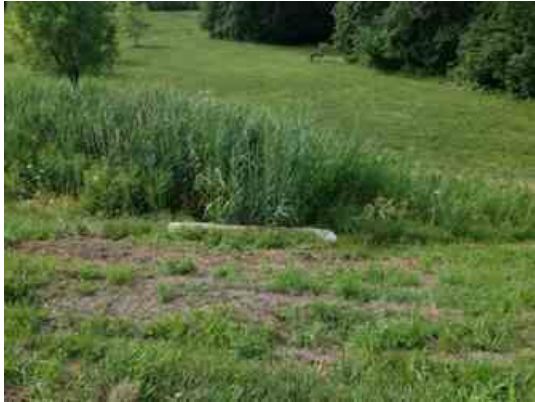
Inspect ID: 2020-0062 Title: 2604000007_CELRC_2020_A_0062_1_20200714T145010.jpg Rated Item: 1. Vegetation and Obstructions Caption: Minimally Acceptable - Hi-7: Vegetation in inlet.

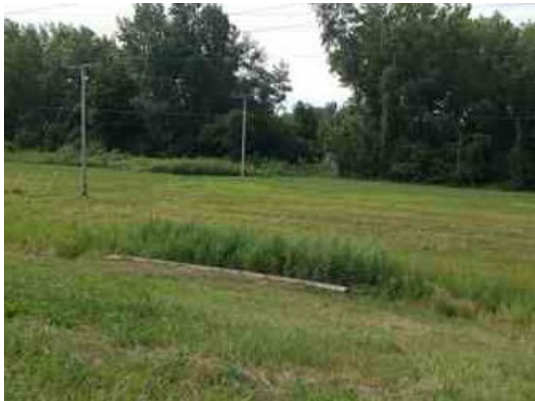
Inspect ID: 2020-0068 Title: 2604000007_CELRC_2020_A_0068_1_20200714T145821.jpg Rated Item: 1. Vegetation and Obstructions Caption: Minimally Acceptable - HI-10: Vegetation at inlet.

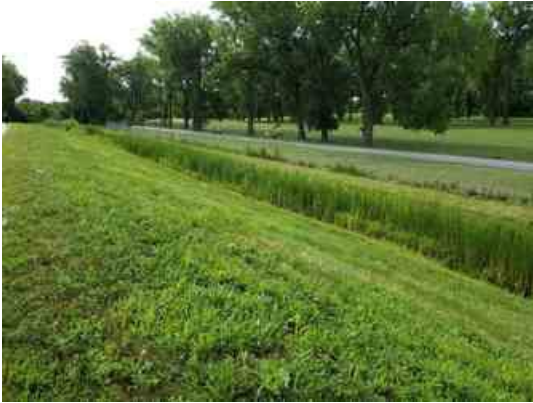
<p>Inspect ID: 2020-0081 Title: 2604000007_CELRC_2020_A_0081_1_20200714T134751.jpg Rated Item: 1. Vegetation and Obstructions Caption: Minimally Acceptable - Tall vegetation in ditch.</p>

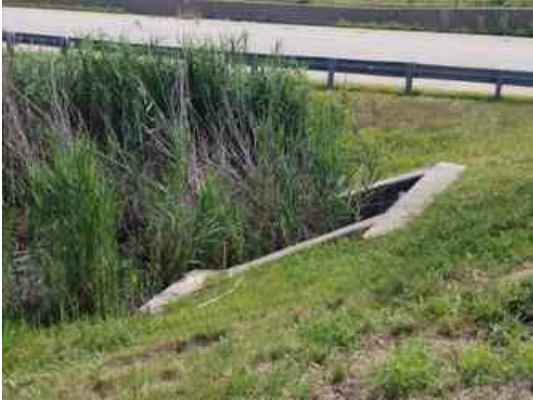
<p>Inspect ID: 2020-0101 Title: 2604000007_CELRC_2020_A_0101_1_20200714T153251.jpg Rated Item: 1. Vegetation and Obstructions Caption: Minimally Acceptable - HI-11: Vegetation at inlet.</p>

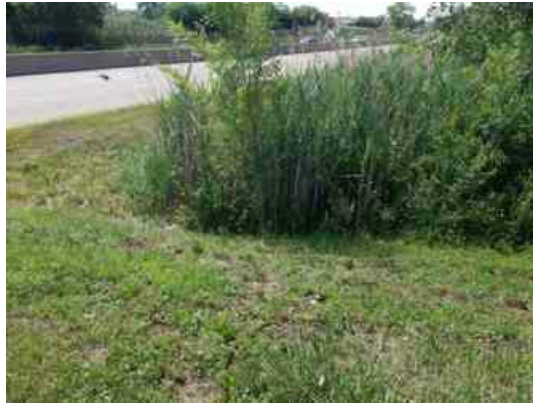
Inspect ID: 2020-0104 **Title:**
2604000007_CELRC_2020_A_0104_1_20200714T153331.jpg **Rated**
Item: 1. Vegetation and Obstructions **Caption:** Acceptable - HI-11:
Vegetation at outlet.

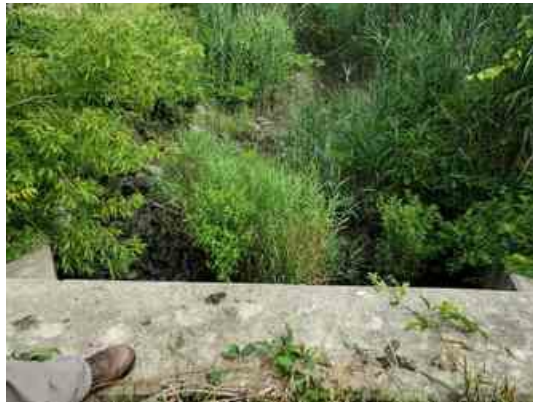
Inspect ID: 2020-0126 **Title:**
2604000007_CELRC_2020_A_0126_2_20200714T142902.jpg **Rated**
Item: 1. Vegetation and Obstructions **Caption:** Minimally Acceptable - HI-
6: Vegetation at outlet.

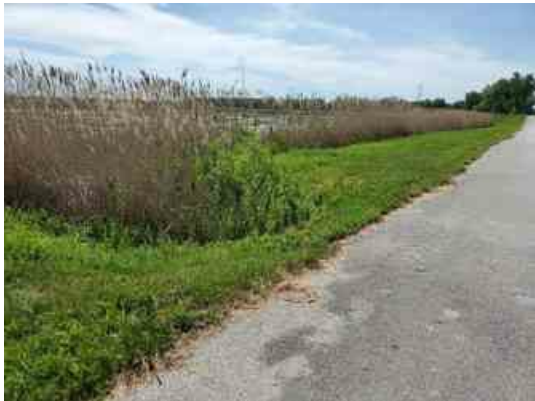
Inspect ID: 2020-0291 Title: 2604000007_CELRC_2020_A_0291_1_20200714T160859.jpg Rated Item: 1. Vegetation and Obstructions Caption: Minimally Acceptable - Outlet under the path next to the Rookery silted in.

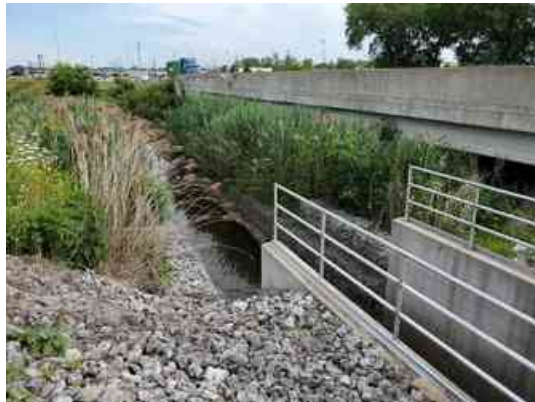
Inspect ID: 2020-0108 **Title:** 2604000007_CELRC_2020_A_0108_1_20200714T140042.jpg **Rated Item:** 15. Revetments other than Riprap **Caption:** Minimally Acceptable - Tall vegetation around gabions.

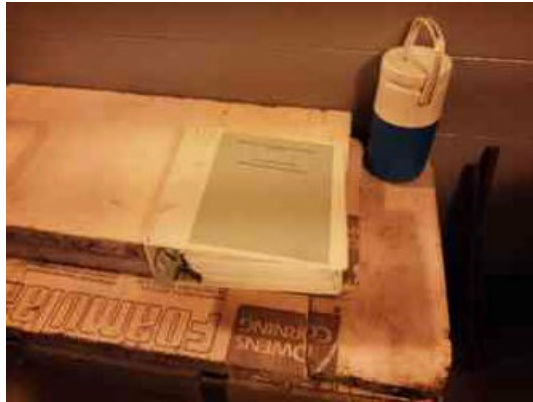
Inspect ID: 2020-0007 **Title:** 2604000007_CELRC_2020_A_0007_1_20200714T131556.jpg **Rated Item:** 2. Pump Station Operations and Maintenance Equipment Manuals **Caption:** Acceptable - PS-81: Manuals present.

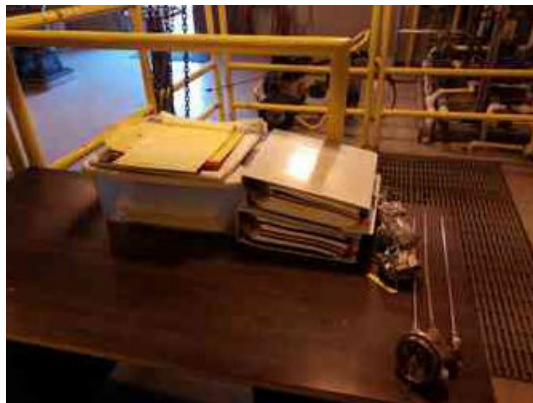
Inspect ID: 2020-0061 **Title:** 2604000007_CELRC_2020_A_0061_1_20200714T135856.jpg **Rated Item:** 2. Pump Station Operations and Maintenance Equipment Manuals **Caption:** Acceptable - PS-N5: Manuals present.

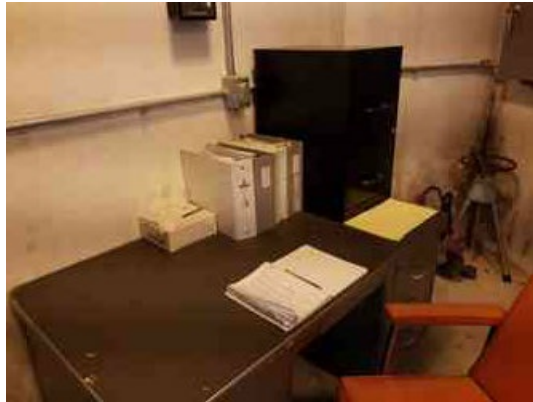
Inspect ID: 2020-0097 **Title:** 2604000007_CELRC_2020_A_0097_1_20200714T143224.jpg **Rated Item:** 2. Pump Station Operations and Maintenance Equipment Manuals **Caption:** Acceptable - PS-ND: Manuals present.

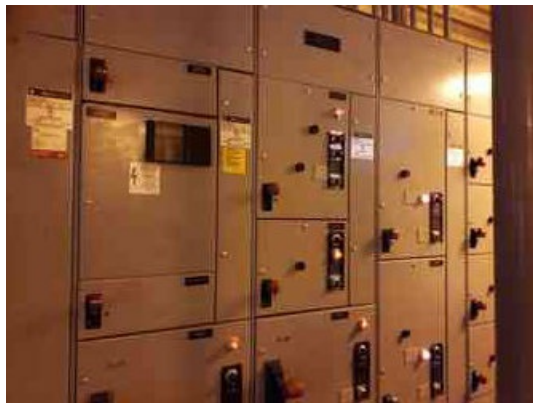
Inspect ID: 2020-0004 **Title:** 2604000007_CELRC_2020_A_0004_1_20200714T131505.jpg **Rated Item:** 3. Safety Compliance **Caption:** Minimally Acceptable - PS-81: No arc flash warning labels.

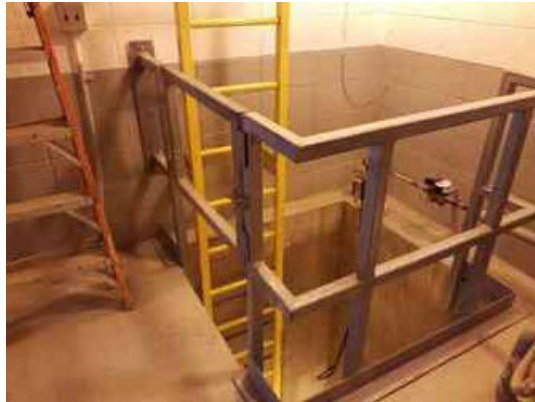
Inspect ID: 2020-0016 **Title:** 2604000007_CELRC_2020_A_0016_1_20200714T131935.jpg **Rated Item:** 3. Safety Compliance **Caption:** Minimally Acceptable - PS-81: No confined space warning label.

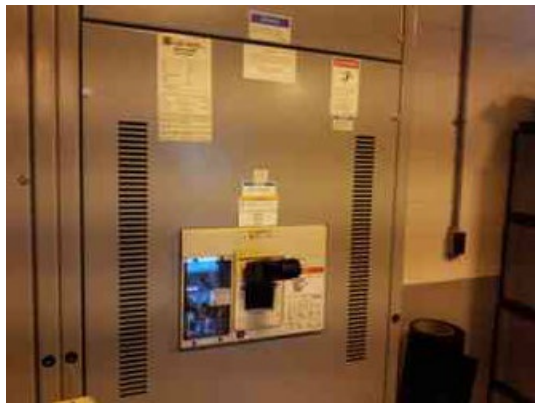
Inspect ID: 2020-0064 **Title:** 2604000007_CELRC_2020_A_0064_1_20200714T135934.jpg **Rated Item:** 3. Safety Compliance **Caption:** Minimally Acceptable - PS-N5: Outdated arc flash warning labels.

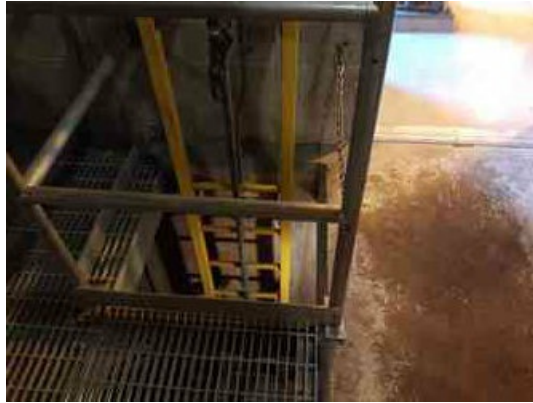
Inspect ID: 2020-0073 **Title:** 2604000007_CELRC_2020_A_0073_1_20200714T140206.jpg **Rated Item:** 3. Safety Compliance **Caption:** Minimally Acceptable - PS-N5: Needs confined space warning label.

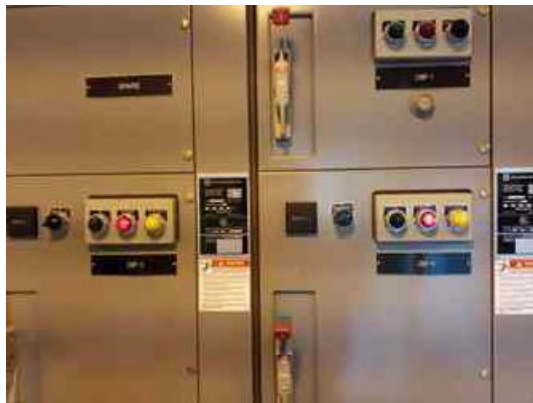
Inspect ID: 2020-0103 **Title:** 2604000007_CELRC_2020_A_0103_1_20200714T143444.jpg **Rated Item:** 3. Safety Compliance **Caption:** Minimally Acceptable - PS-ND: Need updated arc flash warning labels.

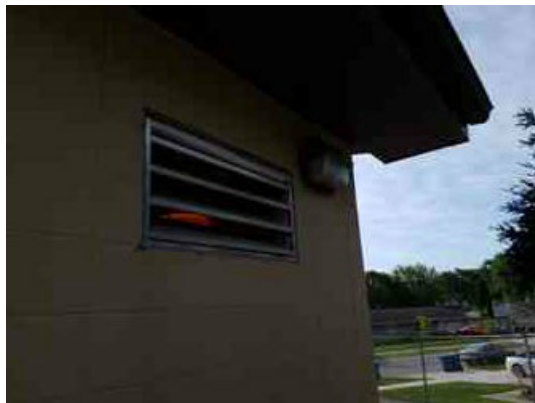
Inspect ID: 2020-0019 **Title:** 2604000007_CELRC_2020_A_0019_1_20200714T132048.jpg **Rated Item:** 5. Plant Building **Caption:** Minimally Acceptable - PS-81: Bird nest in vent.

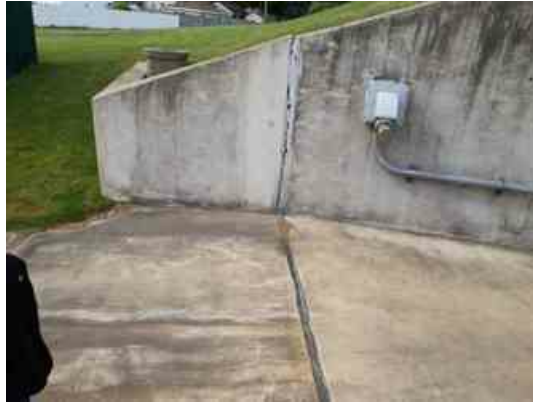
Inspect ID: 2020-0094 **Title:** 2604000007_CELRC_2020_A_0094_1_20200714T143030.jpg **Rated Item:** 5. Plant Building **Caption:** Minimally Acceptable - PS-ND: Splitting on seal of headwall.

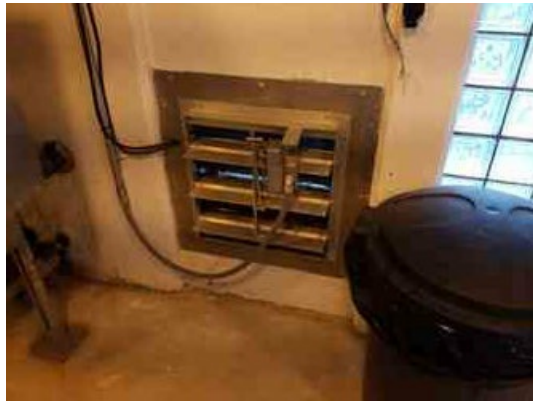
Inspect ID: 2020-0100 **Title:** 2604000007_CELRC_2020_A_0100_1_20200714T143328.jpg **Rated Item:** 5. Plant Building **Caption:** Minimally Acceptable - PS-ND: Screen needs to be cleaned.

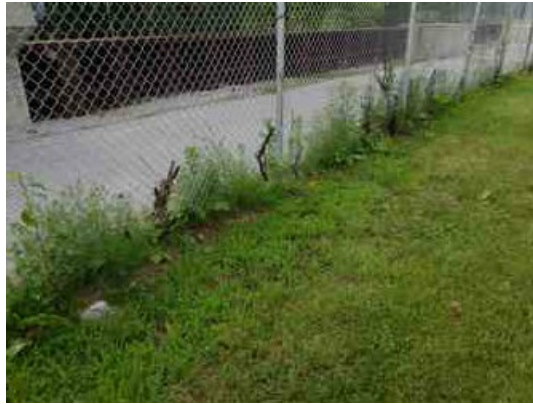
Inspect ID: 2020-0085 **Title:** 2604000007_CELRC_2020_A_0085_1_20200714T141154.jpg **Rated Item:** 6. Fencing and Gates **Caption:** Acceptable - PS-N5: Vegetation in fence.

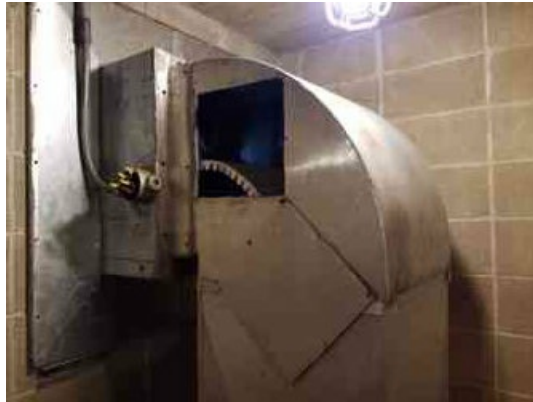
Inspect ID: 2020-0070 **Title:**
2604000007_CELRC_2020_A_0070_1_20200714T140129.jpg **Rated**
Item: 8. Motors, Engines, Fans, Gear Reducers, Back Stop Devices, etc.
Caption: Minimally Acceptable - PS-N5: Supply fan 1 inoperable.

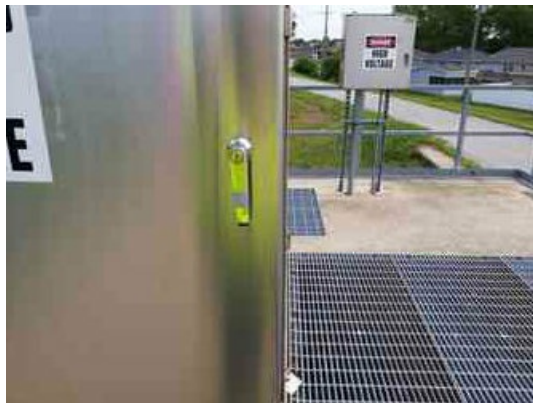
Inspect ID: 2020-0091 **Title:**
2604000007_CELRC_2020_A_0091_1_20200714T142709.jpg **Rated**
Item: 16. Enclosures, Panels, Conduit and Ducts **Caption:** Acceptable -
PS-ND: Replaced handle on panel.

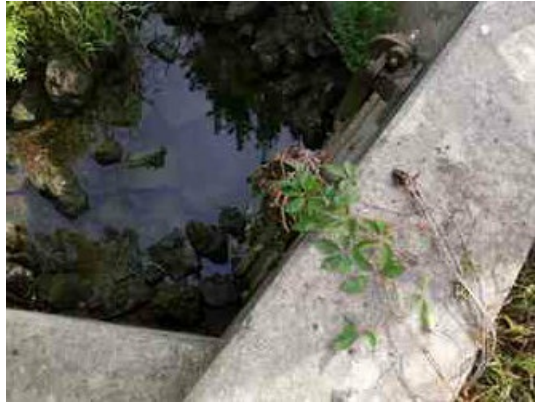
Inspect ID: 2020-0385 **Title:**
2604000007_CELRC_2020_A_0385_1_20200918T175516.jpg **Rated**
Item: 19. Flap Gates/ Flap Valves/ Pinch Valves **Caption:** Minimally
Acceptable - PS-81: Flap gate stuck open.
