**US Army Corps
of Engineers®**

Levee Inspection Report

Name of System: Munster

Date(s) of Inspection: 07/06/2020 - 07/06/2020

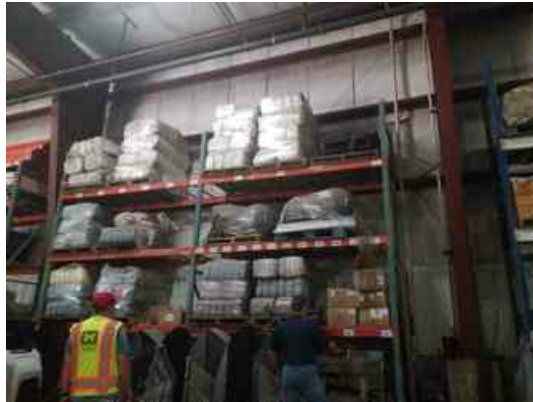
Inspect ID: 2020-0089 **Title:**

Item: 2. Emergency Supplies and Equipment (A or M only) **Caption:**

Acceptable - Supply material and empty sand bags. Around 126000 bags.

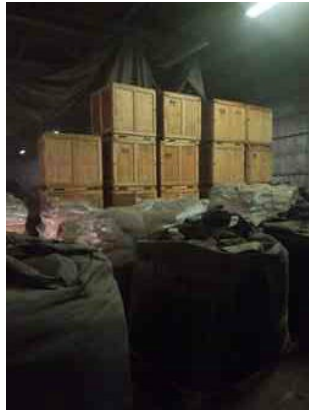
Inspect ID: 2020-0092 **Title:** 2604000009_CELRC_2020_A_2020-0092_2_20200706T160129.jpg **Rated Item:** 2. Emergency Supplies and Equipment (A or M only) **Caption:** Acceptable - Filled sand bags and bags of sand. 14 boxed cases (10000 empty bags per box.) and roughly 20 pallets of filled sandbags. About 11 mega bags of sand

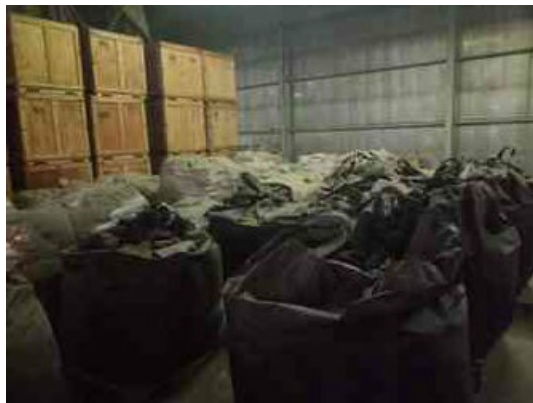
Inspect ID: 2020-0092 **Title:** 2604000009_CELRC_2020_A_2020-0092_3_20200706T160337.jpg **Rated Item:** 2. Emergency Supplies and Equipment (A or M only) **Caption:** Acceptable - Filled sand bags and bags of sand. 14 boxed cases (10000 empty bags per box.) and roughly 20 pallets of filled sandbags. About 11 mega bags of sand

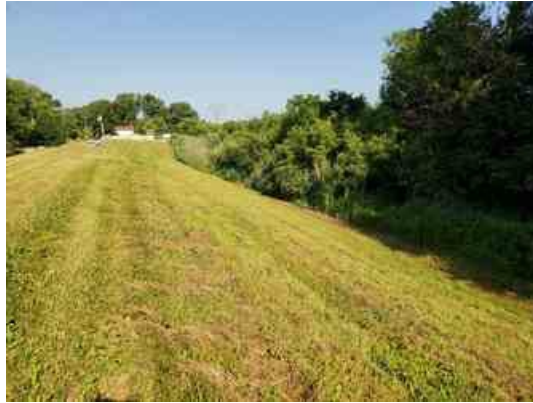
Inspect ID: 2020-0045 **Title:** 2604000009_CELRC_2020_A_0045_1_20200706T133621.jpg **Rated Item:** 1. Unwanted Vegetation Growth **Caption:** Minimally Acceptable - Vegetation close to riverside toe.

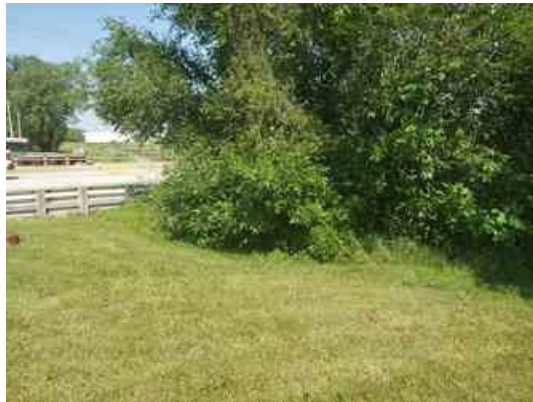
Inspect ID: 2020-0300 **Title:** 2604000009_CELRC_2020_A_0300_1_20200706T153010.jpg **Rated Item:** 1. Unwanted Vegetation Growth **Caption:** Minimally Acceptable - Trees on riverside toe.

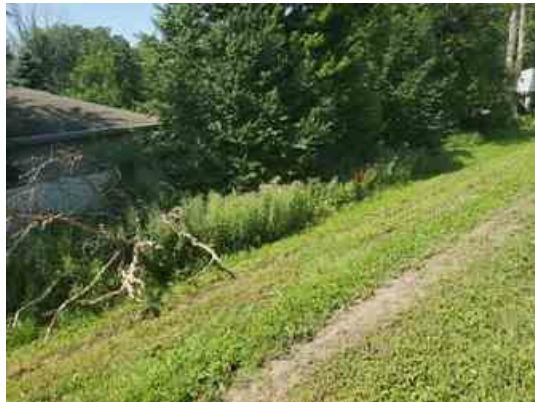
Inspect ID: 2020-0315 **Title:** 2604000009_CELRC_2020_A_0315_1_20200706T153950.jpg **Rated Item:** 1. Unwanted Vegetation Growth **Caption:** Minimally Acceptable - Tall vegetation on landside toe.

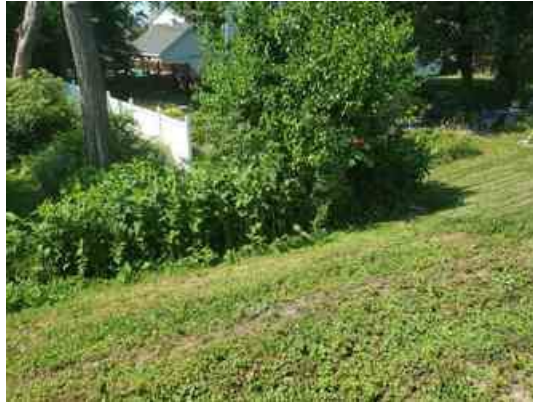
Inspect ID: 2020-0321 **Title:** 2604000009_CELRC_2020_A_0321_1_20200706T154222.jpg **Rated Item:** 1. Unwanted Vegetation Growth **Caption:** Minimally Acceptable - Trees and tall vegetation on landside toe and slope.

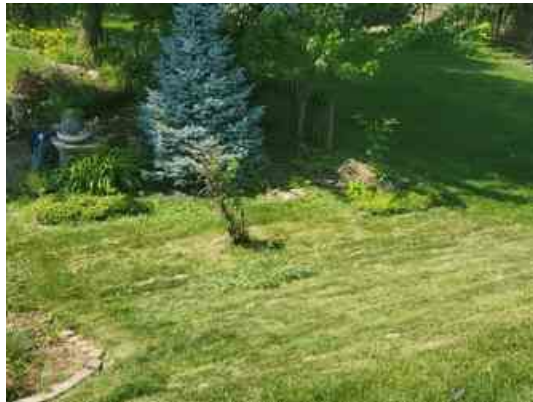
Inspect ID: 2020-0327 **Title:** 2604000009_CELRC_2020_A_0327_1_20200706T154354.jpg **Rated Item:** 1. Unwanted Vegetation Growth **Caption:** Minimally Acceptable - Bushes on landside toe.

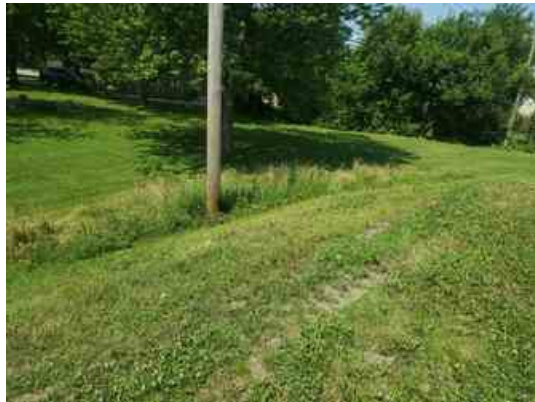
Inspect ID: 2020-0342 **Title:** 2604000009_CELRC_2020_A_0342_1_20200706T154823.jpg **Rated Item:** 1. Unwanted Vegetation Growth **Caption:** Minimally Acceptable - Tall vegetation on landside slope.

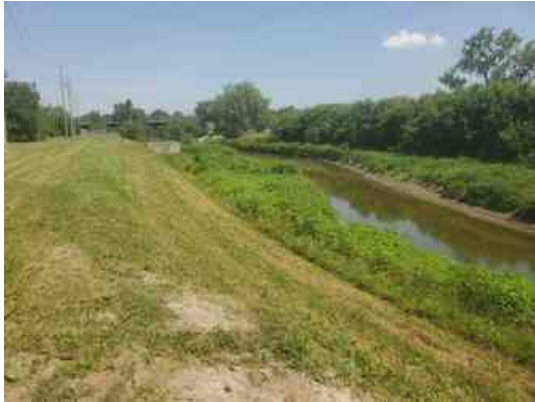
<p>Inspect ID: 2020-0384 Title: 2604000009_CELRC_2020_A_0384_1_20200706T160800.jpg Rated Item: 1. Unwanted Vegetation Growth Caption: Minimally Acceptable - Tall vegetation on riverside toe.</p>

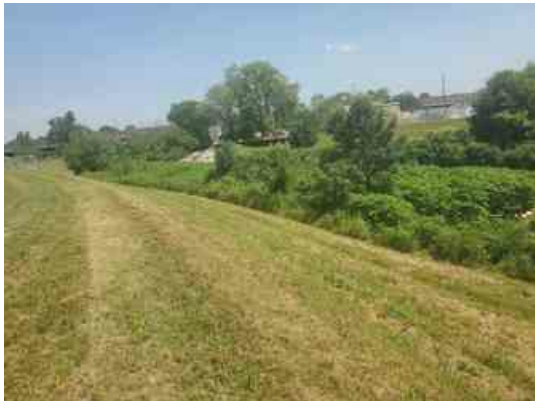
<p>Inspect ID: 2020-0387 Title: 2604000009_CELRC_2020_A_0387_1_20200706T161244.jpg Rated Item: 1. Unwanted Vegetation Growth Caption: Minimally Acceptable - Trees and tall vegetation on riverside toe.</p>

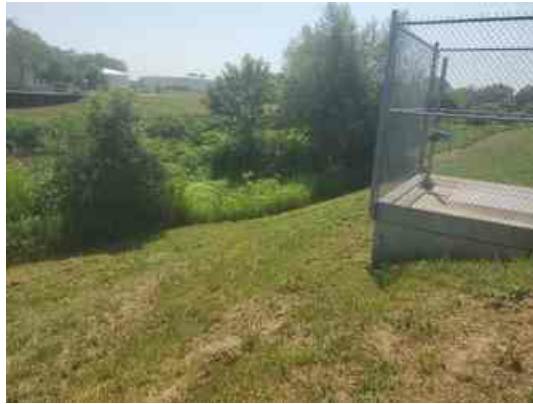
Inspect ID: 2020-0396 **Title:** 2604000009_CELRC_2020_A_0396_1_20200706T161627.jpg **Rated Item:** 1. Unwanted Vegetation Growth **Caption:** Minimally Acceptable - Trees and tall vegetation on riverside toe.

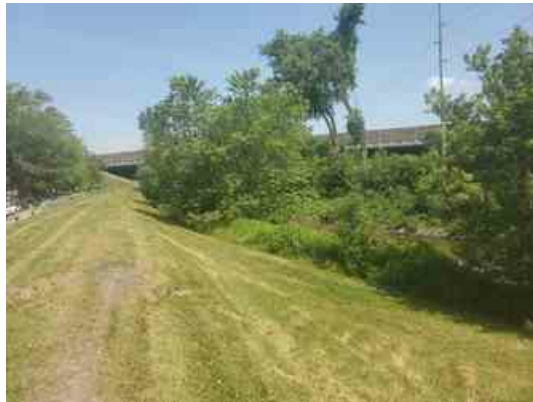
Inspect ID: 2020-0399 **Title:** 2604000009_CELRC_2020_A_0399_1_20200706T161801.jpg **Rated Item:** 1. Unwanted Vegetation Growth **Caption:** Minimally Acceptable - Trees on riverside toe.

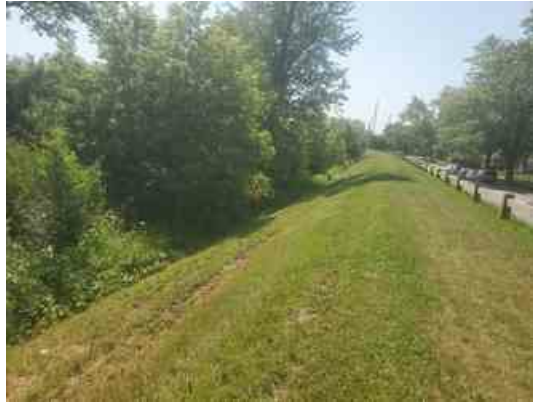
Inspect ID: 2020-0405 **Title:** 2604000009_CELRC_2020_A_0405_1_20200706T162242.jpg **Rated Item:** 1. Unwanted Vegetation Growth **Caption:** Minimally Acceptable - Trees on riverside toe.

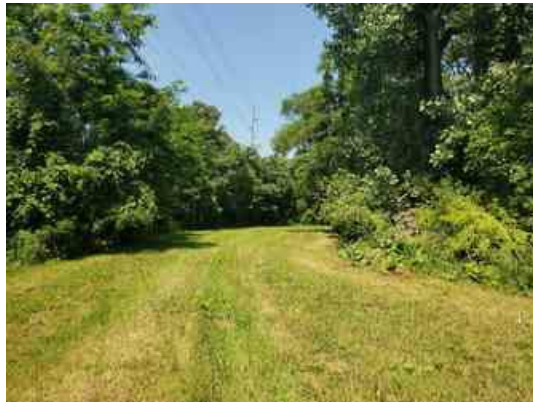
Inspect ID: 2020-0417 **Title:** 2604000009_CELRC_2020_A_0417_1_20200706T163242.jpg **Rated Item:** 1. Unwanted Vegetation Growth **Caption:** Minimally Acceptable - Trees on riverside.

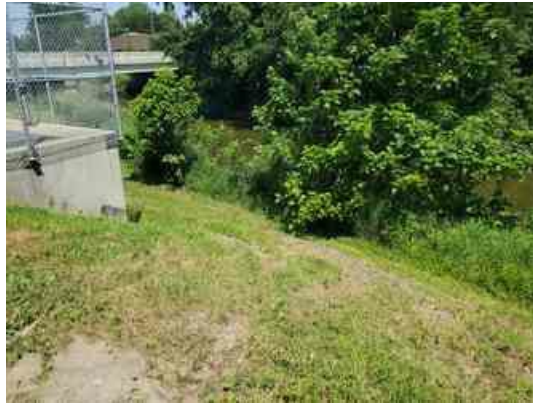
Inspect ID: 2020-0420 **Title:** 2604000009_CELRC_2020_A_0420_1_20200706T163432.jpg **Rated Item:** 1. Unwanted Vegetation Growth **Caption:** Minimally Acceptable - Trees on riverside toe.

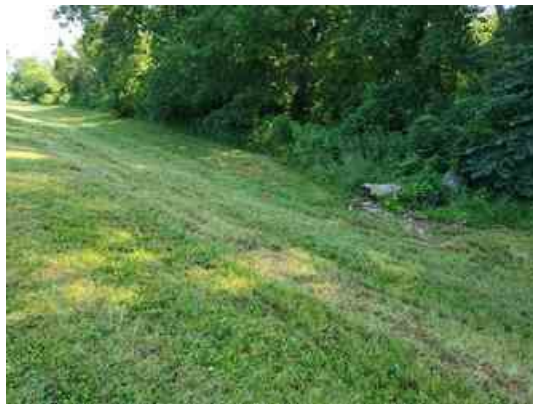
Inspect ID: 2020-0033 **Title:** 2604000009_CELRC_2020_A_0033_1_20200706T132249.jpg **Rated Item:** 3. Encroachments **Caption:** Minimally Acceptable - Large log on riverside toe.

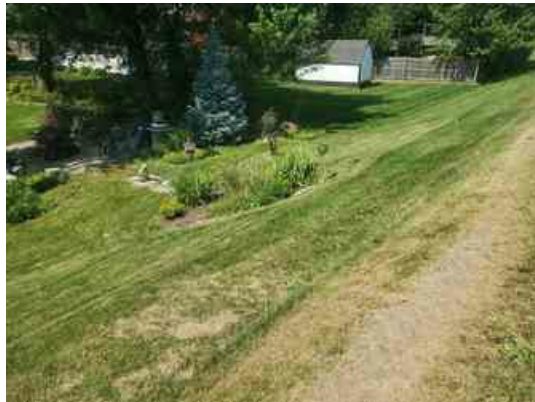
Inspect ID: 2020-0324 **Title:** 2604000009_CELRC_2020_A_0324_1_20200706T154301.jpg **Rated Item:** 3. Encroachments **Caption:** Minimally Acceptable - Garden on landside slope.

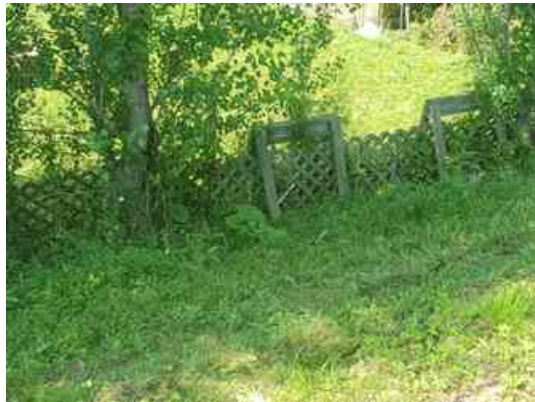
Inspect ID: 2020-0336 **Title:** 2604000009_CELRC_2020_A_0336_1_20200706T154548.jpg **Rated Item:** 3. Encroachments **Caption:** Minimally Acceptable - Small fence on landside toe.

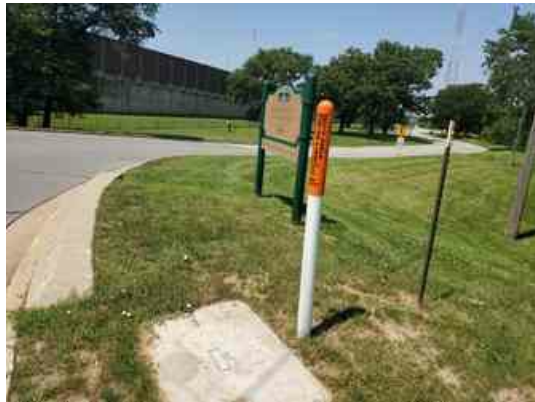
Inspect ID: 2020-0423 **Title:** 2604000009_CELRC_2020_A_0423_1_20200706T163652.jpg **Rated Item:** 3. Encroachments **Caption:** Minimally Acceptable - Sign on levee crest.

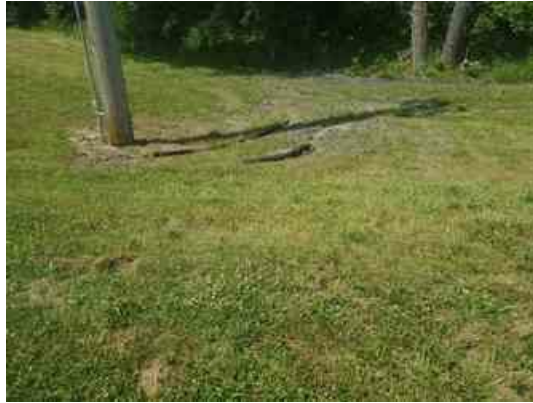
Inspect ID: 2020-0390 **Title:** 2604000009_CELRC_2020_A_0390_1_20200706T161441.jpg **Rated Item:** 8. Depressions/ Rutting **Caption:** Minimally Acceptable - Rutting on landside toe.

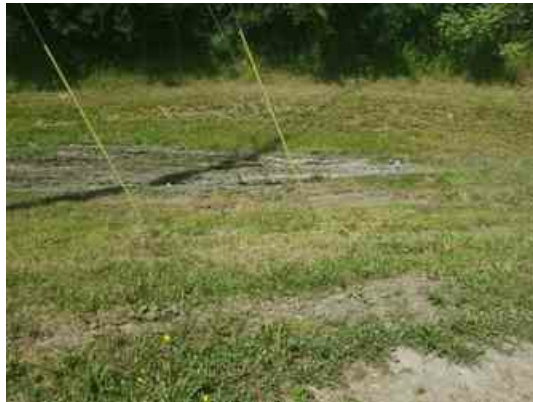
Inspect ID: 2020-0393 **Title:** 2604000009_CELRC_2020_A_0393_1_20200706T161557.jpg **Rated Item:** 8. Depressions/ Rutting **Caption:** Minimally Acceptable - Rutting near landside toe.

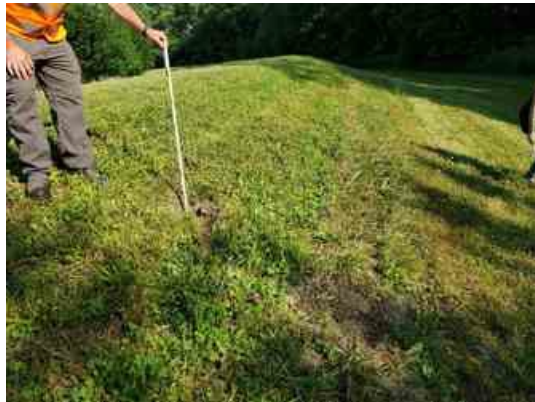
Inspect ID: 2020-0039 **Title:** 2604000009_CELRC_2020_A_0039_1_20200706T133048.jpg **Rated Item:** 10. Animal Control **Caption:** Minimally Acceptable - Holes on riverside slope.

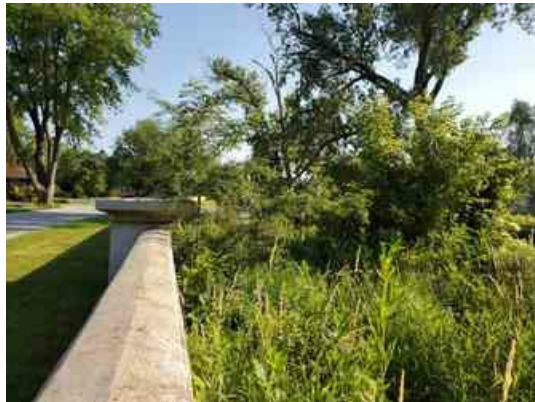
Inspect ID: 2020-0012 **Title:** 2604000009_CELRC_2020_A_0012_1_20200828T193240.jpg **Rated Item:** 1. Unwanted Vegetation Growth **Caption:** Minimally Acceptable - Trees on riverside.

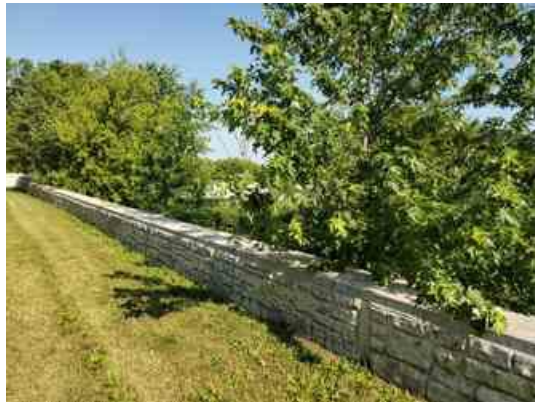
Inspect ID: 2020-0063 **Title:** 2604000009_CELRC_2020_A_0063_1_20200706T134522.jpg **Rated Item:** 1. Unwanted Vegetation Growth **Caption:** Minimally Acceptable - Trees on riverside.

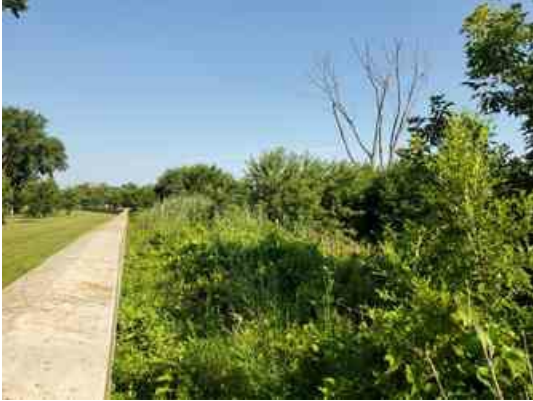
<p>Inspect ID: 2020-0072 Title: 2604000009_CELRC_2020_A_0072_1_20200706T135017.jpg Rated Item: 1. Unwanted Vegetation Growth Caption: Minimally Acceptable - Tall vegetation and trees close to riverside of wall.</p>

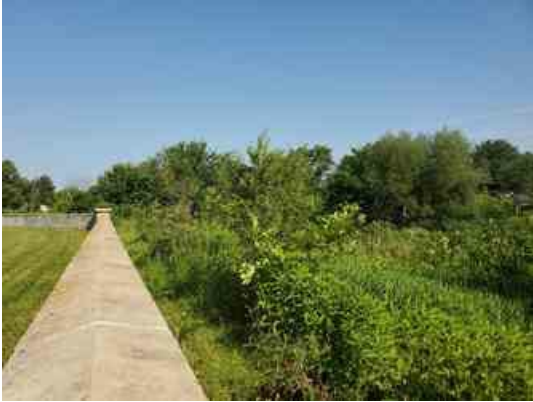
<p>Inspect ID: 2020-0096 Title: 2604000009_CELRC_2020_A_0096_1_20200706T135945.jpg Rated Item: 1. Unwanted Vegetation Growth Caption: Minimally Acceptable - Two small trees close to wall.</p>

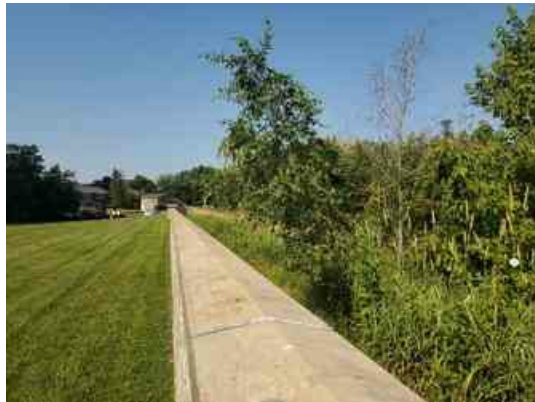
Inspect ID: 2020-0111 **Title:** 2604000009_CELRC_2020_A_0111_1_20200706T140653.jpg **Rated Item:** 1. Unwanted Vegetation Growth **Caption:** Minimally Acceptable - Tree on riverside.

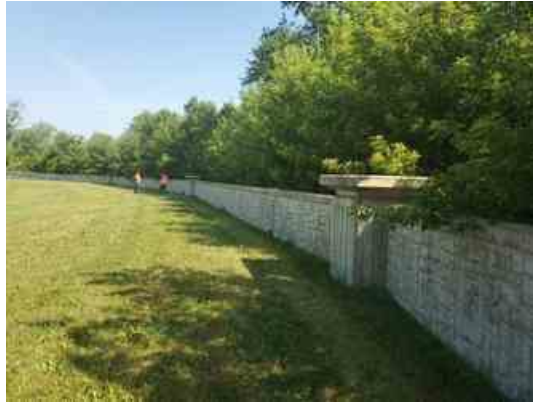
Inspect ID: 2020-0171 **Title:** 2604000009_CELRC_2020_A_0171_1_20200706T143931.jpg **Rated Item:** 1. Unwanted Vegetation Growth **Caption:** Minimally Acceptable - Large trees on riverside.

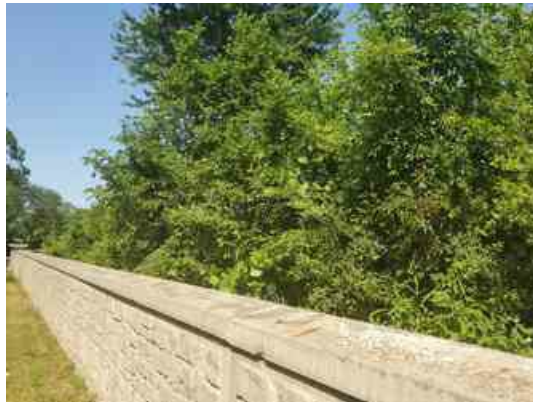
Inspect ID: 2020-0234 **Title:** 2604000009_CELRC_2020_A_0234_1_20200706T150434.jpg **Rated Item:** 1. Unwanted Vegetation Growth **Caption:** Minimally Acceptable - Trees on riverside.

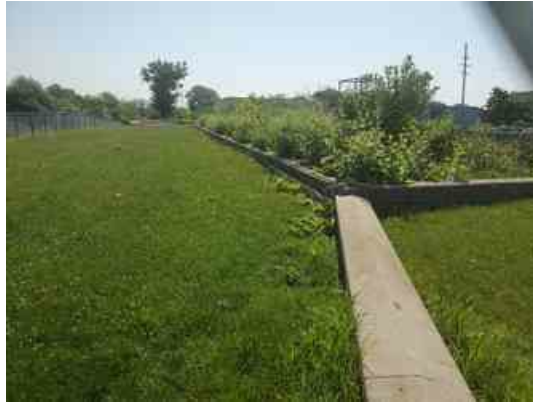
Inspect ID: 2020-0297 **Title:** 2604000009_CELRC_2020_A_0297_1_20200706T152915.jpg **Rated Item:** 1. Unwanted Vegetation Growth **Caption:** Minimally Acceptable - Vegetation on landside.

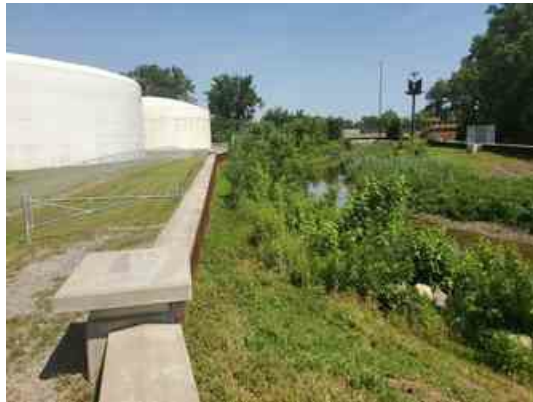
Inspect ID: 2020-0345 **Title:** 2604000009_CELRC_2020_A_0345_1_20200706T154929.jpg **Rated Item:** 1. Unwanted Vegetation Growth **Caption:** Minimally Acceptable - Small trees close to wall.

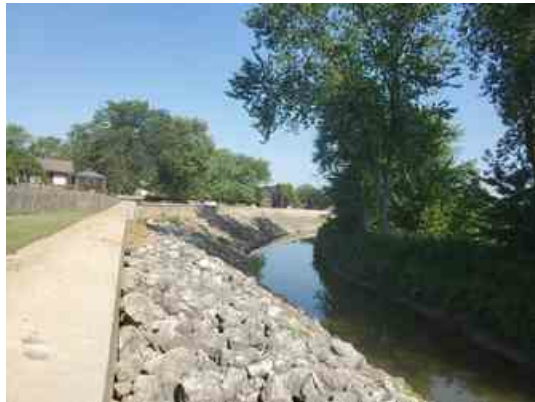
Inspect ID: 2020-0117 **Title:** 2604000009_CELRC_2020_A_0117_1_20200706T141213.jpg **Rated Item:** 2. Encroachments **Caption:** Minimally Acceptable - Grass clippings on riverside.

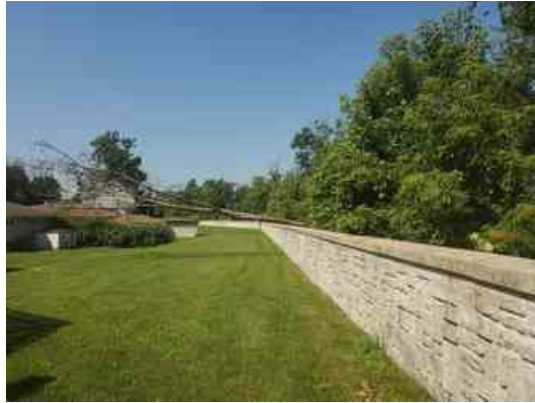
Inspect ID: 2020-0210 **Title:** 2604000009_CELRC_2020_A_0210_1_20200706T145408.jpg **Rated Item:** 2. Encroachments **Caption:** Minimally Acceptable - Downed tree on wall.

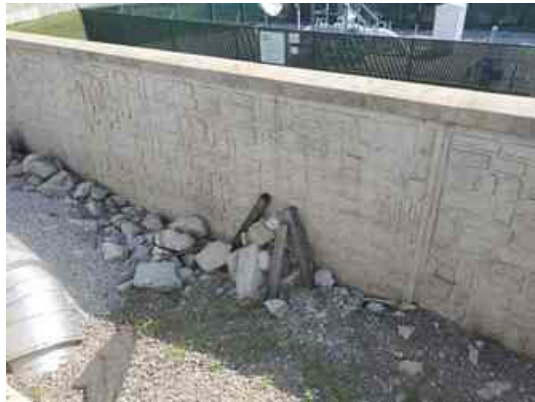
Inspect ID: 2020-0228 **Title:** 2604000009_CELRC_2020_A_0225_1_20200706T150131.jpg **Rated Item:** 2. Encroachments **Caption:** Minimally Acceptable - Debris next to wall on riverside.

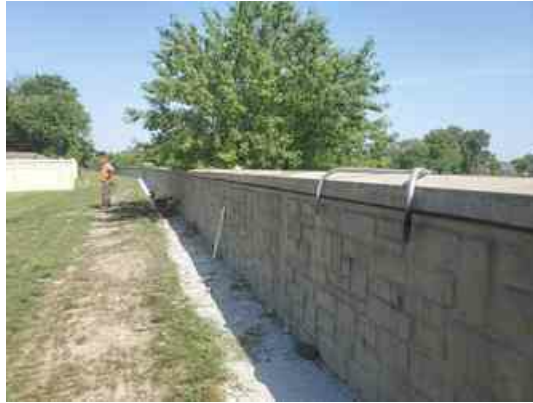
Inspect ID: 2020-0264 **Title:** 2604000009_CELRC_2020_A_0264_1_20200706T151514.jpg **Rated Item:** 2. Encroachments **Caption:** Minimally Acceptable - Debris on landside

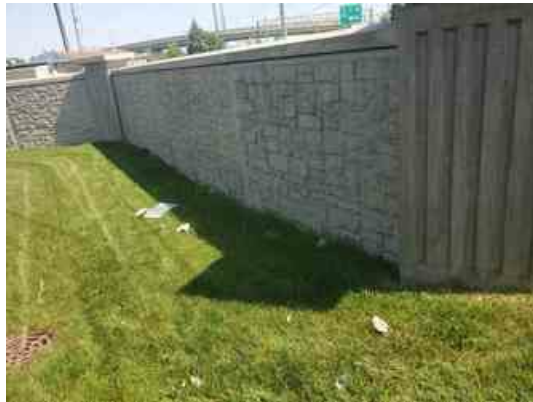
Inspect ID: 2020-0303 **Title:** 2604000009_CELRC_2020_A_0303_1_20200706T153304.jpg **Rated Item:** 2. Encroachments **Caption:** Minimally Acceptable - Debris on landside.

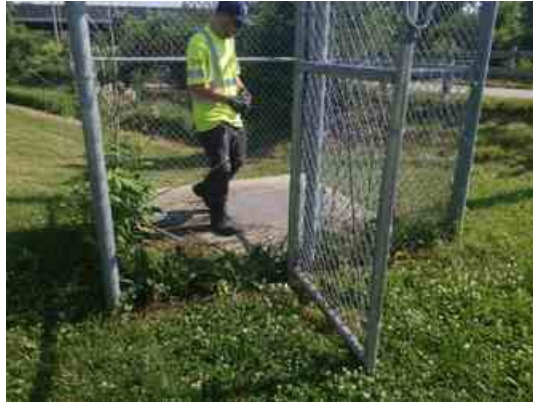
Inspect ID: 2020-0044 **Title:** 2604000009_CELRC_2020_A_0044_1_20200706T142530.jpg **Rated Item:** 1. Vegetation and Obstructions **Caption:** Minimally Acceptable - MU-5: Vegetation at gateway.

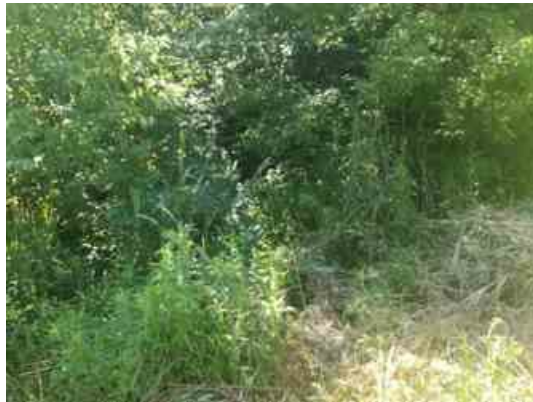
Inspect ID: 2020-0068 **Title:** 2604000009_CELRC_2020_A_0068_1_20200706T144835.jpg **Rated Item:** 1. Vegetation and Obstructions **Caption:** Minimally Acceptable - MU-3: Heavy vegetation at outlet.

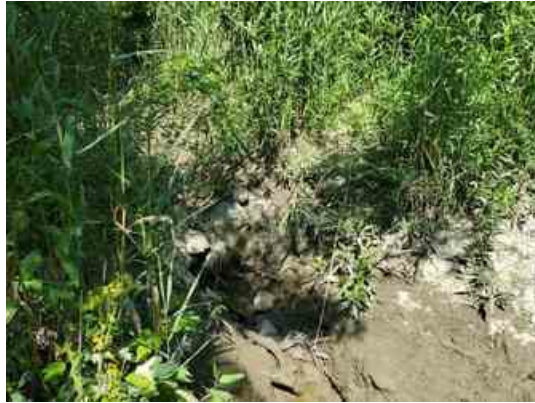
Inspect ID: 2020-0408 **Title:** 2604000009_CELRC_2020_A_0408_1_20200706T162732.jpg **Rated Item:** 1. Vegetation and Obstructions **Caption:** Minimally Acceptable - MU-3: Outlet blocked with silt.

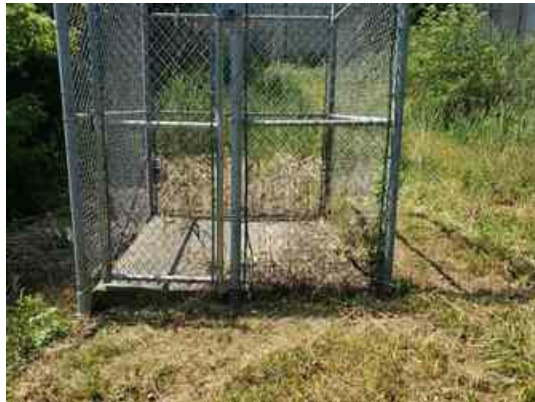
Inspect ID: 2020-0411 **Title:** 2604000009_CELRC_2020_A_0411_1_20200706T163031.jpg **Rated Item:** 1. Vegetation and Obstructions **Caption:** Minimally Acceptable - MU-3: Small trees around gatewell.

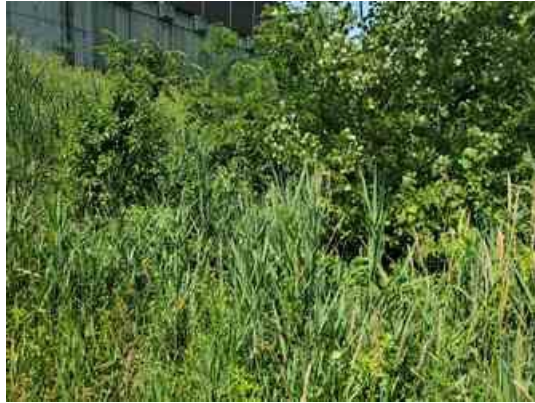
Inspect ID: 2020-0414 **Title:** 2604000009_CELRC_2020_A_0414_1_20200706T163108.jpg **Rated Item:** 1. Vegetation and Obstructions **Caption:** Minimally Acceptable - MU-3: Vegetation around inlet.

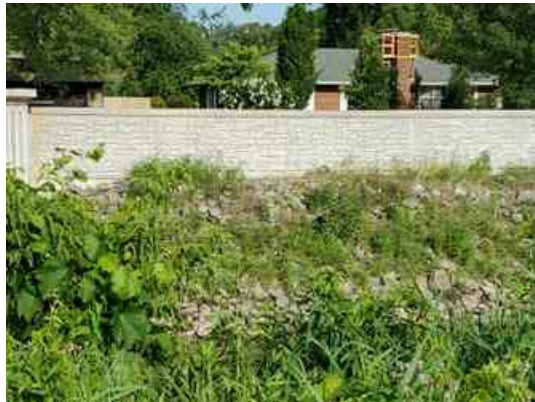
Inspect ID: 2020-0426 **Title:** 2604000009_CELRC_2020_A_0426_1_20200714T132259.jpg **Rated Item:** 1. Vegetation and Obstructions **Caption:** Minimally Acceptable - MU-12: Vegetation at outlet.

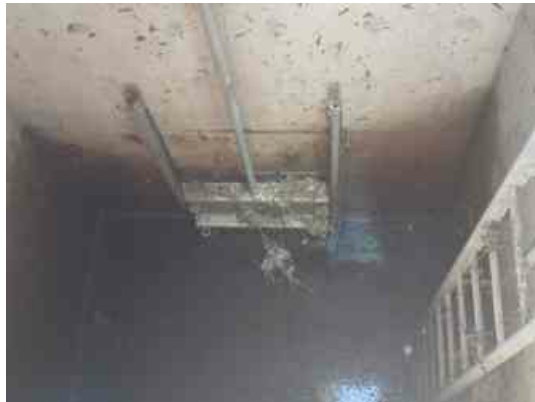
Inspect ID: 2020-0056 **Title:** 2604000009_CELRC_2020_A_0056_1_20200706T143326.jpg **Rated Item:** 10. Sluice/ Slide Gates **Caption:** Minimally Acceptable - MU-4: Sluice gate completely closed. Debris on sluice gate.

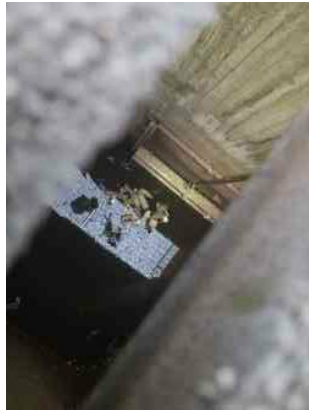
Inspect ID: 2020-0074 **Title:** 2604000009_CELRC_2020_A_0074_1_20200706T145859.jpg **Rated Item:** 10. Sluice/ Slide Gates **Caption:** Minimally Acceptable - MU-2: Gate closed completely. Debris around sluice gate.

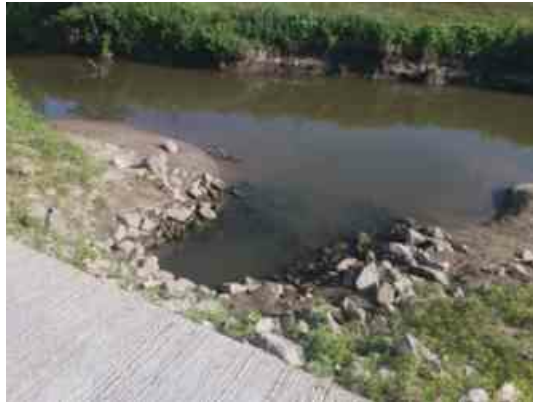
Inspect ID: 2020-0011 **Title:**
2604000009_CELRC_2020_A_0011_1_20200706T131336.jpg **Rated**
Item: 11. Flap Gates/ Flap Valves/ Pinch Valves **Caption:** Acceptable -
MU-11: Water covering outlet structure. Unable to verify.

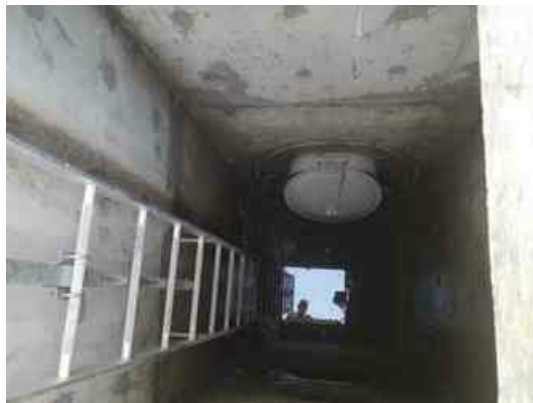
Inspect ID: 2020-0065 **Title:**
2604000009_CELRC_2020_A_0065_1_20200706T144629.jpg **Rated**
Item: 11. Flap Gates/ Flap Valves/ Pinch Valves **Caption:** Minimally
Acceptable - MU-3: Flap gate not closed fully.

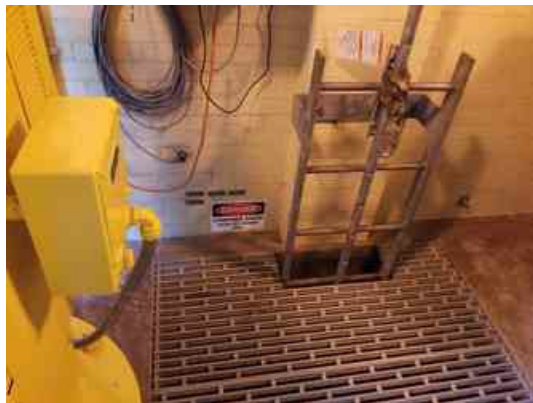
Inspect ID: 2020-0010 **Title:** 2604000009_CELRC_2020_A_0010_1_20200706T142753.jpg **Rated Item:** 3. Safety Compliance **Caption:** Acceptable - PS-BA: Added confined space label.

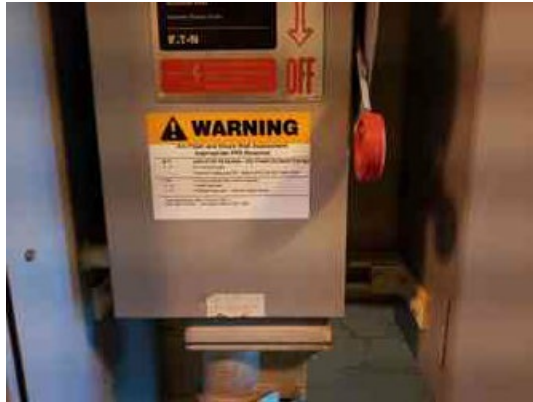
Inspect ID: 2020-0022 **Title:** 2604000009_CELRC_2020_A_0022_1_20200706T143313.jpg **Rated Item:** 3. Safety Compliance **Caption:** Acceptable - PS-BA: Added arc flash warning labels.

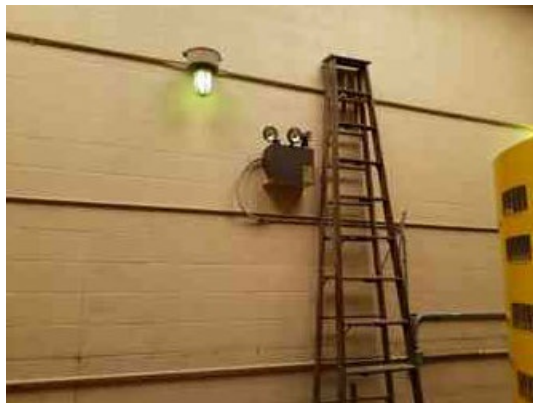
Inspect ID: 2020-0037 **Title:** 2604000009_CELRC_2020_A_0037_1_20200706T145305.jpg **Rated Item:** 3. Safety Compliance **Caption:** Acceptable - PS-CAL: Emergency lighting fixed.

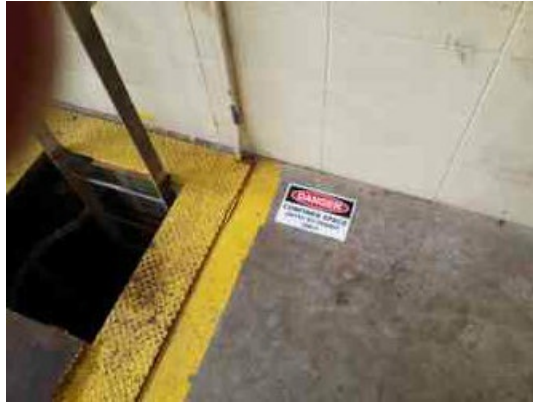
Inspect ID: 2020-0040 **Title:** 2604000009_CELRC_2020_A_0040_1_20200706T145340.jpg **Rated Item:** 3. Safety Compliance **Caption:** Acceptable - PS-CAL: Added confined space label.

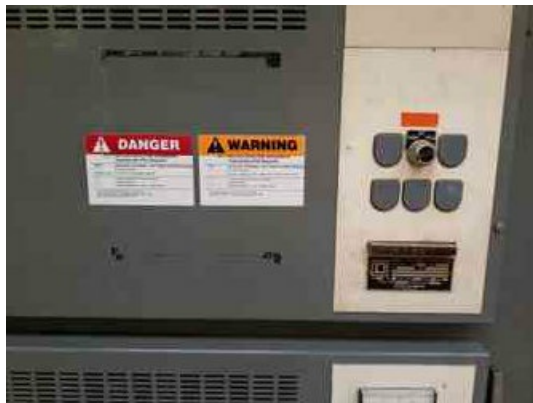
Inspect ID: 2020-0052 **Title:** 2604000009_CELRC_2020_A_0052_1_20200706T150156.jpg **Rated Item:** 3. Safety Compliance **Caption:** Acceptable - PS-CAL: Added arc flash warning label.

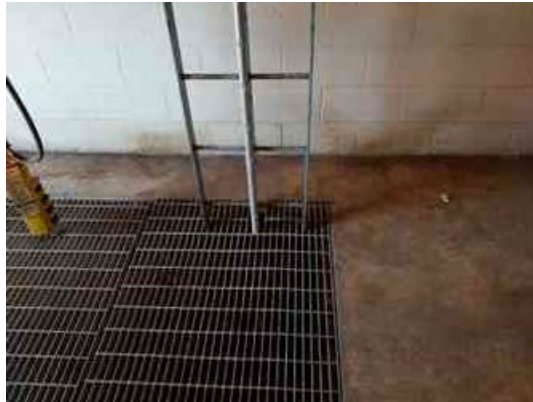
Inspect ID: 2020-0082 **Title:** 2604000009_CELRC_2020_A_0082_1_20200706T152541.jpg **Rated Item:** 3. Safety Compliance **Caption:** Minimally Acceptable - PS-OA: Needs a confined space warning label.

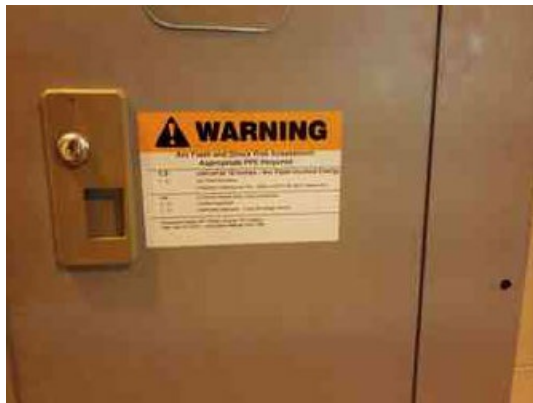
Inspect ID: 2020-0091 **Title:** 2604000009_CELRC_2020_A_0091_1_20200706T152901.jpg **Rated Item:** 3. Safety Compliance **Caption:** Acceptable - PS-OA: Added arc flash warning labels.

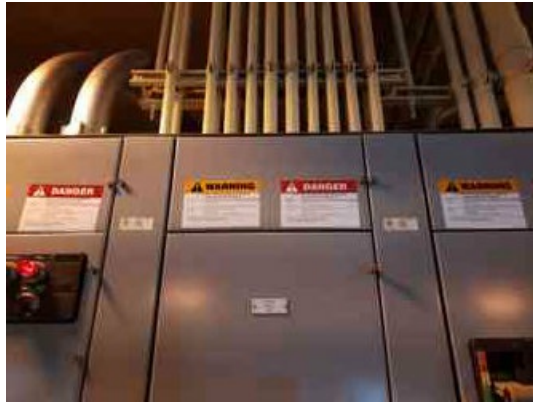
Inspect ID: 2020-0112 **Title:** 2604000009_CELRC_2020_A_0112_1_20200706T154716.jpg **Rated Item:** 3. Safety Compliance **Caption:** Acceptable - PS-HM: Added arc flash warning labels.

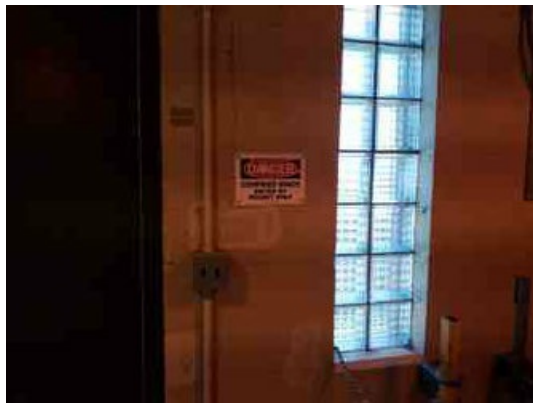
Inspect ID: 2020-0115 **Title:** 2604000009_CELRC_2020_A_0115_1_20200706T154900.jpg **Rated Item:** 3. Safety Compliance **Caption:** Acceptable - PS-HM: Added confined space warning label.

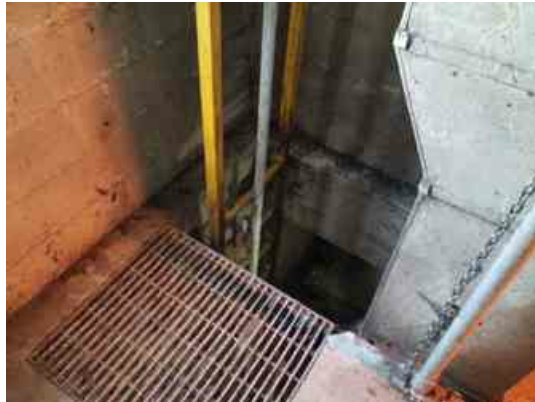
Inspect ID: 2020-0118 **Title:** 2604000009_CELRC_2020_A_0118_1_20200706T155114.jpg **Rated Item:** 3. Safety Compliance **Caption:** Minimally Acceptable - PS-HM: Needs confined space warning label and the chain needs to be up when not in use.

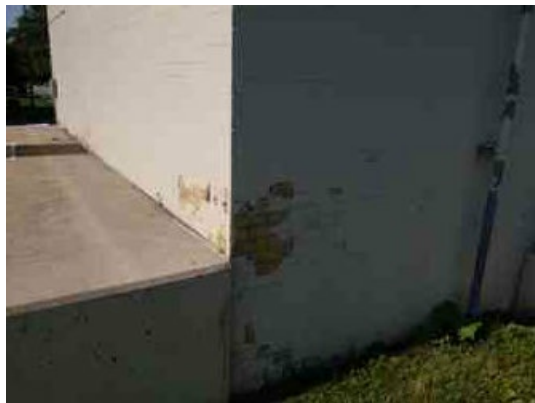
Inspect ID: 2020-0007 **Title:** 2604000009_CELRC_2020_A_0007_1_20200706T142623.jpg **Rated Item:** 5. Plant Building **Caption:** Minimally Acceptable - PS-BA: Peeling paint on northern exterior wall.

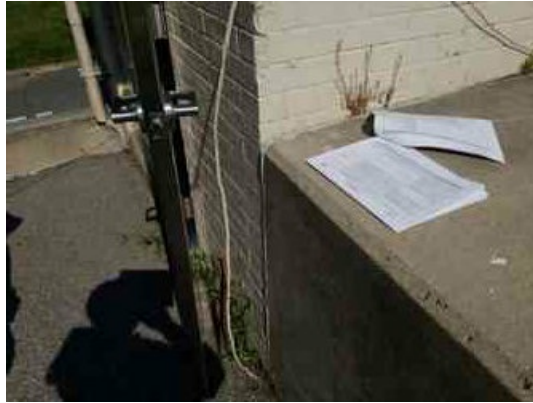
Inspect ID: 2020-0025 **Title:** 2604000009_CELRC_2020_A_0025_1_20200706T143519.jpg **Rated Item:** 5. Plant Building **Caption:** Minimally Acceptable - PS-BA: Grounding wire needs to be reattached.

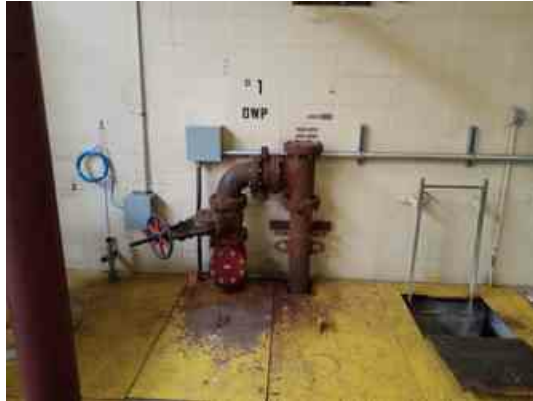
Inspect ID: 2020-0034 **Title:** 2604000009_CELRC_2020_A_0034_1_20200706T145133.jpg **Rated**
Item: 7. Pumps **Caption:** Minimally Acceptable - Ps-dwp1 out of operation

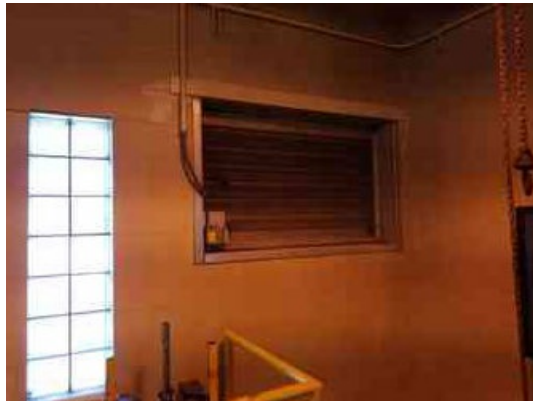
Inspect ID: 2020-0130 **Title:** 2604000009_CELRC_2020_A_0130_1_20200706T155819.jpg **Rated**
Item: 8. Motors, Engines, Fans, Gear Reducers, Back Stop Devices, etc.
Caption: Minimally Acceptable - PS-HM: Vent not in operation.

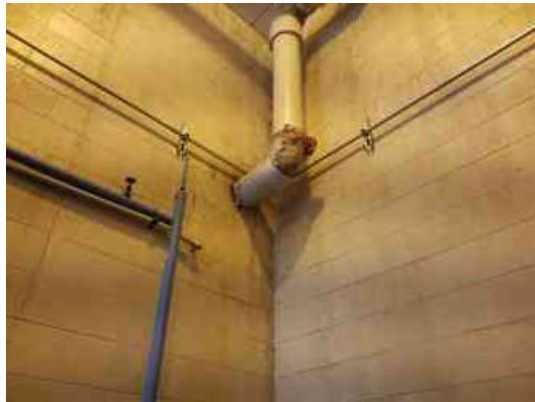
Inspect ID: 2020-0088 **Title:** 2604000009_CELRC_2020_A_0088_1_20200706T152744.jpg **Rated Item:** 16. Enclosures, Panels, Conduit and Ducts **Caption:** Minimally Acceptable - PS-OA: Pipe insulation peeling.

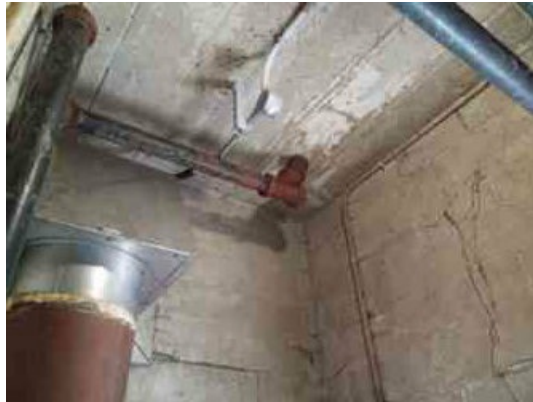
Inspect ID: 2020-0121 **Title:** 2604000009_CELRC_2020_A_0121_1_20200706T155327.jpg **Rated Item:** 21. Other Metallic Items (Equipment, Ladders, Platform Anchors, etc) **Caption:** Minimally Acceptable - PS-HM: Pipe from roof drain is heavily corroded.

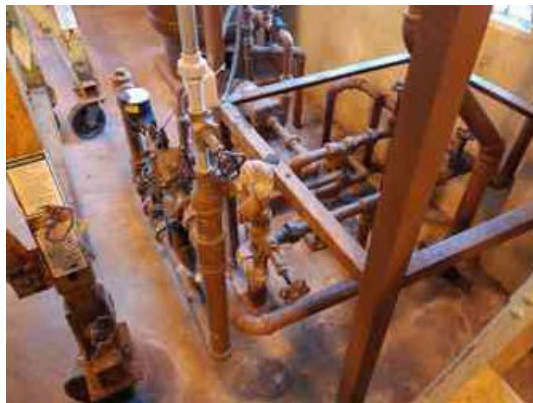
Inspect ID: 2020-0127 **Title:** 2604000009_CELRC_2020_A_0127_1_20200706T155616.jpg **Rated Item:** 21. Other Metallic Items (Equipment, Ladders, Platform Anchors, etc) **Caption:** Minimally Acceptable - PS-HM: Corrosion on pipes.
