**US Army Corps
of Engineers®**

Levee Inspection Report

Name of System: Burr Street

Name of Segment: Gary Burr St

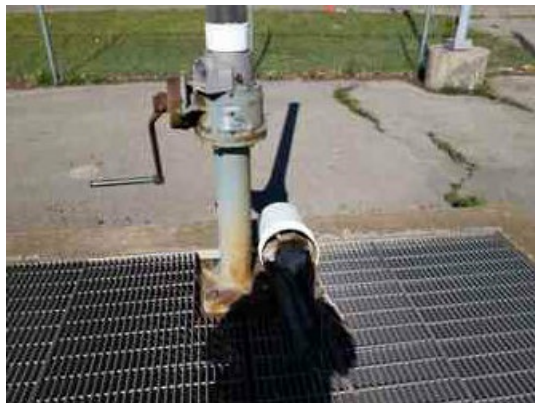
Inspect ID: 2021-0016 **Title:**
2604000005_CELRC_2021_A_0016_1_20210430T142347.jpg **Rated**
Item: 16. Enclosures, Panels, Conduit and Ducts **Caption:** Acceptable -
PS-BS: Conduits and panel good but lots of debris.
