Levee Inspection Report

Name of System: Burr Street

Name of Segment: Griffith River Road Levee

Date(s) of Inspection: 04/30/2021 - 04/30/2021

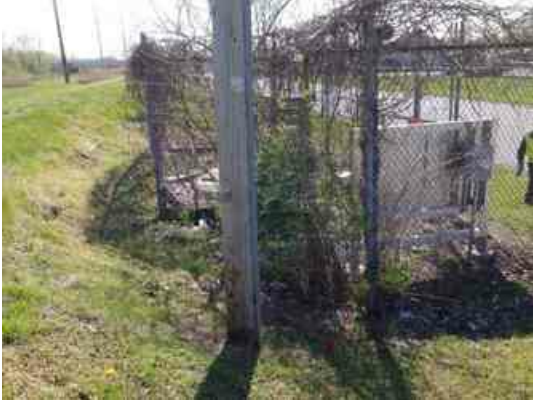
<p>Inspect ID: 2021-0058 Title: 2604000014_CELRC_2021_A_0058_1_20210430T142805.jpg Rated Item: 1. Unwanted Vegetation Growth Caption: Minimally Acceptable - Small trees on landside toe.</p>

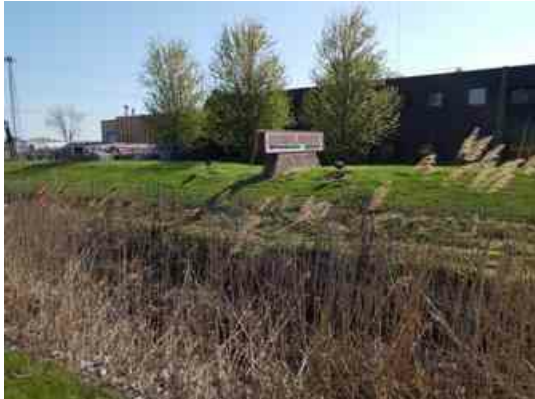
Inspect ID: 2021-0018 Title: 2604000014_CELRC_2021_A_0018_1_20210430T134822.jpg Rated Item: 3. Encroachments Caption: Minimally Acceptable - Sign on crest.

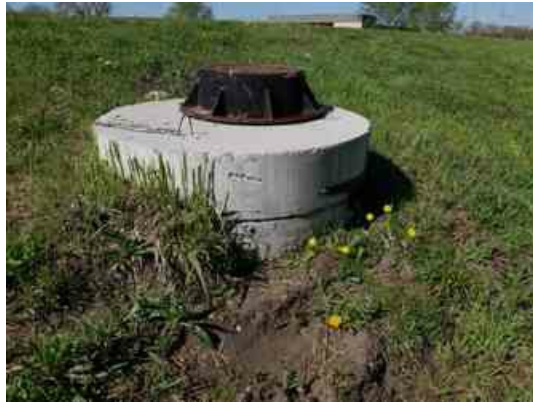
Inspect ID: 2021-0070 **Title:**

2604000014_CELRC_2021_A_0070_2_20210430T143931.jpg **Rated**

Item: 11. Culverts/ Discharge Pipes (This item includes both concrete and corrugated metal pipes.) **Caption:** Minimally Acceptable - Manhole on riverside slope installed in 2018. Tape removed around gaps.

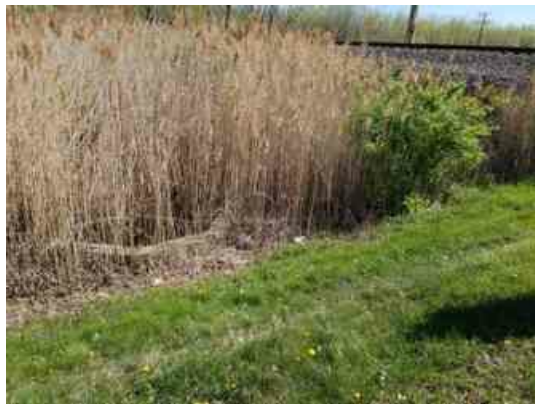
Inspect ID: 2021-0081 **Title:** 2604000014_CELRC_2021_A_0081_1_20210430T145137.jpg **Rated Item:** 1. Vegetation and Obstructions **Caption:** Minimally Acceptable - Small trees and tall vegetation on riverside toe.

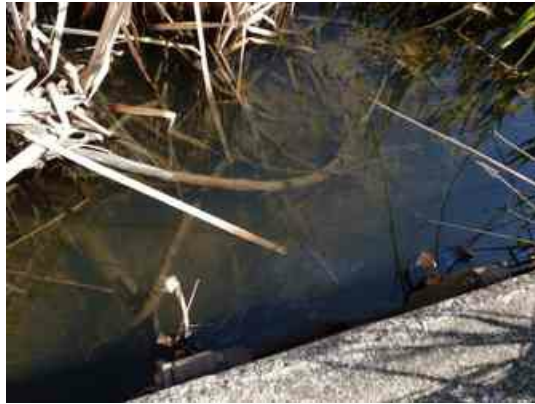
Inspect ID: 2021-0033 **Title:** 2604000014_CELRC_2021_A_0033_1_20210430T140211.jpg **Rated Item:** 11. Flap Gates/ Flap Valves/ Pinch Valves **Caption:** Acceptable - Flap gate closed.

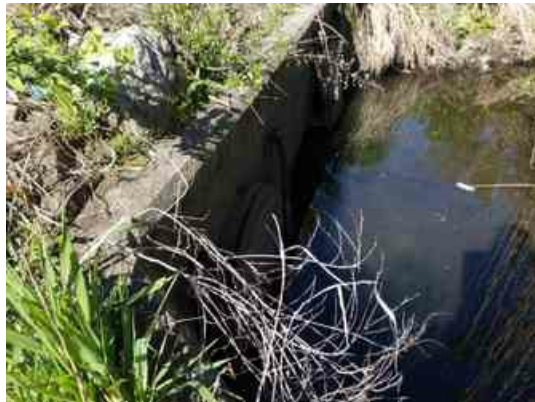
Inspect ID: 2021-0052 **Title:** 2604000014_CELRC_2021_A_0052_1_20210430T142207.jpg **Rated Item:** 11. Flap Gates/ Flap Valves/ Pinch Valves **Caption:** Minimally Acceptable - Both gates stuck open.

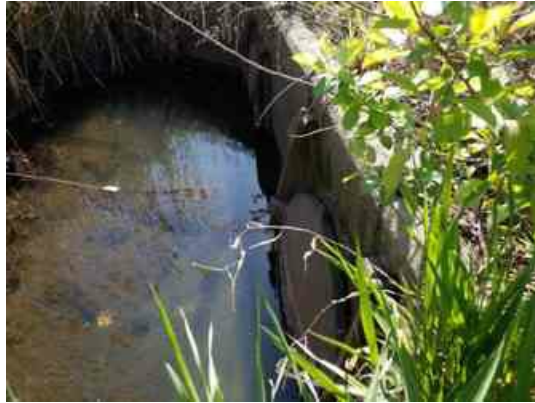
Inspect ID: 2021-0052 **Title:** 2604000014_CELRC_2021_A_2021-0052_2_20210430T142415.jpg **Rated Item:** 11. Flap Gates/ Flap Valves/ Pinch Valves **Caption:** Minimally Acceptable - Both gates stuck open

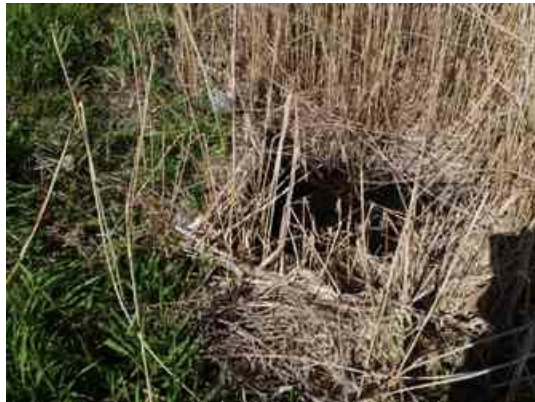
Inspect ID: 2021-0068 **Title:** 2604000014_CELRC_2021_A_0068_1_20210430T143543.jpg **Rated Item:** 11. Flap Gates/ Flap Valves/ Pinch Valves **Caption:** Acceptable - Flap gate underwater.

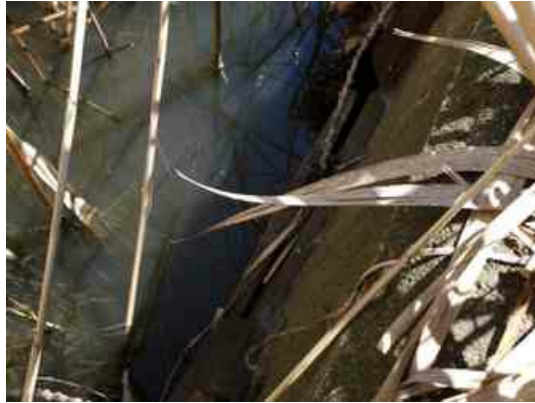
Inspect ID: 2021-0073 **Title:** 2604000014_CELRC_2021_A_0073_1_20210430T144353.jpg **Rated Item:** 11. Flap Gates/ Flap Valves/ Pinch Valves **Caption:** Minimally Acceptable - Flap gate stuck open with twig.

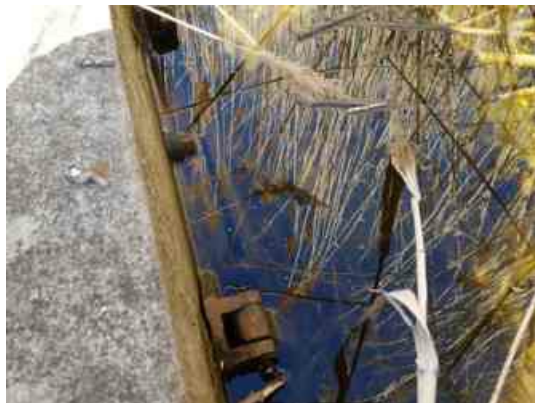
Inspect ID: 2021-0082 **Title:** 2604000014_CELRC_2021_A_0082_1_20210430T145220.jpg **Rated Item:** 11. Flap Gates/ Flap Valves/ Pinch Valves **Caption:** Minimally Acceptable - Open flapgate
