**US Army Corps
of Engineers®**

Levee Inspection Report

Name of System: Hammond

Date(s) of Inspection: 06/23/2021 - 06/24/2021

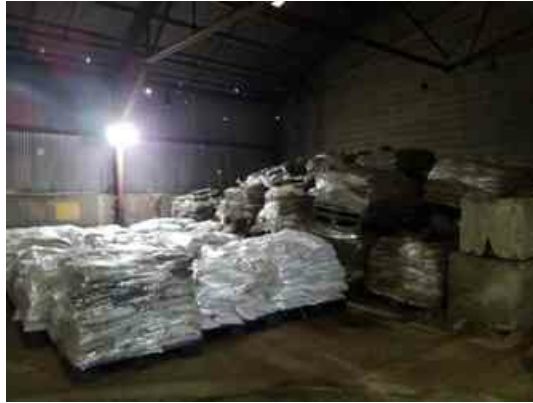
Inspect ID: 2021-0173 **Title:** 2604000008_CELRC_2021_A_0173_1_20210623T183035.jpg **Rated Item:** 2. Emergency Supplies and Equipment (A or M only) **Caption:** Acceptable - The sandbags are located at the water facility right off of Calumet Avenue. There are about 1200 sand bags and sand to make more bags if needed.

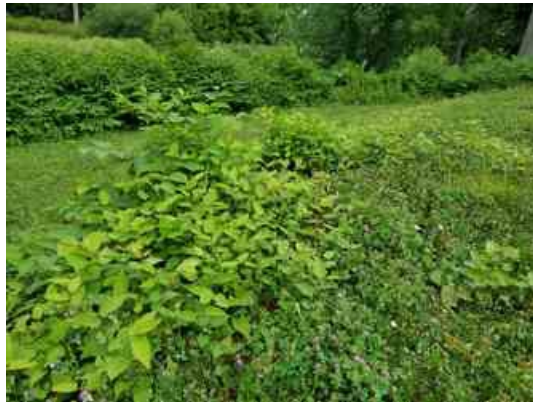
Inspect ID: 2021-0024 **Title:** 2604000008_CELRC_2021_A_0024_1_20210623T131056.jpg **Rated Item:** 1. Unwanted Vegetation Growth **Caption:** Minimally Acceptable - Tall veg on riverside slope. Cut.

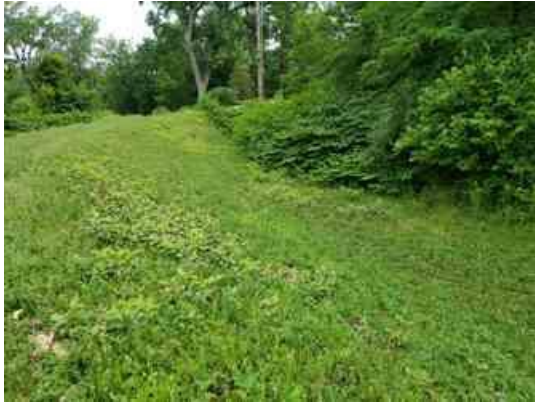
Inspect ID: 2021-0028 Title: 2604000008_CELRC_2021_A_0028_1_20210623T131238.jpg Rated Item: 1. Unwanted Vegetation Growth Caption: Minimally Acceptable - Large bushes about 5 ft from landside toe. Cut.

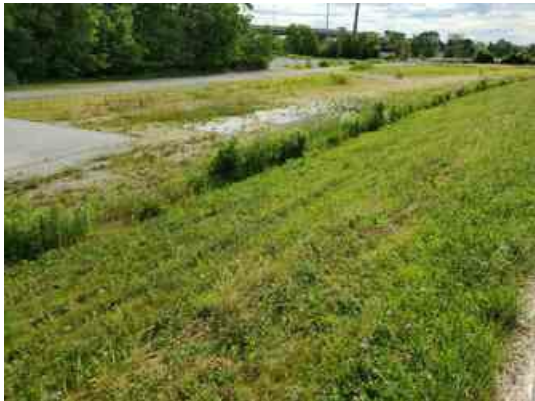
Inspect ID: 2021-0108 Title: 2604000008_CELRC_2021_A_2021-0108_2_20210623T134922.jpg Rated Item: 1. Unwanted Vegetation Growth Caption: Minimally Acceptable - Tall veg from lack of mowing around stakes on landside. Remove stakes and mow.

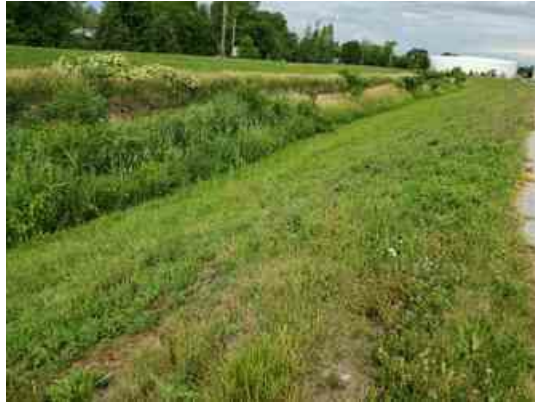
Inspect ID: 2021-0124 **Title:** 2604000008_CELRC_2021_A_0124_1_20210623T135227.jpg **Rated Item:** 1. Unwanted Vegetation Growth **Caption:** Minimally Acceptable - Small trees, tall veg on riverside toe. Cut.

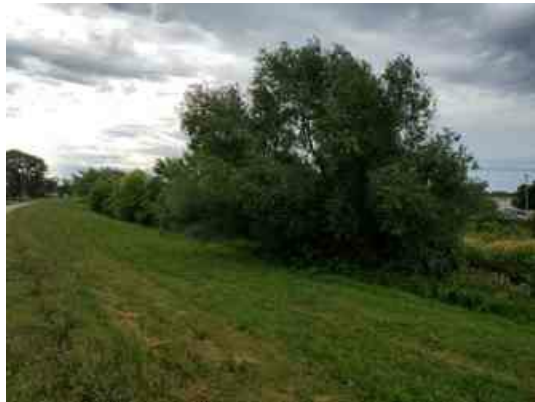
Inspect ID: 2021-0148 **Title:** 2604000008_CELRC_2021_A_0148_1_20210623T140508.jpg **Rated Item:** 1. Unwanted Vegetation Growth **Caption:** Minimally Acceptable - Overhang from trees on the riverside. Cut back.

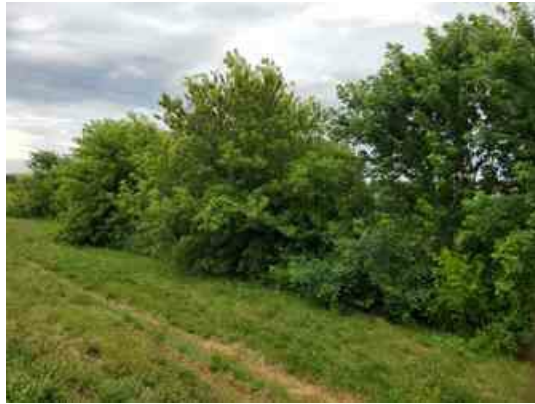
Inspect ID: 2021-0160 **Title:** 2604000008_CELRC_2021_A_0160_1_20210623T141352.jpg **Rated Item:** 1. Unwanted Vegetation Growth **Caption:** Minimally Acceptable - Trim trees back.

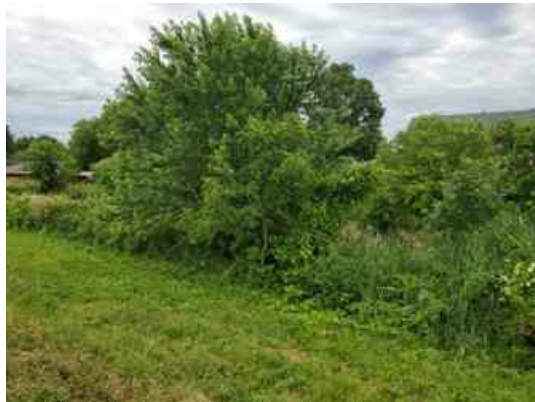
Inspect ID: 2021-0172 **Title:** 2604000008_CELRC_2021_A_0172_1_20210623T142317.jpg **Rated Item:** 1. Unwanted Vegetation Growth **Caption:** Minimally Acceptable - Trees on riverside toe. Cut.

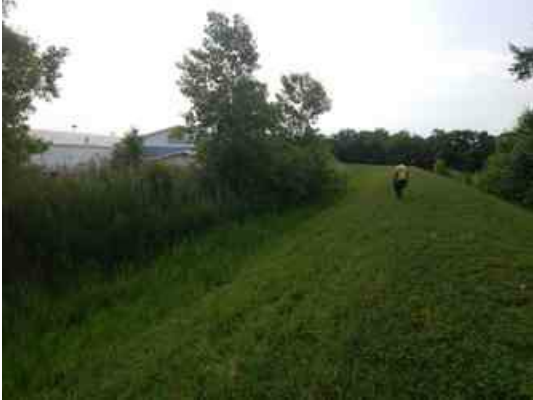
<p>Inspect ID: 2021-0257 Title: 2604000008_CELRC_2021_A_0257_1_20210624T132755.jpg Rated Item: 1. Unwanted Vegetation Growth Caption: Minimally Acceptable - Tall vegetation on landside toe. Remove within 15ft from the toe.</p>
 	<p>Inspect ID: 2021-0360 Title: 2604000008_CELRC_2021_A_0360_1_20210623T155626.jpg Rated Item: 1. Unwanted Vegetation Growth Caption: Minimally Acceptable - Vegetation near riverside toe. Cut.</p>

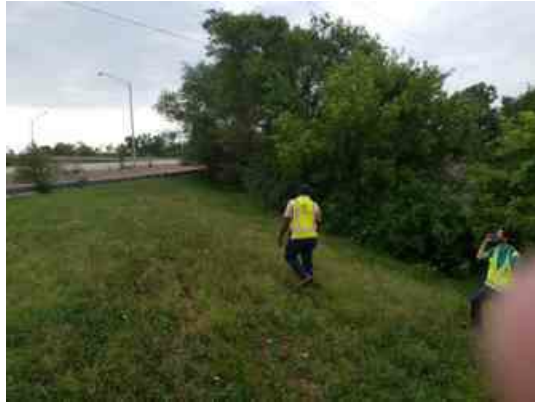
Inspect ID: 2021-0377 **Title:** 2604000008_CELRC_2021_A_0377_1_20210624T135800.jpg **Rated Item:** 1. Unwanted Vegetation Growth **Caption:** Minimally Acceptable - Trees on riverside toe and slope. Cut.

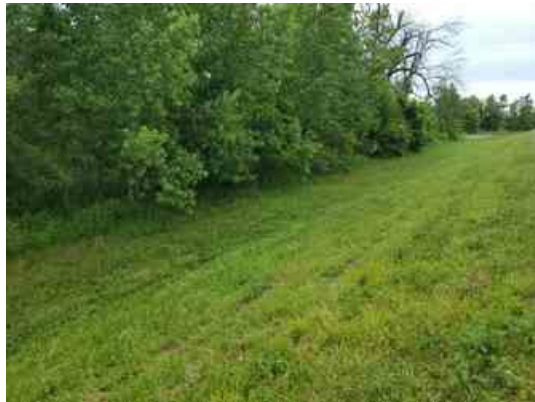
Inspect ID: 2021-0380 **Title:** 2604000008_CELRC_2021_A_0380_1_20210623T160852.jpg **Rated Item:** 1. Unwanted Vegetation Growth **Caption:** Minimally Acceptable - Trees within 15 ft of landside toe. Cut back.

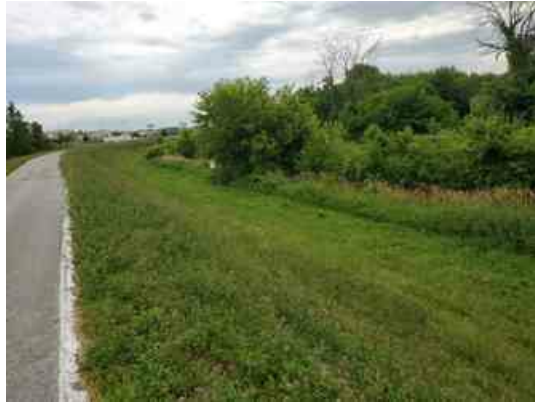
Inspect ID: 2021-0384 **Title:** 2604000008_CELRC_2021_A_0384_1_20210623T160950.jpg **Rated Item:** 1. Unwanted Vegetation Growth **Caption:** Minimally Acceptable - Trees near riverside toe. Cut back.

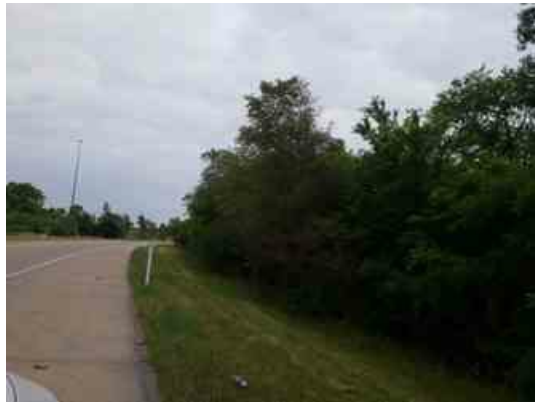
Inspect ID: 2021-0389 **Title:** 2604000008_CELRC_2021_A_0389_1_20210624T140912.jpg **Rated Item:** 1. Unwanted Vegetation Growth **Caption:** Acceptable - Tall vegetation on riverside slope. Monitor.

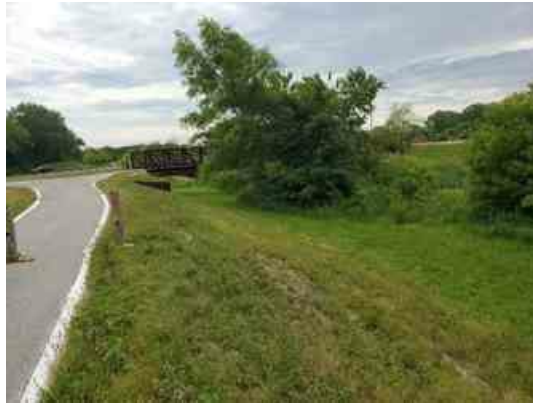
Inspect ID: 2021-0404 **Title:** 2604000008_CELRC_2021_A_0404_1_20210623T161547.jpg **Rated Item:** 1. Unwanted Vegetation Growth **Caption:** Minimally Acceptable - Tree and tall vegetation on riverside toe. Cut.

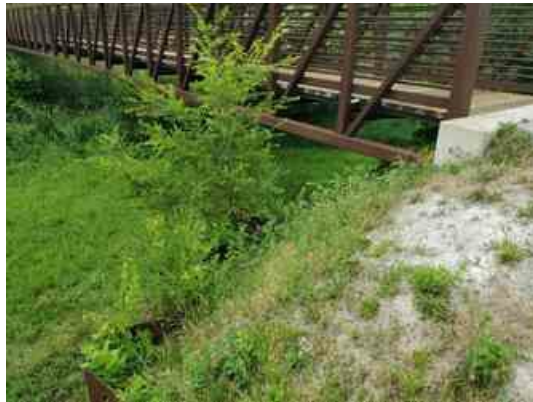
Inspect ID: 2021-0408 **Title:** 2604000008_CELRC_2021_A_0408_1_20210623T161640.jpg **Rated Item:** 1. Unwanted Vegetation Growth **Caption:** Minimally Acceptable - Small tree on riverside. Cut.

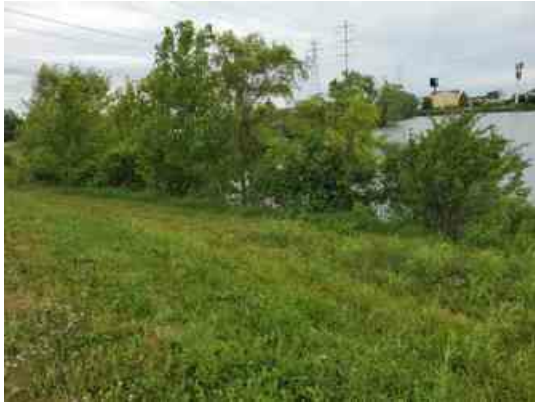
<p>Inspect ID: 2021-0532 Title: 2604000008_CELRC_2021_A_0532_1_20210623T173803.jpg Rated Item: 1. Unwanted Vegetation Growth Caption: Minimally Acceptable - Trees on landside toe. Cut.</p>

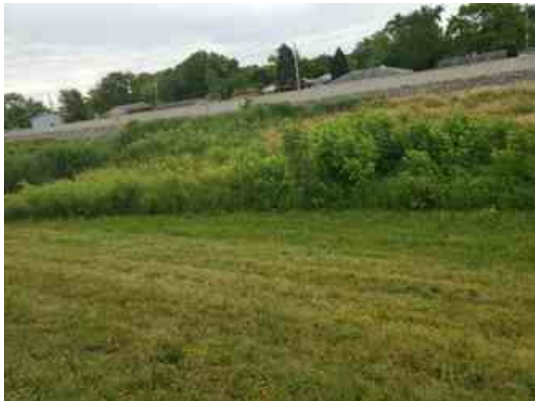
<p>Inspect ID: 2021-0536 Title: 2604000008_CELRC_2021_A_0536_1_20210623T174107.jpg Rated Item: 1. Unwanted Vegetation Growth Caption: Minimally Acceptable - Tall vegetation and trees on riverside. Cut.</p>

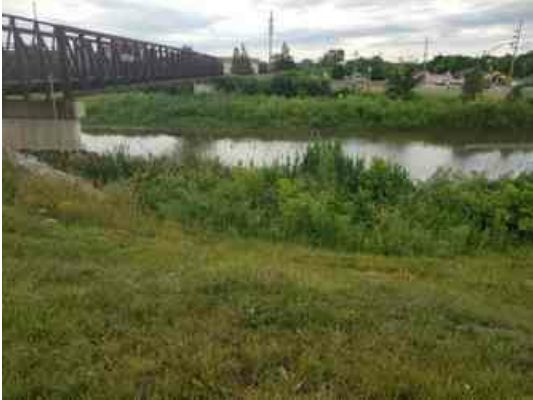
<p>Inspect ID: 2021-0596 Title: 2604000008_CELRC_2021_A_0596_1_20210623T185929.jpg Rated Item: 1. Unwanted Vegetation Growth Caption: Minimally Acceptable - Tall vegetation on riverside toe and slope. Cut.</p>

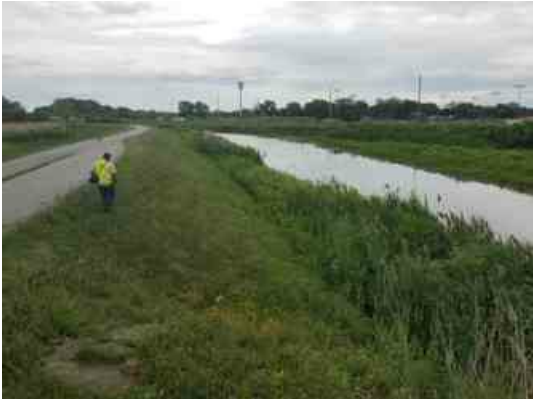
<p>Inspect ID: 2021-0600 Title: 2604000008_CELRC_2021_A_0600_1_20210623T190012.jpg Rated Item: 1. Unwanted Vegetation Growth Caption: Minimally Acceptable - Start line</p>

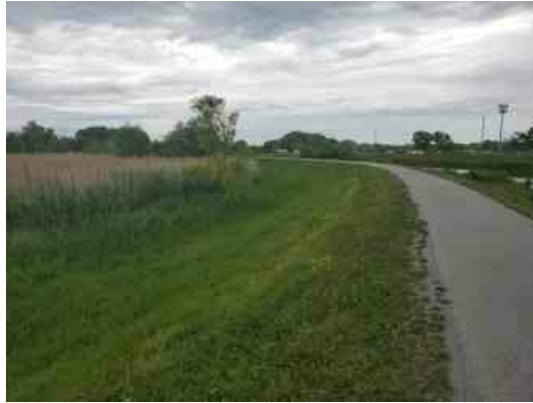
Inspect ID: 2021-0604 **Title:** 2604000008_CELRC_2021_A_0604_1_20210623T190130.jpg **Rated Item:** 1. Unwanted Vegetation Growth **Caption:** Minimally Acceptable - Tall vegetation and trees on landside toe. Cut back.

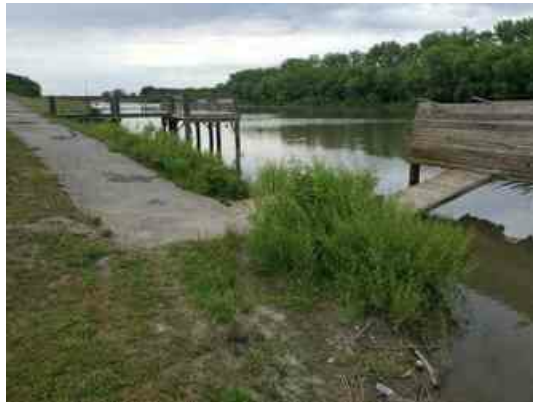
Inspect ID: 2021-0636 **Title:** 2604000008_CELRC_2021_A_0636_1_20210623T191723.jpg **Rated Item:** 1. Unwanted Vegetation Growth **Caption:** Minimally Acceptable - Tall vegetation on riverside toe. Cut.

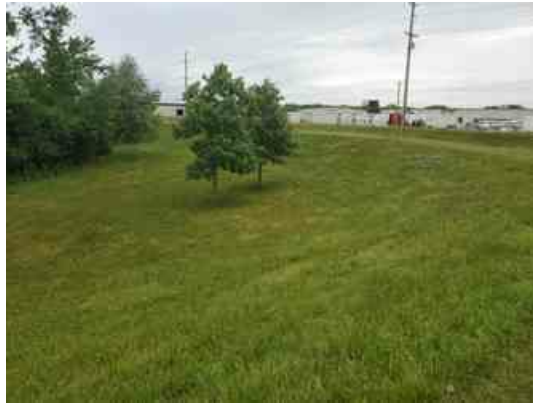
Inspect ID: 2021-0664 **Title:** 2604000008_CELRC_2021_A_0664_1_20210623T193201.jpg **Rated Item:** 1. Unwanted Vegetation Growth **Caption:** Minimally Acceptable - Remove two trees near landside toe.

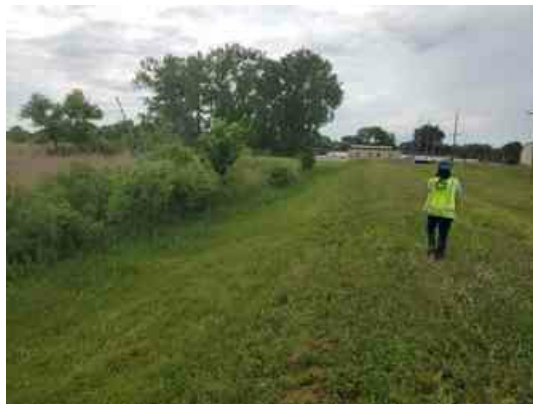
Inspect ID: 2021-0676 **Title:** 2604000008_CELRC_2021_A_0676_1_20210623T193422.jpg **Rated Item:** 1. Unwanted Vegetation Growth **Caption:** Minimally Acceptable - Remove tall vegetation and trees within 15 ft from the landside toe.

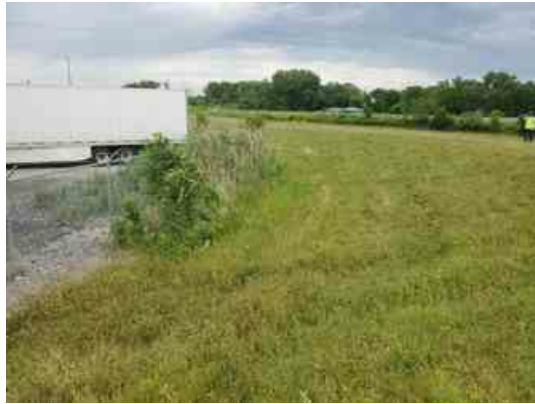
Inspect ID: 2021-0728 **Title:**

2604000008_CELRC_2021_A_0728_1_20210623T194759.jpg **Rated**
Item: 1. Unwanted Vegetation Growth **Caption:** Minimally Acceptable -
Remove tall vegetation and trees within 15 ft from the landside toe.

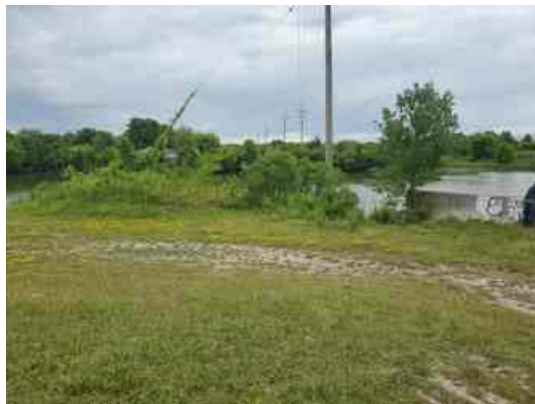
Inspect ID: 2021-0736 **Title:**

2604000008_CELRC_2021_A_0736_1_20210623T194912.jpg **Rated**
Item: 1. Unwanted Vegetation Growth **Caption:** Minimally Acceptable -
Cut trees within 15 ft from the riverside toe.

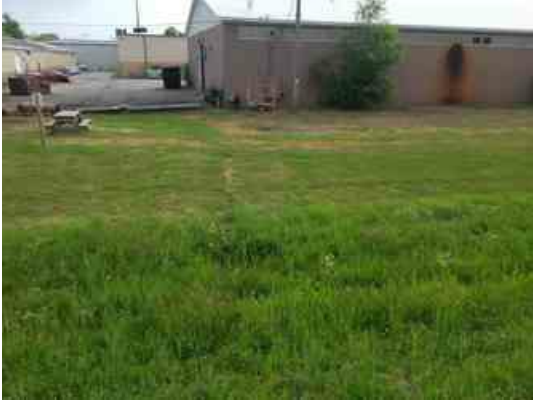
Inspect ID: 2021-0253 Title: 2604000008_CELRC_2021_A_0253_2_20210624T132642.jpg Rated Item: 3. Encroachments Caption: Minimally Acceptable - Attached property draining onto landside toe and causing erosion. Local sponsor notified and addressing.

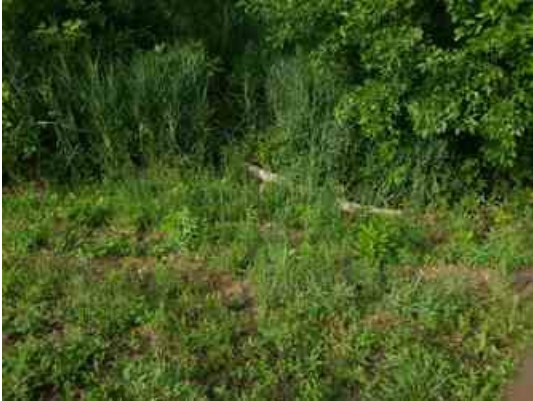
Inspect ID: 2021-0265 Title: 2604000008_CELRC_2021_A_0265_1_20210624T133013.jpg Rated Item: 3. Encroachments Caption: Minimally Acceptable - Remove fallen tree.

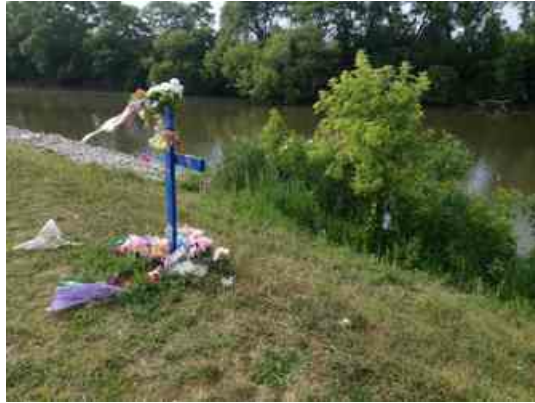
Inspect ID: 2021-0277 **Title:** 2604000008_CELRC_2021_A_0277_1_20210624T133142.jpg **Rated Item:** 3. Encroachments **Caption:** Minimally Acceptable - Memorial on levee crest. Remove.

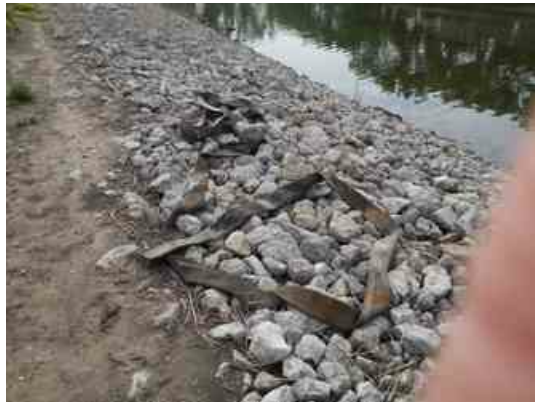
Inspect ID: 2021-0281 **Title:** 2604000008_CELRC_2021_A_0281_1_20210624T133348.jpg **Rated Item:** 3. Encroachments **Caption:** Minimally Acceptable - Remove fire hose on riverside slope.

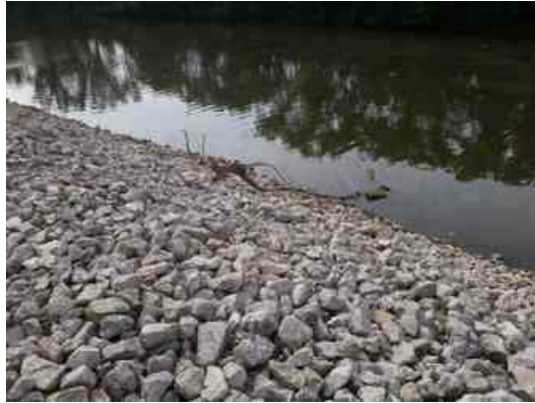
Inspect ID: 2021-0289 **Title:** 2604000008_CELRC_2021_A_0289_1_20210624T133450.jpg **Rated Item:** 3. Encroachments **Caption:** Minimally Acceptable - Remove dead tree on riverside toe.

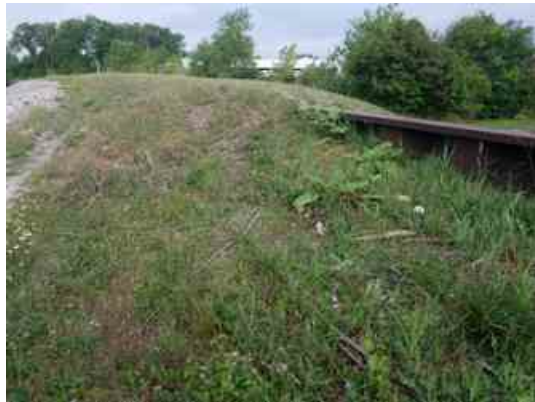
Inspect ID: 2021-0293 **Title:** 2604000008_CELRC_2021_A_0293_1_20210624T133545.jpg **Rated Item:** 3. Encroachments **Caption:** Minimally Acceptable - Remove debris pile from riverside slope.

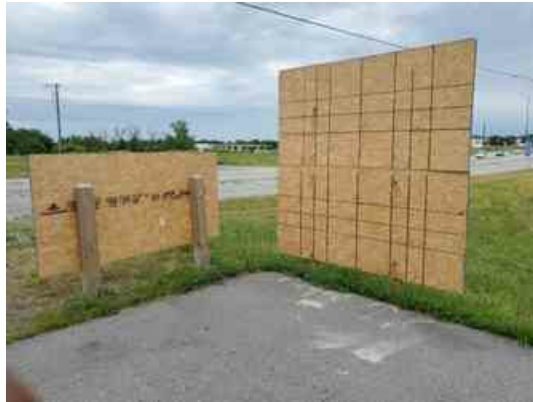
Inspect ID: 2021-0420 **Title:** 2604000008_CELRC_2021_A_0420_1_20210623T162506.jpg **Rated Item:** 3. Encroachments **Caption:** Minimally Acceptable - Signs on the crest. Remove and restore the levee.

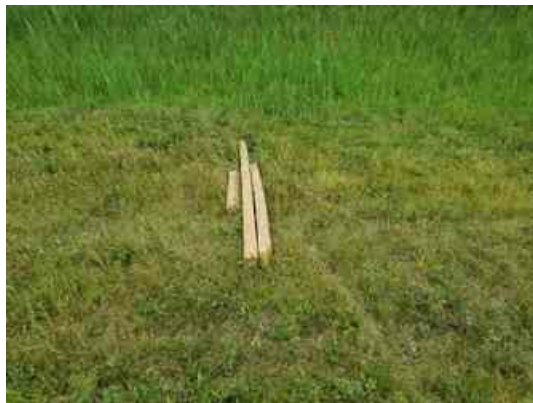
Inspect ID: 2021-0440 **Title:** 2604000008_CELRC_2021_A_0440_1_20210623T163623.jpg **Rated Item:** 3. Encroachments **Caption:** Minimally Acceptable - Three wood beams on the riverside. Remove.

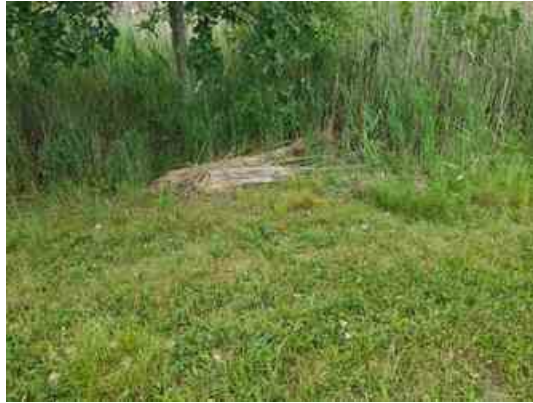
Inspect ID: 2021-0640 **Title:** 2604000008_CELRC_2021_A_0640_1_20210623T192014.jpg **Rated Item:** 3. Encroachments **Caption:** Minimally Acceptable - Remove various logs on the landside.

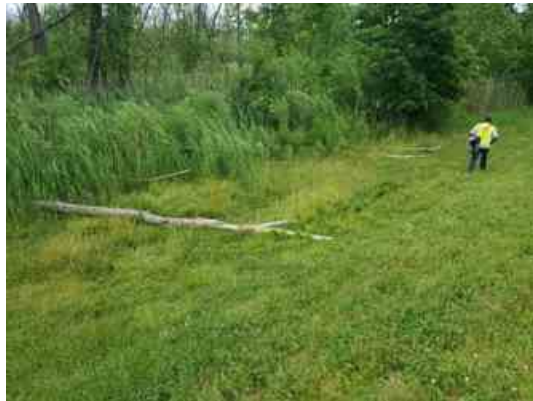
Inspect ID: 2021-0644 **Title:** 2604000008_CELRC_2021_A_0644_1_20210623T192055.jpg **Rated Item:** 3. Encroachments **Caption:** Minimally Acceptable - Remove fallen trees and logs from the landside.

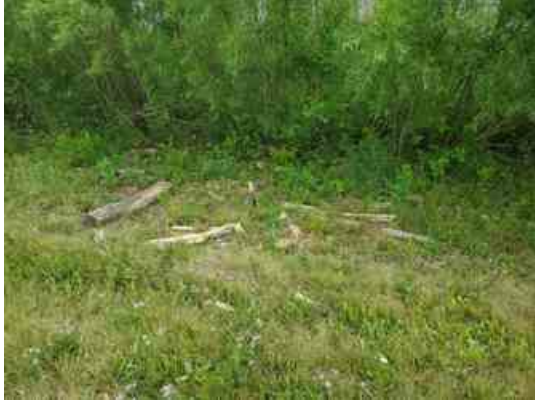
Inspect ID: 2021-0656 Title: 2604000008_CELRC_2021_A_0656_1_20210623T192808.jpg Rated Item: 3. Encroachments Caption: Minimally Acceptable - Remove logs from the riverside.

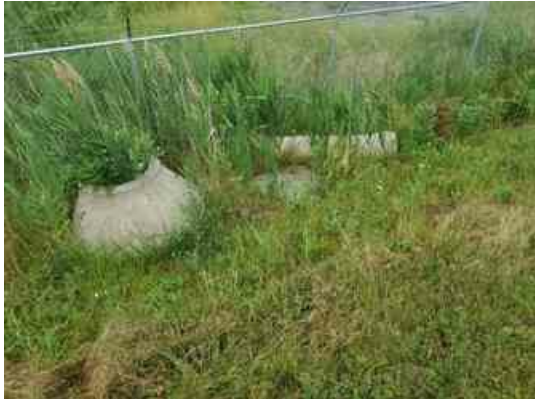
Inspect ID: 2021-0708 Title: 2604000008_CELRC_2021_A_0708_1_20210623T194330.jpg Rated Item: 3. Encroachments Caption: Minimally Acceptable - Remove concrete pipes on the landside.

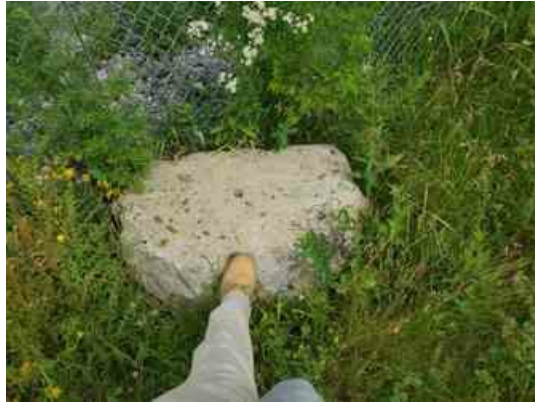
Inspect ID: 2021-0724 **Title:** 2604000008_CELRC_2021_A_0724_1_20210623T194648.jpg **Rated Item:** 3. Encroachments **Caption:** Minimally Acceptable - Remove concrete debris along landside toe.

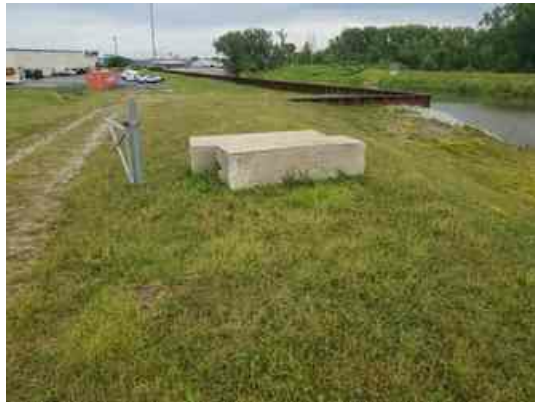
Inspect ID: 2021-0760 **Title:** 2604000008_CELRC_2021_A_0760_1_20210623T195500.jpg **Rated Item:** 3. Encroachments **Caption:** Minimally Acceptable - Remove two concrete blocks from crest.

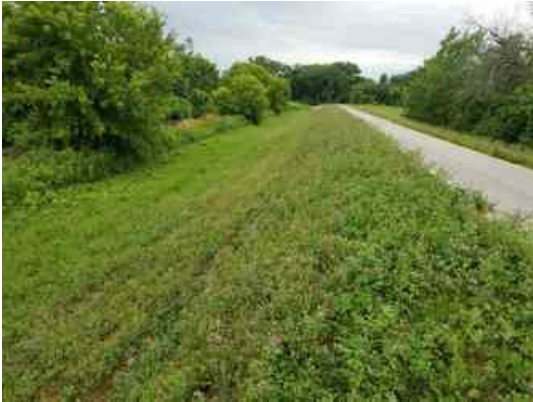
<p>Inspect ID: 2021-0392 Title: 2604000008_CELRC_2021_A_0392_1_20210623T161050.jpg Rated Item: 5. Slope Stability Caption: Acceptable - Steep riverside slope, 1.5:1. Monitor.</p>

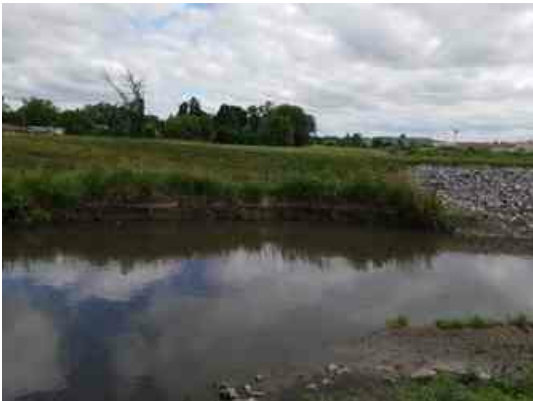
<p>Inspect ID: 2021-0001 Title: 2604000008_CELRC_2021_A_0001_1_20210621T135855.jpg Rated Item: 6. Erosion/ Bank Caving Caption: Minimally Acceptable - Erosion on riverside toe. About 5 feet of bank remaining from toe. Significant change since 2020. If the cause is determined to be from the Baring Pump Station, extend the pipe with a bend to direct flow away from the bank, otherwise, armor with riprap.</p>

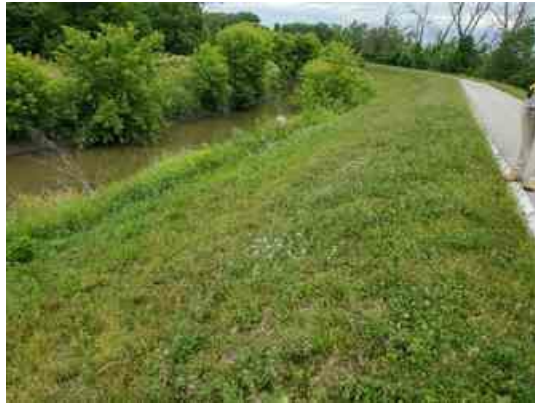
Inspect ID: 2021-0396 **Title:** 2604000008_CELRC_2021_A_0396_1_20210623T161355.jpg **Rated Item:** 6. Erosion/ Bank Caving **Caption:** Minimally Acceptable - Erosion on riverside toe. Armor.

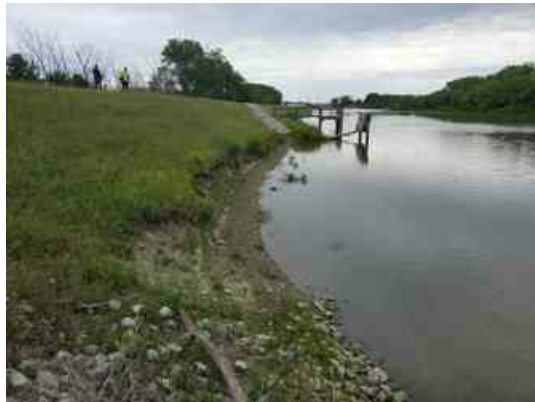
Inspect ID: 2021-0632 **Title:** 2604000008_CELRC_2021_A_0632_1_20210623T191625.jpg **Rated Item:** 6. Erosion/ Bank Caving **Caption:** Minimally Acceptable - Typical erosion along riverside toe. Armor.

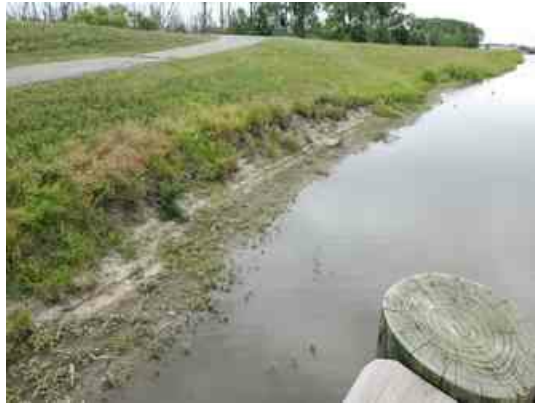
Inspect ID: 2021-0632 **Title:** 2604000008_CELRC_2021_A_2021-0632_2_20210623T191847.jpg **Rated Item:** 6. Erosion/ Bank Caving
Caption: Minimally Acceptable - Typical erosion along riverside toe. Armor.

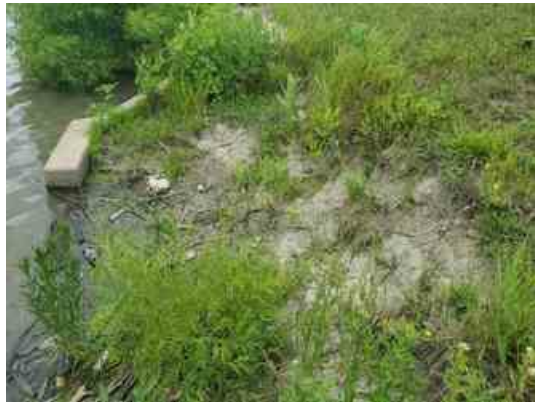
Inspect ID: 2021-0660 **Title:** 2604000008_CELRC_2021_A_0660_1_20210623T193054.jpg **Rated Item:** 6. Erosion/ Bank Caving
Caption: Minimally Acceptable - Erosion next to headwall. Armor.

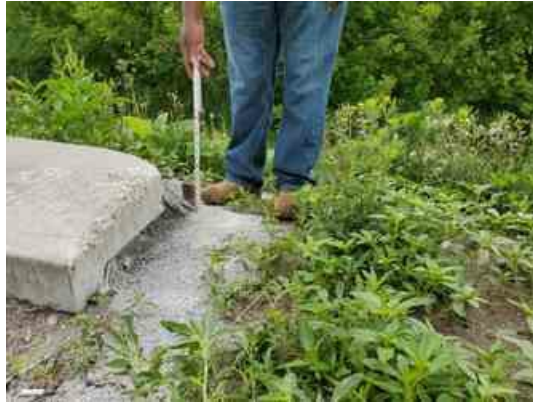
Inspect ID: 2021-0080 **Title:** 2604000008_CELRC_2021_A_0080_1_20210623T133610.jpg **Rated Item:** 7. Settlement **Caption:** Minimally Acceptable - Settlement at tie in, 4 inches lower than sheet pile. Restore levee crest.

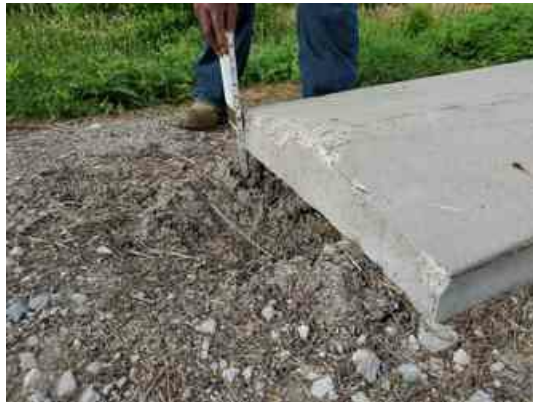
Inspect ID: 2021-0100 **Title:** 2604000008_CELRC_2021_A_0100_1_20210623T134503.jpg **Rated Item:** 7. Settlement **Caption:** Minimally Acceptable - 3 inch settlement at wall. Restore levee crest.

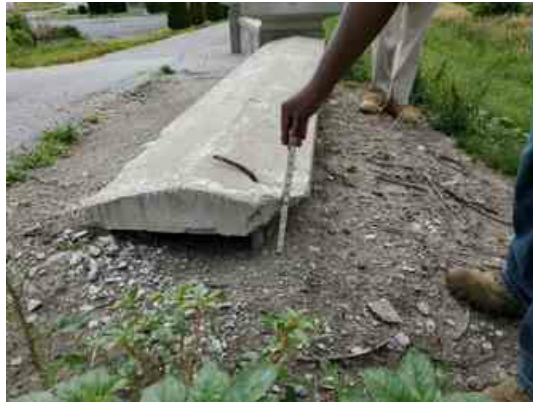
Inspect ID: 2021-0128 **Title:** 2604000008_CELRC_2021_A_0128_1_20210623T135309.jpg **Rated Item:** 7. Settlement **Caption:** Minimally Acceptable - 2 inch settlement at wall tie-in. Restore levee crest.

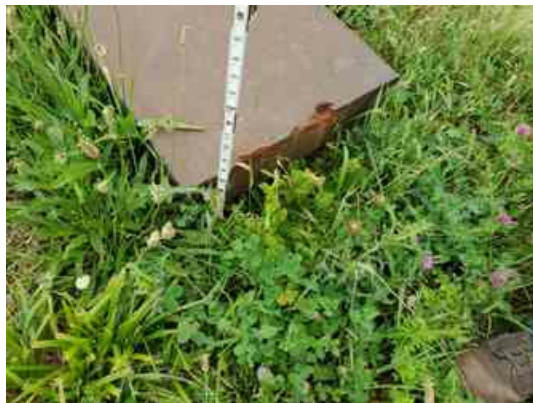
Inspect ID: 2021-0164 **Title:** 2604000008_CELRC_2021_A_0164_1_20210623T141802.jpg **Rated Item:** 7. Settlement **Caption:** Minimally Acceptable - Settlement 6 inches at the wall. Restore levee crest.

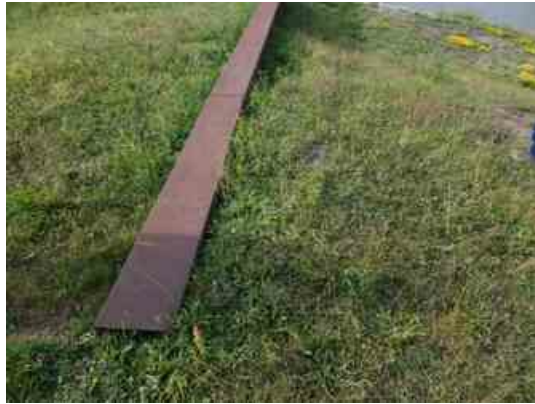
Inspect ID: 2021-0177 **Title:** 2604000008_CELRC_2021_A_0177_1_20210624T130411.jpg **Rated**
Item: 7. Settlement **Caption:** Minimally Acceptable - Wall tie in is 2 inches lower than levee and depressions forming. Fill to grade.

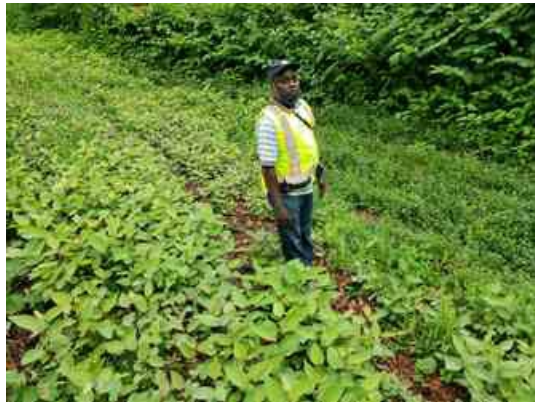
Inspect ID: 2021-0016 **Title:** 2604000008_CELRC_2021_A_0016_1_20210623T130859.jpg **Rated**
Item: 8. Depressions/ Rutting **Caption:** Minimally Acceptable - Depression on landside slope. Fill to grade.

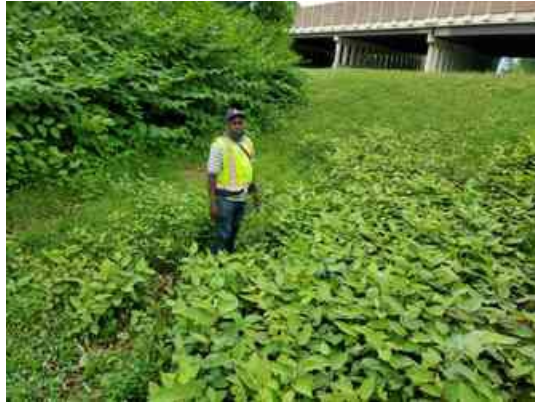
Inspect ID: 2021-0020 **Title:** 2604000008_CELRC_2021_A_0020_1_20210623T130944.jpg **Rated Item:** 8. Depressions/ Rutting **Caption:** Minimally Acceptable - Deep rut on landside toe. Fill to grade.

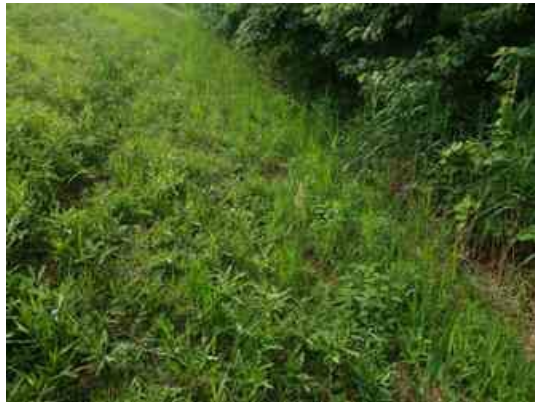
Inspect ID: 2021-0261 **Title:** 2604000008_CELRC_2021_A_0261_1_20210624T132911.jpg **Rated Item:** 8. Depressions/ Rutting **Caption:** Minimally Acceptable - Deep ruts on riverside toe. Fill.

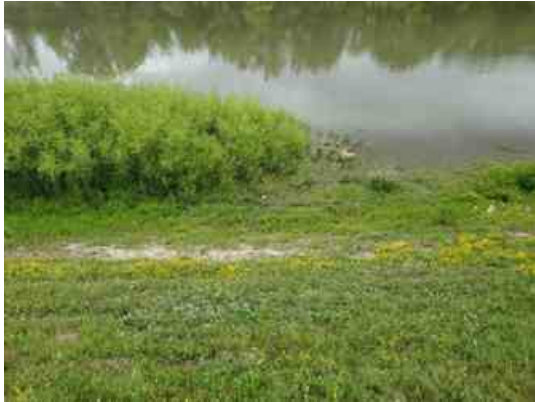
<p>Inspect ID: 2021-0648 Title: 2604000008_CELRC_2021_A_0648_1_20210623T192328.jpg Rated Item: 8. Depressions/ Rutting Caption: Minimally Acceptable - Depression on riverside toe. Fill.</p>

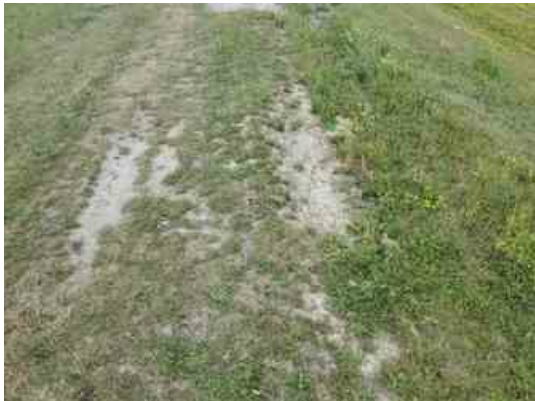
<p>Inspect ID: 2021-0740 Title: 2604000008_CELRC_2021_A_0740_1_20210623T195137.jpg Rated Item: 8. Depressions/ Rutting Caption: Minimally Acceptable - Rutting on the crest. Fill and seed.</p>

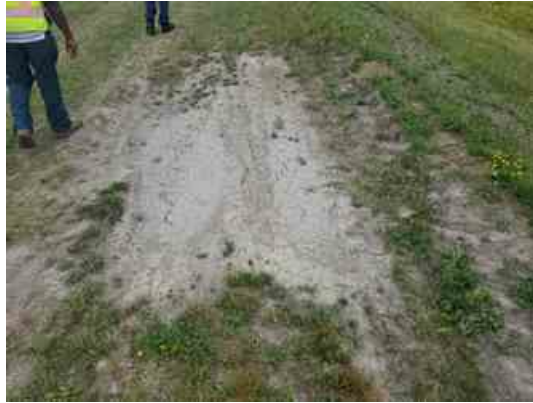
Inspect ID: 2021-0744 **Title:** 2604000008_CELRC_2021_A_0744_1_20210623T195158.jpg **Rated Item:** 8. Depressions/ Rutting **Caption:** Minimally Acceptable - Rutting on the crest. Fill and seed.

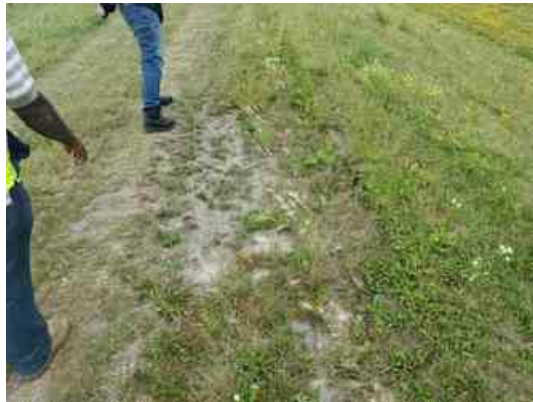
Inspect ID: 2021-0748 **Title:** 2604000008_CELRC_2021_A_0748_1_20210623T195226.jpg **Rated Item:** 8. Depressions/ Rutting **Caption:** Minimally Acceptable - Rutting on the crest. Fill and seed.

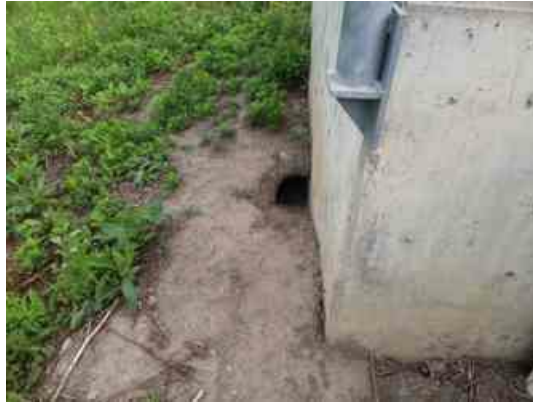
Inspect ID: 2021-0025 **Title:** 2604000008_CELRC_2021_A_0025_1_20210623T135404.jpg **Rated Item:** 10. Animal Control **Caption:** Minimally Acceptable - HA-6: There is an animal burrow on the opposite side of the sluice gate fence . Fill.

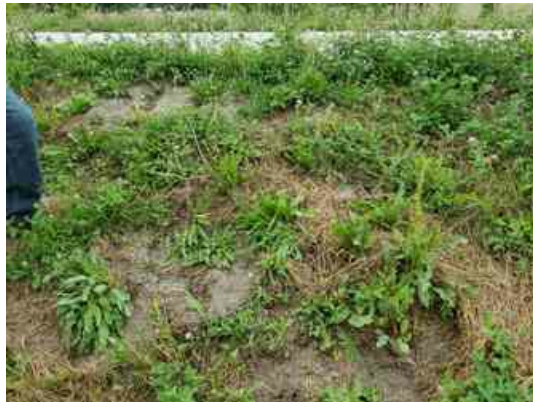
Inspect ID: 2021-0192 **Title:** 2604000008_CELRC_2021_A_0192_1_20210623T143118.jpg **Rated Item:** 10. Animal Control **Caption:** Minimally Acceptable - Animal holes, 2 inches deep. Fill.

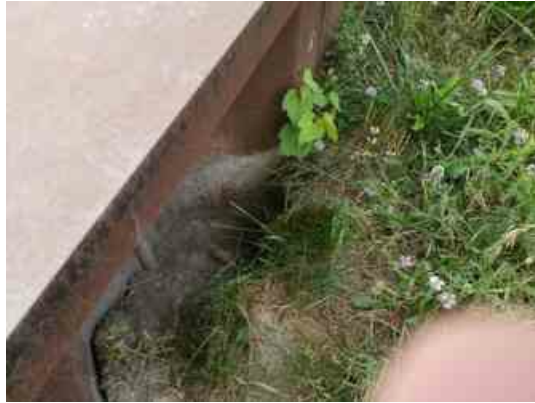
Inspect ID: 2021-0245 **Title:** 2604000008_CELRC_2021_A_0245_1_20210624T132353.jpg **Rated Item:** 10. Animal Control **Caption:** Minimally Acceptable - Animal burrow going into floodwall. 8 inch diameter. Fill.

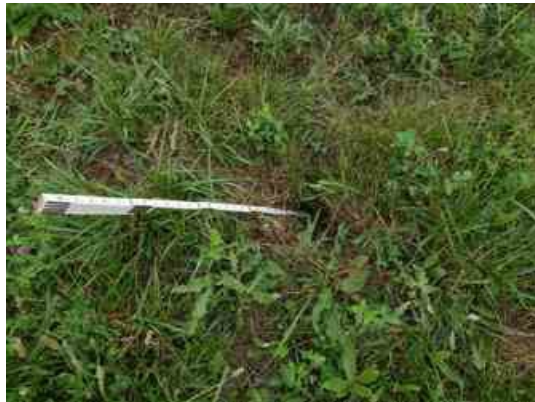
Inspect ID: 2021-0373 **Title:** 2604000008_CELRC_2021_A_0373_1_20210624T135657.jpg **Rated Item:** 10. Animal Control **Caption:** Minimally Acceptable - 3 burrows, 6 inches deep each. Fill.

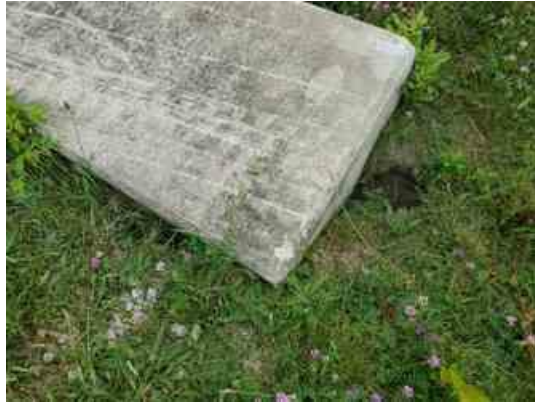
Inspect ID: 2021-0444 **Title:** 2604000008_CELRC_2021_A_0444_1_20210623T163935.jpg **Rated Item:** 10. Animal Control **Caption:** Minimally Acceptable - Two foot deep, five inch diameter hole by wall. Fill.

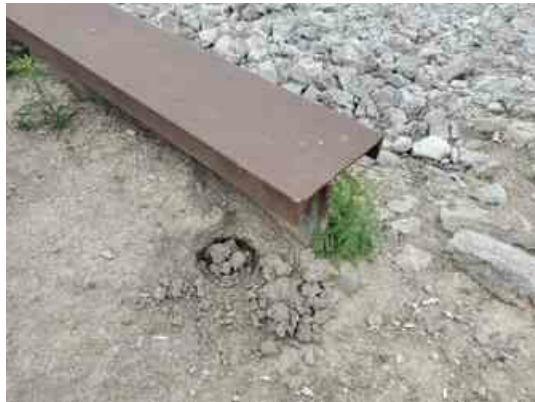
Inspect ID: 2021-0616 **Title:** 2604000008_CELRC_2021_A_0616_1_20210623T190609.jpg **Rated Item:** 10. Animal Control **Caption:** Minimally Acceptable - Animal burrow at floodwall tie in. Fill.

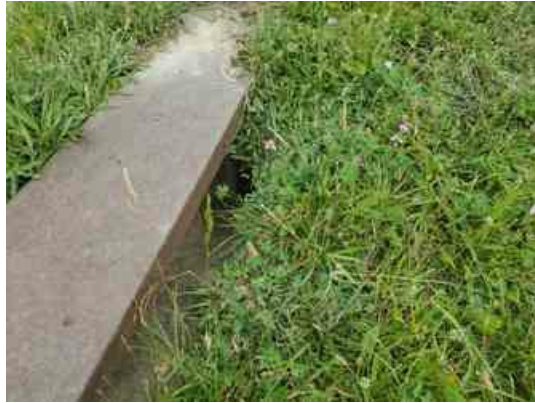
Inspect ID: 2021-0684 **Title:** 2604000008_CELRC_2021_A_0684_1_20210623T193746.jpg **Rated Item:** 10. Animal Control **Caption:** Minimally Acceptable - Very deep burrow on floodwall tie in. Fill.

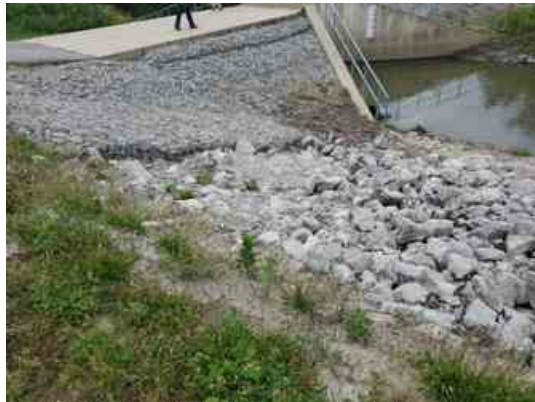
Inspect ID: 2021-0348 **Title:** 2604000008_CELRC_2021_A_0348_1_20210623T155009.jpg **Rated Item:** 12. Riprap Revetments & Bank Protection **Caption:** Minimally Acceptable - Riprap on upper half of riverside slope displaced. Restore.

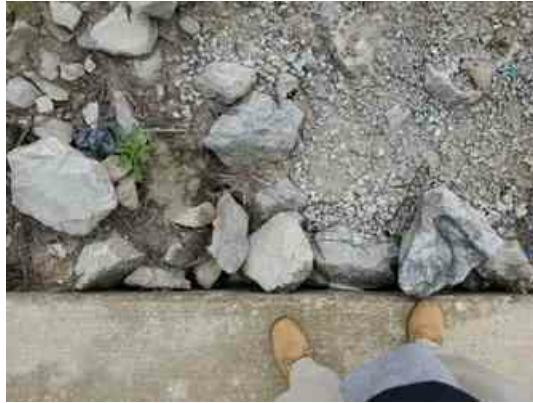
Inspect ID: 2021-0376 **Title:** 2604000008_CELRC_2021_A_0376_1_20210623T160057.jpg **Rated Item:** 12. Riprap Revetments & Bank Protection **Caption:** Minimally Acceptable - Displaced riprap by the outlet structure. Restore.

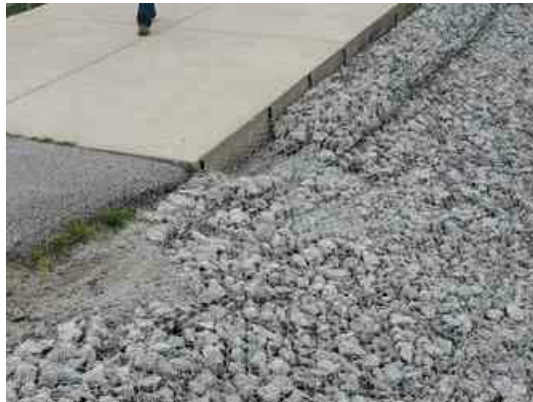
Inspect ID: 2021-0352 **Title:** 2604000008_CELRC_2021_A_0352_1_20210623T155042.jpg **Rated Item:** 13. Revetments other than Riprap **Caption:** Minimally Acceptable - Missing stone from gabion. Restore.

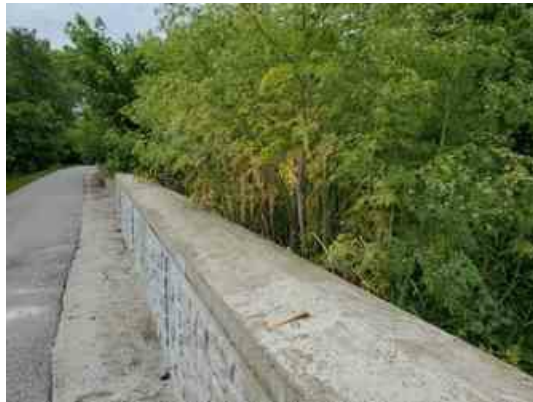
Inspect ID: 2021-0040 **Title:** 2604000008_CELRC_2021_A_0040_1_20210623T131923.jpg **Rated Item:** 1. Unwanted Vegetation Growth **Caption:** Minimally Acceptable - Tall vegetation and small trees on riverside. Cut.

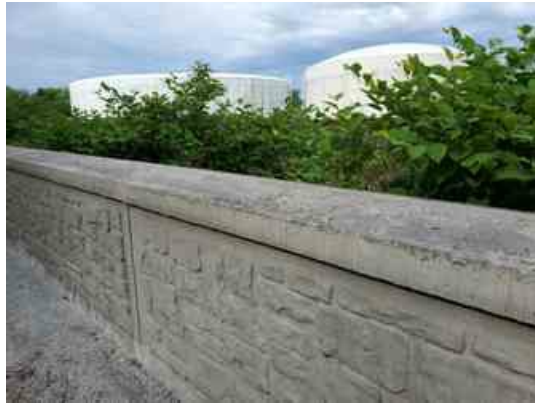
Inspect ID: 2021-0092 **Title:** 2604000008_CELRC_2021_A_0092_1_20210623T134230.jpg **Rated Item:** 1. Unwanted Vegetation Growth **Caption:** Minimally Acceptable - Large bushes on riverside. Cut.

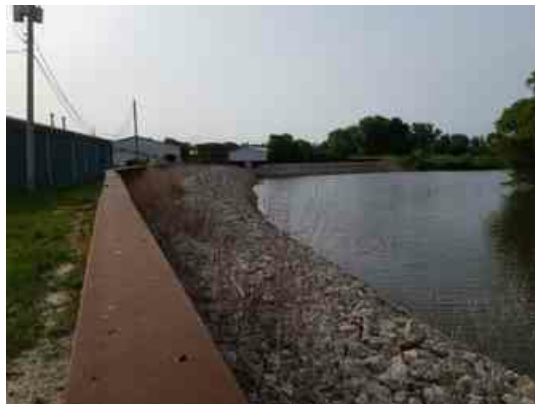
Inspect ID: 2021-0209 **Title:** 2604000008_CELRC_2021_A_0209_1_20210624T131449.jpg **Rated Item:** 1. Unwanted Vegetation Growth **Caption:** Minimally Acceptable - Remove small trees along riverside of floodwall.

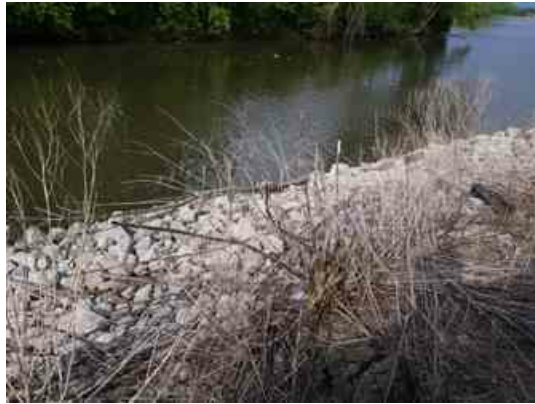
Inspect ID: 2021-0213 **Title:**

2604000008_CELRC_2021_A_0213_1_20210624T131543.jpg **Rated**
Item: 1. Unwanted Vegetation Growth **Caption:** Minimally Acceptable -
Remove tree branches and bushes on riverside of floodwall.

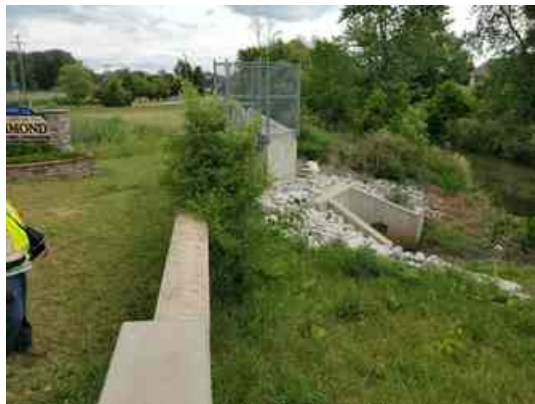
Inspect ID: 2021-0220 **Title:**

2604000008_CELRC_2021_A_0220_2_20210623T150114.jpg **Rated**
Item: 1. Unwanted Vegetation Growth **Caption:** Minimally Acceptable -
Remove small trees on riverside.

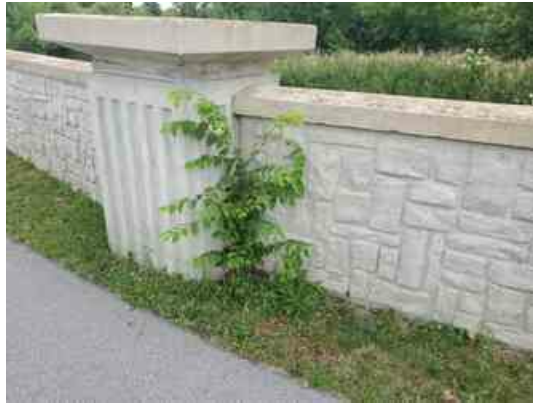
Inspect ID: 2021-0248 **Title:** 2604000008_CELRC_2021_A_0248_1_20210623T151129.jpg **Rated Item:** 1. Unwanted Vegetation Growth **Caption:** Minimally Acceptable - Remove small tree on landside.

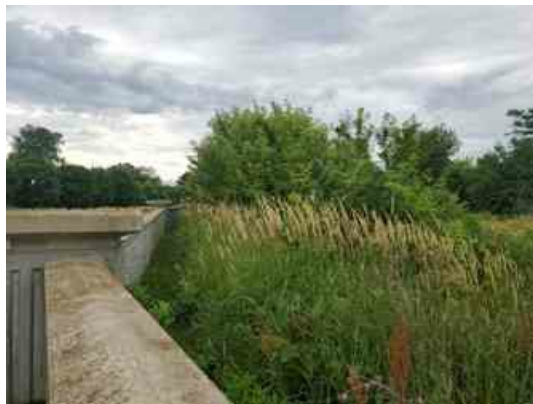
Inspect ID: 2021-0256 **Title:** 2604000008_CELRC_2021_A_0256_1_20210623T151339.jpg **Rated Item:** 1. Unwanted Vegetation Growth **Caption:** Minimally Acceptable - Tall vegetation and trees on riverside. Cut.

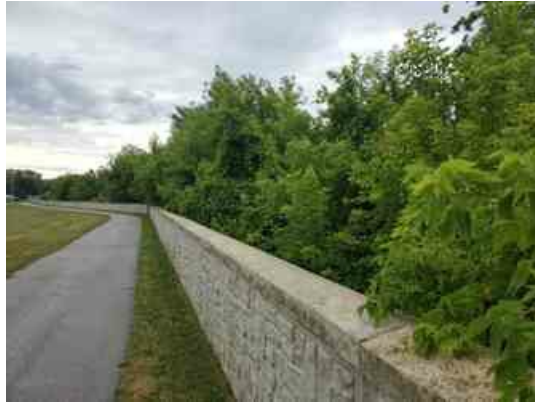
Inspect ID: 2021-0272 **Title:** 2604000008_CELRC_2021_A_0272_1_20210623T151843.jpg **Rated Item:** 1. Unwanted Vegetation Growth **Caption:** Minimally Acceptable - Trees on riverside. Cut.

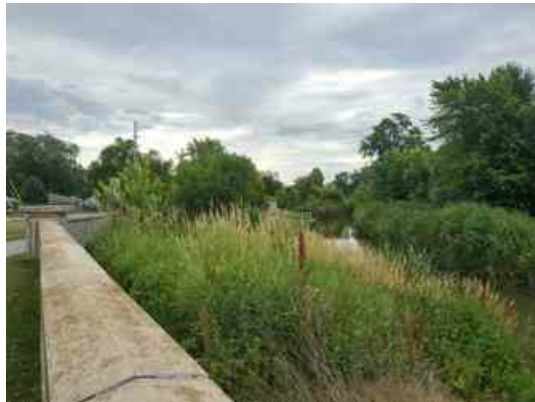
Inspect ID: 2021-0284 **Title:** 2604000008_CELRC_2021_A_0284_1_20210623T152239.jpg **Rated Item:** 1. Unwanted Vegetation Growth **Caption:** Minimally Acceptable - Tall vegetation on riverside. Cut.

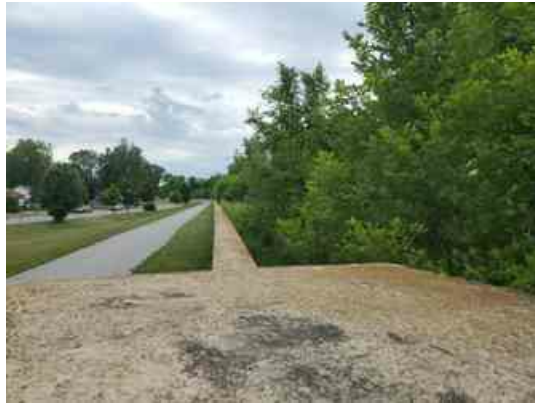
Inspect ID: 2021-0296 **Title:** 2604000008_CELRC_2021_A_0296_1_20210623T152520.jpg **Rated Item:** 1. Unwanted Vegetation Growth **Caption:** Minimally Acceptable - Trees on riverside. Cut.

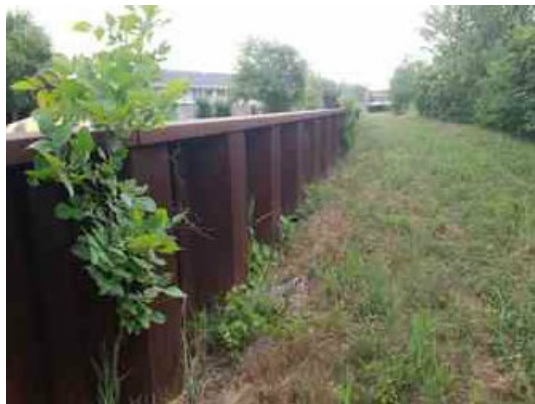
Inspect ID: 2021-0301 **Title:** 2604000008_CELRC_2021_A_0301_1_20210624T133820.jpg **Rated Item:** 1. Unwanted Vegetation Growth **Caption:** Minimally Acceptable - Small Trees on riverside of floodwall. Cut.

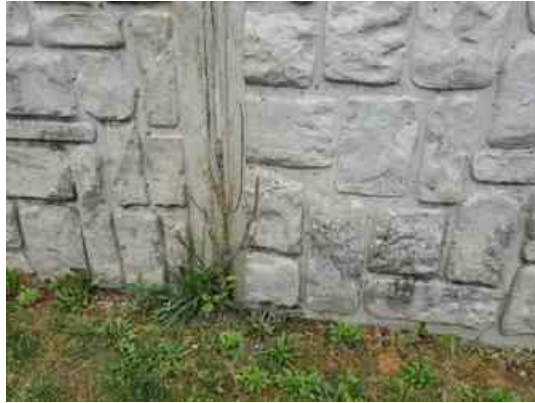
Inspect ID: 2021-0304 **Title:** 2604000008_CELRC_2021_A_0304_1_20210623T153327.jpg **Rated Item:** 1. Unwanted Vegetation Growth **Caption:** Minimally Acceptable - Small tree on landside. Cut.

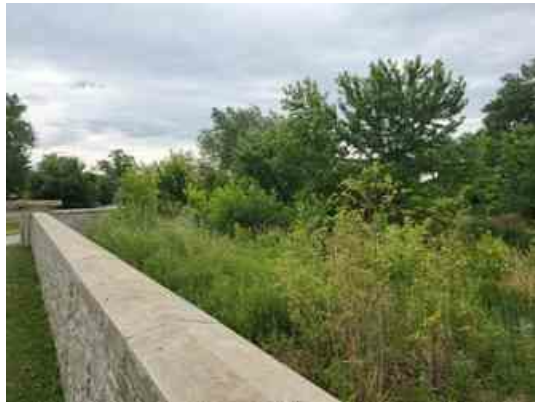
Inspect ID: 2021-0308 **Title:** 2604000008_CELRC_2021_A_0308_1_20210623T153456.jpg **Rated Item:** 1. Unwanted Vegetation Growth **Caption:** Minimally Acceptable - Tall vegetation on riverside. Cut.

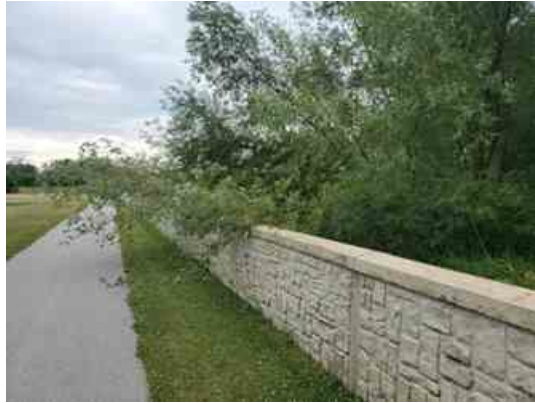
Inspect ID: 2021-0312 **Title:** 2604000008_CELRC_2021_A_0312_1_20210623T153619.jpg **Rated Item:** 1. Unwanted Vegetation Growth **Caption:** Minimally Acceptable - Trim back overhanging trees.

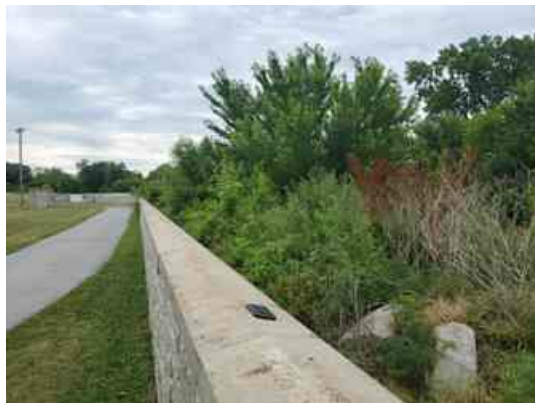
Inspect ID: 2021-0320 **Title:** 2604000008_CELRC_2021_A_0320_1_20210623T153928.jpg **Rated Item:** 1. Unwanted Vegetation Growth **Caption:** Minimally Acceptable - Trees on riverside. Cut.

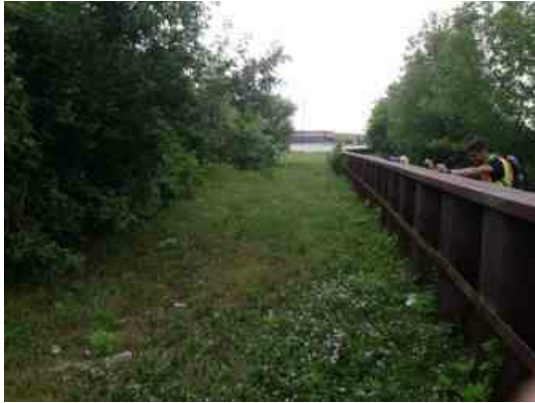
<p>Inspect ID: 2021-0325 Title: 2604000008_CELRC_2021_A_0325_1_20210624T134318.jpg Rated Item: 1. Unwanted Vegetation Growth Caption: Minimally Acceptable - Trim back tree branches out of the 15 ft vegetation free zone.</p>
 	<p>Inspect ID: 2021-0328 Title: 2604000008_CELRC_2021_A_0328_1_20210623T154059.jpg Rated Item: 1. Unwanted Vegetation Growth Caption: Minimally Acceptable - Remove small tree on landside.</p>
