**US Army Corps
of Engineers®**

Levee Inspection Report

Name of System: Hammond

Date(s) of Inspection: 06/23/2021 - 06/24/2021

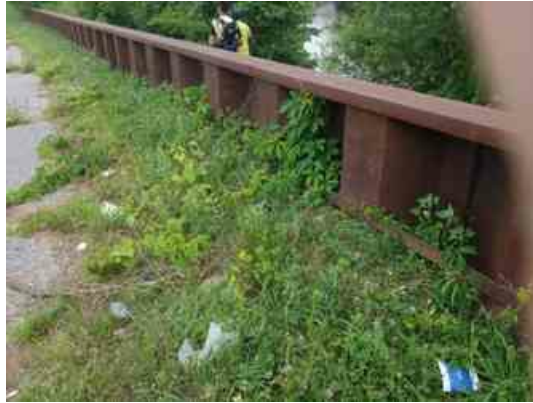
Inspect ID: 2021-0357 **Title:** 2604000008_CELRC_2021_A_0357_1_20210624T135301.jpg **Rated Item:** 1. Unwanted Vegetation Growth **Caption:** Minimally Acceptable - Remove bushes on landside.

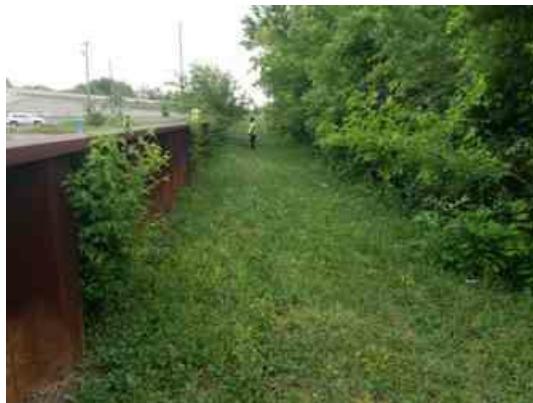
Inspect ID: 2021-0361 **Title:** 2604000008_CELRC_2021_A_0361_1_20210624T135402.jpg **Rated Item:** 1. Unwanted Vegetation Growth **Caption:** Minimally Acceptable - Cut trees and bushes on riverside. Cut back overhanging trees.

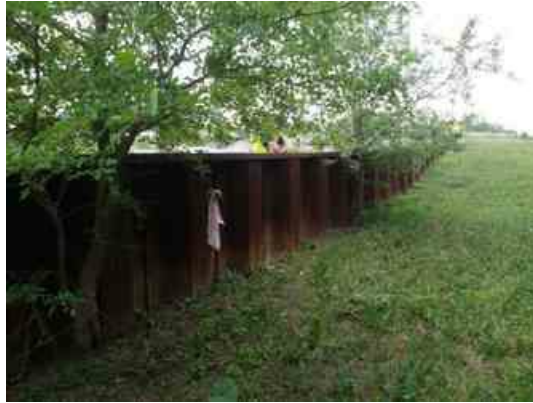
Inspect ID: 2021-0365 **Title:** 2604000008_CELRC_2021_A_0365_1_20210624T135508.jpg **Rated Item:** 1. Unwanted Vegetation Growth **Caption:** Minimally Acceptable - Two large trees on riverside. Cut.

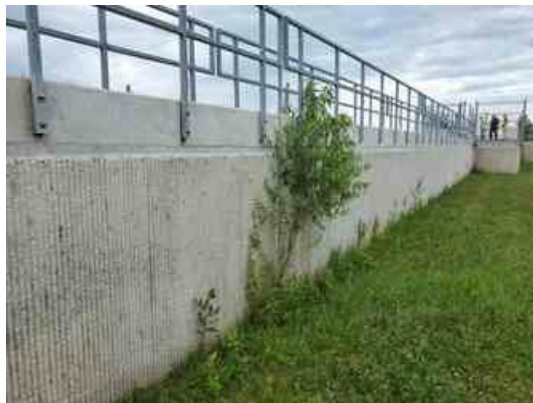
Inspect ID: 2021-0452 **Title:** 2604000008_CELRC_2021_A_0452_1_20210623T164356.jpg **Rated Item:** 1. Unwanted Vegetation Growth **Caption:** Minimally Acceptable - Small trees on riverside. Cut.

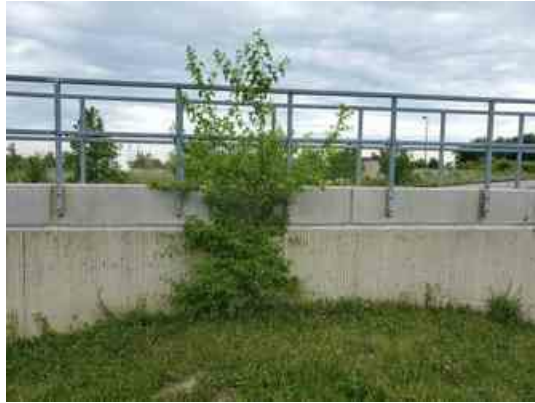
Inspect ID: 2021-0456 **Title:** 2604000008_CELRC_2021_A_0456_1_20210623T164940.jpg **Rated Item:** 1. Unwanted Vegetation Growth **Caption:** Minimally Acceptable - Small trees on riverside. Cut.

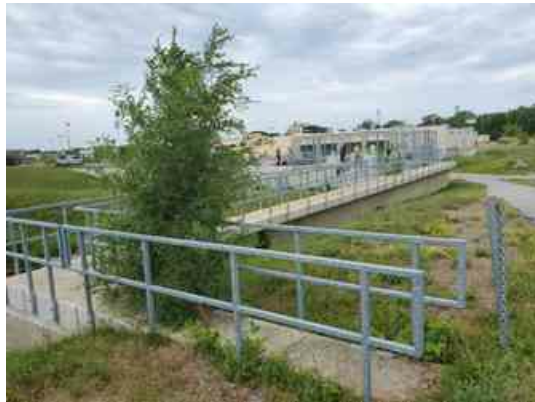
Inspect ID: 2021-0460 **Title:** 2604000008_CELRC_2021_A_0460_1_20210623T165131.jpg **Rated Item:** 1. Unwanted Vegetation Growth **Caption:** Minimally Acceptable - Remove trees on landside.

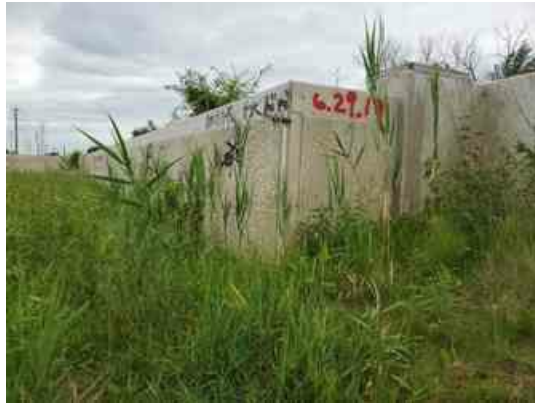
Inspect ID: 2021-0508 **Title:** 2604000008_CELRC_2021_A_0508_1_20210623T171847.jpg **Rated Item:** 1. Unwanted Vegetation Growth **Caption:** Minimally Acceptable - Tall vegetation on the landside. Cut.

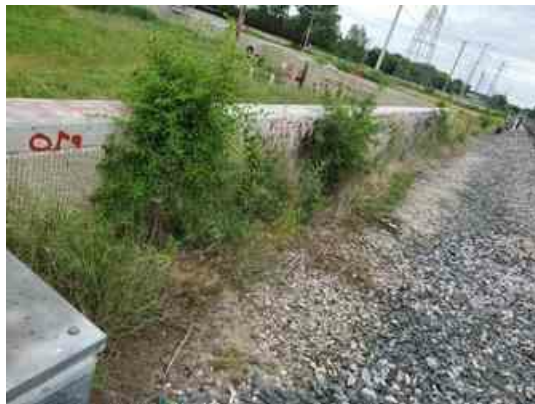
Inspect ID: 2021-0520 **Title:** 2604000008_CELRC_2021_A_0520_1_20210623T172520.jpg **Rated Item:** 1. Unwanted Vegetation Growth **Caption:** Minimally Acceptable - Vegetation on the riverside floodwall

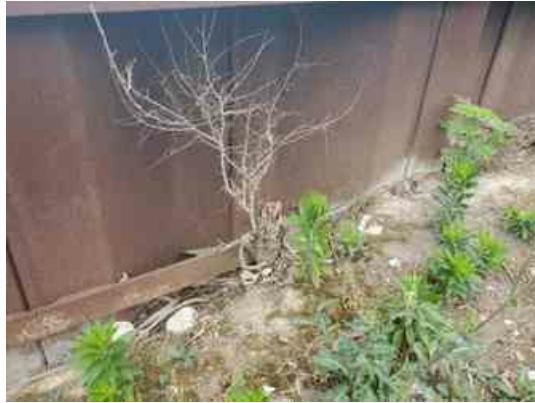
Inspect ID: 2021-0620 **Title:** 2604000008_CELRC_2021_A_0620_1_20210623T190706.jpg **Rated Item:** 1. Unwanted Vegetation Growth **Caption:** Minimally Acceptable - Small trees on landside of floodwall. Remove.

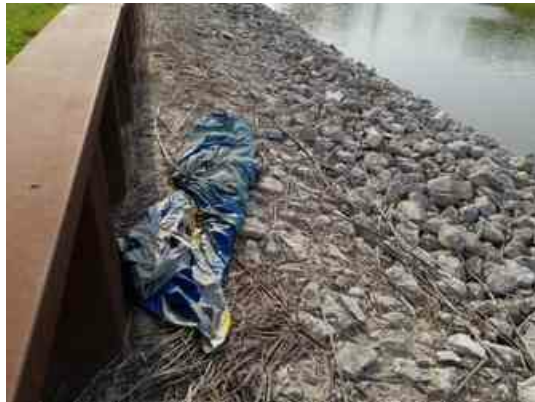
Inspect ID: 2021-0193 **Title:** 2604000008_CELRC_2021_A_0193_1_20210624T130935.jpg **Rated Item:** 2. Encroachments **Caption:** Minimally Acceptable - Remove inflatable tube on riverside.

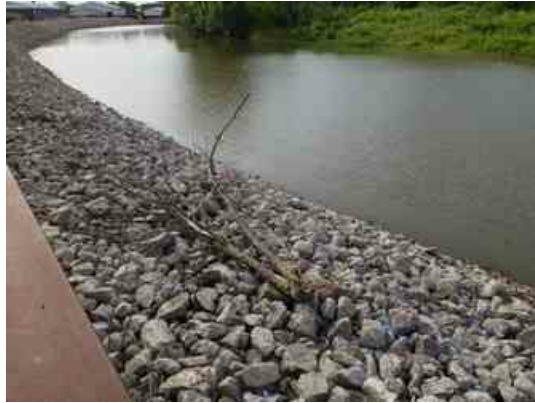
Inspect ID: 2021-0201 **Title:** 2604000008_CELRC_2021_A_0201_1_20210624T131142.jpg **Rated Item:** 2. Encroachments **Caption:** Minimally Acceptable - Remove tree branch on riverside.

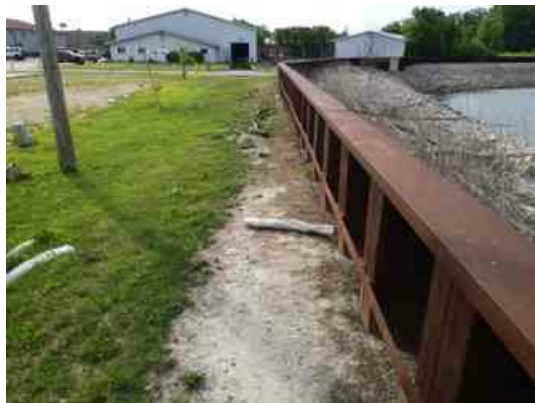
Inspect ID: 2021-0217 **Title:** 2604000008_CELRC_2021_A_0217_1_20210624T131645.jpg **Rated Item:** 2. Encroachments **Caption:** Minimally Acceptable - Remove tubes on landside.

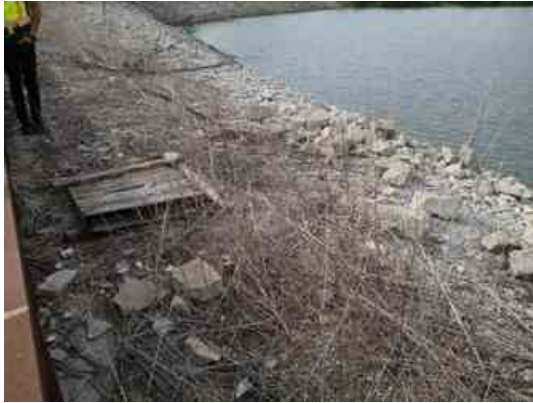
Inspect ID: 2021-0221 **Title:** 2604000008_CELRC_2021_A_0221_1_20210624T131717.jpg **Rated Item:** 2. Encroachments **Caption:** Minimally Acceptable - Remove debris on riverside.

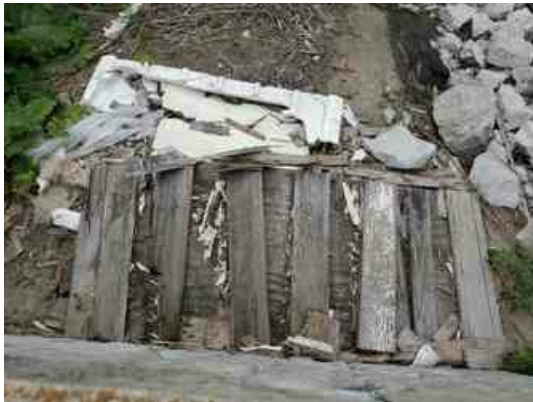
Inspect ID: 2021-0224 **Title:** 2604000008_CELRC_2021_A_0224_1_20210623T150212.jpg **Rated Item:** 2. Encroachments **Caption:** Minimally Acceptable - Remove debris pile on riverside.

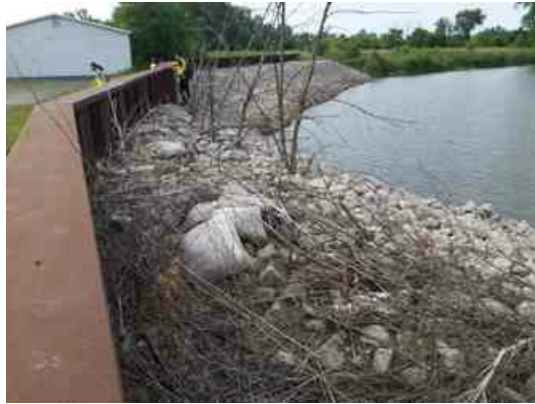
Inspect ID: 2021-0229 **Title:** 2604000008_CELRC_2021_A_0229_1_20210624T131901.jpg **Rated Item:** 2. Encroachments **Caption:** Minimally Acceptable - Remove debris pile on riverside.

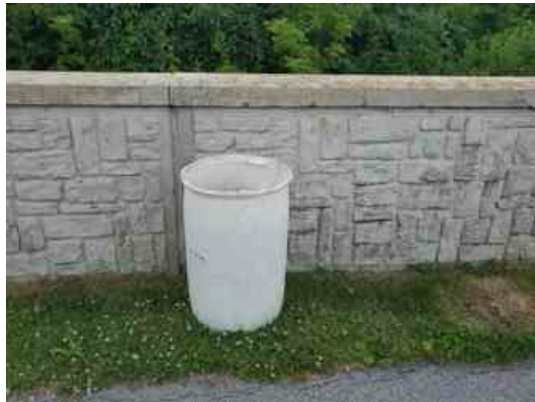
Inspect ID: 2021-0260 **Title:** 2604000008_CELRC_2021_A_0260_1_20210623T151522.jpg **Rated Item:** 2. Encroachments **Caption:** Minimally Acceptable - Move trash can.

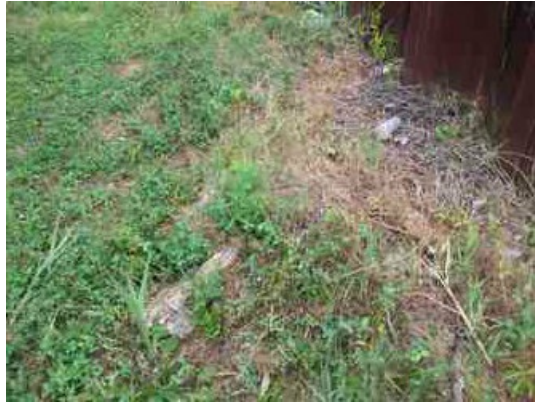
Inspect ID: 2021-0305 **Title:** 2604000008_CELRC_2021_A_0305_1_20210624T133904.jpg **Rated Item:** 2. Encroachments **Caption:** Minimally Acceptable - Remove logs on riverside.

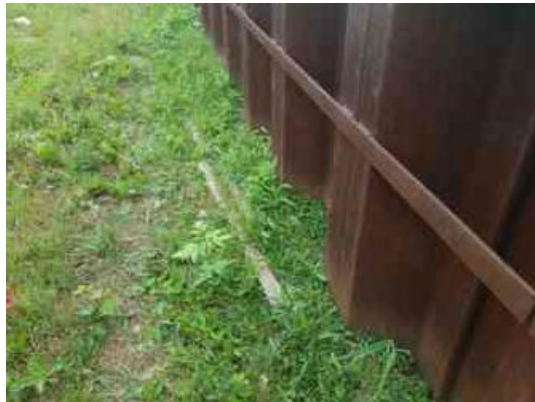
Inspect ID: 2021-0309 **Title:** 2604000008_CELRC_2021_A_0309_1_20210624T134000.jpg **Rated Item:** 2. Encroachments **Caption:** Minimally Acceptable - Remove two 4x4s on landside.

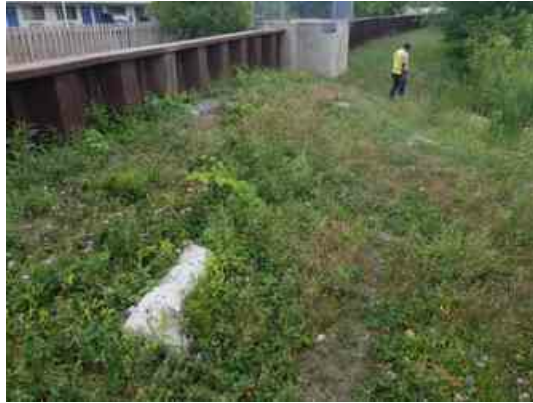
Inspect ID: 2021-0313 **Title:** 2604000008_CELRC_2021_A_0313_3_20210624T134105.jpg **Rated Item:** 2. Encroachments **Caption:** Minimally Acceptable - Remove concrete and beam on riverside.

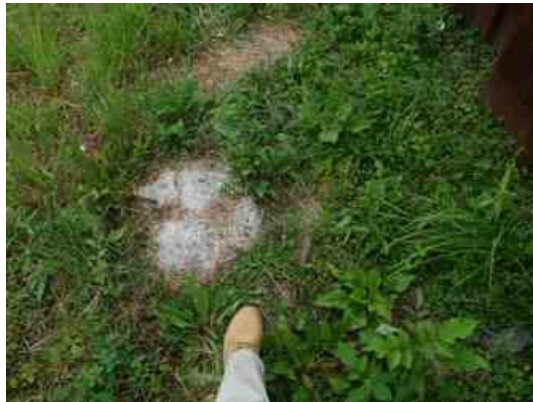
Inspect ID: 2021-0317 **Title:** 2604000008_CELRC_2021_A_0317_1_20210624T134139.jpg **Rated Item:** 2. Encroachments **Caption:** Minimally Acceptable - Remove concrete block and 4x4 on landside.

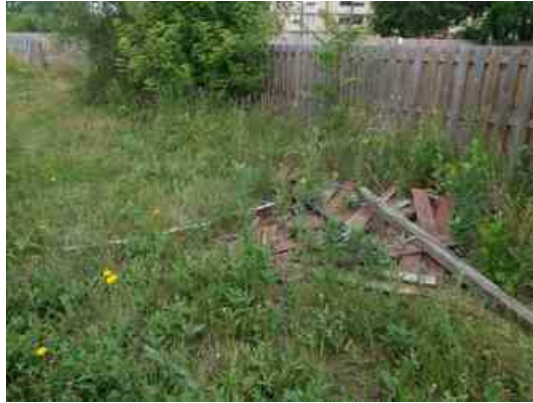
Inspect ID: 2021-0321 **Title:** 2604000008_CELRC_2021_A_0321_1_20210624T134236.jpg **Rated Item:** 2. Encroachments **Caption:** Minimally Acceptable - Remove debris pile on landside.

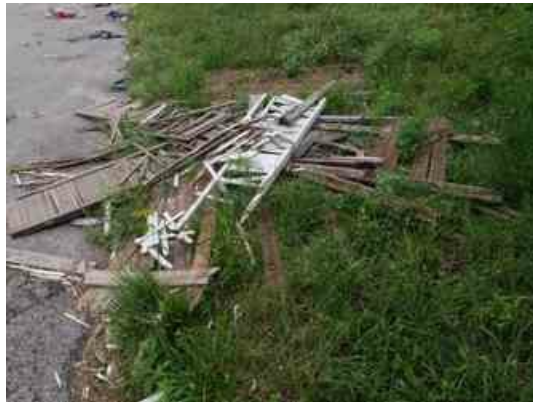
Inspect ID: 2021-0369 **Title:** 2604000008_CELRC_2021_A_0369_1_20210624T135548.jpg **Rated Item:** 2. Encroachments **Caption:** Minimally Acceptable - Remove debris pile on landside.

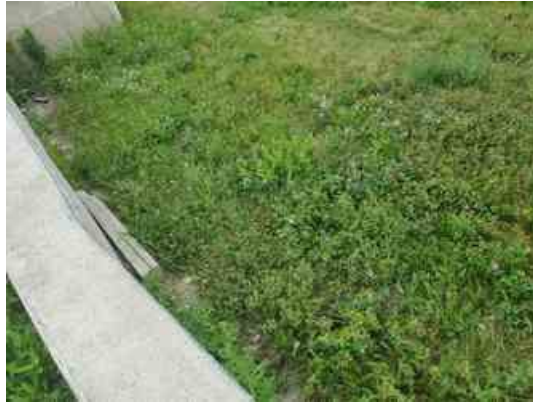
Inspect ID: 2021-0572 **Title:** 2604000008_CELRC_2021_A_0572_1_20210623T175957.jpg **Rated Item:** 2. Encroachments **Caption:** Minimally Acceptable - Remove 4x4 on riverside.

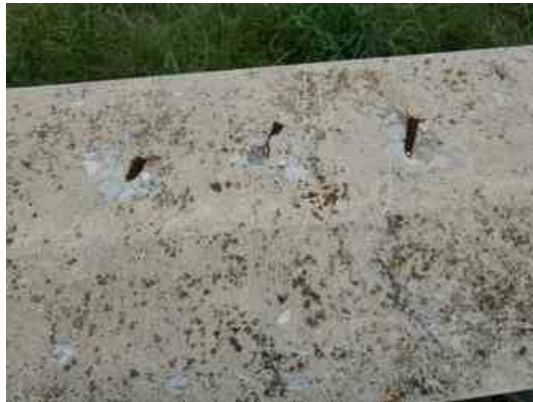
Inspect ID: 2021-0228 **Title:** 2604000008_CELRC_2021_A_0228_1_20210623T150344.jpg **Rated Item:** 4. Concrete Surfaces **Caption:** Minimally Acceptable - Exposed rebar. Patch.

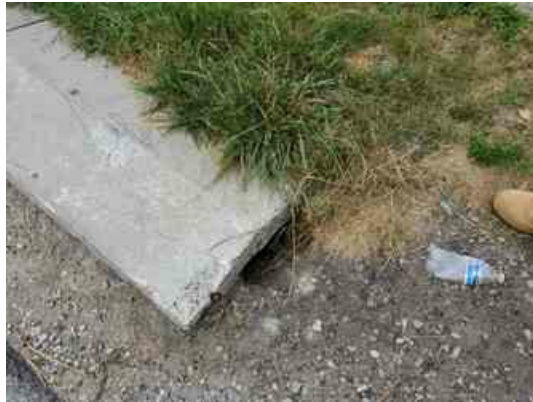
Inspect ID: 2021-0036 **Title:**
2604000008_CELRC_2021_A_0036_1_20210623T131732.jpg **Rated**
Item: 6. Foundation of Concrete Structures **Caption:** Minimally
Acceptable - Settlement at west end of wall. Fill.

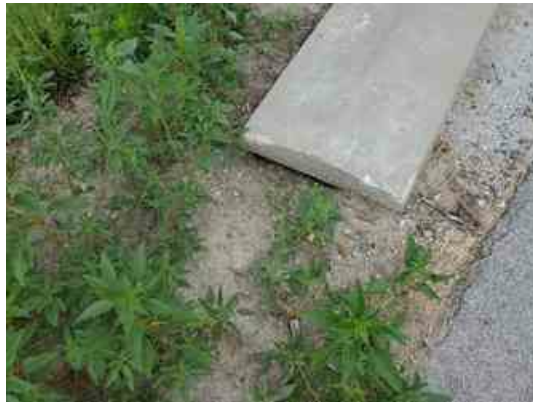
Inspect ID: 2021-0068 **Title:** 2604000008_CELRC_2021_A_0068_1_20210623T132952.jpg **Rated Item:** 6. Foundation of Concrete Structures **Caption:** Minimally Acceptable - Minor settlement at end of floodwall. Fill.

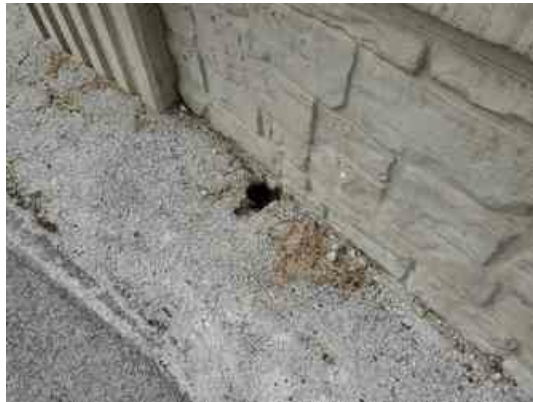
Inspect ID: 2021-0132 **Title:** 2604000008_CELRC_2021_A_0132_1_20210623T135510.jpg **Rated**
Item: 6. Foundation of Concrete Structures **Caption:** Minimally Acceptable - Hole on landside. Fill.

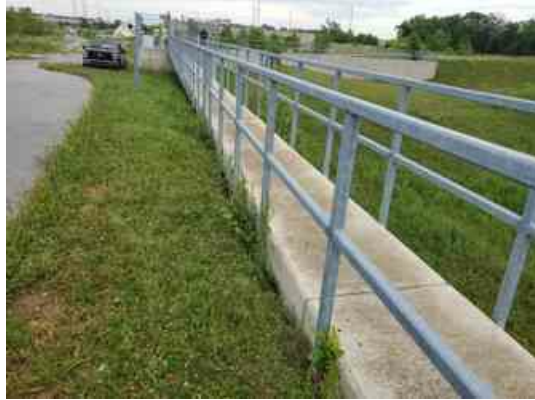
Inspect ID: 2021-0448 **Title:** 2604000008_CELRC_2021_A_0448_1_20210623T164200.jpg **Rated Item:** 6. Foundation of Concrete Structures **Caption:** Minimally Acceptable - Holes along the wall. Fill.

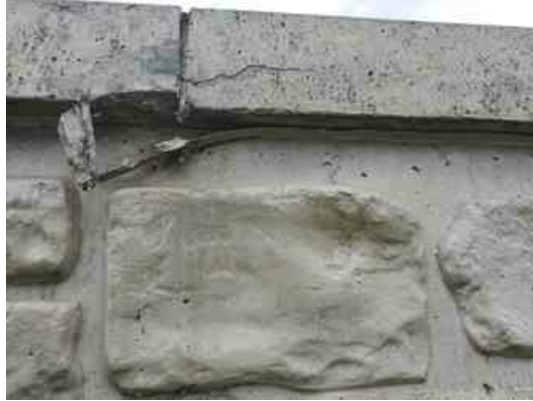
Inspect ID: 2021-0324 **Title:** 2604000008_CELRC_2021_A_0324_1_20210623T154021.jpg **Rated Item:** 7. Monolith Joints **Caption:** Minimally Acceptable - Sealant under cap deteriorating. Reseal.

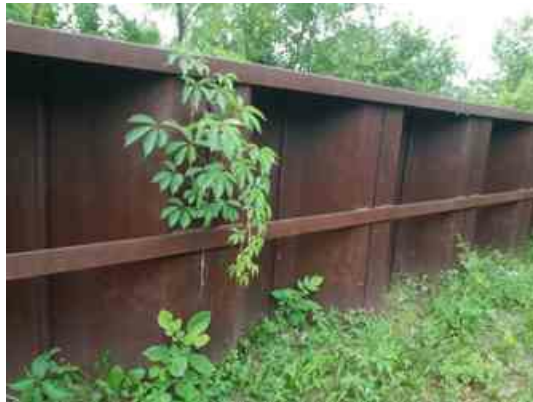
Inspect ID: 2021-0333 **Title:** 2604000008_CELRC_2021_A_0333_1_20210624T134457.jpg **Rated Item:** 7. Monolith Joints **Caption:** Minimally Acceptable - Tree growing in joint. Remove.

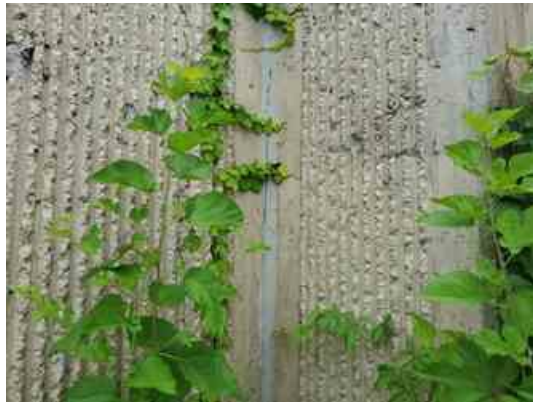
Inspect ID: 2021-0516 **Title:** 2604000008_CELRC_2021_A_0516_1_20210623T172303.jpg **Rated Item:** 7. Monolith Joints **Caption:** Minimally Acceptable - Deteriorating sealant. Remove old caulk and reseal.

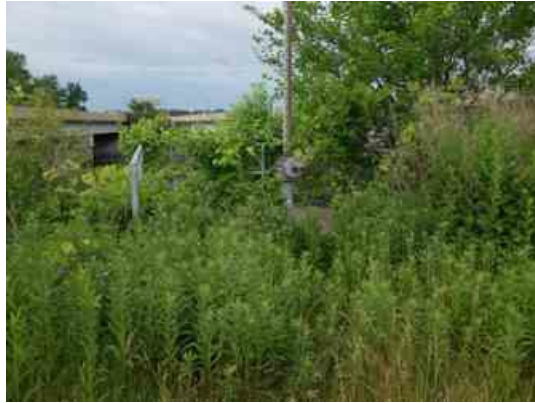
Inspect ID: 2021-0002 **Title:** 2604000008_CELRC_2021_A_0002_1_20210623T131926.jpg **Rated Item:** 1. Vegetation and Obstructions **Caption:** Minimally Acceptable - HA-38: Too much vegetation. Clear.

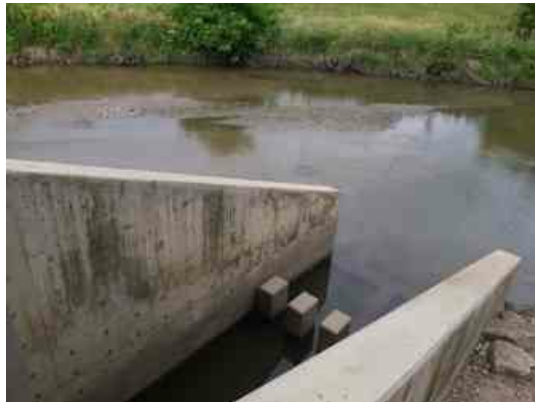
Inspect ID: 2021-0005 **Title:** 2604000008_CELRC_2021_A_0005_1_20210623T131830.jpg **Rated Item:** 1. Vegetation and Obstructions **Caption:** Acceptable - HA-4: Outlet is free of debris.

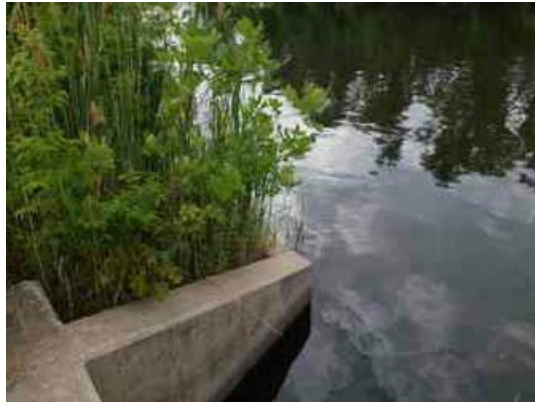
Inspect ID: 2021-0018 **Title:** 2604000008_CELRC_2021_A_0018_1_20210623T133715.jpg **Rated Item:** 1. Vegetation and Obstructions **Caption:** Minimally Acceptable - HA-35: Tree growing near outlet structure. Remove.

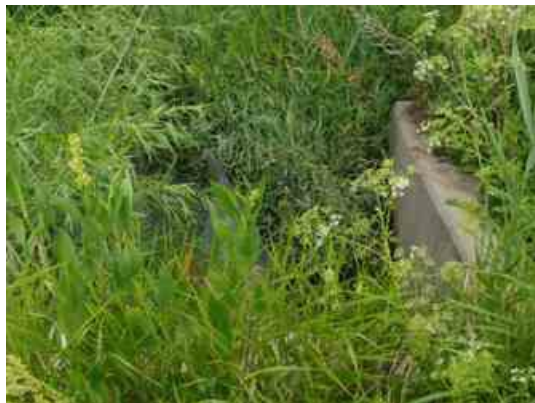
Inspect ID: 2021-0021 **Title:** 2604000008_CELRC_2021_A_0021_1_20210623T135148.jpg **Rated Item:** 1. Vegetation and Obstructions **Caption:** Minimally Acceptable - HA-6: The culvert is surrounded by vegetation, this needs too be removed.

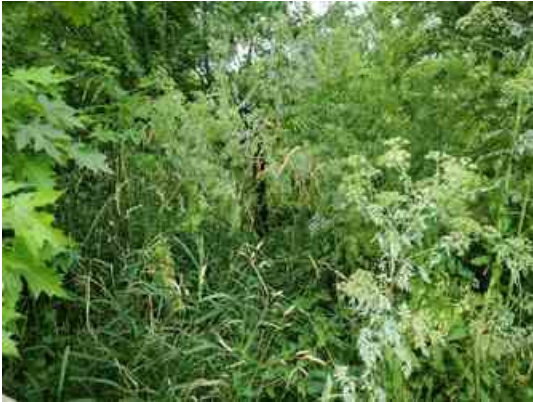
<p>Inspect ID: 2021-0044 Title: 2604000008_CELRC_2021_A_0044_1_20210623T132011.jpg Rated Item: 1. Vegetation and Obstructions Caption: Minimally Acceptable - HA-3: Tall vegetation around structure. Clear.</p>

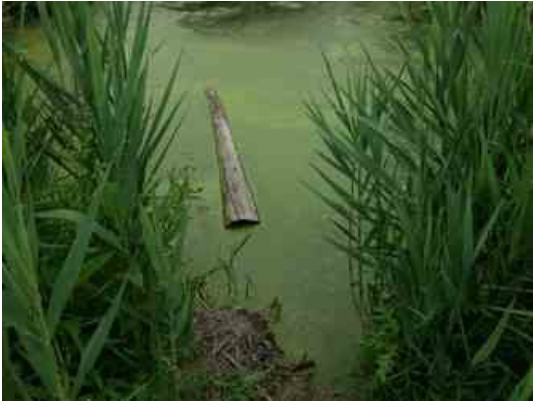
<p>Inspect ID: 2021-0046 Title: 2604000008_CELRC_2021_A_0046_1_20210623T141629.jpg Rated Item: 1. Vegetation and Obstructions Caption: Minimally Acceptable - HA-31: Inlet has heavy vegetation and tree logs that need to be cleared.</p>

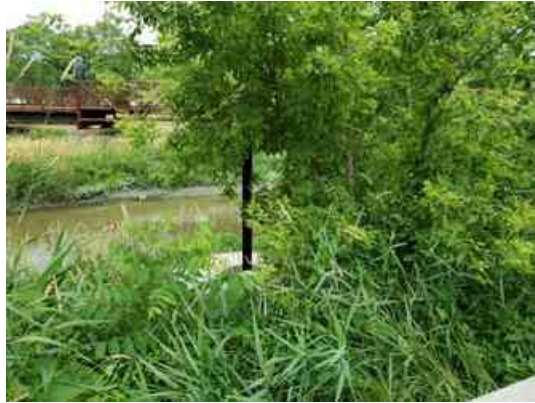
Inspect ID: 2021-0048 **Title:** 2604000008_CELRC_2021_A_0048_1_20210623T132201.jpg **Rated Item:** 1. Vegetation and Obstructions **Caption:** Minimally Acceptable - HA-4: Small tree next to structure. Cut.

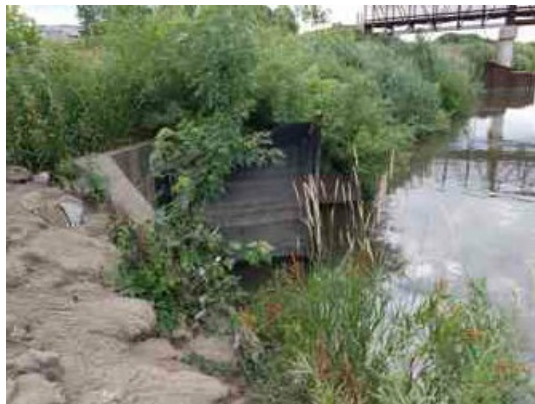
Inspect ID: 2021-0054 **Title:** 2604000008_CELRC_2021_A_0054_2_20210623T142738.jpg **Rated Item:** 1. Vegetation and Obstructions **Caption:** Minimally Acceptable - HA-28: Trees growing at outlet structure. Clear. Duckbills are adequate.

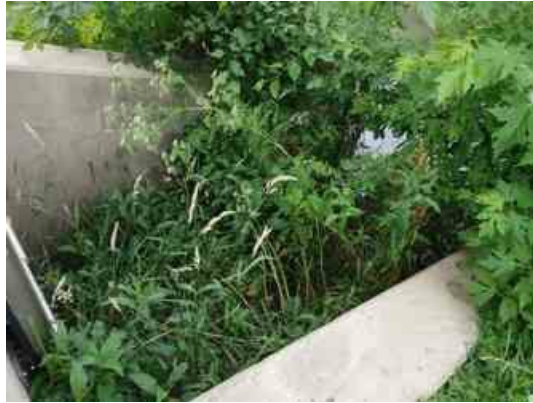
Inspect ID: 2021-0057 **Title:** 2604000008_CELRC_2021_A_0057_1_20210623T142542.jpg **Rated Item:** 1. Vegetation and Obstructions **Caption:** Minimally Acceptable - HA-10: The sluice gate is blocked by heavy vegetation that should be removed

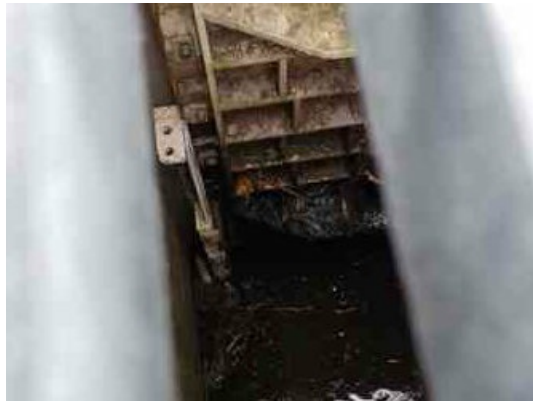
Inspect ID: 2021-0058 **Title:** 2604000008_CELRC_2021_A_0058_2_20210623T143408.jpg **Rated Item:** 1. Vegetation and Obstructions **Caption:** Minimally Acceptable - HA-28: Debris and some small vegetation. Gate operated without issue.

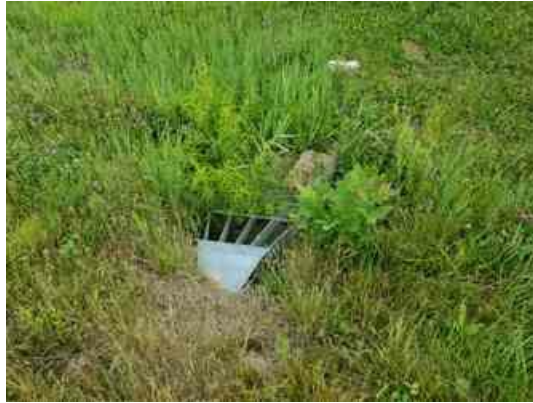
Inspect ID: 2021-0072 **Title:** 2604000008_CELRC_2021_A_0072_1_20210623T133328.jpg **Rated Item:** 1. Vegetation and Obstructions **Caption:** Minimally Acceptable - HA-5: Inlet has tall vegetation. Clear.

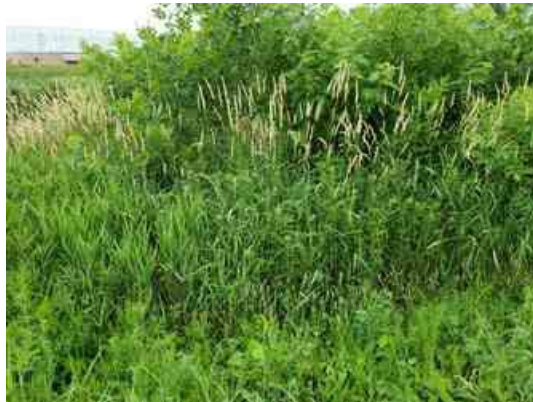
Inspect ID: 2021-0076 **Title:** 2604000008_CELRC_2021_A_0076_1_20210623T133417.jpg **Rated Item:** 1. Vegetation and Obstructions **Caption:** Minimally Acceptable - HA-5: Tall vegetation around outlet. Can't find headwall. Clear.

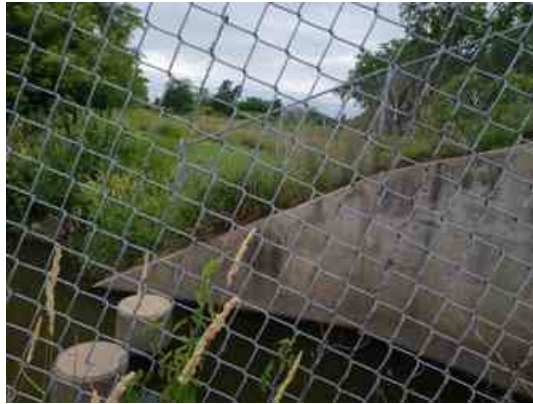
Inspect ID: 2021-0089 **Title:** 2604000008_CELRC_2021_A_0089_1_20210623T145405.jpg **Rated Item:** 1. Vegetation and Obstructions **Caption:** Minimally Acceptable - HA-12: Vegetation beginning to grow on concrete structure for the flap gate. Clear.

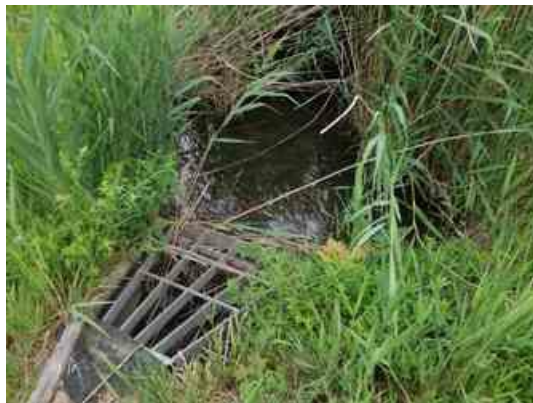
Inspect ID: 2021-0090 **Title:** 2604000008_CELRC_2021_A_0090_1_20210623T155543.jpg **Rated Item:** 1. Vegetation and Obstructions **Caption:** Minimally Acceptable - HA-23: Inlet needs to be cleared.

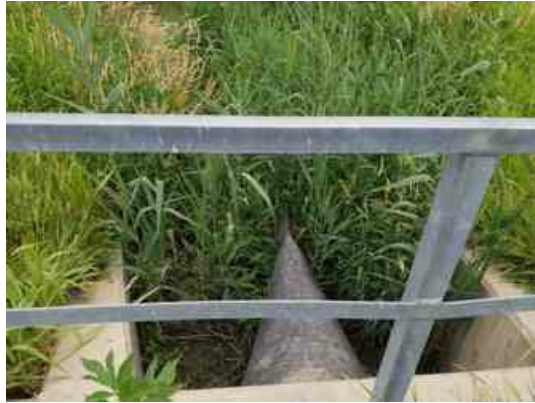
Inspect ID: 2021-0093 **Title:** 2604000008_CELRC_2021_A_0093_1_20210623T145554.jpg **Rated Item:** 1. Vegetation and Obstructions **Caption:** Minimally Acceptable - HA-13: Outlet is surrounded by vegetation. The vegetation needs to be removed.

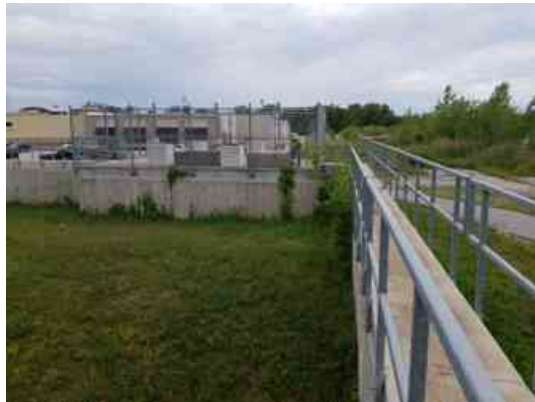
Inspect ID: 2021-0102 **Title:** 2604000008_CELRC_2021_A_0102_3_20210623T160839.jpg **Rated Item:** 1. Vegetation and Obstructions **Caption:** Minimally Acceptable - HA-21: Vegetation around the structure. Clear.

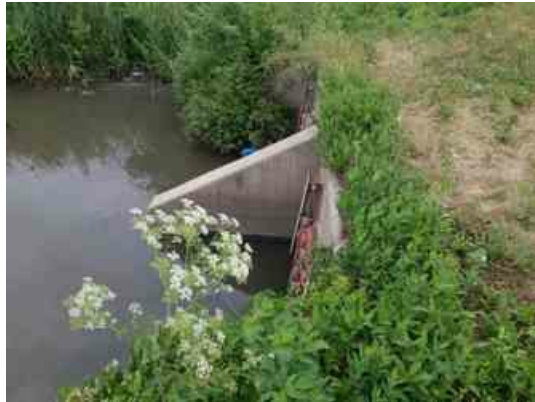
Inspect ID: 2021-0136 **Title:** 2604000008_CELRC_2021_A_0136_1_20210914T153402.jpg **Rated Item:** 1. Vegetation and Obstructions **Caption:** Minimally Acceptable - HA-7: Tall vegetation and small trees at outlet. Clear.

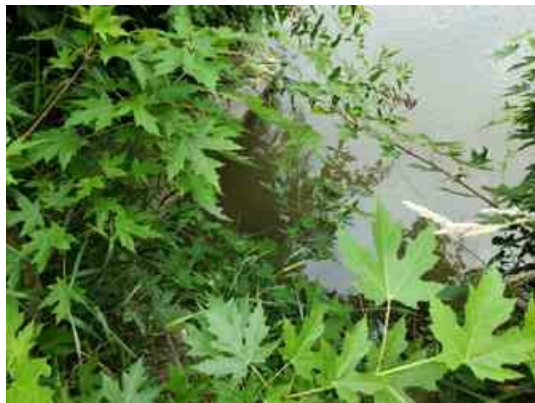
Inspect ID: 2021-0152 **Title:** 2604000008_CELRC_2021_A_0152_1_20210623T140846.jpg **Rated Item:** 1. Vegetation and Obstructions **Caption:** Minimally Acceptable - HA-9: Remove vegetation.

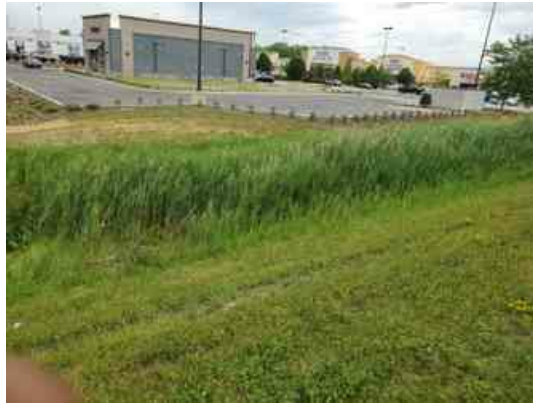
Inspect ID: 2021-0428 **Title:** 2604000008_CELRC_2021_A_0428_1_20210623T163014.jpg **Rated Item:** 1. Vegetation and Obstructions **Caption:** Minimally Acceptable - Tall vegetation in ditch. Clear.

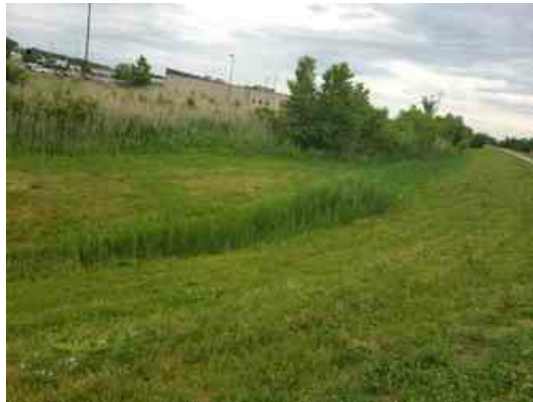
Inspect ID: 2021-0464 **Title:** 2604000008_CELRC_2021_A_0464_1_20210623T165508.jpg **Rated Item:** 1. Vegetation and Obstructions **Caption:** Minimally Acceptable - Tall vegetation in ditch. Clear.

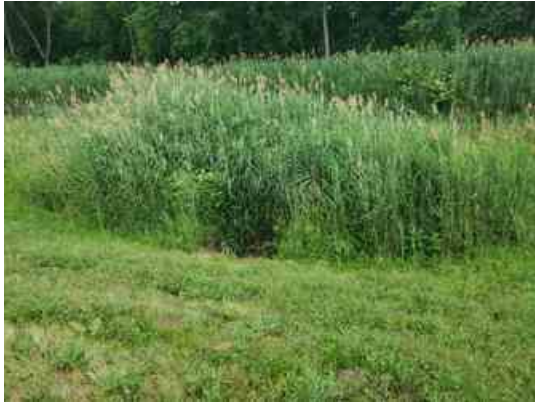
Inspect ID: 2021-0468 Title: 2604000008_CELRC_2021_A_0468_1_20210623T165656.jpg Rated Item: 1. Vegetation and Obstructions Caption: Minimally Acceptable - HA-22: Vegetation around outlet. Clear.

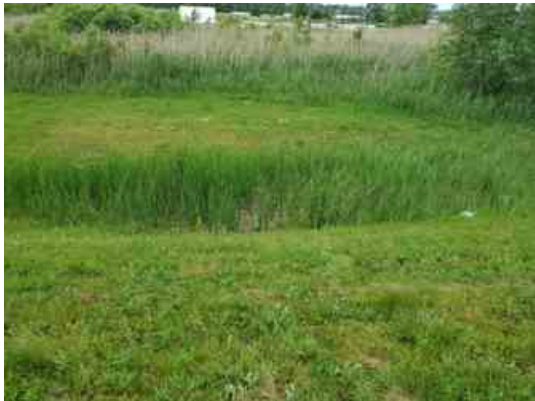
Inspect ID: 2021-0476 Title: 2604000008_CELRC_2021_A_0476_1_20210623T165914.jpg Rated Item: 1. Vegetation and Obstructions Caption: Minimally Acceptable - HA-22: Vegetation around inlet. Clear.

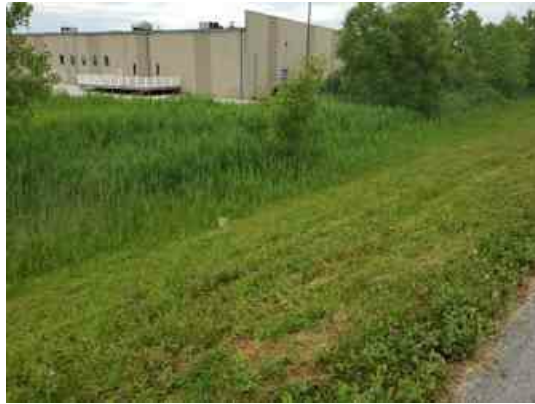
Inspect ID: 2021-0480 **Title:** 2604000008_CELRC_2021_A_0480_1_20210623T170216.jpg **Rated Item:** 1. Vegetation and Obstructions **Caption:** Minimally Acceptable - Trees in ditch.

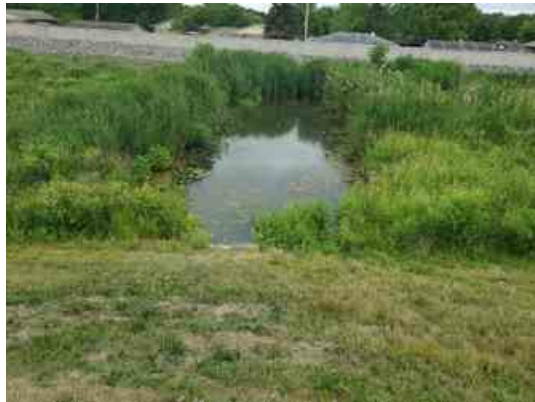
Inspect ID: 2021-0548 **Title:** 2604000008_CELRC_2021_A_0548_1_20210623T174647.jpg **Rated Item:** 1. Vegetation and Obstructions **Caption:** Minimally Acceptable - HA-25: Tall vegetation around the outlet. Clear.

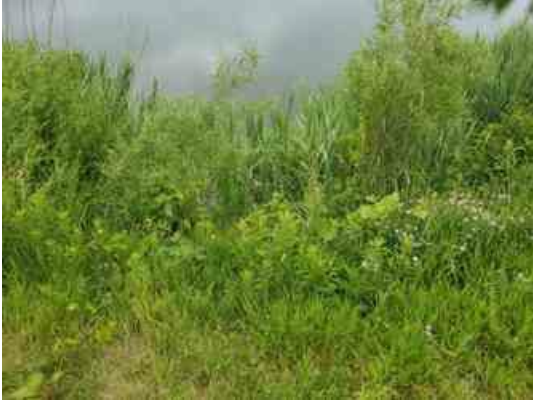
<p>Inspect ID: 2021-0552 Title: 2604000008_CELRC_2021_A_0552_1_20210623T174821.jpg Rated Item: 1. Vegetation and Obstructions Caption: Minimally Acceptable - HA-25: Vegetation around inlet. Clear.</p>

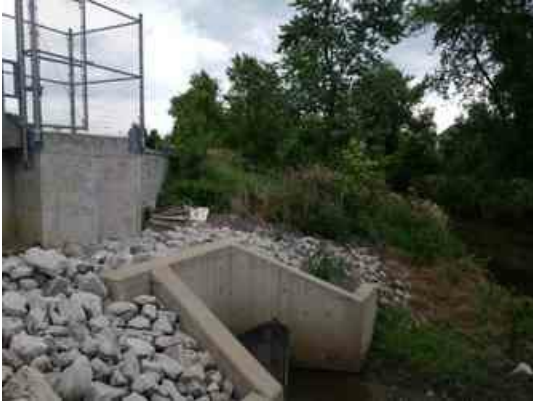
<p>Inspect ID: 2021-0117 Title: 2604000008_CELRC_2021_A_0117_1_20210623T150918.jpg Rated Item: 2. Encroachments Caption: Minimally Acceptable - HA-14: Trash in riprap area. Clean.</p>

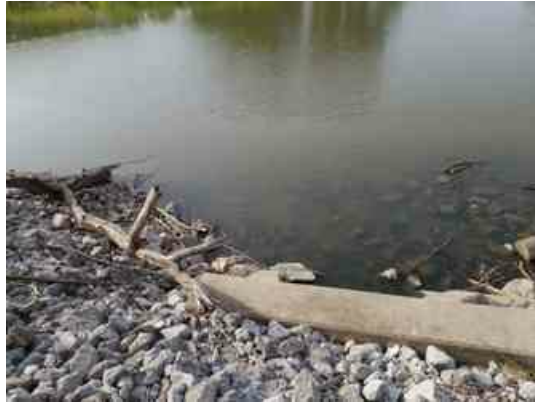
Inspect ID: 2021-0181 **Title:** 2604000008_CELRC_2021_A_0181_1_20210624T130623.jpg **Rated Item:** 2. Encroachments **Caption:** Minimally Acceptable - HA-33: Tree logs on riprap. Clean.

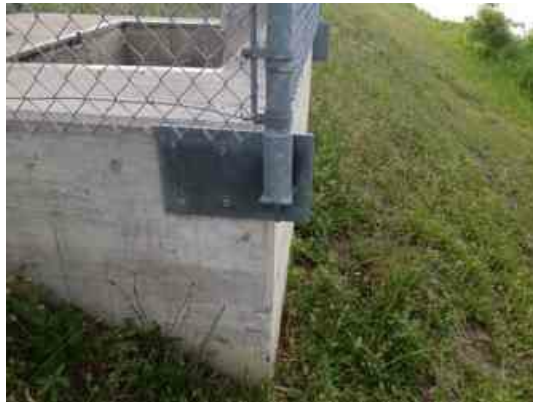
Inspect ID: 2021-0030 **Title:** 2604000008_CELRC_2021_A_0030_1_20210623T140512.jpg **Rated Item:** 4. Fencing and Gates **Caption:** Minimally Acceptable - HA-31: Missing stud and nut for fence.

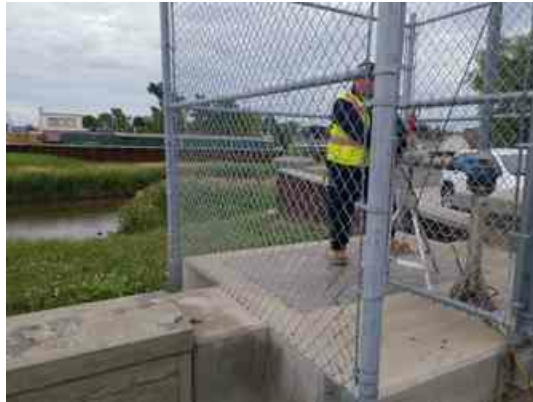
Inspect ID: 2021-0049 **Title:** 2604000008_CELRC_2021_A_0049_1_20210623T141548.jpg **Rated Item:** 4. Fencing and Gates **Caption:** Acceptable - HA-7: The sluice gate fencing is in good condition.

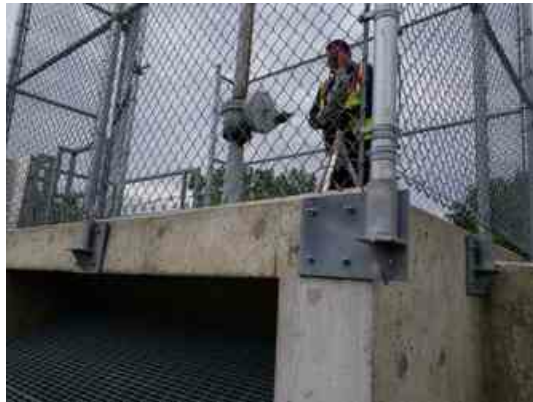
Inspect ID: 2021-0141 **Title:** 2604000008_CELRC_2021_A_0141_1_20210623T161215.jpg **Rated Item:** 4. Fencing and Gates **Caption:** Acceptable - Ha16 The fence is in good condition.

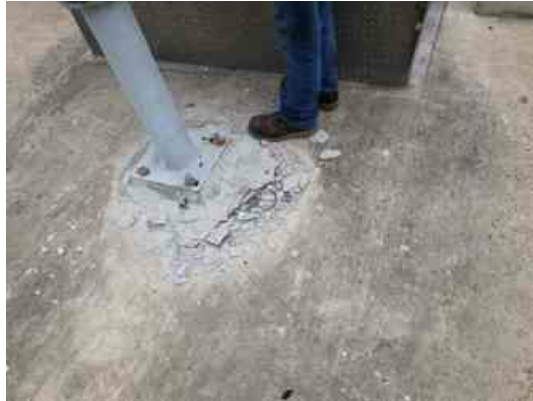
Inspect ID: 2021-0106 **Title:** 2604000008_CELRC_2021_A_0106_1_20210623T161100.jpg **Rated Item:** 5. Concrete Surfaces (Such as gate wells, outfalls, intakes, or culverts) **Caption:** Minimally Acceptable - HA-23: Broken concrete. Patch.

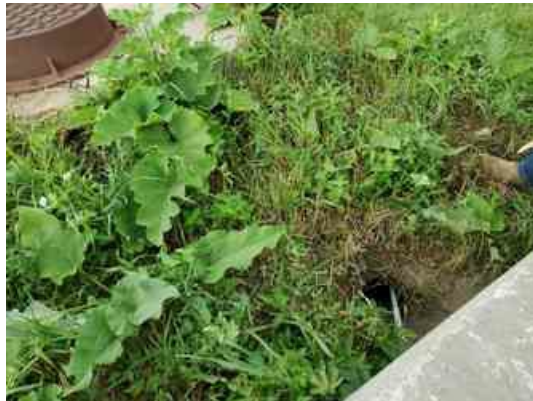
Inspect ID: 2021-0140 **Title:** 2604000008_CELRC_2021_A_0140_1_20210623T135842.jpg **Rated Item:** 7. Foundation of Concrete Structures (Such as culverts, inlet and discharge structures, or gatewells.) **Caption:** Minimally Acceptable - HA-7: 2 large burrows around manhole, deeper than 6 ft. Fill.

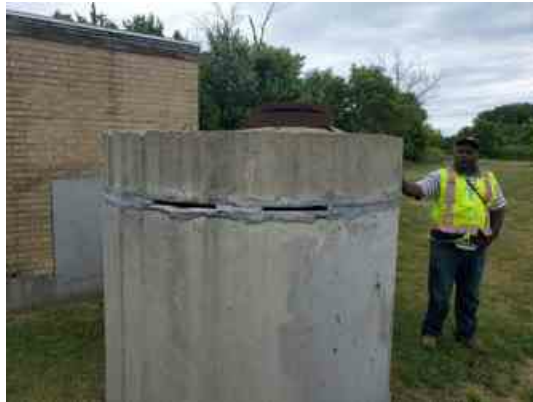
Inspect ID: 2021-0624 **Title:** 2604000008_CELRC_2021_A_0624_1_20210623T190925.jpg **Rated Item:** 8. Monolith Joints **Caption:** Minimally Acceptable - HA-29: Cracking at joint. Not water tight. Remove old caulking and reseal.

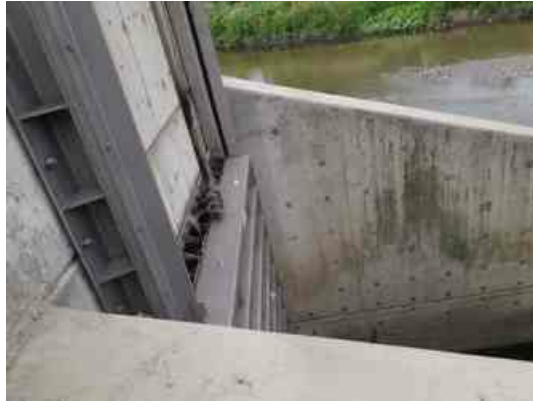
Inspect ID: 2021-0013 **Title:** 2604000008_CELRC_2021_A_0013_1_20210623T132718.jpg **Rated Item:** 10. Sluice/ Slide Gates **Caption:** Acceptable - HA-4: The sluice gate was opened we arrived and we left it open when we left. The gate was able to close completely.

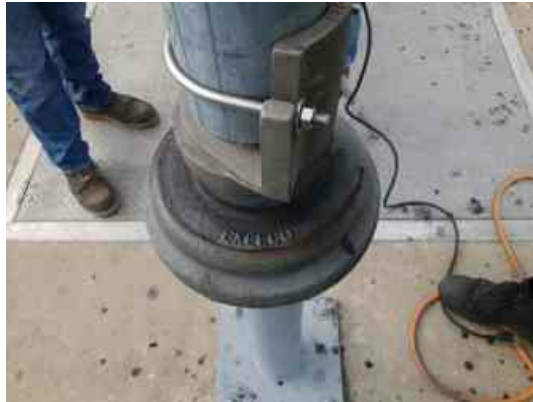
Inspect ID: 2021-0022 **Title:** 2604000008_CELRC_2021_A_0022_1_20210623T134832.jpg **Rated Item:** 10. Sluice/ Slide Gates **Caption:** Minimally Acceptable - HA-35: Lifting mechanism structure cracking, shakes when the gate is near the top. Investigate and repair.

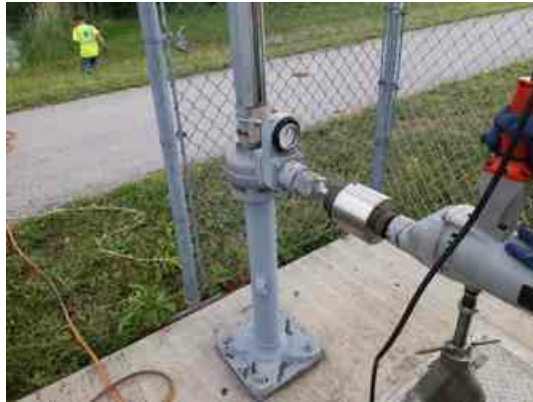
Inspect ID: 2021-0038 **Title:** 2604000008_CELRC_2021_A_0038_1_20210623T140925.jpg **Rated Item:** 10. Sluice/ Slide Gates **Caption:** Minimally Acceptable - HA-31: Gate gauge malfunctioning, gets stuck in the process. Repair.

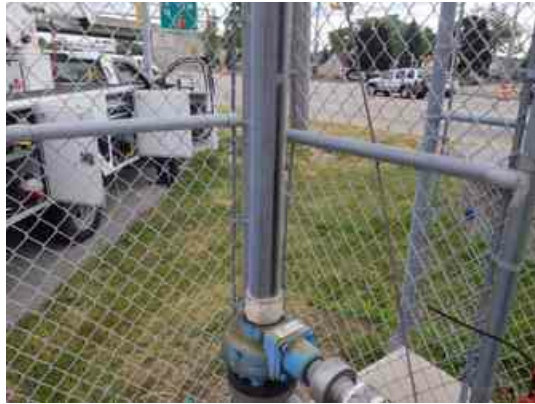
Inspect ID: 2021-0053 **Title:**

Item: 10. Sluice/ Slide Gates **Caption:** Minimally Acceptable - HA-8: The sluice gate pinion in good condition and well greased. The operator greased it the day of. There is some very mild corrosion on the spigot, recommend painting.

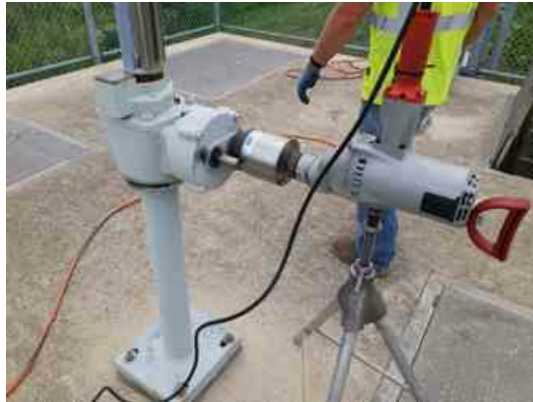
Inspect ID: 2021-0070 **Title:**

2604000008_CELRC_2021_A_0070_1_20210623T150018.jpg **Rated Item:** 10. Sluice/ Slide Gates **Caption:** Minimally Acceptable - HA-26B: Operates without issue. The left gear is seized and cannot open the gate. Repair.

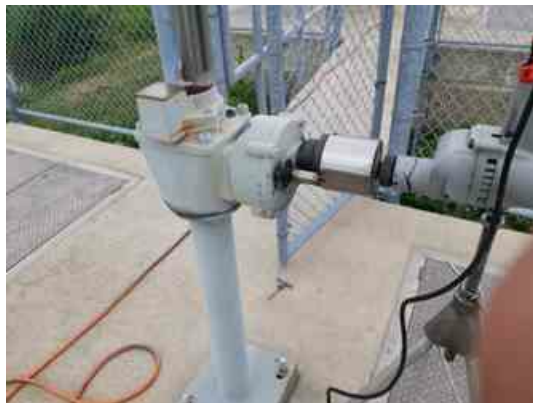
Inspect ID: 2021-0074 **Title:**

2604000008_CELRC_2021_A_0074_3_20210623T151533.jpg **Rated Item:** 10. Sluice/ Slide Gates **Caption:** Acceptable - HA-27a: Operated without issue. A lot of debris on top of the gate, recommend cleaning. The left gear was not able to open the gate, repair.

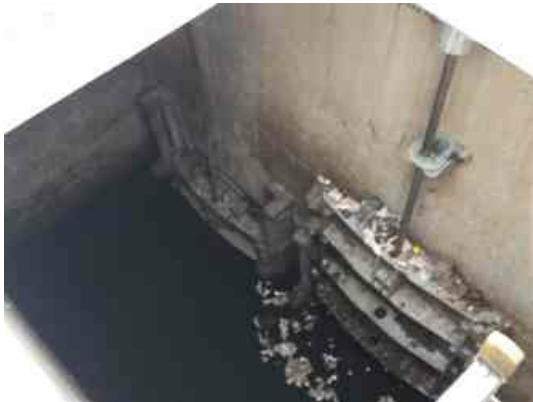
Inspect ID: 2021-0078 **Title:** 2604000008_CELRC_2021_A_0078_1_20210623T152116.jpg **Rated Item:** 10. Sluice/ Slide Gates **Caption:** Acceptable - HA-27b: Operates without issue.

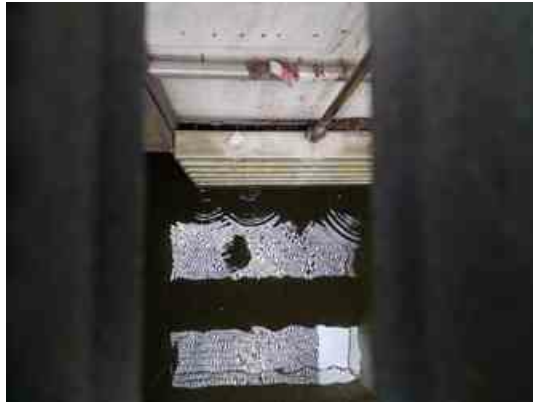
Inspect ID: 2021-0081 **Title:**

2604000008_CELRC_2021_A_0081_1_20210623T144644.jpg **Rated Item:** 10. Sluice/ Slide Gates **Caption:** Minimally Acceptable - HA-12: The sluice gate is in good condition but didn't close all of the way. It was opened when we arrived and we left it open when we left. Remove obstructions.

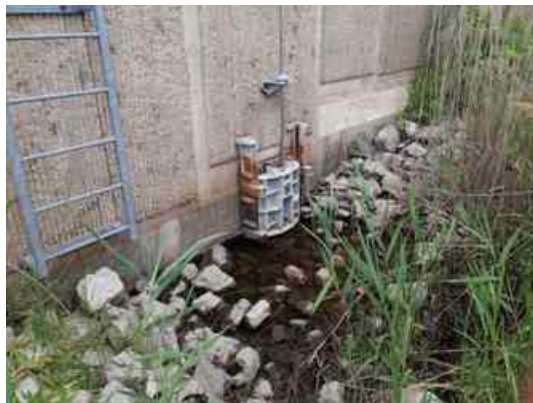
Inspect ID: 2021-0082 **Title:**

2604000008_CELRC_2021_A_0082_2_20210623T153713.jpg **Rated Item:** 10. Sluice/ Slide Gates **Caption:** Acceptable - HA-24: Operates without issue.

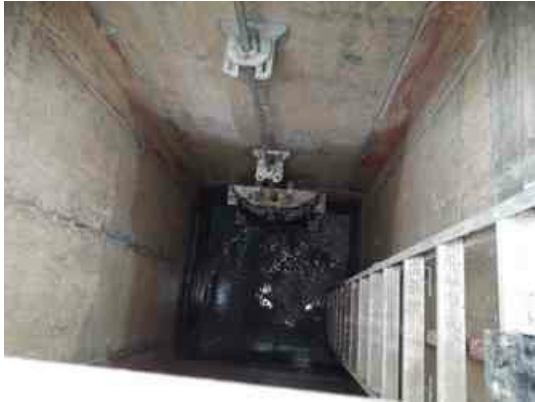
<p>Inspect ID: 2021-0098 Title: 2604000008_CELRC_2021_A_0098_2_20210623T160330.jpg Rated Item: 10. Sluice/ Slide Gates Caption: Minimally Acceptable - HA-23: Gate operates fine, too much silt and some branches inside though. Clean.</p>

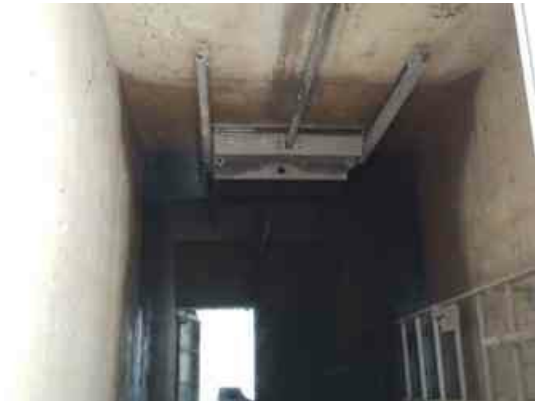
<p>Inspect ID: 2021-0105 Title: _1_20210623T150005.jpg Rated Item: 10. Sluice/ Slide Gates Caption: Acceptable - HA-13: The sluice gate is in good condition. It opened and closed completely. It was opened when we arrived we left it open when we left.</p>

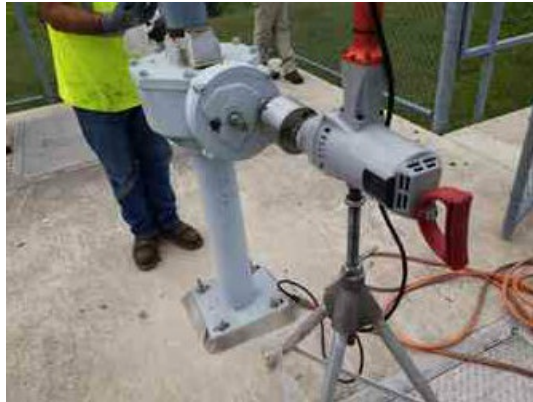
Inspect ID: 2021-0110 **Title:** 2604000008_CELRC_2021_A_0110_3_20210623T161549.jpg **Rated Item:** 10. Sluice/ Slide Gates **Caption:** Acceptable - HA-23a: Operates only using right gear.

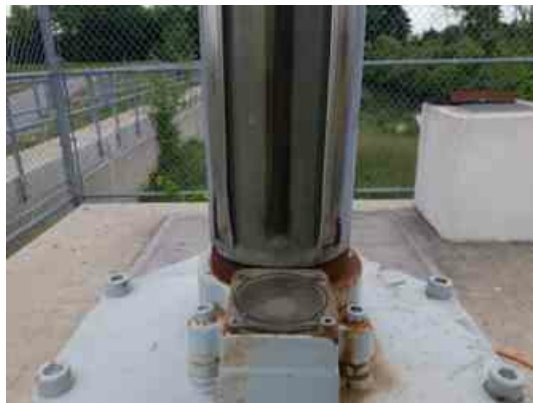
Inspect ID: 2021-0114 **Title:** 2604000008_CELRC_2021_A_0114_2_20210623T170312.jpg **Rated Item:** 10. Sluice/ Slide Gates **Caption:** Minimally Acceptable - HA-21c: Operates on the right gear only. Corrosion at the base. Repaint.

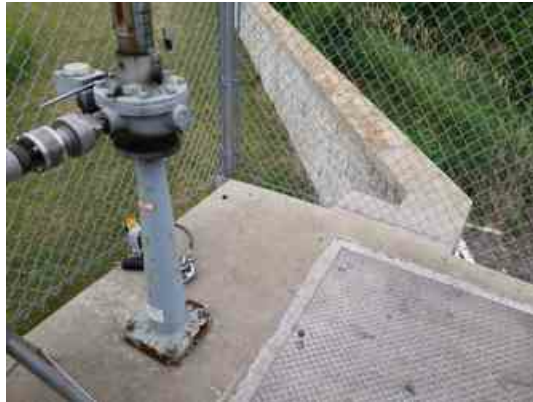
Inspect ID: 2021-0121 **Title:**

2604000008_CELRC_2021_A_0121_1_20210623T151421.jpg **Rated**

Item: 10. Sluice/ Slide Gates **Caption:** Minimally Acceptable - HA-14:

The sluice gate pinion operated good. The crew greased the equipment the day were out there. Slight rusting at base, recommend painting

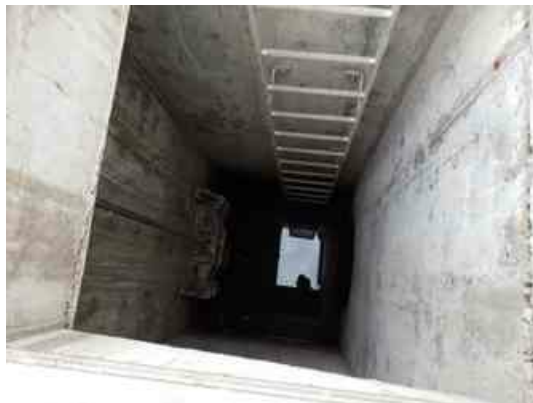
Inspect ID: 2021-0125 **Title:**

2604000008_CELRC_2021_A_0125_1_20210623T153949.jpg **Rated**

gate is in good condition, it was able to close and open completely. It was open when we arrived we left it open when we left

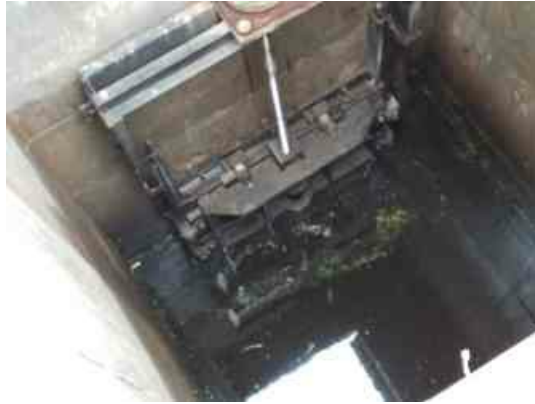
Inspect ID: 2021-0126 **Title:** 2604000008_CELRC_2021_A_0126_2_20210623T180926.jpg **Rated Item:** 10. Sluice/ Slide Gates **Caption:** Acceptable - HA-20: Operates without issue.

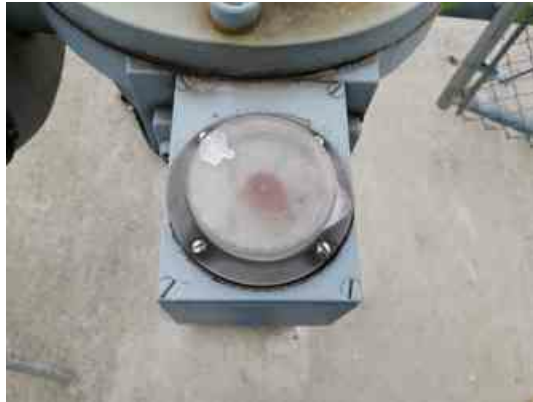
Inspect ID: 2021-0137 **Title:** 2604000008_CELRC_2021_A_0137_1_20210623T160107.jpg **Rated Item:** 10. Sluice/ Slide Gates **Caption:** Minimally Acceptable - HA-15: Gate is hard to see. Replace.

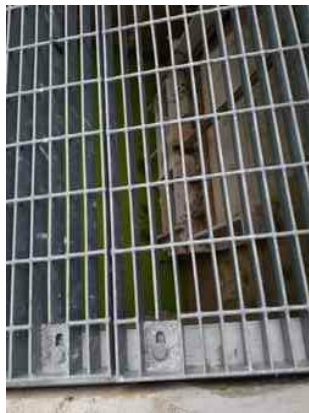
Inspect ID: 2021-0145 **Title:** 2604000008_CELRC_2021_A_2021-0145_1_20210623T162942.jpg **Rated Item:** 10. Sluice/ Slide Gates **Caption:** Minimally Acceptable - HA-16: The sluice gate opens and close fully but there is a lot of resistance. Recommend greasing. There is a lot of sediment in the gate pit. Recommend cleaning. Mild corrosion on the railing. The gate was closed when we arrived we left it closed when we left.

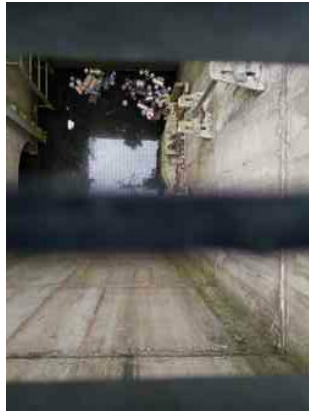
Inspect ID: 2021-0157 **Title:** 2604000008_CELRC_2021_A_0157_1_20210623T164227.jpg **Rated Item:** 10. Sluice/ Slide Gates **Caption:** Minimally Acceptable - HA-17: Sluice gate has minor corrosion but closed and opened completely. There is a lot of trash in the sluice gate pit. Clean and repaint.
