**US Army Corps
of Engineers®**

Levee Inspection Report

Name of System: Hammond

Date(s) of Inspection: 06/23/2021 - 06/24/2021

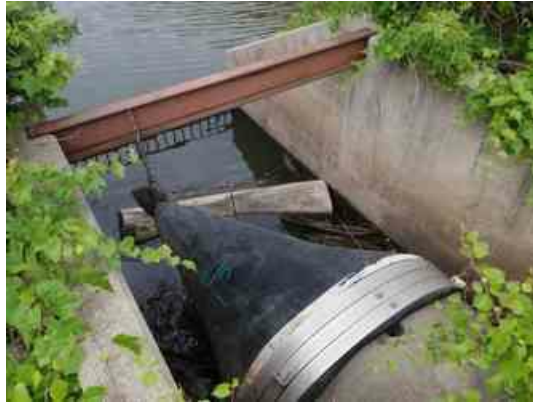
Inspect ID: 2021-0006 **Title:** 2604000008_CELRC_2021_A_0006_1_20210623T132036.jpg **Rated Item:** 11. Flap Gates/ Flap Valves/ Pinch Valves **Caption:** Minimally Acceptable - HA-38. Duckbill is in good condition.

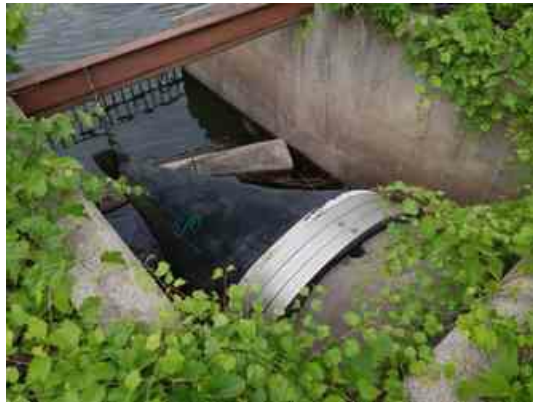
Inspect ID: 2021-0006 **Title:** 2604000008_CELRC_2021_A_0006_2_20210623T132121.jpg **Rated Item:** 11. Flap Gates/ Flap Valves/ Pinch Valves **Caption:** Minimally Acceptable - HA 38. Tree logs and debris at outlet, duckbill is in good condition. Too much vegetation around the concrete structure

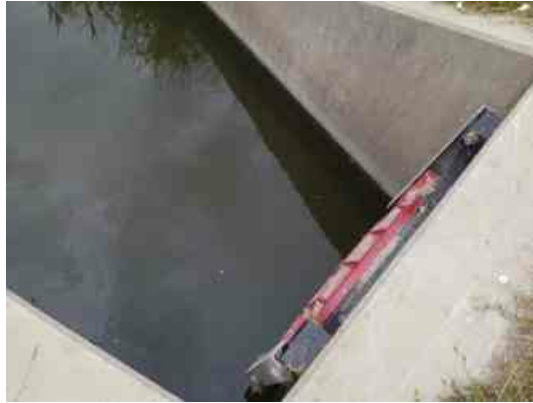
Inspect ID: 2021-0041 **Title:** 2604000008_CELRC_2021_A_0041_1_20210623T141141.jpg **Rated Item:** 11. Flap Gates/ Flap Valves/ Pinch Valves **Caption:** Acceptable - HA-8: The gate closed completely and no obstructions.

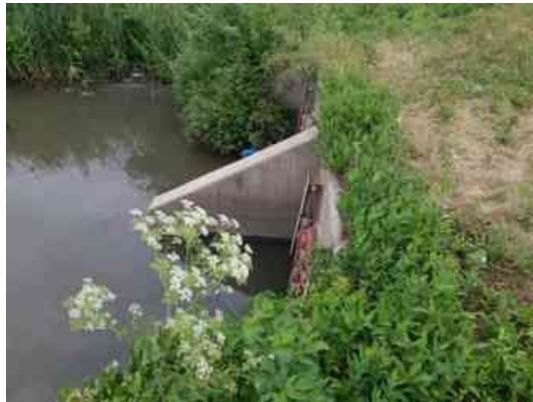
Inspect ID: 2021-0062 **Title:** 2604000008_CELRC_2021_A_0062_1_20210623T144351.jpg **Rated Item:** 11. Flap Gates/ Flap Valves/ Pinch Valves **Caption:** Acceptable - HA-27: Flap gates are closed

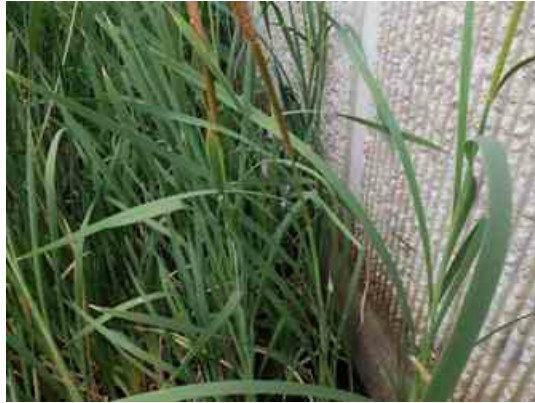
Inspect ID: 2021-0086 **Title:** 2604000008_CELRC_2021_A_0086_1_20210623T153934.jpg **Rated Item:** 11. Flap Gates/ Flap Valves/ Pinch Valves **Caption:** Minimally Acceptable - HA-24: Flap gate has too much vegetation around it. Clear.

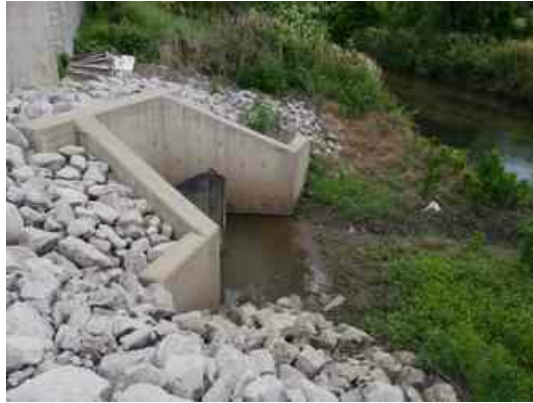
Inspect ID: 2021-0113 **Title:** 2604000008_CELRC_2021_A_0113_1_20210623T150831.jpg **Rated Item:** 11. Flap Gates/ Flap Valves/ Pinch Valves **Caption:** Acceptable - HA-14: Good condition.

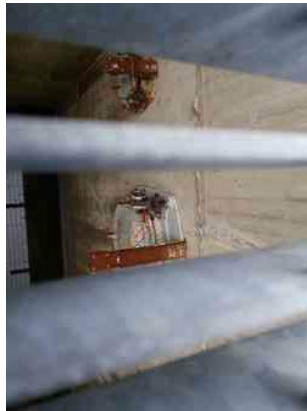
Inspect ID: 2021-0149 **Title:** 2604000008_CELRC_2021_A_0149_1_20210623T163952.jpg **Rated Item:** 11. Flap Gates/ Flap Valves/ Pinch Valves **Caption:** Minimally Acceptable - HA-18a-b: Flap gates are corroded. Recommend painting.

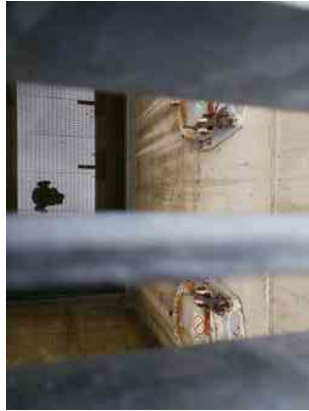
Inspect ID: 2021-0153 **Title:** 2604000008_CELRC_2021_A_0153_1_20210623T164124.jpg **Rated Item:** 11. Flap Gates/ Flap Valves/ Pinch Valves **Caption:** Minimally Acceptable - HA-18c-d: Flap gates are corroded. Recommend painting.

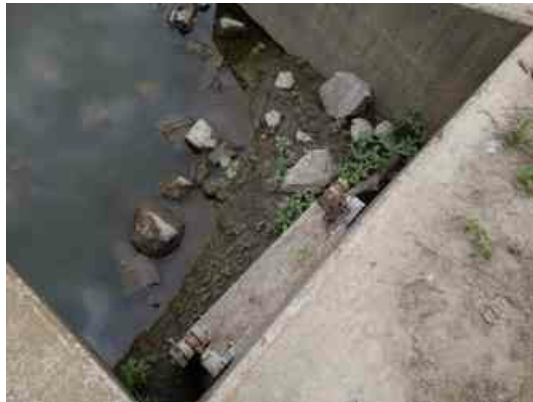
Inspect ID: 2021-0165 **Title:** 2604000008_CELRC_2021_A_0165_1_20210623T164650.jpg **Rated Item:** 11. Flap Gates/ Flap Valves/ Pinch Valves **Caption:** Minimally Acceptable - HA-17: Flap gate is closed but there is sediment and rocks blocking and preventing from opening. Clear obstructions.

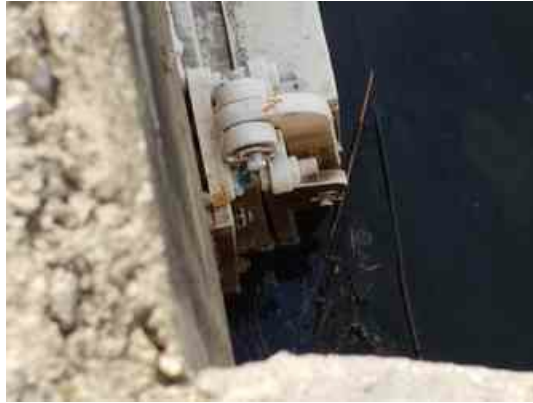
Inspect ID: 2021-0185 **Title:** 2604000008_CELRC_2021_A_0185_1_20210624T130702.jpg **Rated Item:** 11. Flap Gates/ Flap Valves/ Pinch Valves **Caption:** Minimally Acceptable - HA-33: Flap gate open. Clear.

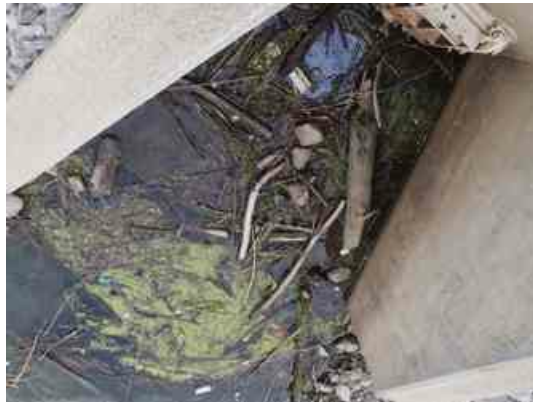
Inspect ID: 2021-0233 **Title:** 2604000008_CELRC_2021_A_0233_1_20210624T132001.jpg **Rated Item:** 11. Flap Gates/ Flap Valves/ Pinch Valves **Caption:** Minimally Acceptable - HA-34: Logs and debris obstructing the outlet. Clear.

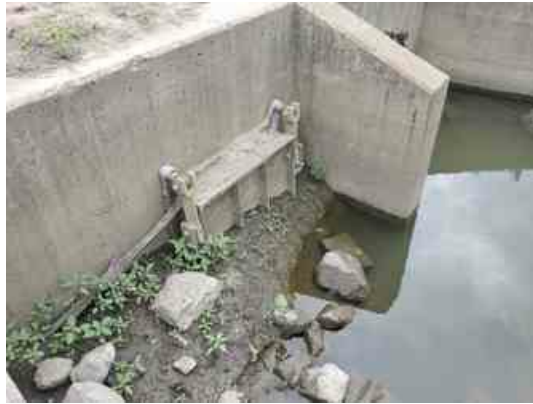
Inspect ID: 2021-0368 **Title:**
2604000008_CELRC_2021_A_0368_1_20210623T155849.jpg **Rated**
Item: 11. Flap Gates/ Flap Valves/ Pinch Valves **Caption:** Minimally
Acceptable - HA-17: Covered in sediment. Clear.

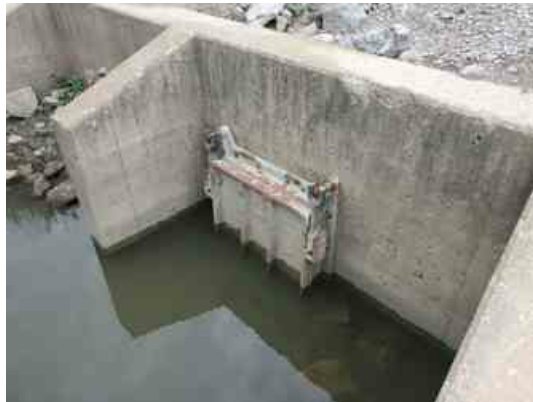
Inspect ID: 2021-0372 **Title:**
2604000008_CELRC_2021_A_0372_1_20210623T155942.jpg **Rated**
Item: 11. Flap Gates/ Flap Valves/ Pinch Valves **Caption:** Acceptable -
HA-18: Closed.

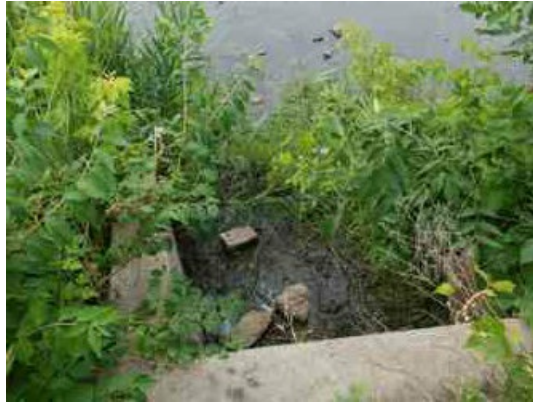
Inspect ID: 2021-0381 **Title:** 2604000008_CELRC_2021_A_0381_1_20210624T135959.jpg **Rated Item:** 11. Flap Gates/ Flap Valves/ Pinch Valves **Caption:** Minimally Acceptable - HA-36: Flap gate not shut all the way, rocks, tree logs and vegetation obstructing the outlet. Clear.

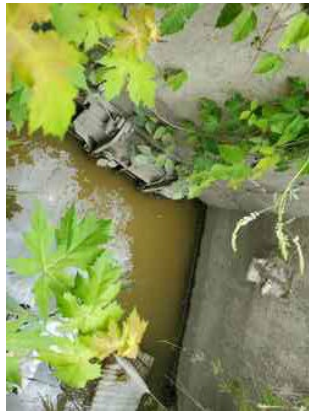
Inspect ID: 2021-0416 **Title:** 2604000008_CELRC_2021_A_0416_1_20210623T162040.jpg **Rated Item:** 11. Flap Gates/ Flap Valves/ Pinch Valves **Caption:** Acceptable - HA-19. Closed.

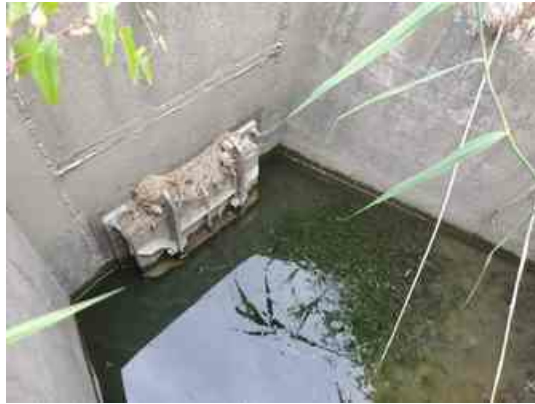
Inspect ID: 2021-0472 **Title:** 2604000008_CELRC_2021_A_0472_1_20210623T165749.jpg **Rated Item:** 11. Flap Gates/ Flap Valves/ Pinch Valves **Caption:** Acceptable - HA-22: Closed.

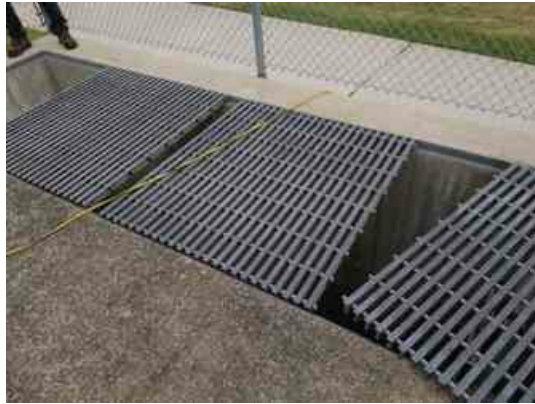
Inspect ID: 2021-0073 **Title:**

2604000008_CELRC_2021_A_0073_1_20210623T144008.jpg **Rated**

Item: 13. Other Metallic Items **Caption:** Minimally Acceptable - HA-12: One of the metal coverings is missing. It appears as if it may have fell through. Replace.

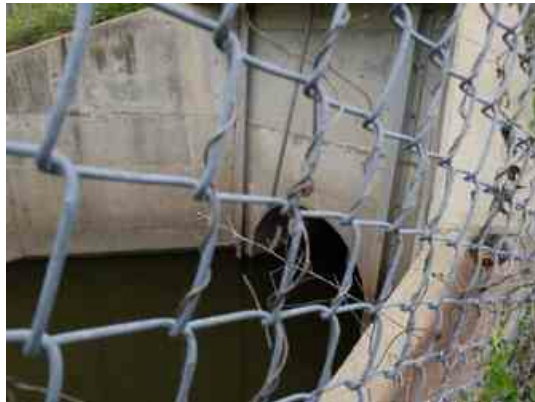
Inspect ID: 2021-0085 **Title:**

2604000008_CELRC_2021_A_0085_1_20210623T145246.jpg **Rated**

Item: 13. Other Metallic Items **Caption:** Unacceptable - HA-12: Screen is broken and needs to be replaced.

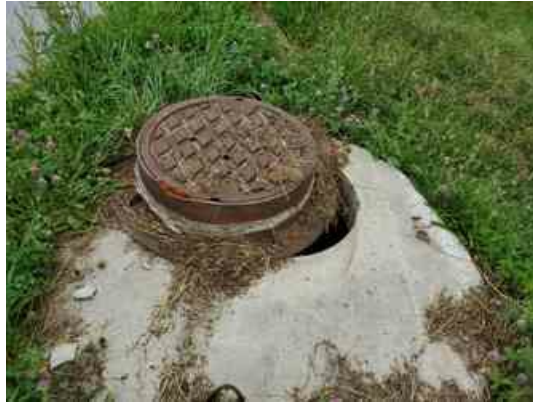
Inspect ID: 2021-0176 **Title:** 2604000008_CELRC_2021_A_0176_1_20210623T142600.jpg **Rated Item:** 13. Other Metallic Items **Caption:** Minimally Acceptable - HA-11: Manhole cover offset. Move.

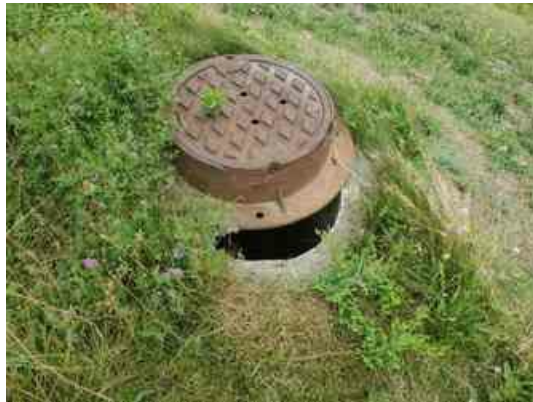
Inspect ID: 2021-0540 **Title:** 2604000008_CELRC_2021_A_0540_1_20210623T174310.jpg **Rated Item:** 13. Other Metallic Items **Caption:** Minimally Acceptable - HA-25: Manhole is offset. Move.

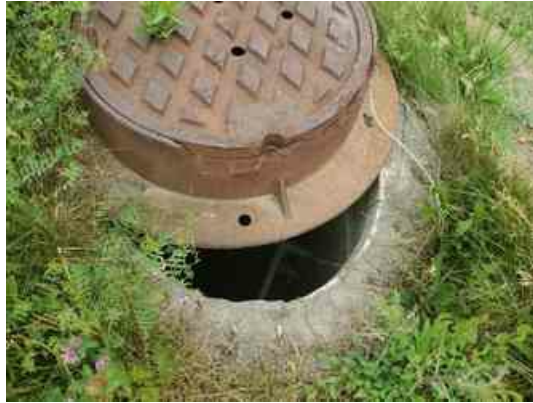
Inspect ID: 2021-0544 **Title:** 2604000008_CELRC_2021_A_0544_1_20210623T174526.jpg **Rated Item:** 13. Other Metallic Items **Caption:** Minimally Acceptable - HA-25: Manhole cover is chipping. Replace.

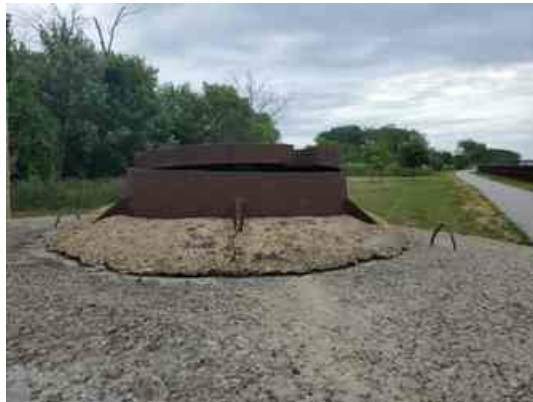
Inspect ID: 2021-0628 **Title:** 2604000008_CELRC_2021_A_0628_1_20210623T191011.jpg **Rated Item:** 13. Other Metallic Items **Caption:** Minimally Acceptable - HA-29: Manhole lid open and cracking on attached concrete. Repair.

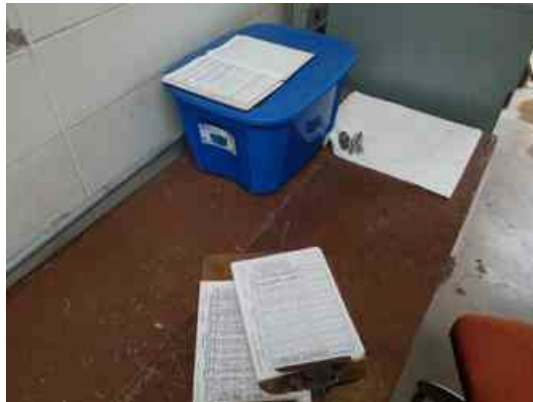
Inspect ID: 2021-0019 **Title:** 2604000008_CELRC_2021_A_0019_1_20210621T154039.jpg **Rated Item:** 2. Pump Station Operations and Maintenance Equipment Manuals **Caption:** Acceptable - PS-JA: Operations manuals on site.

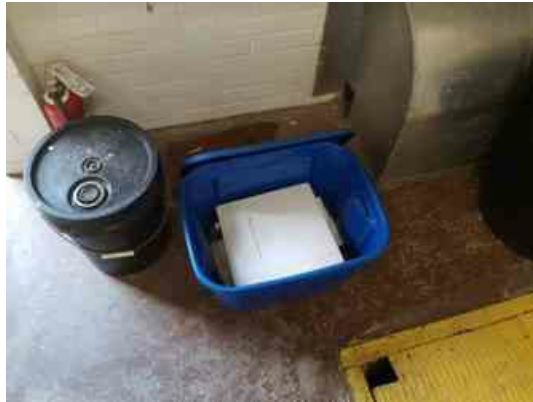
Inspect ID: 2021-0047 **Title:** 2604000008_CELRC_2021_A_0047_1_20210621T160438.jpg **Rated Item:** 2. Pump Station Operations and Maintenance Equipment Manuals **Caption:** Acceptable - PS-TA: Operations manuals on site.

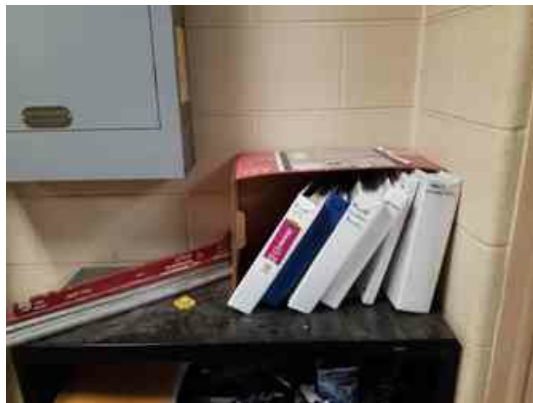
Inspect ID: 2021-0079 **Title:** 2604000008_CELRC_2021_A_0079_2_20210621T163213.jpg **Rated Item:** 2. Pump Station Operations and Maintenance Equipment Manuals **Caption:** Acceptable - PS-SS: Operations manuals on site.

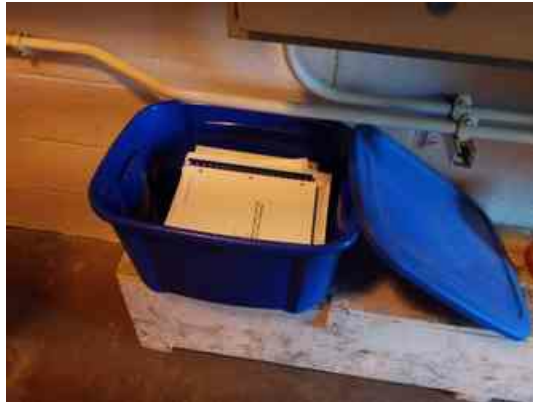
Inspect ID: 2021-0111 **Title:** 2604000008_CELRC_2021_A_0111_1_20210621T165652.jpg **Rated Item:** 2. Pump Station Operations and Maintenance Equipment Manuals **Caption:** Acceptable - PS-WA: Operations manuals on site.

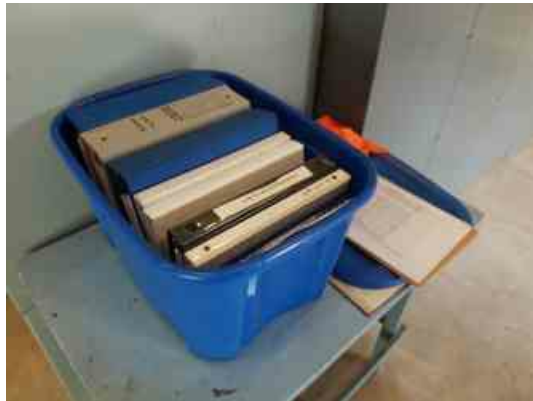
Inspect ID: 2021-0123 **Title:** 2604000008_CELRC_2021_A_2021-0123_1_20210623T135242.jpg **Rated Item:** 2. Pump Station Operations and Maintenance Equipment Manuals **Caption:** Acceptable - PS-CA: Operations manuals on site.

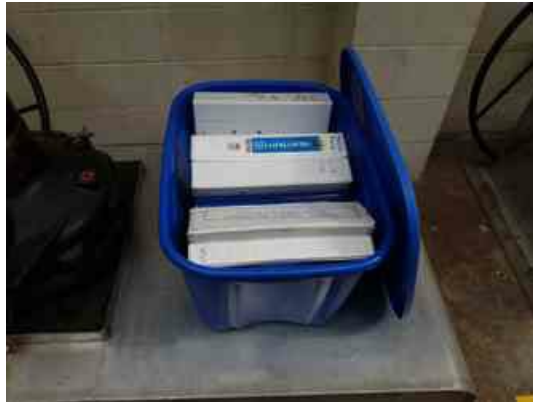
Inspect ID: 2021-0143 **Title:** 2604000008_CELRC_2021_A_0143_1_20210623T142646.jpg **Rated Item:** 2. Pump Station Operations and Maintenance Equipment Manuals **Caption:** Acceptable - PS-IN: Operations manual on site.

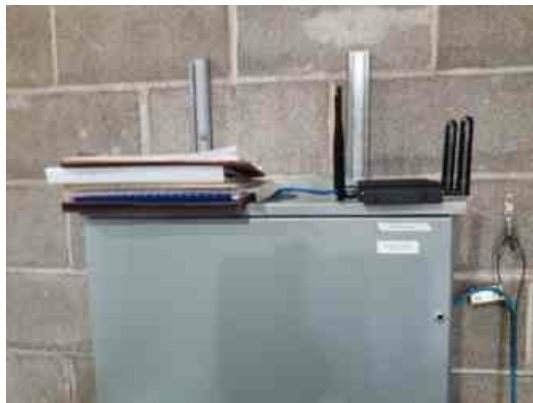
Inspect ID: 2021-0163 **Title:** 2604000008_CELRC_2021_A_0163_1_20210623T144921.jpg **Rated Item:** 2. Pump Station Operations and Maintenance Equipment Manuals **Caption:** Acceptable - PS-KA: Operations manuals on site.

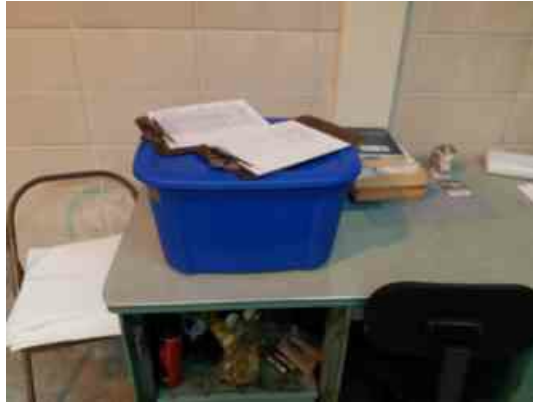
Inspect ID: 2021-0179 **Title:** 2604000008_CELRC_2021_A_0179_1_20210623T150523.jpg **Rated Item:** 2. Pump Station Operations and Maintenance Equipment Manuals
Caption: Acceptable - PS-HV: Operations manual on site.

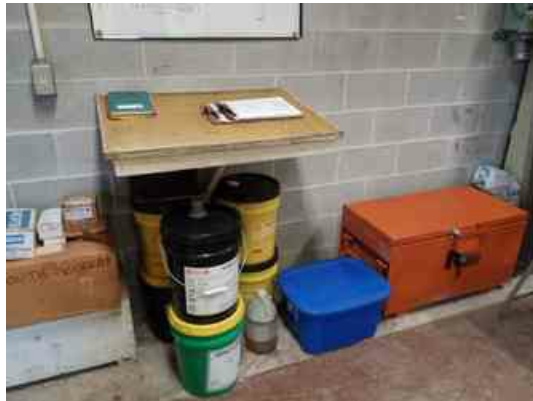
Inspect ID: 2021-0227 **Title:** 2604000008_CELRC_2021_A_0227_1_20210623T154316.jpg **Rated Item:** 2. Pump Station Operations and Maintenance Equipment Manuals
Caption: Acceptable - PS-SK: Operations manual on site.

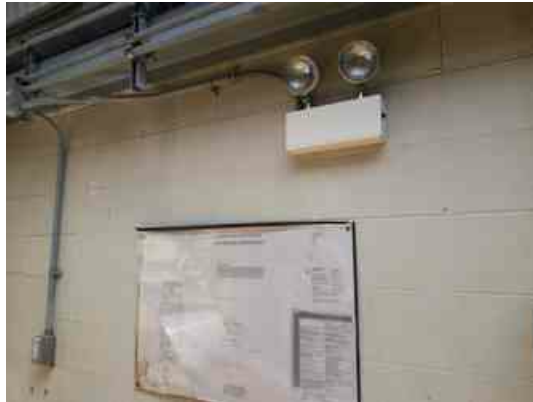
Inspect ID: 2021-0015 **Title:** 2604000008_CELRC_2021_A_0015_1_20210621T153906.jpg **Rated Item:** 3. Safety Compliance **Caption:** Minimally Acceptable - PS-JA: Fire safety exit light not functioning. Repair.

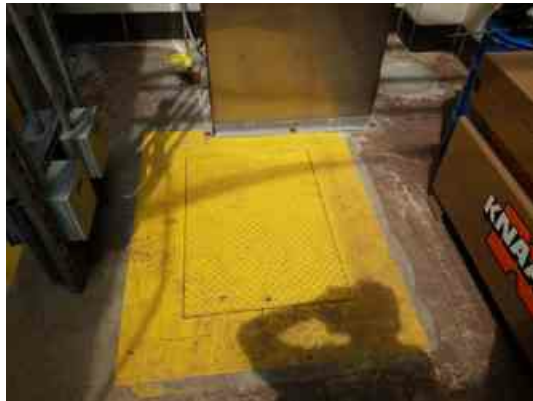
Inspect ID: 2021-0027 **Title:** 2604000008_CELRC_2021_A_0027_1_20210621T154620.jpg **Rated Item:** 3. Safety Compliance **Caption:** Minimally Acceptable - PS-JA: Confined space warning needed near E5 exhaust fan.

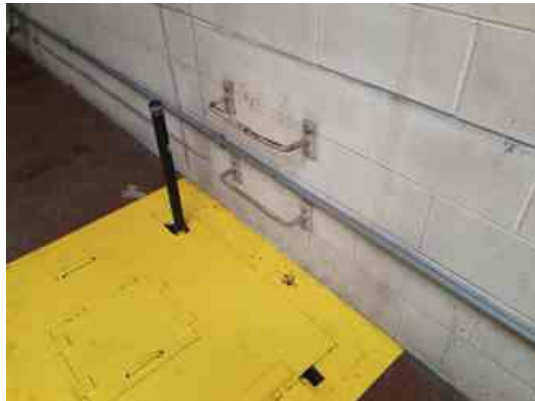
Inspect ID: 2021-0151 **Title:** 2604000008_CELRC_2021_A_0151_1_20210623T143053.jpg **Rated Item:** 3. Safety Compliance **Caption:** Minimally Acceptable - PS-IN: Confined space label needed.

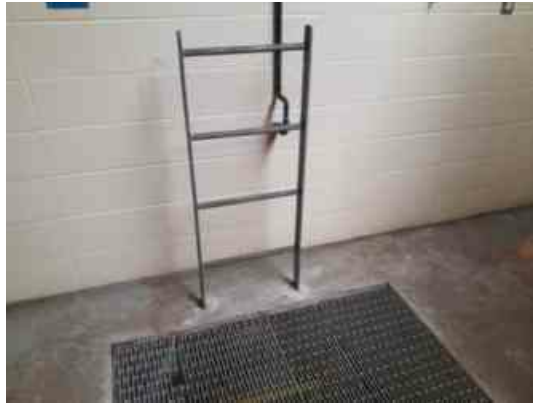
Inspect ID: 2021-0183 **Title:** 2604000008_CELRC_2021_A_0183_1_20210623T150618.jpg **Rated Item:** 3. Safety Compliance **Caption:** Minimally Acceptable - S-HV: Confined space label needed.

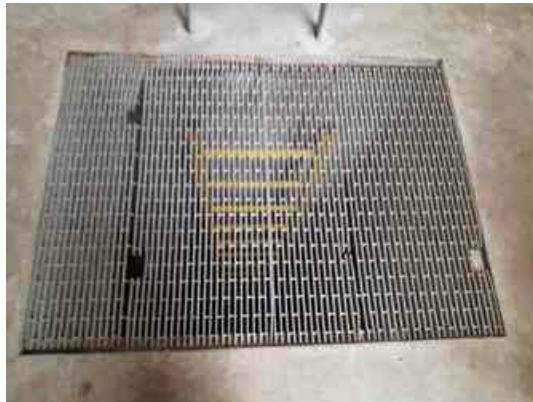
Inspect ID: 2021-0187 **Title:** 2604000008_CELRC_2021_A_0187_1_20210623T150724.jpg **Rated Item:** 3. Safety Compliance **Caption:** Minimally Acceptable - PS-HV: Clips to secure grate from slip and fall hazard recommended.

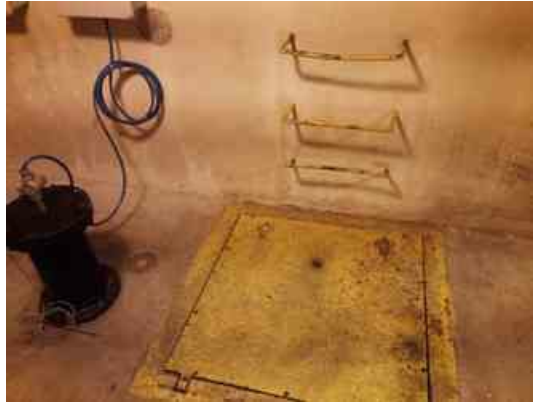
Inspect ID: 2021-0195 **Title:** 2604000008_CELRC_2021_A_0195_1_20210623T151030.jpg **Rated Item:** 3. Safety Compliance **Caption:** Minimally Acceptable - PS-HV: Confined space label needed.

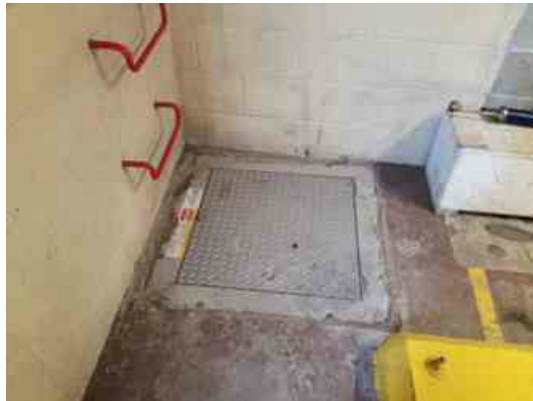
Inspect ID: 2021-0215 **Title:** 2604000008_CELRC_2021_A_0215_1_20210623T153725.jpg **Rated Item:** 3. Safety Compliance **Caption:** Minimally Acceptable - PS-SK: Confined space label needed.

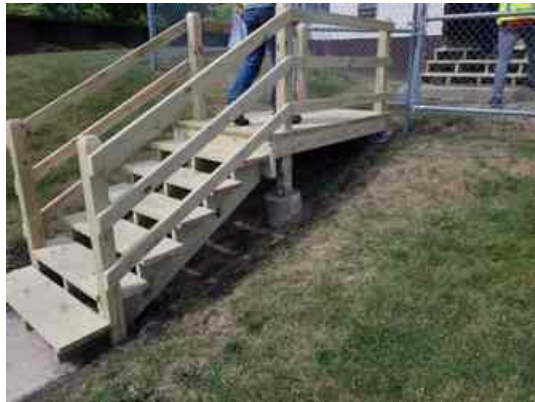
Inspect ID: 2021-0031 **Title:** 2604000008_CELRC_2021_A_0031_1_20210621T155652.jpg **Rated Item:** 5. Plant Building **Caption:** Acceptable - PS-TA: Stairs to pump station replaced, in great condition.

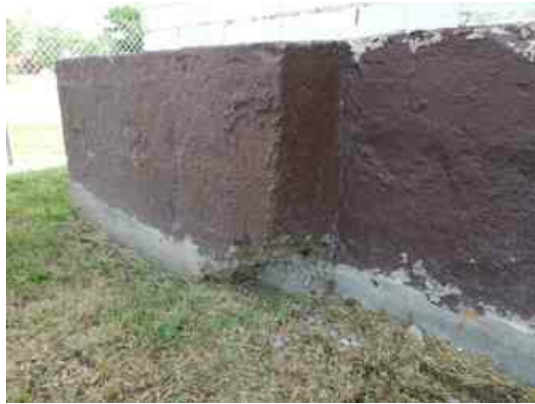
Inspect ID: 2021-0035 **Title:** 2604000008_CELRC_2021_A_0035_1_20210621T155825.jpg **Rated Item:** 5. Plant Building **Caption:** Minimally Acceptable - PS-TA: Minor spalling on underside of foundation at ground level. Patch.

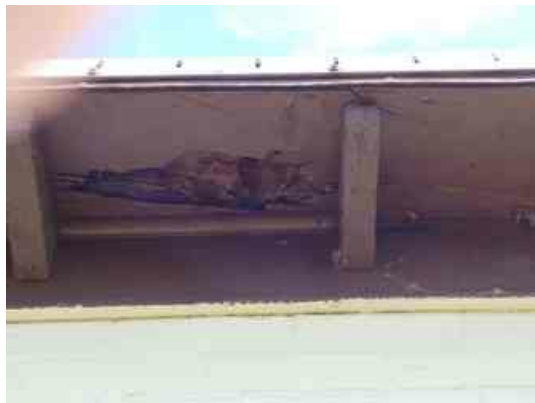
Inspect ID: 2021-0039 **Title:** 2604000008_CELRC_2021_A_0039_1_20210621T160001.jpg **Rated Item:** 5. Plant Building **Caption:** Minimally Acceptable - PS-TA: Rotting on eaves. Repair or replace.

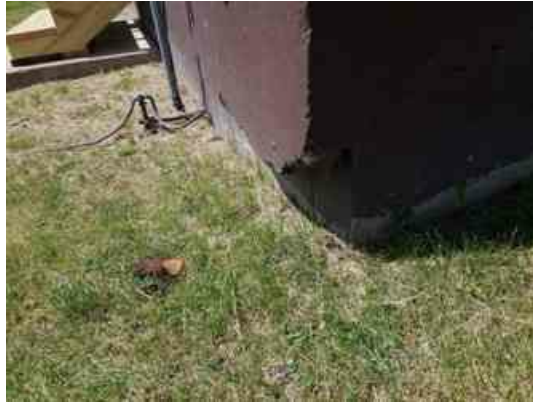
Inspect ID: 2021-0043 **Title:** 2604000008_CELRC_2021_A_0043_1_20210621T160259.jpg **Rated Item:** 5. Plant Building **Caption:** Minimally Acceptable - PS-TA: Lost concrete on corner of building. No damage ongoing. Repair.

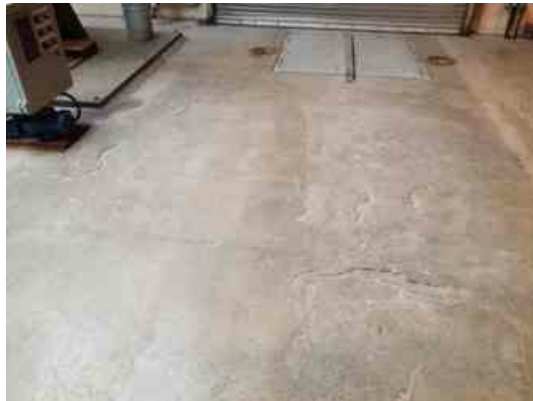
Inspect ID: 2021-0051 **Title:** 2604000008_CELRC_2021_A_0051_1_20210621T161615.jpg **Rated Item:** 5. Plant Building **Caption:** Minimally Acceptable - PS-SS: Minor spalling on concrete floor. Patch.

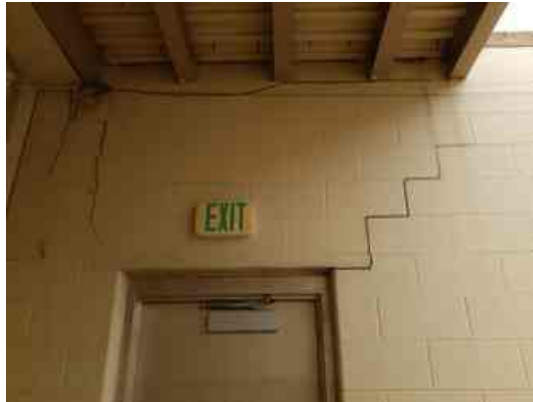
Inspect ID: 2021-0059 **Title:** 2604000008_CELRC_2021_A_0059_1_20210621T162144.jpg **Rated Item:** 5. Plant Building **Caption:** Acceptable - PS-SS: Crack near door frame to roof. Monitor as needed

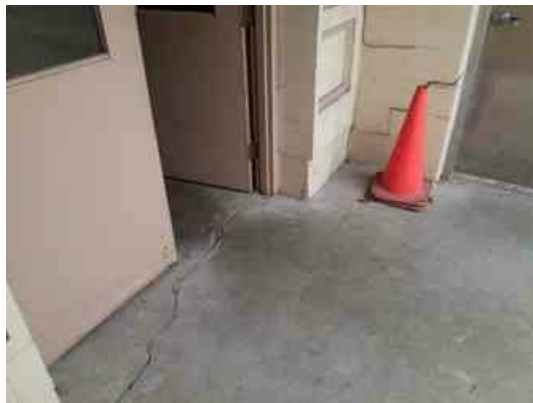
Inspect ID: 2021-0075 **Title:** 2604000008_CELRC_2021_A_0075_1_20210621T162949.jpg **Rated Item:** 5. Plant Building **Caption:** Minimally Acceptable - PS-SS: Crack in floor near sanitary district side of building. Crack extends up to door frame. Inspect for structural causes.

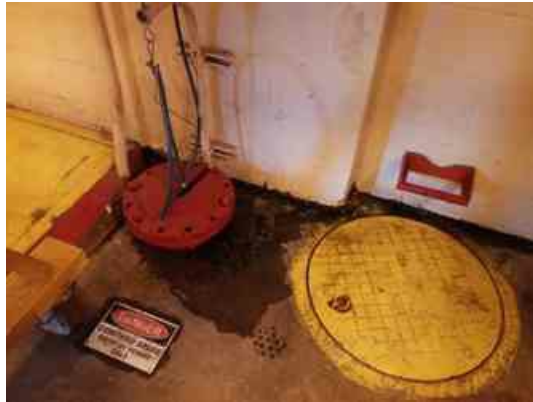
Inspect ID: 2021-0103 **Title:** 2604000008_CELRC_2021_A_0103_1_20210621T165439.jpg **Rated Item:** 5. Plant Building **Caption:** Minimally Acceptable - PS-WA: Mold growth not likely to be coming from roof. Investigate leak.

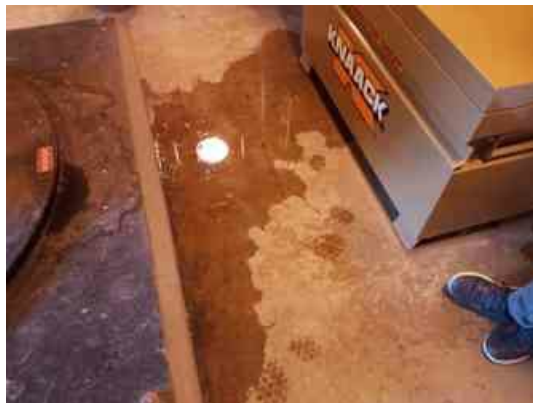
Inspect ID: 2021-0107 **Title:** 2604000008_CELRC_2021_A_0107_1_20210621T165606.jpg **Rated Item:** 5. Plant Building **Caption:** Minimally Acceptable - PS-WA: Investigate water leak in main pump room

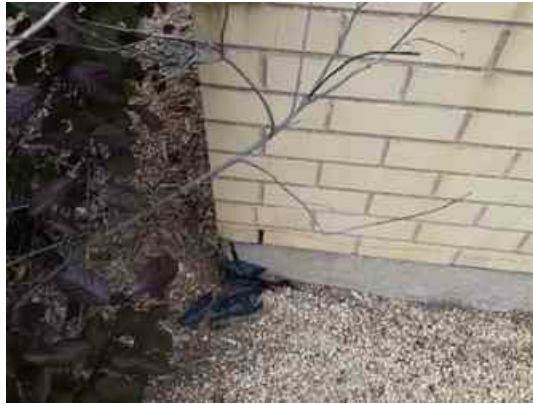
Inspect ID: 2021-0131 **Title:** 2604000008_CELRC_2021_A_0131_1_20210623T141207.jpg **Rated Item:** 5. Plant Building **Caption:** Acceptable - PS-IN: Minor cracking near foundation. Monitor and repair as needed.

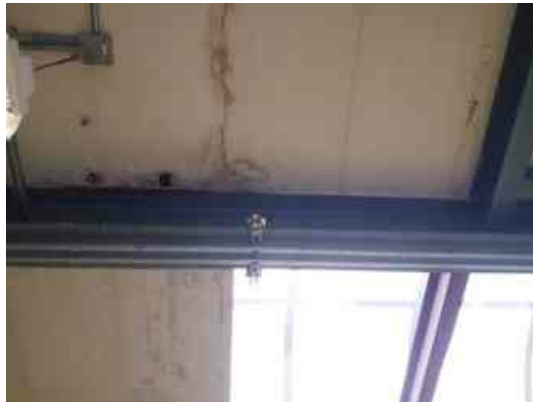
Inspect ID: 2021-0147 **Title:** 2604000008_CELRC_2021_A_0147_1_20210623T142857.jpg **Rated Item:** 5. Plant Building **Caption:** Minimally Acceptable - PS-IN: Minor corrosion in ceiling. Clean.

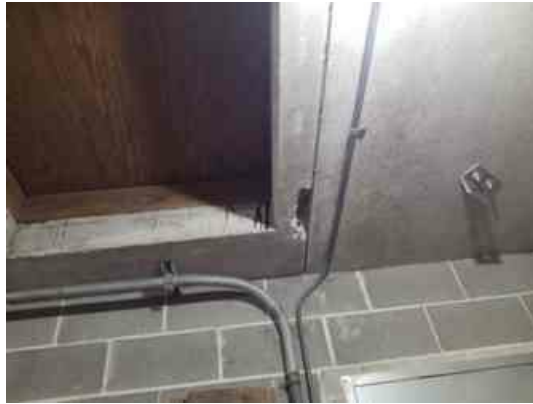
Inspect ID: 2021-0155 **Title:** 2604000008_CELRC_2021_A_0155_1_20210623T144648.jpg **Rated Item:** 5. Plant Building **Caption:** Minimally Acceptable - PS-KA: Minor spalling on ceiling. Repair.

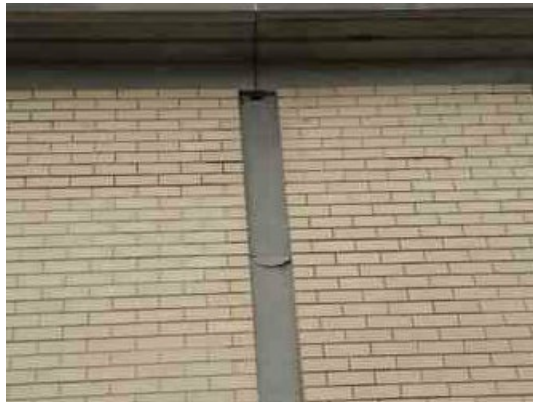
Inspect ID: 2021-0167 **Title:** 2604000008_CELRC_2021_A_0167_1_20210623T145621.jpg **Rated Item:** 5. Plant Building **Caption:** Minimally Acceptable - PS-HV: Minor concrete spalling along exterior. Repair.

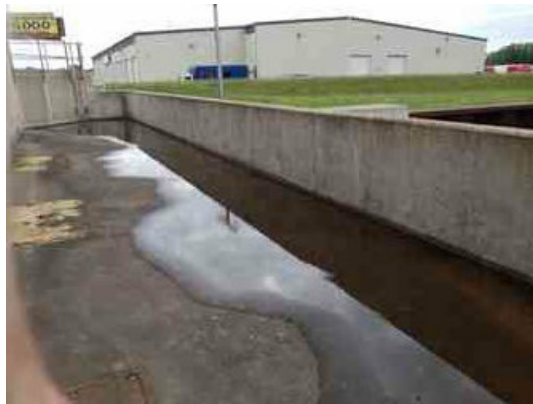
Inspect ID: 2021-0171 **Title:** 2604000008_CELRC_2021_A_0171_1_20210623T150001.jpg **Rated Item:** 5. Plant Building **Caption:** Minimally Acceptable - PS-HV: Ponding water could crack concrete during winter months. Drain.

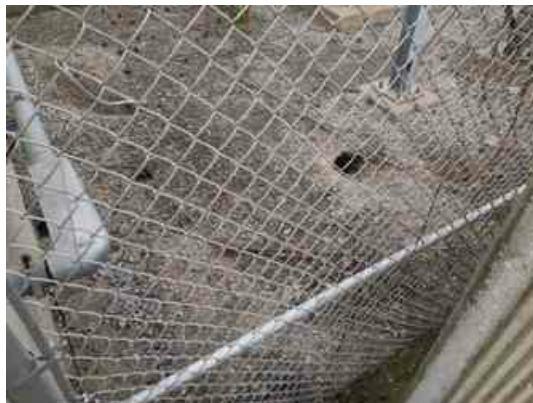
Inspect ID: 2021-0175 **Title:** 2604000008_CELRC_2021_A_0175_1_20210623T150222.jpg **Rated Item:** 5. Plant Building **Caption:** Minimally Acceptable - PS-HV: Multiple (at least 4 visible) large animal burrows in power station area. Backfill with compacted clay

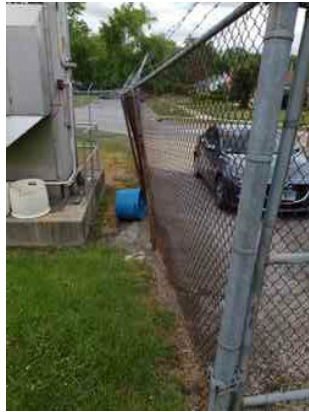
Inspect ID: 2021-0091 **Title:** 2604000008_CELRC_2021_A_0091_1_20210621T164909.jpg **Rated Item:** 6. Fencing and Gates **Caption:** Minimally Acceptable - PS-WA: Fence is collapsing due to rusted pipes. Replace.

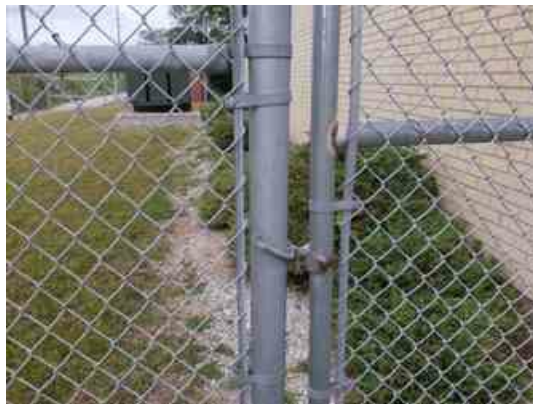
Inspect ID: 2021-0135 **Title:** 2604000008_CELRC_2021_A_0135_1_20210623T141443.jpg **Rated Item:** 6. Fencing and Gates **Caption:** Minimally Acceptable - PS-IN: Gate fence found without lock, leaving pump station perimeter accessible. Place lock on gate to secure.

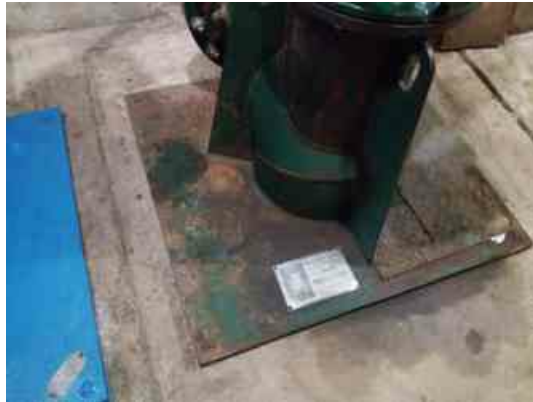
Inspect ID: 2021-0159 **Title:** 2604000008_CELRC_2021_A_0159_1_20210623T144751.jpg **Rated Item:** 7. Pumps **Caption:** Minimally Acceptable - PS-KA: Corrosion on pump base and pump 2. Recommend repainting.

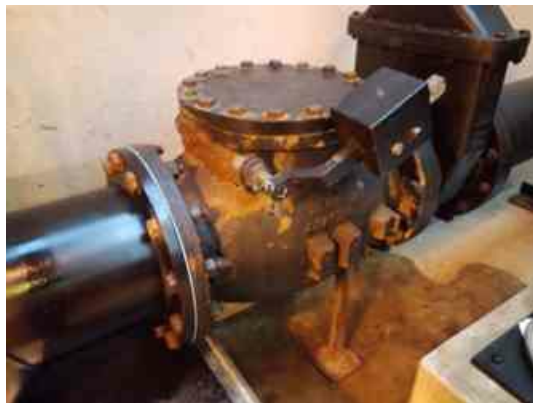
Inspect ID: 2021-0199 **Title:** 2604000008_CELRC_2021_A_0199_1_20210623T151147.jpg **Rated Item:** 7. Pumps **Caption:** Minimally Acceptable - PS-HV: DWP excessive corrosion on pump. Recommend repainting

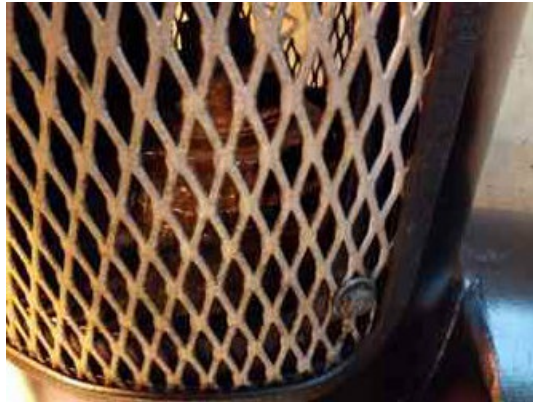
Inspect ID: 2021-0203 **Title:** 2604000008_CELRC_2021_A_0203_1_20210623T151429.jpg **Rated Item:** 7. Pumps **Caption:** Minimally Acceptable - PS-HV: Leakage in shaft impeller system of DWP. Repair.

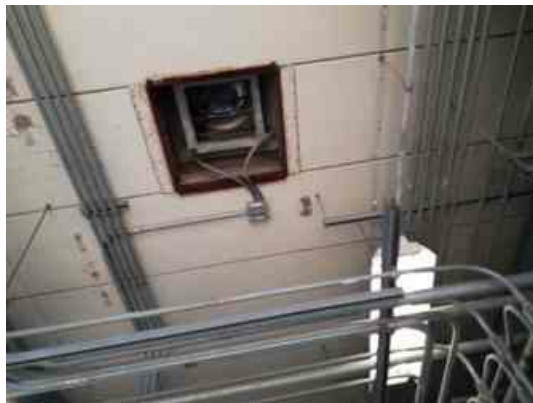
Inspect ID: 2021-0023 **Title:** 2604000008_CELRC_2021_A_0023_1_20210621T154305.jpg **Rated Item:** 8. Motors, Engines, Fans, Gear Reducers, Back Stop Devices, etc. **Caption:** Minimally Acceptable - PS-JA: Exhaust fans EF1 and EF2 not operating correctly. Motor runs but blades do not turn. Repair.

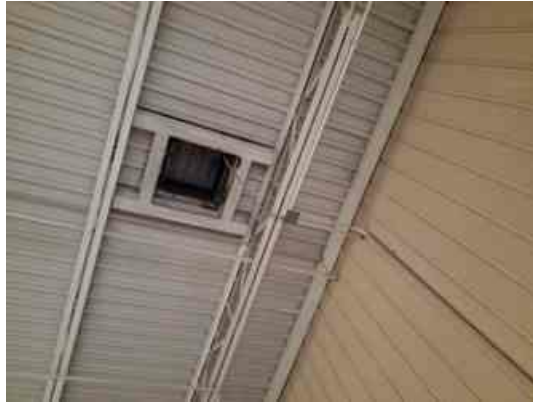
Inspect ID: 2021-0063 **Title:** 2604000008_CELRC_2021_A_0063_1_20210621T162309.jpg **Rated Item:** 8. Motors, Engines, Fans, Gear Reducers, Back Stop Devices, etc. **Caption:** Minimally Acceptable - PS-SS: EF1 exhaust fan operates but damper does not open. Repair.

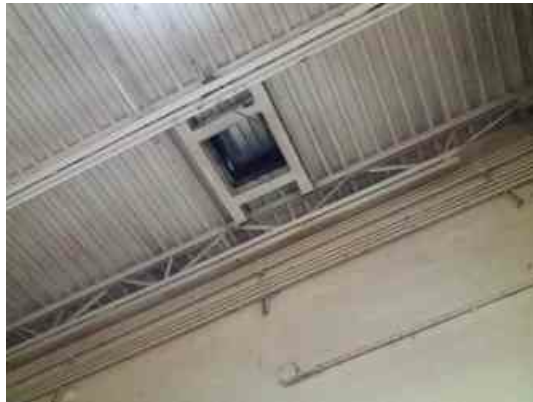
Inspect ID: 2021-0067 **Title:** 2604000008_CELRC_2021_A_0067_1_20210621T162418.jpg **Rated Item:** 8. Motors, Engines, Fans, Gear Reducers, Back Stop Devices, etc. **Caption:** Minimally Acceptable - PS-SS: EF1 exhaust fan does not operate at all. Repair.

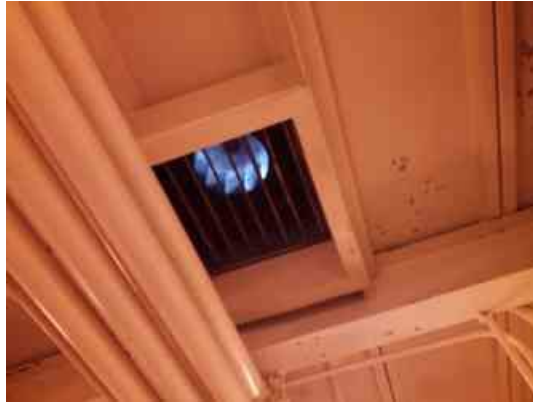
Inspect ID: 2021-0095 **Title:** 2604000008_CELRC_2021_A_0095_1_20210621T165030.jpg **Rated Item:** 8. Motors, Engines, Fans, Gear Reducers, Back Stop Devices, etc. **Caption:** Minimally Acceptable - PS-WA: EF1 exhaust fan damper stuck open. Repair.

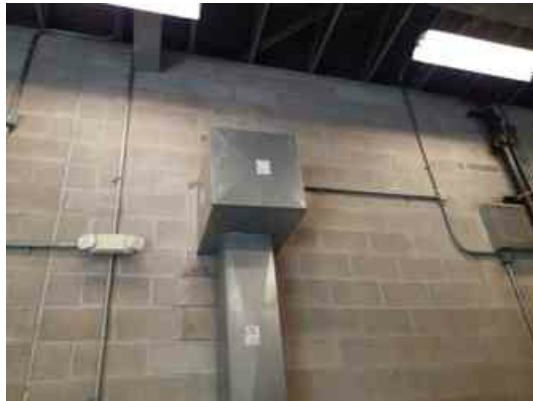
Inspect ID: 2021-0127 **Title:** 2604000008_CELRC_2021_A_0127_1_20210623T135614.jpg **Rated Item:** 8. Motors, Engines, Fans, Gear Reducers, Back Stop Devices, etc. **Caption:** Minimally Acceptable - PS-CA: Sump exhaust fan inoperable. Investigate and repair.

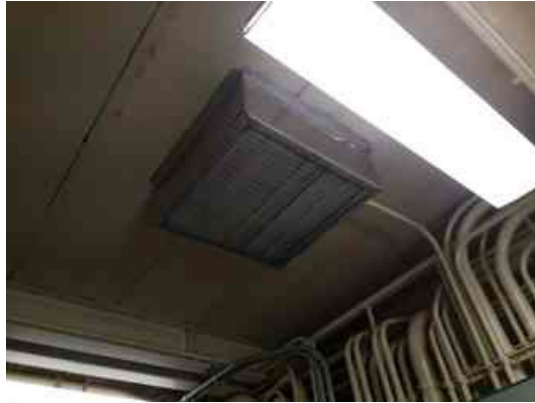
Inspect ID: 2021-0219 **Title:** 2604000008_CELRC_2021_A_0219_1_20210623T153904.jpg **Rated Item:** 8. Motors, Engines, Fans, Gear Reducers, Back Stop Devices, etc. **Caption:** Minimally Acceptable - PS-SK: Exhaust fan EF2 is inoperable.

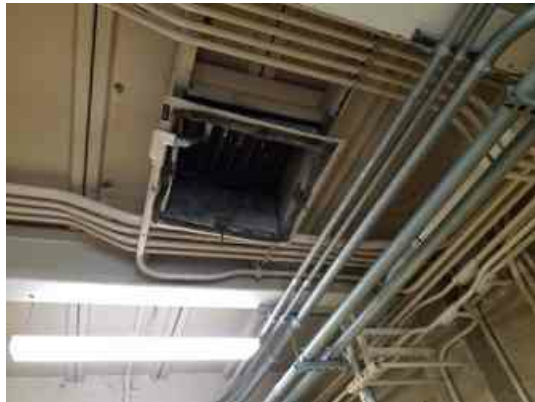
Inspect ID: 2021-0223 **Title:** 2604000008_CELRC_2021_A_0223_2_20210623T154054.jpg **Rated Item:** 8. Motors, Engines, Fans, Gear Reducers, Back Stop Devices, etc. **Caption:** Minimally Acceptable - PS-SK: EF1 working but housing is detached and could fall. Repair.

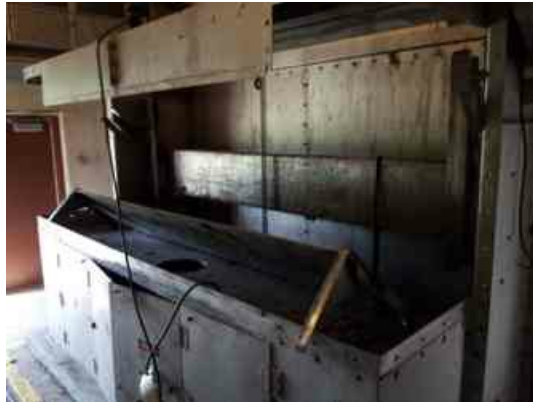
Inspect ID: 2021-0007 **Title:** 2604000008_CELRC_2021_A_0007_1_20210621T153500.jpg **Rated Item:** 10. Mechanical Operating Trash Rakes **Caption:** Minimally Acceptable - PS-JA: Trash rake is not operational. HSD aware and currently coordinating repairs.

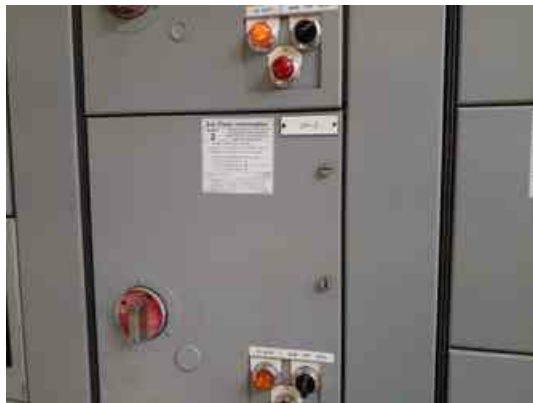
Inspect ID: 2021-0011 **Title:** 2604000008_CELRC_2021_A_0011_1_20210621T153741.jpg **Rated Item:** 14. Electrical Systems **Caption:** Minimally Acceptable - PS-JA: Arc flash warnings need updating.

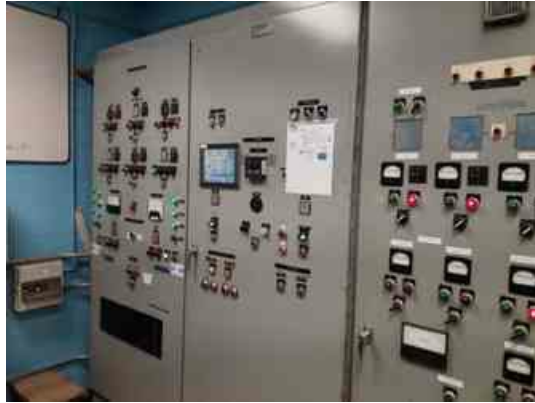
Inspect ID: 2021-0071 **Title:** 2604000008_CELRC_2021_A_0071_1_20210621T162715.jpg **Rated Item:** 14. Electrical Systems **Caption:** Minimally Acceptable - PS-SS: Arc-flash labels required on all 4 electrical panels.

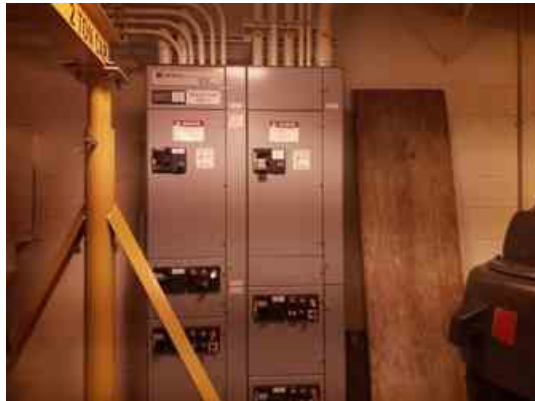
Inspect ID: 2021-0115 **Title:** 2604000008_CELRC_2021_A_0115_1_20210621T165748.jpg **Rated Item:** 14. Electrical Systems **Caption:** Minimally Acceptable - PS-WA: Update arc flash labels on all applicable equipment.

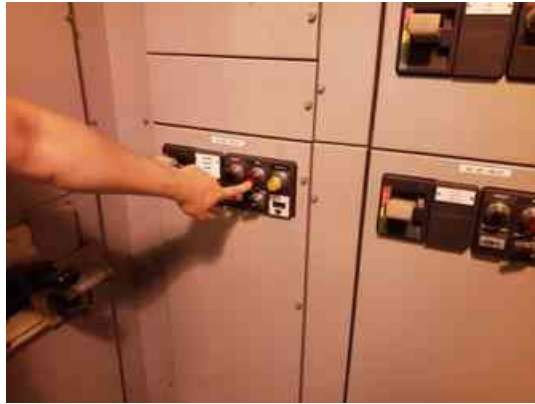
Inspect ID: 2021-0119 **Title:** 2604000008_CELRC_2021_A_0119_1_20210621T165852.jpg **Rated Item:** 14. Electrical Systems **Caption:** Minimally Acceptable - PS-WA: Indicator light needs to be replaced.

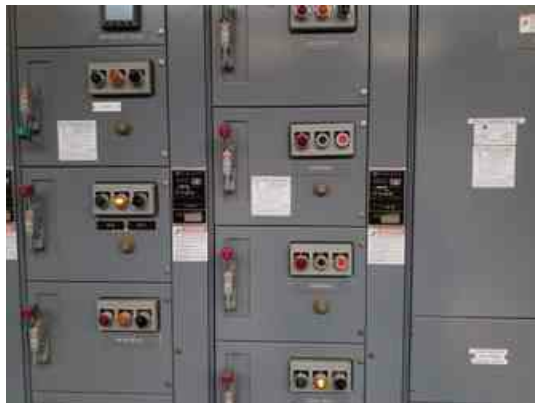
Inspect ID: 2021-0139 **Title:** 2604000008_CELRC_2021_A_0139_1_20210623T142512.jpg **Rated Item:** 14. Electrical Systems **Caption:** Minimally Acceptable - PS-IN: Arc flash labels need updating.

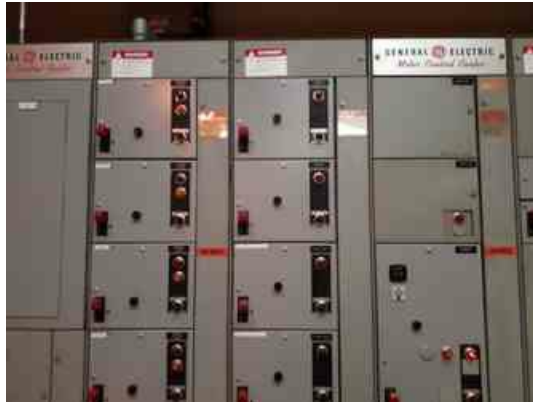
Inspect ID: 2021-0191 **Title:** 2604000008_CELRC_2021_A_0191_1_20210623T150851.jpg **Rated Item:** 14. Electrical Systems **Caption:** Minimally Acceptable - PS-HC: Arc flash labels need updating.

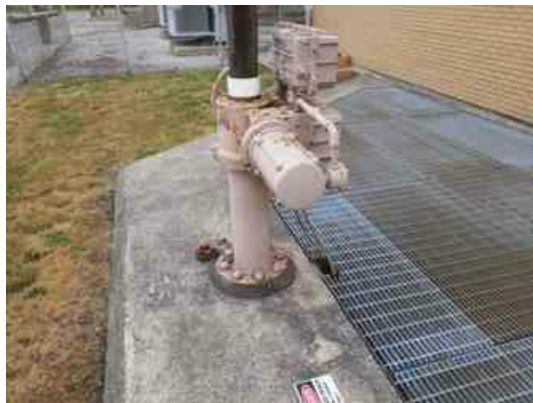
Inspect ID: 2021-0083 **Title:** 2604000008_CELRC_2021_A_0083_1_20210621T163557.jpg **Rated Item:** 18. Sluice/ Slide Gates **Caption:** Minimally Acceptable - PS-SS: Influence sluice gate not operational. Not critical. Repair.

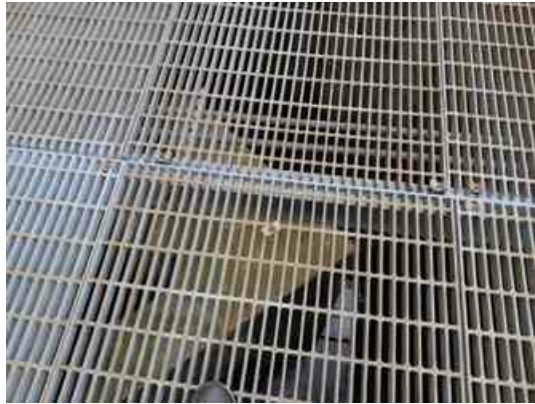
Inspect ID: 2021-0087 **Title:** 2604000008_CELRC_2021_A_0087_1_20210621T163732.jpg **Rated Item:** 21. Other Metallic Items (Equipment, Ladders, Platform Anchors, etc) **Caption:** Minimally Acceptable - PS-SS: Grating anchors loose or missing. Recommend replacement.
