**US Army Corps
of Engineers®**

Levee Inspection Report

Name of System: Highland

Date(s) of Inspection: 06/22/2021 - 06/22/2021

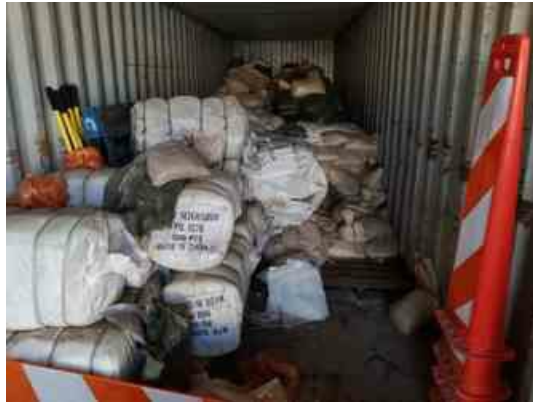
Inspect ID: 2021-0035 **Title:** 2604000007_CELRC_2021_A_0035_1_20210622T144122.jpg **Rated Item:** 2. Emergency Supplies and Equipment (A or M only) **Caption:** Acceptable - Sandbag storage

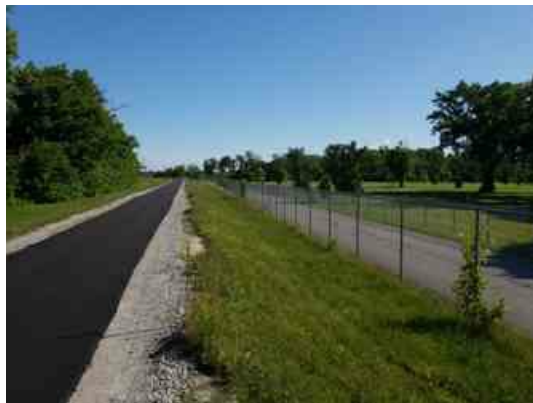
Inspect ID: 2021-0034 **Title:** 2604000007_CELRC_2021_A_0034_1_20210622T133821.jpg **Rated Item:** 1. Unwanted Vegetation Growth **Caption:** Minimally Acceptable - Small trees and bushes on landside along fence. Cut.

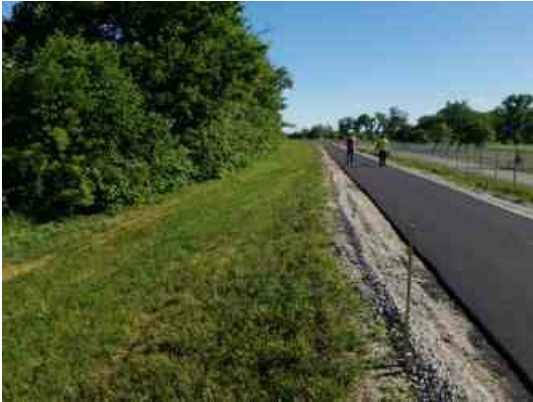
<p>Inspect ID: 2021-0037 Title: 2604000007_CELRC_2021_A_0037_1_20210622T133933.jpg Rated Item: 1. Unwanted Vegetation Growth Caption: Minimally Acceptable - Tree line around bend of levee on riverside within 15 ft. Cut.</p>

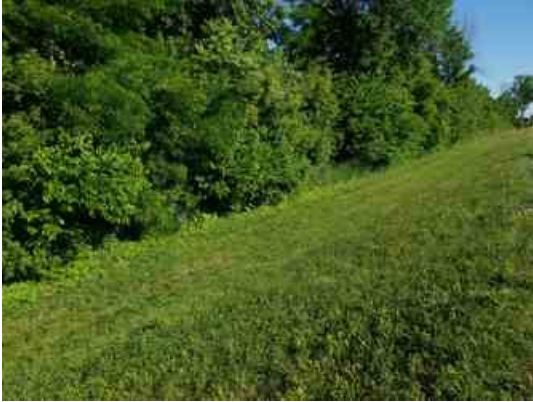
<p>Inspect ID: 2021-0040 Title: 2604000007_CELRC_2021_A_0040_1_20210622T134441.jpg Rated Item: 1. Unwanted Vegetation Growth Caption: Minimally Acceptable - Trim tree line back in this area.</p>

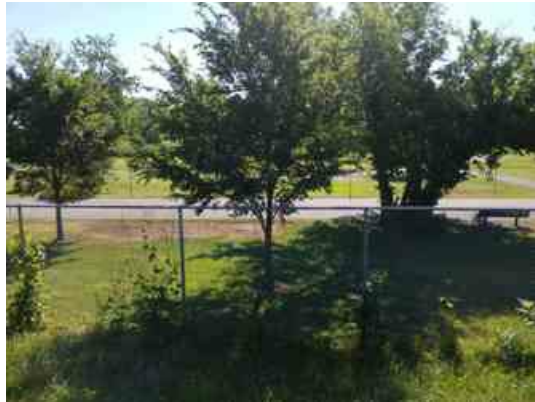
Inspect ID: 2021-0043 **Title:** 2604000007_CELRC_2021_A_0043_1_20210622T134652.jpg **Rated Item:** 1. Unwanted Vegetation Growth **Caption:** Minimally Acceptable - Tree on landside of fence within 15 ft of toe. Cut.

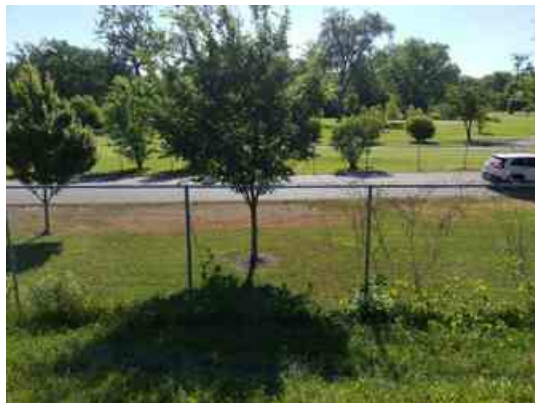
Inspect ID: 2021-0046 **Title:** 2604000007_CELRC_2021_A_0046_1_20210622T134823.jpg **Rated Item:** 1. Unwanted Vegetation Growth **Caption:** Minimally Acceptable - Tree on landside of fence within 15 ft of toe. Cut.

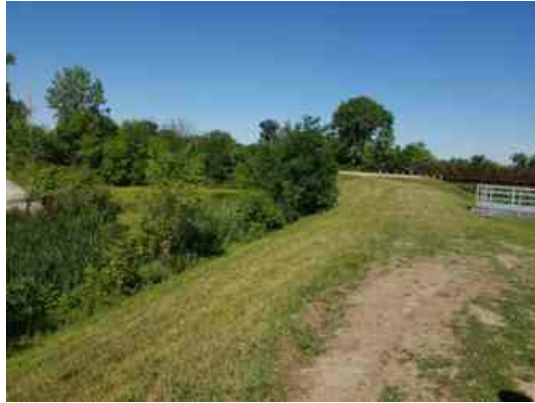
Inspect ID: 2021-0079 **Title:** 2604000007_CELRC_2021_A_0079_1_20210622T141218.jpg **Rated Item:** 1. Unwanted Vegetation Growth **Caption:** Minimally Acceptable - Trees on landside toe. Cut.

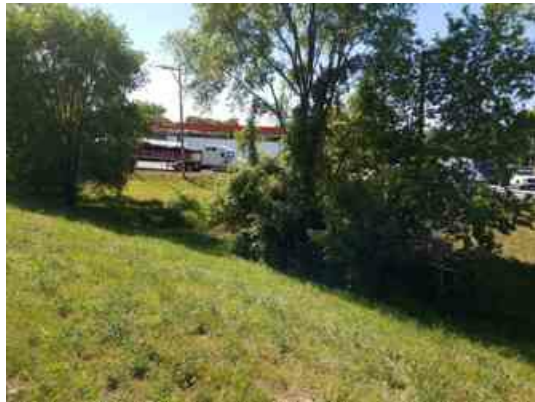
Inspect ID: 2021-0091 **Title:** 2604000007_CELRC_2021_A_0091_1_20210622T141929.jpg **Rated Item:** 1. Unwanted Vegetation Growth **Caption:** Minimally Acceptable - Trees on landside toe. Cut.

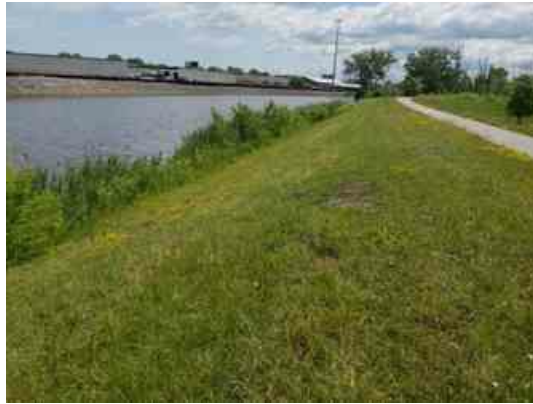
Inspect ID: 2021-0196 **Title:**

2604000007_CELRC_2021_A_0196_1_20210622T160313.jpg **Rated**
Item: 1. Unwanted Vegetation Growth **Caption:** Minimally Acceptable -
Small trees and tall veg on riverside toe. Cut.

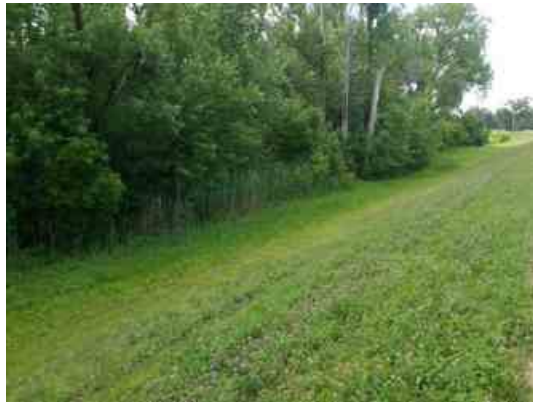
Inspect ID: 2021-0208 **Title:**

2604000007_CELRC_2021_A_0208_1_20210622T161047.jpg **Rated**
Item: 1. Unwanted Vegetation Growth **Caption:** Minimally Acceptable -
Clear back trees to 15 ft.

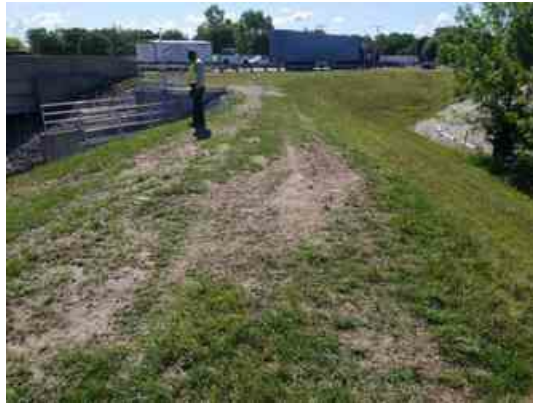
Inspect ID: 2021-0082 **Title:** 2604000007_CELRC_2021_A_0082_1_20210622T141252.jpg **Rated Item:** 2. Sod Cover **Caption:** Minimally Acceptable - Poor sod on crest. Reseed.

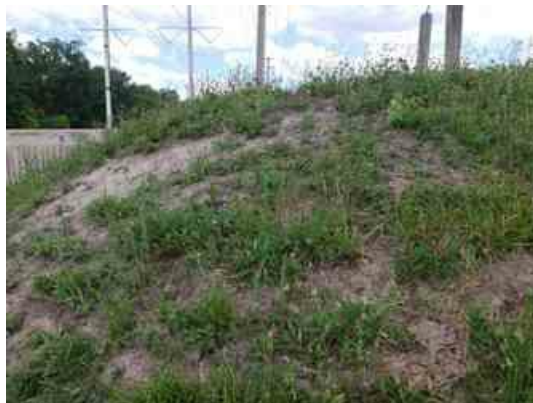
Inspect ID: 2021-0146 **Title:** 2604000007_CELRC_2021_A_0146_1_20210622T163137.jpg **Rated Item:** 2. Sod Cover **Caption:** Minimally Acceptable - Poor sod cover. Reseed.

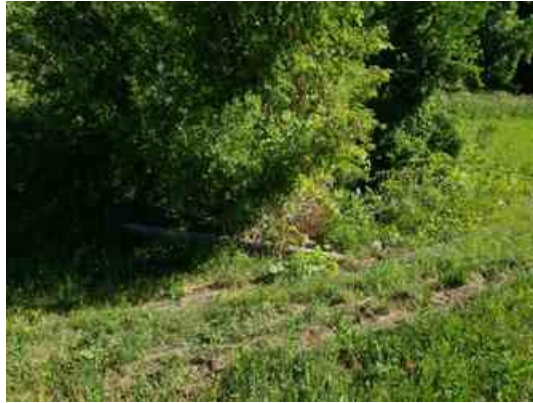
Inspect ID: 2021-0097 **Title:** 2604000007_CELRC_2021_A_0097_1_20210622T142802.jpg **Rated Item:** 3. Encroachments **Caption:** Minimally Acceptable - Logs on riverside slope. Remove.

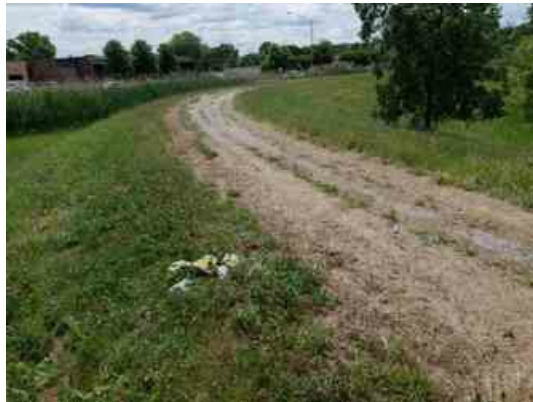
Inspect ID: 2021-0137 **Title:** 2604000007_CELRC_2021_A_0137_1_20210622T162444.jpg **Rated Item:** 3. Encroachments **Caption:** Minimally Acceptable - Large rocks on crown. Remove.

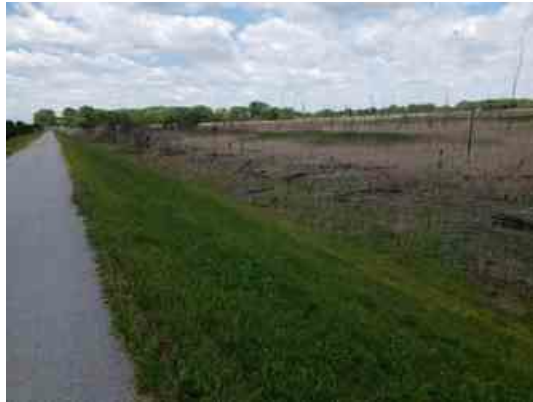
Inspect ID: 2021-0152 **Title:** 2604000007_CELRC_2021_A_0152_1_20210622T163624.jpg **Rated Item:** 3. Encroachments **Caption:** Minimally Acceptable - Logs close to riverside toe. Remove.

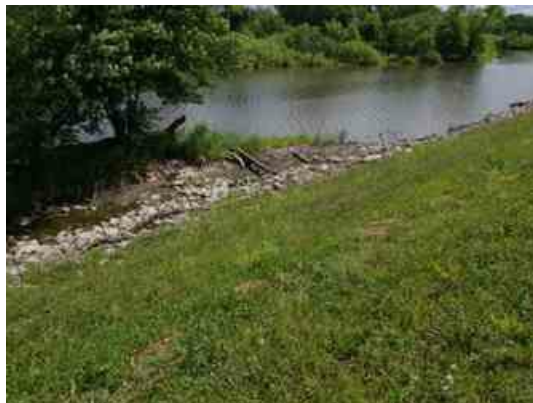
Inspect ID: 2021-0157 **Title:** 2604000007_CELRC_2021_A_0157_1_20210622T154623.jpg **Rated Item:** 3. Encroachments **Caption:** Minimally Acceptable - Logs on riverside toe in riprap. Remove.

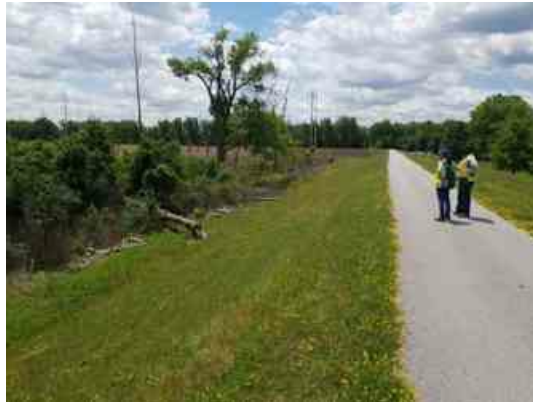
Inspect ID: 2021-0253 **Title:** 2604000007_CELRC_2021_A_0253_1_20210622T164203.jpg **Rated Item:** 3. Encroachments **Caption:** Minimally Acceptable - Remove logs and debris on riverside slope.

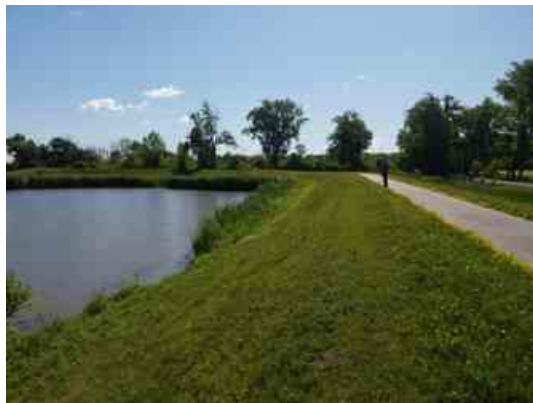
Inspect ID: 2021-0061 **Title:** 2604000007_CELRC_2021_A_0061_1_20210622T140131.jpg **Rated Item:** 6. Erosion/ Bank Caving **Caption:** Minimally Acceptable - Erosion on riverside toe that is starting to eat into the toe. Add riprap to restore the bank.

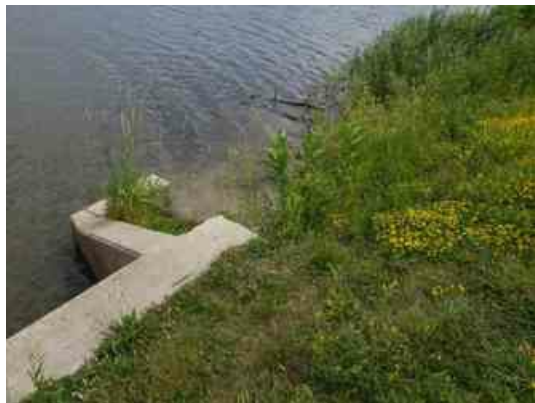
Inspect ID: 2021-0199 **Title:** 2604000007_CELRC_2021_A_0199_1_20210622T160459.jpg **Rated Item:** 6. Erosion/ Bank Caving **Caption:** Minimally Acceptable - Erosion around HI-9 headwall on both sides. Add riprap or fill.

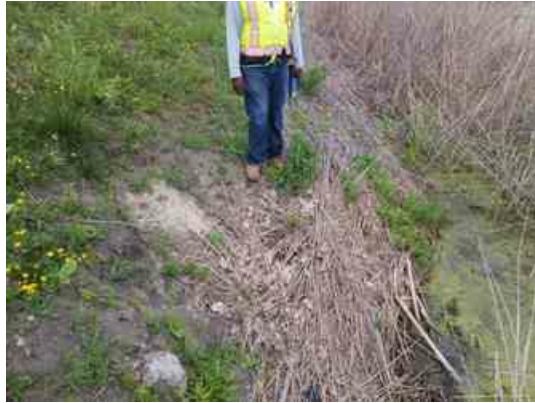
Inspect ID: 2021-0232 **Title:** 2604000007_CELRC_2021_A_0232_1_20210622T163110.jpg **Rated Item:** 6. Erosion/ Bank Caving **Caption:** Minimally Acceptable - Erosion along riverside toe. Add fill to restore slope.

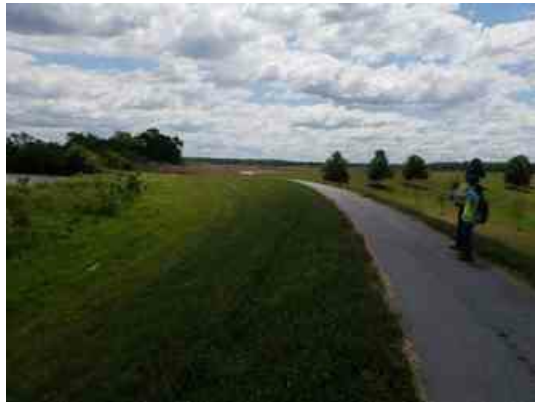
Inspect ID: 2021-0214 **Title:** 2604000007_CELRC_2021_A_0214_1_20210622T161718.jpg **Rated Item:** 7. Settlement **Caption:** Acceptable - Possible low spot. Location where two contracts tie in. Monitor.

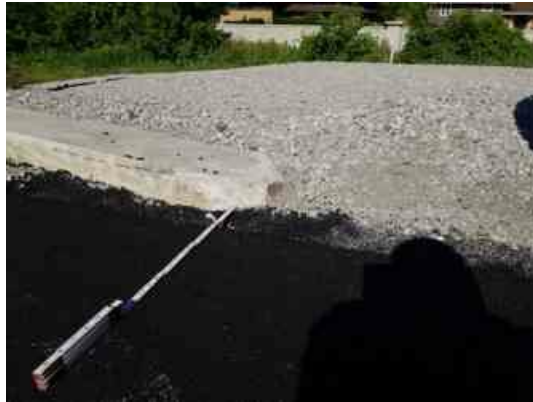
Inspect ID: 2021-0031 **Title:** 2604000007_CELRC_2021_A_0031_2_20210622T133606.jpg **Rated Item:** 8. Depressions/ Rutting **Caption:** Acceptable - Floodwall does not tie in to height of road from 408 permit modification, 3 inches higher. Monitor.

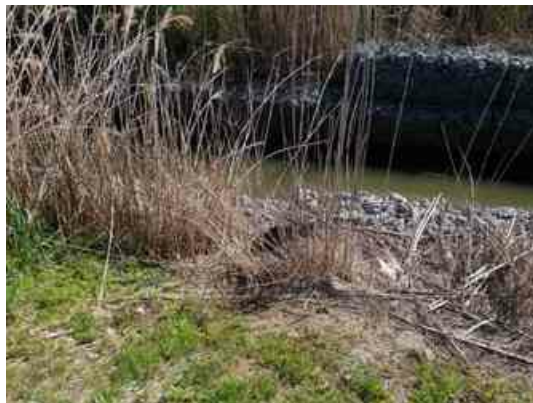
Inspect ID: 2021-0085 **Title:** 2604000007_CELRC_2021_A_0085_1_20210622T141401.jpg **Rated Item:** 8. Depressions/ Rutting **Caption:** Minimally Acceptable - Depression on riverside toe and slope. Fill.

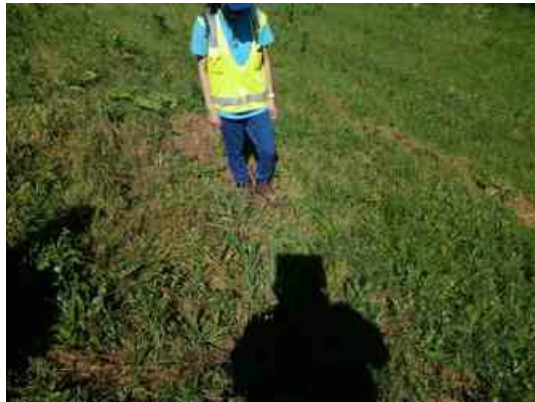
Inspect ID: 2021-0100 **Title:** 2604000007_CELRC_2021_A_0100_1_20210622T143319.jpg **Rated Item:** 8. Depressions/ Rutting **Caption:** Minimally Acceptable - Depression on riverside slope. Fill to grade.

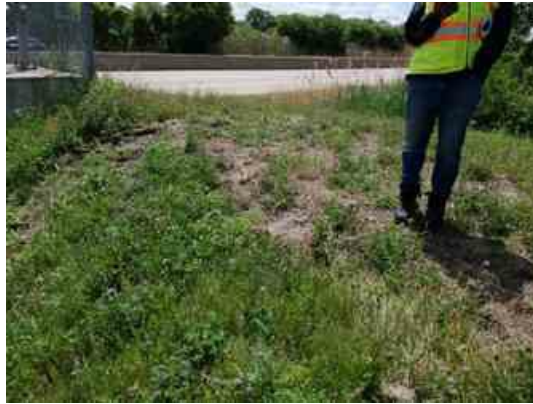
Inspect ID: 2021-0125 **Title:** 2604000007_CELRC_2021_A_0125_1_20210622T161818.jpg **Rated Item:** 8. Depressions/ Rutting **Caption:** Minimally Acceptable - Rutting on crown by HI-11. Fill.

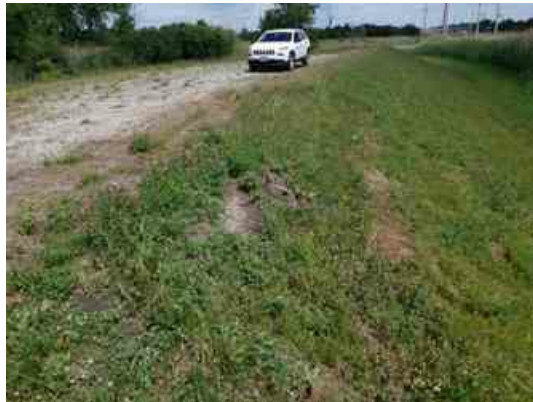
Inspect ID: 2021-0128 **Title:** 2604000007_CELRC_2021_A_0128_1_20210622T161914.jpg **Rated Item:** 8. Depressions/ Rutting **Caption:** Minimally Acceptable - Rutting on crown closer to landside slope. Fill.

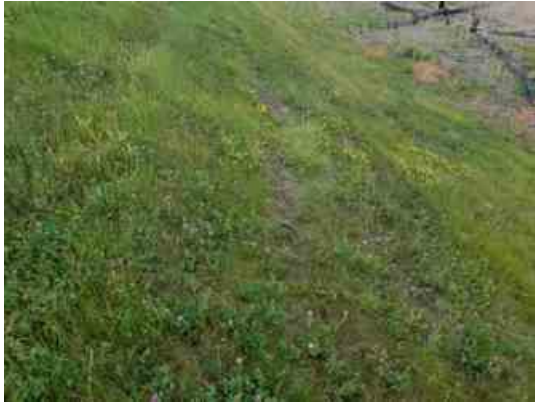
Inspect ID: 2021-0149 Title: 2604000007_CELRC_2021_A_0149_1_20210622T163335.jpg Rated Item: 8. Depressions/ Rutting Caption: Minimally Acceptable - Rutting riverside slope. Fill to grade.

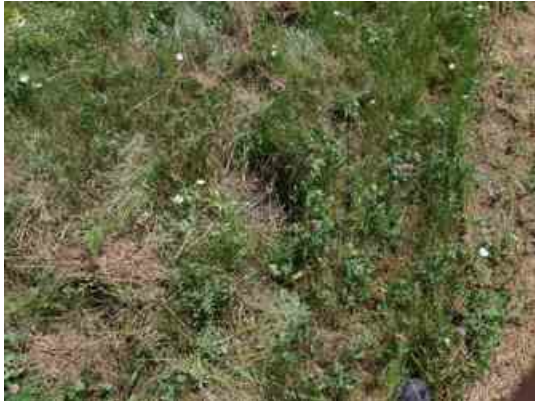
Inspect ID: 2021-0158 Title: 2604000007_CELRC_2021_A_0158_1_20210622T164056.jpg Rated Item: 8. Depressions/ Rutting Caption: Minimally Acceptable - Depression on landside. Fill.

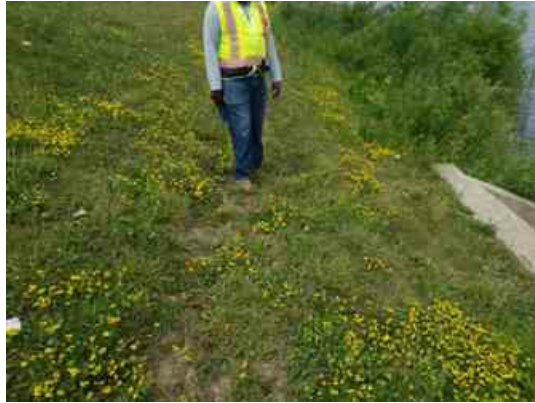
Inspect ID: 2021-0202 **Title:** 2604000007_CELRC_2021_A_0202_1_20210622T160712.jpg **Rated Item:** 8. Depressions/ Rutting **Caption:** Minimally Acceptable - Depression on riverside slope. Fill.

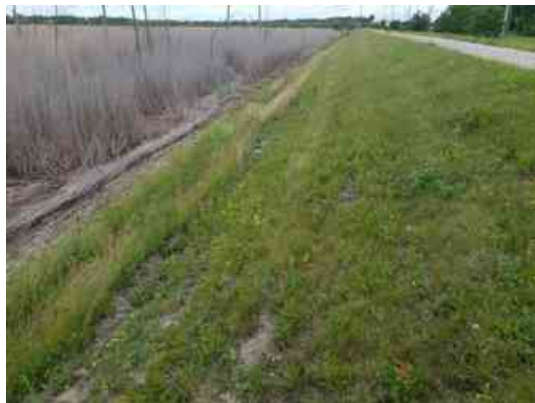
Inspect ID: 2021-0259 **Title:** 2604000007_CELRC_2021_A_0259_1_20210622T164833.jpg **Rated Item:** 8. Depressions/ Rutting **Caption:** Minimally Acceptable - Rutting on riverside toe. Fill to grade.

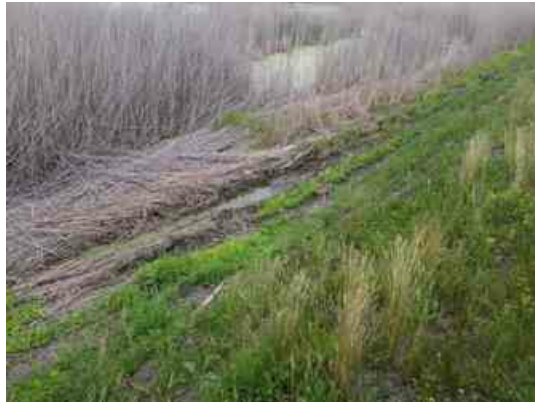
Inspect ID: 2021-0262 **Title:** 2604000007_CELRC_2021_A_0262_1_20210622T165150.jpg **Rated Item:** 8. Depressions/ Rutting **Caption:** Minimally Acceptable - Rutting on riverside toe. Fill to grade.

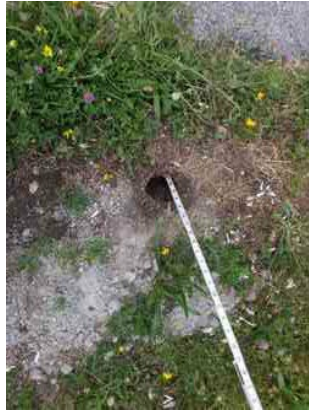
Inspect ID: 2021-0223 **Title:** 2604000007_CELRC_2021_A_0223_1_20210622T162732.jpg **Rated Item:** 10. Animal Control **Caption:** Minimally Acceptable - Turtle egg holes on riverside slope, 7 inches deep. Fill holes.

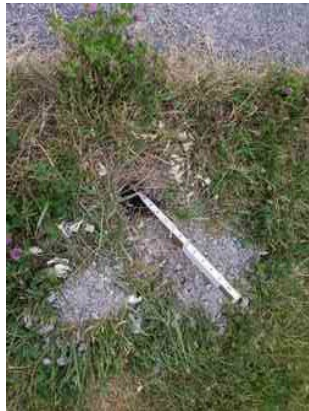
Inspect ID: 2021-0226 **Title:** 2604000007_CELRC_2021_A_0226_1_20210622T162828.jpg **Rated Item:** 10. Animal Control **Caption:** Minimally Acceptable - Turtle egg holes on riverside slope, 8 inches deep. Fill holes.

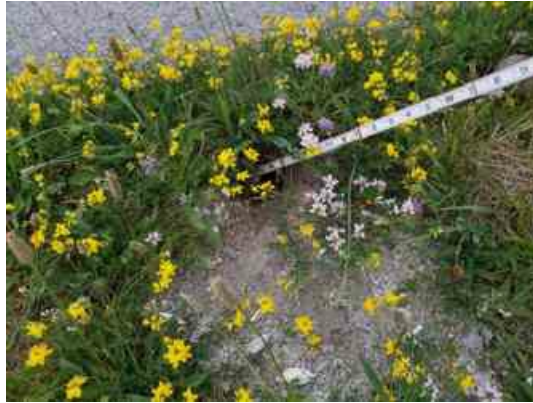
Inspect ID: 2021-0229 **Title:** 2604000007_CELRC_2021_A_0229_1_20210622T163012.jpg **Rated Item:** 10. Animal Control **Caption:** Minimally Acceptable - 6 inches deep on riverside slope, turtle hole. Fill hole.

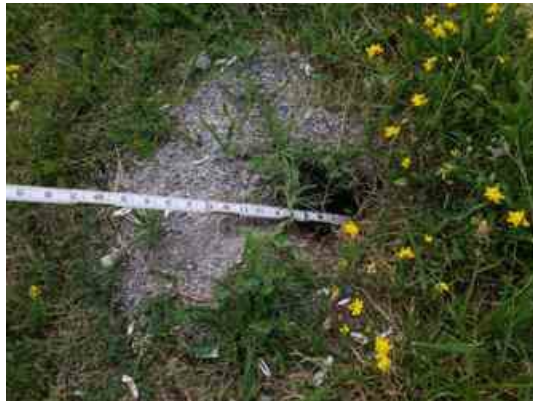
Inspect ID: 2021-0235 **Title:** 2604000007_CELRC_2021_A_0235_1_20210622T163308.jpg **Rated Item:** 10. Animal Control **Caption:** Minimally Acceptable - Turtle egg hole on riverside toe and slope. Fill hole.

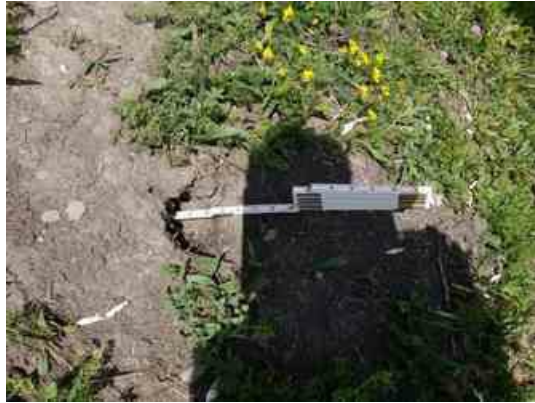
Inspect ID: 2021-0238 **Title:** 2604000007_CELRC_2021_A_2021-0238_2_20210622T163453.jpg **Rated Item:** 10. Animal Control **Caption:** Minimally Acceptable - Multiple animal burrows on riverside toe and slope, 1.5 ft deep. Fill holes.

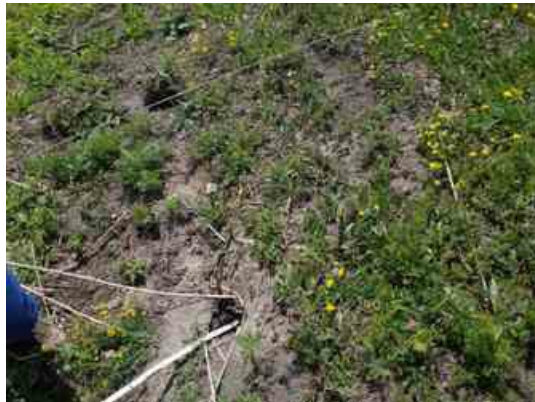
Inspect ID: 2021-0241 **Title:** 2604000007_CELRC_2021_A_0241_1_20210622T163722.jpg **Rated Item:** 10. Animal Control **Caption:** Minimally Acceptable - Multiple turtle egg holes on riverside toe and slope, 8 inch deep. Fill holes.

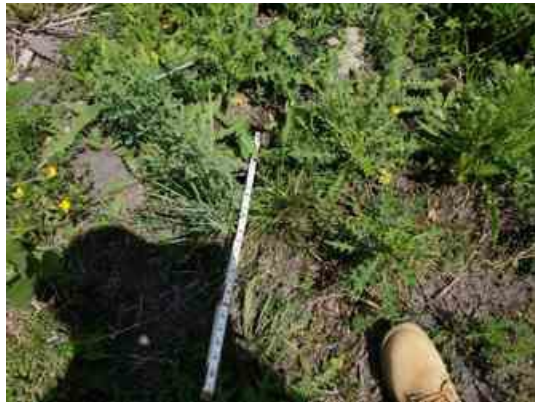
Inspect ID: 2021-0247 **Title:** 2604000007_CELRC_2021_A_0247_1_20210622T163946.jpg **Rated Item:** 10. Animal Control **Caption:** Minimally Acceptable - Burrow cluster on riverside toe and slope. Fill holes.

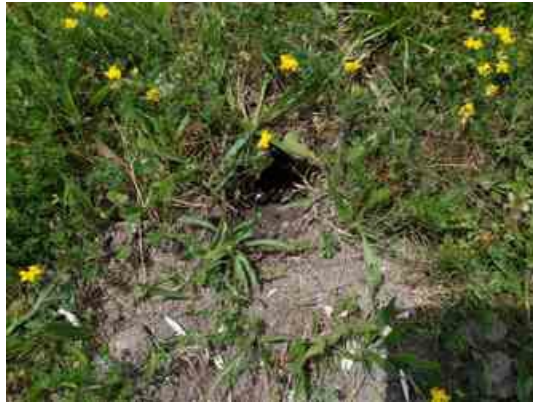
Inspect ID: 2021-0256 **Title:** 2604000007_CELRC_2021_A_0256_1_20210622T164449.jpg **Rated Item:** 10. Animal Control **Caption:** Minimally Acceptable - Turtle egg hole on riverside slope.

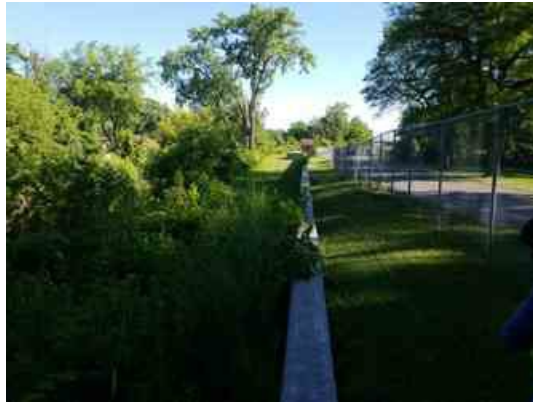
Inspect ID: 2021-0007 **Title:** 2604000007_CELRC_2021_A_0007_1_20210622T131640.jpg **Rated Item:** 1. Unwanted Vegetation Growth **Caption:** Minimally Acceptable - Bushes on riverside. Cut.

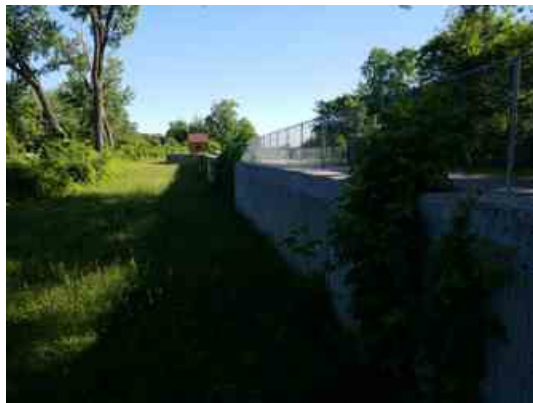
Inspect ID: 2021-0019 **Title:** 2604000007_CELRC_2021_A_0019_1_20210622T132537.jpg **Rated Item:** 1. Unwanted Vegetation Growth **Caption:** Minimally Acceptable - Bushes on riverside. Cut.

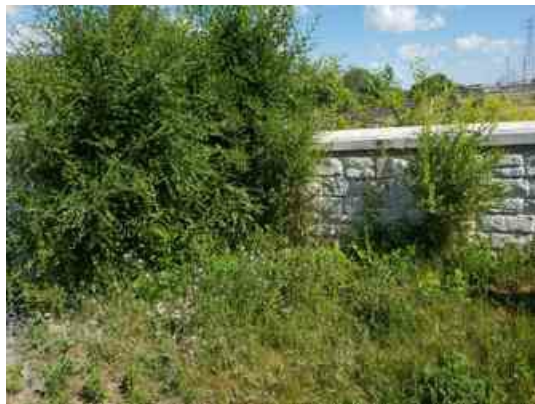
Inspect ID: 2021-0112 **Title:** 2604000007_CELRC_2021_A_0112_1_20210622T145053.jpg **Rated Item:** 1. Unwanted Vegetation Growth **Caption:** Minimally Acceptable - Large bushes on landside. Cut.

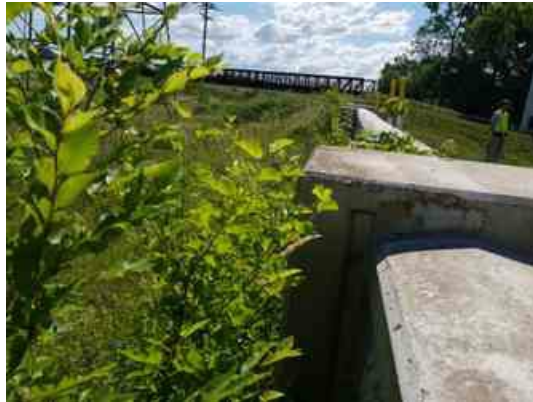
Inspect ID: 2021-0115 **Title:**

2604000007_CELRC_2021_A_0115_1_20210622T145308.jpg **Rated**
Item: 1. Unwanted Vegetation Growth **Caption:** Minimally Acceptable -
Small trees and bushes on waterside. Cut.

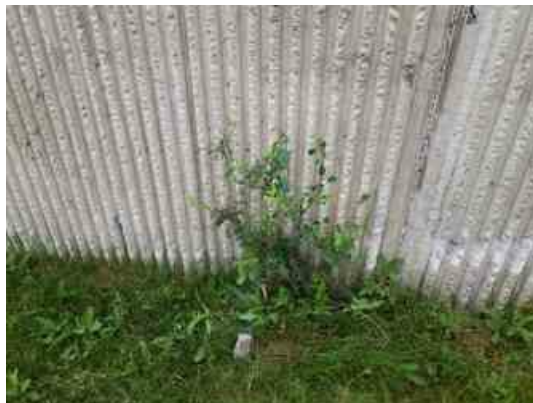
Inspect ID: 2021-0140 **Title:**

2604000007_CELRC_2021_A_0140_1_20210622T162829.jpg **Rated**
Item: 1. Unwanted Vegetation Growth **Caption:** Acceptable - Small tree
growing at the bottom of floodwall on landside.

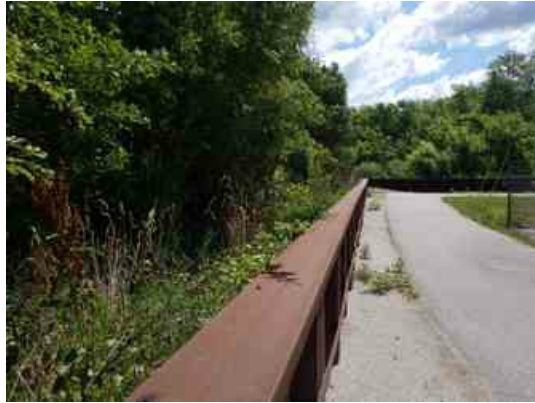
Inspect ID: 2021-0145 **Title:** 2604000007_CELRC_2021_A_0145_1_20210622T153620.jpg **Rated Item:** 1. Unwanted Vegetation Growth **Caption:** Minimally Acceptable - Trees on riverside. Cut.

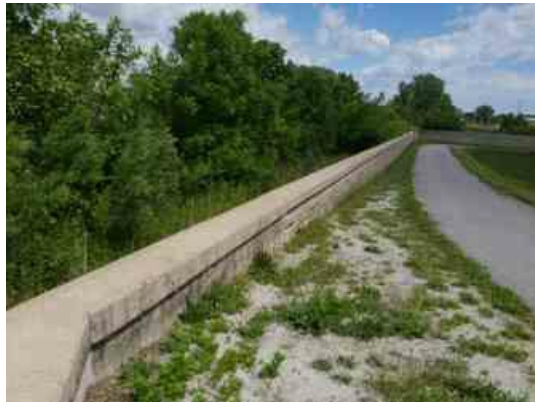
Inspect ID: 2021-0172 **Title:** 2604000007_CELRC_2021_A_0172_1_20210622T155320.jpg **Rated Item:** 1. Unwanted Vegetation Growth **Caption:** Minimally Acceptable - Trees on riverside. Cut.

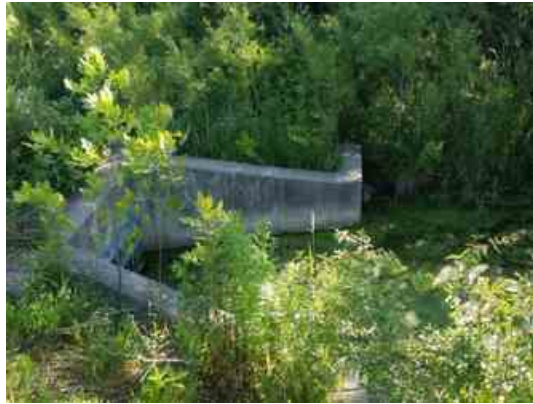
Inspect ID: 2021-0008 **Title:** 2604000007_CELRC_2021_A_0008_1_20210622T132900.jpg **Rated Item:** 1. Vegetation and Obstructions **Caption:** Minimally Acceptable - HI-4: The inlet is free of debris but there is vegetation and trees growing around the concrete structure. Cut.

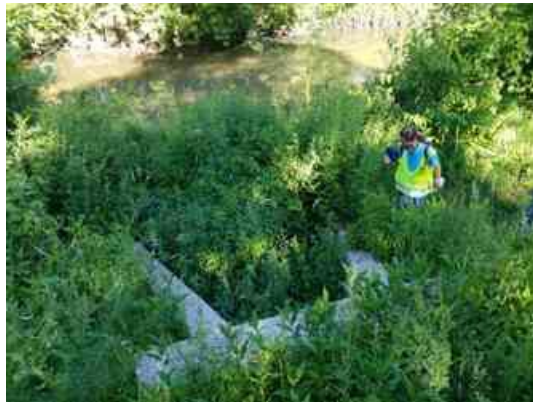
Inspect ID: 2021-0010 **Title:** 2604000007_CELRC_2021_A_0010_1_20210622T131924.jpg **Rated Item:** 1. Vegetation and Obstructions **Caption:** Minimally Acceptable - HI-1: Clear vegetation.

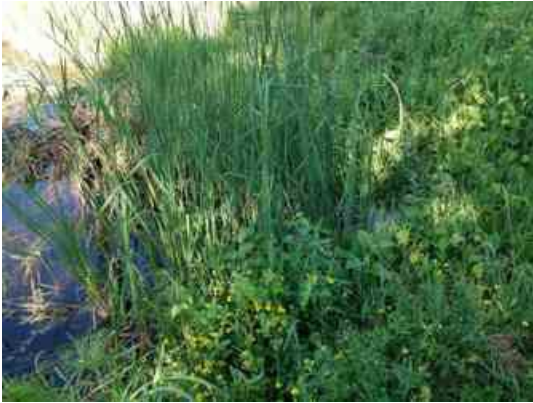
<p>Inspect ID: 2021-0017 Title: 2604000007_CELRC_2021_A_0017_1_20210622T135701.jpg Rated Item: 1. Vegetation and Obstructions Caption: Minimally Acceptable - HI-5: Large amount vegetation/debris in the inlet. Clear.</p>

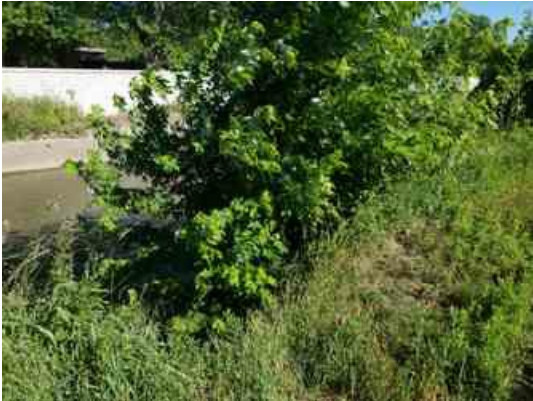
<p>Inspect ID: 2021-0028 Title: 2604000007_CELRC_2021_A_2021-0028_2_20210622T133326.jpg Rated Item: 1. Vegetation and Obstructions Caption: Minimally Acceptable - HI-2: Remove tree.</p>

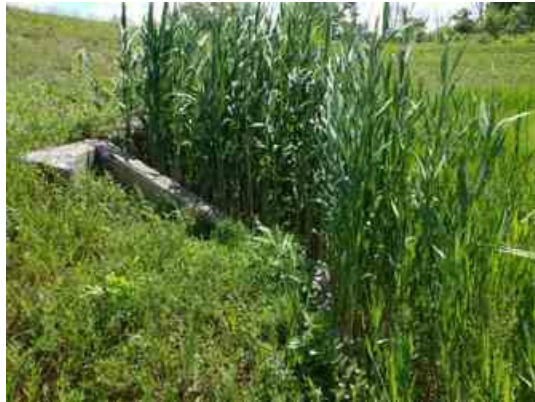
Inspect ID: 2021-0050 **Title:** 2604000007_CELRC_2021_A_0050_1_20210622T150247.jpg **Rated Item:** 1. Vegetation and Obstructions **Caption:** Minimally Acceptable - HI-9: Tall vegetation blocking inlet.

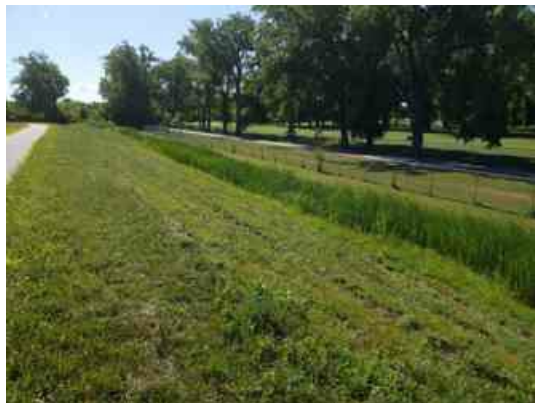
Inspect ID: 2021-0055 **Title:** 2604000007_CELRC_2021_A_2021-0055_1_20210622T140009.jpg **Rated Item:** 1. Vegetation and Obstructions **Caption:** Minimally Acceptable - Whole length of ditch filled with tall vegetation. Cut.

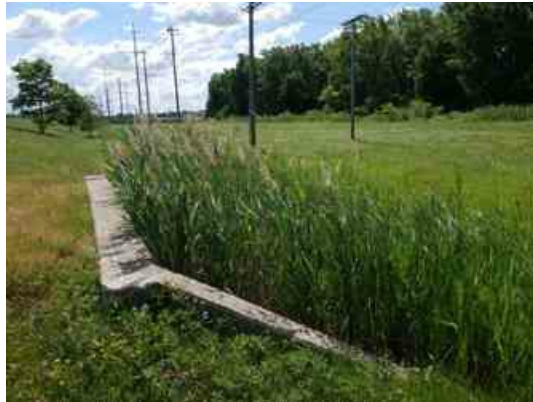
Inspect ID: 2021-0068 **Title:** 2604000007_CELRC_2021_A_0068_2_20210622T151714.jpg **Rated**
Item: 1. Vegetation and Obstructions **Caption:** Minimally Acceptable - HI-1: Vegetation blocking outlet. Clear.

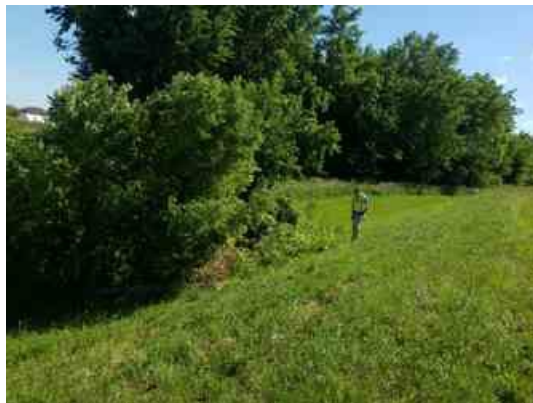
Inspect ID: 2021-0094 **Title:** 2604000007_CELRC_2021_A_0094_1_20210622T142621.jpg **Rated**
Item: 1. Vegetation and Obstructions **Caption:** Minimally Acceptable - HI-6: Trees on riverside toe. Remove.

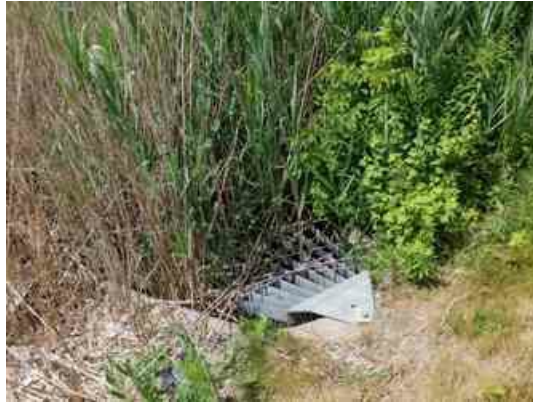
Inspect ID: 2021-0104 **Title:** 2604000007_CELRC_2021_A_0104_1_20210622T155636.jpg **Rated**
Item: 1. Vegetation and Obstructions **Caption:** Minimally Acceptable - HI-11: Tall vegetation blocking inlet. Clear.

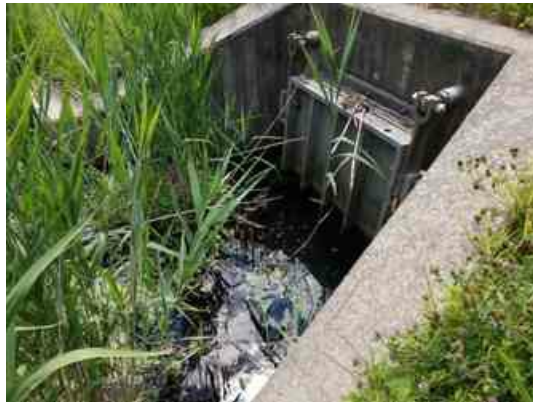
Inspect ID: 2021-0107 **Title:** 2604000007_CELRC_2021_A_0107_1_20210622T155716.jpg **Rated**
Item: 1. Vegetation and Obstructions **Caption:** Minimally Acceptable - HI-11: Tall vegetation blocking outlet. Clear.

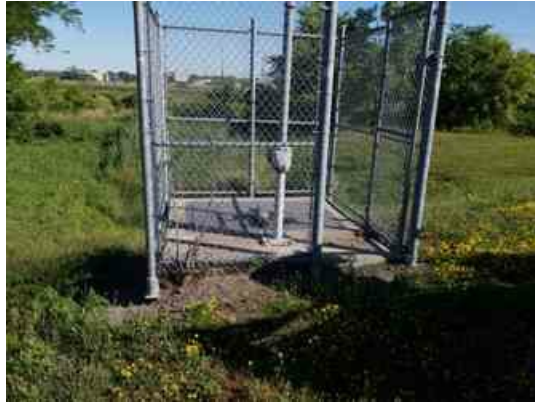
Inspect ID: 2021-0002 **Title:** 2604000007_CELRC_2021_A_0002_1_20210622T132231.jpg **Rated Item:** 4. Fencing and Gates **Caption:** Acceptable - HI-4: Minor vegetation growing along the fence.

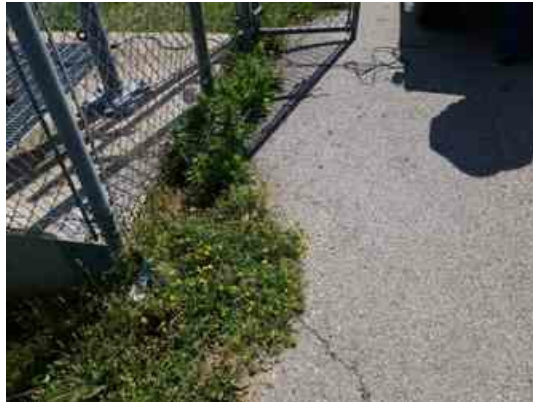
Inspect ID: 2021-0053 **Title:** 2604000007_CELRC_2021_A_2021-0053_1_20210622T150354.jpg **Rated Item:** 4. Fencing and Gates
Caption: Acceptable - HI-9: Minor vegetation near fence.

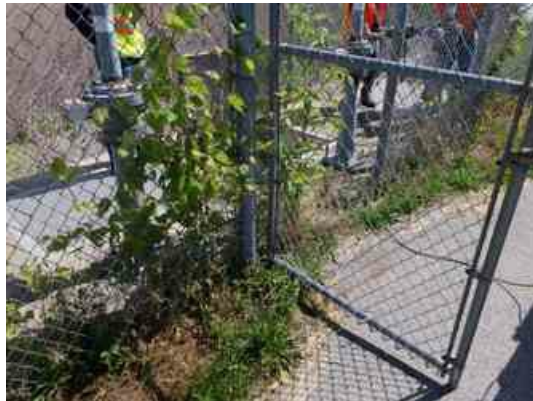
Inspect ID: 2021-0071 **Title:** 2604000007_CELRC_2021_A_0071_1_20210622T151847.jpg **Rated Item:** 4. Fencing and Gates
Caption: Minimally Acceptable - HI-10: Tall vegetation in fence, remove.

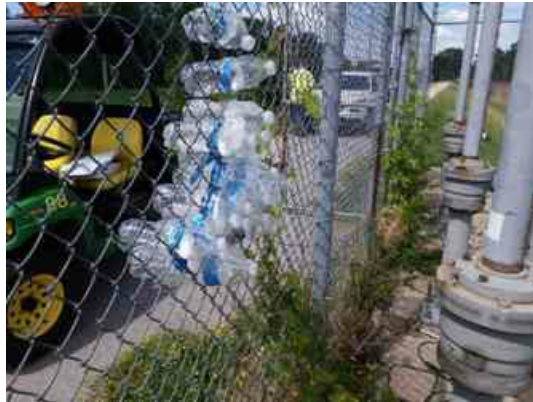
Inspect ID: 2021-0083 **Title:** 2604000007_CELRC_2021_A_0083_1_20210622T152945.jpg **Rated Item:** 4. Fencing and Gates **Caption:** Minimally Acceptable - HI-10a-d: Trash needs to be remove from gate periodically.

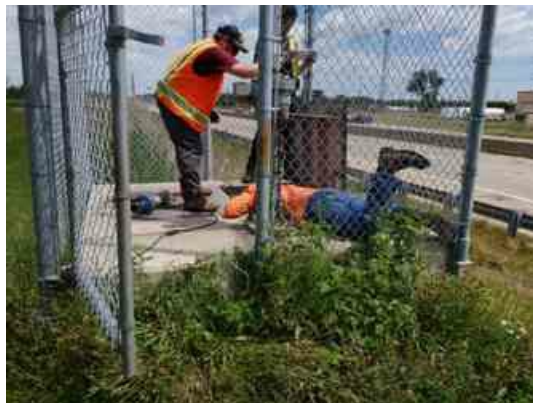
Inspect ID: 2021-0122 **Title:** 2604000007_CELRC_2021_A_0122_1_20210622T160733.jpg **Rated Item:** 4. Fencing and Gates **Caption:** Acceptable - HI-11: The fence has minor vegetation.

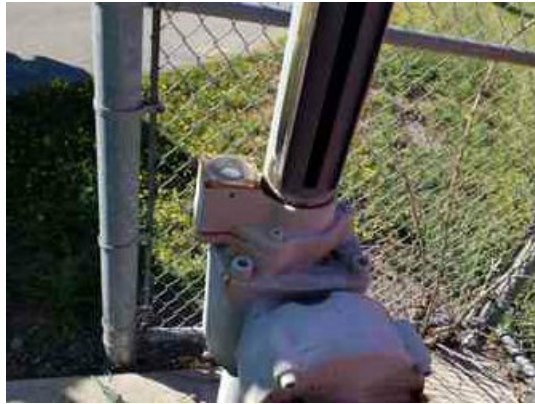
Inspect ID: 2021-0011 **Title:** 2604000007_CELRC_2021_A_0011_1_20210622T133321.jpg **Rated Item:** 10. Sluice/ Slide Gates **Caption:** Acceptable - HI-3: The sluice gate moved up and down without any resistance. Note that the crew in charge of operating these gates oiled it before starting.

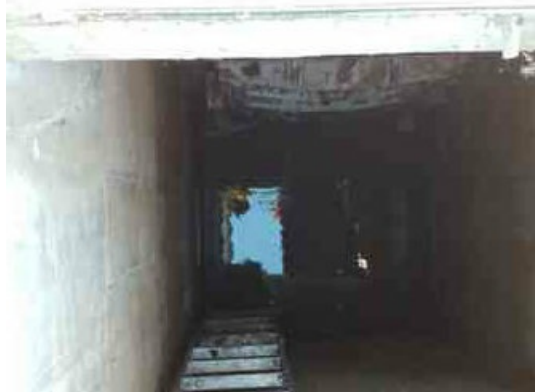
Inspect ID: 2021-0014 **Title:** 2604000007_CELRC_2021_A_0014_1_20210622T133553.jpg **Rated Item:** 10. Sluice/ Slide Gates **Caption:** Acceptable - HI-3: The sluice gate opens and closed without resistance. There was a small amount of sediment inside the gatewell.

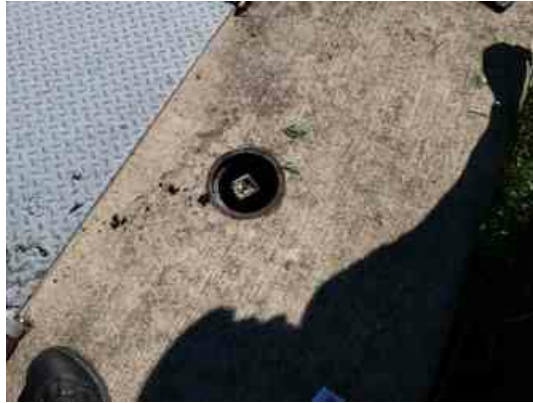
Inspect ID: 2021-0026 **Title:**

2604000007_CELRC_2021_A_0026_1_20210622T142056.jpg **Rated Item:** 10. Sluice/ Slide Gates **Caption:** Minimally Acceptable - HI-5: The gate is having issues when it comes to opening. It appears there was a cover over the opening but has been removed. This can lead to corrosion. Replace cover.

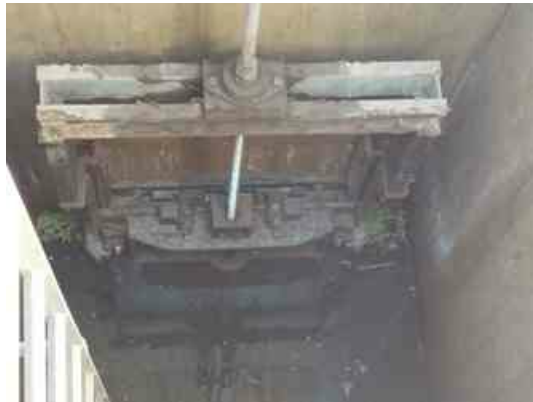
Inspect ID: 2021-0032 **Title:**

2604000007_CELRC_2021_A_0032_1_20210622T142613.jpg **Rated Item:** 10. Sluice/ Slide Gates **Caption:** Minimally Acceptable - HI-5: The sluice gate couldn't be closed all the way. Viewing the picture you can see that the top bolt doesn't match line up with the side bars. The gate also moves back and forth when being raised and lowered so the side rails are corroded or have sediment inside of it. Investigate and repair.

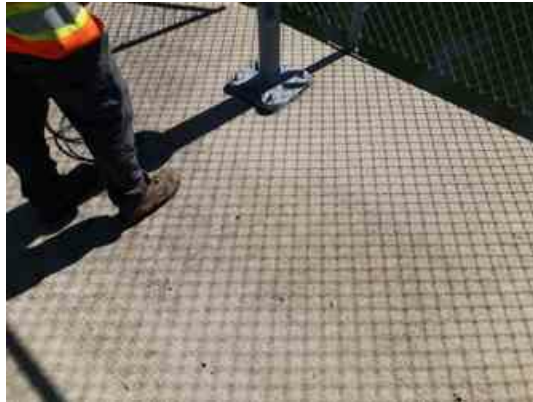
Inspect ID: 2021-0041 **Title:** 2604000007_CELRC_2021_A_0041_1_20210622T144840.jpg **Rated Item:** 10. Sluice/ Slide Gates **Caption:** Acceptable - HI-7: There isn't an appropriate wet well to view the gate for an proper inspection.

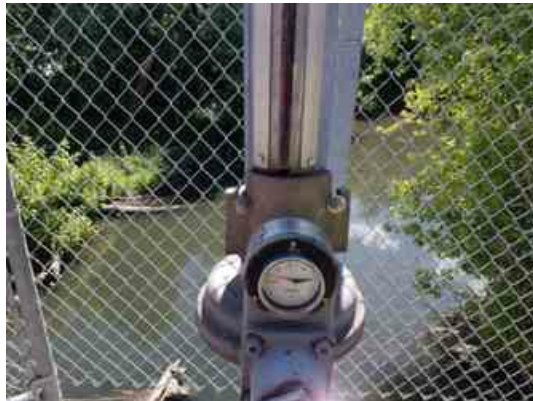
Inspect ID: 2021-0044 **Title:** 2604000007_CELRC_2021_A_0044_1_20210622T144920.jpg **Rated Item:** 10. Sluice/ Slide Gates **Caption:** Acceptable - HI-7 The sluice gate opened without any resistance. The operators oiled it that day.

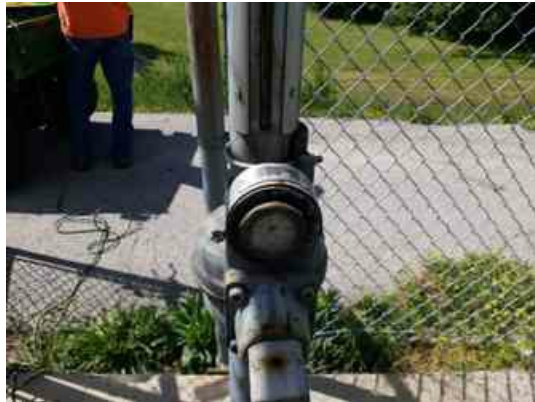
Inspect ID: 2021-0056 **Title:** 2604000007_CELRC_2021_A_0056_1_20210622T150432.jpg **Rated Item:** 10. Sluice/ Slide Gates **Caption:** Acceptable - HI-9: Sluice gate opened and closed without resistance. The team oiled the gate the same day.

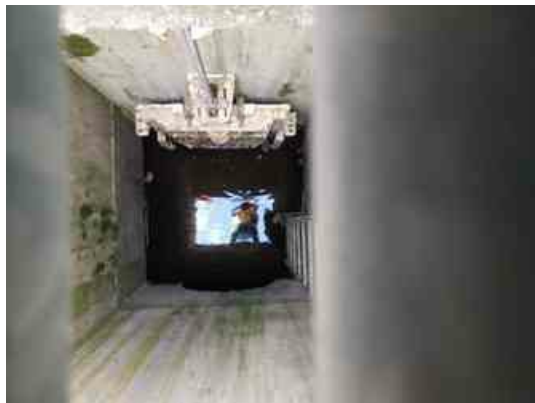
Inspect ID: 2021-0059 **Title:** 2604000007_CELRC_2021_A_0059_1_20210622T150648.jpg **Rated Item:** 10. Sluice/ Slide Gates **Caption:** Acceptable - HI-9: The sluice gate opened and closed without any resistance.

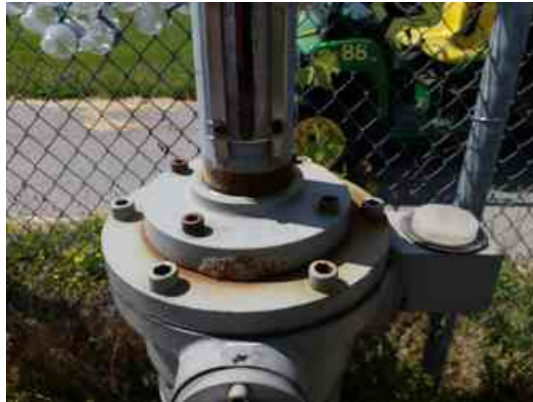
Inspect ID: 2021-0077 **Title:**

2604000007_CELRC_2021_A_0077_1_20210622T152400.jpg **Rated**

Item: 10. Sluice/ Slide Gates **Caption:** Minimally Acceptable - HI-10d:

The sluice gate operated but there was some resistance on the way down. The gate also made squeaking noises. Investigate and repair. The operators oiled the gates that day.

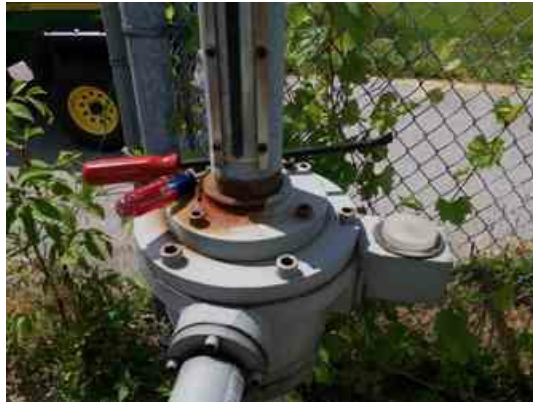
Inspect ID: 2021-0098 **Title:**

2604000007_CELRC_2021_A_0098_1_20210622T154652.jpg **Rated Item:** 10. Sluice/ Slide Gates **Caption:** Minimally Acceptable - HI-10b: The sluice gate opened without any resistance. There is mild corrosion on the outside of the metallic casing, recommend painting.

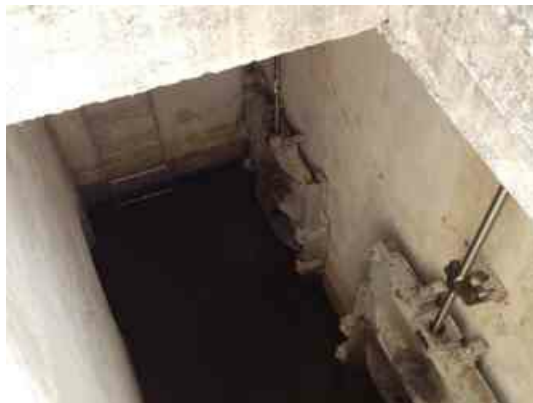
Inspect ID: 2021-0101 **Title:**

2604000007_CELRC_2021_A_0101_1_20210622T154815.jpg **Rated Item:** 10. Sluice/ Slide Gates **Caption:** Acceptable - HI-10b: The sluice gate opened and closed without any resistance.

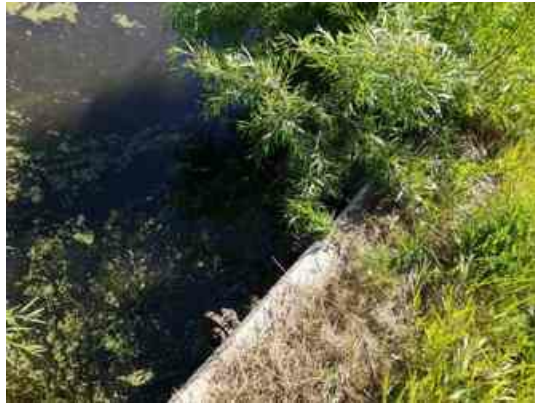
Inspect ID: 2021-0020 **Title:** 2604000007_CELRC_2021_A_0020_1_20210622T140046.jpg **Rated Item:** 11. Flap Gates/ Flap Valves/ Pinch Valves **Caption:** Acceptable - HI-5: Flap gate is closed completely, no obstruction blocks the outlet path. Trees around the concrete structure.

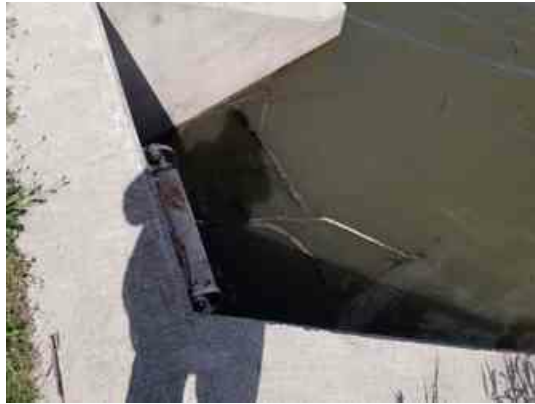
Inspect ID: 2021-0062 **Title:** 2604000007_CELRC_2021_A_0062_1_20210622T150750.jpg **Rated Item:** 11. Flap Gates/ Flap Valves/ Pinch Valves **Caption:** Acceptable - HI-9: The flap gate is completely closed. There is a small amount of debris at the outlet point.

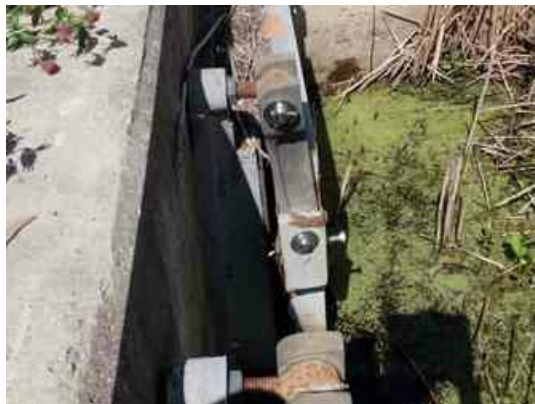
Inspect ID: 2021-0074 **Title:** 2604000007_CELRC_2021_A_0074_1_20210622T152100.jpg **Rated Item:** 11. Flap Gates/ Flap Valves/ Pinch Valves **Caption:** Minimally Acceptable - HI-10: Multiple flap gates not shut completely. Clear debris.

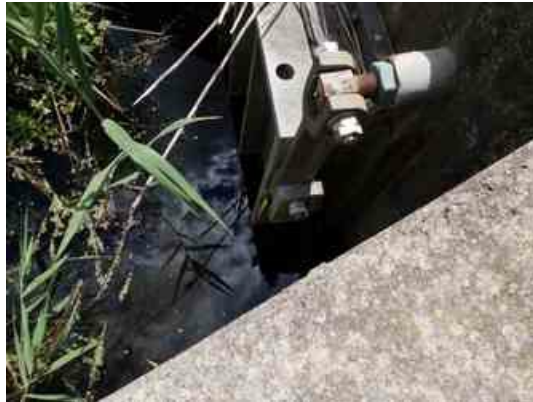
Inspect ID: 2021-0110 **Title:** 2604000007_CELRC_2021_A_0110_1_20210622T155812.jpg **Rated Item:** 11. Flap Gates/ Flap Valves/ Pinch Valves **Caption:** Minimally Acceptable - HI-11: Flap gate not fully closed. Clear debris.

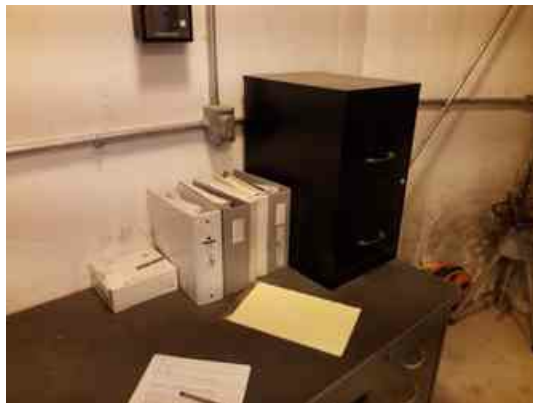
Inspect ID: 2021-0066 **Title:** 2604000007_CELRC_2021_A_0066_1_20210622T145119.jpg **Rated Item:** 1. Pump Stations Operating, Maintenance, Training, & Inspection Records **Caption:** Acceptable - PS-ND: Operations manuals on site.

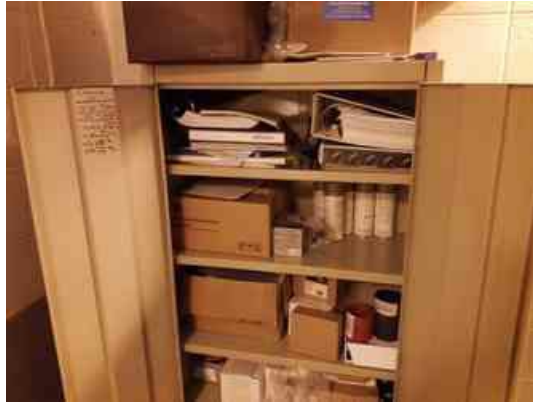
Inspect ID: 2021-0024 **Title:** 2604000007_CELRC_2021_A_0024_1_20210622T133613.jpg **Rated Item:** 2. Pump Station Operations and Maintenance Equipment Manuals **Caption:** Acceptable - PS-81: Operations manuals on site.

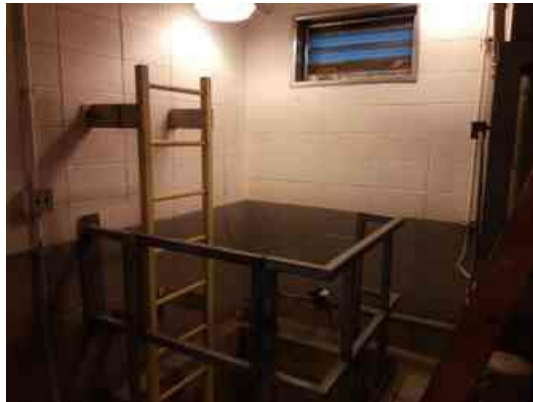
Inspect ID: 2021-0021 **Title:** 2604000007_CELRC_2021_A_0021_1_20210622T133521.jpg **Rated Item:** 3. Safety Compliance **Caption:** Minimally Acceptable - PS-81: Confined space warnings needed throughout.

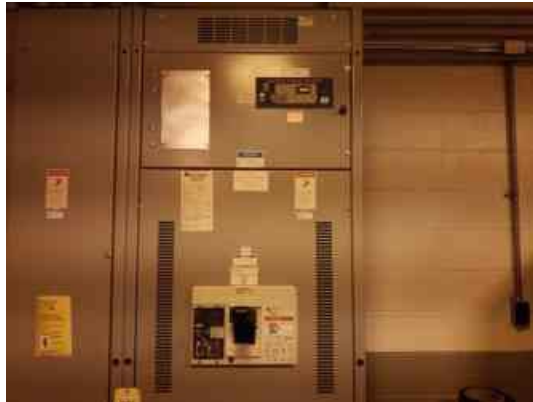
Inspect ID: 2021-0045 **Title:** 2604000007_CELRC_2021_A_0045_1_20210622T141724.jpg **Rated Item:** 3. Safety Compliance **Caption:** Minimally Acceptable - PS-N5: Arc flash labels on switchboard needed.

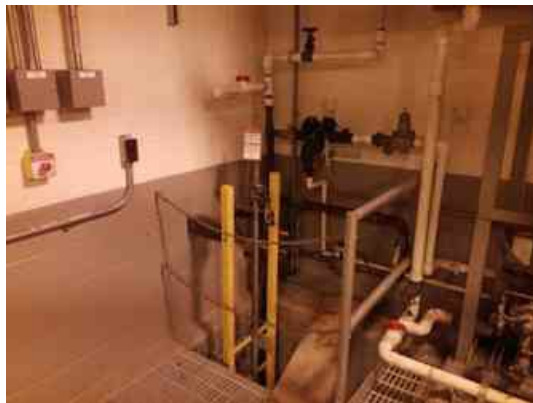
Inspect ID: 2021-0048 **Title:** 2604000007_CELRC_2021_A_0048_1_20210622T141908.jpg **Rated Item:** 3. Safety Compliance **Caption:** Minimally Acceptable - PS-N5: Confined space labels needed throughout building.

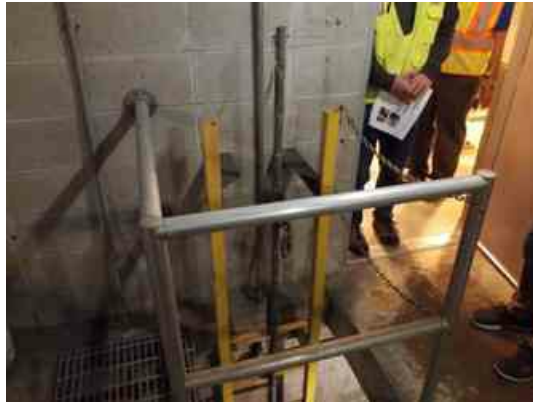
Inspect ID: 2021-0051 **Title:** 2604000007_CELRC_2021_A_0051_1_20210622T142106.jpg **Rated Item:** 3. Safety Compliance **Caption:** Minimally Acceptable - PS-N5: Confined space label needed.

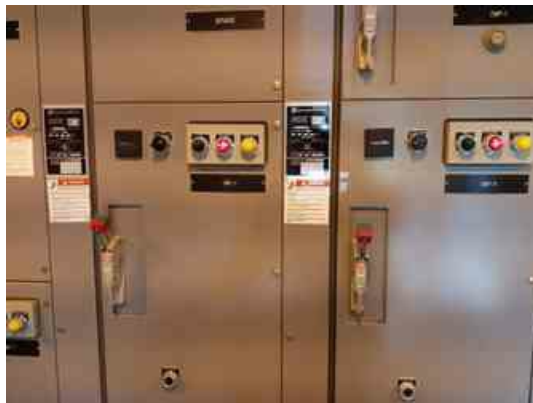
Inspect ID: 2021-0069 **Title:** 2604000007_CELRC_2021_A_0069_1_20210622T145318.jpg **Rated Item:** 3. Safety Compliance **Caption:** Minimally Acceptable - PS-N5: Arc flash labels need updating.
