**US Army Corps
of Engineers®**

Levee Inspection Report

Name of System: Highland

Date(s) of Inspection: 06/22/2021 - 06/22/2021

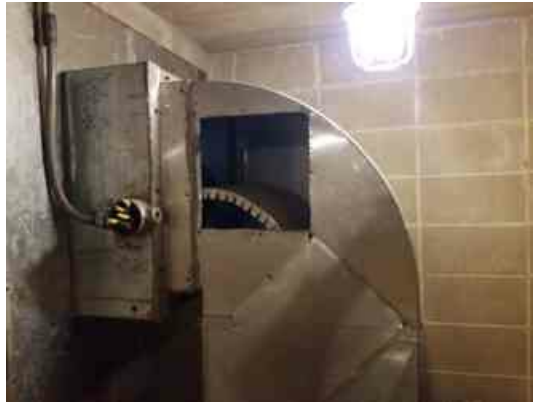
Caption: Minimally Acceptable - PS-N5: EF-3 exhaust fan is inoperable. Local sponsor is aware of issue and planning for replacement.

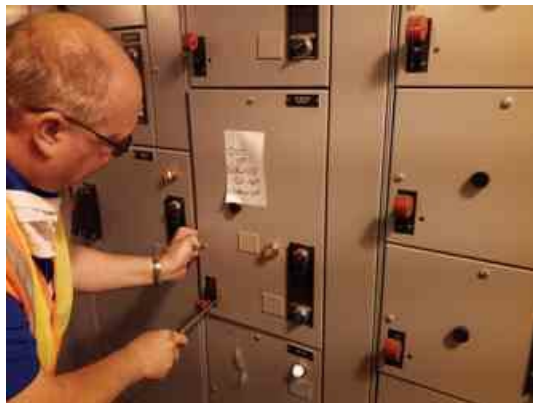
DWP-2 MCC connection is inoperable. Pump appears to be fine, but contacts to energize it are damaged. Investigate and repair.

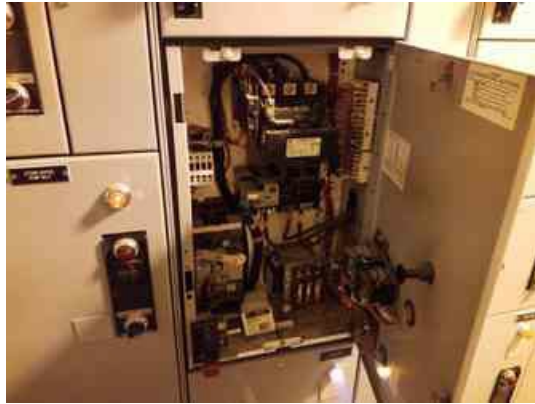
Inspect ID: 2021-0009 **Title:** 2604000007_CELRC_2021_A_2021-0009_2_20210622T133741.jpg **Rated Item:** 14. Electrical Systems
Caption: Minimally Acceptable - PS-81: DWP-2 MCC connection is inoperable. Pump appears to be fine, but contacts to energize it are damaged. Investigate and repair.

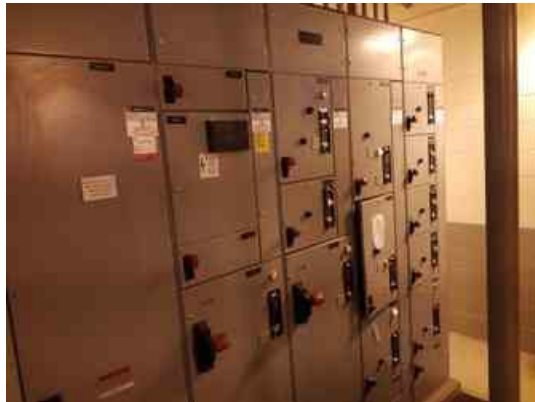
Inspect ID: 2021-0030 **Title:** 2604000007_CELRC_2021_A_0030_1_20210622T135045.jpg **Rated Item:** 14. Electrical Systems
Caption: Minimally Acceptable - PS-81: Arc-flash warnings are needed for equipment throughout building.
