**US Army Corps
of Engineers®**

Levee Inspection Report

Name of System: Munster

Date(s) of Inspection: 06/21/2021 - 06/21/2021

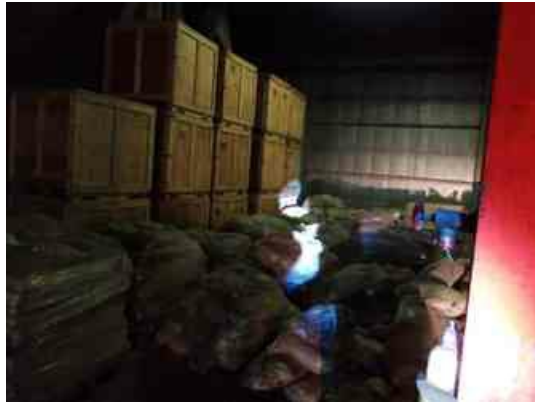
Inspect ID: 2021-0101 **Title:** 2604000009_CELRC_2021_A_0101_1_20210621T152201.jpg **Rated Item:** 2. Emergency Supplies and Equipment (A or M only) **Caption:** Acceptable - Materials and sandbags, no change from last year around 120,000 sandbags. Forklift on site, emergency access available.

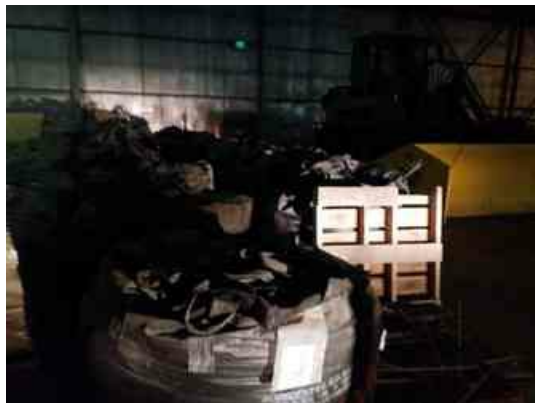
Inspect ID: 2021-0101 **Title:** 2604000009_CELRC_2021_A_2021-0101_2_20210621T152244.jpg **Rated Item:** 2. Emergency Supplies and Equipment (A or M only) **Caption:** Acceptable - Materials and sandbags, no change from last year around 120,000 sandbags. Forklift on site, emergency access available.

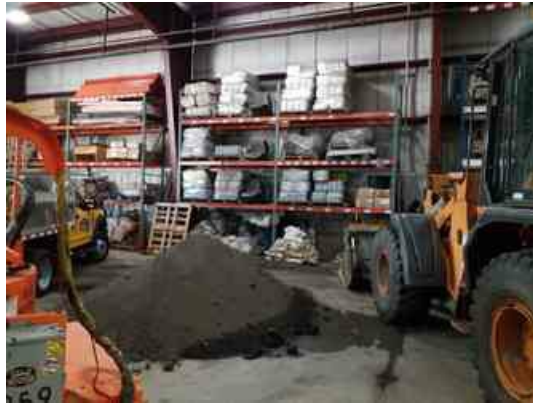
Inspect ID: 2021-0104 **Title:** 2604000009_CELRC_2021_A_0104_1_20210621T153216.jpg **Rated Item:** 2. Emergency Supplies and Equipment (A or M only) **Caption:** Acceptable - A more immediate location for emergency supplies storage. Sangbags and sandbag machine present.

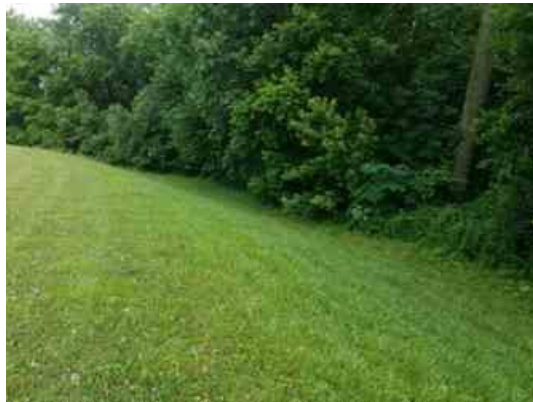
Inspect ID: 2021-0052 **Title:** 2604000009_CELRC_2021_A_0052_1_20210621T134740.jpg **Rated Item:** 1. Unwanted Vegetation Growth **Caption:** Minimally Acceptable - Trees near riverside toe. Clear within vegetation free zone.

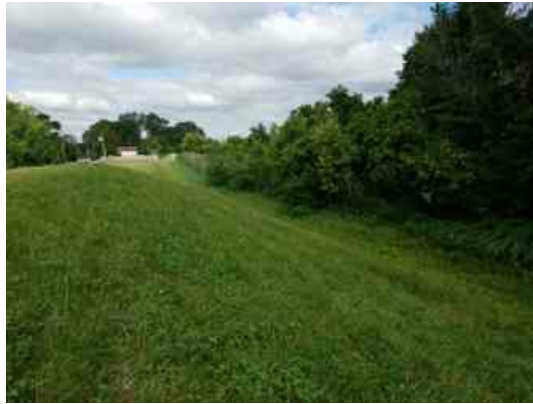
Inspect ID: 2021-0055 **Title:** 2604000009_CELRC_2021_A_0055_1_20210621T135014.jpg **Rated Item:** 1. Unwanted Vegetation Growth **Caption:** Minimally Acceptable - Trees near riverside toe. Clear within vegetation free zone.

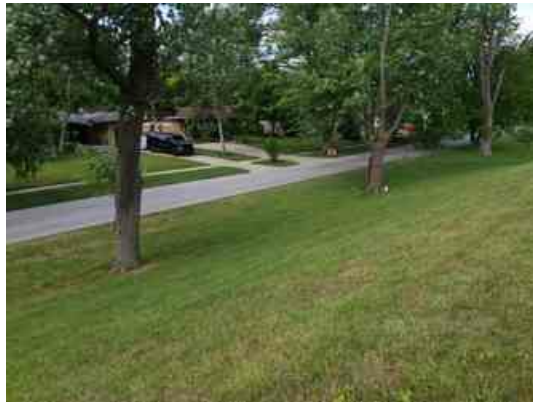
Inspect ID: 2021-0058 **Title:** 2604000009_CELRC_2021_A_0058_1_20210621T135239.jpg **Rated Item:** 1. Unwanted Vegetation Growth **Caption:** Minimally Acceptable - Large trees on landside toe, dying. Remove.

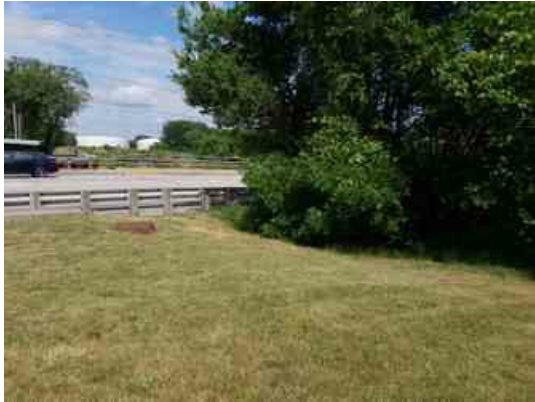
<p>Inspect ID: 2021-0187 Title: 2604000009_CELRC_2021_A_0187_1_20210621T152800.jpg Rated Item: 1. Unwanted Vegetation Growth Caption: Minimally Acceptable - Trees near riverside toe. Clear within vegetation free zone.</p>

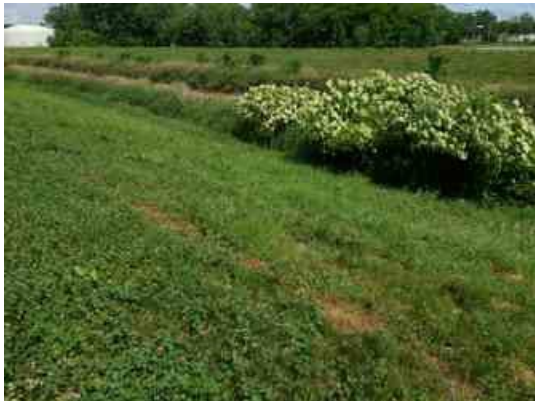
<p>Inspect ID: 2021-0196 Title: 2604000009_CELRC_2021_A_0196_1_20210621T153550.jpg Rated Item: 1. Unwanted Vegetation Growth Caption: Acceptable - Large bushes on riverside toe. Monitor.</p>

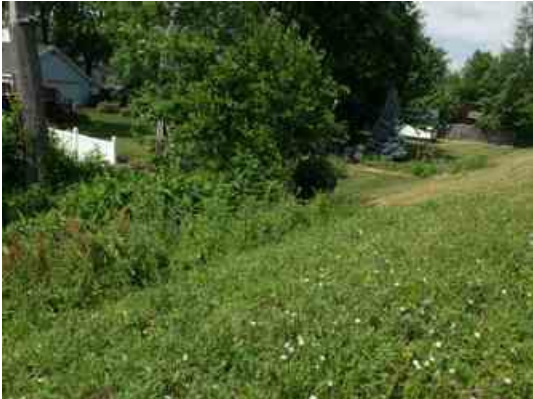
<p>Inspect ID: 2021-0205 Title: 2604000009_CELRC_2021_A_0205_1_20210621T153932.jpg Rated Item: 1. Unwanted Vegetation Growth Caption: Minimally Acceptable - Tall veg and trees on landside. Clear within vegetation free zone.</p>

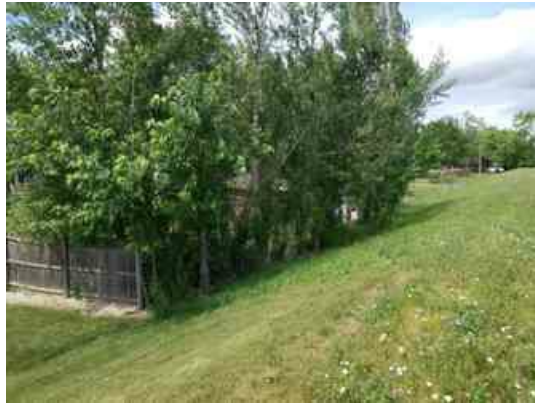
Inspect ID: 2021-0214 **Title:** 2604000009_CELRC_2021_A_0214_1_20210621T154225.jpg **Rated Item:** 1. Unwanted Vegetation Growth **Caption:** Minimally Acceptable - Trees on landside toe. Clear within vegetation free zone.

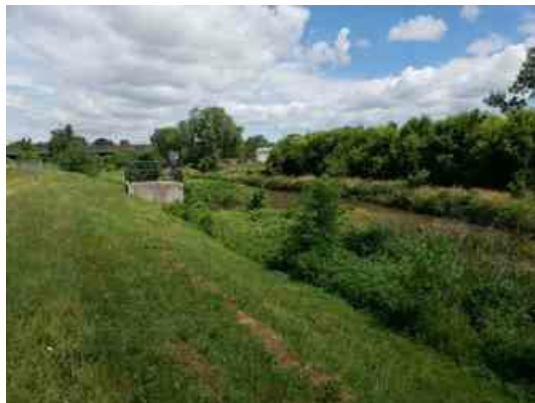
Inspect ID: 2021-0265 **Title:** 2604000009_CELRC_2021_A_0265_1_20210621T161217.jpg **Rated Item:** 1. Unwanted Vegetation Growth **Caption:** Acceptable - Tall vegetation on riverside. Monitor.

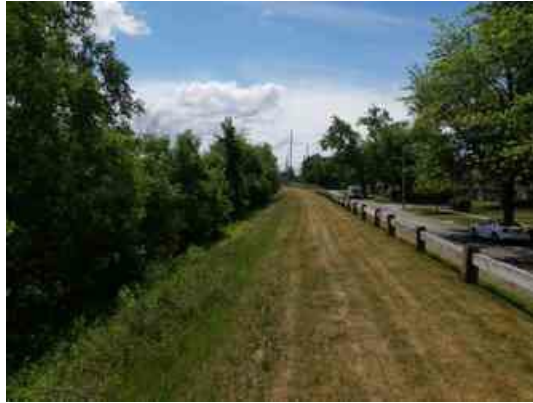
Inspect ID: 2021-0271 **Title:** 2604000009_CELRC_2021_A_0271_1_20210621T162015.jpg **Rated Item:** 1. Unwanted Vegetation Growth **Caption:** Minimally Acceptable - Trees on riverside. Clear within vegetation free zone.

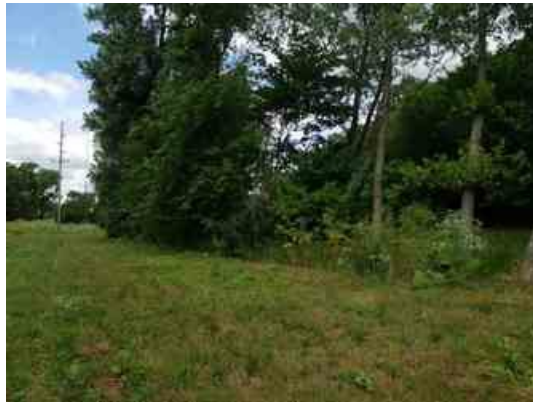
Inspect ID: 2021-0274 **Title:** 2604000009_CELRC_2021_A_0274_1_20210621T162658.jpg **Rated Item:** 1. Unwanted Vegetation Growth **Caption:** Minimally Acceptable - Trees on landside. Clear within vegetation free zone.

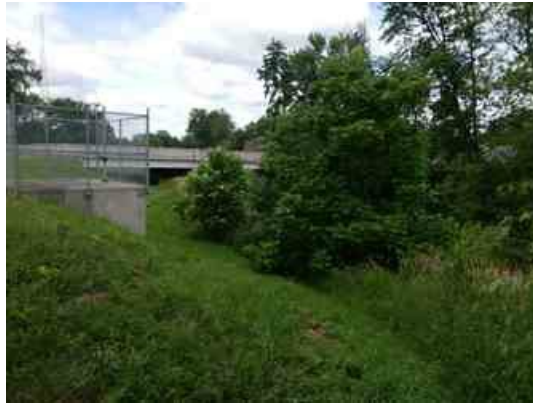
Inspect ID: 2021-0277 **Title:** 2604000009_CELRC_2021_A_0277_1_20210621T162944.jpg **Rated Item:** 1. Unwanted Vegetation Growth **Caption:** Minimally Acceptable - Trees on riverside. Clear within vegetation free zone.

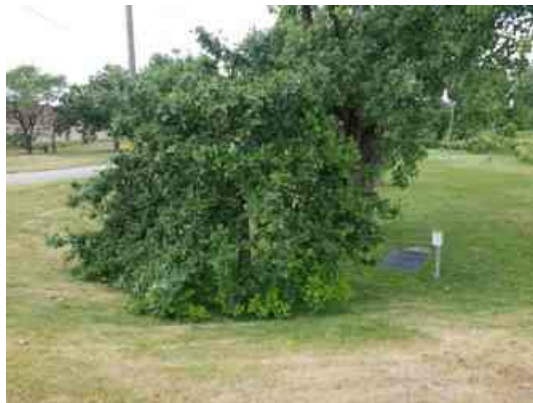
Inspect ID: 2021-0280 **Title:** 2604000009_CELRC_2021_A_0280_1_20210621T163206.jpg **Rated Item:** 1. Unwanted Vegetation Growth **Caption:** Minimally Acceptable - Trees on landside. Clear within vegetation free zone.

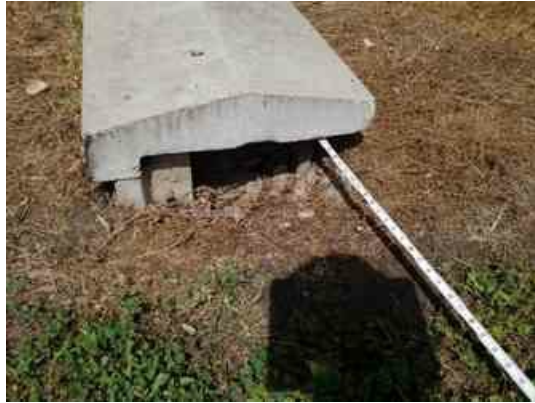
Inspect ID: 2021-0241 **Title:** 2604000009_CELRC_2021_A_0241_1_20210621T155547.jpg **Rated Item:** 7. Settlement **Caption:** Minimally Acceptable - Settlement at floodwall tie-in. Fill to match as-built elevation.

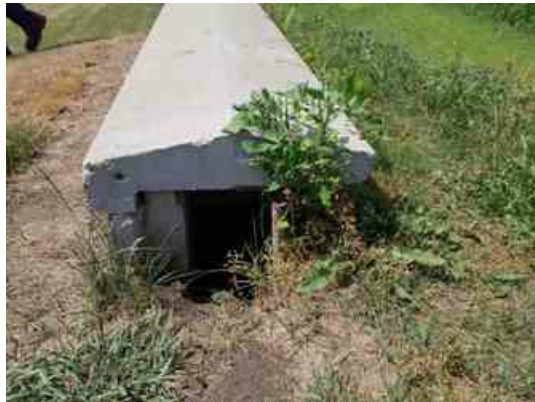
Inspect ID: 2021-0253 **Title:** 2604000009_CELRC_2021_A_0253_1_20210621T160157.jpg **Rated Item:** 7. Settlement **Caption:** Minimally Acceptable - Settlement at floodwall tie-in. Fill to match as-built elevation.

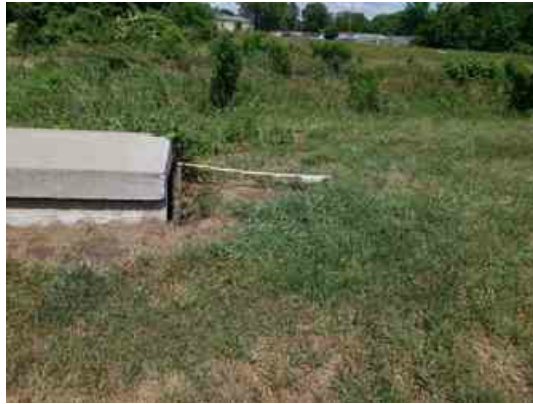
Inspect ID: 2021-0253 **Title:** 2604000009_CELRC_2021_A_2021-0253_2_20210621T160300.jpg **Rated Item:** 7. Settlement **Caption:** Minimally Acceptable - Settlement at floodwall tie-in. Fill to match as-built elevation.

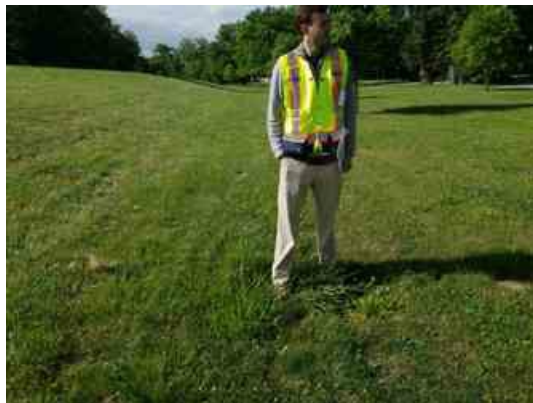
Inspect ID: 2021-0049 **Title:** 2604000009_CELRC_2021_A_0049_1_20210621T134229.jpg **Rated Item:** 8. Depressions/ Rutting **Caption:** Acceptable - Small depression on landside toe. Monitor.

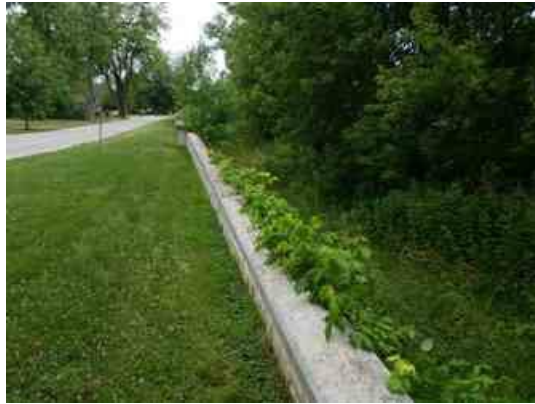
Inspect ID: 2021-0004 **Title:** 2604000009_CELRC_2021_A_0004_1_20210621T132007.jpg **Rated Item:** 1. Unwanted Vegetation Growth **Caption:** Acceptable - Small trees on riverside. Monitor.

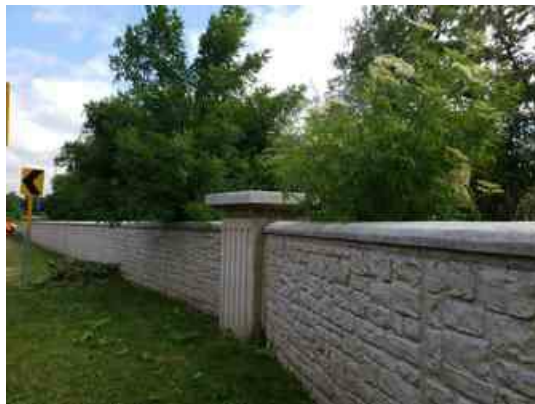
Inspect ID: 2021-0025 **Title:** 2604000009_CELRC_2021_A_0025_1_20210621T133135.jpg **Rated Item:** 1. Unwanted Vegetation Growth **Caption:** Minimally Acceptable - Trees on riverside. Remove.

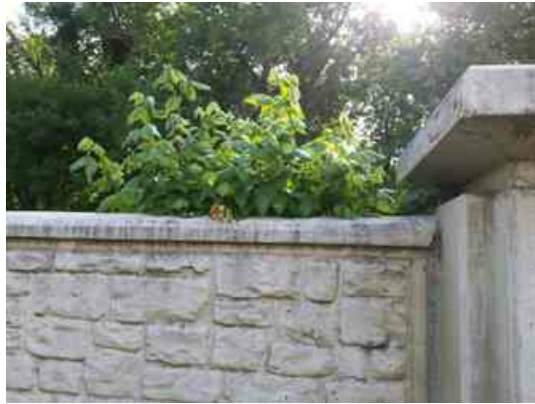
Inspect ID: 2021-0034 **Title:** 2604000009_CELRC_2021_A_0034_1_20210621T133352.jpg **Rated Item:** 1. Unwanted Vegetation Growth **Caption:** Acceptable - Bush on riverside. Monitor.

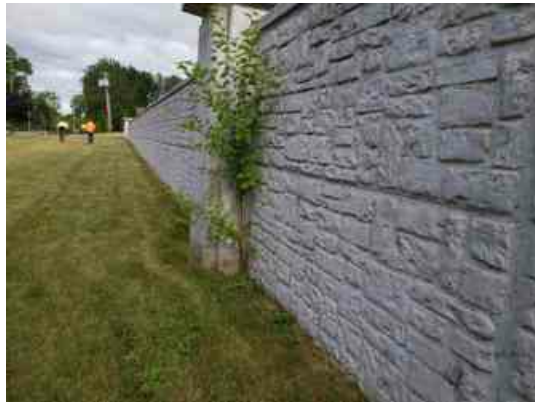
Inspect ID: 2021-0064 **Title:** 2604000009_CELRC_2021_A_0064_1_20210621T135530.jpg **Rated Item:** 1. Unwanted Vegetation Growth **Caption:** Acceptable - Small tree on landside. Monitor.

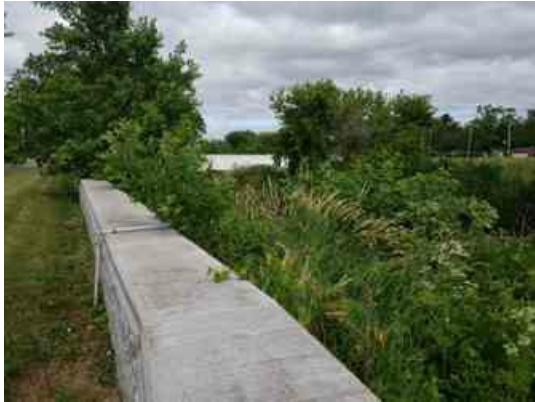
<p>Inspect ID: 2021-0079 Title: 2604000009_CELRC_2021_A_0079_1_20210621T140233.jpg Rated Item: 1. Unwanted Vegetation Growth Caption: Minimally Acceptable - Small trees on riverside. Remove.</p>

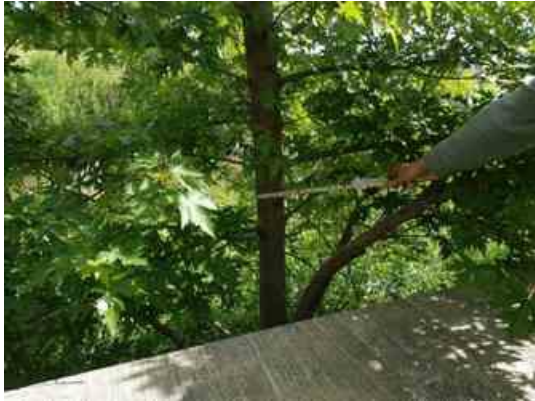
<p>Inspect ID: 2021-0085 Title: 2604000009_CELRC_2021_A_0085_1_20210621T140415.jpg Rated Item: 1. Unwanted Vegetation Growth Caption: Minimally Acceptable - Medium tree on riverside. Remove.</p>

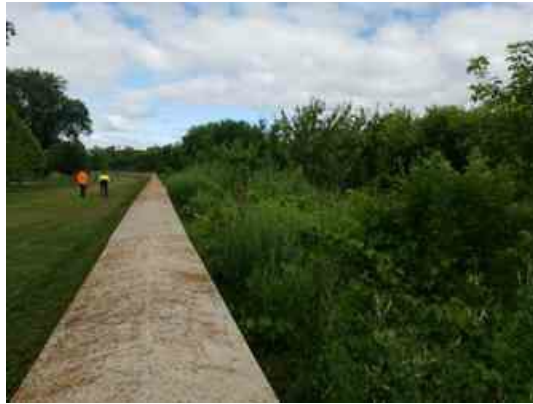
Inspect ID: 2021-0094 **Title:** 2604000009_CELRC_2021_A_0094_1_20210621T140832.jpg **Rated Item:** 1. Unwanted Vegetation Growth **Caption:** Acceptable - Tall vegetation on riverside. Monitor.

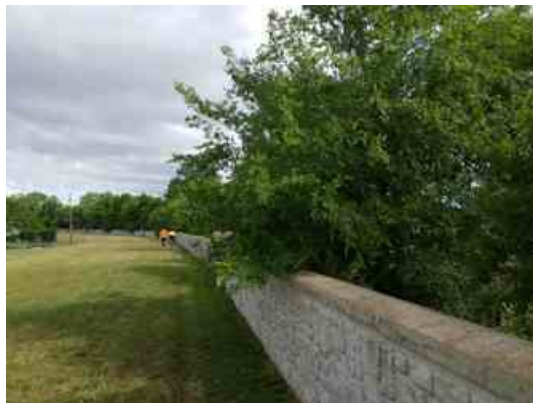
Inspect ID: 2021-0133 **Title:** 2604000009_CELRC_2021_A_0133_1_20210621T144126.jpg **Rated Item:** 1. Unwanted Vegetation Growth **Caption:** Minimally Acceptable - Trees on riverside. Remove.

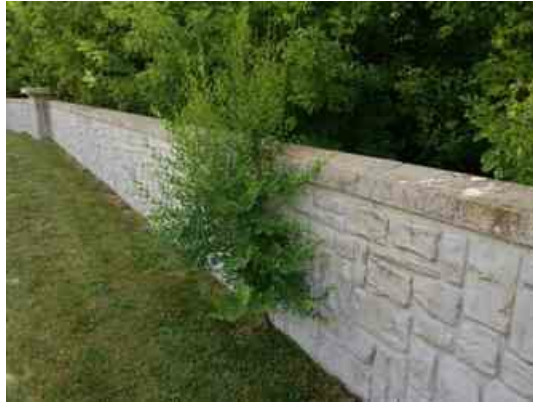
Inspect ID: 2021-0136 **Title:** 2604000009_CELRC_2021_A_0136_1_20210621T144342.jpg **Rated Item:** 1. Unwanted Vegetation Growth **Caption:** Minimally Acceptable - Small tree on landside. Remove.

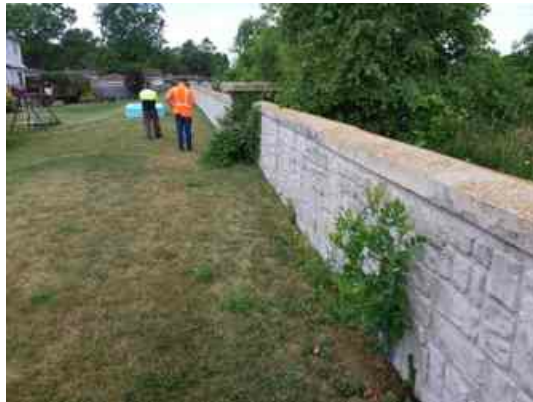
Inspect ID: 2021-0139 **Title:** 2604000009_CELRC_2021_A_0139_1_20210621T144651.jpg **Rated Item:** 1. Unwanted Vegetation Growth **Caption:** Acceptable - Bushes on landside. Monitor.

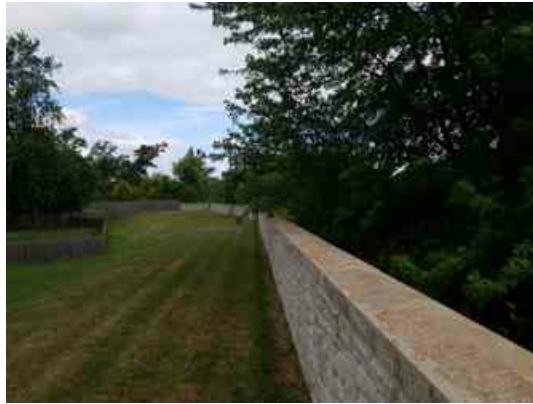
Inspect ID: 2021-0151 **Title:** 2604000009_CELRC_2021_A_0151_1_20210621T145350.jpg **Rated Item:** 1. Unwanted Vegetation Growth **Caption:** Minimally Acceptable - Trees on riverside. Remove.

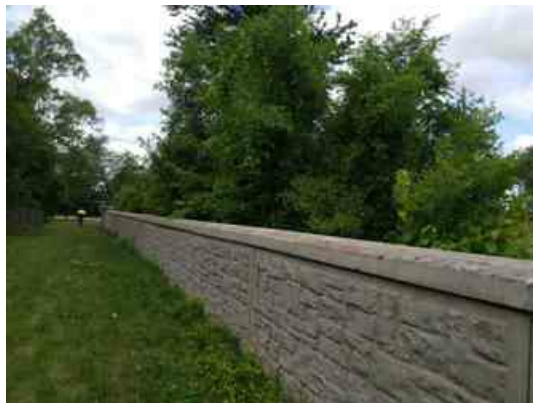
Inspect ID: 2021-0163 **Title:** 2604000009_CELRC_2021_A_0163_1_20210621T150439.jpg **Rated Item:** 1. Unwanted Vegetation Growth **Caption:** Minimally Acceptable - Trees on riverside. Remove.

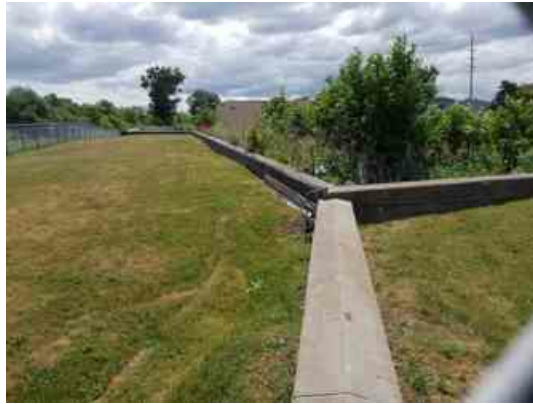
Inspect ID: 2021-0184 **Title:** 2604000009_CELRC_2021_A_0184_1_20210621T152702.jpg **Rated Item:** 1. Unwanted Vegetation Growth **Caption:** Acceptable - Tall veg on landside. Monitor.

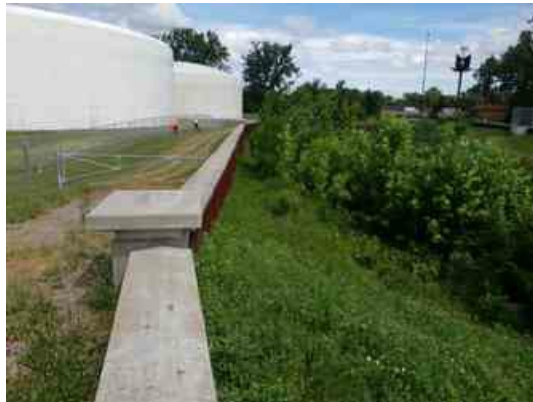
Inspect ID: 2021-0223 **Title:** 2604000009_CELRC_2021_A_0223_1_20210621T154643.jpg **Rated Item:** 1. Unwanted Vegetation Growth **Caption:** Minimally Acceptable - Tall vegetation on riverside. Monitor.

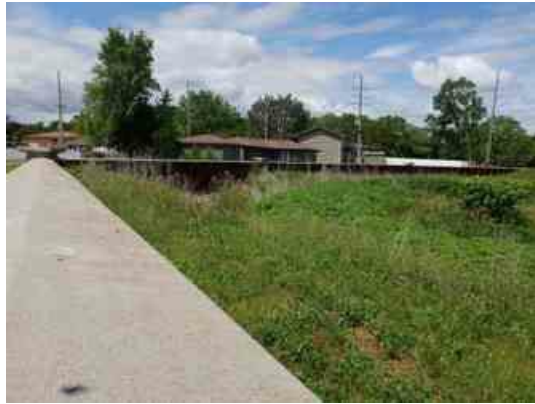
Inspect ID: 2021-0259 **Title:** 2604000009_CELRC_2021_A_0259_1_20210621T160840.jpg **Rated Item:** 1. Unwanted Vegetation Growth **Caption:** Acceptable - Tall vegetation on riverside. Monitor.

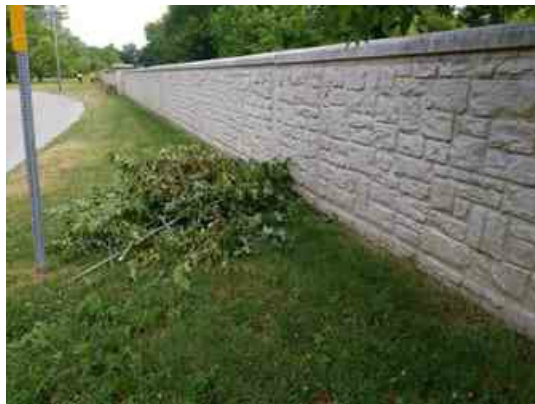
Inspect ID: 2021-0028 **Title:** 2604000009_CELRC_2021_A_0028_1_20210621T133217.jpg **Rated Item:** 2. Encroachments **Caption:** Minimally Acceptable - Pile of branches on landside. Remove.

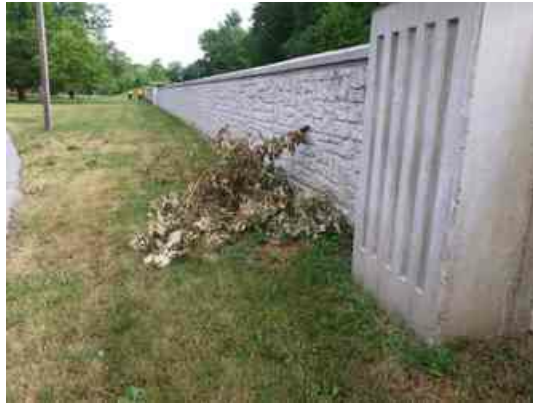
Inspect ID: 2021-0031 **Title:** 2604000009_CELRC_2021_A_0031_1_20210621T133258.jpg **Rated Item:** 2. Encroachments **Caption:** Minimally Acceptable - Pile of branches on landside. Remove.

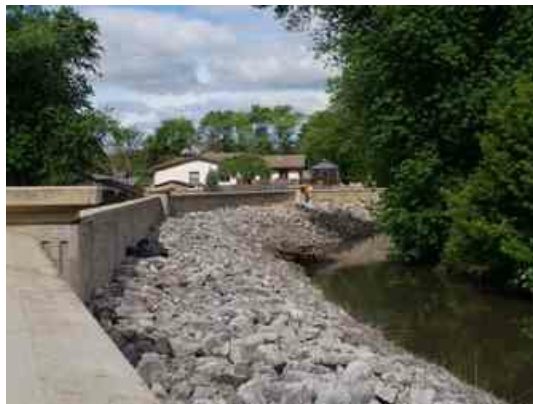
Inspect ID: 2021-0124 **Title:** 2604000009_CELRC_2021_A_0124_1_20210621T142807.jpg **Rated Item:** 2. Encroachments **Caption:** Minimally Acceptable - Trash bags on riverside. Remove.

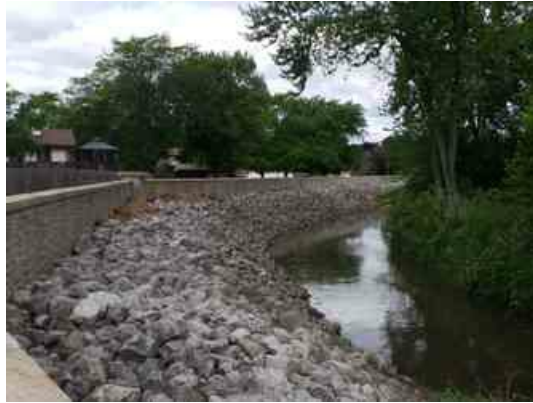
Inspect ID: 2021-0130 **Title:** 2604000009_CELRC_2021_A_0130_1_20210621T143204.jpg **Rated Item:** 2. Encroachments **Caption:** Minimally Acceptable - Grass trimmings on riverside. Remove.

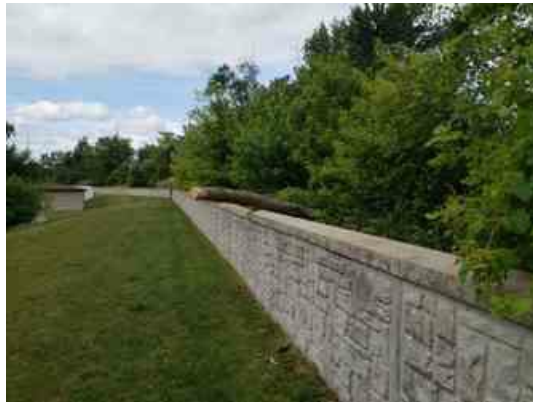
Inspect ID: 2021-0154 **Title:** 2604000009_CELRC_2021_A_0154_1_20210621T145633.jpg **Rated Item:** 2. Encroachments **Caption:** Minimally Acceptable - Remove tree from top of wall.

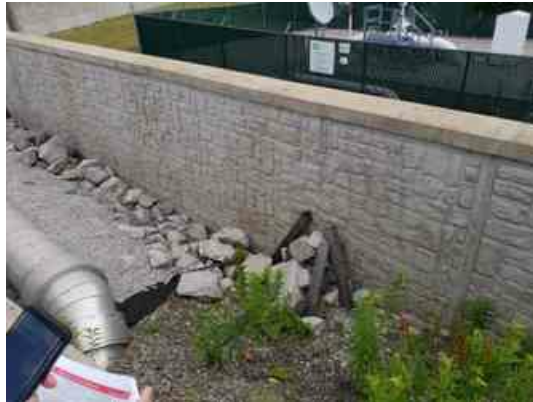
Inspect ID: 2021-0160 **Title:** 2604000009_CELRC_2021_A_0160_1_20210621T150227.jpg **Rated Item:** 2. Encroachments **Caption:** Minimally Acceptable - Timber stone debris pile on riverside. Remove.

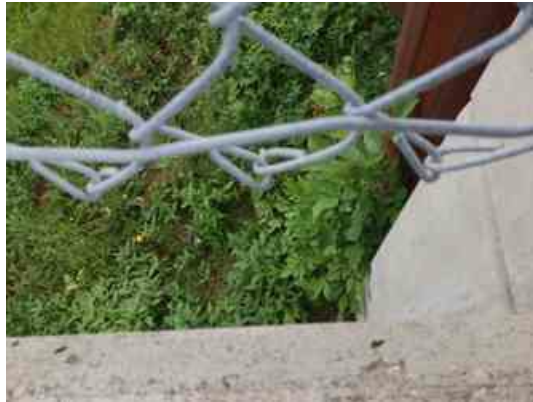
Inspect ID: 2021-0026 **Title:** 2604000009_CELRC_2021_A_0026_1_20210621T140042.jpg **Rated Item:** 1. Vegetation and Obstructions **Caption:** Minimally Acceptable - MU-8: Tree growing by the joint connecting MU-8 and floodwall. Remove.

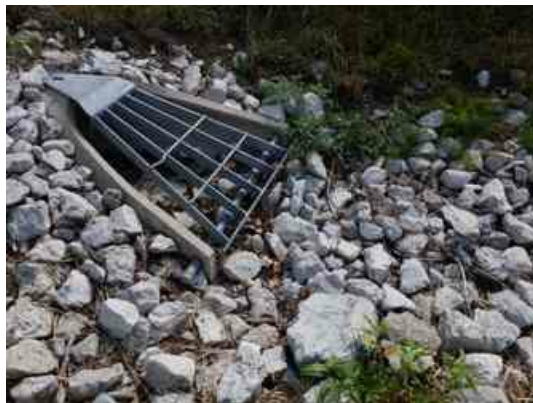
Inspect ID: 2021-0053 **Title:** 2604000009_CELRC_2021_A_0053_1_20210621T142223.jpg **Rated Item:** 1. Vegetation and Obstructions **Caption:** Acceptable - MU-5: Small amount of trash and vegetation at inlet trash rack.

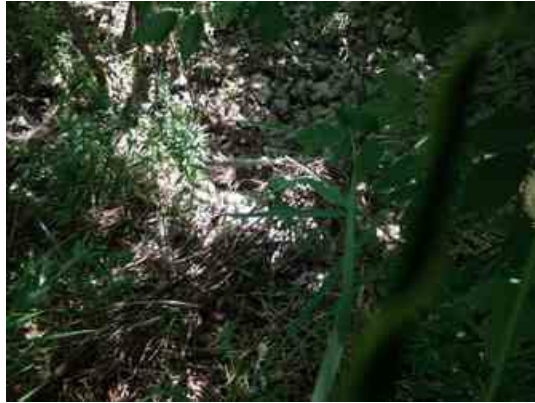
Inspect ID: 2021-0107 **Title:** 2604000009_CELRC_2021_A_0107_1_20210621T161422.jpg **Rated Item:** 1. Vegetation and Obstructions **Caption:** Minimally Acceptable - MU-3: Intake structure blocked by vegetation, clear.

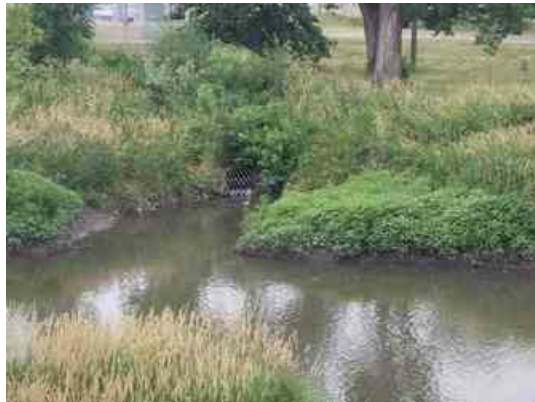
Inspect ID: 2021-0286 **Title:** 2604000009_CELRC_2021_A_0286_1_20210624T160312.jpg **Rated Item:** 1. Vegetation and Obstructions **Caption:** Minimally Acceptable - MU-1: Vegetation at outlet, clear.

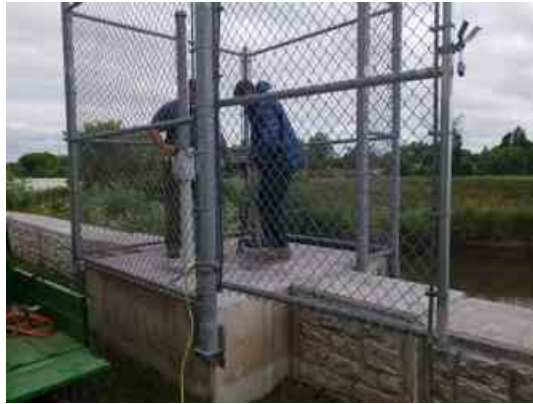
Inspect ID: 2021-0008 **Title:** 2604000009_CELRC_2021_A_0008_1_20210621T132634.jpg **Rated Item:** 4. Fencing and Gates **Caption:** Acceptable - MU-11: Gate and concrete structure for the sluice gate is in good shape.

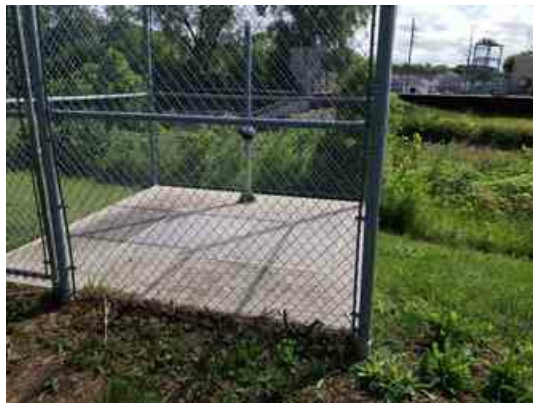
Inspect ID: 2021-0047 **Title:** 2604000009_CELRC_2021_A_0047_1_20210621T141903.jpg **Rated Item:** 4. Fencing and Gates **Caption:** Acceptable - MU-6: Gate structure has a very small branch growing at the bottom right hand corner.

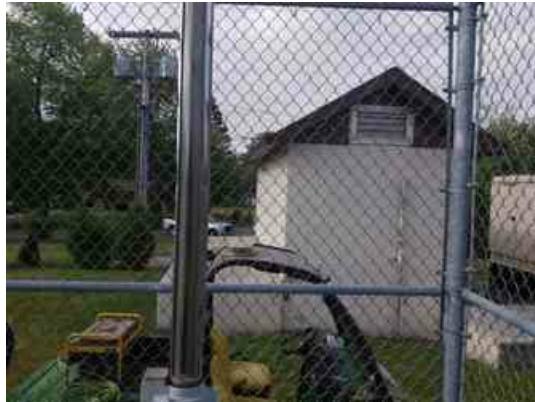
Inspect ID: 2021-0005 **Title:** 2604000009_CELRC_2021_A_2021-0005_2_20210621T133136.jpg **Rated Item:** 10. Sluice/ Slide Gates
Caption: Acceptable - MU-11: Sluice gate is well oiled, goes up and down with no resistance.

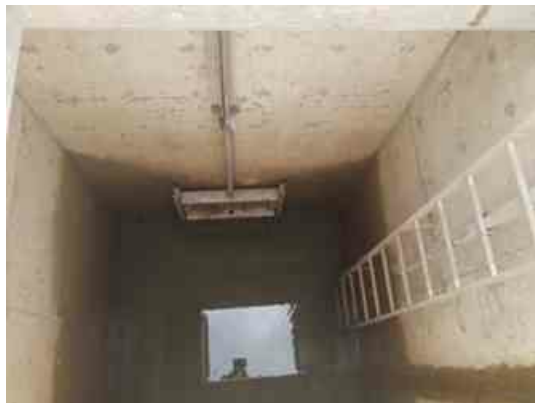
Inspect ID: 2021-0020 **Title:** 2604000009_CELRC_2021_A_0020_1_20210621T135543.jpg **Rated Item:** 10. Sluice/ Slide Gates **Caption:** Acceptable - MU-8: Not much silt in the gatewell.

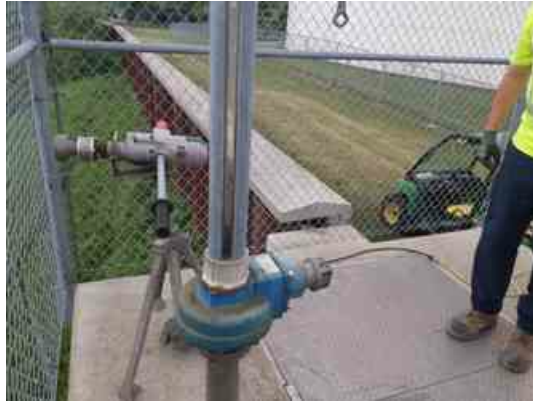
Inspect ID: 2021-0023 **Title:** 2604000009_CELRC_2021_A_0023_1_20210621T135830.jpg **Rated Item:** 10. Sluice/ Slide Gates **Caption:** Acceptable - MU-8: Sluice gate is well oiled, it opens and closes without any resistance.

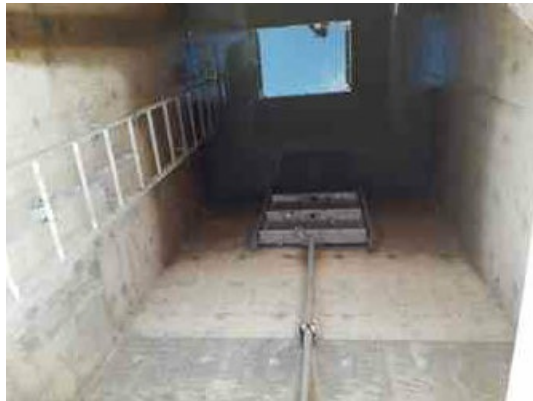
Inspect ID: 2021-0038 **Title:** 2604000009_CELRC_2021_A_0038_1_20210621T141309.jpg **Rated Item:** 10. Sluice/ Slide Gates **Caption:** Acceptable - MU-6: No silt inside the gatewell.

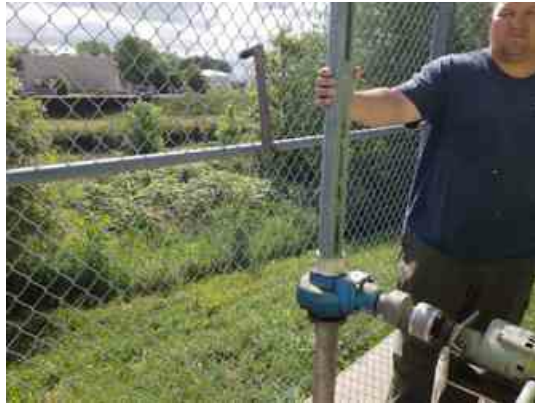
Inspect ID: 2021-0041 **Title:** 2604000009_CELRC_2021_A_0041_1_20210621T141702.jpg **Rated Item:** 10. Sluice/ Slide Gates **Caption:** Acceptable - MU-6: Sluice gate opened and closed without any resistance.

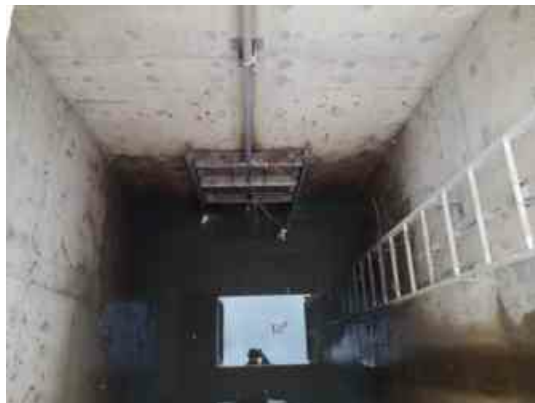
Inspect ID: 2021-0059 **Title:** 2604000009_CELRC_2021_A_0059_1_20210621T142609.jpg **Rated Item:** 10. Sluice/ Slide Gates **Caption:** Minimally Acceptable - MU-4: Sluice gate has sediment/vegetation inside of the gatewell. Clean.

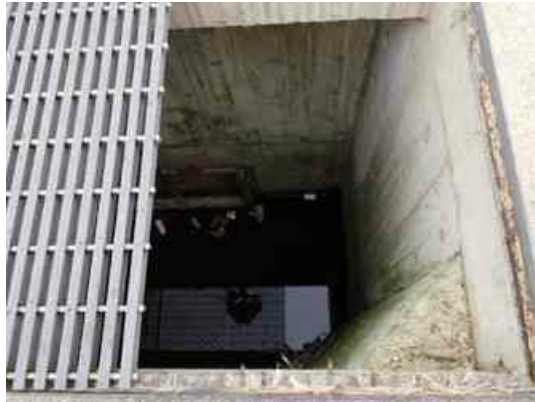
Inspect ID: 2021-0080 **Title:** 2604000009_CELRC_2021_A_0080_1_20210621T144854.jpg **Rated Item:** 10. Sluice/ Slide Gates **Caption:** Minimally Acceptable - MU-2: Gatewell has minor trash and debris that needs to be cleared.

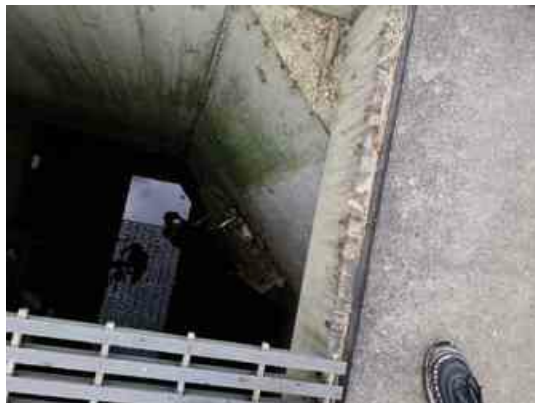
Inspect ID: 2021-0083 **Title:** 2604000009_CELRC_2021_A_0083_1_20210621T145119.jpg **Rated Item:** 10. Sluice/ Slide Gates **Caption:** Acceptable - MU-3: Trash in gatewell. Clean.

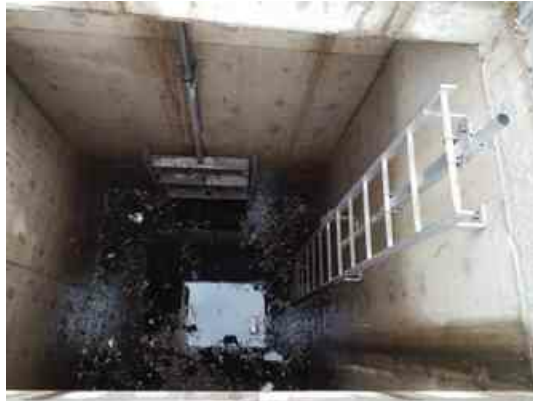
Item: 10. Sluice/ Slide Gates **Caption:** Acceptable - MU-2: Sluice gate is in good condition. Minor sediment inside of the pit.

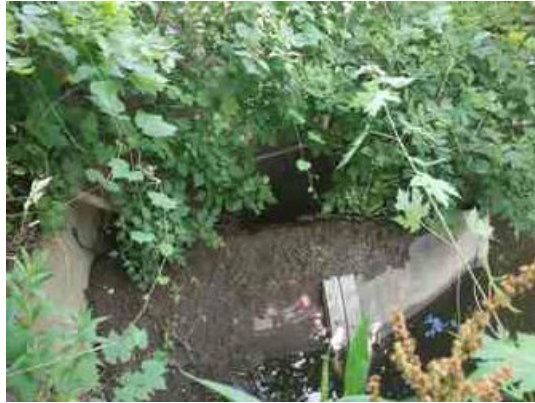
Inspect ID: 2021-0011 **Title:** 2604000009_CELRC_2021_A_0011_1_20210621T134501.jpg **Rated Item:** 11. Flap Gates/ Flap Valves/ Pinch Valves **Caption:** Minimally Acceptable - MU-10: Sediment and vegetation by the duck bill. Clear.

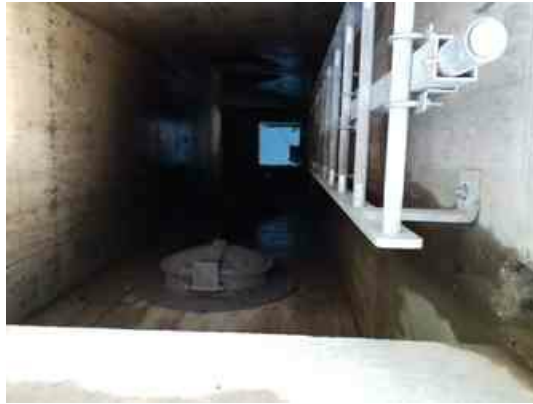
Inspect ID: 2021-0050 **Title:** 2604000009_CELRC_2021_A_0050_1_20210621T142115.jpg **Rated Item:** 11. Flap Gates/ Flap Valves/ Pinch Valves **Caption:** Acceptable - MU-5: Flap gate is closed completely.

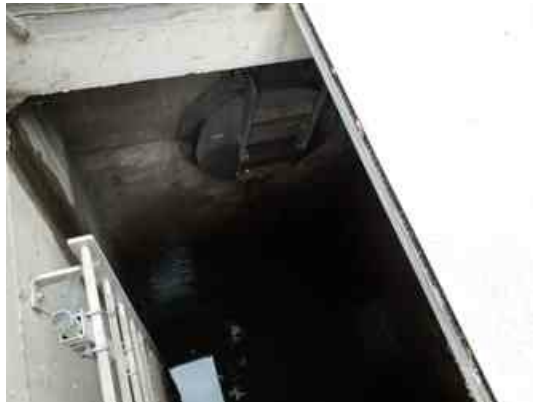
Inspect ID: 2021-0071 **Title:** 2604000009_CELRC_2021_A_0071_1_20210621T143325.jpg **Rated Item:** 11. Flap Gates/ Flap Valves/ Pinch Valves **Caption:** Acceptable - MU-4: The flap gate is closed completely.

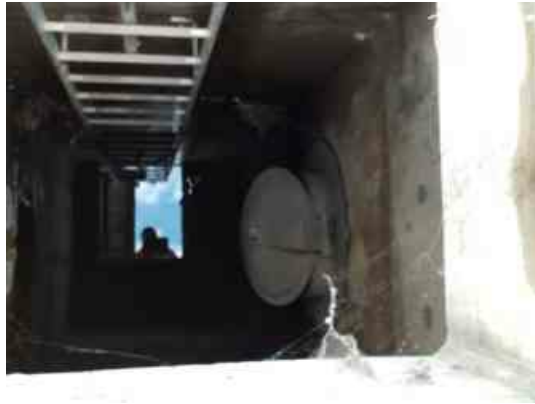
Item: 11. Flap Gates/ Flap Valves/ Pinch Valves **Caption:** Minimally Acceptable - MU-3: Flap gate isn't completely closed. Clear obstructions.

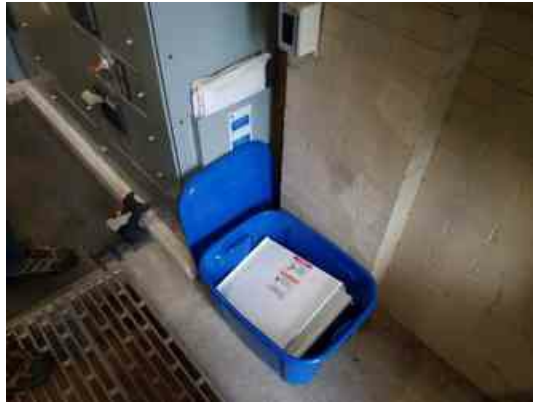
Inspect ID: 2021-0006 **Title:** 2604000009_CELRC_2021_A_0006_1_20210621T132644.jpg **Rated Item:** 2. Pump Station Operations and Maintenance Equipment Manuals
Caption: Acceptable - Ps_ba operations manuals on site

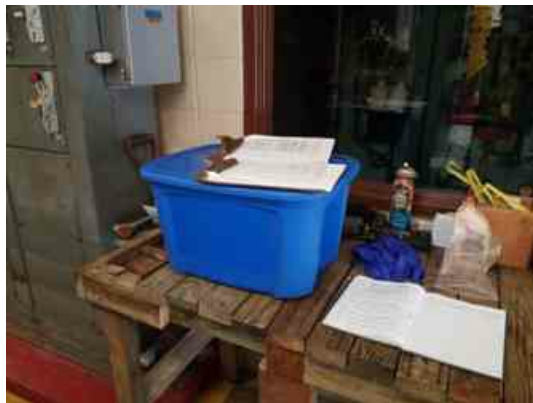
Inspect ID: 2021-0021 **Title:** 2604000009_CELRC_2021_A_0021_1_20210621T134951.jpg **Rated Item:** 2. Pump Station Operations and Maintenance Equipment Manuals
Caption: Acceptable - Ps-ca operations manuals on site

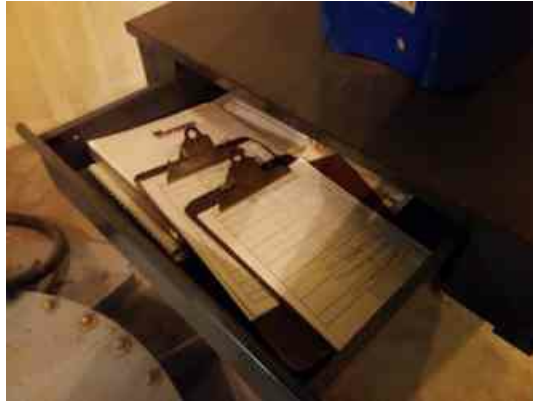
Inspect ID: 2021-0048 **Title:**
2604000009_CELRC_2021_A_0048_1_20210621T142033.jpg **Rated**
Item: 2. Pump Station Operations and Maintenance Equipment Manuals
Caption: Acceptable - Ps-ca pump station manuals on site

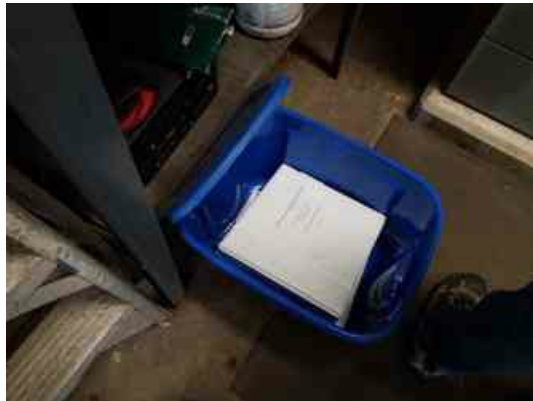
Inspect ID: 2021-0057 **Title:**
2604000009_CELRC_2021_A_0057_1_20210621T143953.jpg **Rated**
Item: 2. Pump Station Operations and Maintenance Equipment Manuals
Caption: Acceptable - Ps hm operations manuals on site

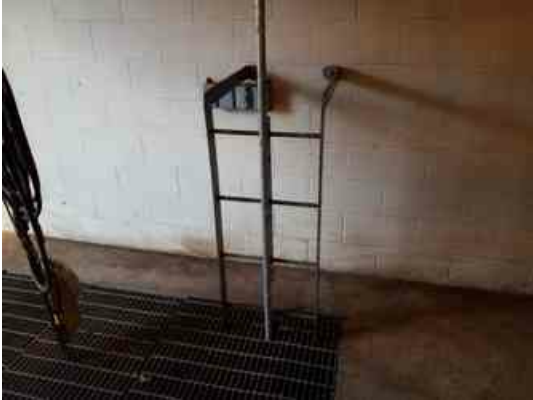
<p>Inspect ID: 2021-0045 Title: 2604000009_CELRC_2021_A_0045_1_20210621T141529.jpg Rated Item: 3. Safety Compliance Caption: Minimally Acceptable - PS-OA: Add confined space warnings throughout building.</p>

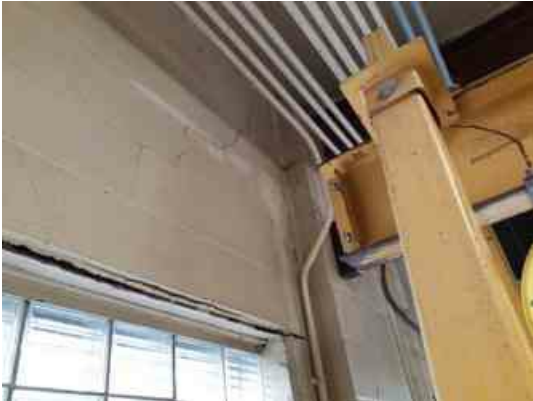
Inspect ID: 2021-0060 Title: 2604000009_CELRC_2021_A_0060_2_20210621T144117.jpg Rated Item: 5. Plant Building Caption: Minimally Acceptable - PS-HM: Cracks near window frames should be repaired.

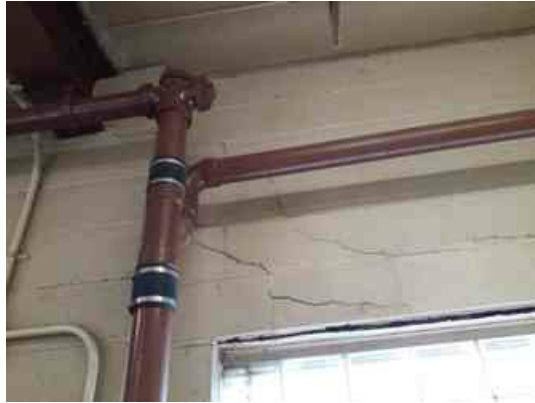
Inspect ID: 2021-0060 **Title:** 2604000009_CELRC_2021_A_0060_3_20210621T144127.jpg **Rated Item:** 5. Plant Building **Caption:** Minimally Acceptable - PS-HM: Cracks near window frames should be repaired.

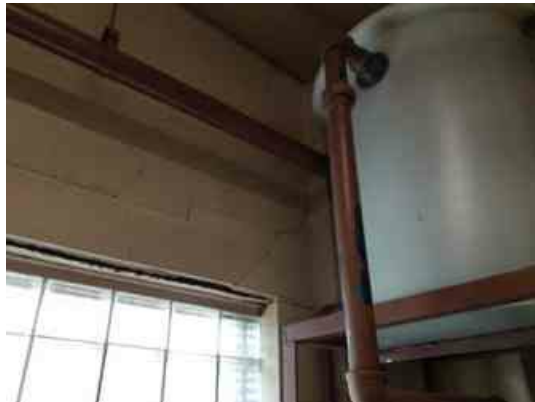
Inspect ID: 2021-0060 **Title:** 2604000009_CELRC_2021_A_0060_4_20210621T144223.jpg **Rated Item:** 5. Plant Building **Caption:** Minimally Acceptable - PS-HM: Cracks near window frames should be repaired.

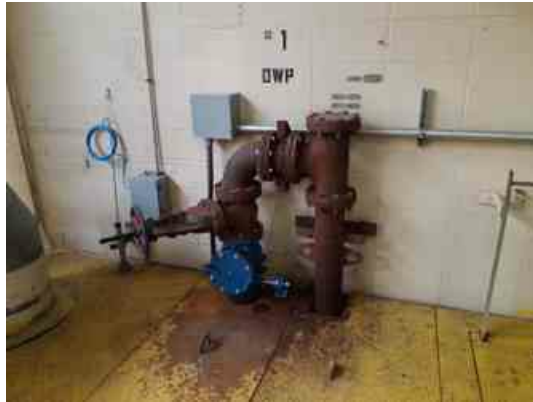
Inspect ID: 2021-0015 **Title:** 2604000009_CELRC_2021_A_0015_1_20210621T134403.jpg **Rated Item:** 7. Pumps **Caption:** Acceptable - PS-CA: DWP-1 pump in service.

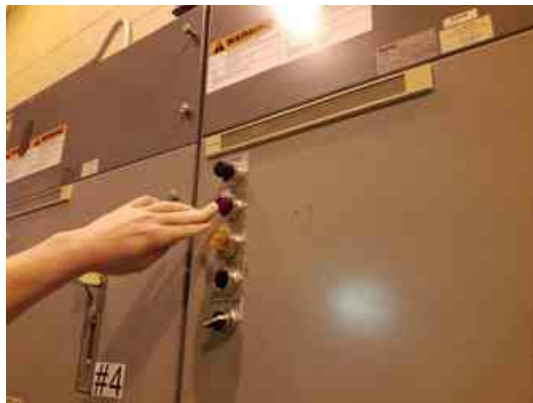
Inspect ID: 2021-0051 **Title:** 2604000009_CELRC_2021_A_0051_1_20210621T142411.jpg **Rated Item:** 14. Electrical Systems **Caption:** Minimally Acceptable - PS-OA: Red indicator lights on switches for 3 and cable lift screen are out. Replace.

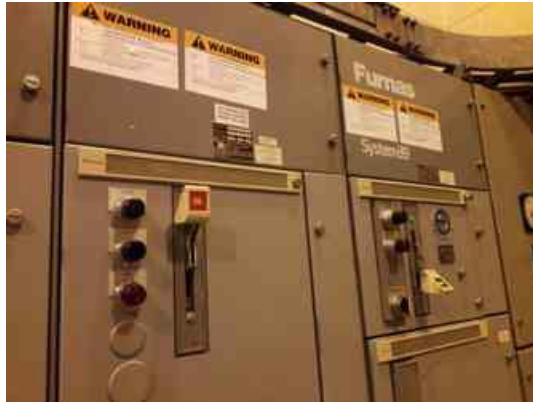
Inspect ID: 2021-0051 **Title:** 2604000009_CELRC_2021_A_0051_2_20210621T142425.jpg **Rated Item:** 14. Electrical Systems **Caption:** Minimally Acceptable - PS-OA: Red indicator lights on switches for 3 and cable lift screen are out. Replace.

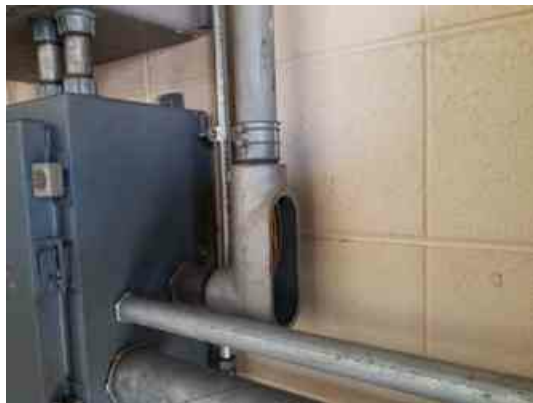
Inspect ID: 2021-0024 **Title:** 2604000009_CELRC_2021_A_0024_1_20210621T135145.jpg **Rated Item:** 16. Enclosures, Panels, Conduit and Ducts **Caption:** Minimally Acceptable - PS-CA: Missing cover on LB connector, replace.

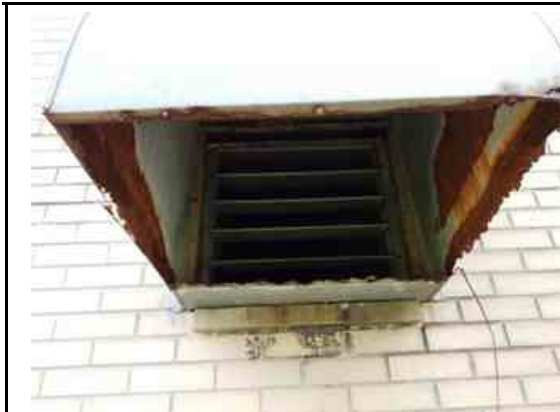
Inspect ID: 2021-0027 **Title:** 2604000009_CELRC_2021_A_0027_1_20210621T135452.jpg **Rated Item:** 16. Enclosures, Panels, Conduit and Ducts **Caption:** Minimally Acceptable - PS-CA: Corroded screen on vent exterior. Replace screen.
