## Levee Inspection Report

Name of System: Gary  
Name of Segment: Gary North  
NLD System ID: 2605000003 NLD Segment ID: 2604000003

Segment Type: USACE Federally constructed, turned over to public sponsor operations and maintenance  
Levee Sponsor (Name and Organization): Little Calumet River Basin Development Commission  
Inspection Report Prepared by: Christopher Schaal Date(s) of Inspection: 06/06/2022 - 06/10/2022

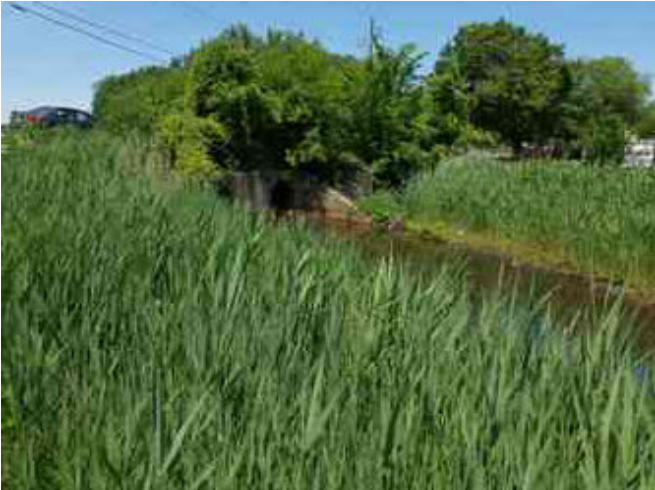
<p><b>Inspect ID:</b> 2022-0286 <b>Title:</b> 2604000003_CELRC_2022_A_0286_1_20220609T171818.jpg <b>Rated Item:</b> 2. Encroachments <b>Caption:</b> Minimally Acceptable - Culvert at Colfax in good condition. Trees around headwall.</p>

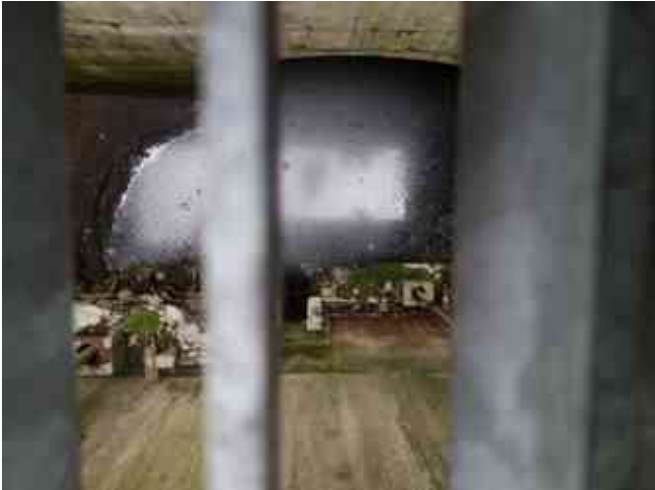
<p><b>Inspect ID:</b> 2022-0020 <b>Title:</b> 2604000003_CELRC_2022_A_0020_1_20220607T161045.jpg <b>Rated Item:</b> 10. Sluice/ Slide Gates <b>Caption:</b> Acceptable - GN-19a: Closed completely.</p>

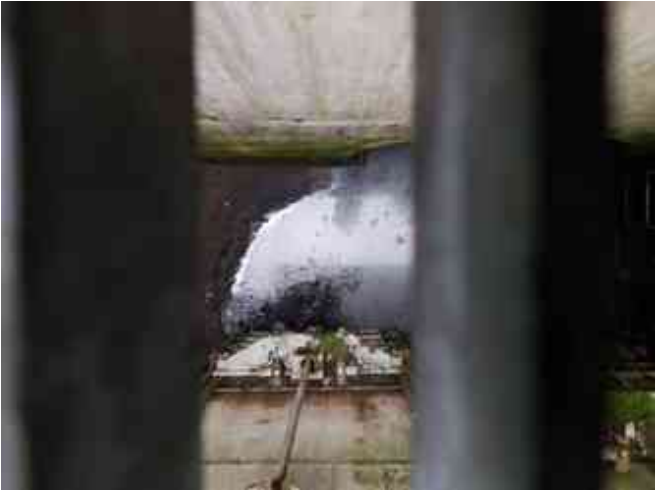
<p><b>Inspect ID:</b> 2022-0023 <b>Title:</b> 2604000003_CELRC_2022_A_0023_1_20220607T161616.jpg <b>Rated Item:</b> 10. Sluice/ Slide Gates <b>Caption:</b> Acceptable - GN-19b: Closed completely.</p>

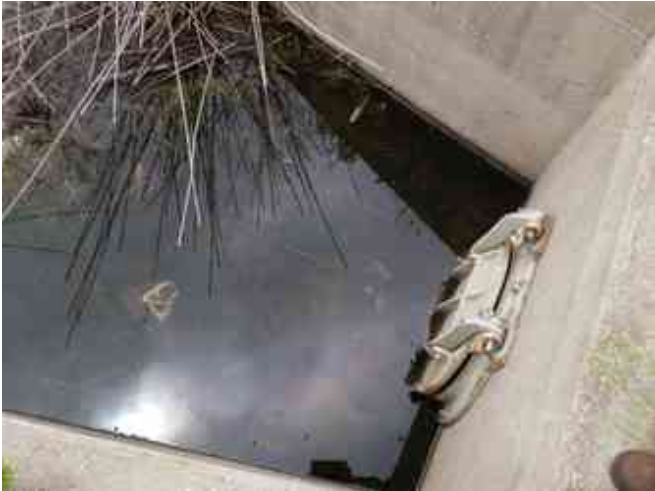
<p><b>Inspect ID:</b> 2022-0062 <b>Title:</b> 2604000003_CELRC_2022_A_0062_1_20220607T172716.jpg <b>Rated Item:</b> 11. Flap Gates/ Flap Valves/ Pinch Valves <b>Caption:</b> Minimally Acceptable - GN-13: Flap gate stuck open. Sandbags in outlet.</p>

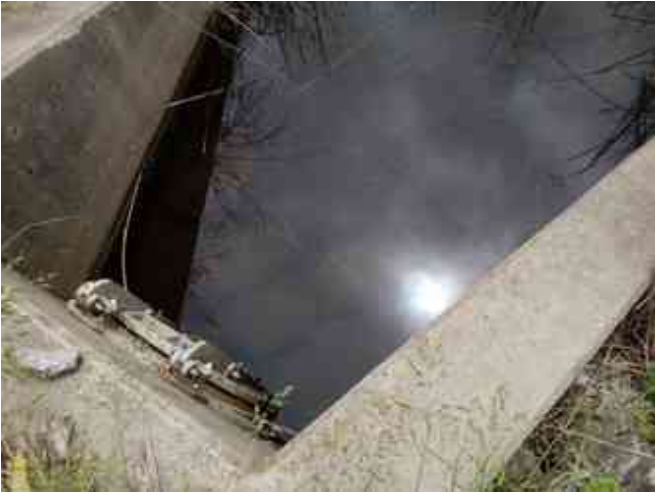
<p><b>Inspect ID:</b> 2022-0068 <b>Title:</b> 2604000003_CELRC_2022_A_0068_1_20220607T173325.jpg <b>Rated Item:</b> 11. Flap Gates/ Flap Valves/ Pinch Valves <b>Caption:</b> Minimally Acceptable - GN-15: Flap gate stuck open, sandbags in outlet.</p>

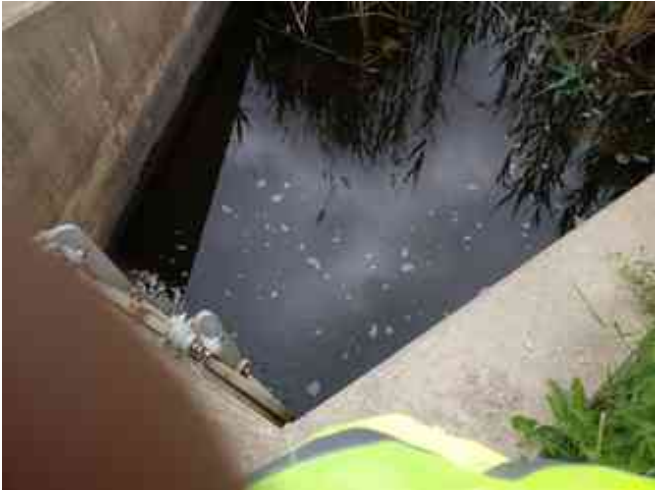
<p><b>Inspect ID:</b> 2022-0074 <b>Title:</b> 2604000003_CELRC_2022_A_0074_1_20220607T174521.jpg <b>Rated Item:</b> 11. Flap Gates/ Flap Valves/ Pinch Valves <b>Caption:</b> Acceptable - GN-12: Gate completely closed.</p>

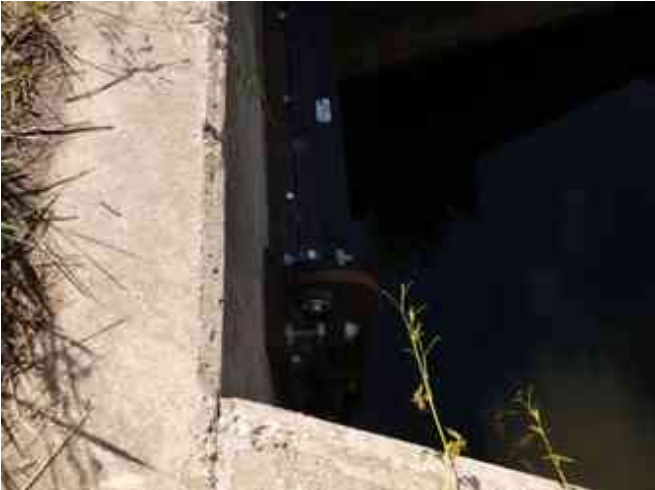
<p><b>Inspect ID:</b> 2022-0083 <b>Title:</b> 2604000003_CELRC_2022_A_0083_1_20220609T142812.jpg <b>Rated Item:</b> 11. Flap Gates/ Flap Valves/ Pinch Valves <b>Caption:</b> Minimally Acceptable - GN-3: Debris stuck in flap gate.</p>

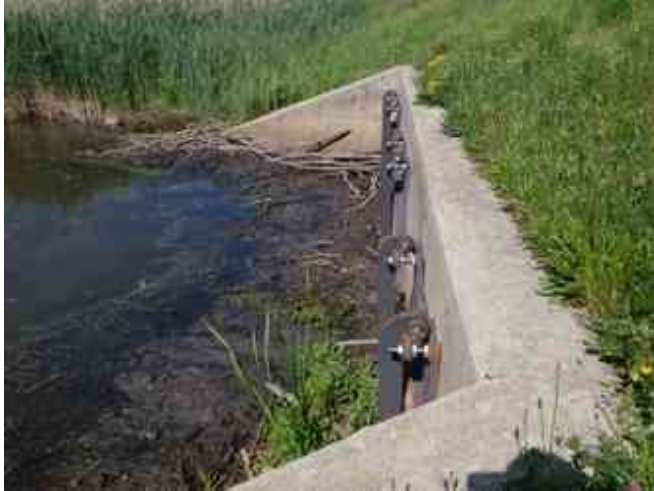
**Inspect ID:** 2022-0092 **Title:**  
2604000003\_CELRC\_2022\_A\_0092\_1\_20220609T145508.jpg  
**Rated Item:** 11. Flap Gates/ Flap Valves/ Pinch Valves  
**Caption:** Minimally Acceptable - GN-8: Mud and sticks  
blocking flap gates from opening.

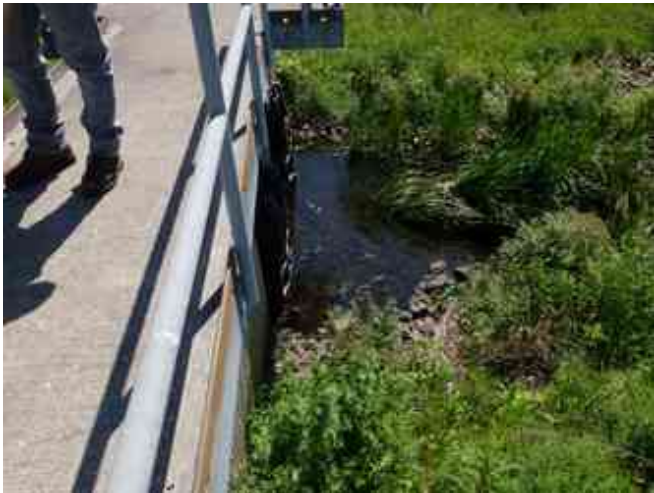
**Inspect ID:** 2022-0101 **Title:**  
2604000003\_CELRC\_2022\_A\_0101\_1\_20220609T153701.jpg  
**Rated Item:** 11. Flap Gates/ Flap Valves/ Pinch Valves  
**Caption:** Minimally Acceptable - GN-9: Debris stuck in gate.

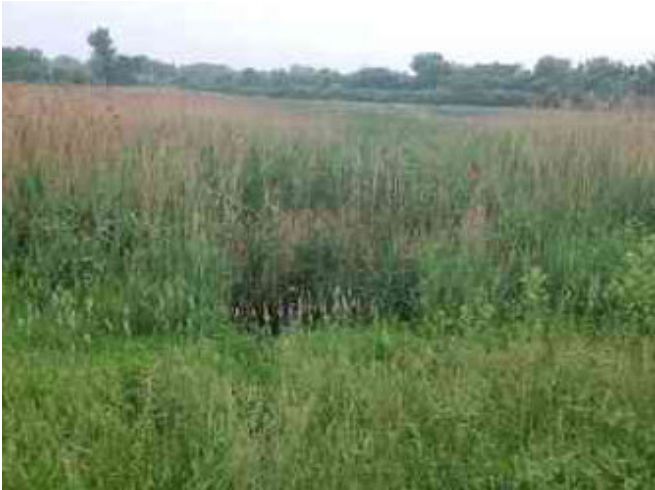
<p><b>Inspect ID:</b> 2022-0008 <b>Title:</b> 2604000003_CELRC_2022_A_0008_1_20220606T161056.jpg <b>Rated Item:</b> 14. Riprap Revetments of Inlet/ Discharge Areas <b>Caption:</b> Minimally Acceptable - Gate 950: Significant vegetation at outlet.</p>

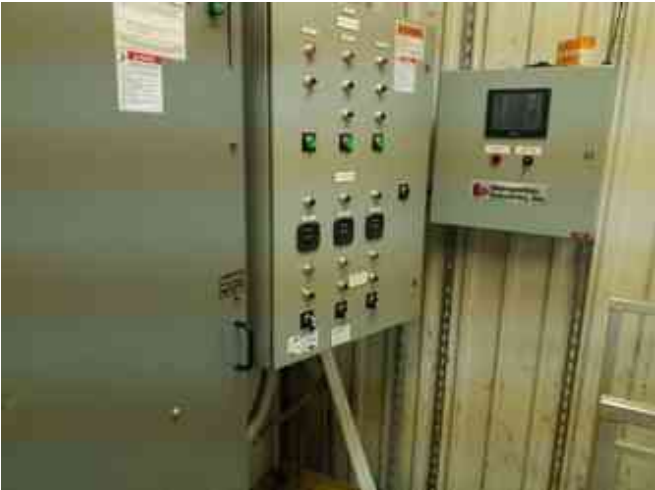
<p><b>Inspect ID:</b> 2022-0021 <b>Title:</b> 2604000003_CELRC_2022_A_0021_1_20220607T150759.jpg <b>Rated Item:</b> 2. Pump Station Operations and Maintenance Equipment Manuals <b>Caption:</b> Minimally Acceptable - PS-BR: Operations manuals not onsite.</p>

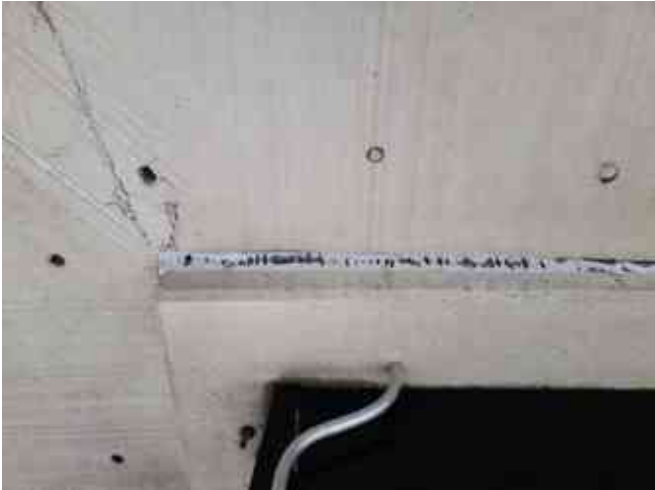
<p><b>Inspect ID:</b> 2022-0030 <b>Title:</b> 2604000003_CELRC_2022_A_0030_1_20220607T151600.jpg <b>Rated Item:</b> 5. Plant Building <b>Caption:</b> Minimally Acceptable - PS-BR: Settlement on generator pad.</p>

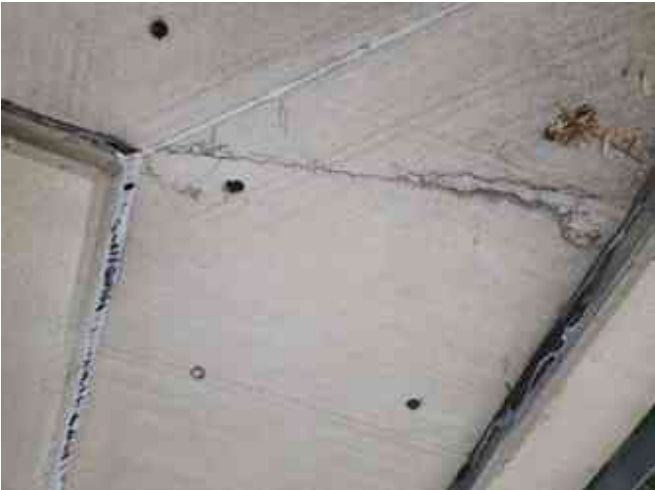
<p><b>Inspect ID:</b> 2022-0033 <b>Title:</b> 2604000003_CELRC_2022_A_0033_1_20220607T151726.jpg <b>Rated Item:</b> 5. Plant Building <b>Caption:</b> Minimally Acceptable - PS-BR: Cracking in concrete.</p>
