Levee Inspection Report

Name of System: Gary

Name of Segment: Gary South

Inspection Report Prepared by: Christopher Schaal Date(s) of Inspection: 06/07/2022 - 06/10/2022

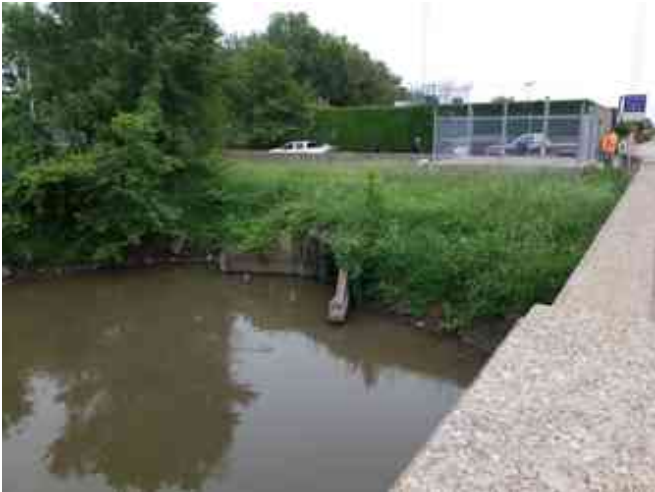
<p>Inspect ID: 2022-0044 Title: 2604000004_CELRC_2022_A_0044_1_20220607T141159.jpg Rated Item: 5. Concrete Surfaces (Such as gate wells, outfalls, intakes, or culverts) Caption: Acceptable - GS-11: Outlet clear of debris.</p>

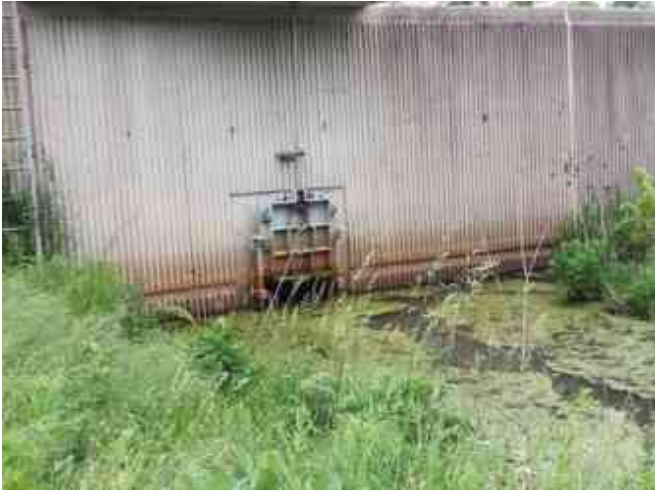
<p>Inspect ID: 2022-0035 Title: 2604000004_CELRC_2022_A_0035_1_20220607T135943.jpg Rated Item: 10. Sluice/ Slide Gates Caption: Acceptable - GS-10: Gate was opened, no sediment.</p>

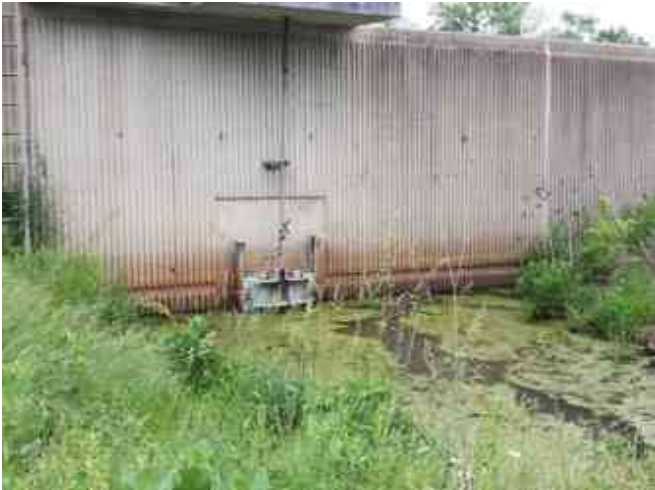
<p>Inspect ID: 2022-0038 Title: 2604000004_CELRC_2022_A_0038_1_20220607T140144.jpg Rated Item: 10. Sluice/ Slide Gates Caption: Acceptable - GS-10: Gate closed completely.</p>

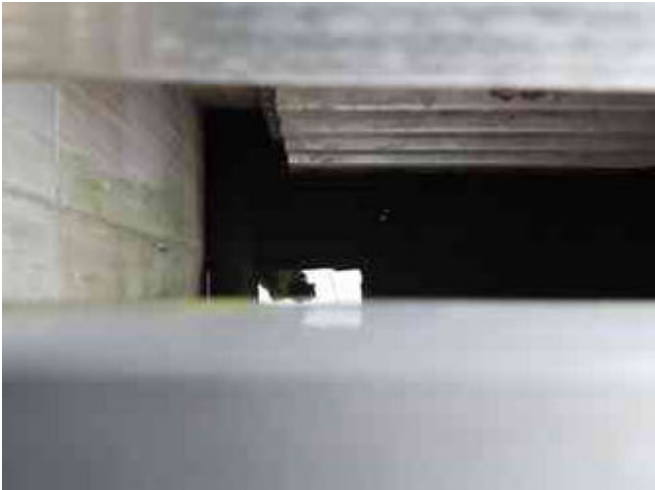
<p>Inspect ID: 2022-0080 Title: 2604000004_CELRC_2022_A_0080_1_20220607T152022.jpg Rated Item: 10. Sluice/ Slide Gates Caption: Acceptable - GS-14: Sluice gate closed completely.</p>

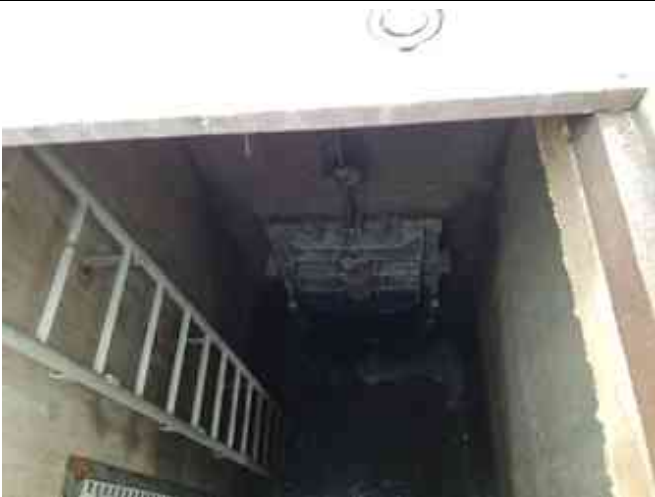
<p>Inspect ID: 2022-0089 Title: 2604000004_CELRC_2022_A_0089_1_20220607T153709.jpg Rated Item: 10. Sluice/ Slide Gates Caption: Acceptable - GS-15: Gate worked properly, sediment at bottom.</p>

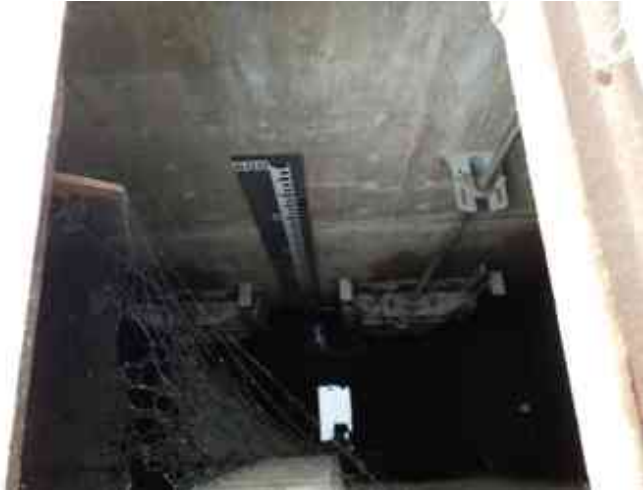
<p>Inspect ID: 2022-0098 Title: 2604000004_CELRC_2022_A_0098_1_20220607T154636.jpg Rated Item: 10. Sluice/ Slide Gates Caption: Acceptable - GS-16a,b: Both gates shut completely.</p>

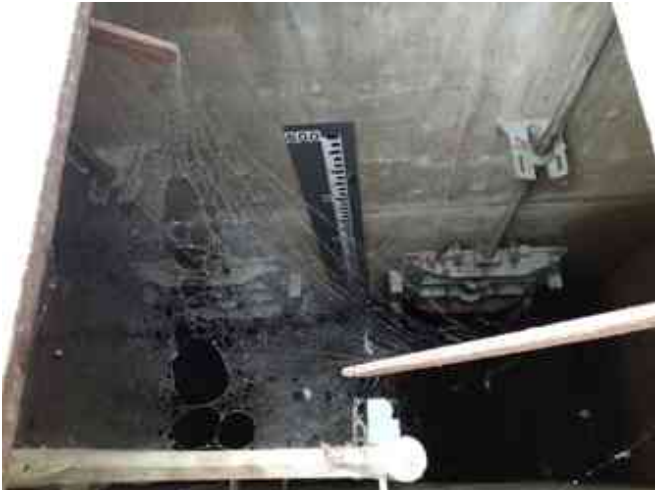
<p>Inspect ID: 2022-0101 Title: 2604000004_CELRC_2022_A_0101_1_20220607T155112.jpg Rated Item: 10. Sluice/ Slide Gates Caption: Acceptable - GS-16: Both gates closed.</p>

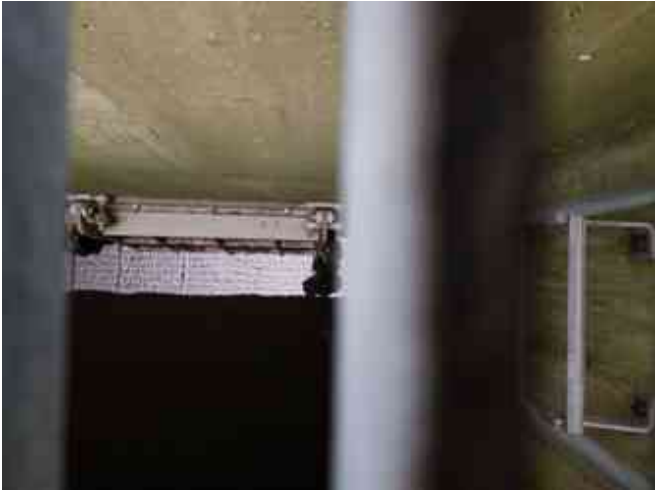
<p>Inspect ID: 2022-0047 Title: 2604000004_CELRC_2022_A_0047_1_20220607T141333.jpg Rated Item: 11. Flap Gates/ Flap Valves/ Pinch Valves Caption: Acceptable - GS-11: Both flapgates completely sealed.</p>

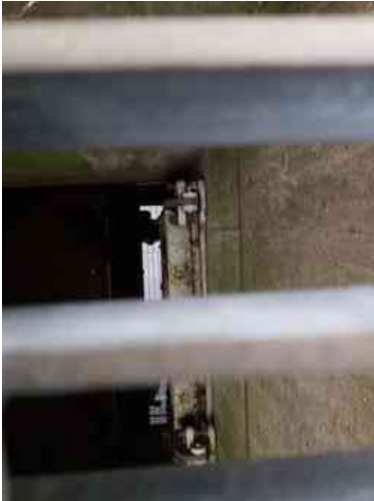
<p>Inspect ID: 2022-0065 Title: 2604000004_CELRC_2022_A_0065_1_20220607T145931.jpg Rated Item: 11. Flap Gates/ Flap Valves/ Pinch Valves Caption: Acceptable - GS-12: Both flapgates completely closed.</p>

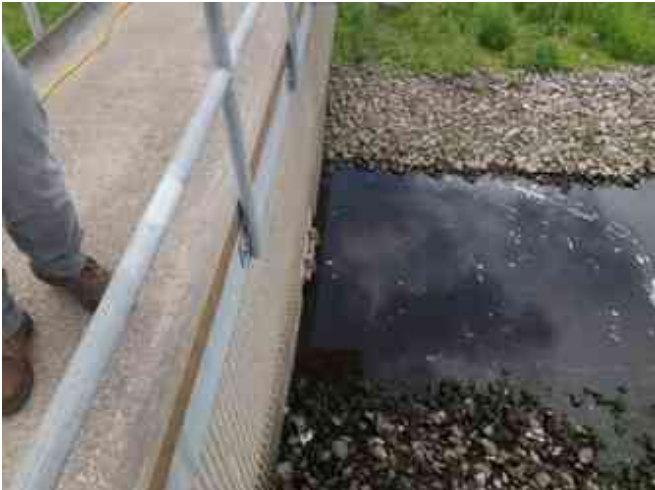
<p>Inspect ID: 2022-0110 Title: 2604000004_CELRC_2022_A_0110_1_20220607T185311.jpg Rated Item: 11. Flap Gates/ Flap Valves/ Pinch Valves Caption: Acceptable - GS-5: Flapgate completely closed.</p>

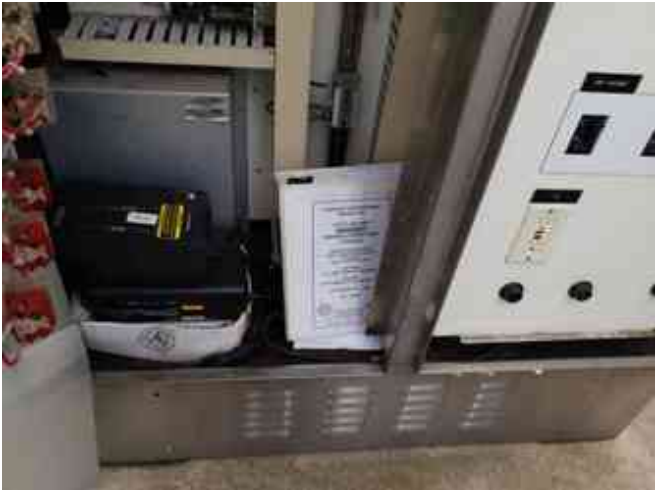
<p>Inspect ID: 2022-0030 Title: 2604000004_CELRC_2022_A_0030_1_20220607T133756.jpg Rated Item: 2. Pump Station Operations and Maintenance Equipment Manuals Caption: Acceptable - PS-CL: Manuals present onsite.</p>

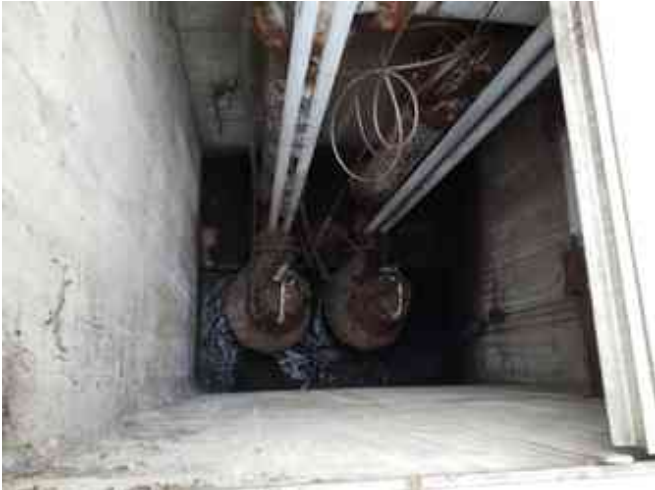
<p>Inspect ID: 2022-0048 Title: 2604000004_CELRC_2022_A_0048_1_20220607T144828.jpg Rated Item: 7. Pumps Caption: Acceptable - PS-BW: Pumps could not be run since the wet well is very dry. Local sponsor noted this station does not get much water and pumps run infrequently</p>

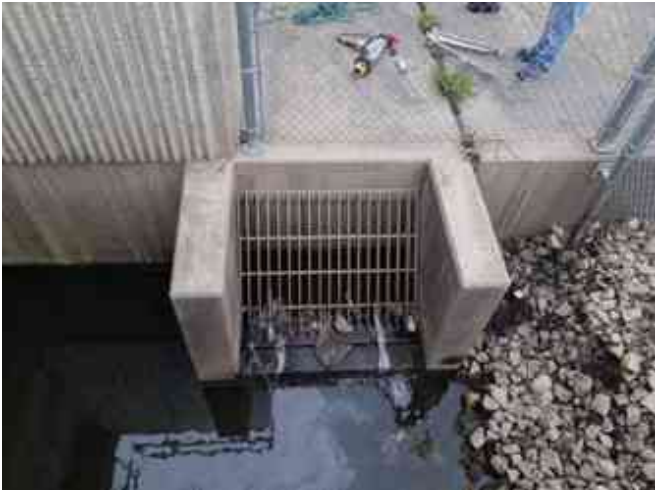
<p>Inspect ID: 2022-0006 Title: 2604000004_CELRC_2022_A_0006_1_20220607T130737.jpg Rated Item: 11. Non-Mechanical Trash Racks Caption: Minimally Acceptable - PS-GE: Some debris buildup.</p>

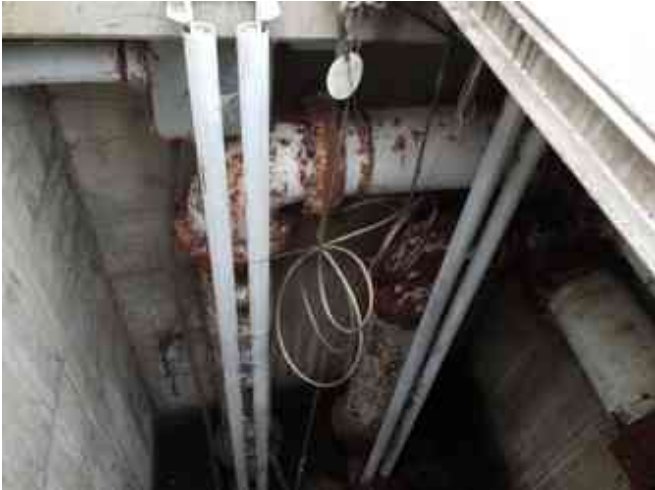
<p>Inspect ID: 2022-0045 Title: 2604000004_CELRC_2022_A_0045_1_20220607T144718.jpg Rated Item: 17. Intake and Discharge Pipelines Caption: Minimally Acceptable - PS-BW: Discharge pipes coming from pumps are very corroded.</p>

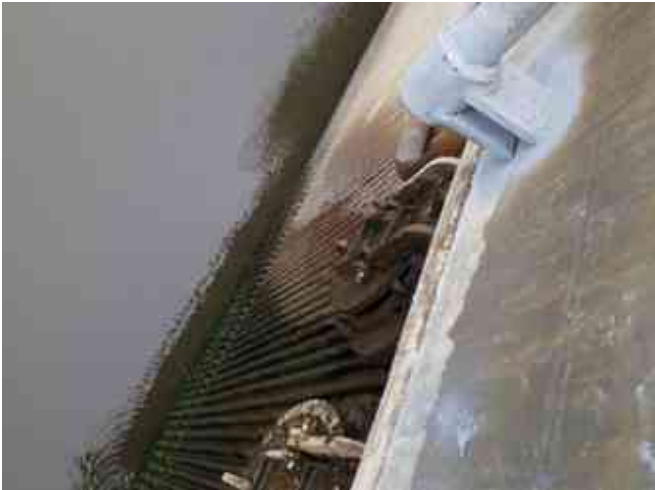
<p>Inspect ID: 2022-0012 Title: 2604000004_CELRC_2022_A_0012_1_20220607T131150.jpg Rated Item: 19. Flap Gates/ Flap Valves/ Pinch Valves Caption: Minimally Acceptable - PS-GE: Right flap gate stuck open a little. Recommend monitoring and addressing if it becomes problematic.</p>
