Levee Inspection Report

Name of System: Highland

NLD System ID: 2605000005

Date(s) of Inspection: 04/14/2022 - 04/14/2022

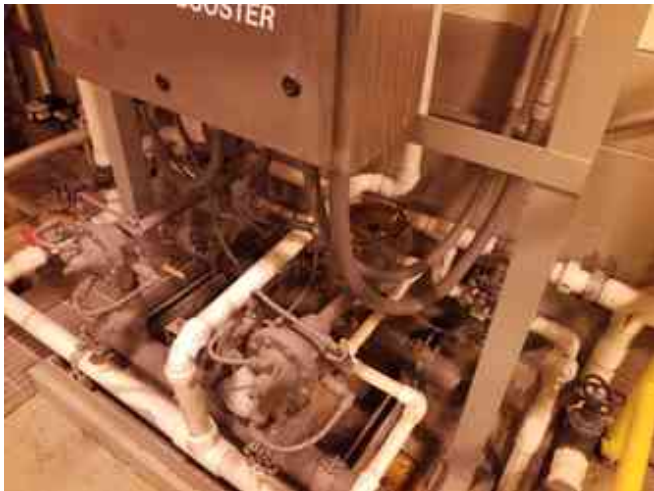
Rated Item: 7. Pumps

Caption: Minimally Acceptable - PS-N5: Pump DWP-1 out of service, staff reported evidence of cavitation on impeller. Pump is out for repairs and will be rebuilt.
