DEPARTMENT OF THE ARMY
CORPS OF ENGINEERS, CHICAGO DISTRICT
231 SOUTH LA SALLE STREET, SUITE 1500
CHICAGO IL 60604

May 11, 2022

The Chicago District performed an inspection of the Munster Levee on April 11, 2022. The purpose of the U.S. Army Corps of Engineers (Corps) Levee Safety Program is to make sure levee systems are reliable and do not present unacceptable risks to the public, property, or the environment, with the emphasis on public safety. Two important principles that guide our program are the shared responsibility among partners at all levels for levee safety and the need for continuous and periodic project inspections and assessments. More information about the Levee Safety Program can be found in EC 1165-2-218.

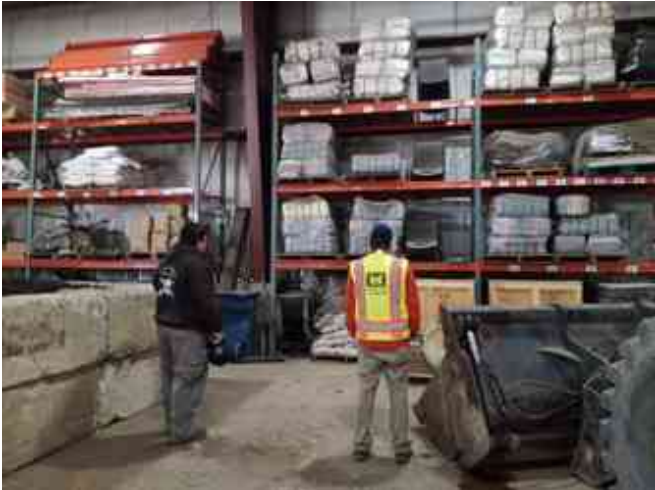
A photograph showing the interior of a warehouse. Two workers are visible: one in a dark jacket and the other in a high-visibility orange vest. They are standing near a large stack of concrete blocks on the left. In the background, there are tall metal shelving units filled with various supplies, including bags and boxes. A piece of equipment, possibly a forklift or pallet jack, is partially visible on the right.	<p>Inspect ID: 2022-0023 Title: 2604000009_CELRC_2022_A_0023_1_20220411T151554.jpg Rated Item: 2. Emergency Supplies and Equipment (A or M only) Caption: Acceptable - 8 full pallets of sandbags, 9 open pallets of sandbags, concrete blocks at the Public Works facility..</p>
  A photograph of a warehouse interior. In the center, there is a yellow sandbag machine. To the left, there are large stacks of concrete blocks. To the right, there are metal shelving units filled with various supplies, including bags and boxes. The floor is concrete and appears to be in good condition.	<p>Inspect ID: 2022-0023 Title: 2604000009_CELRC_2022_A_0023_4_20220411T151804.jpg Rated Item: 2. Emergency Supplies and Equipment (A or M only) Caption: Acceptable - 1 sandbag machine and concrete blocks at the Public Works facility..</p>
