**US Army Corps
of Engineers®**

Flood Damage Reduction Segment / System Inspection Report

Name of Segment / System: Little Cal - Munster

Inspection Start Date: 4/29/2014

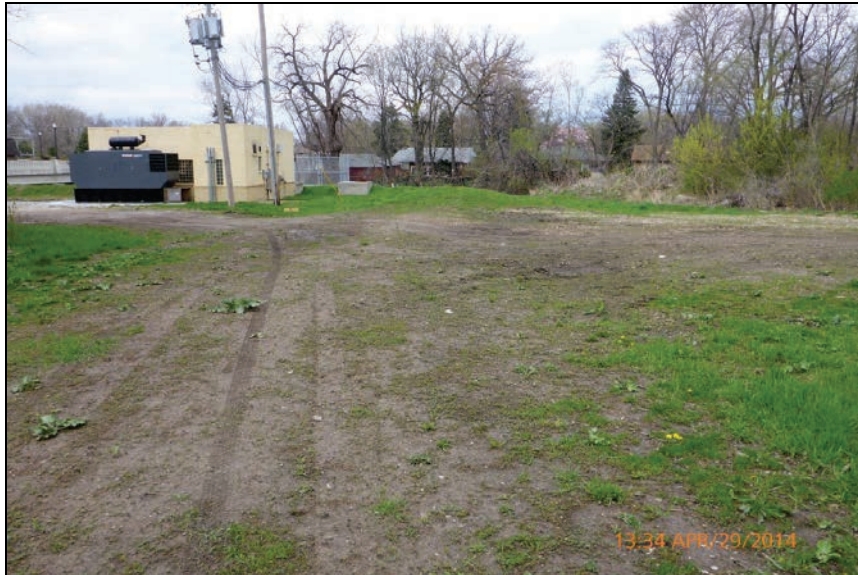
Inspect ID: LCMN_2014_a_0064 **Title:** USACE_CELRC_LCMN_2014_a_0064_1.jpg
Rated Item: 2. Sod Cover **Caption:** Rating: Minimally Acceptable; Remarks: Poor sod cover; Action: Seed

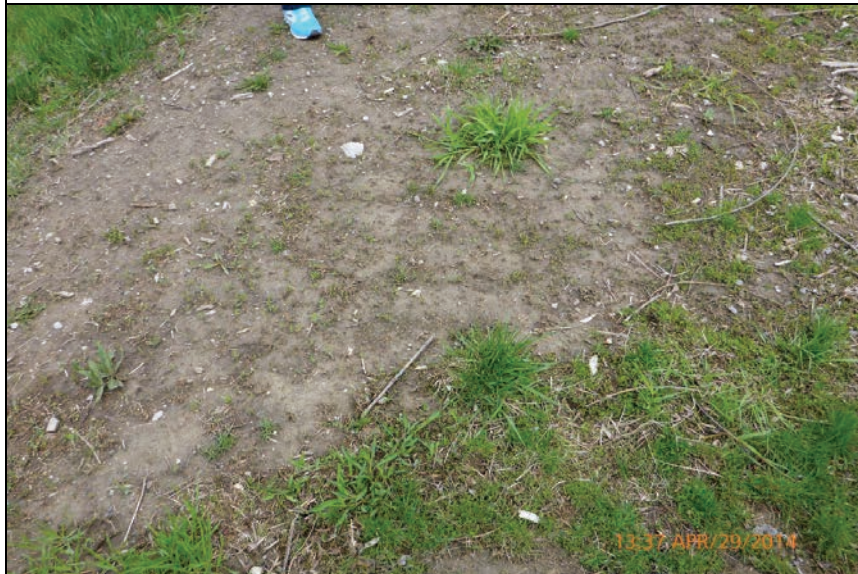
Inspect ID: LCMN_2014_a_0065 **Title:** USACE_CELRC_LCMN_2014_a_0065_1.jpg
Rated Item: 2. Sod Cover **Caption:** Rating: Minimally Acceptable; Remarks: Poor sod; Action: Seed

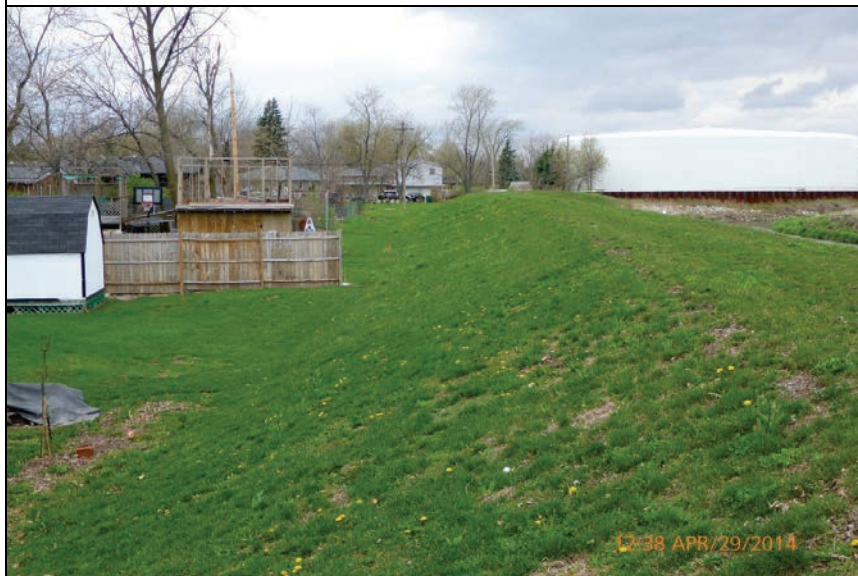
Inspect ID: LCMN_2014_a_0049 **Title:** USACE_CELRC_LCMN_2014_a_0049_1.jpg
Rated Item: 3. Encroachments **Caption:** Rating: Minimally Acceptable; Remarks: Fence near landside toe; Action: Remove within 15 ft of the levee or request permit

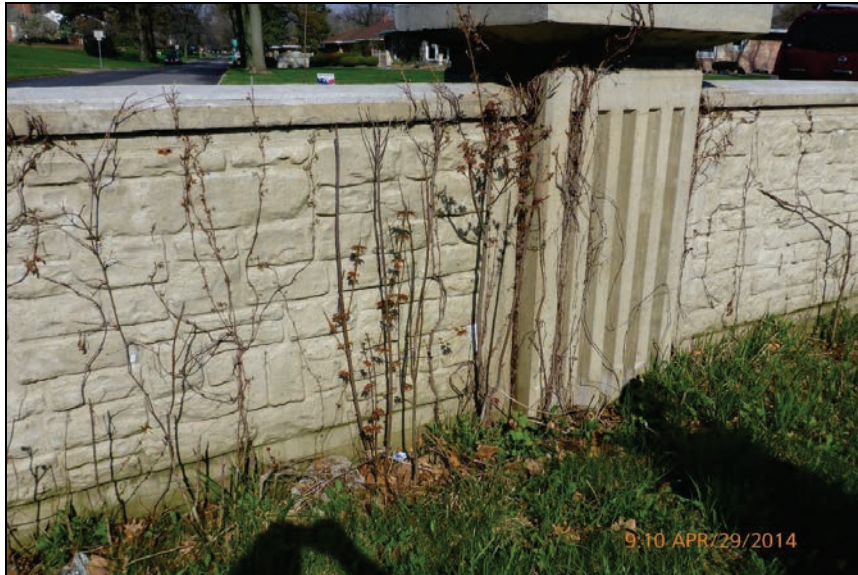
Inspect ID: LCMN_2014_a_0003 **Title:** USACE_CELRC_LCMN_2014_a_0003_1.jpg
Rated Item: 1. Unwanted Vegetation Growth **Caption:** Rating: Minimally Acceptable;
Remarks: Small trees along floodwall; **Action:** Clear

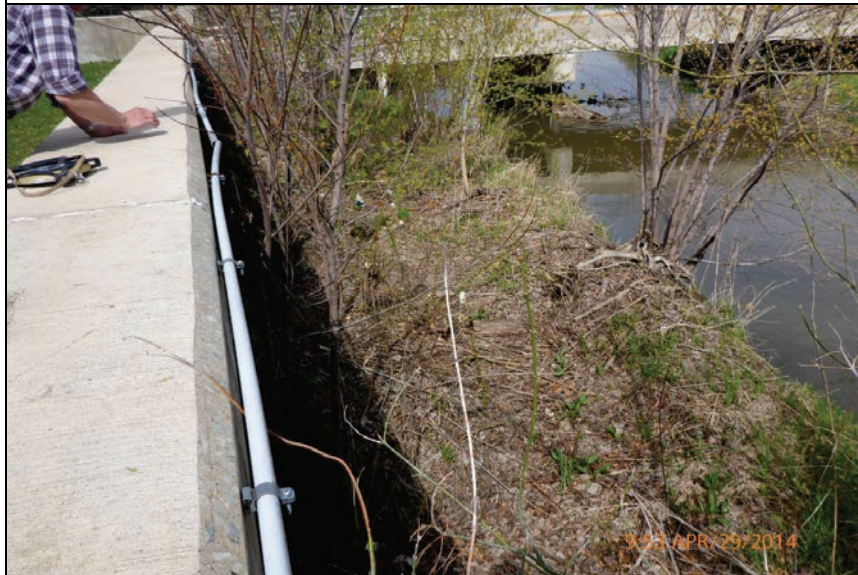
Inspect ID: LCMN_2014_a_0016 **Title:** USACE_CELRC_LCMN_2014_a_0016_1.jpg
Rated Item: 1. Unwanted Vegetation Growth **Caption:** Rating: Minimally Acceptable;
Remarks: Trees on riverside of floodwall at Northcote; **Action:** Clear

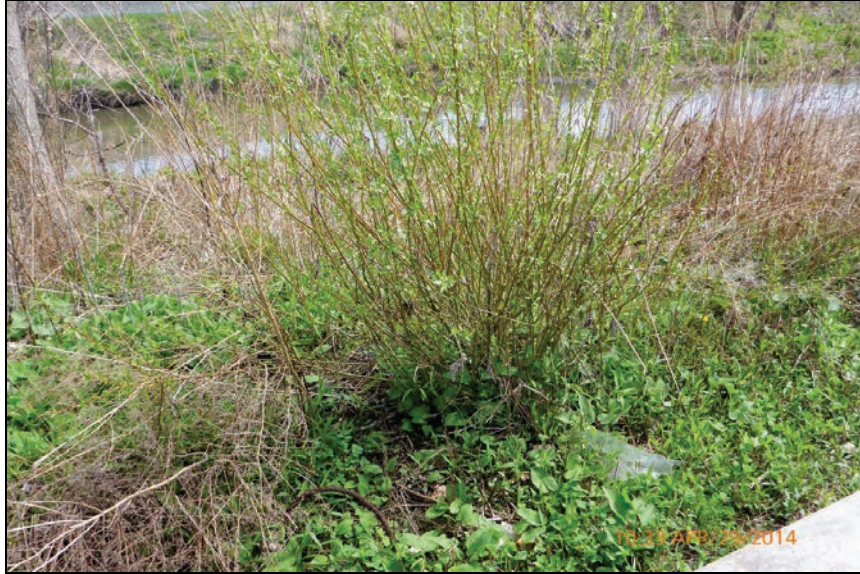
Inspect ID: LCMN_2014_a_0020 **Title:** USACE_CELRC_LCMN_2014_a_0020_1.jpg
Rated Item: 1. Unwanted Vegetation Growth **Caption:** Rating: Minimally Acceptable;
Remarks: Bush on riverside; Action: Clear

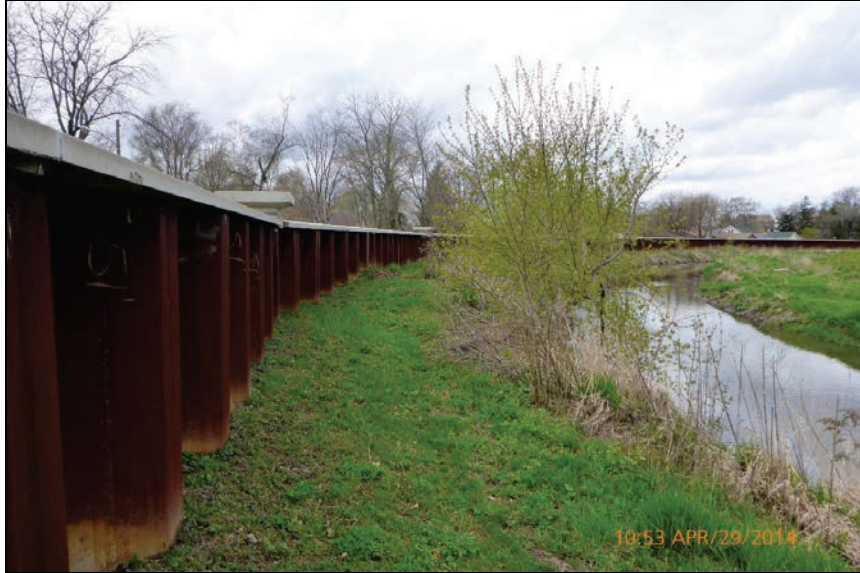
Inspect ID: LCMN_2014_a_0023 **Title:** USACE_CELRC_LCMN_2014_a_0023_1.jpg
Rated Item: 1. Unwanted Vegetation Growth **Caption:** Rating: Minimally Acceptable;
Remarks: Tree on riverside of floodwall; Action: Clear

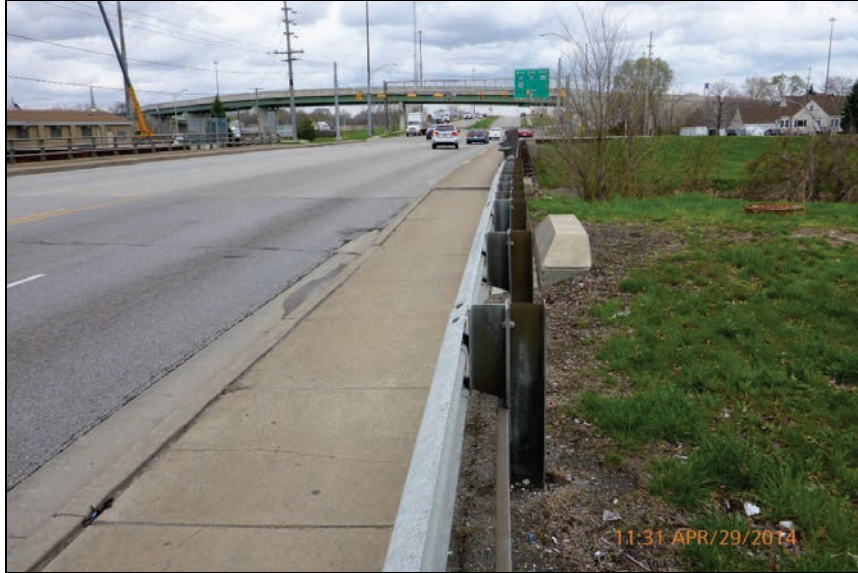
Inspect ID: LCMN_2014_a_0040 **Title:** USACE_CELRC_LCMN_2014_a_0040_1.jpg
Rated Item: 3. Closure Structures (Stop Log Closures and Gates) (A or U only)
Caption: Rating: Acceptable; Remarks: Guardrail blocking closure wingwall; Action: Discuss alternatives and conduct a closure exercise at location to verify effectiveness of closure.

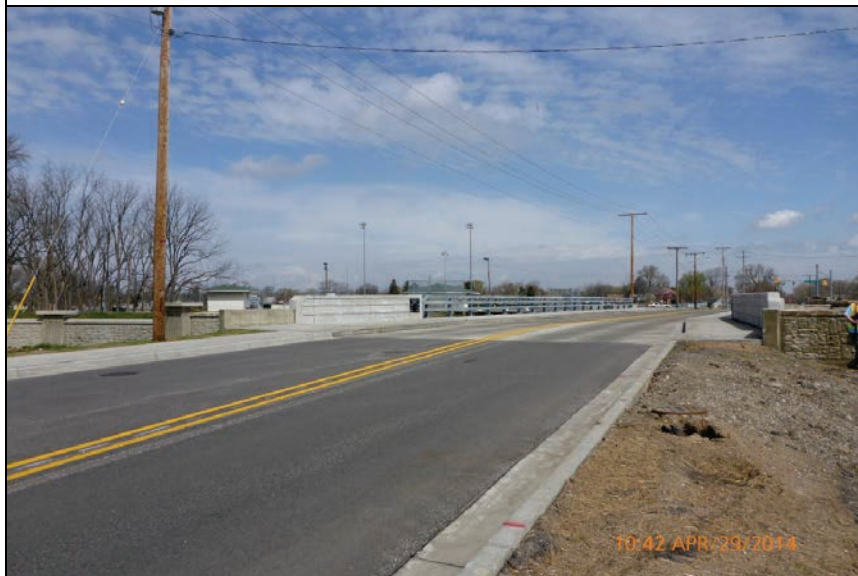
Inspect ID: LCMN_2014_a_0067 **Title:** USACE_CELRC_LCMN_2014_a_0067_1.jpg
Rated Item: 3. Closure Structures (Stop Log Closures and Gates) (A or U only)
Caption: Rating: Acceptable; Remarks: Modification to Columbia Ave Bridge not approved by USACE. Work is near completion. Concerns raised during construction seem to have been addressed. ; Action: Provide as-builts. May possibly need to revise closure plan for Columbia Ave Bridge as a result of bridge modifications.

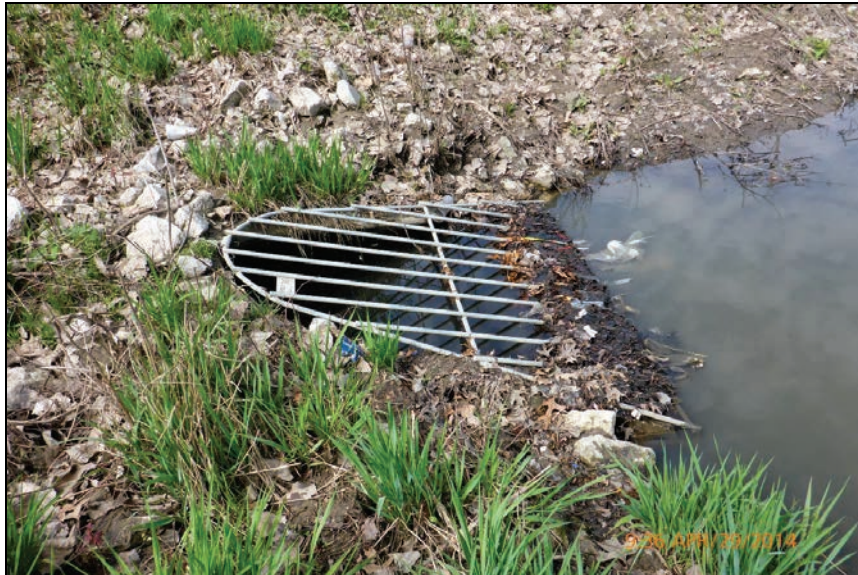
Inspect ID: LCMN_2014_a_0068 **Title:** USACE_CELRC_LCMN_2014_a_0068_1.jpg
Rated Item: 1. Vegetation and Obstructions **Caption:** Rating: Minimally Acceptable;
Remarks: MU-1: Debris at inlet; Action: Clean

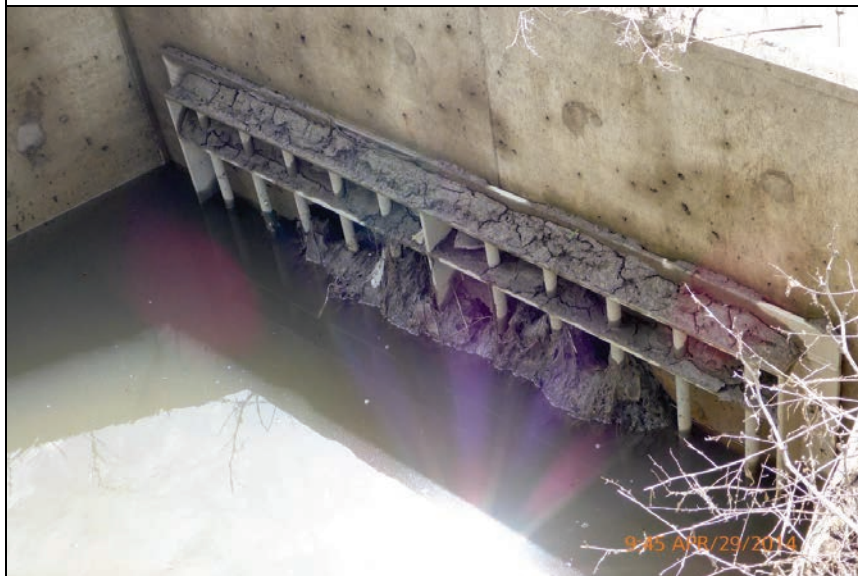
Inspect ID: LCMN_2014_a_0069 **Title:** USACE_CELRC_LCMN_2014_a_0069_1.jpg
Rated Item: 1. Vegetation and Obstructions **Caption:** Rating: Minimally Acceptable;
Remarks: MU-2: Outlet clogged with trash and silt; Action: Clean

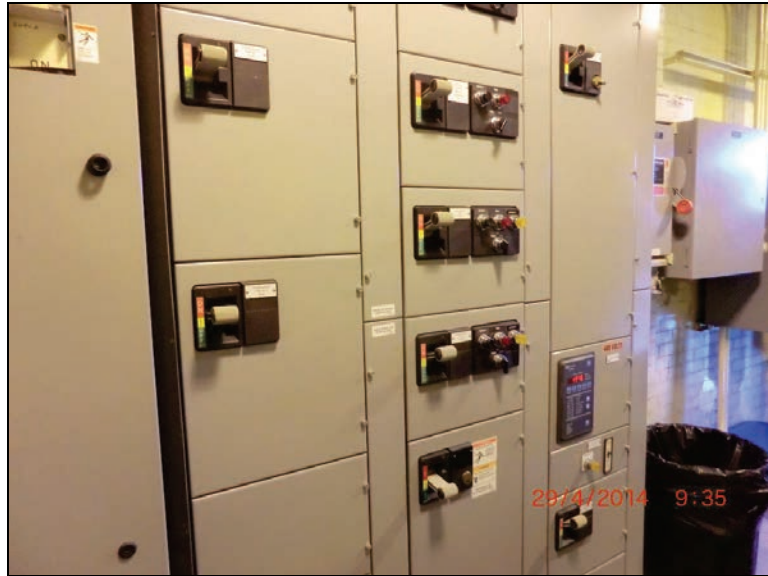
Inspect ID: LCMN_2014_a_0085 **Title:** USACE_CELRC_LCMN_2014_a_0085_1.jpg
Rated Item: 3. Safety Compliance **Caption:** Rating: Minimally Acceptable; Remarks:
PS-BA: MCC and pump control cabinet must be posted with proper Arc-Flash warning
sign per latest NFPA 70 and NFPA70E
; Action: Post Arc-Flash warning signs;
;

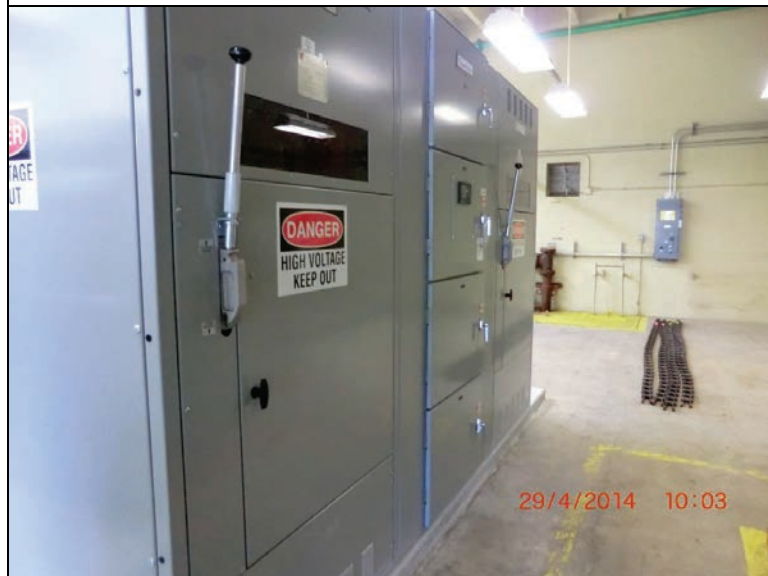
Inspect ID: LCMN_2014_a_0092 **Title:** USACE_CELRC_LCMN_2014_a_0092_1.jpg
Rated Item: 3. Safety Compliance **Caption:** Rating: Minimally Acceptable; Remarks:
PS-CAL: MCC and pump control cabinet must be posted with proper Arc-Flash warning
sign per latest NFPA 70 and NFPA70E; Action: Post Arc-Flash warning signs

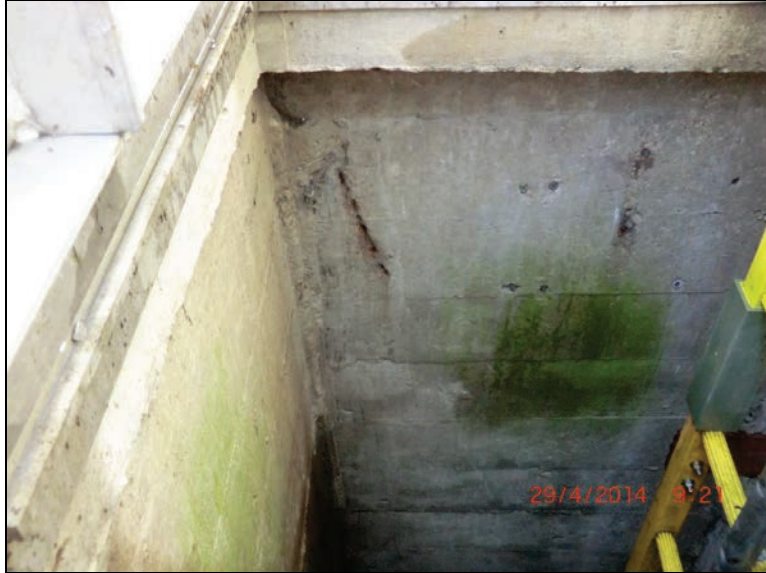
Inspect ID: LCMN_2014_a_0084 **Title:** USACE_CELRC_LCMN_2014_a_0084_1.jpg
Rated Item: 5. Plant Building **Caption:** Rating: Minimally Acceptable; Remarks: PS-BA: Exposed rebar in concrete; Action: Patch

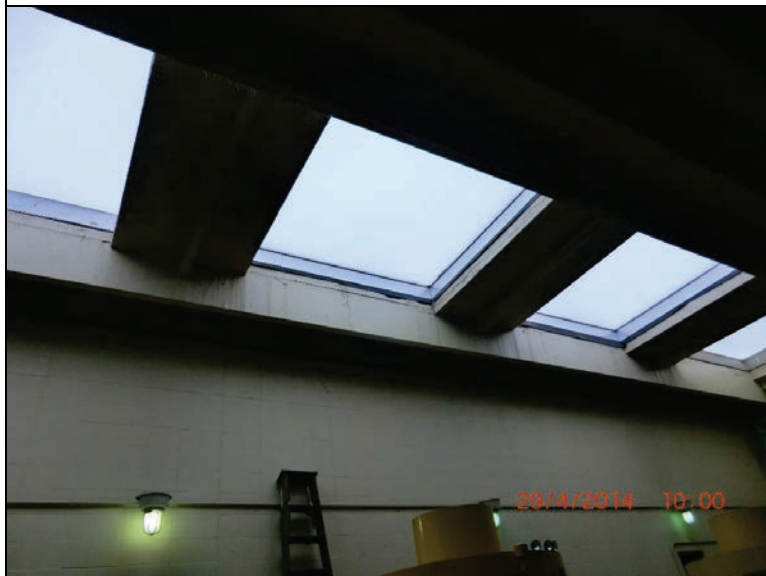
Inspect ID: LCMN_2014_a_0086 **Title:** USACE_CELRC_LCMN_2014_a_0086_1.jpg
Rated Item: 5. Plant Building **Caption:** Rating: Minimally Acceptable; Remarks: PS-CAL: Broken concrete and leaking at skylights; Action: Seal cracks

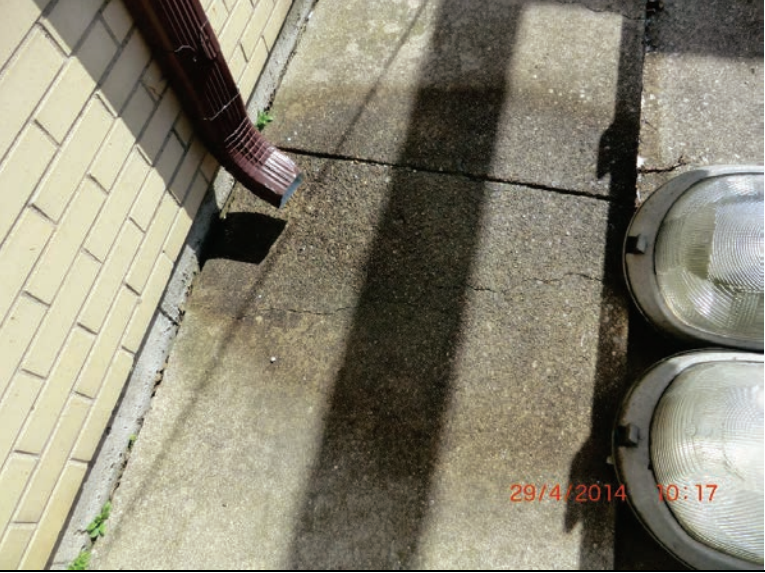
<p>Inspect ID: LCMN_2014_a_0087 Title: USACE_CELRC_LCMN_2014_a_0087_1.jpg Rated Item: 5. Plant Building Caption: Rating: Minimally Acceptable; Remarks: PS-CAL: Exposed rebar; Action: Patch concrete</p>

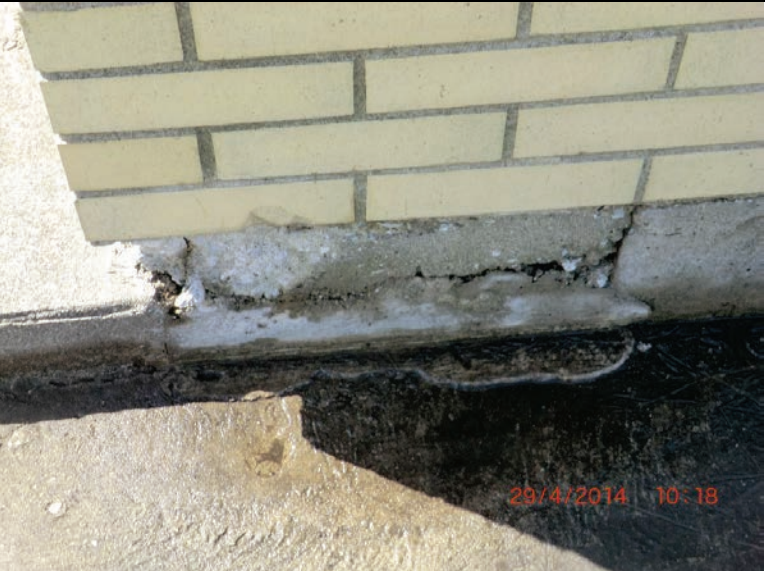
<p>Inspect ID: LCMN_2014_a_0088 Title: USACE_CELRC_LCMN_2014_a_0088_1.jpg Rated Item: 5. Plant Building Caption: Rating: Minimally Acceptable; Remarks: PS-CAL: Spalling in foundation slab; Action: Patch</p>

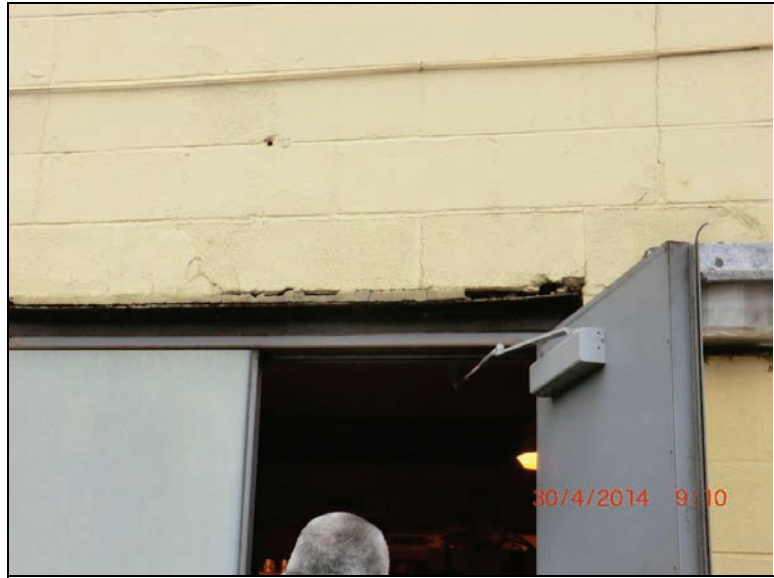
<p>30/4/2014 9:10</p>	<p>Inspect ID: LCMN_2014_a_0095 Title: USACE_CELRC_LCMN_2014_a_0095_1.jpg Rated Item: 5. Plant Building Caption: Rating: Minimally Acceptable; Remarks: PS-HM: Deteriorating lintel; Action: Fix</p>

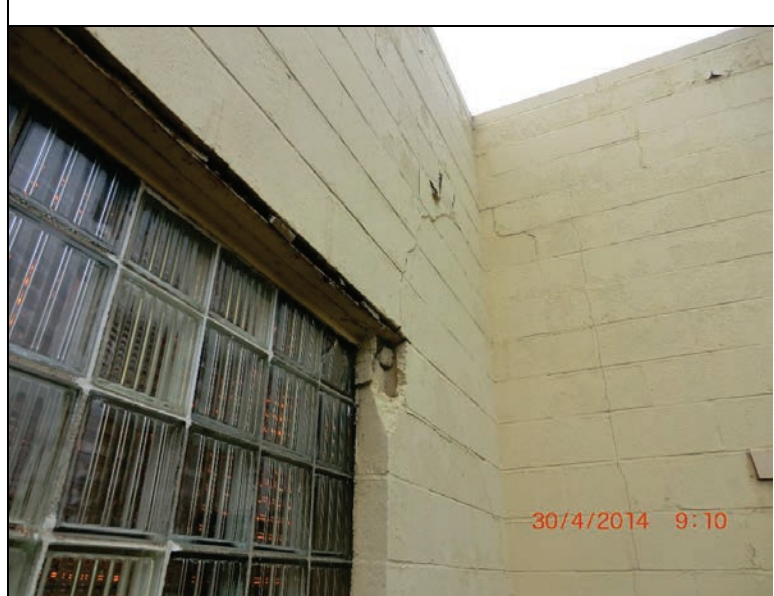
<p>30/4/2014 9:10</p>	<p>Inspect ID: LCMN_2014_a_0096 Title: USACE_CELRC_LCMN_2014_a_0096_1.jpg Rated Item: 5. Plant Building Caption: Rating: Minimally Acceptable; Remarks: PS-HM: Broken masonry at south window; Action: Fix masonry</p>

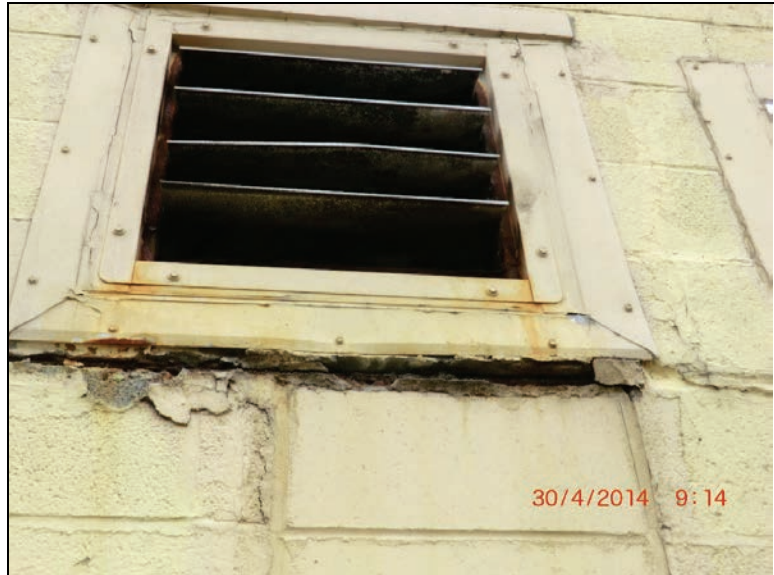
<p>Inspect ID: LCMN_2014_a_0097 Title: USACE_CELRC_LCMN_2014_a_0097_1.jpg Rated Item: 5. Plant Building Caption: Rating: Minimally Acceptable; Remarks: PS-HM: Masonry under vent deteriorating; Action: Repair</p>

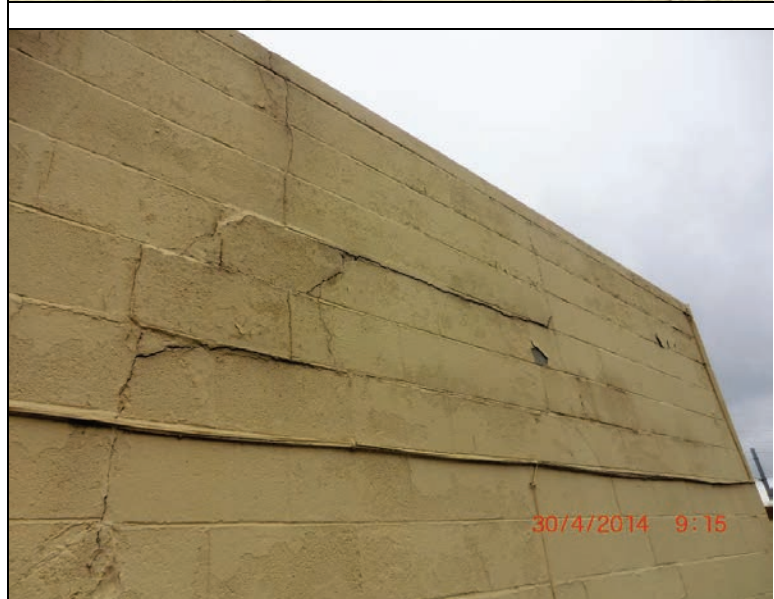
<p>Inspect ID: LCMN_2014_a_0098 Title: USACE_CELRC_LCMN_2014_a_0098_1.jpg Rated Item: 5. Plant Building Caption: Rating: Minimally Acceptable; Remarks: PS-HM: Cracking of masonry wall; Action: Seal</p>

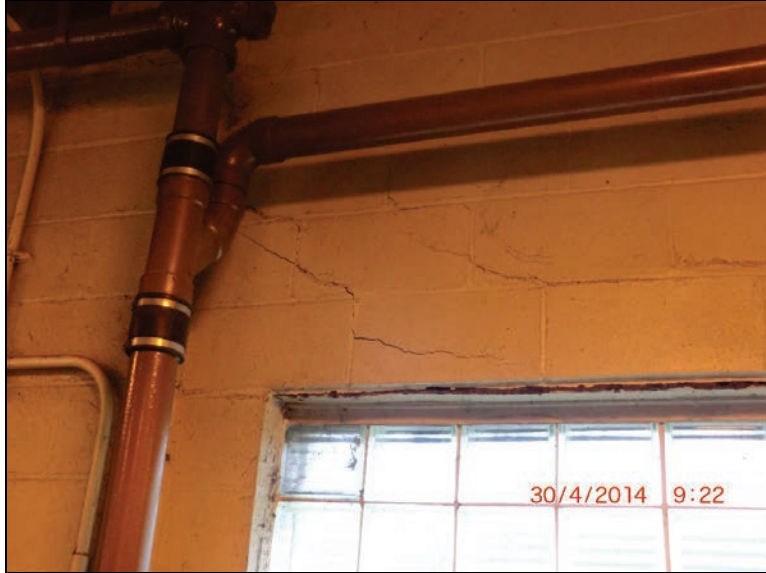
Inspect ID: LCMN_2014_a_0099 **Title:** USACE_CELRC_LCMN_2014_a_0099_1.jpg
Rated Item: 5. Plant Building **Caption:** Rating: Minimally Acceptable; Remarks: PS-HM: Cracking of masonry wall; Action: Seal

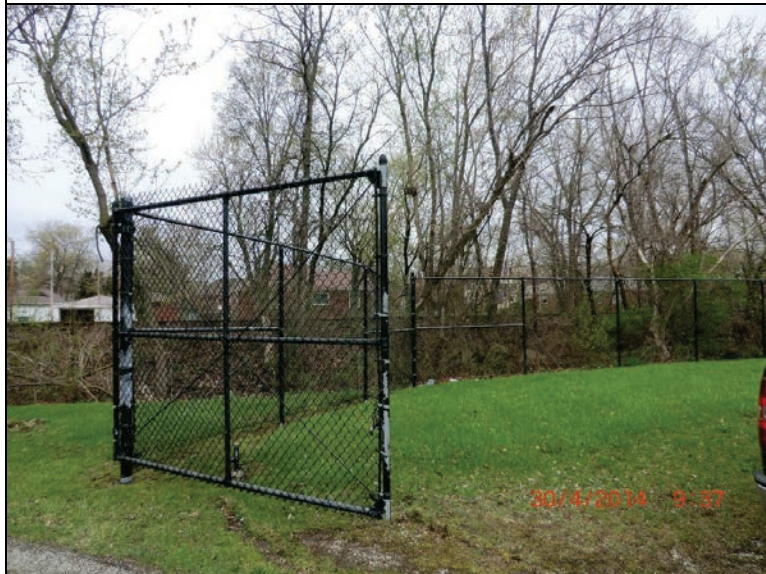
Inspect ID: LCMN_2014_a_0078 **Title:** USACE_CELRC_LCMN_2014_a_0078_1.jpg
Rated Item: 6. Fencing and Gates **Caption:** Rating: Minimally Acceptable; Remarks: PS-OA: Damaged fence; Action: Repair

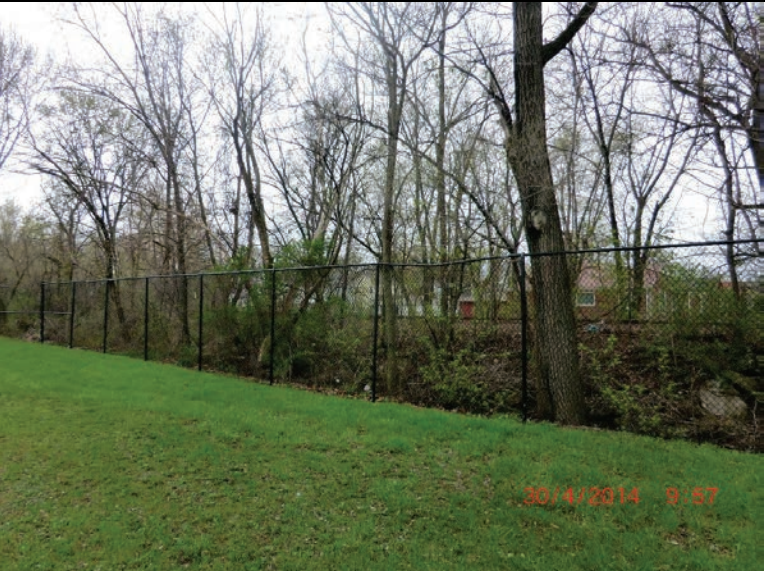
<p>Inspect ID: LCMN_2014_a_0080 Title: USACE_CELRC_LCMN_2014_a_0080_1.jpg Rated Item: 6. Fencing and Gates Caption: Rating: Minimally Acceptable; Remarks: PS-OA: Damaged fence; Action: Repair</p>

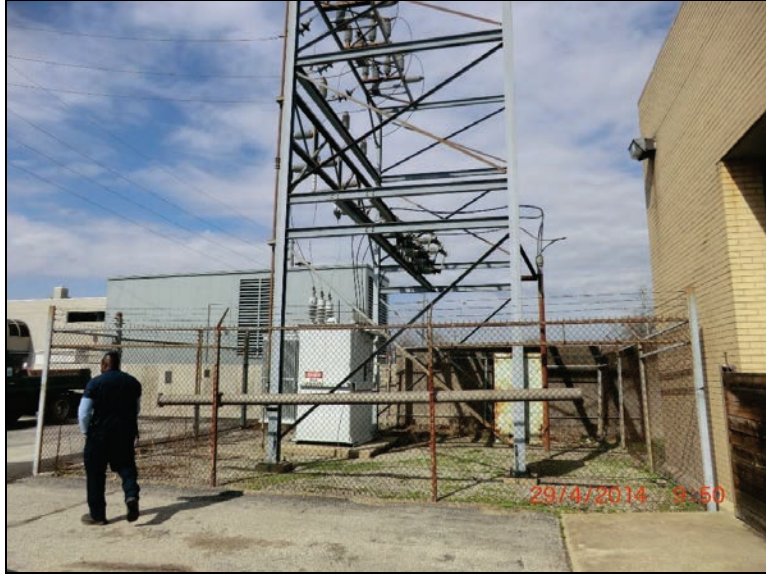
Inspect ID: LCMN_2014_a_0089 **Title:** USACE_CELRC_LCMN_2014_a_0089_1.jpg
Rated Item: 6. Fencing and Gates **Caption:** Rating: Acceptable; Remarks: PS-CAL: Rusted fencing; Action: Clean

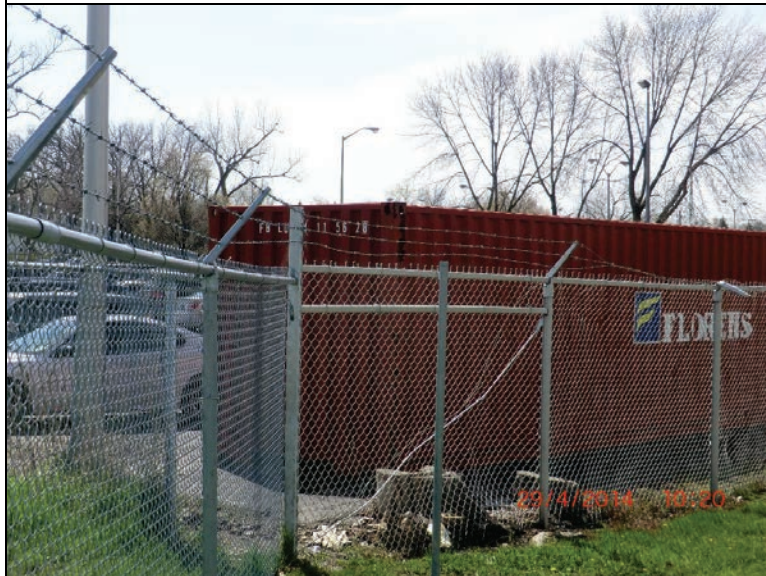
Inspect ID: LCMN_2014_a_0090 **Title:** USACE_CELRC_LCMN_2014_a_0090_1.jpg
Rated Item: 6. Fencing and Gates **Caption:** Rating: Minimally Acceptable; Remarks: PS-CAL: Damaged fence; Action: Repair

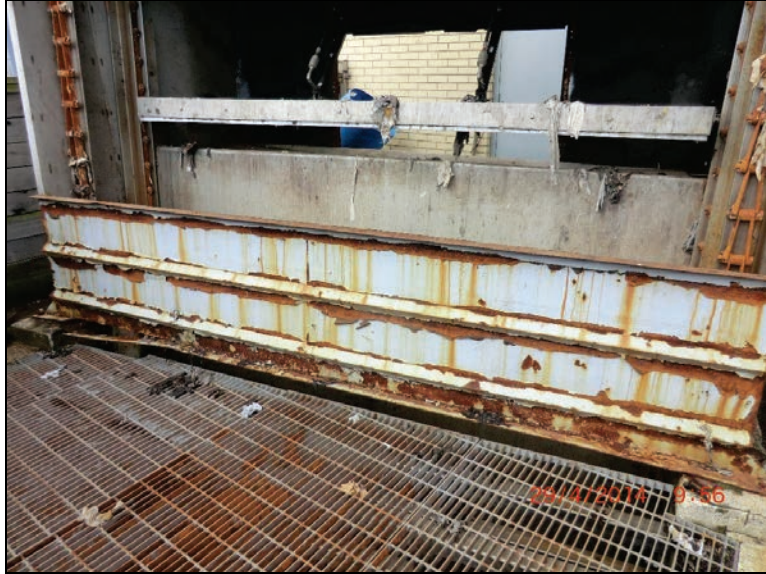
Inspect ID: LCMN_2014_a_0091 **Title:** USACE_CELRC_LCMN_2014_a_0091_1.jpg

Rated Item: 10. Mechanical Operating Trash Rakes **Caption:** Rating: Minimally Acceptable; Remarks: PS-CAL: Corroding trash rake; Action: Clean and paint

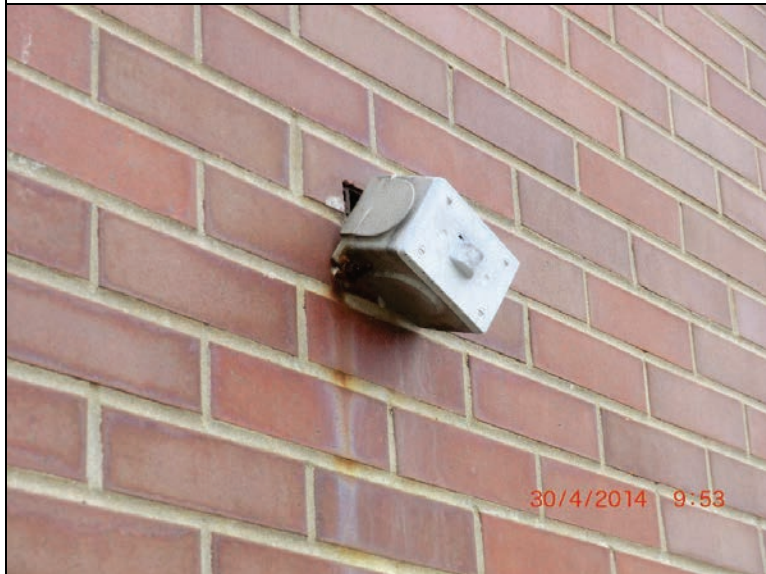
Inspect ID: LCMN_2014_a_0082 **Title:** USACE_CELRC_LCMN_2014_a_0082_1.jpg

Rated Item: 16. Enclosures, Panels, Conduit and Ducts **Caption:** Rating: Minimally Acceptable; Remarks: PS-OA: Exterior duplex receptacle is broken; Action: Replace

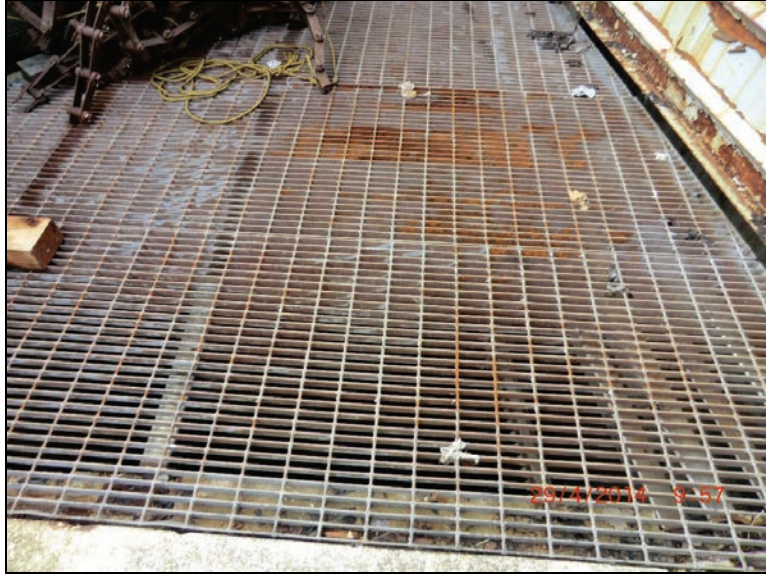
Inspect ID: LCMN_2014_a_0093 **Title:** USACE_CELRC_LCMN_2014_a_0093_1.jpg
Rated Item: 21. Other Metallic Items (Equipment, Ladders, Platform Anchors, etc)
Caption: Rating: Minimally Acceptable; Remarks: PS-CAL: Rusted grate; Action: Clean and repaint

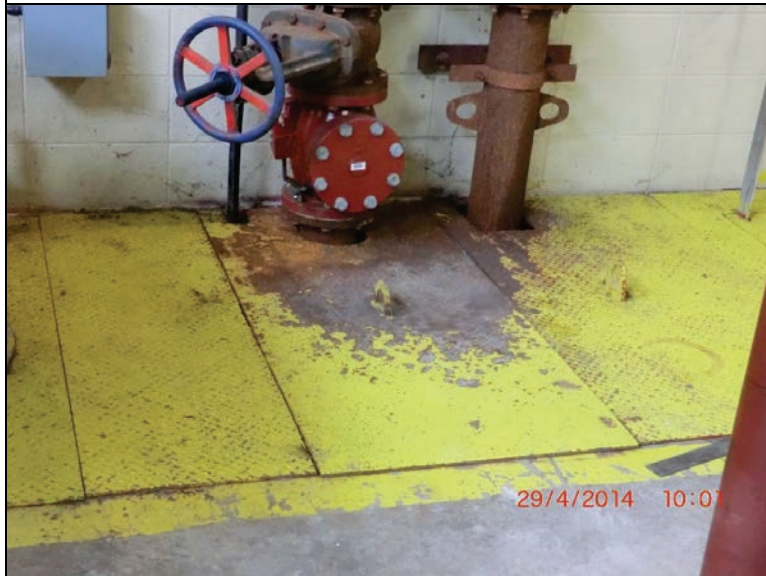
Inspect ID: LCMN_2014_a_0094 **Title:** USACE_CELRC_LCMN_2014_a_0094_1.jpg
Rated Item: 21. Other Metallic Items (Equipment, Ladders, Platform Anchors, etc)
Caption: Rating: Minimally Acceptable; Remarks: PS-CAL: Rusted floor cover; Action: Repaint
