US Army Corps
of Engineers ®

Site Visit Summary

Name of System: Hammond

Date of Site Visit: 04/29/2024 - 04/30/2024

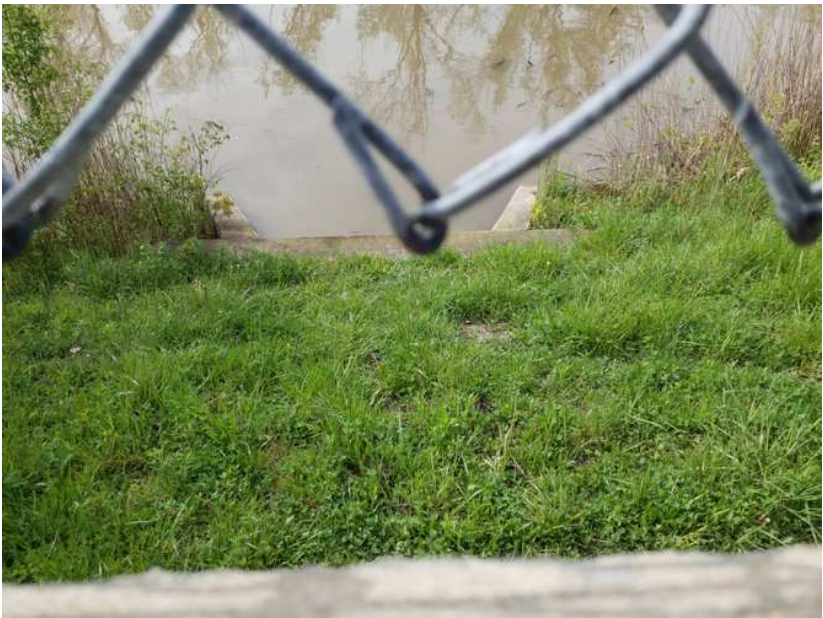
Inspect ID: 2024-0005
Rated Item: 1. Unwanted Vegetation Growth
Lat/Long: 41.56770/-87.43326
Caption:
No User Rating (Site Visit) - Trees and brush on riverside toe.

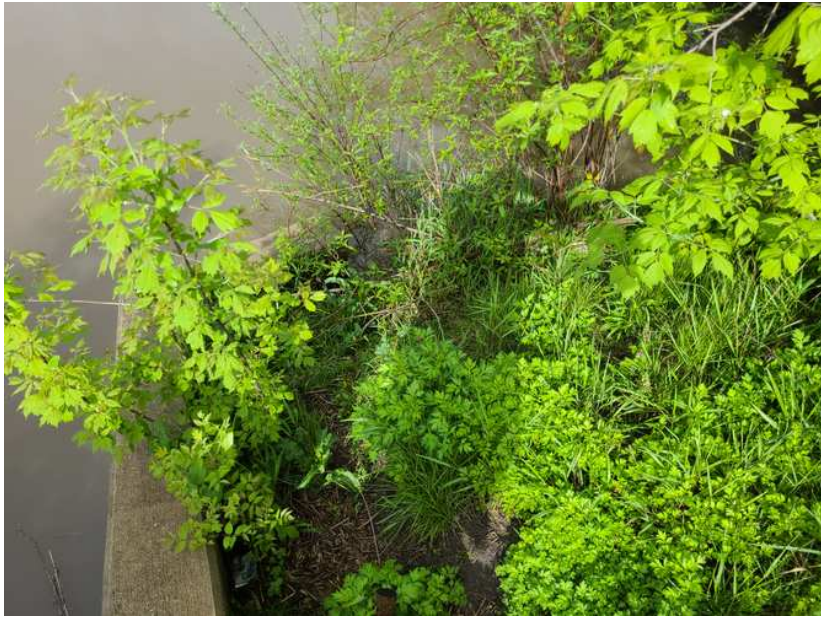
Inspect ID: 2024-0006
Rated Item: 1. Unwanted Vegetation Growth
Lat/Long: 41.56833/-87.43645
Caption:
No User Rating (Site Visit) - HA-35: Vegetation around the headwall at outlet

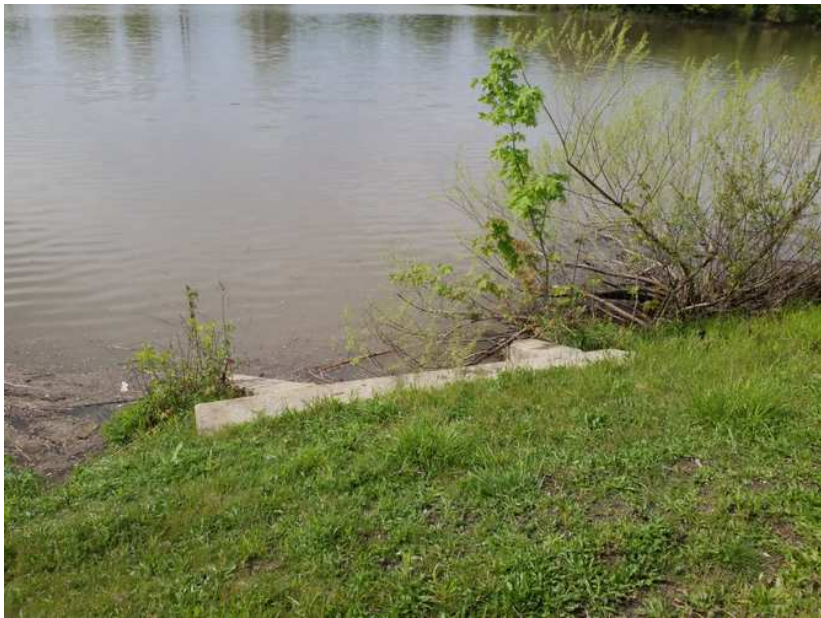
Inspect ID: 2024-0013

No User Rating (Site Visit) - HA-37: Vegetation around wingwall.

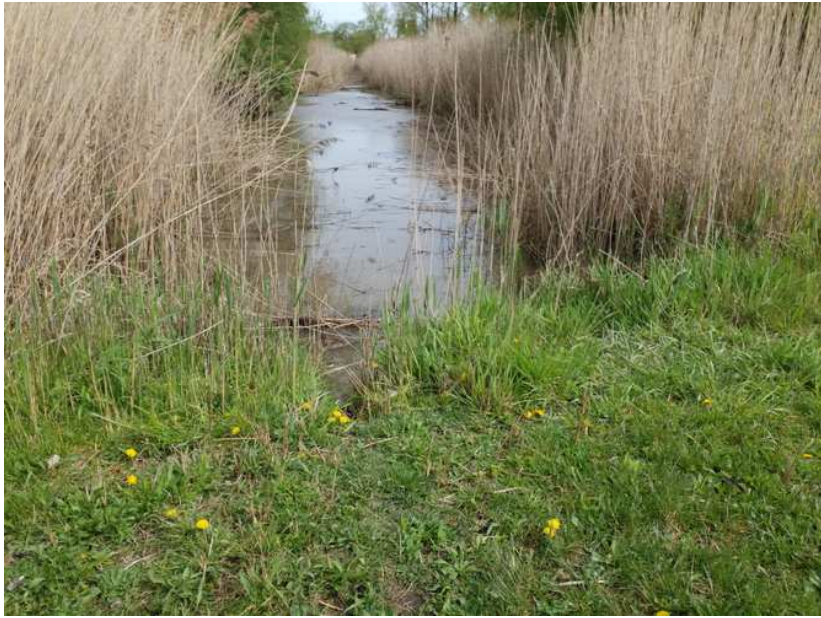
Inspect ID: 2024-0034

No User Rating (Site Visit) - HA-31: Vegetation around the headwall at the outlet structure.

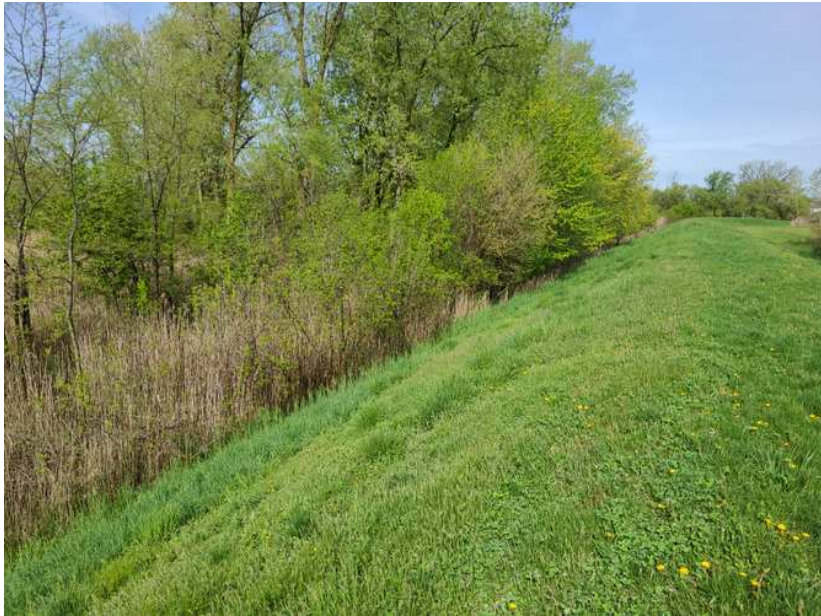
Inspect ID: 2024-0042

No User Rating (Site Visit) - HA-31: Vegetation around inlet structure

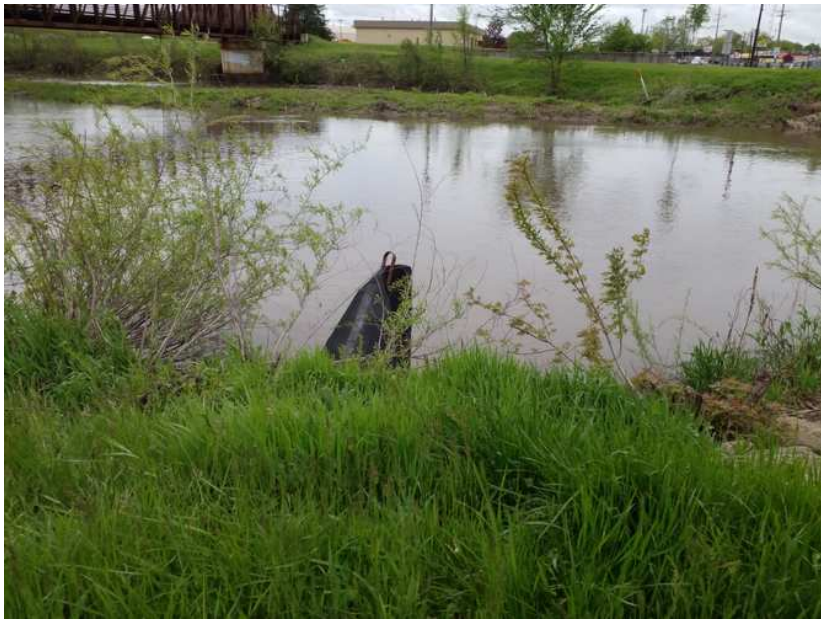
Inspect ID: 2024-0069

No User Rating (Site Visit) - Vegetation on riverside toe.

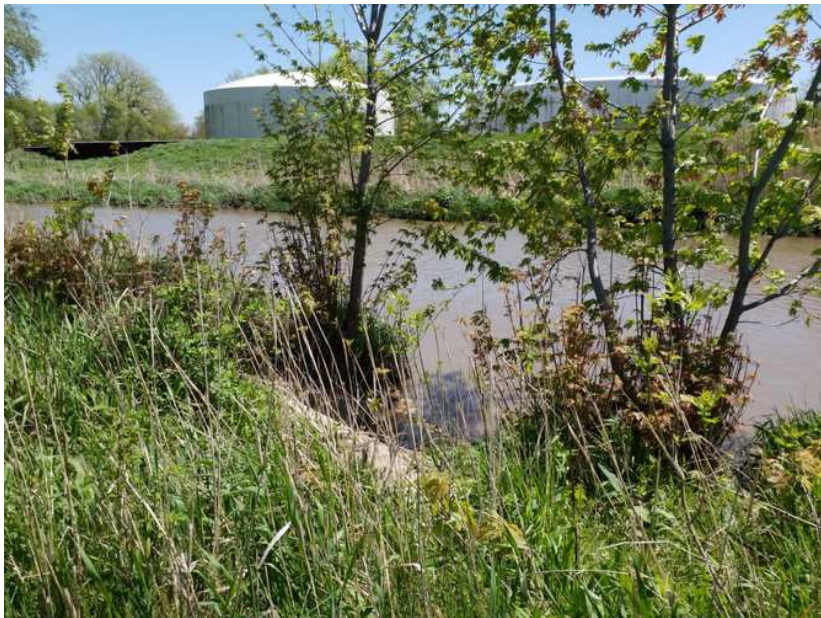
Inspect ID: 2024-0070

No User Rating (Site Visit) - HA-28: Vegetation around outlet structure

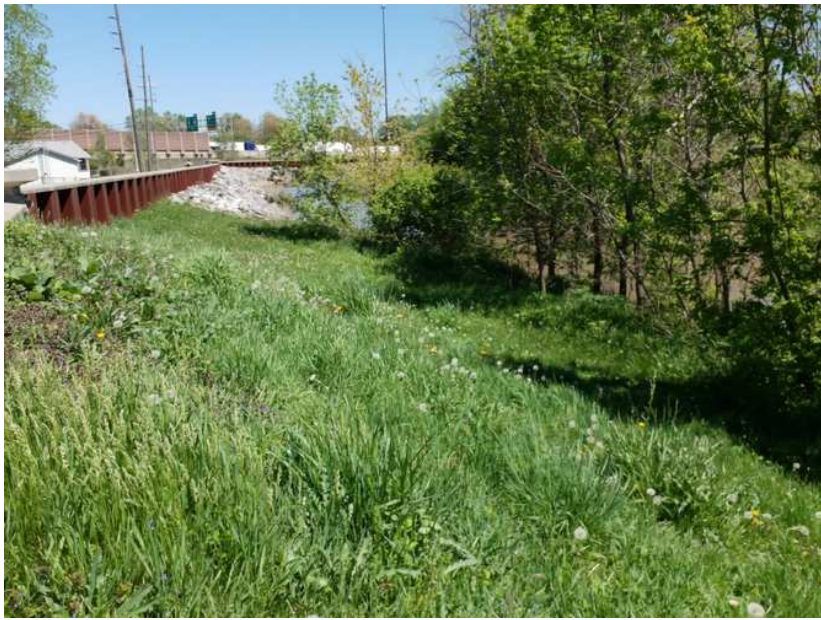
Inspect ID: 2024-0135

No User Rating (Site Visit) - HA-05: Vegetation around the outlet structure.

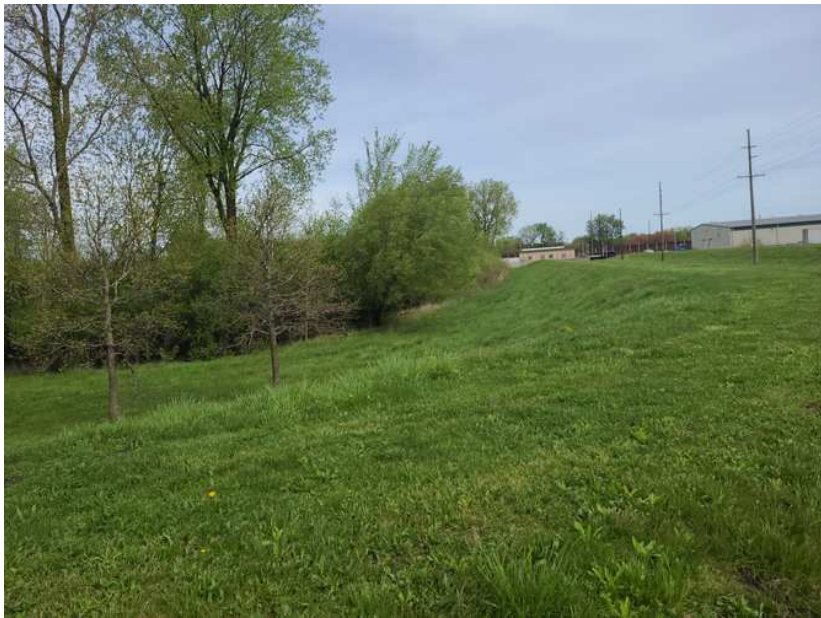
Inspect ID: 2024-0139

No User Rating (Site Visit) - Riverside trees and brush within 15' of levee toe.

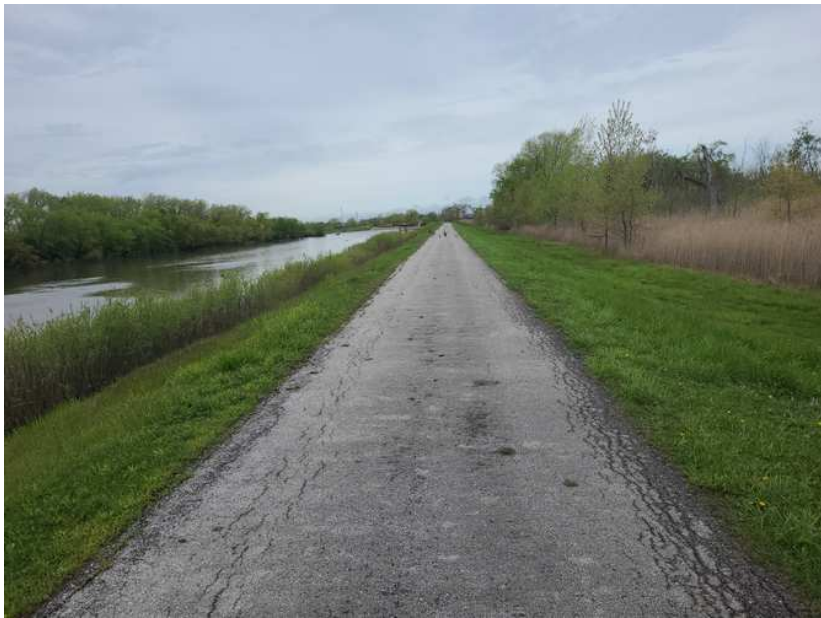
Inspect ID: 2024-0153

No User Rating (Site Visit) - Small vegetation on riverside toe.

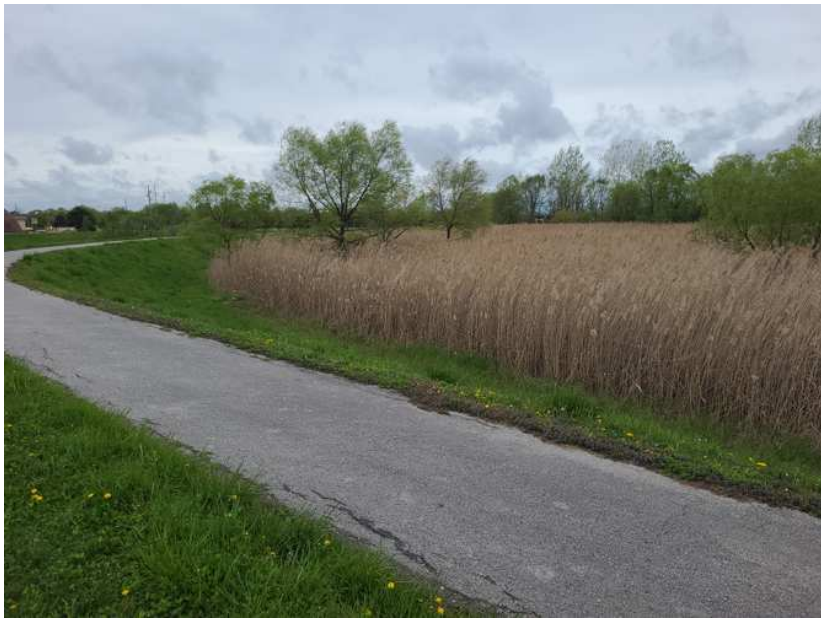
Inspect ID: 2024-0190

No User Rating (Site Visit) - New trees planted exactly 15 ft away from levee toe.

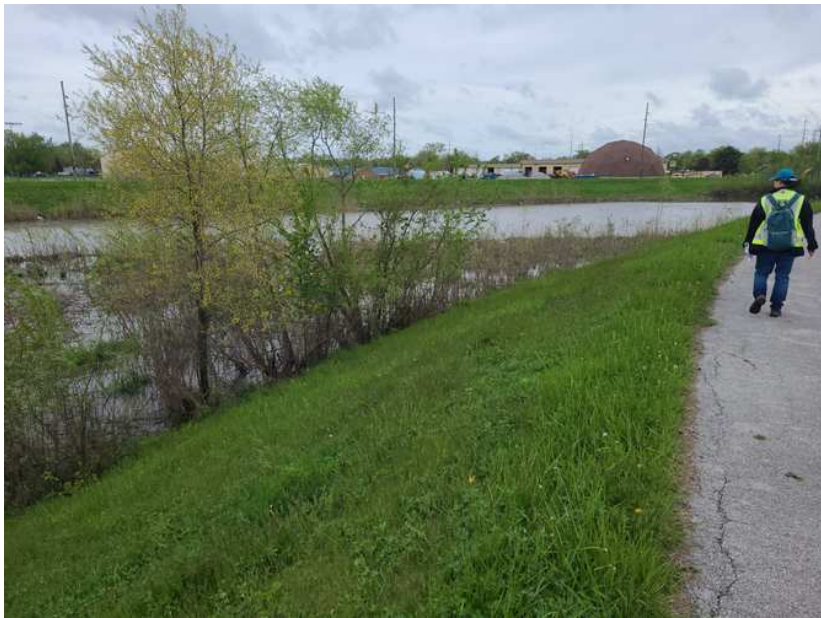
Inspect ID: 2024-0217

No User Rating (Site Visit) - Landside vegetation.

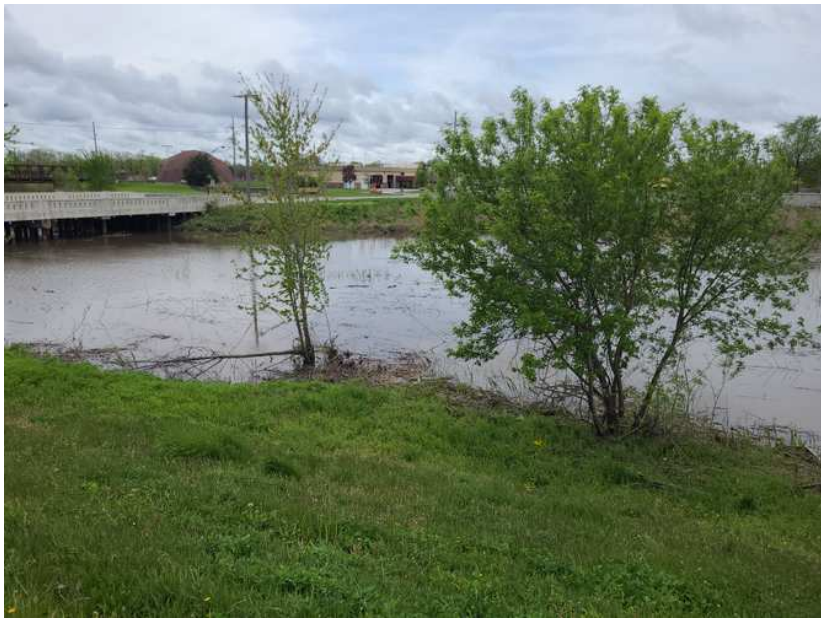
Inspect ID: 2024-0221

No User Rating (Site Visit) - Riverside vegetation.

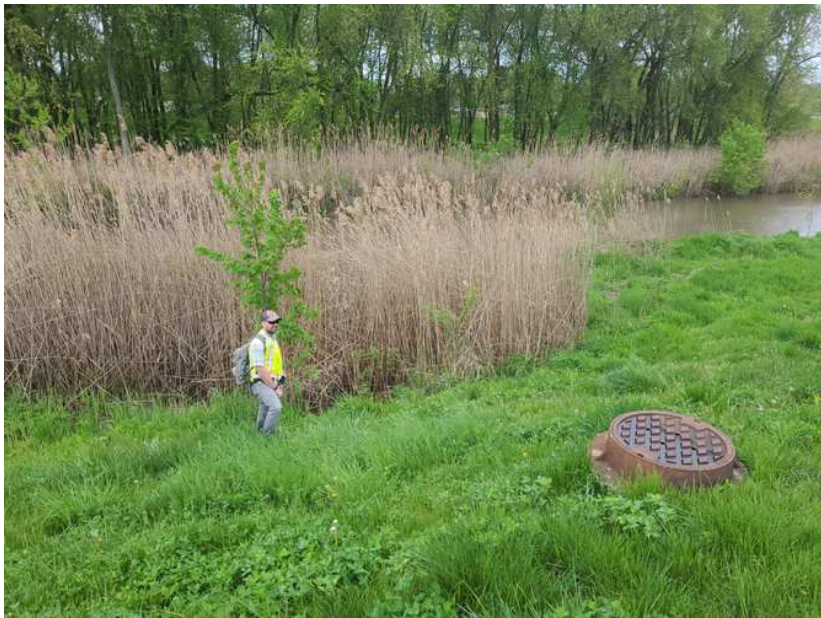
Inspect ID: 2024-0249

No User Rating (Site Visit) - Small trees riverside toe.

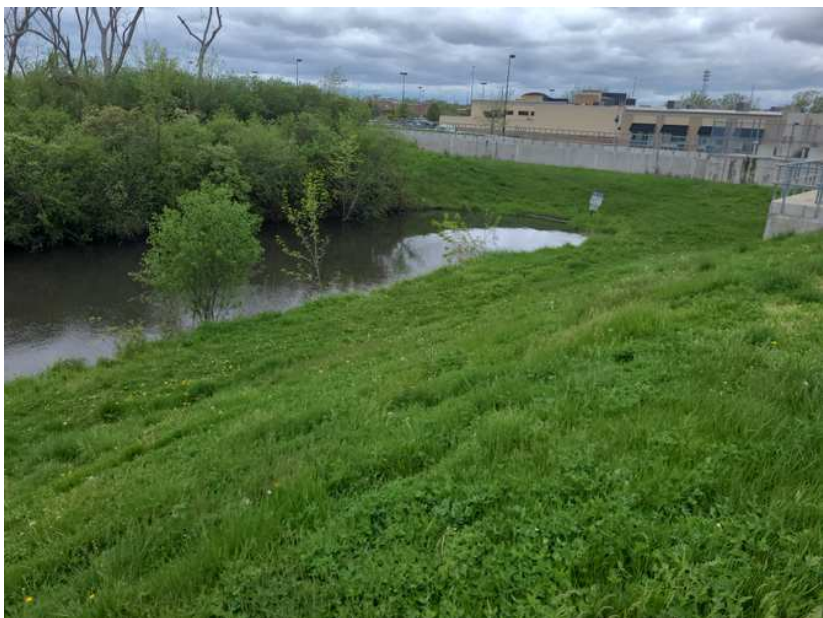
Inspect ID: 2024-0301

No User Rating (Site Visit) - Riverside vegetation on HA-22 outlet structure.

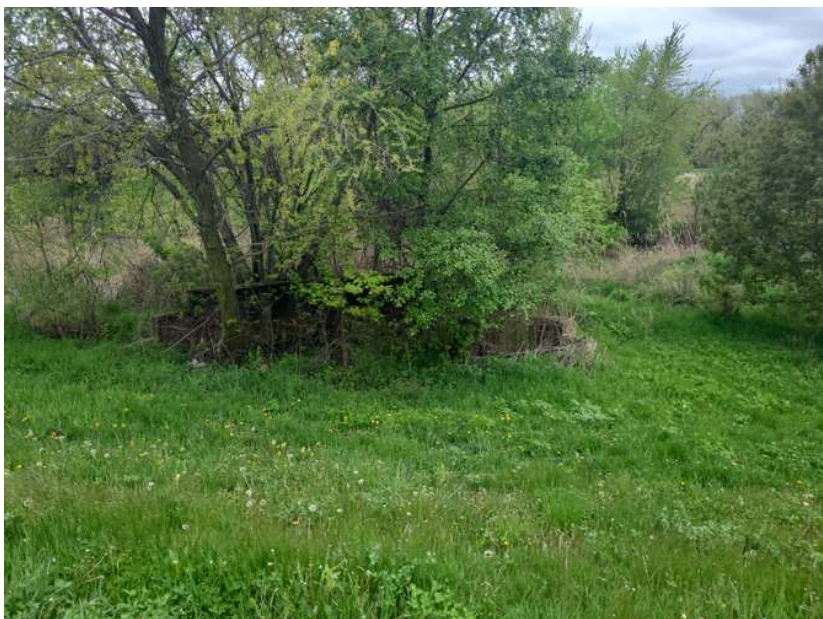
Inspect ID: 2024-0309

No User Rating (Site Visit) - Small trees on riverside toe

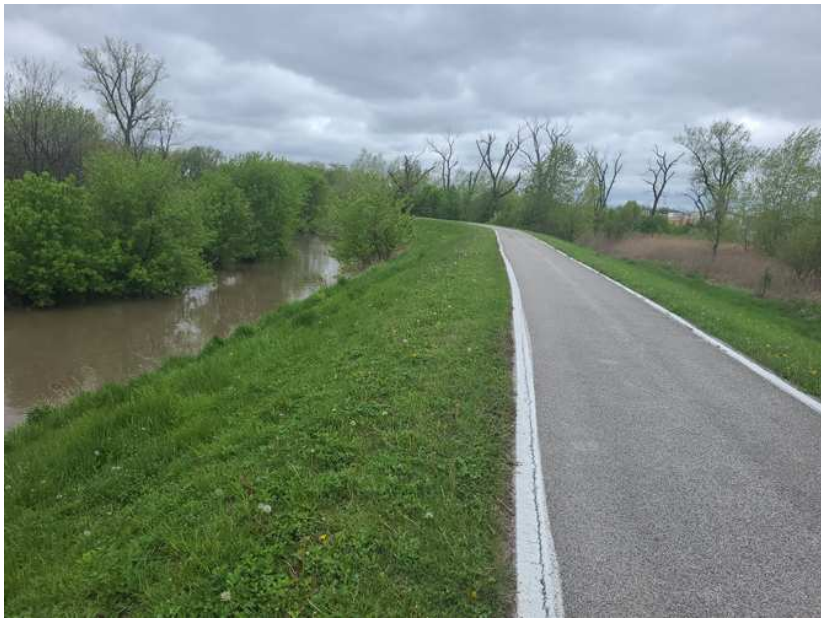
Inspect ID: 2024-0357

No User Rating (Site Visit) - Trees on riverside toe.

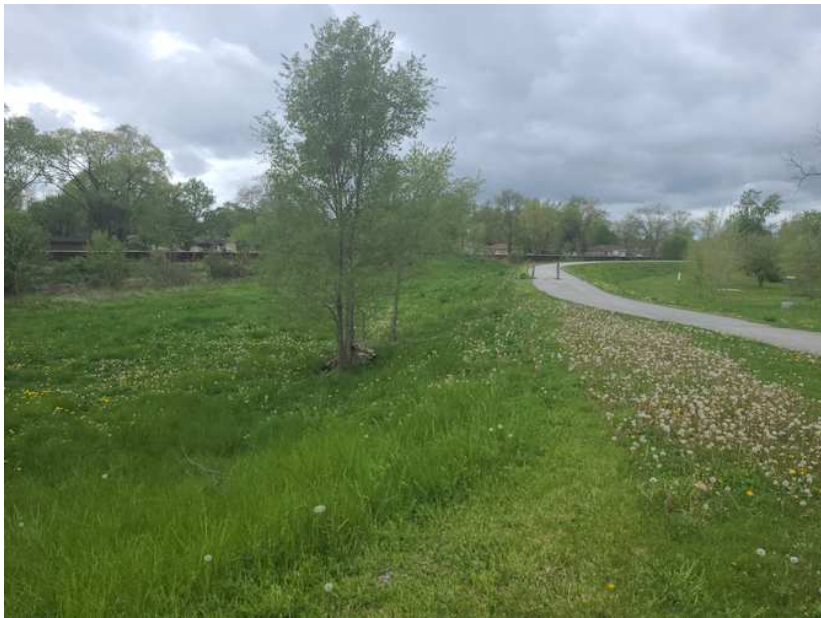
Inspect ID: 2024-0365

No User Rating (Site Visit) - Vegetation on riverside toe.

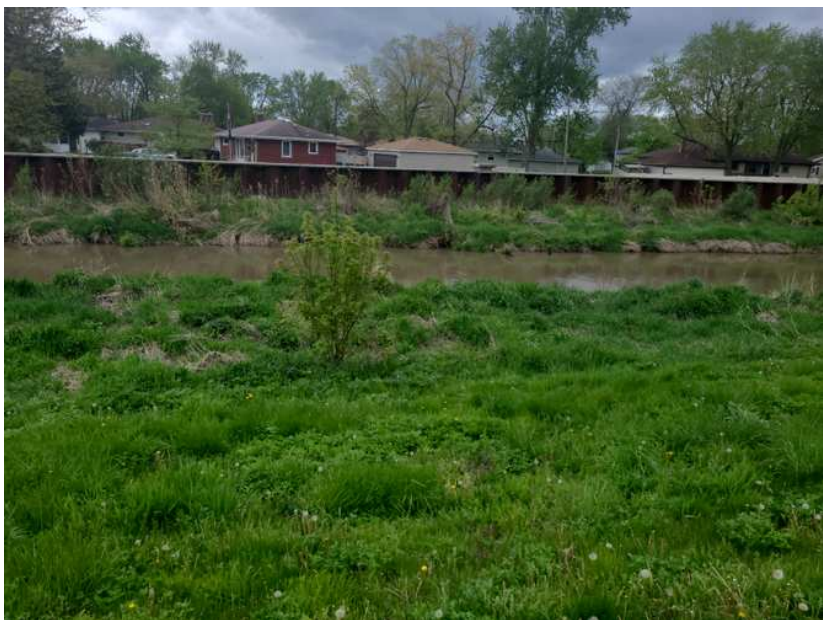
Inspect ID: 2024-0481

No User Rating (Site Visit) - Columbia Ave tree still present on riverside toe.

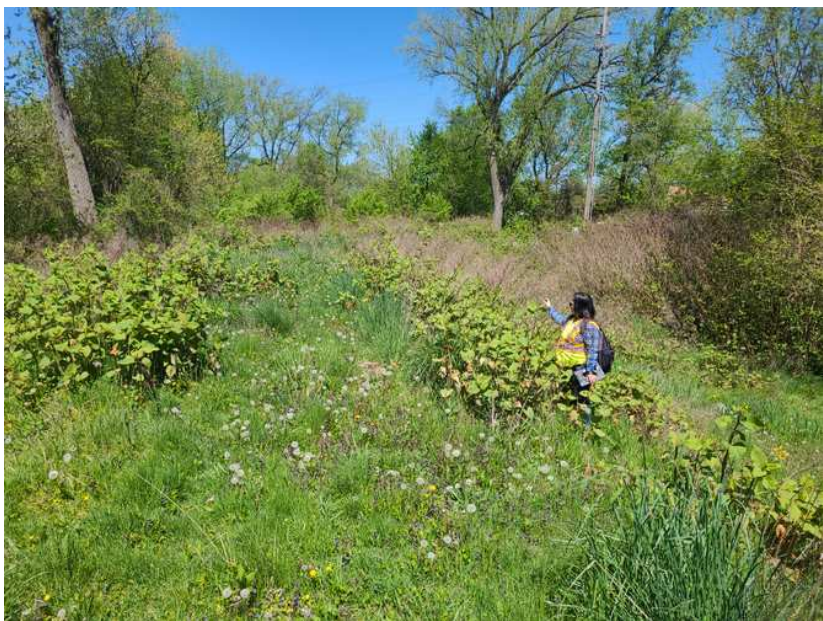
Inspect ID: 2024-0485

No User Rating (Site Visit) - Small tree on riverside toe

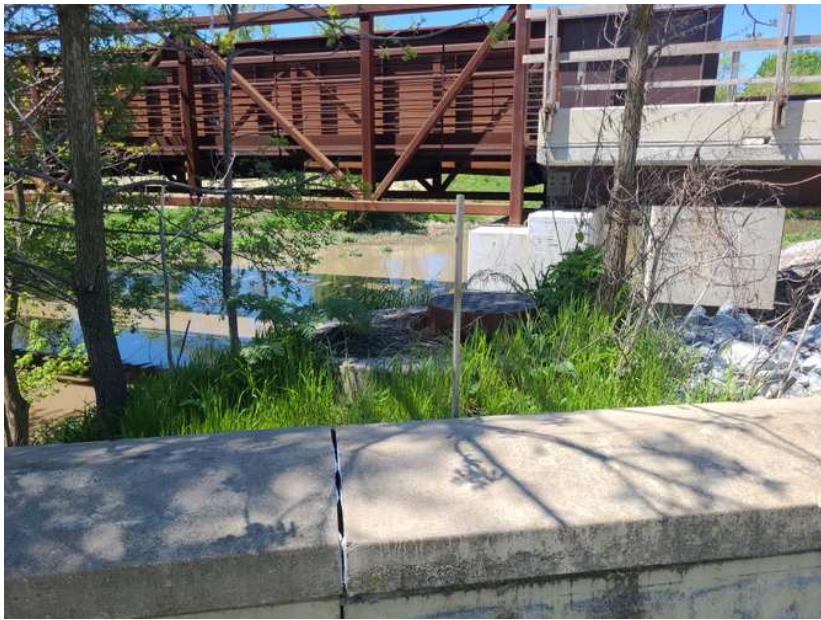
Inspect ID: 2024-0529

No User Rating (Site Visit) - Tall vegetation on both landside and riverside slopes

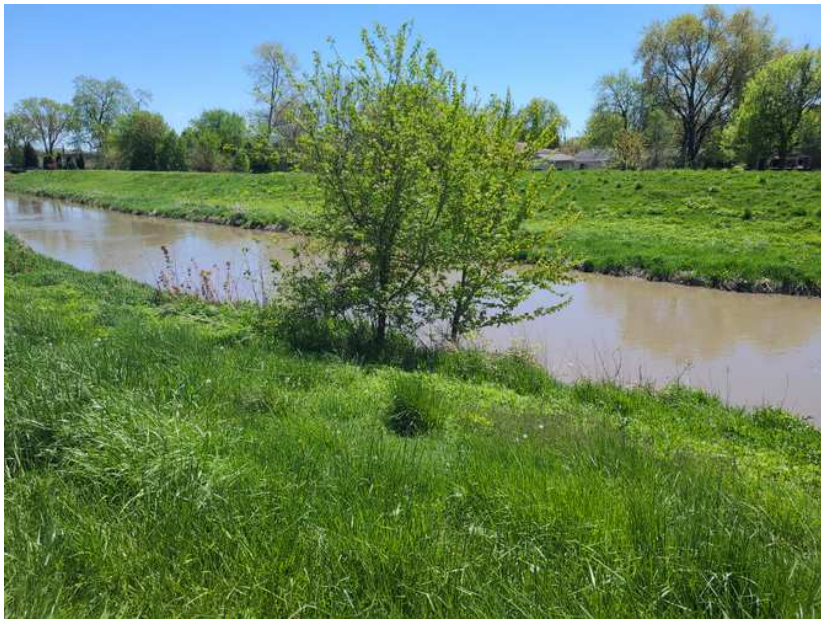
Inspect ID: 2024-0553

No User Rating (Site Visit) - HA-03: Vegetation around manhole.

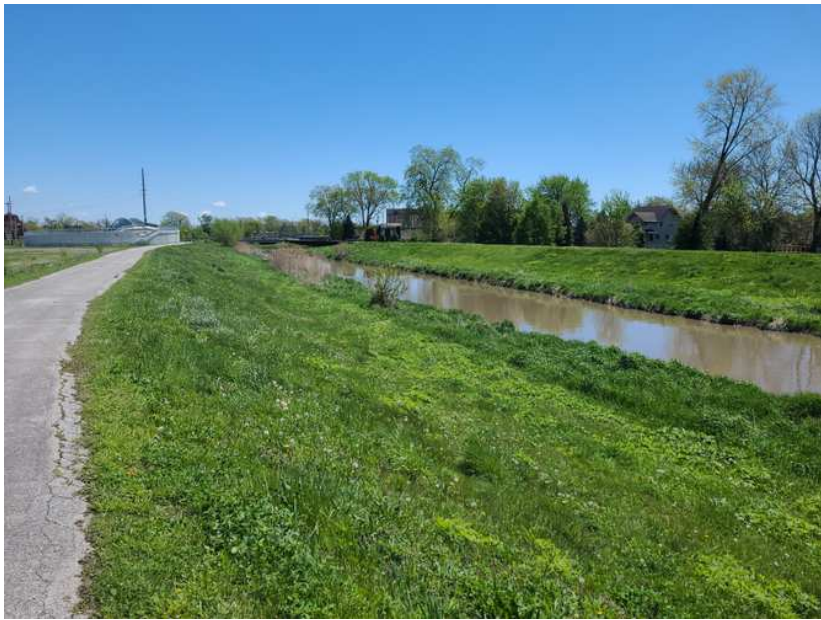
Inspect ID: 2024-0585

No User Rating (Site Visit) - Tree on riverside toe

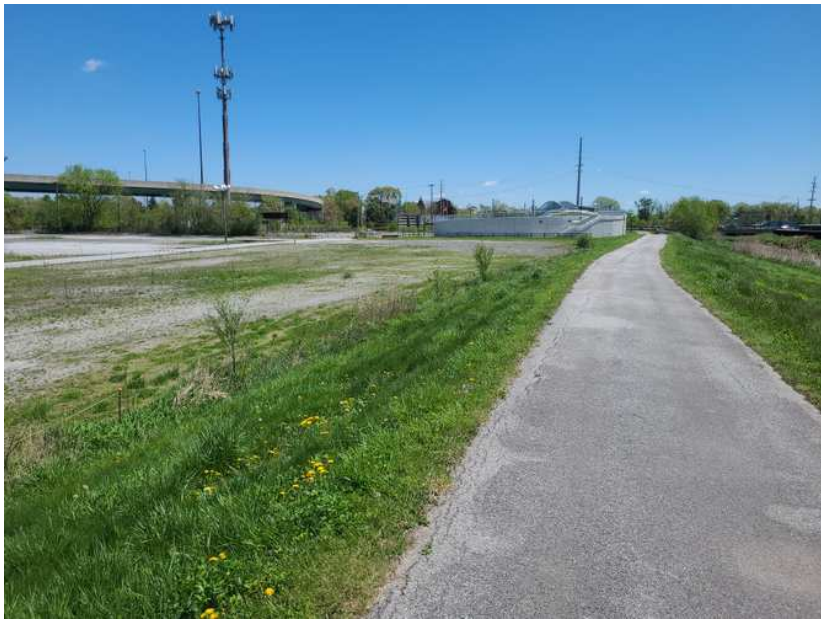
Inspect ID: 2024-0589

No User Rating (Site Visit) - Vegetation on riverside toe

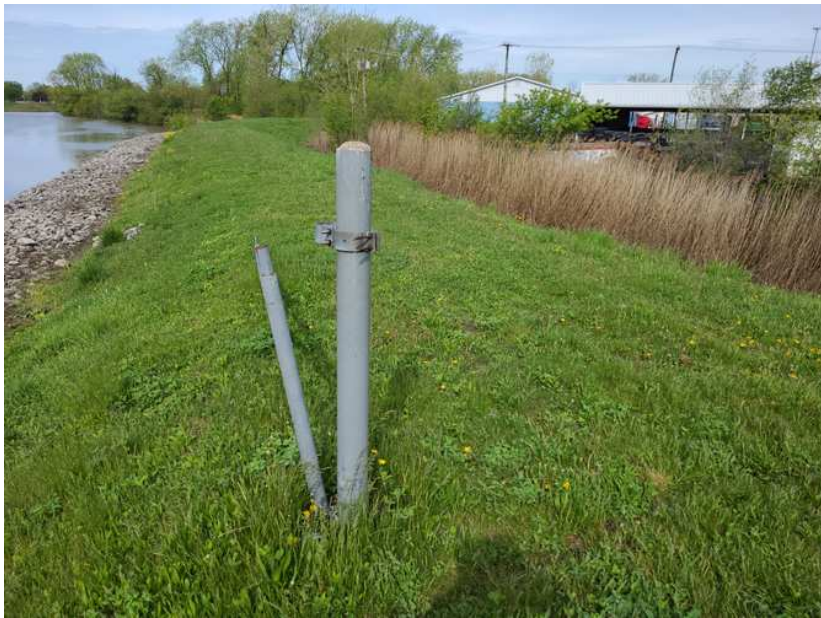
Inspect ID: 2024-0593

No User Rating (Site Visit) - Small trees on landside toe along encroachment line

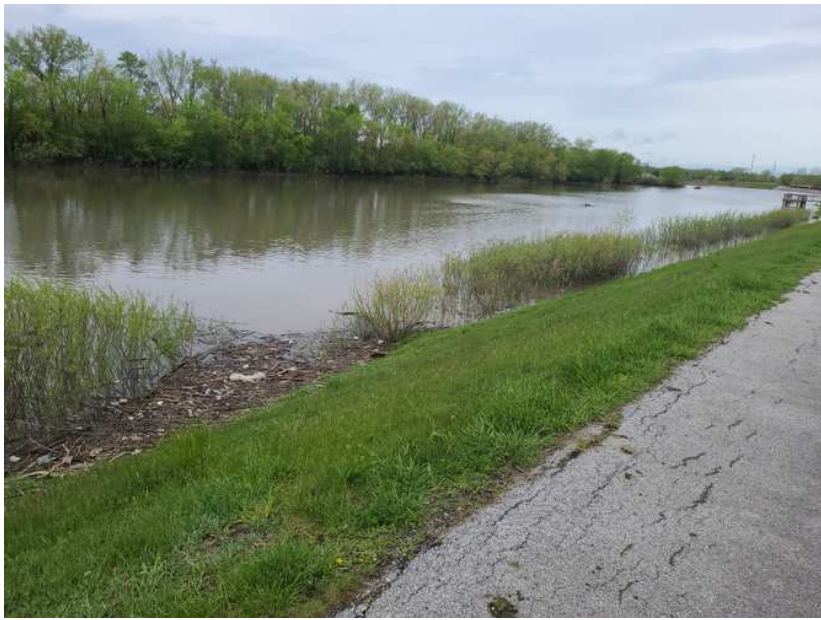
Inspect ID: 2024-0143

No User Rating (Site Visit) - Landside toe debris and vegetation.

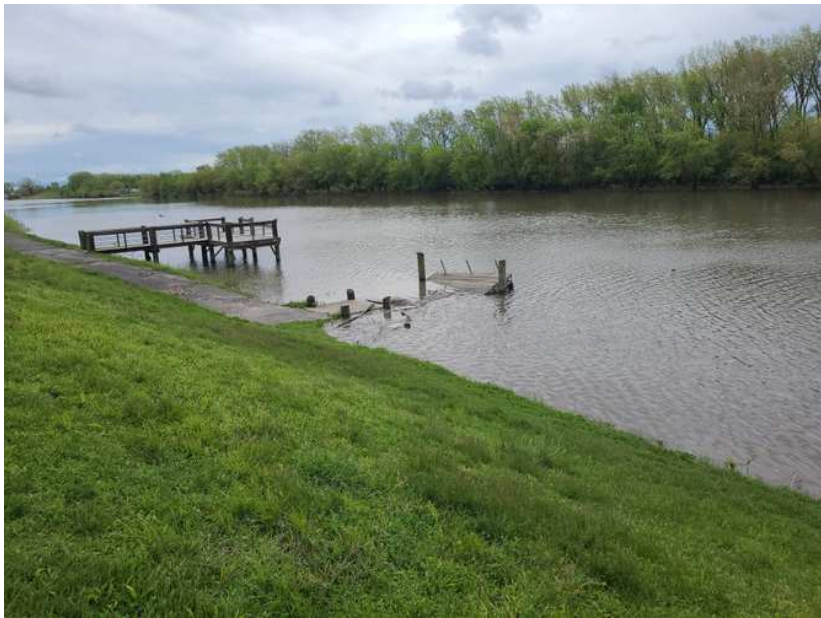
Inspect ID: 2024-0173

No User Rating (Site Visit) - Debris typical on riverside toe.

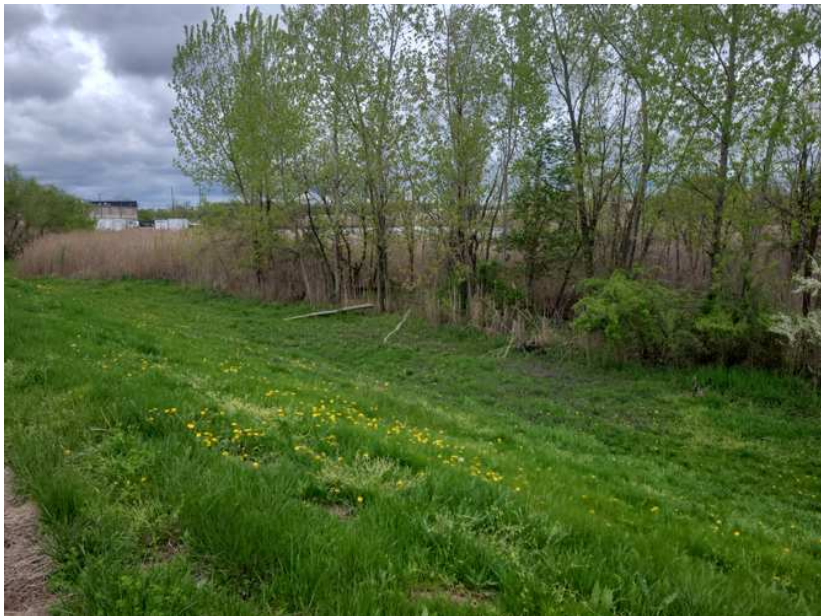
No User Rating (Site Visit) - Downed tree on landside toe.

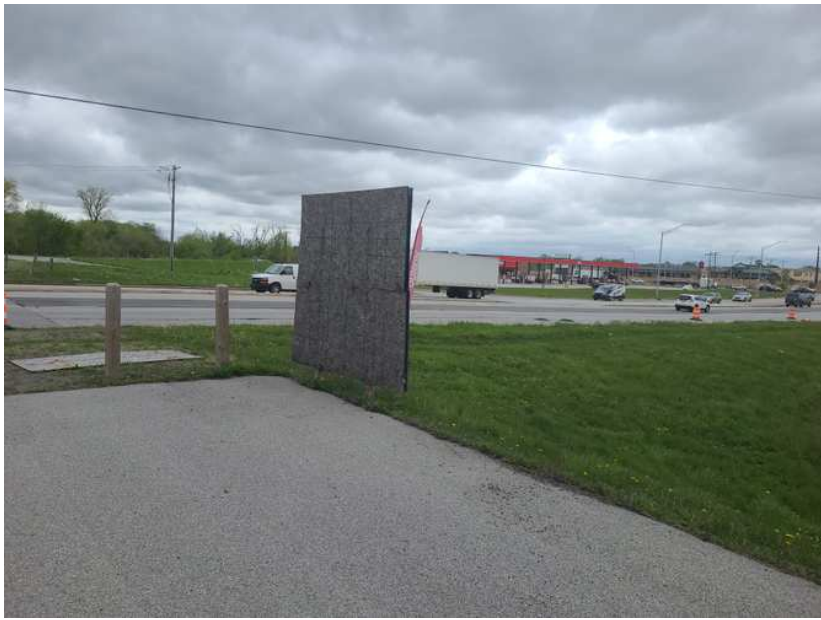
Inspect ID: 2024-0341

No User Rating (Site Visit) - Sign on crest of levee.

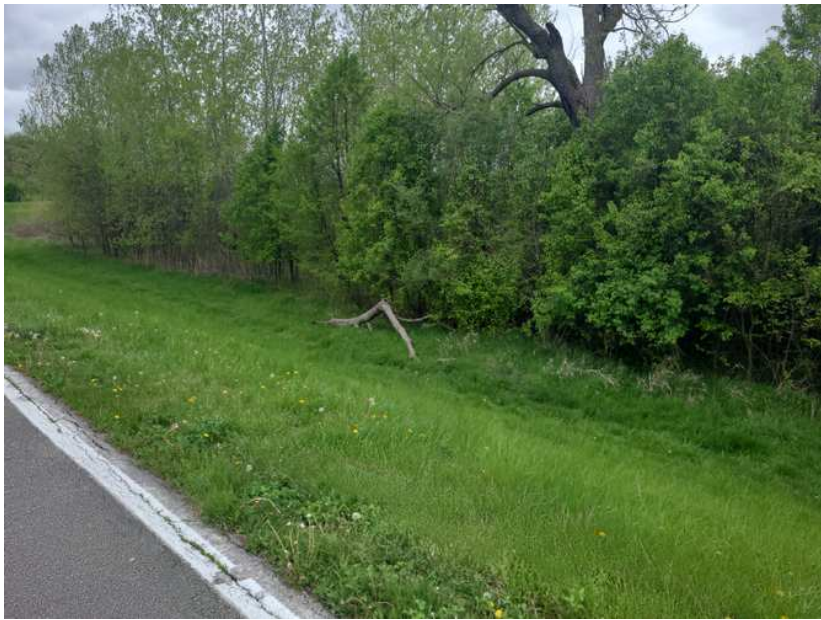
Inspect ID: 2024-0369

No User Rating (Site Visit) - Downed tree on landside toe

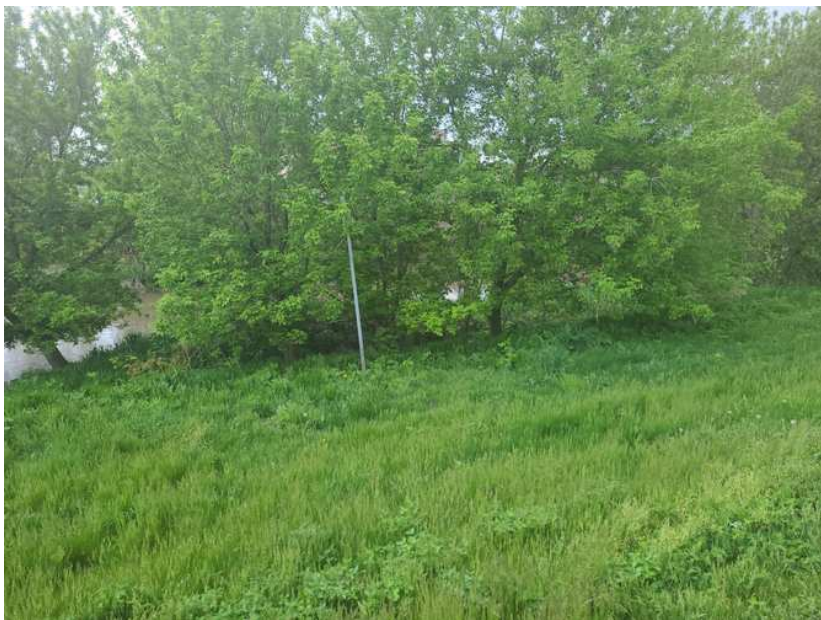
Inspect ID: 2024-0501

No User Rating (Site Visit) - Sign and pole on riverside toe

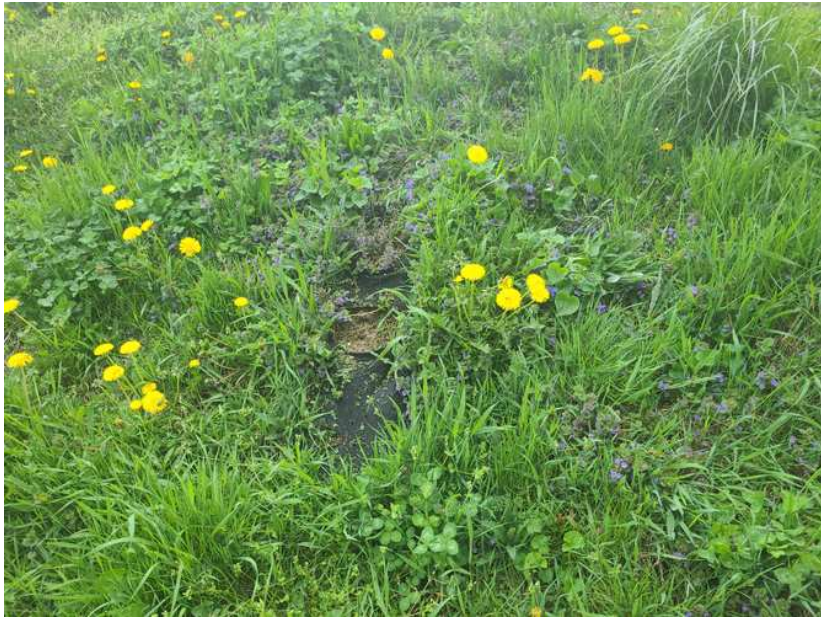
Inspect ID: 2024-0505

No User Rating (Site Visit) - Geosynthetic on landside.

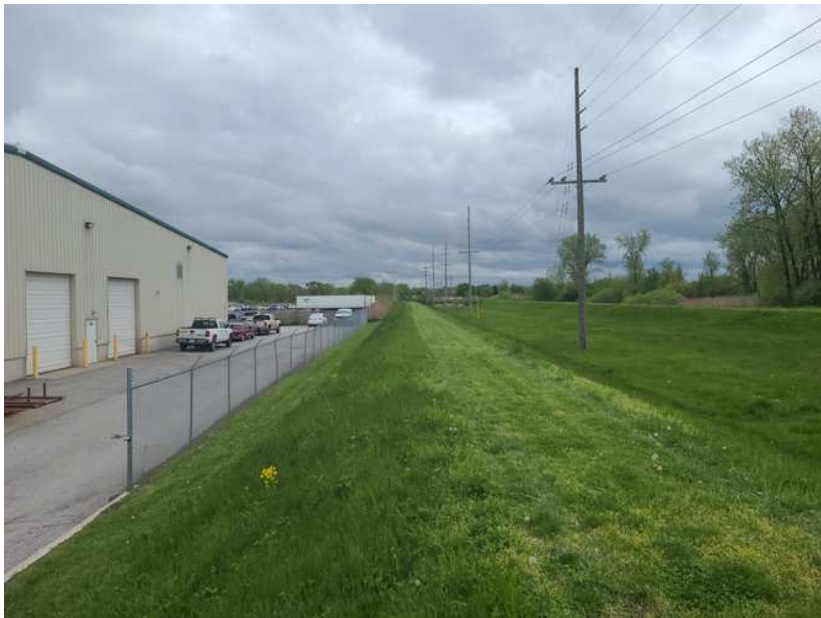
Inspect ID: 2024-0517

No User Rating (Site Visit) - Vegetation and fence on landside.

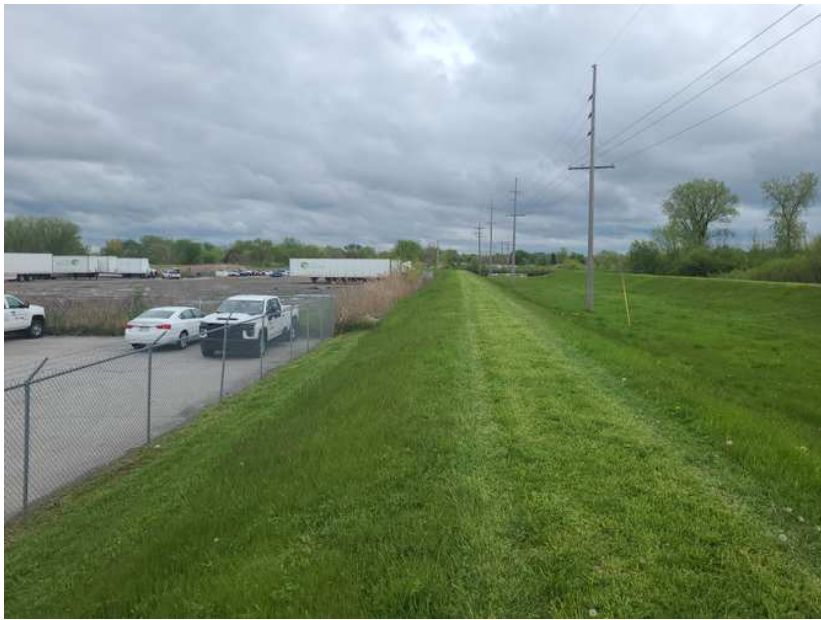
Inspect ID: 2024-0517

No User Rating (Site Visit) - Vegetation and fence on landside.

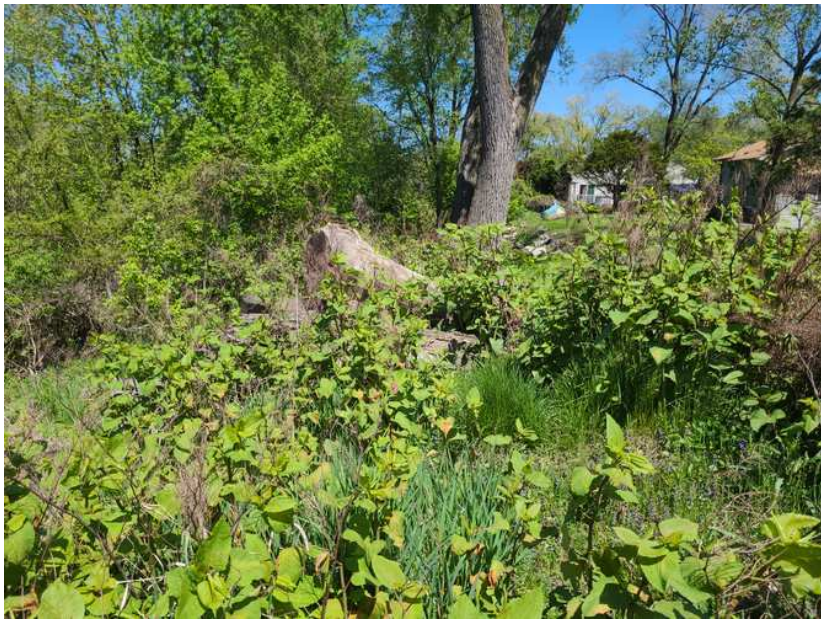
Inspect ID: 2024-0533

No User Rating (Site Visit) - Large logs on levee crest

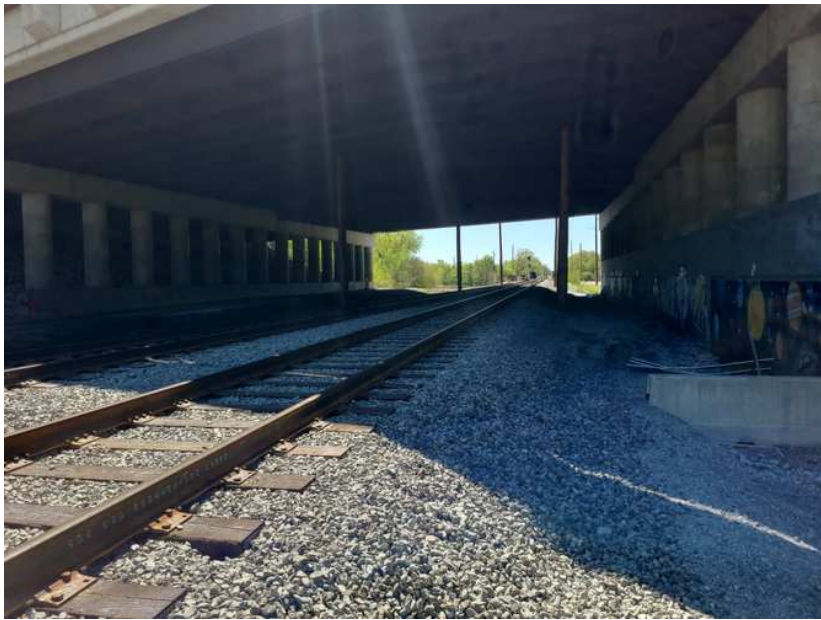
Inspect ID: 2024-0545

No User Rating (Site Visit) - Typical view of construction of the new 408 NICTD railroad

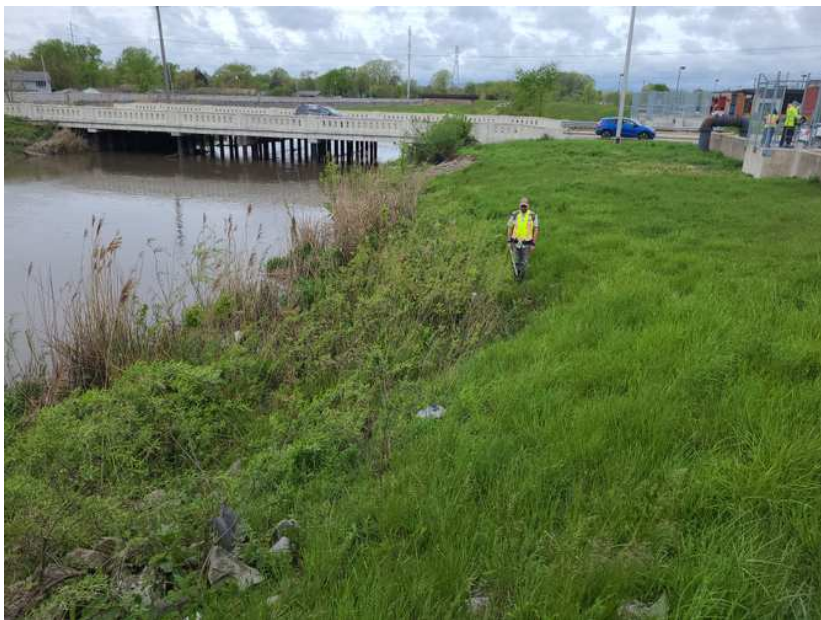
Inspect ID: 2024-0233

No User Rating (Site Visit) - Large bank cave on riverside toe

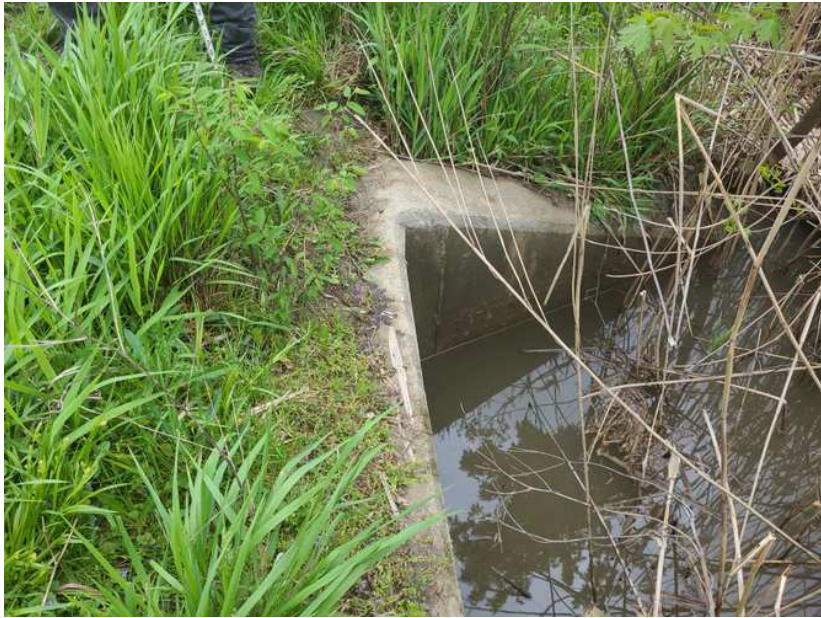
Inspect ID: 2024-0305

No User Rating (Site Visit) - HA-22: Slope sloughing down onto top of wingwall on riverside slope and toe.

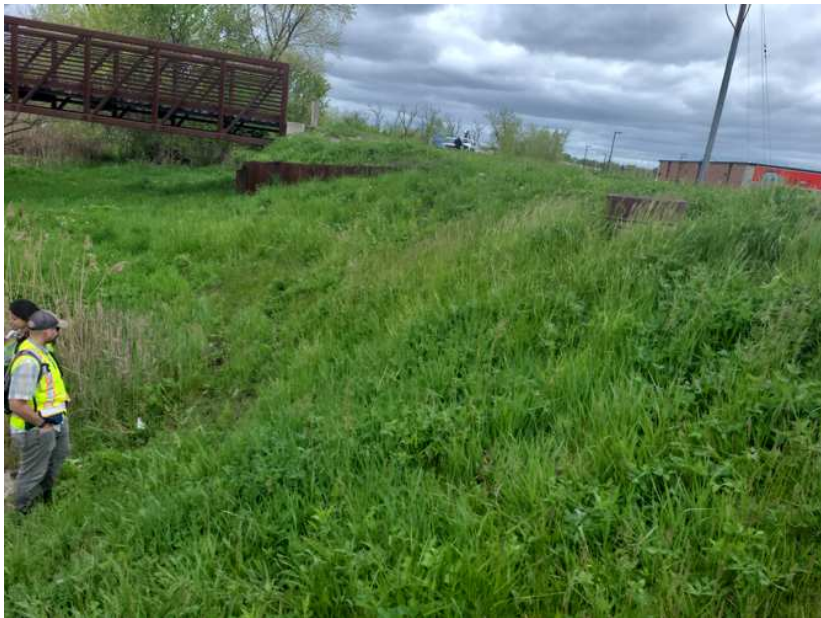
Inspect ID: 2024-0353

No User Rating (Site Visit) - Steep riverside slope at HA-19, approximately 1:1

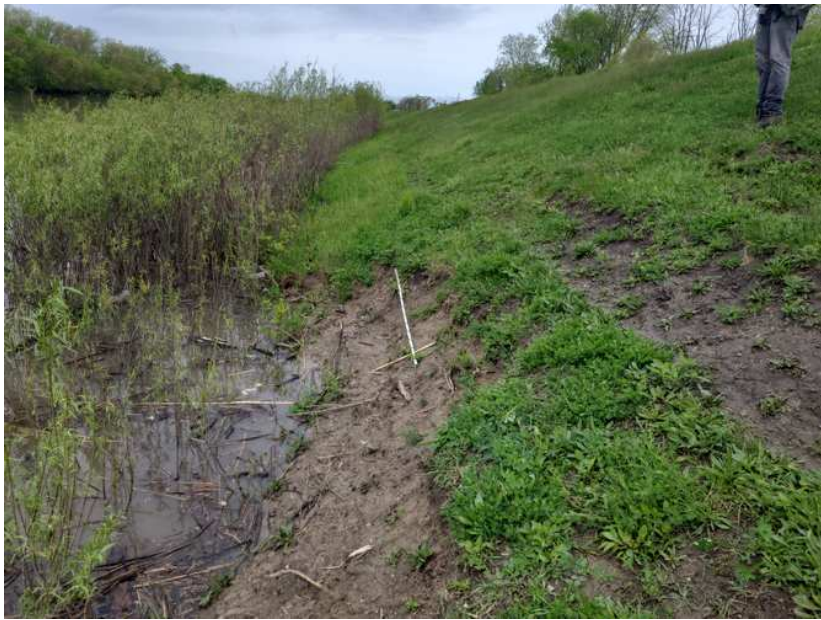
Inspect ID: 2024-0169

No User Rating (Site Visit) - Erosion and bank caving on riverside toe.

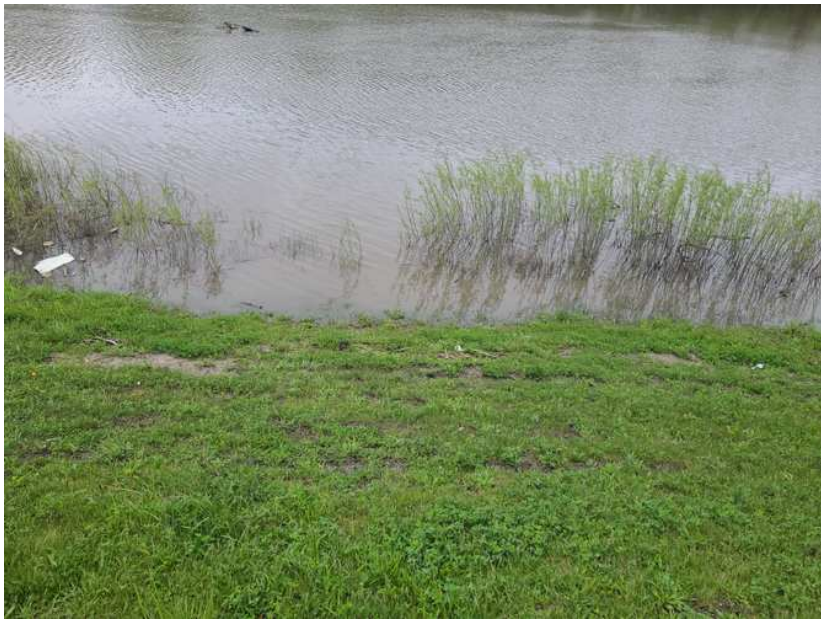
Inspect ID: 2024-0177

No User Rating (Site Visit) - Sloughing on riverside slope, bank caving

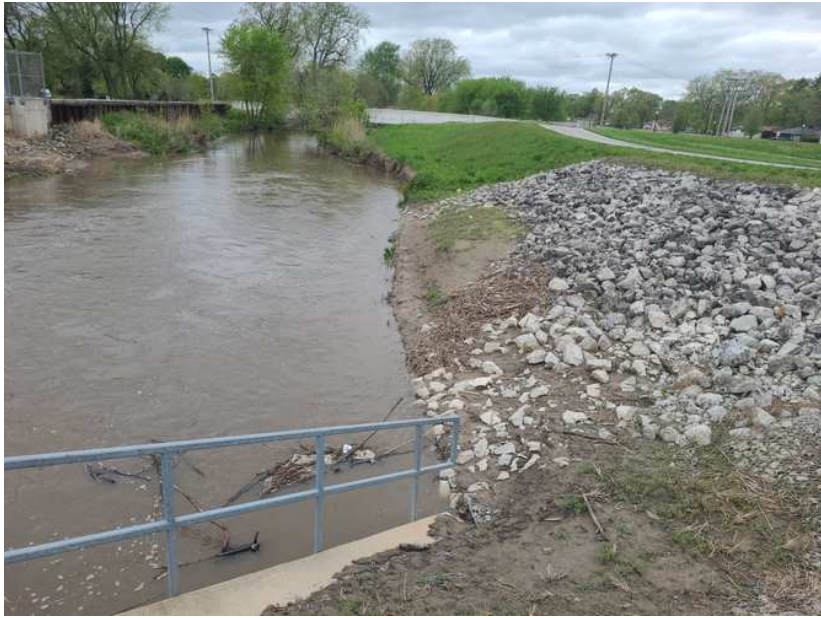
Inspect ID: 2024-0401

No User Rating (Site Visit) - Ongoing erosion and bank caving on riverside.

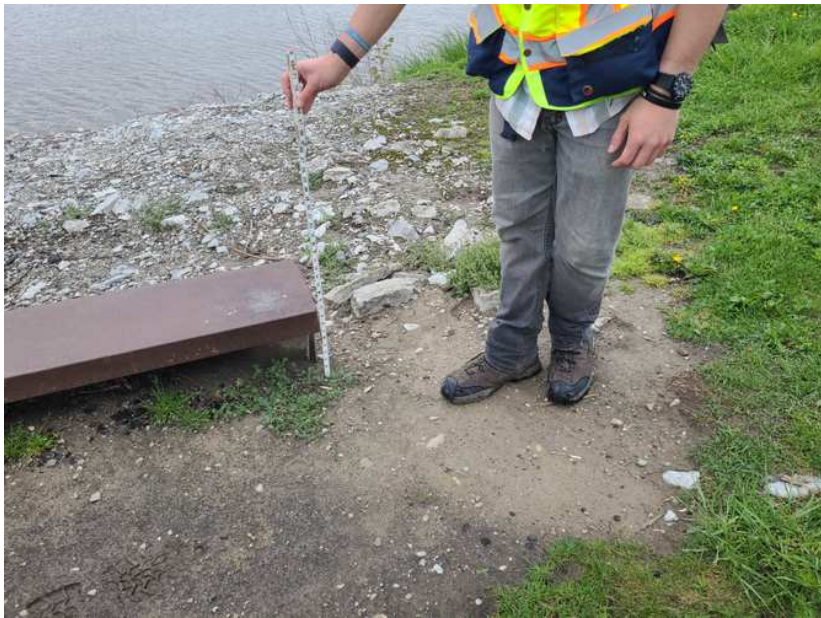
Inspect ID: 2024-0213

No User Rating (Site Visit) - Settlement of levee at the floodwall tie-in.
