US Army Corps
of Engineers ®

Site Visit Summary

Name of System: Hammond

Date of Site Visit: 04/29/2024 - 04/30/2024

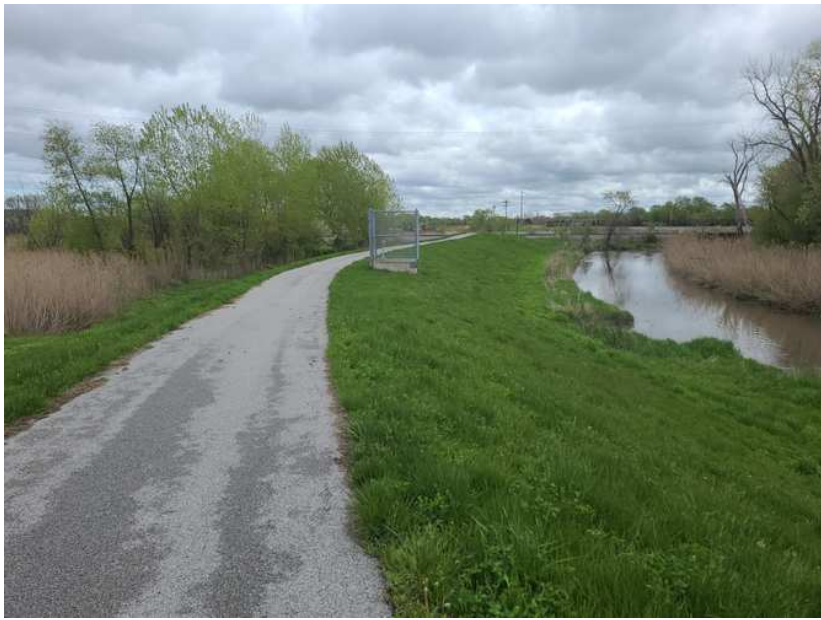
Inspect ID: 2024-0293

No User Rating (Site Visit) - Dip in crest along long section of crest

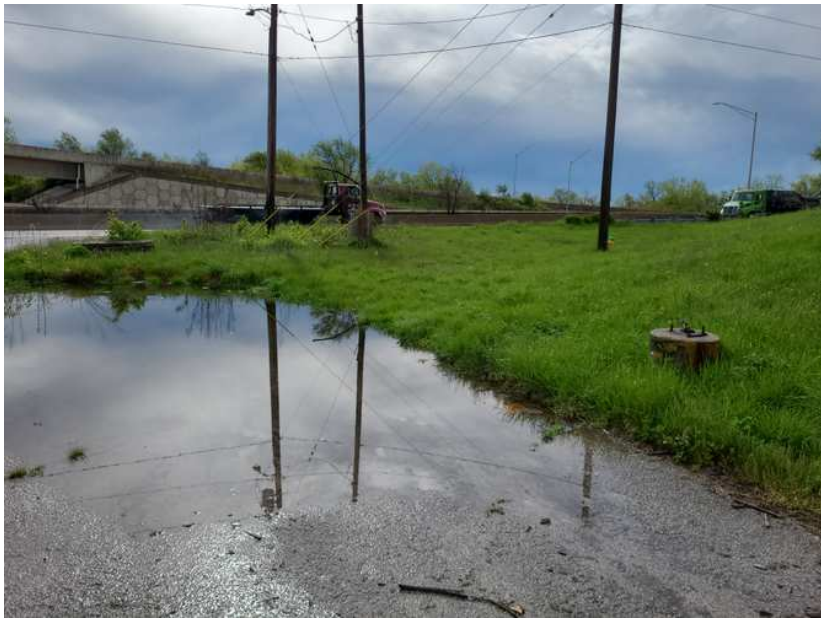
Inspect ID: 2024-0001

No User Rating (Site Visit) - Ponding on landside toe. Was not as noticeable in previous years.

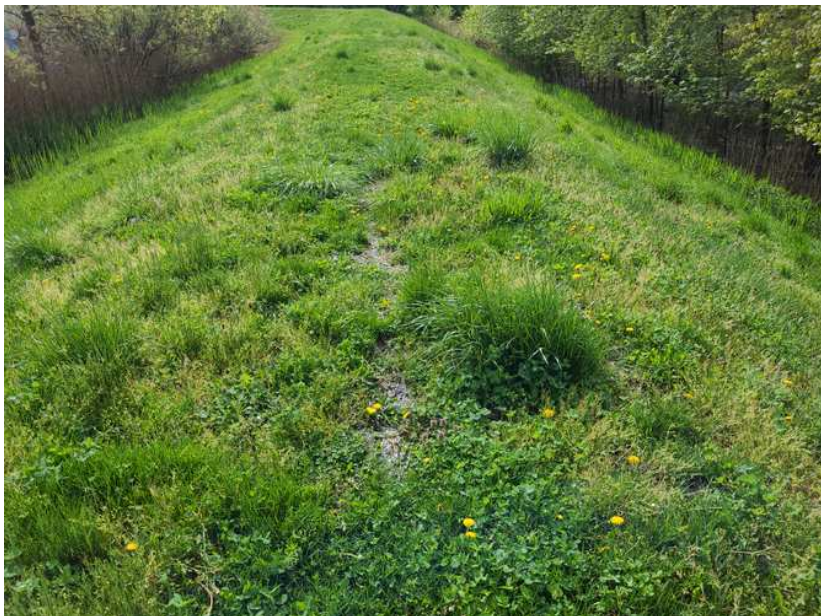
Inspect ID: 2024-0077

No User Rating (Site Visit) - Rutting on crest.

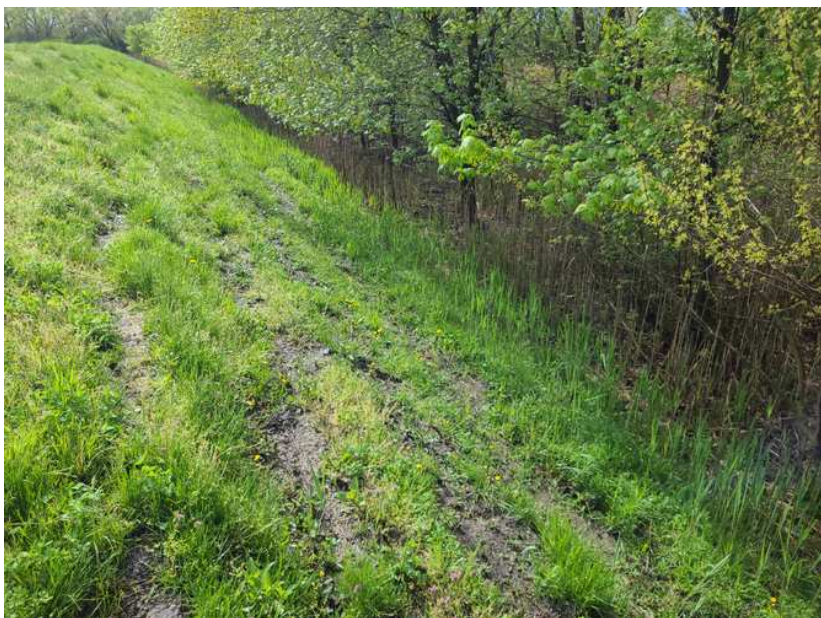
Inspect ID: 2024-0081

No User Rating (Site Visit) - Rutting on riverside slope

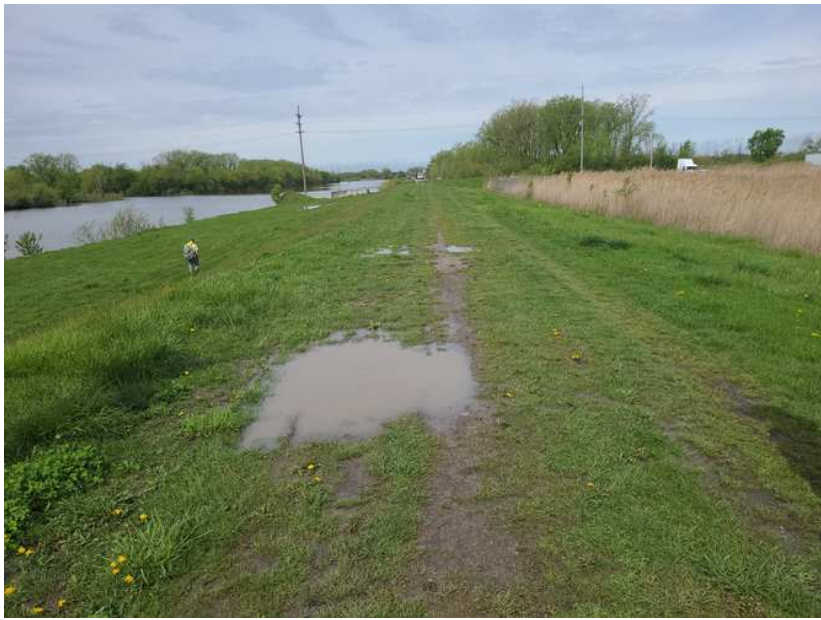
Inspect ID: 2024-0141

No User Rating (Site Visit) - Deep ruts with ponding on the levee crest.

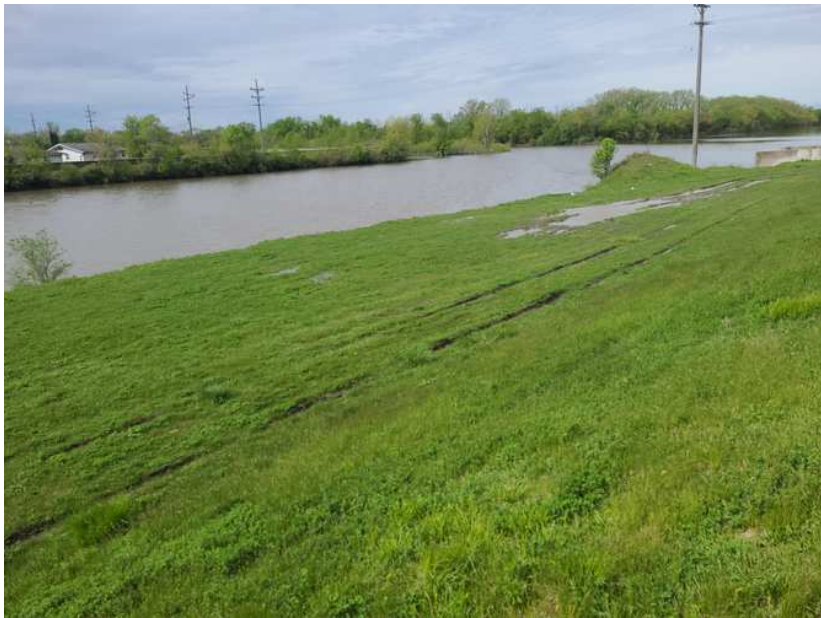
Inspect ID: 2024-0145

No User Rating (Site Visit) - Rutting on riverside toe.

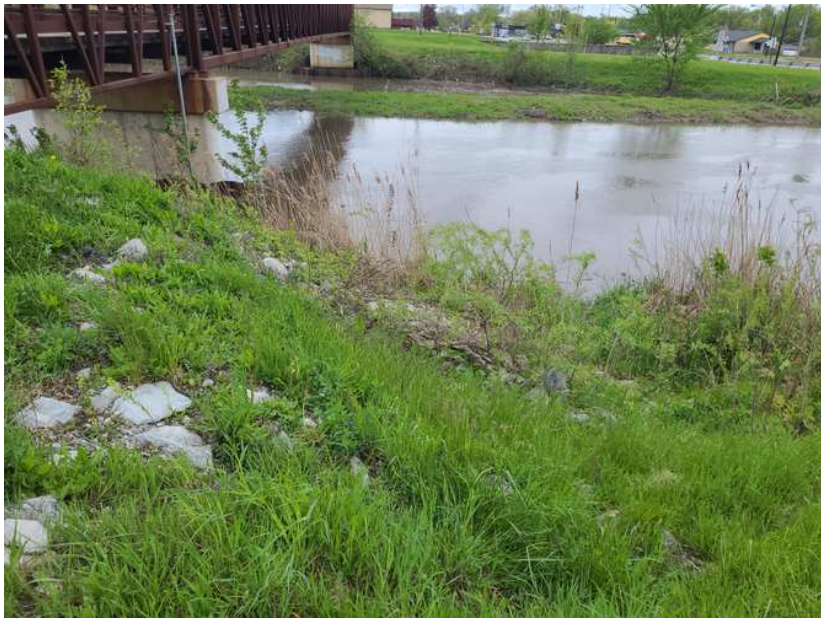
Inspect ID: 2024-0229

No User Rating (Site Visit) - Uneven and depressed surfaces approaching bridge on riverside slope.

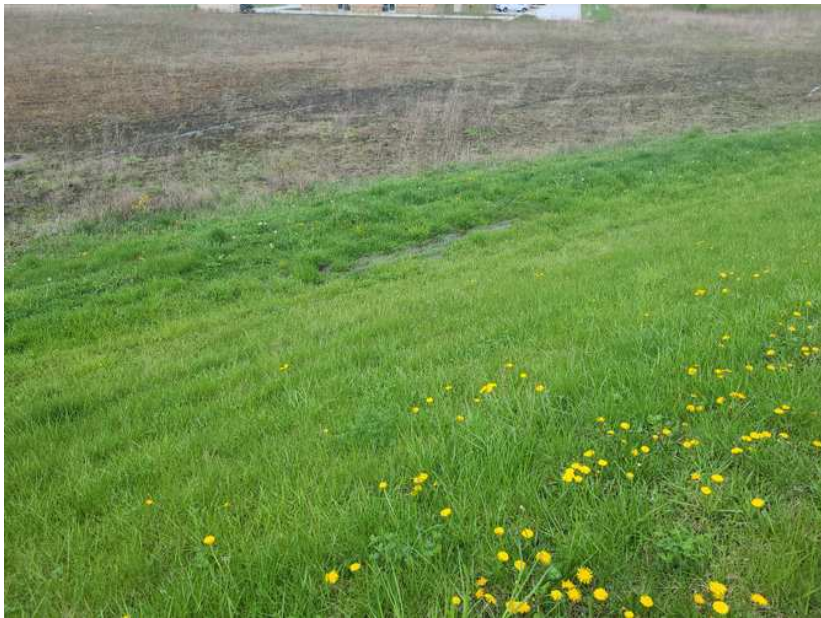
Inspect ID: 2024-0377

No User Rating (Site Visit) - Rutting on landside toe

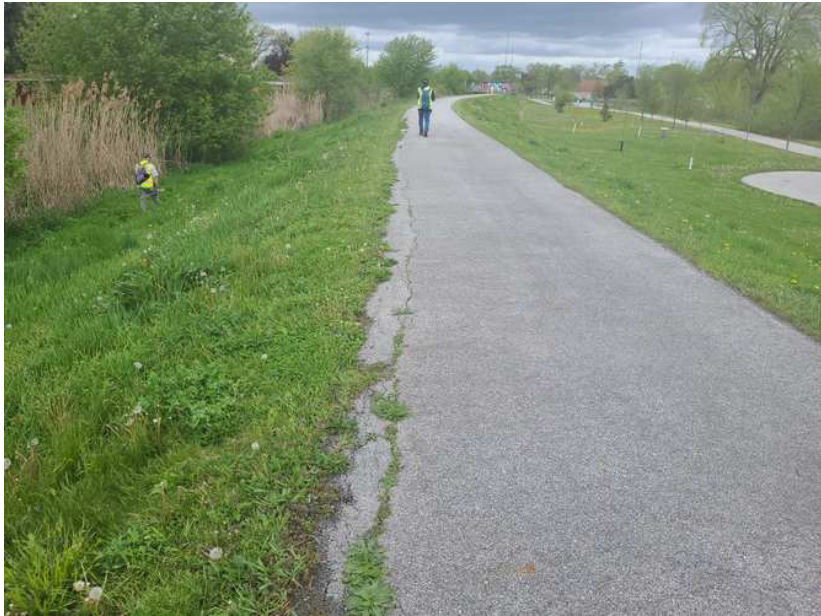
Inspect ID: 2024-0489

No User Rating (Site Visit) - Typical asphalt cracking on crest

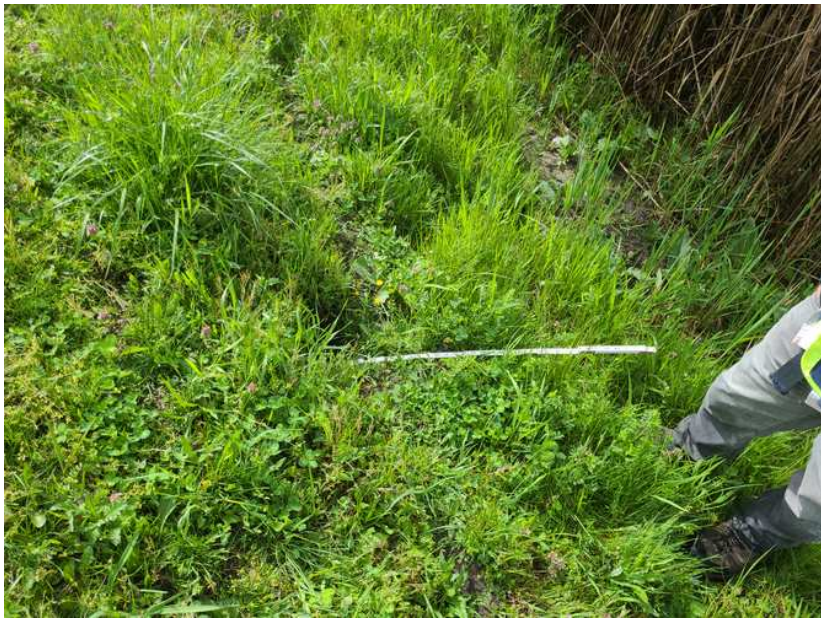
Inspect ID: 2024-0085

No User Rating (Site Visit) - 29 inch animal burrow on riverside toe

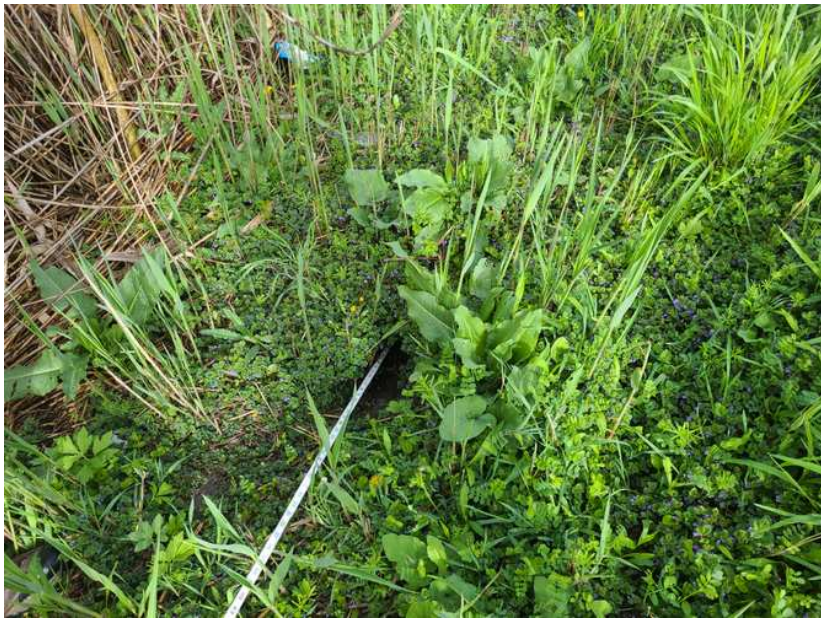
Inspect ID: 2024-0089

No User Rating (Site Visit) - 14 inch burrow on riverside toe

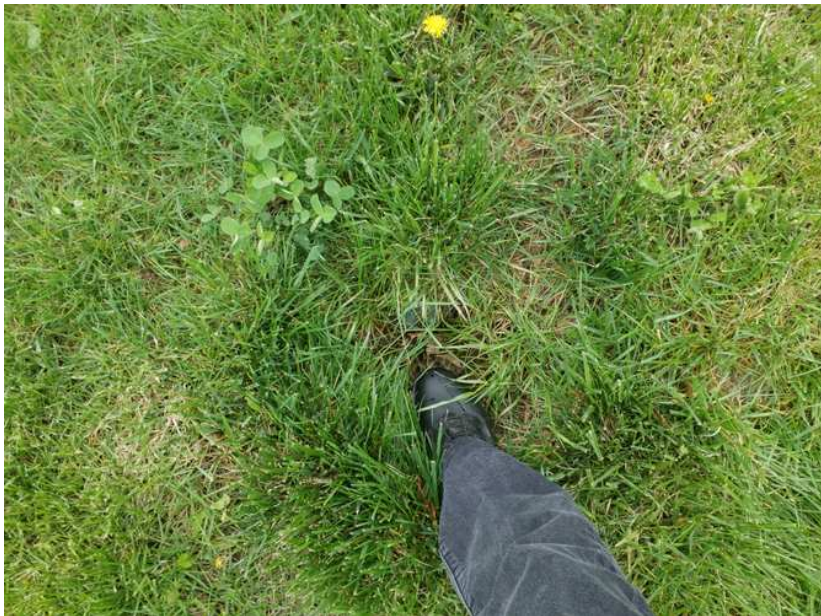
Inspect ID: 2024-0091

No User Rating (Site Visit) - HA-16: Animal burrow northeast of gate

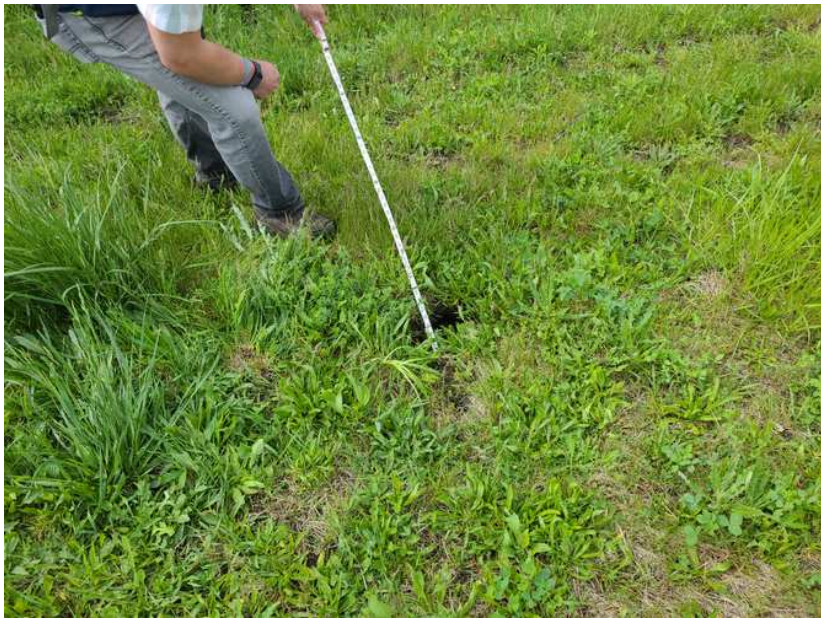
Inspect ID: 2024-0161

No User Rating (Site Visit) - Animal burrow about 9 inches deep.

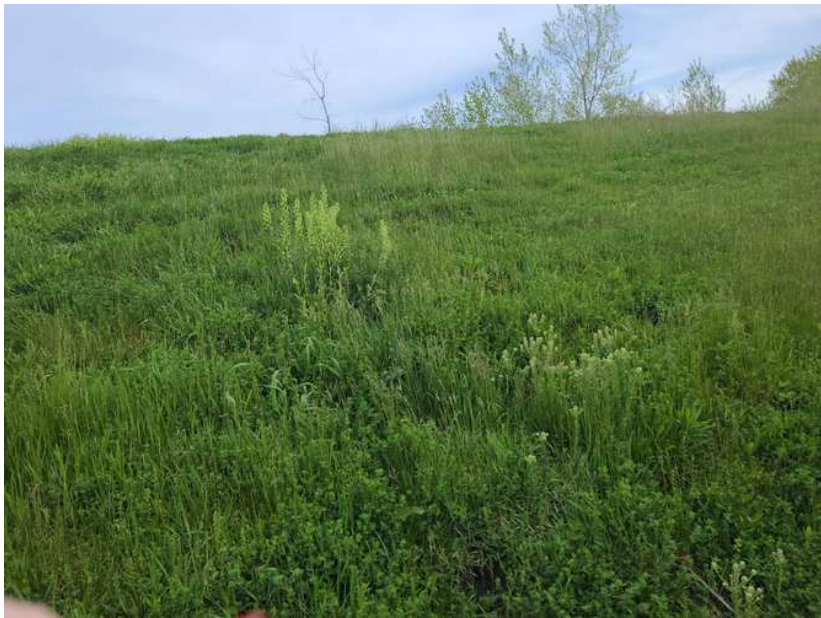
Inspect ID: 2024-0165

No User Rating (Site Visit) - Line of burrows and possibly erosion along waterside slope.

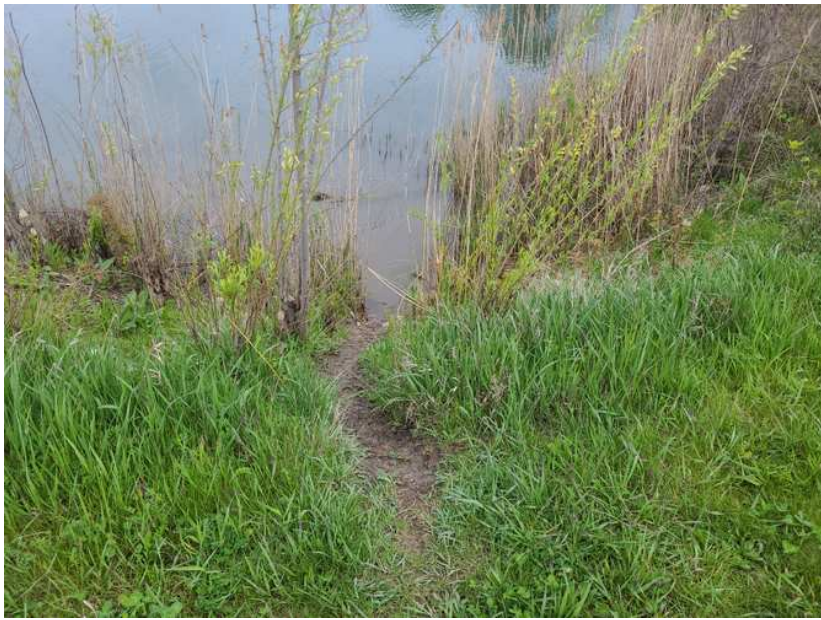
Inspect ID: 2024-0253

No User Rating (Site Visit) - Animal path near HA-25

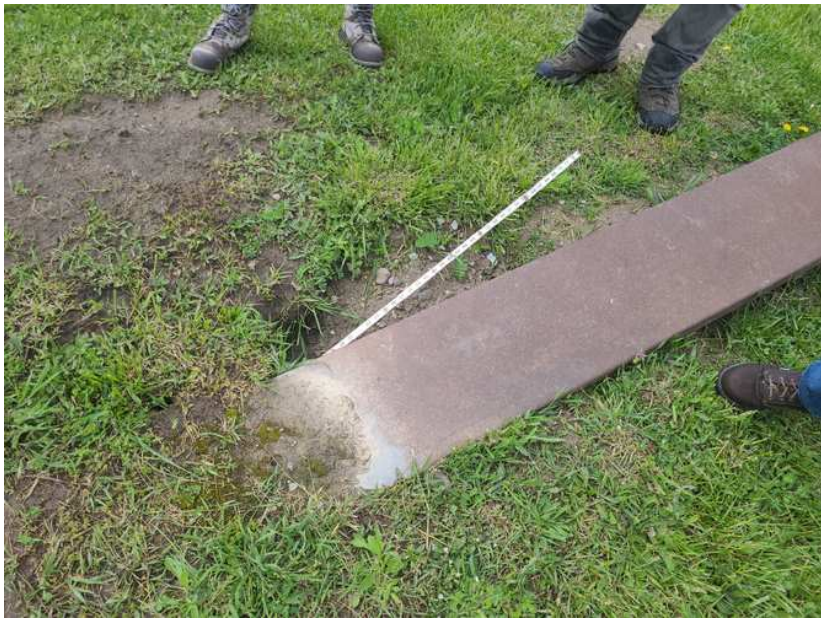
Inspect ID: 2024-0525

No User Rating (Site Visit) - Animal burrow in crest at wall transition.

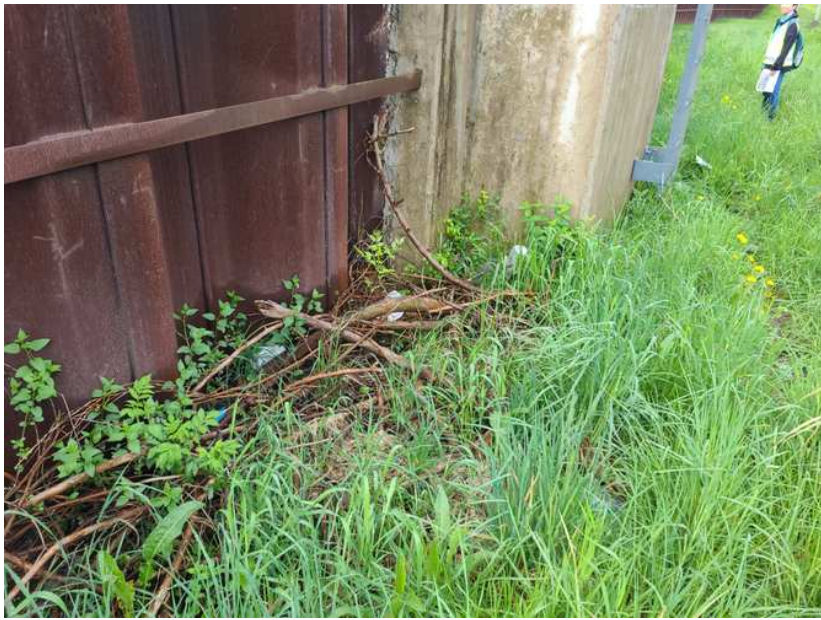
Inspect ID: 2024-0033

No User Rating (Site Visit) - Thick vegetation on landside

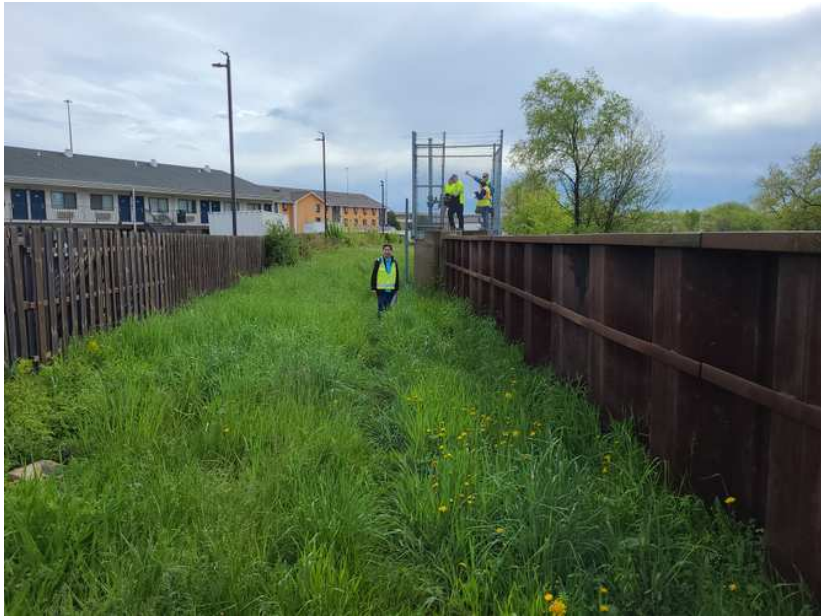
Inspect ID: 2024-0041

No User Rating (Site Visit) - Tall grass on landside

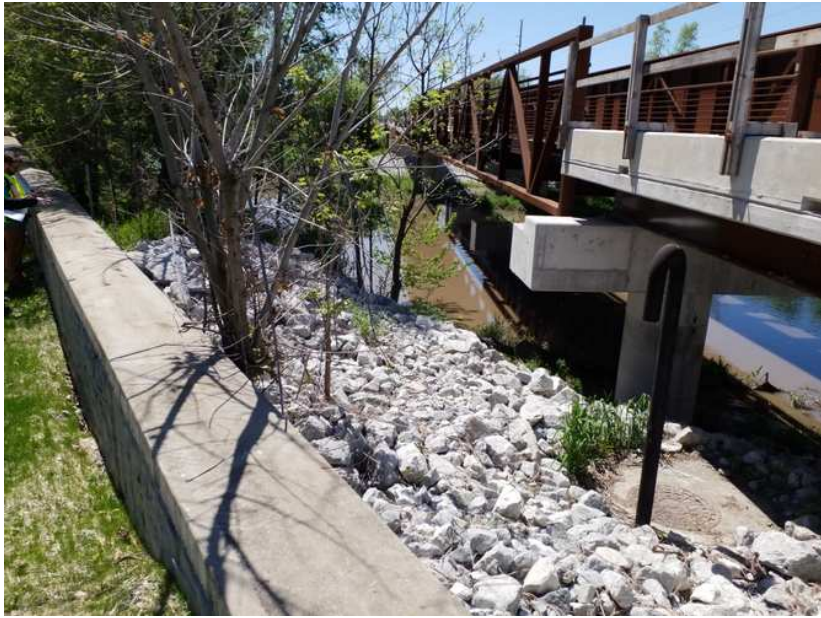
Inspect ID: 2024-0182

No User Rating (Site Visit) - Small trees on riverside.

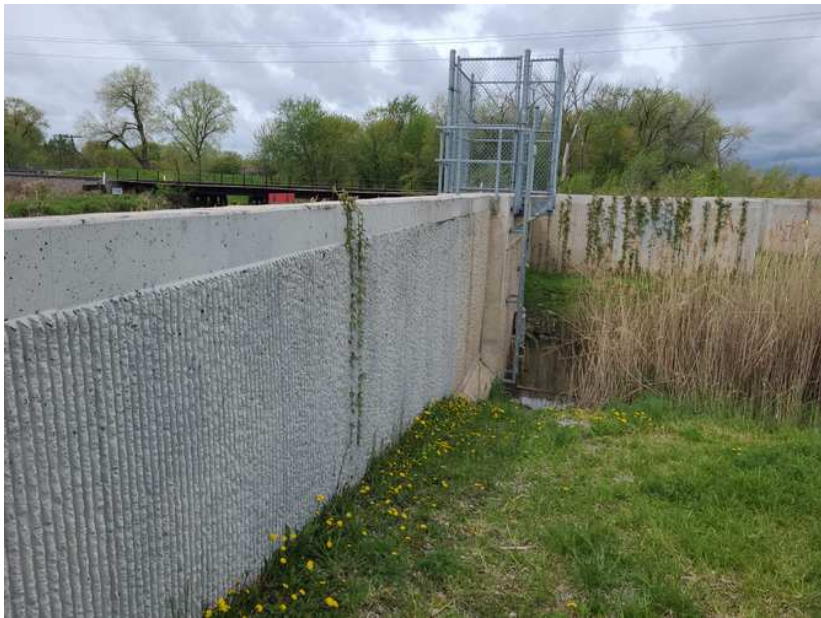
Inspect ID: 2024-0261

No User Rating (Site Visit) - Vegetation on landside floodwall

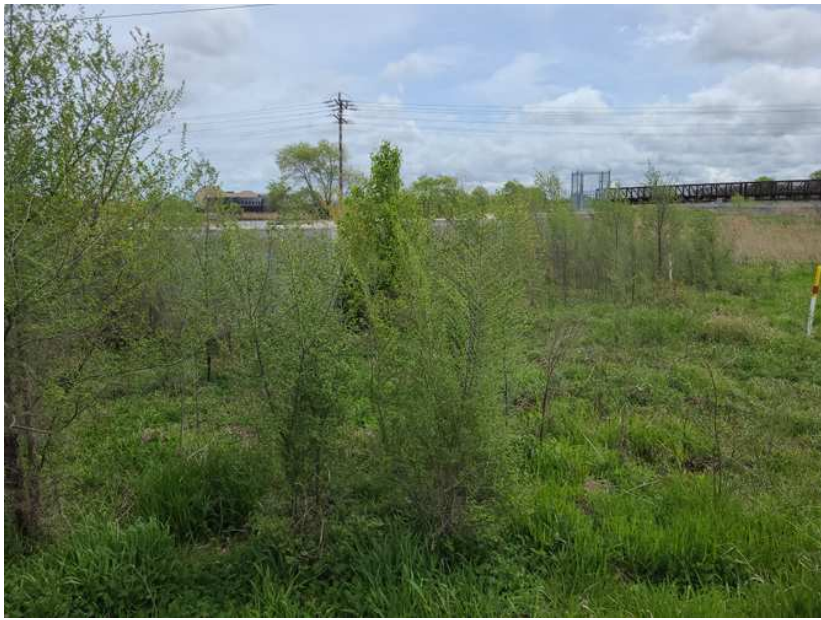
Inspect ID: 2024-0265

No User Rating (Site Visit) - Vegetation on riverside floodwall.

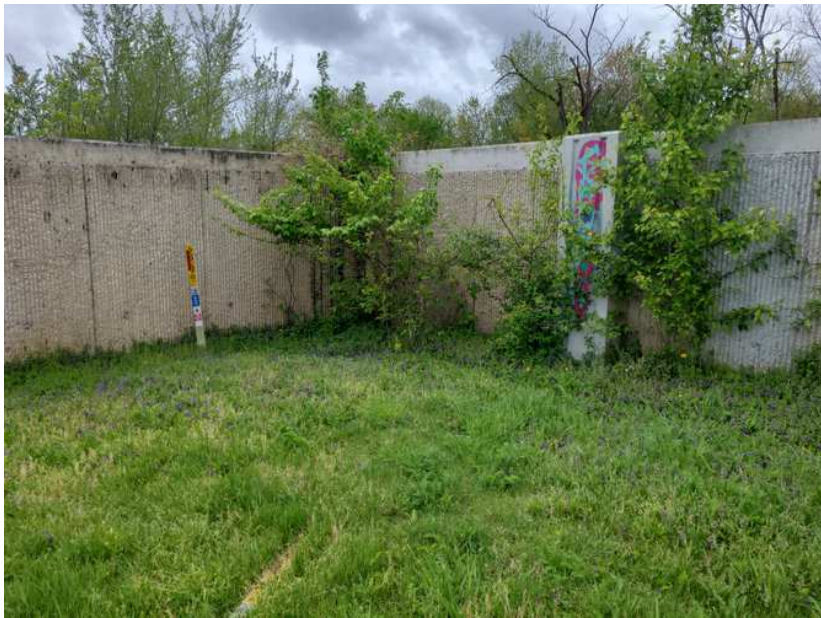
Inspect ID: 2024-0277

No User Rating (Site Visit) - Small tree on the landside floodwall.

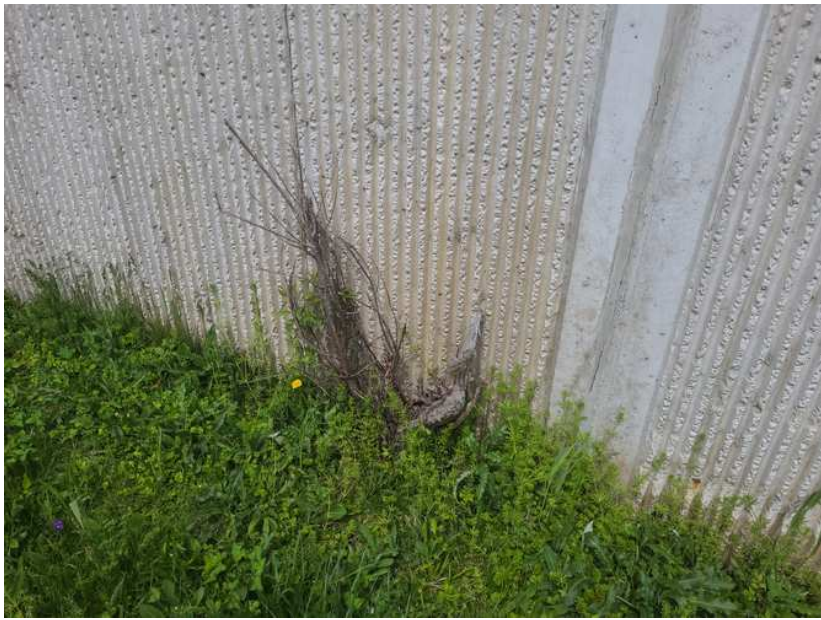
Inspect ID: 2024-0333

No User Rating (Site Visit) - Vegetation along riverside of floodwall.

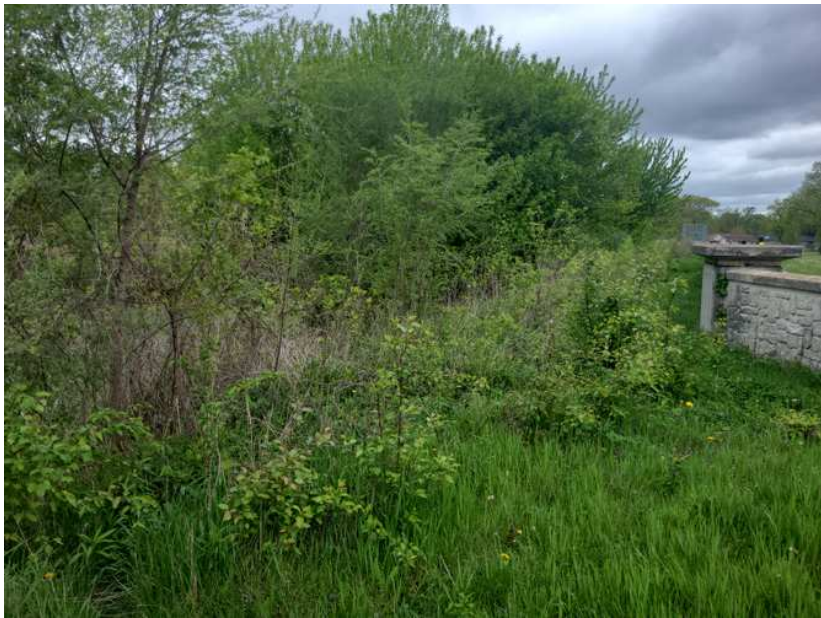
Inspect ID: 2024-0409

No User Rating (Site Visit) - Vegetation on riverside of floodwall.

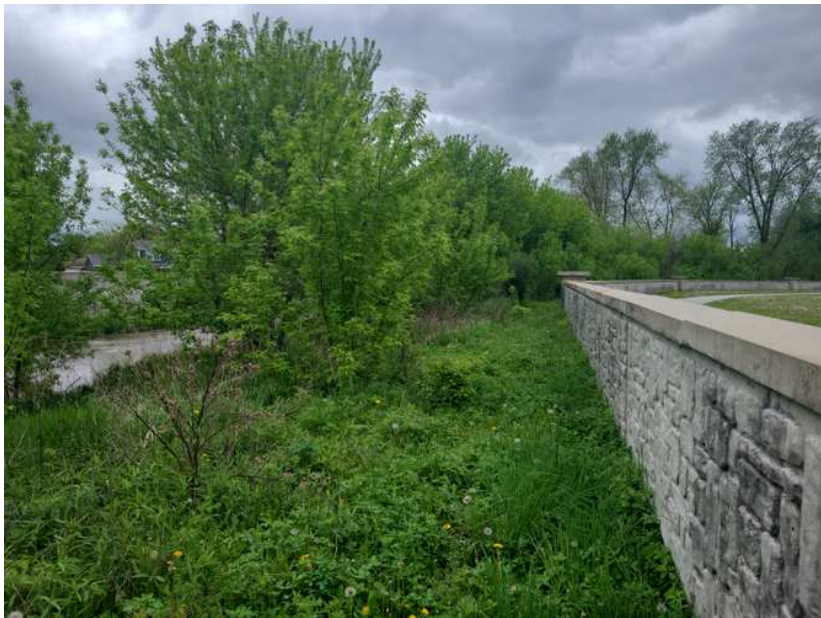
Inspect ID: 2024-0429

No User Rating (Site Visit) - Vegetation along the riverside of the floodwall.

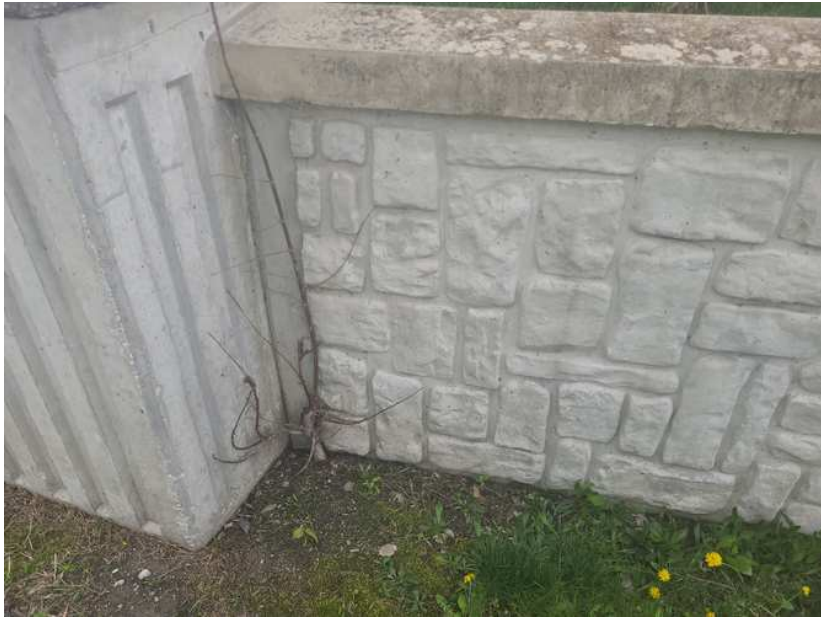
Inspect ID: 2024-0461

No User Rating (Site Visit) - Riverside vegetation

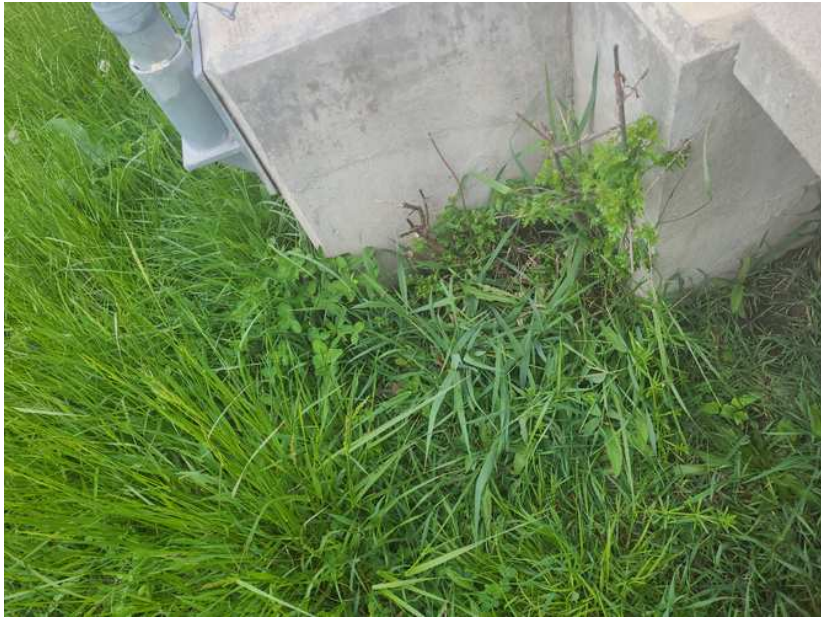
Inspect ID: 2024-0477

No User Rating (Site Visit) - Vegetation on landside of wall

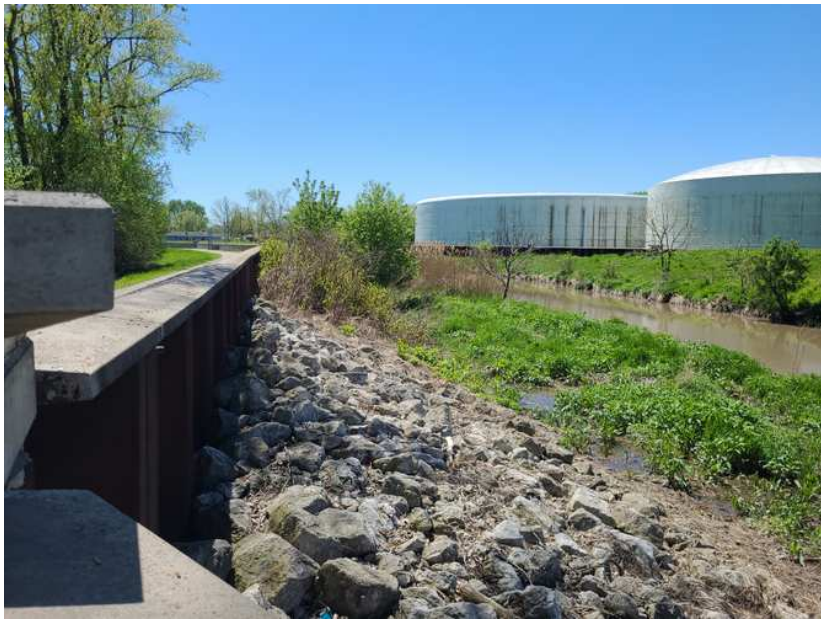
Inspect ID: 2024-0577

No User Rating (Site Visit) - Vegetation on riverside of wall

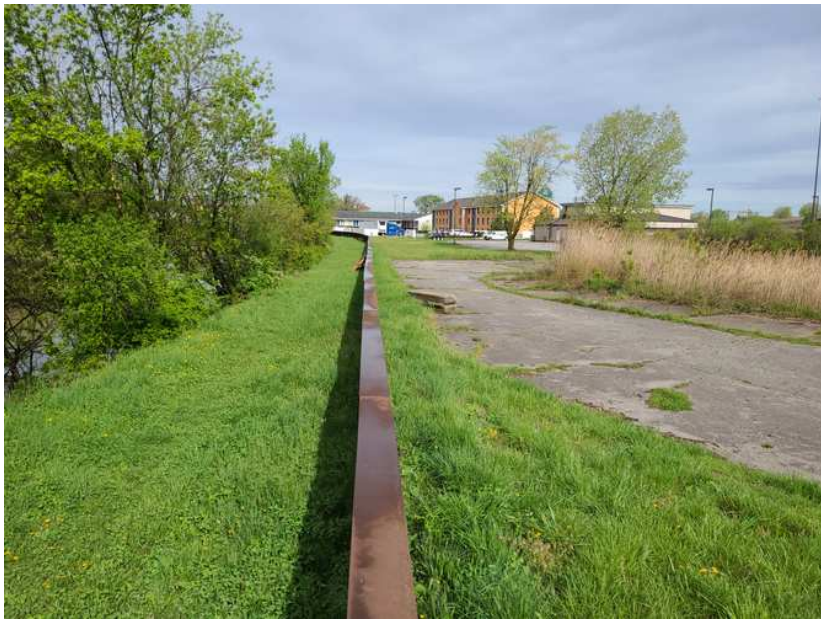
Inspect ID: 2024-0021

No User Rating (Site Visit) - Vegetation on riverside of floodwall

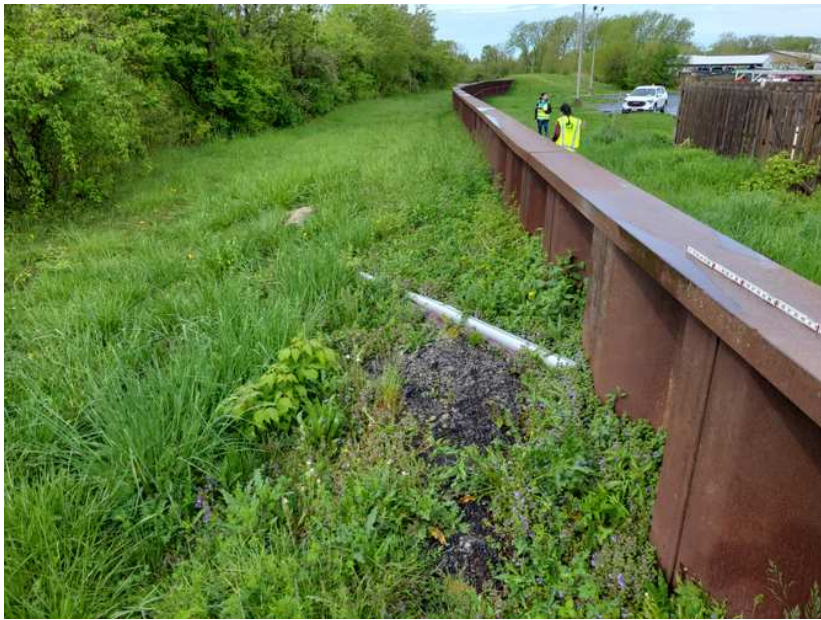
Inspect ID: 2024-0037

No User Rating (Site Visit) - Concrete on landside and lumber on riverside.

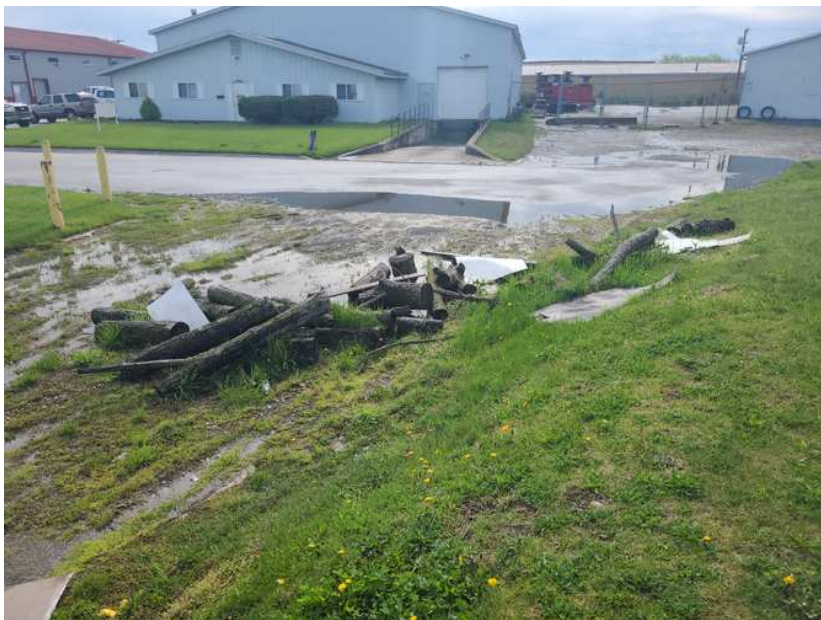
Inspect ID: 2024-0101

No User Rating (Site Visit) - Debris on riverside.

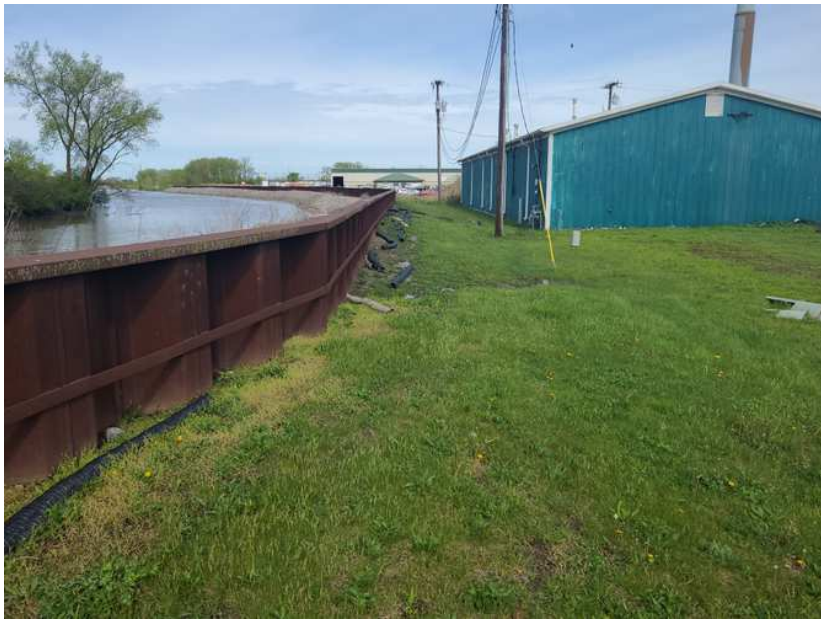
Inspect ID: 2024-0105

No User Rating (Site Visit) - Debris on landside

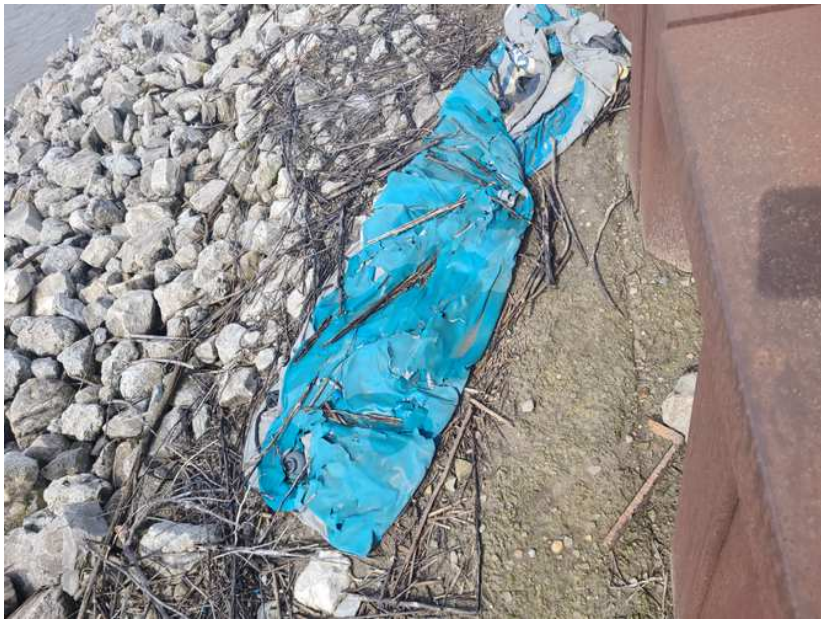
Inspect ID: 2024-0121

No User Rating (Site Visit) - Debris on landside

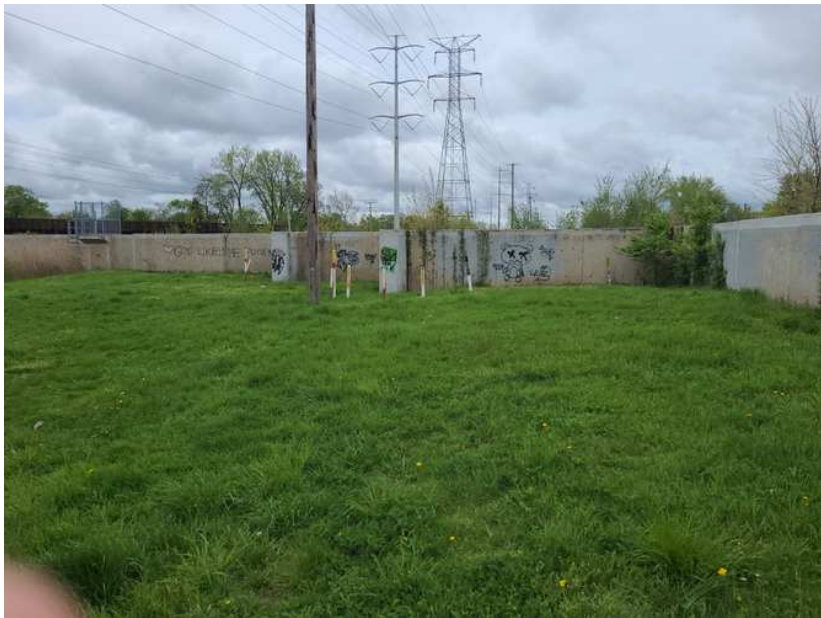
Inspect ID: 2024-0273

No User Rating (Site Visit) - Graffiti on landside and riverside of floodwall

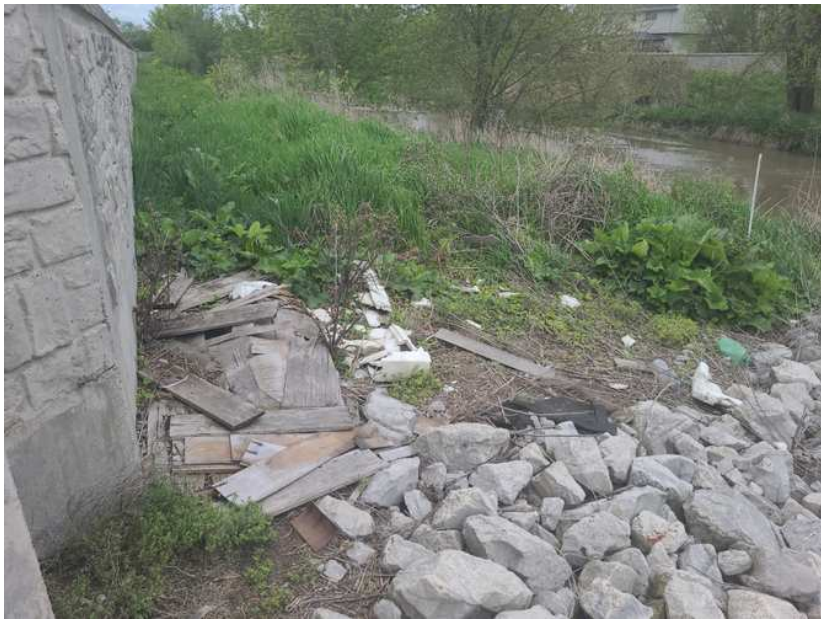
Inspect ID: 2024-0469

No User Rating (Site Visit) - Downed tree on riverside

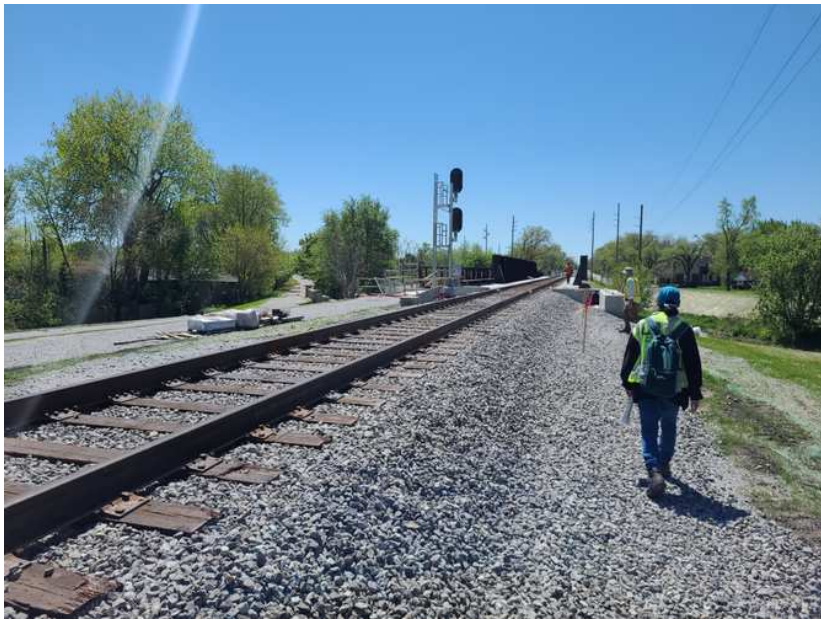
Inspect ID: 2024-0549

No User Rating (Site Visit) - Debris on riverside

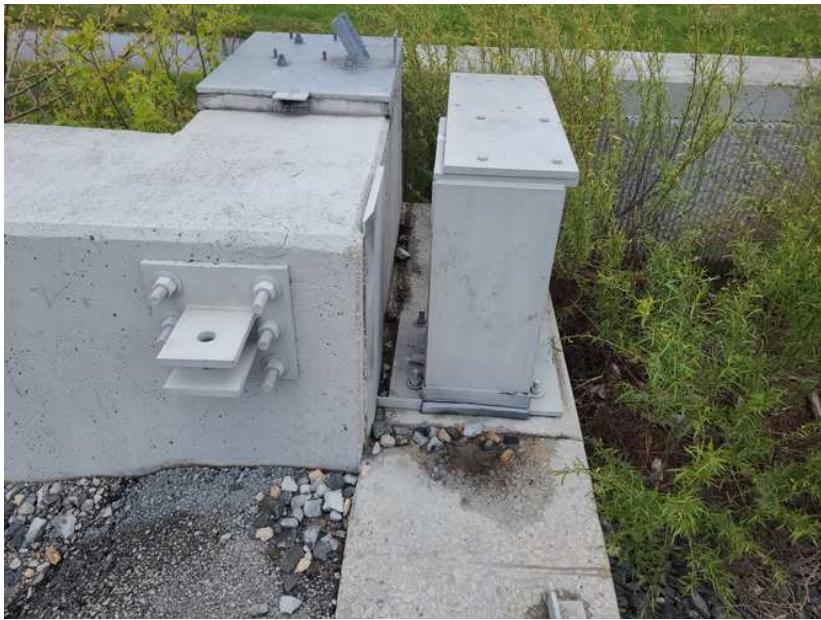
Inspect ID: 2024-0281

No User Rating (Site Visit) - Guardrail blocking Kennedy Ave closure.

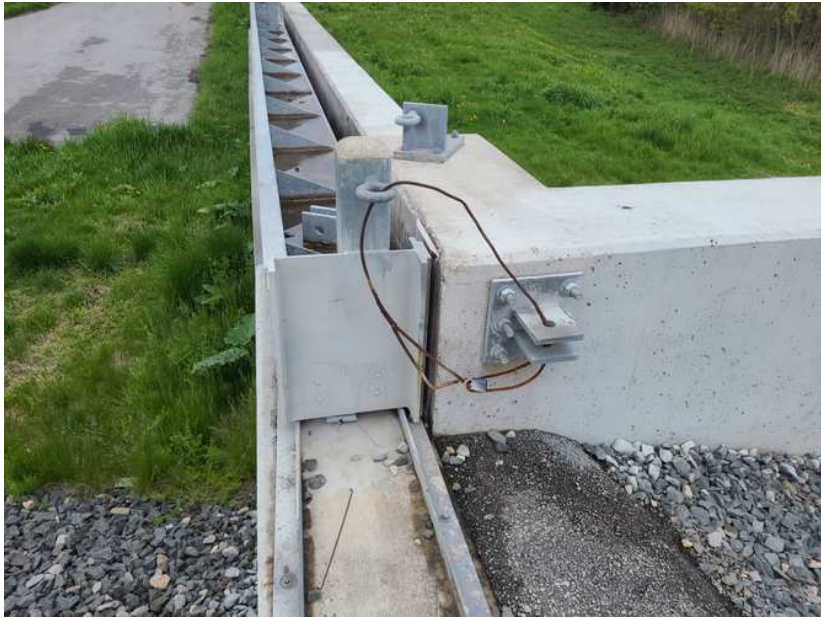
Inspect ID: 2024-0285

No User Rating (Site Visit) - No rubber seal

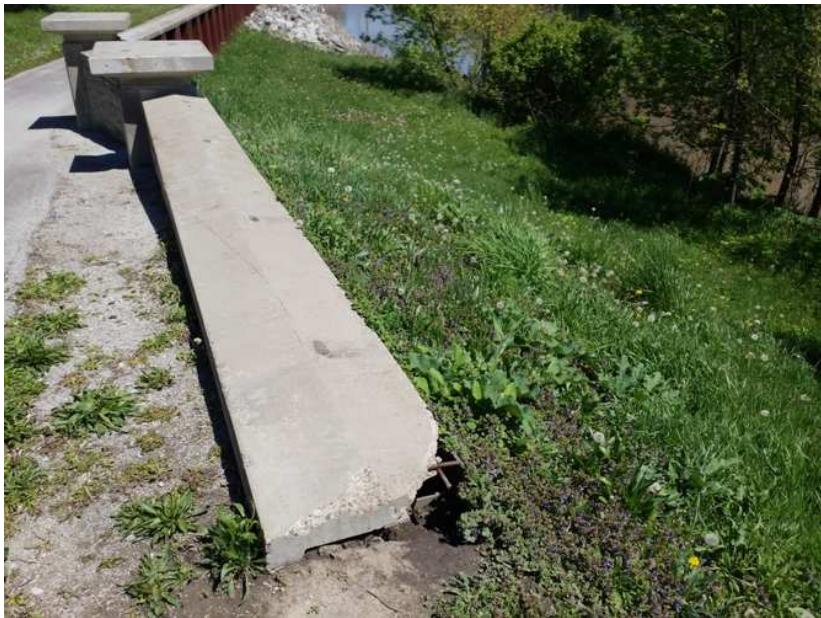
Inspect ID: 2024-0198

No User Rating (Site Visit) - No rubber seal

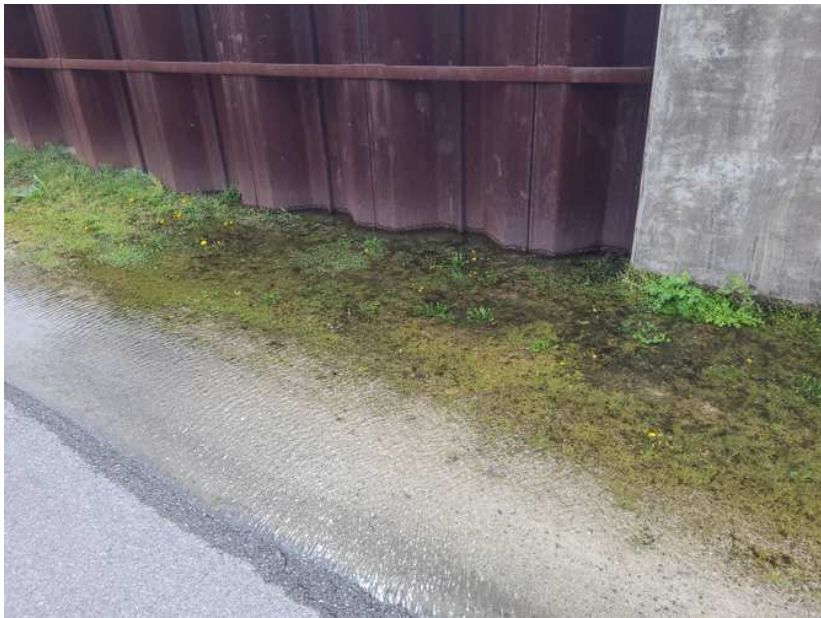
Inspect ID: 2024-0205

No User Rating (Site Visit) - Gap at the bottom of landside floodwall extends in 2 ft towards the riverside.

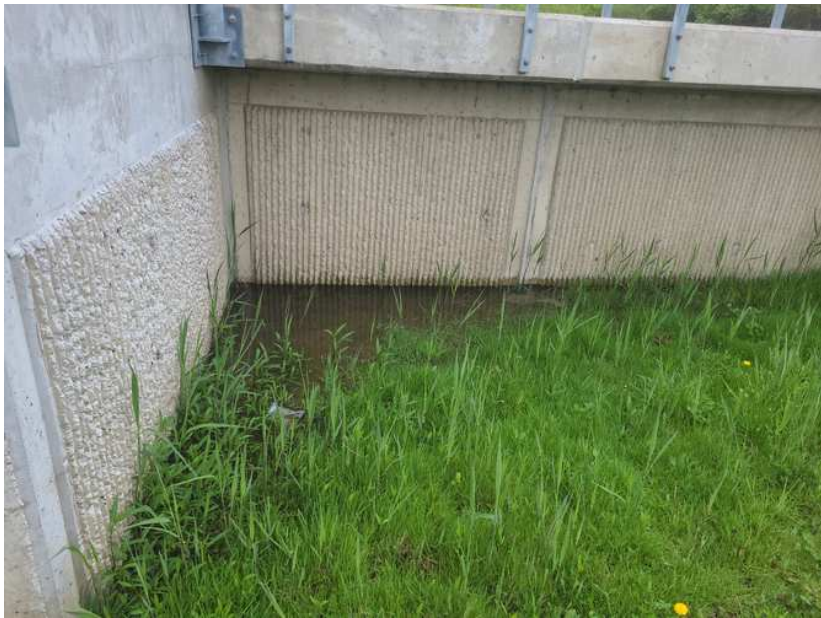
Inspect ID: 2024-0325

No User Rating (Site Visit) - Animal burrows on landside of floodwall.

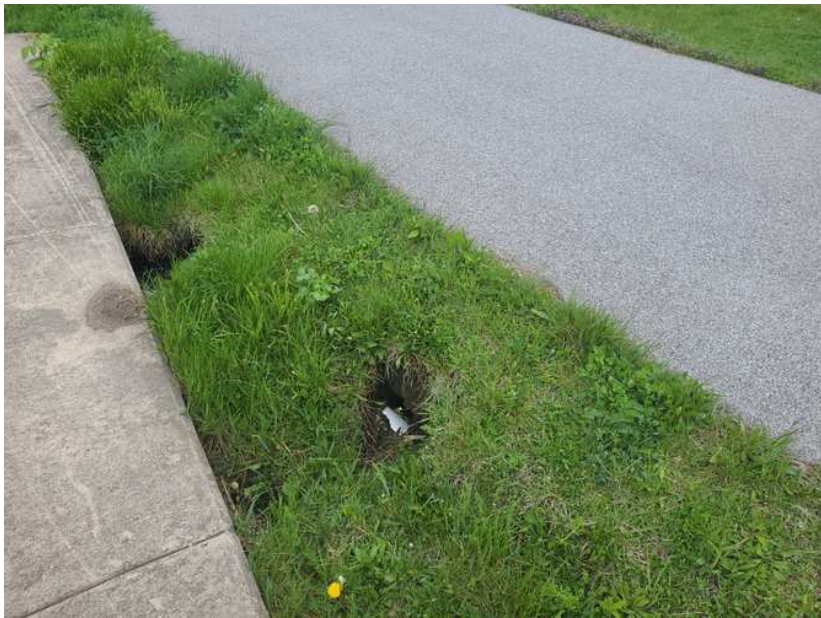
Inspect ID: 2024-0329

No User Rating (Site Visit) - Animal burrows on the landside of floodwall.

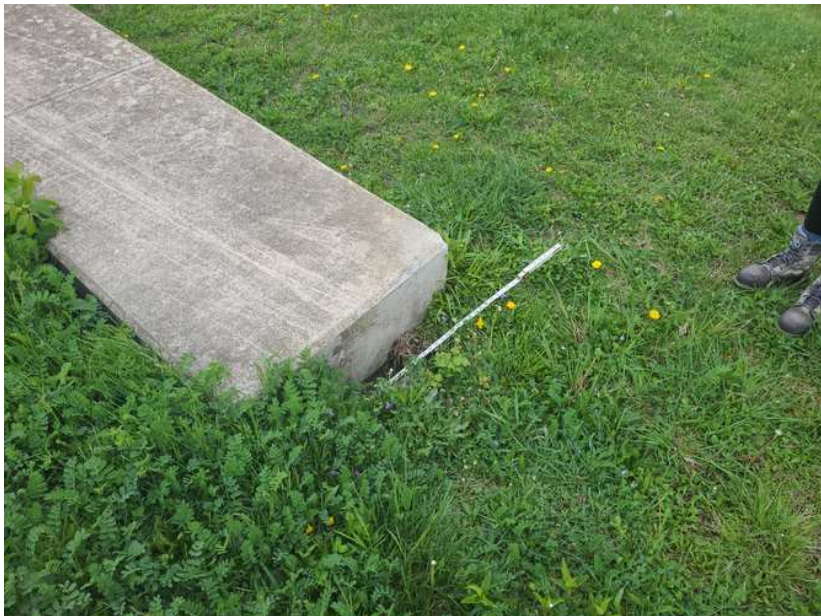
Inspect ID: 2024-0337

No User Rating (Site Visit) - Animal activity landside floodwall
