US Army Corps
of Engineers ®

Site Visit Summary

Name of System: Hammond

Date of Site Visit: 04/29/2024 - 04/30/2024

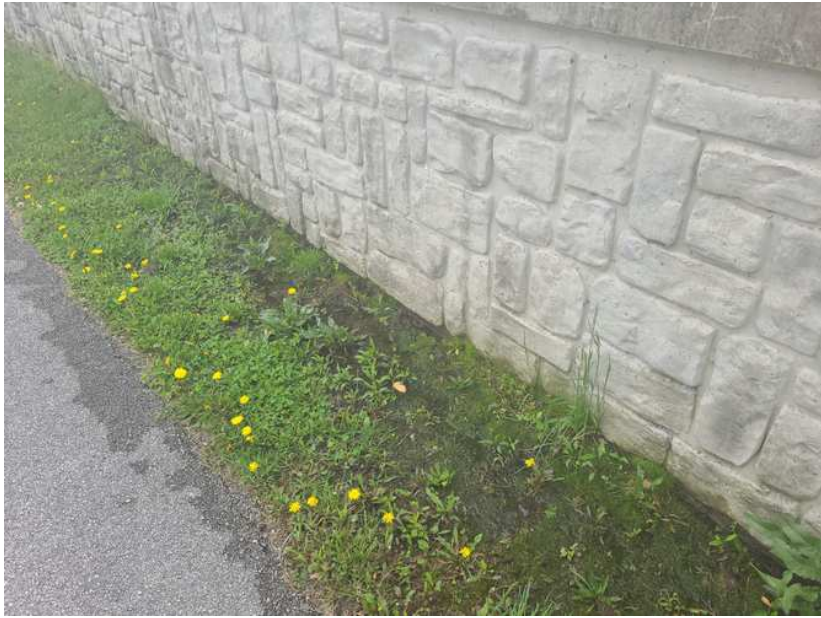
Inspect ID: 2024-0453

No User Rating (Site Visit) - 1 foot burrow along wall

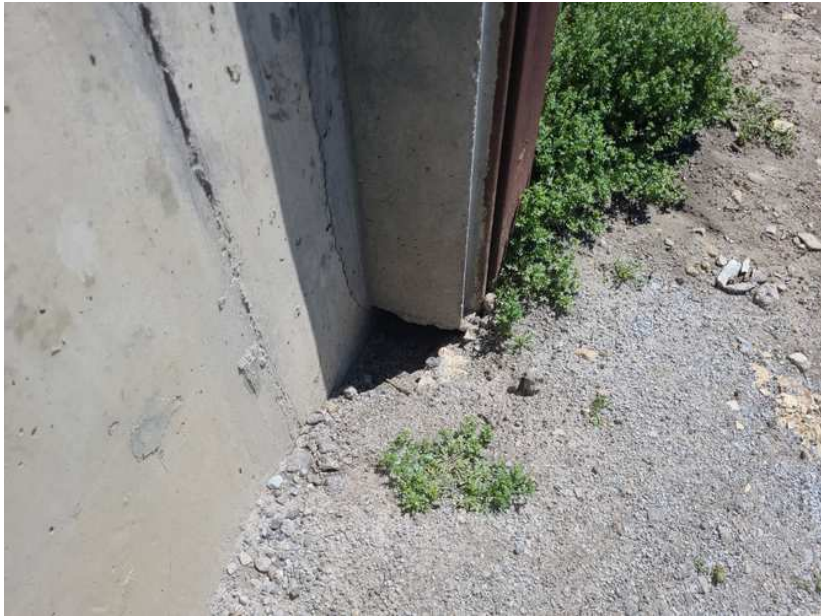
Inspect ID: 2024-0561

No User Rating (Site Visit) - Ponding on landside of floodwall

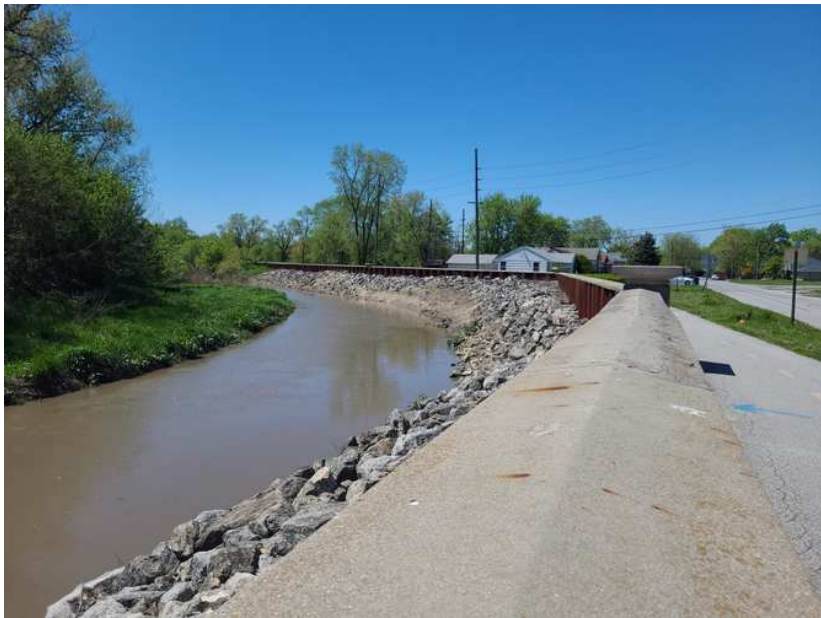
Inspect ID: 2024-0569

No User Rating (Site Visit) - Riprap is moving down into the river.

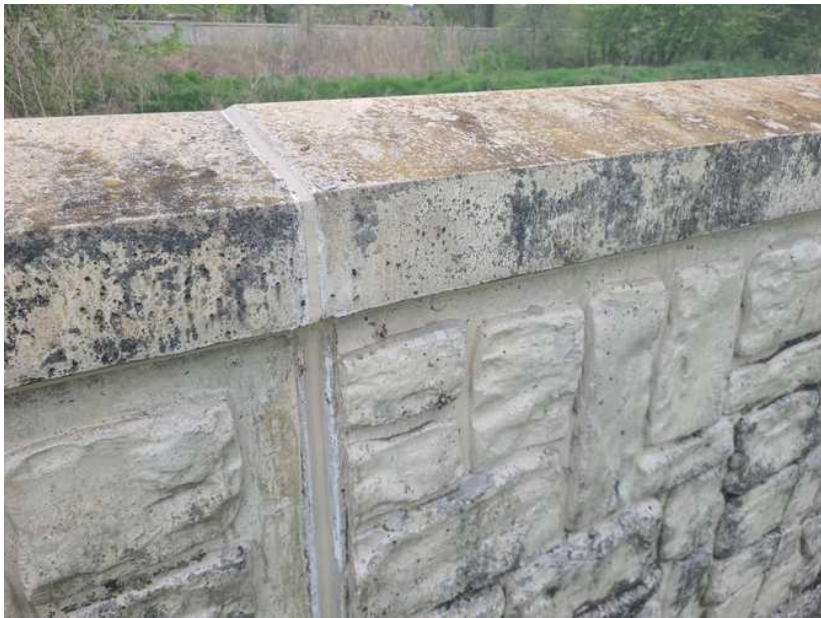
Inspect ID: 2024-0417

No User Rating (Site Visit) - Spalling concrete along monolith joint on riverside of floodwall.

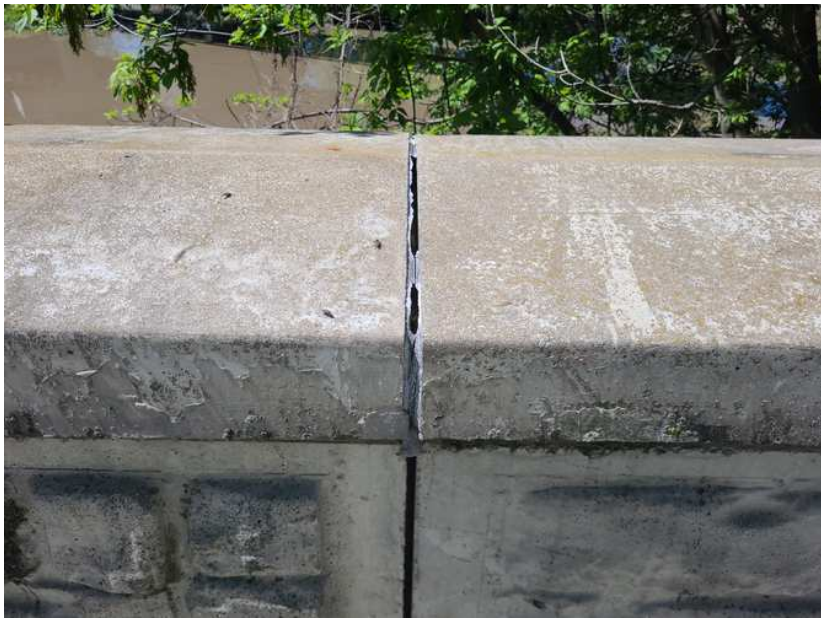
Inspect ID: 2024-0557

No User Rating (Site Visit) - Typical sealant in great condition

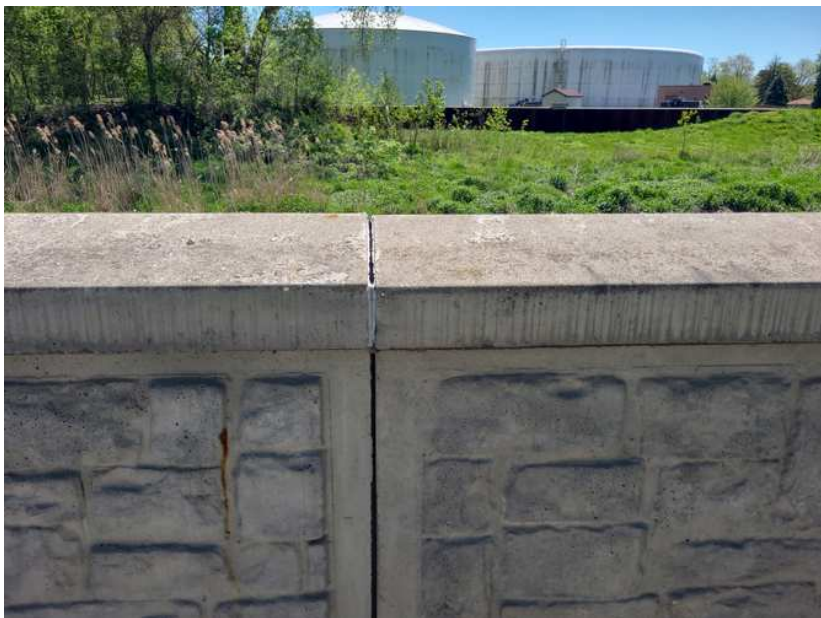
Inspect ID: 2024-0573

No User Rating (Site Visit) - Typical sealant cracked and exposed

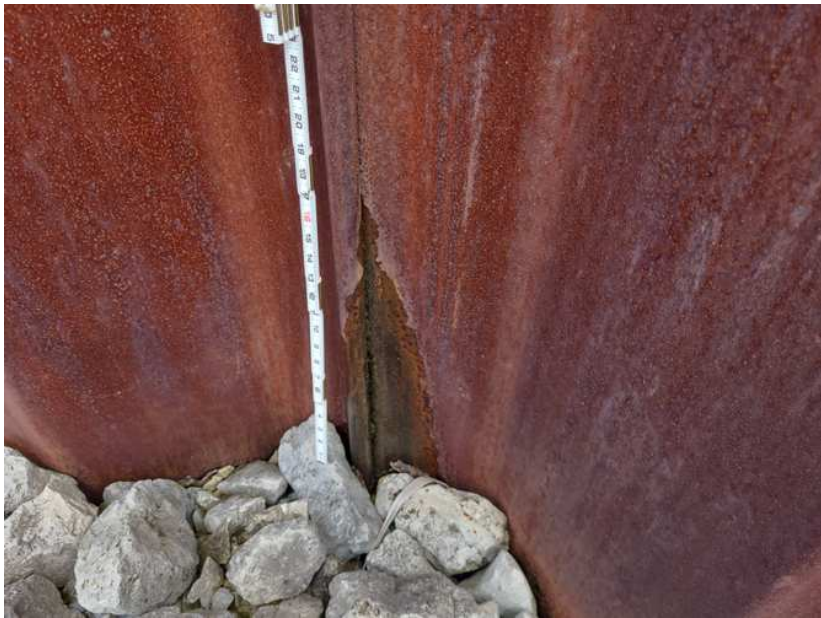
No User Rating (Site Visit) - Seepage between sheetpiles on the riverside.

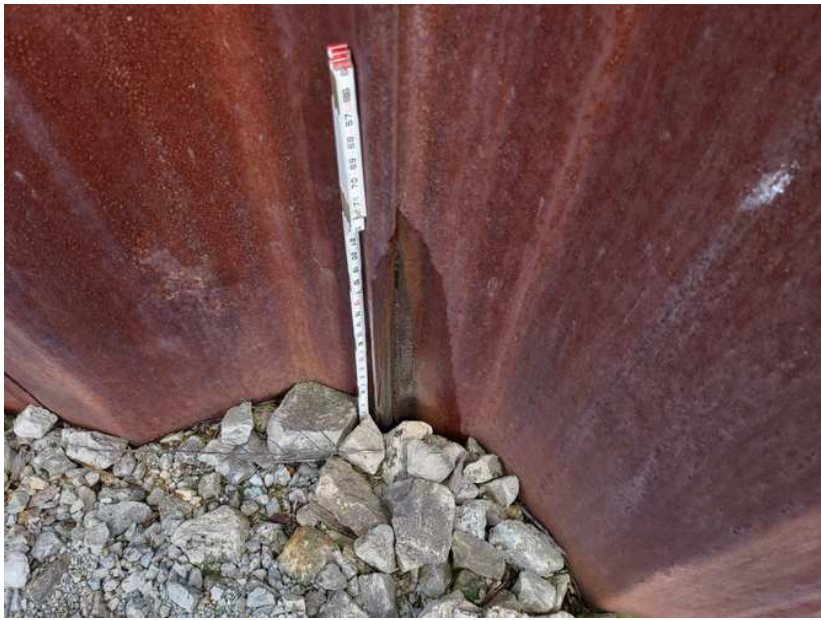
No User Rating (Site Visit) - Seepage between sheetpiles riverside.

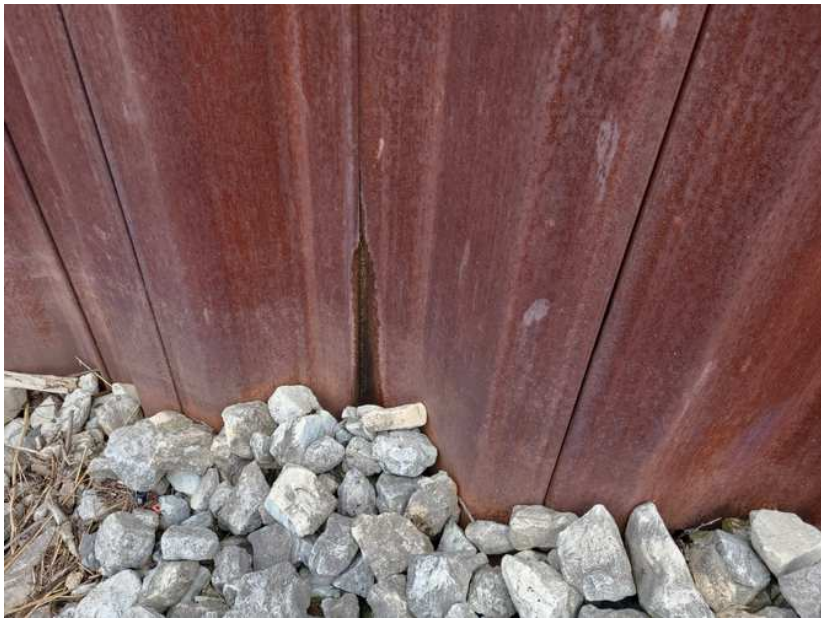
No User Rating (Site Visit) - Seepage between sheetpiles on the riverside.

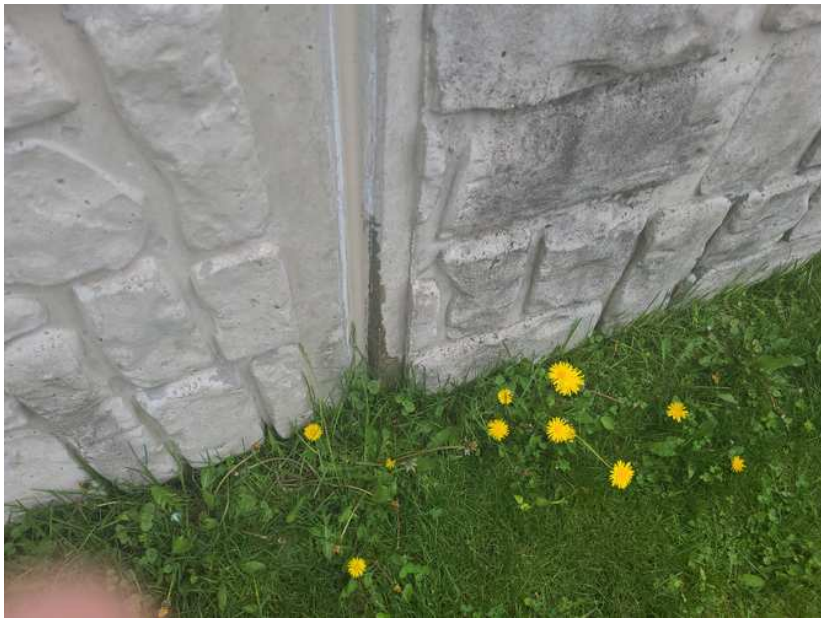
No User Rating (Site Visit) - Seepage between sheetpiles on the riverside.

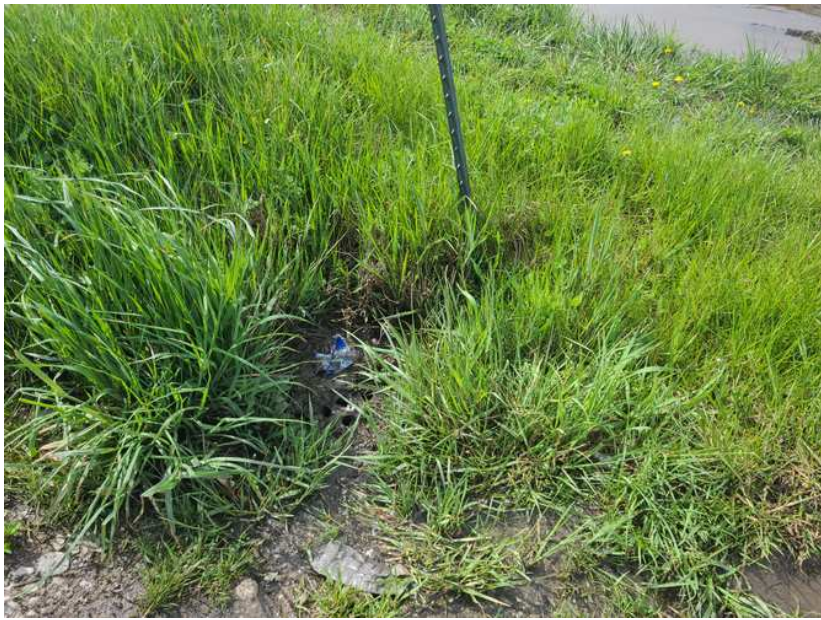
Inspect ID: 2024-0133

No User Rating (Site Visit) - Landside ditch vegetation.

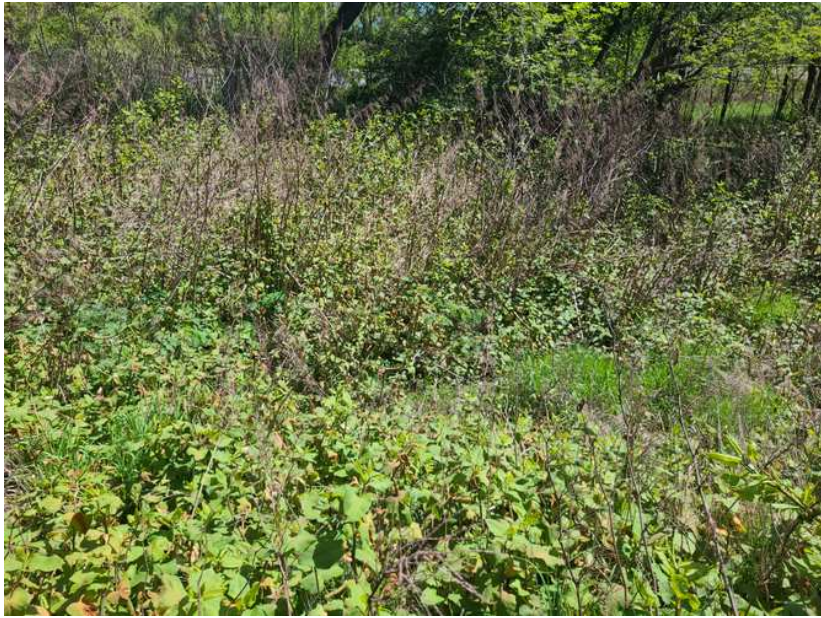
Inspect ID: 2024-0541

No User Rating (Site Visit) - Vegetation in landside ditch

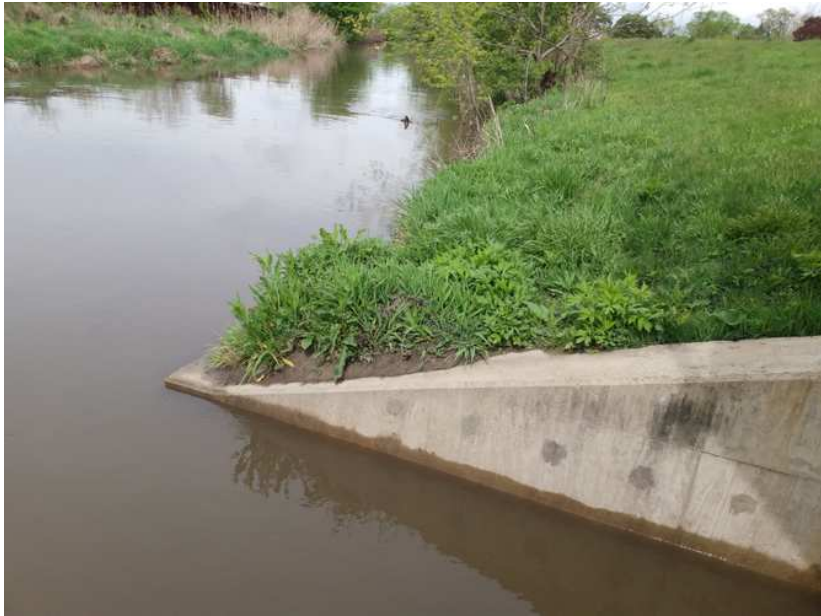
Inspect ID: 2024-0047

No User Rating (Site Visit) - HA-01: Inlet completely covered with vegetation

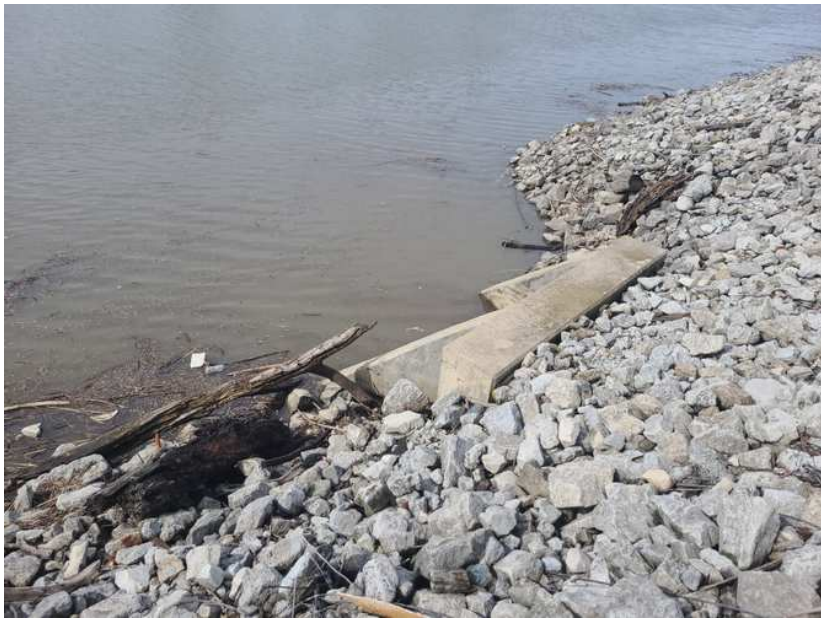
Inspect ID: 2024-0129

No User Rating (Site Visit) - HA-10: Sediment build up on wingwalls

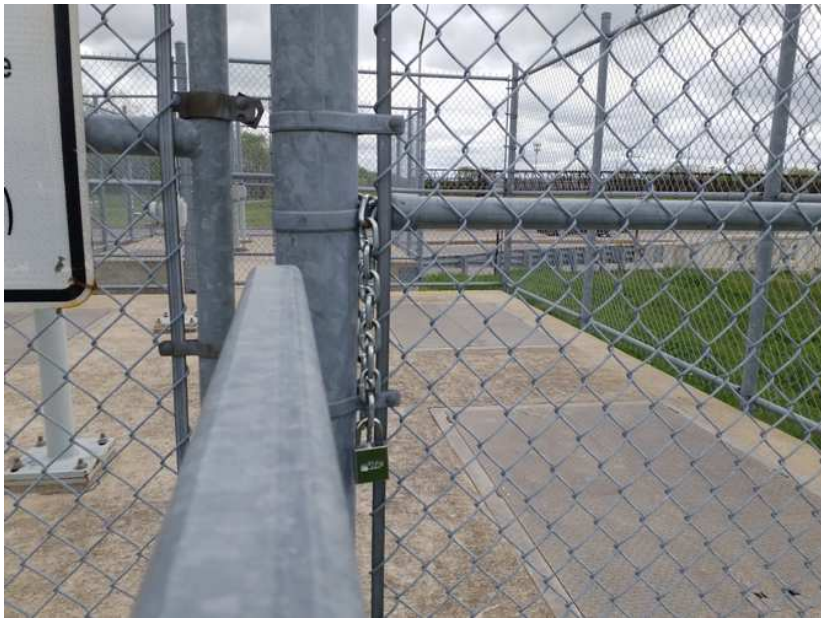
No User Rating (Site Visit) - HA-31: No lock on gate well structure.

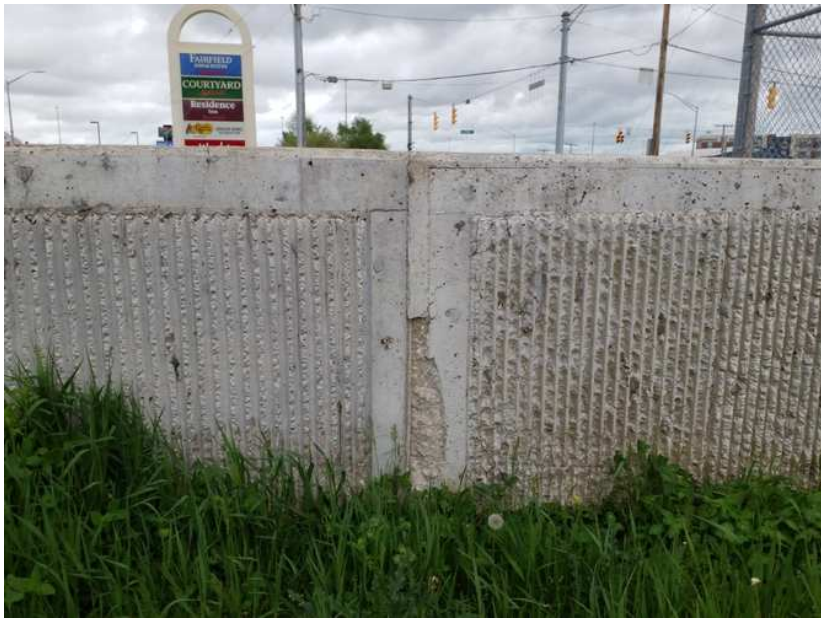
No User Rating (Site Visit) - HA-34: Cracking on headwall of inlet structure.

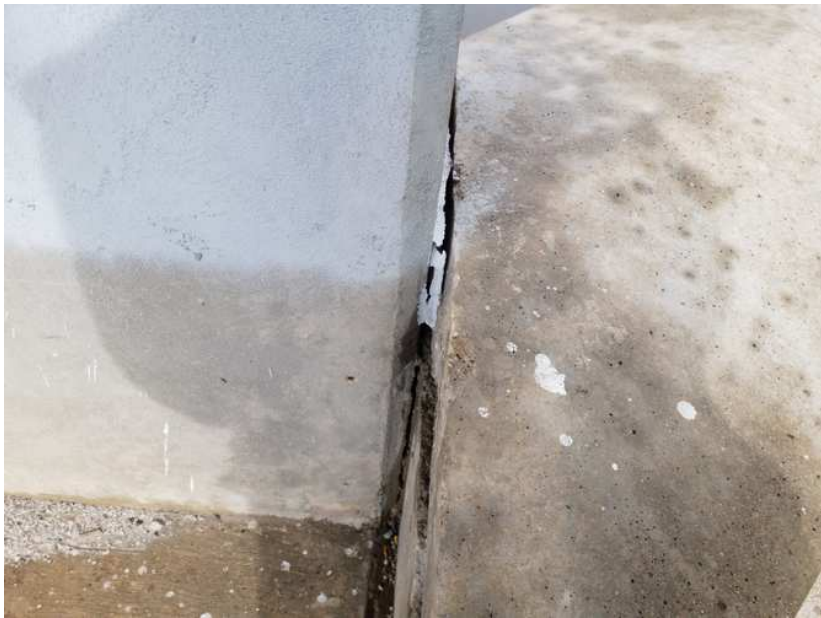
No User Rating (Site Visit) - HA-18: Spalling on concrete headwall of outlet structure.

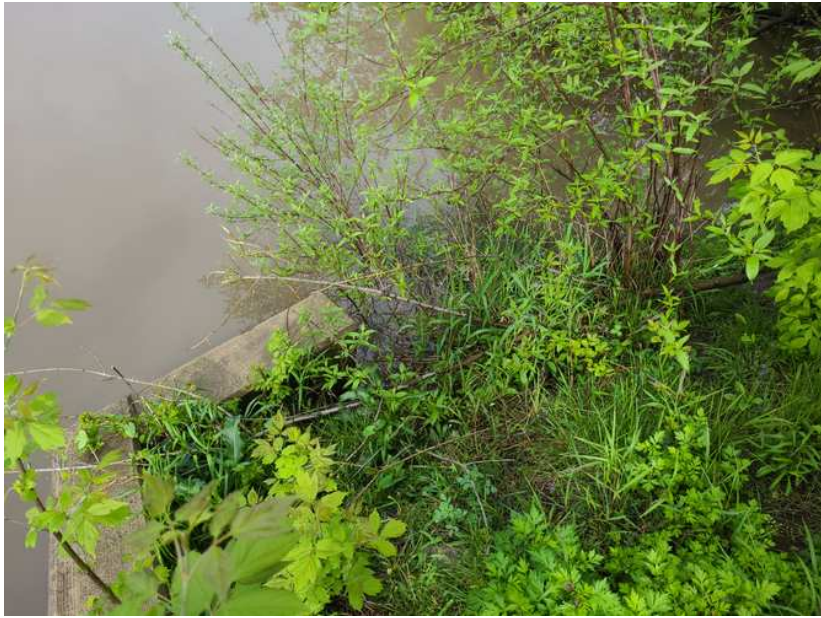
No User Rating (Site Visit) - HA-04: Separation between floodwall and gate structure, could indicate movement.

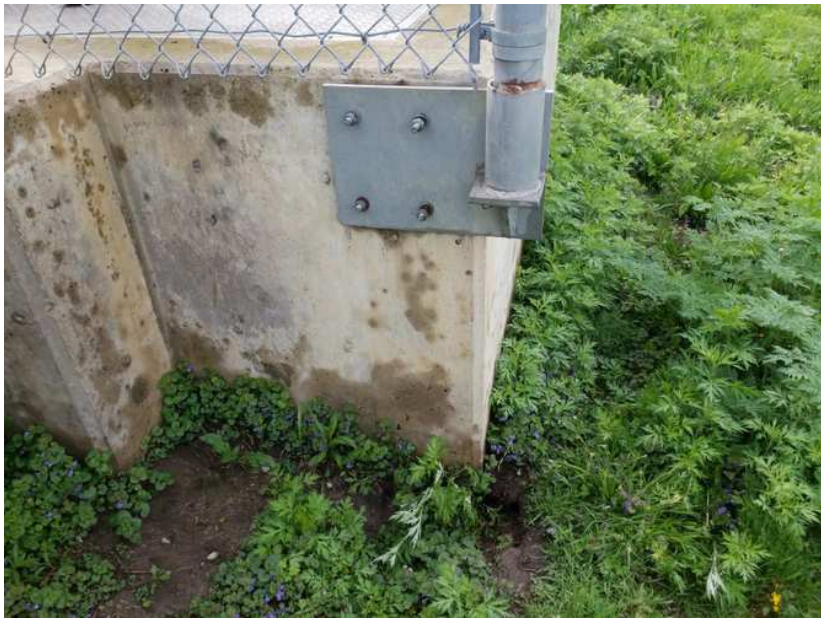
No User Rating (Site Visit) - HA-37: Erosion around wingwall at the outlet structure.

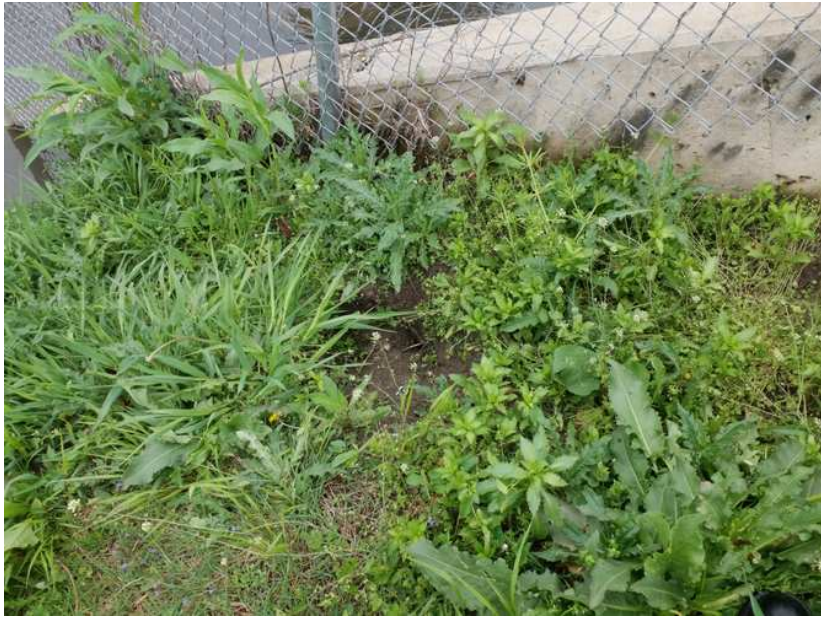
No User Rating (Site Visit) - HA-06: Animal burrow at corner of structure

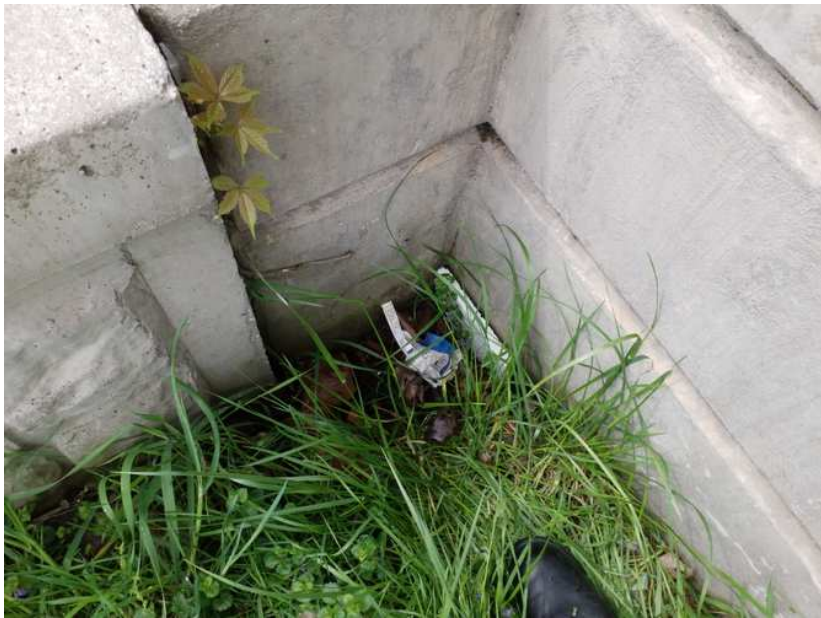
No User Rating (Site Visit) - HA-12: Erosion around wingwall

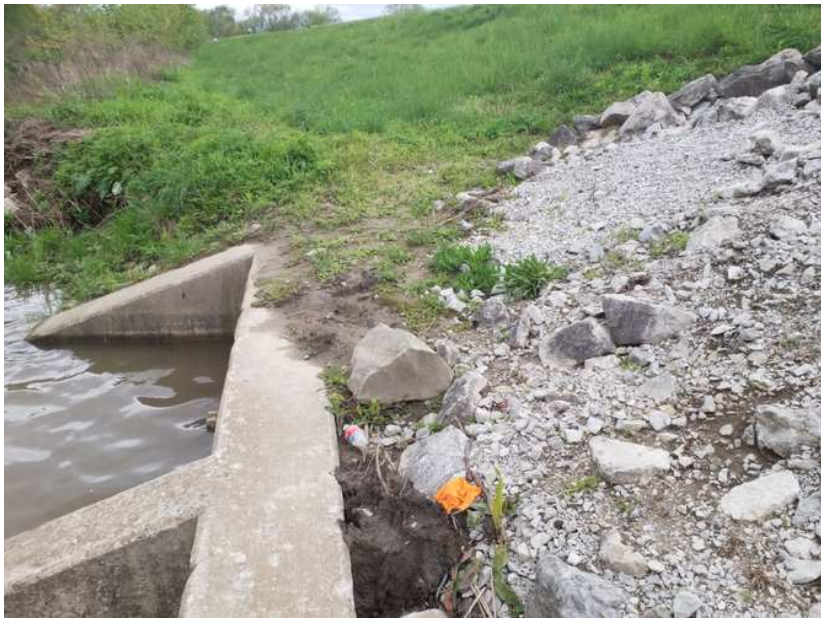
No User Rating (Site Visit) - HA-26: Erosion on the east side of concrete structure

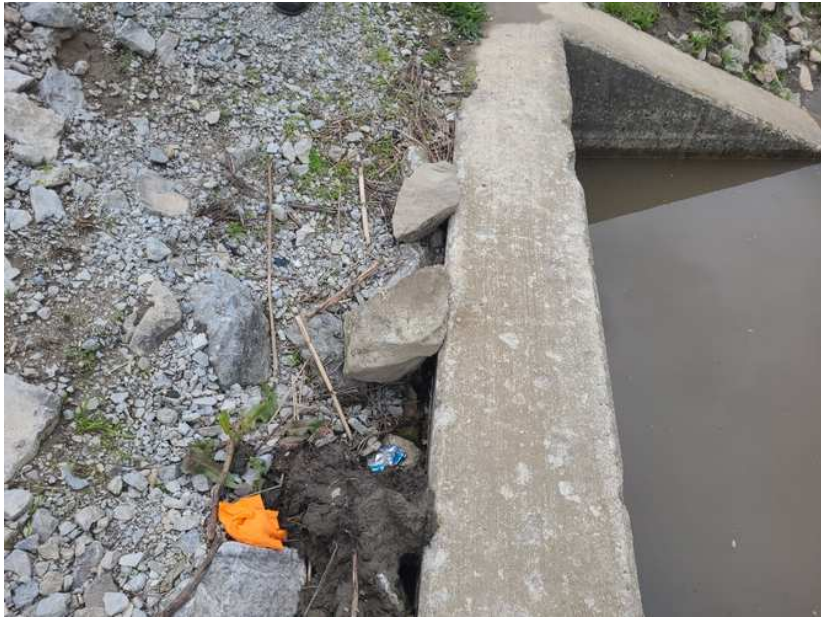
No User Rating (Site Visit) - HA-21: Erosion around outlet structure.

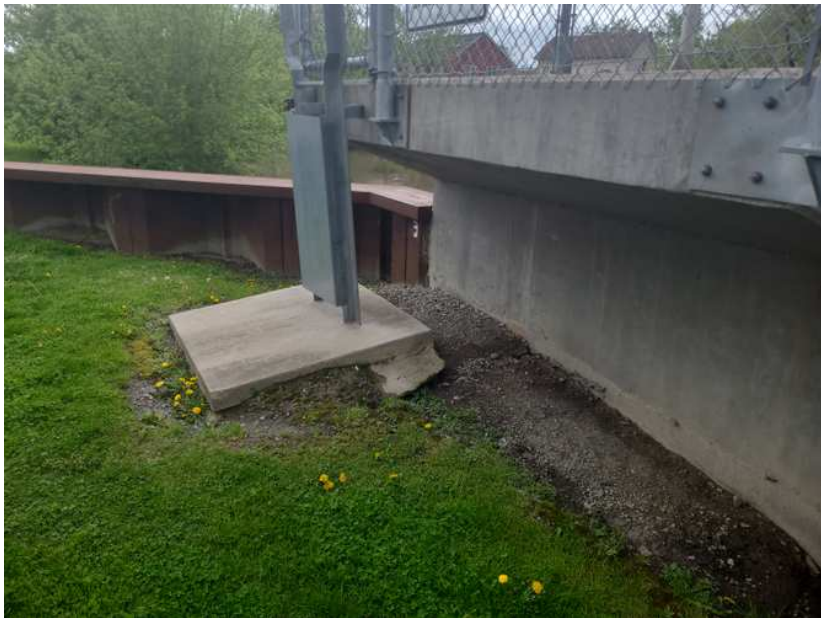
No User Rating (Site Visit) - HA-18: Settlement behind headwall of outlet structure.

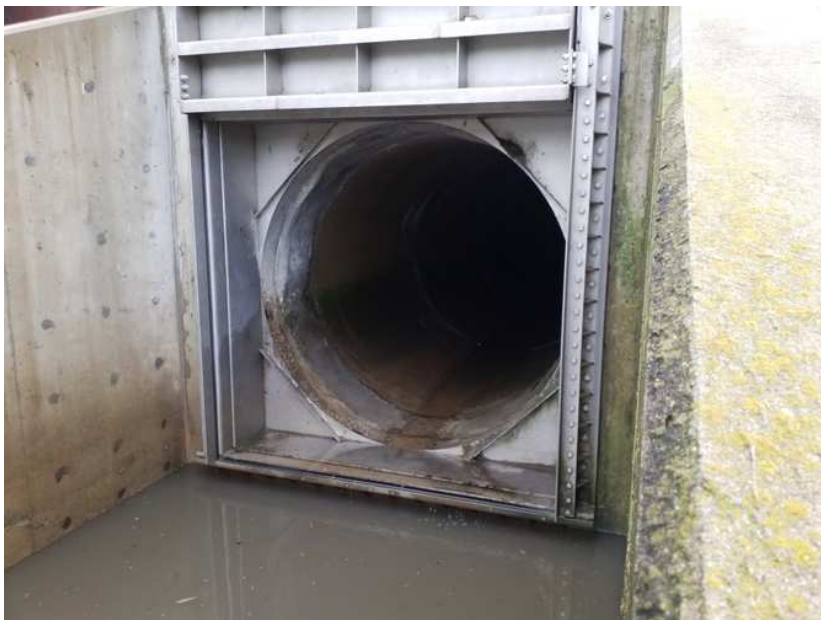
No User Rating (Site Visit) - Long term ponding on landside of gatewell structure.

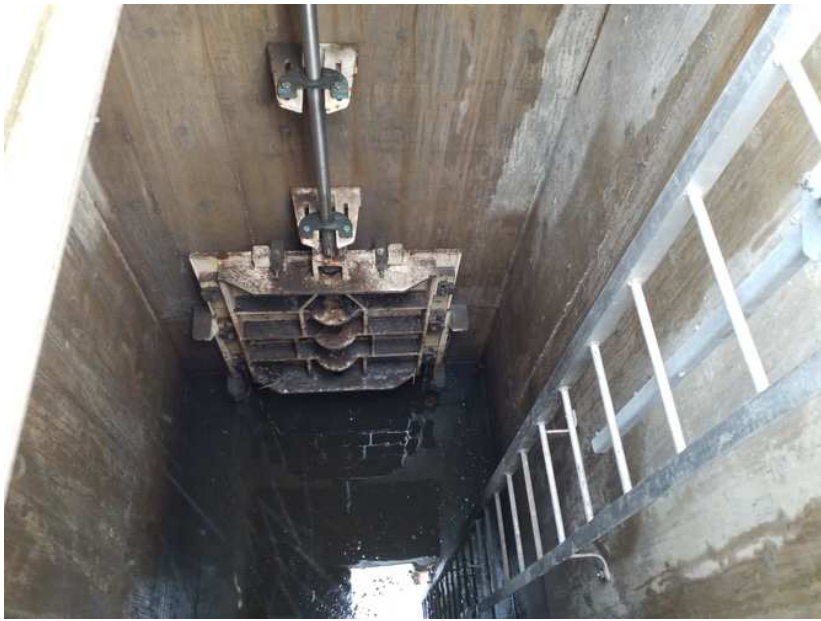
No User Rating (Site Visit) - HA-04: Open and clear of debris. Baffle blocks are not visible.

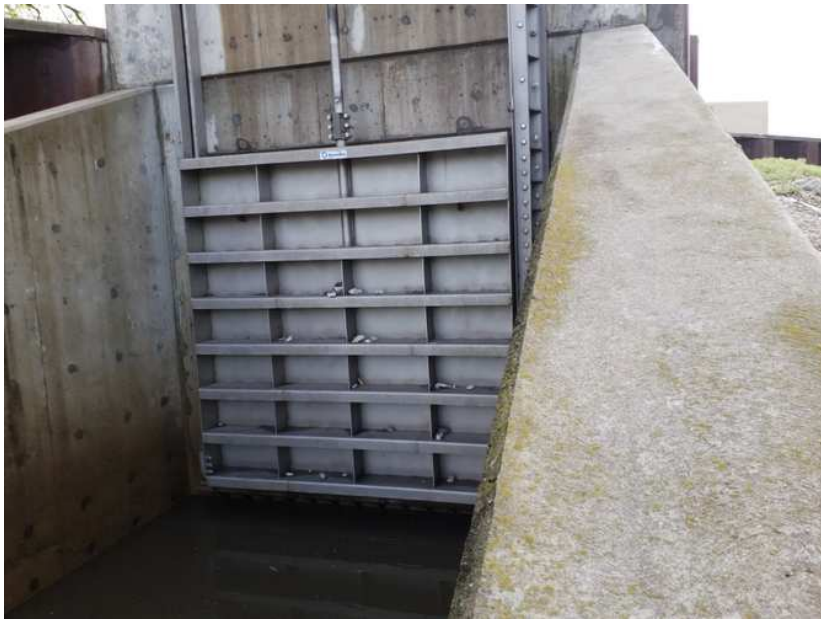
No User Rating (Site Visit) - HA-35: Open position after closing, a bit of muck on the gate.

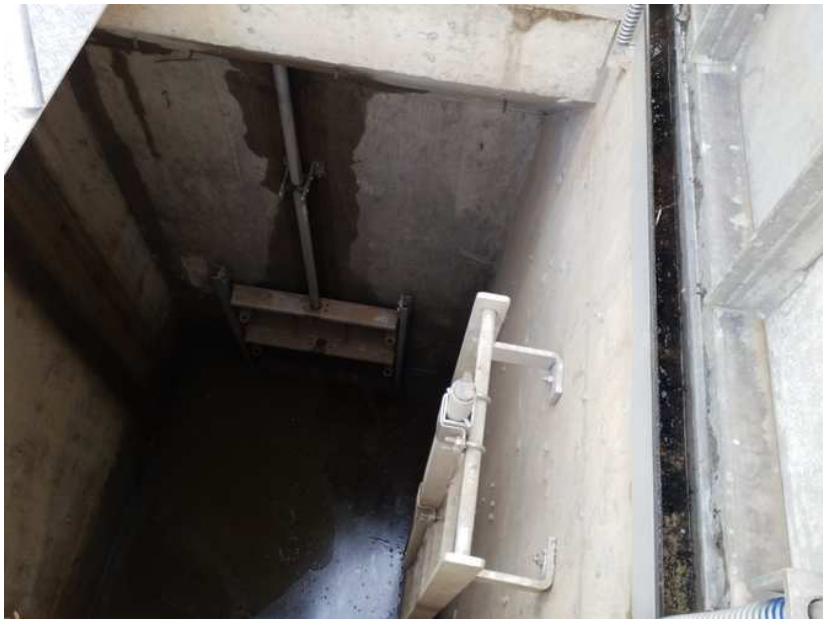
No User Rating (Site Visit) - HA-04: Gate closed, operates smoothly

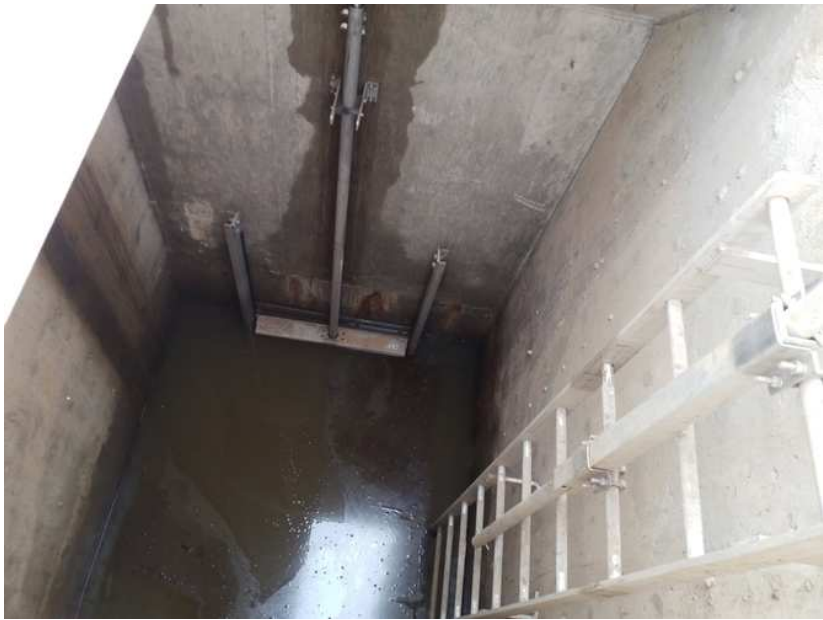
No User Rating (Site Visit) - HA-06: Gate open, hard to see in due to high water level.

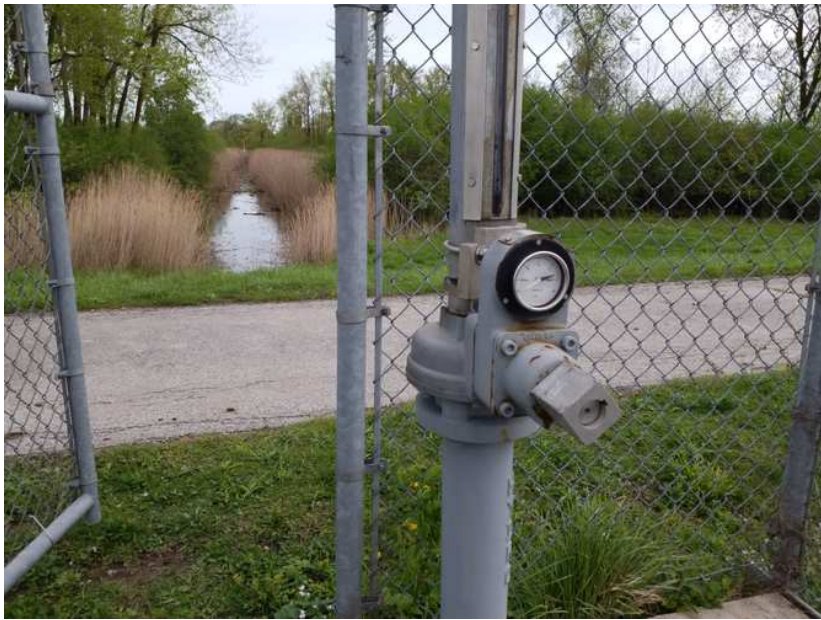
No User Rating (Site Visit) - HA-06: Closed operates smoothly

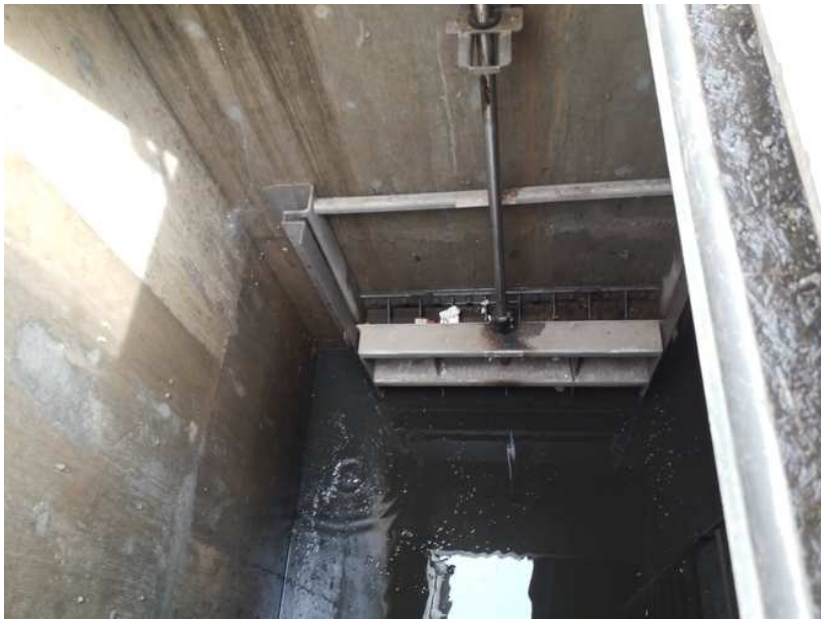
No User Rating (Site Visit) - HA-31: Fully closed position, no issues.

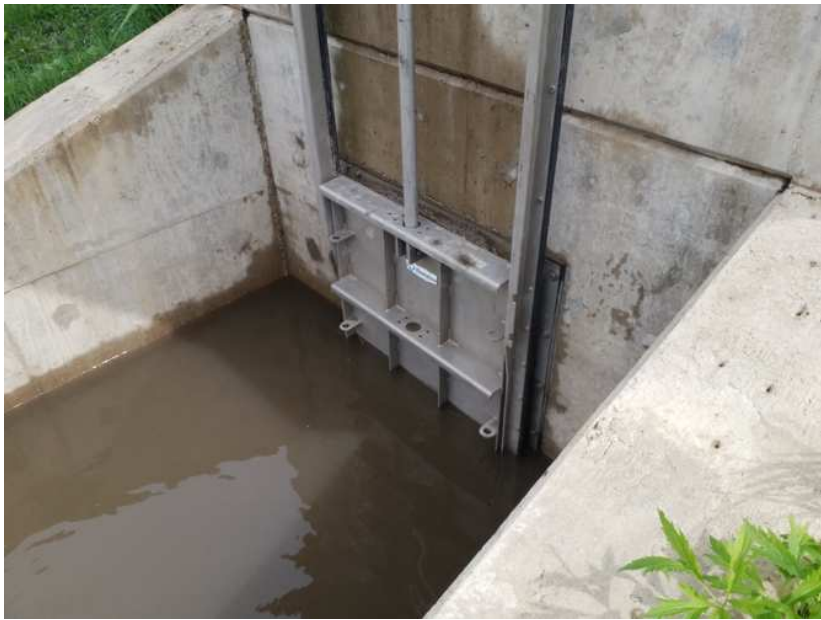
No User Rating (Site Visit) - HA-07: Gate closed, operates smoothly

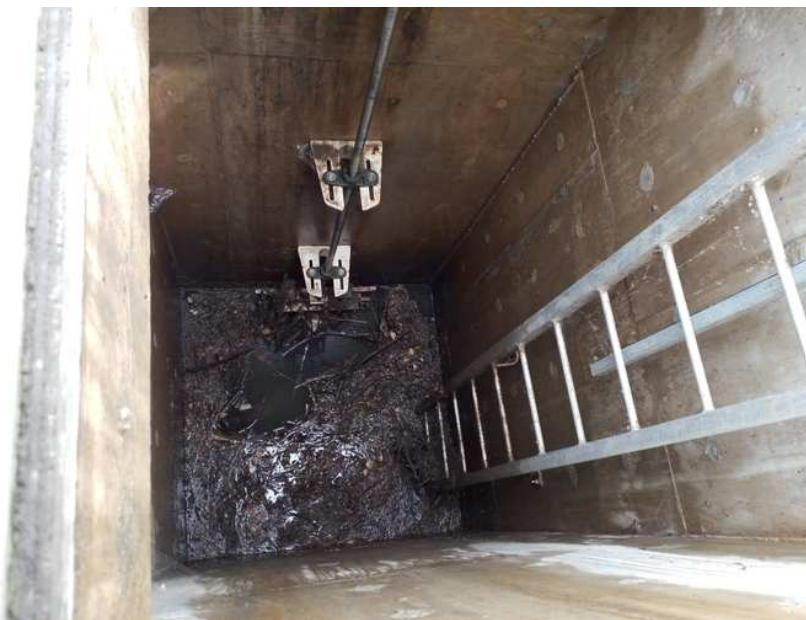
No User Rating (Site Visit) - HA-10: Gate closed, operates smoothly. Hard to check seal because of water level.

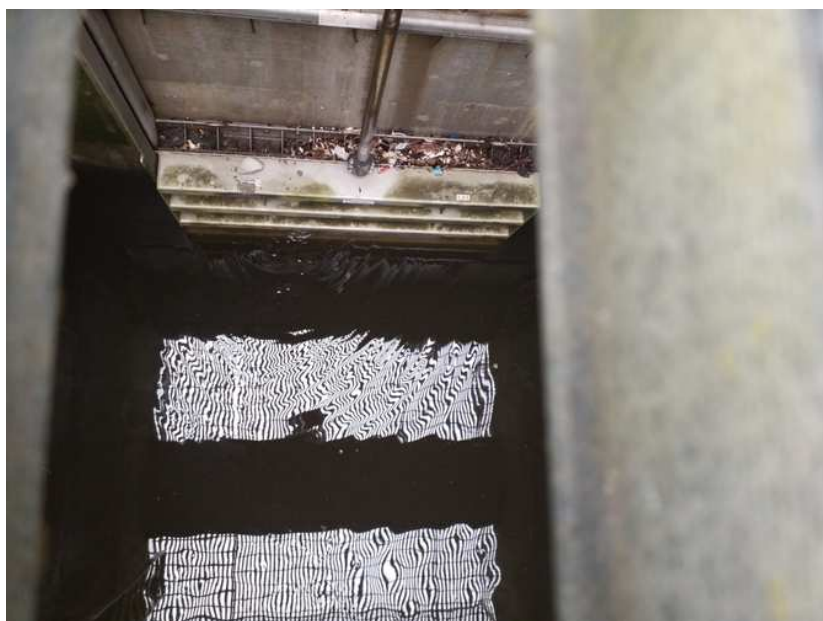
No User Rating (Site Visit) - HA-30: Operated smoothly, no issues with gate. Some debris in the gatewell chamber.

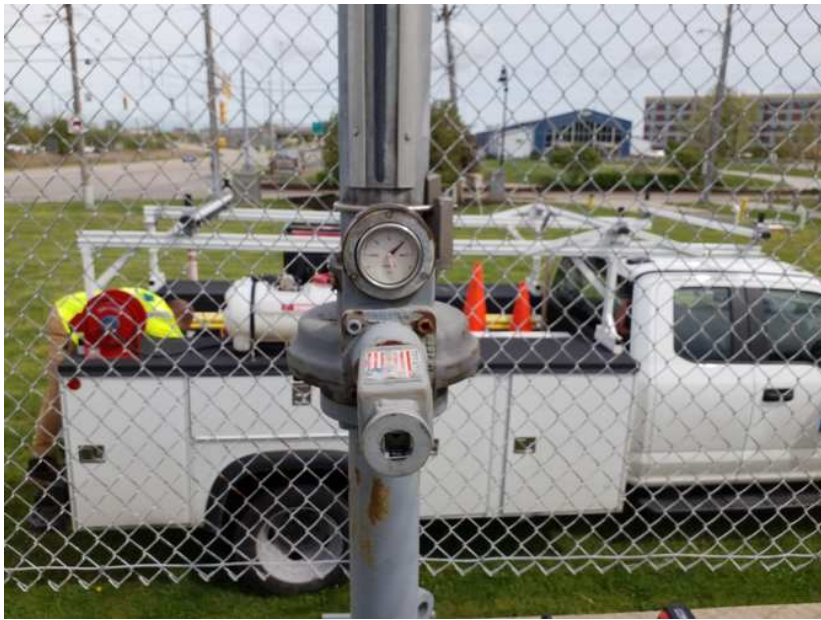
No User Rating (Site Visit) - HA-12: Gate closed position, operates smoothly

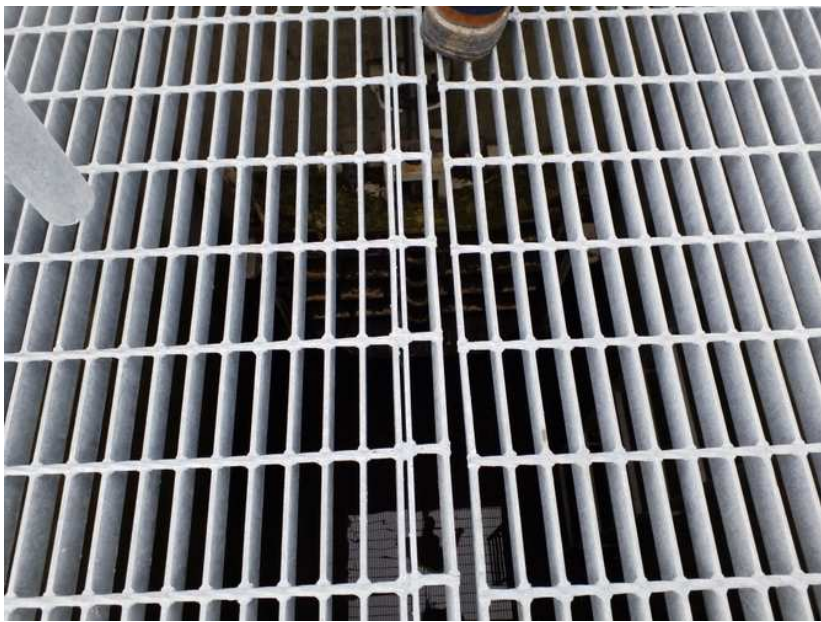
No User Rating (Site Visit) - HA-28: 3/4 closed initially

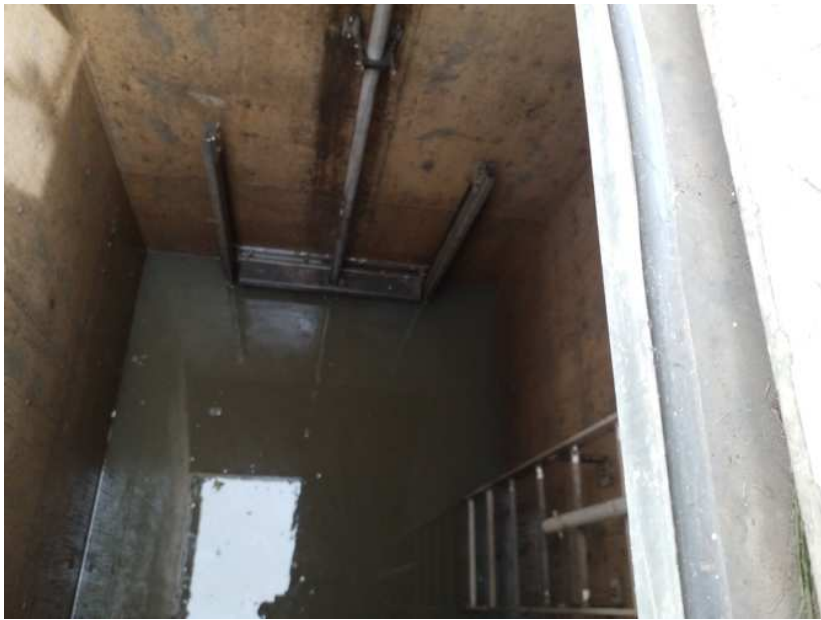
No User Rating (Site Visit) - HA-28: No issues with gate operation

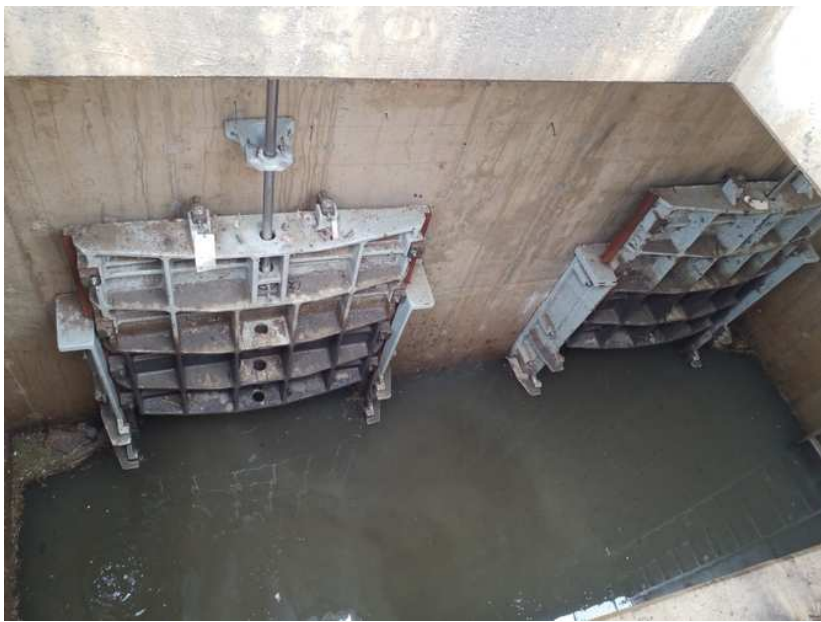
No User Rating (Site Visit) - HA-13: Gate closed. Operates smoothly

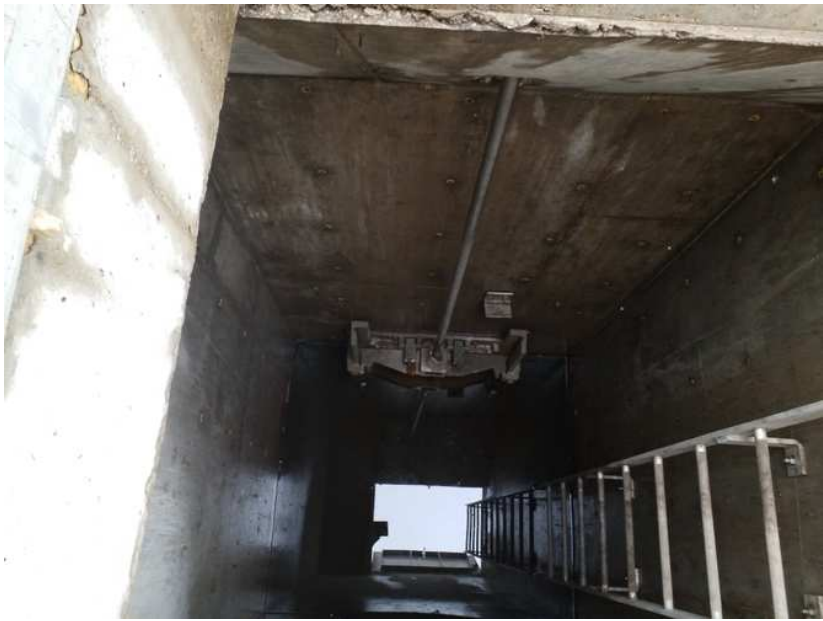
No User Rating (Site Visit) - HA-26: A(right) B(left) gates in open position prior to testing.

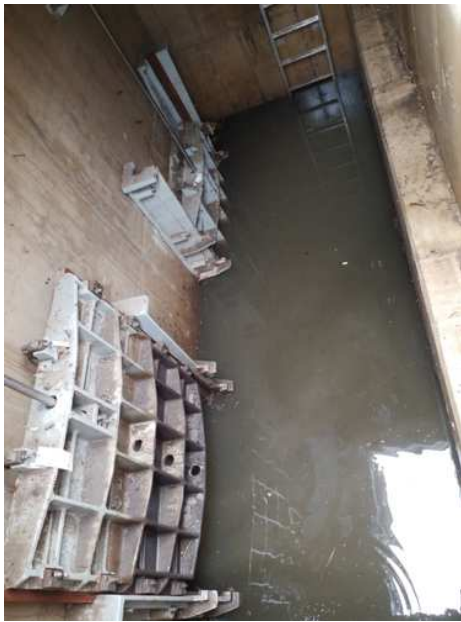
No User Rating (Site Visit) - HA-14: Gate closed, operates smoothly.

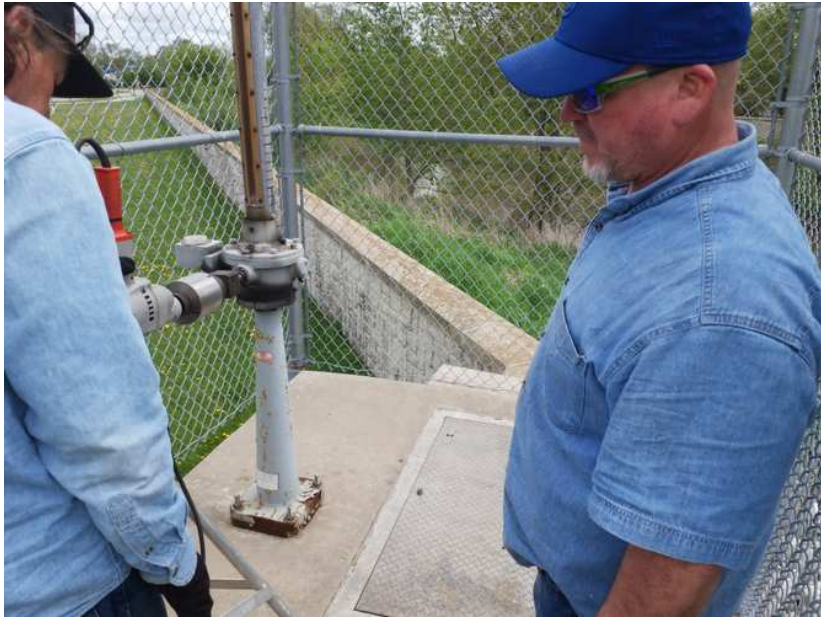
No User Rating (Site Visit) - HA-26A: Gate closed position, no issues with operation.

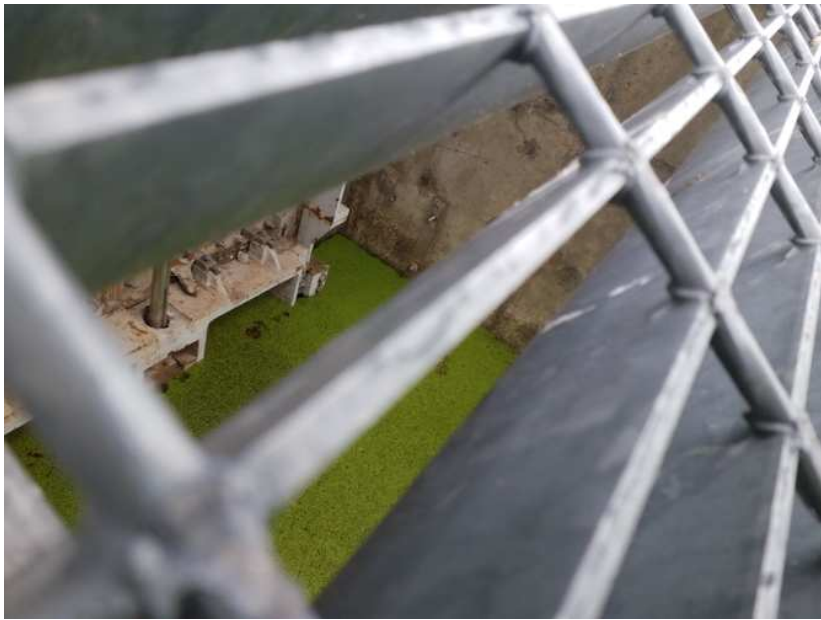
No User Rating (Site Visit) - HA-26: Debris in the gatewell chamber.

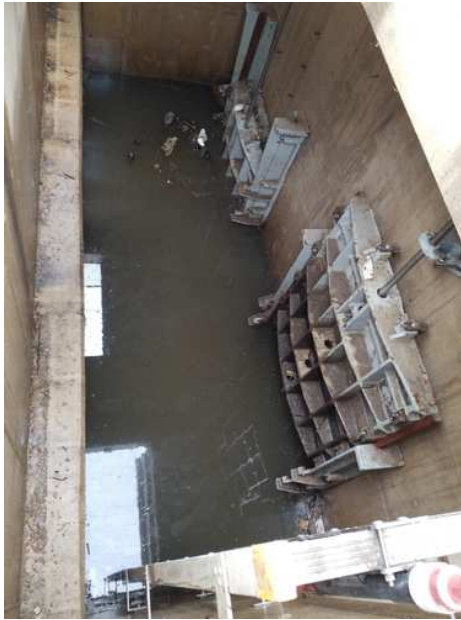
No User Rating (Site Visit) - HA-16: Gate closed. Skips some when operated. Loose and missing bolts on wingwalls.

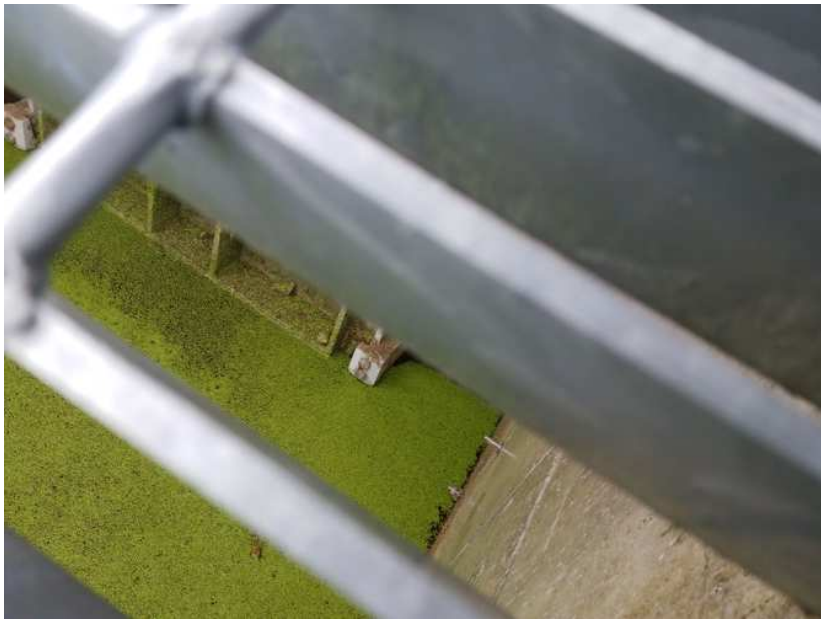
No User Rating (Site Visit) - HA-26B: Gate in closed position with no issues.
