US Army Corps
of Engineers ®

Site Visit Summary

Name of System: Hammond

Date of Site Visit: 04/29/2024 - 04/30/2024

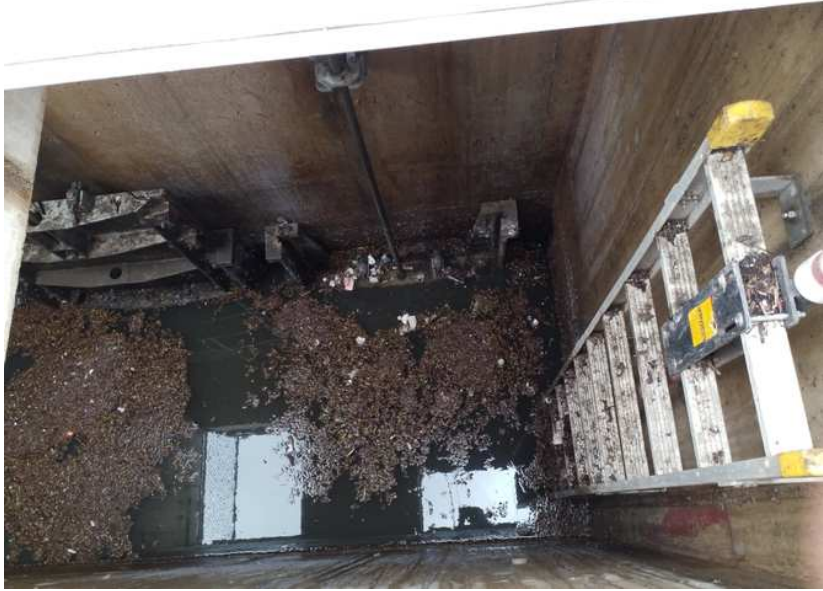
No User Rating (Site Visit) - HA-17: Gate only closed halfway because of the pump station operating nearby. Gate operates smoothly. A lot of debris in the gatewell chamber.

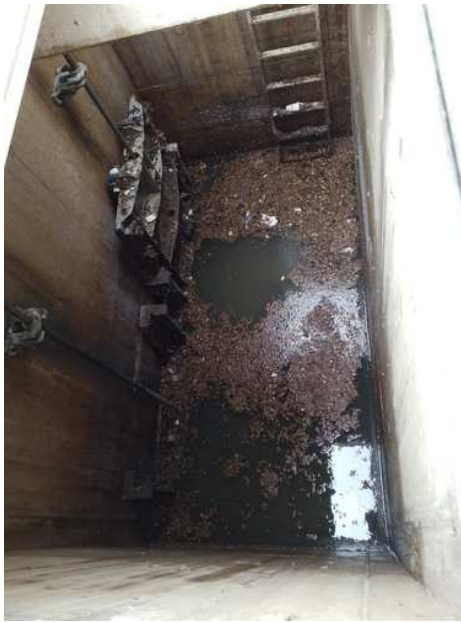
No User Rating (Site Visit) - HA-27A: Closed position, no issues with operation

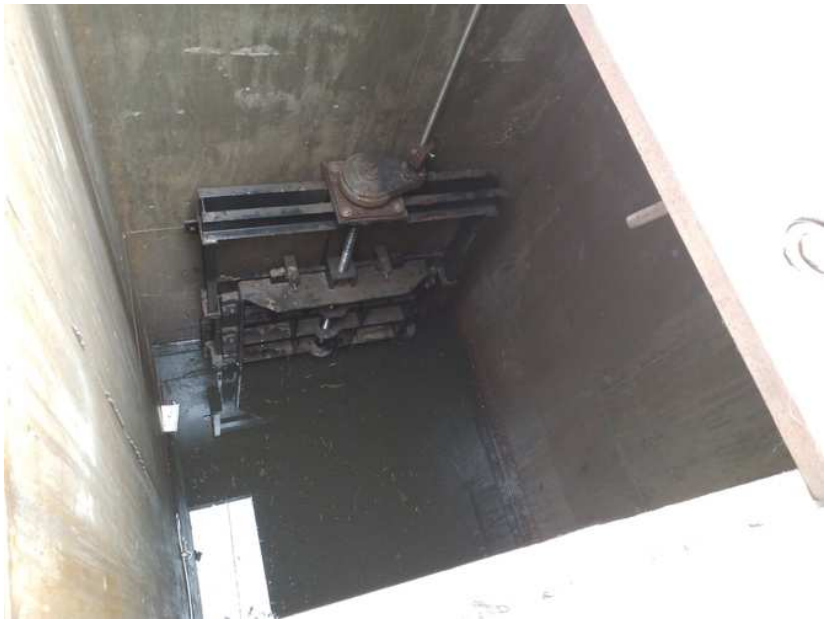
No User Rating (Site Visit) - HA-27b: Closed position, no issue with operation.

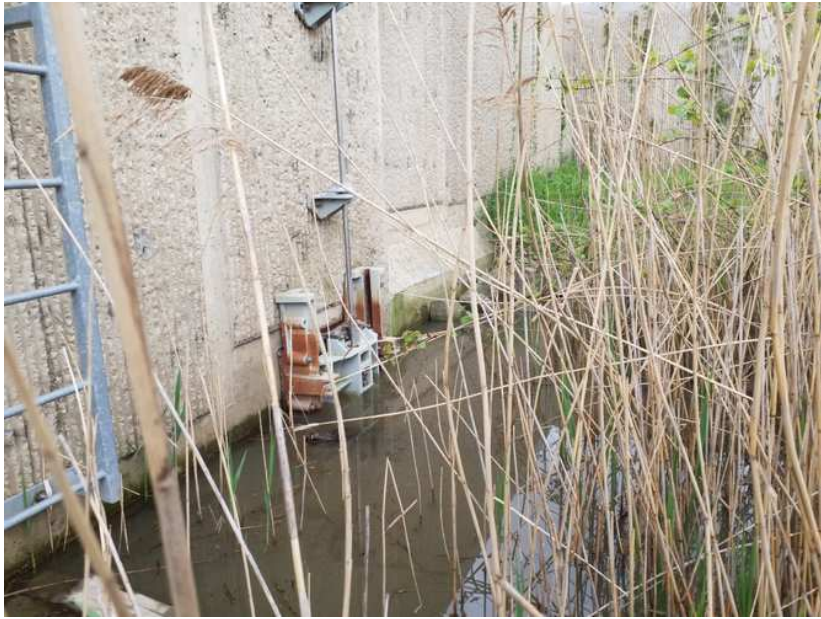
No User Rating (Site Visit) - HA-20: Some squeaking and knocking when closed.

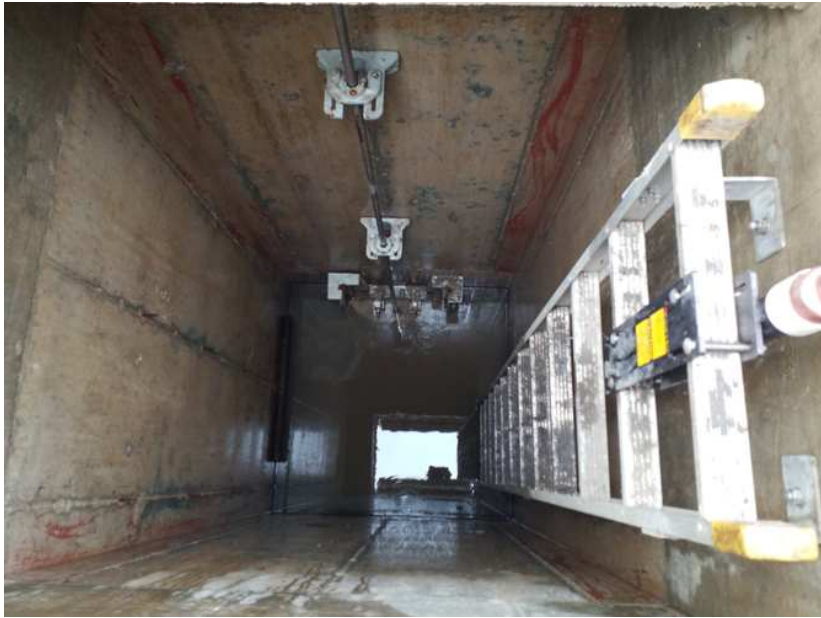
No User Rating (Site Visit) - HA-24: Closed position, no issues with operation

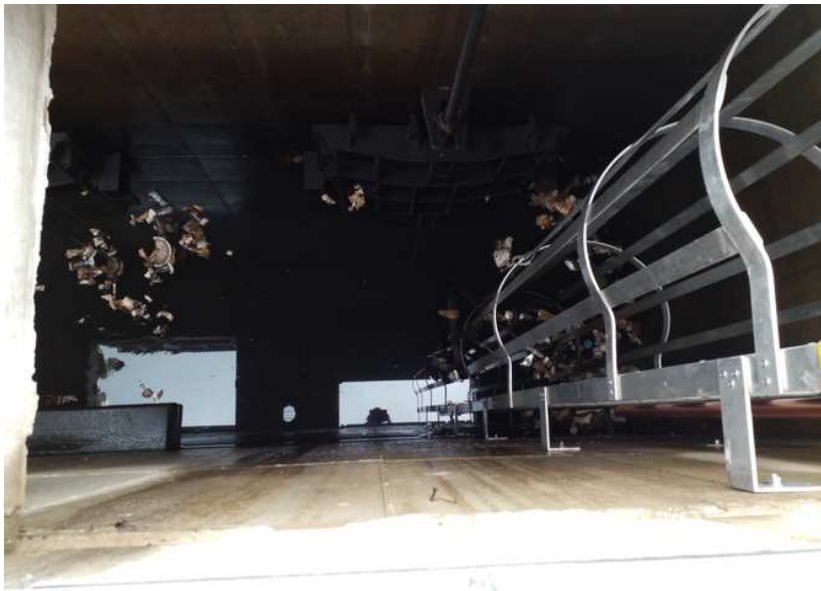
No User Rating (Site Visit) - HA-23: Closed position, no issues with operation

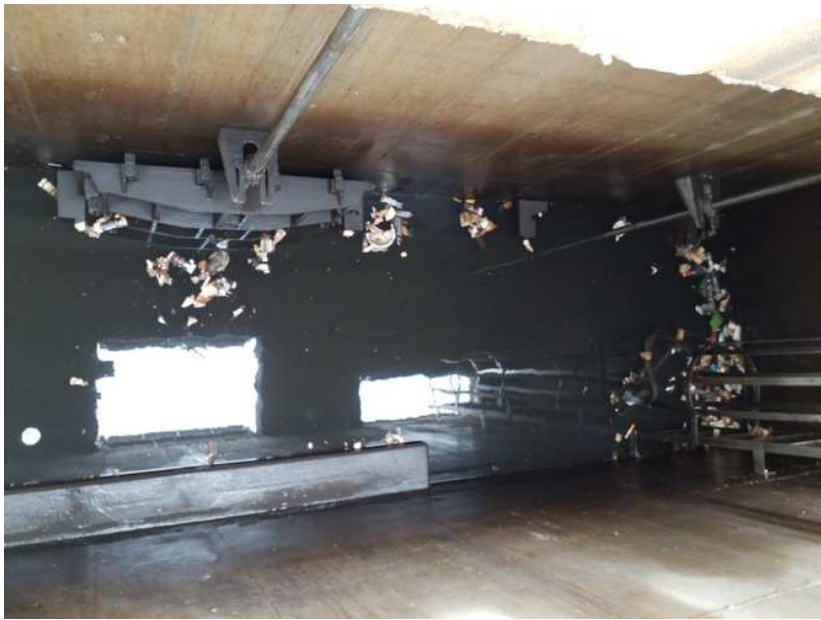
No User Rating (Site Visit) - HA-21: Debris in the gatewell chamber.

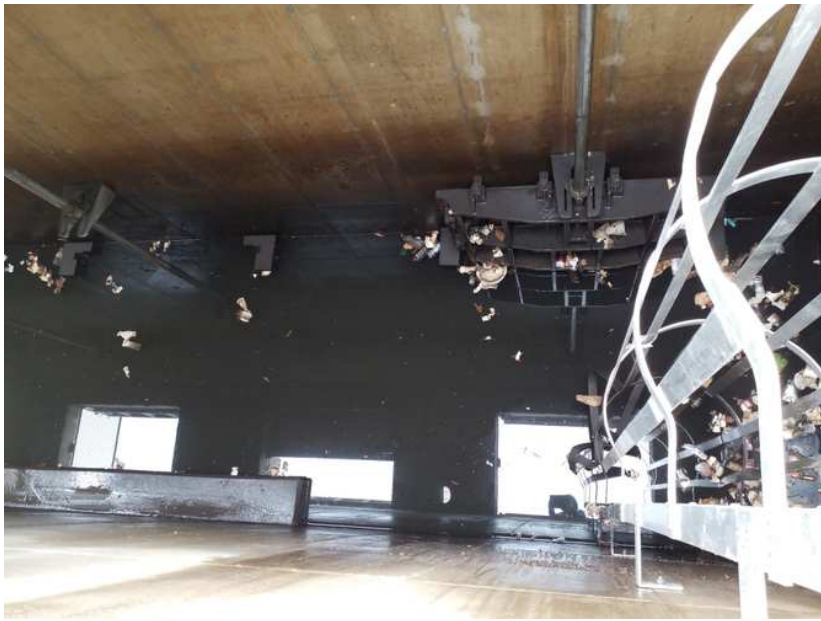
No User Rating (Site Visit) - HA-21a: Right gate fully closed; water is too high inside chamber to see closed gate.

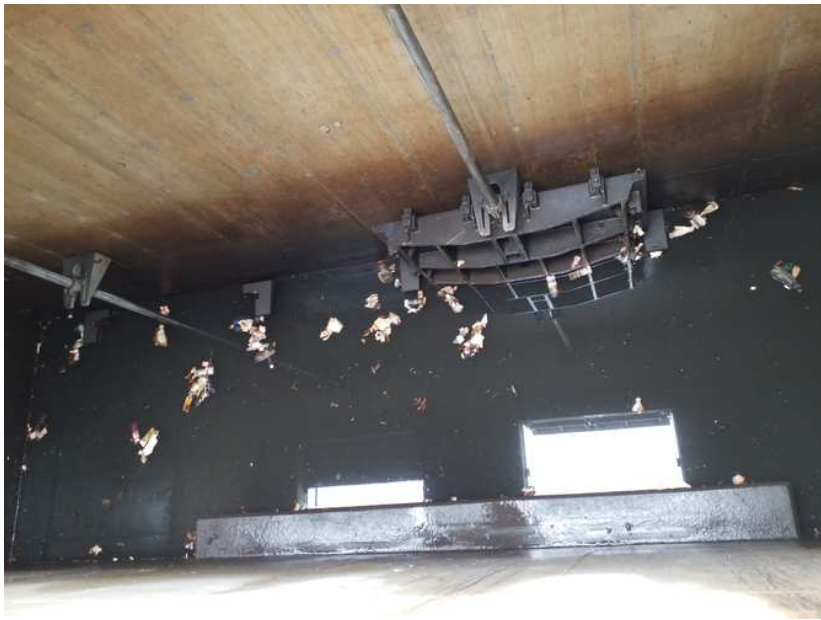
No User Rating (Site Visit) - HA-21b: Left gate fully closed, water in the chamber is too high to see gate, no issues with operation.

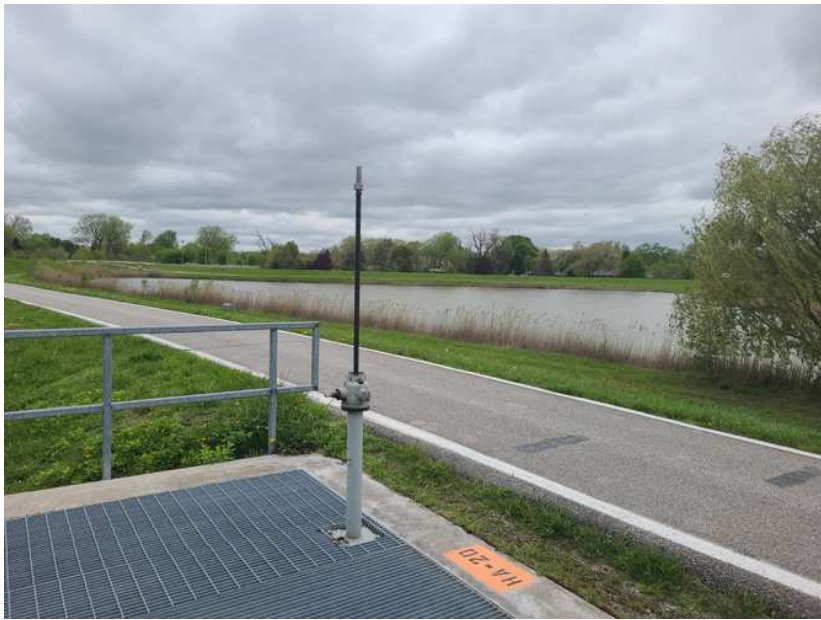
No User Rating (Site Visit) - HA-21c: Left gate fully closed, was noisy when closing

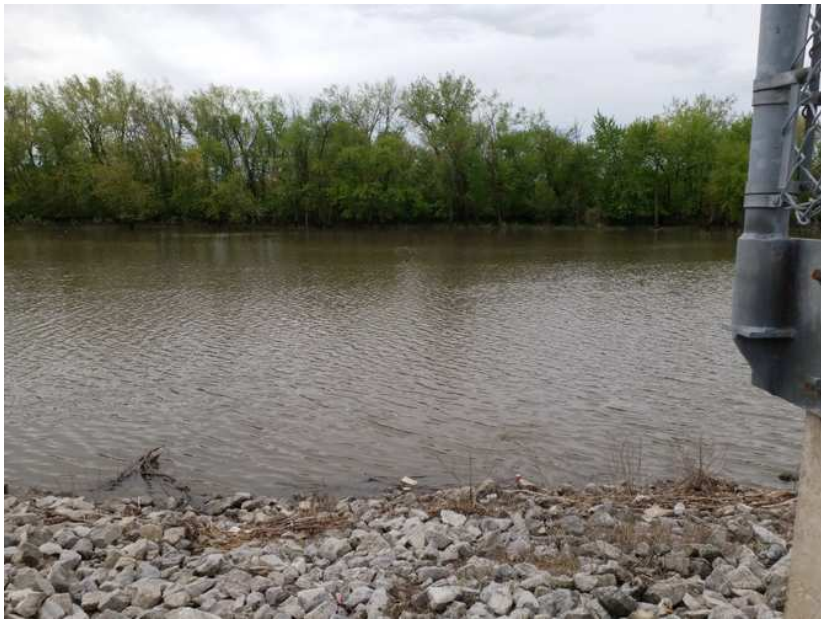
No User Rating (Site Visit) - HA-07: Flap gate not completely sealed.

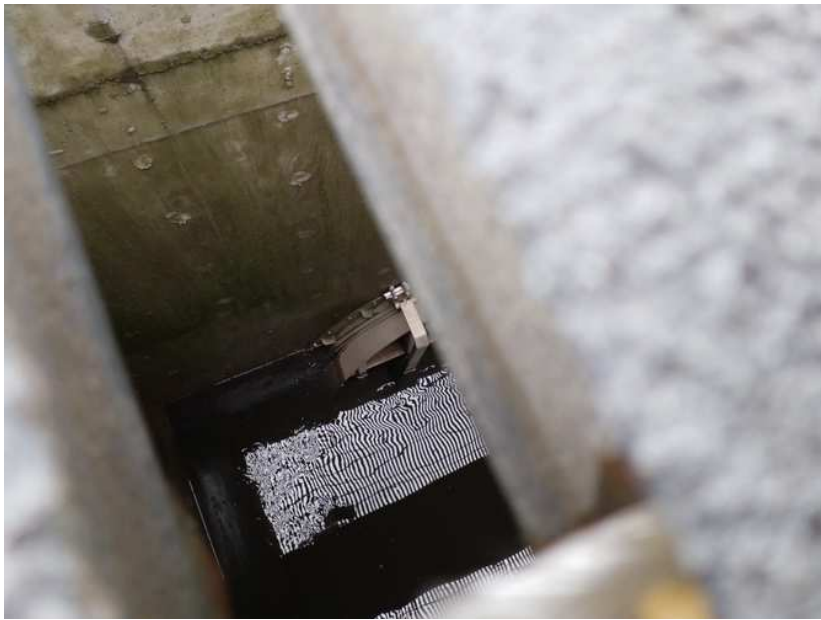
No User Rating (Site Visit) - HA-30: Flap gate is not working correctly, forming whirlpool on outlet side will leave the gate closed to prevent backflow.

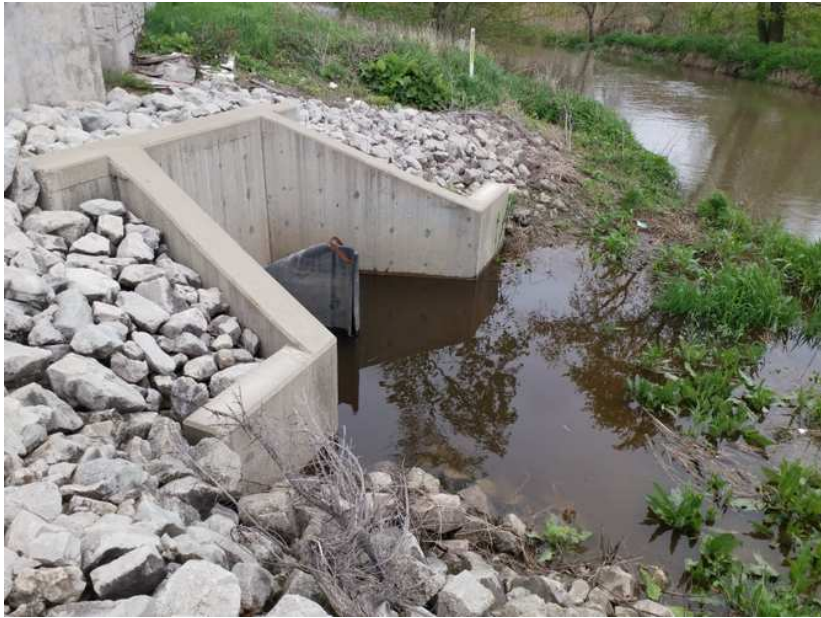
No User Rating (Site Visit) - HA-12: Flap gate not sealing completely

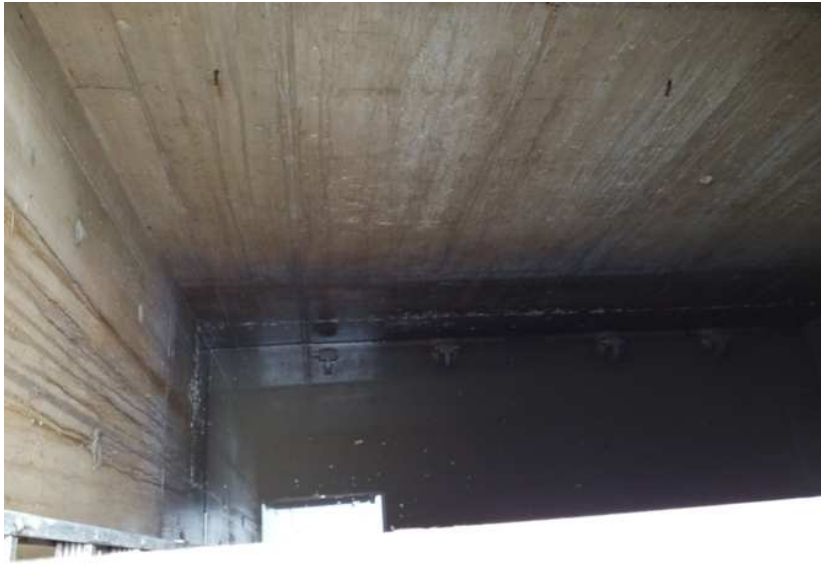
No User Rating (Site Visit) - HA-26b: Flapgate is leaking on sides.

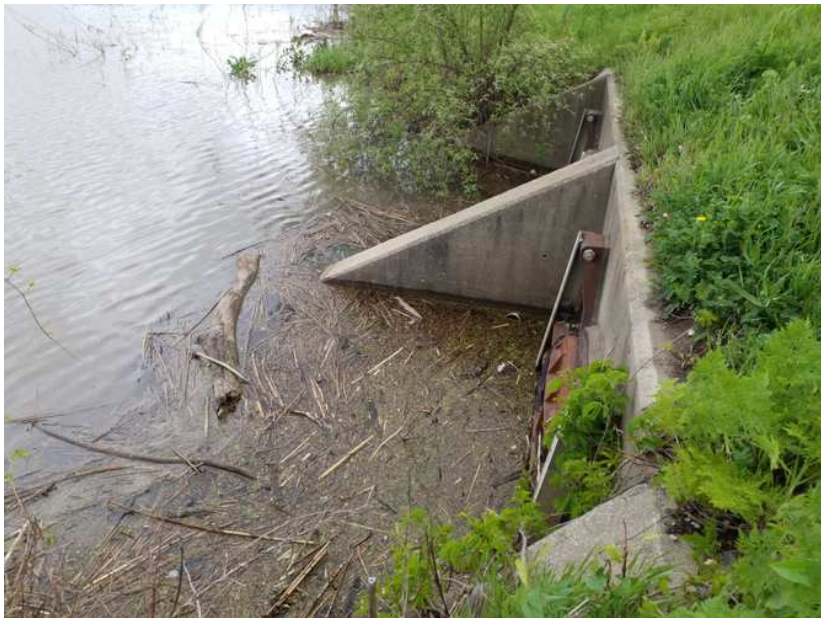
No User Rating (Site Visit) - HA-27a: Water too high to see flap gate

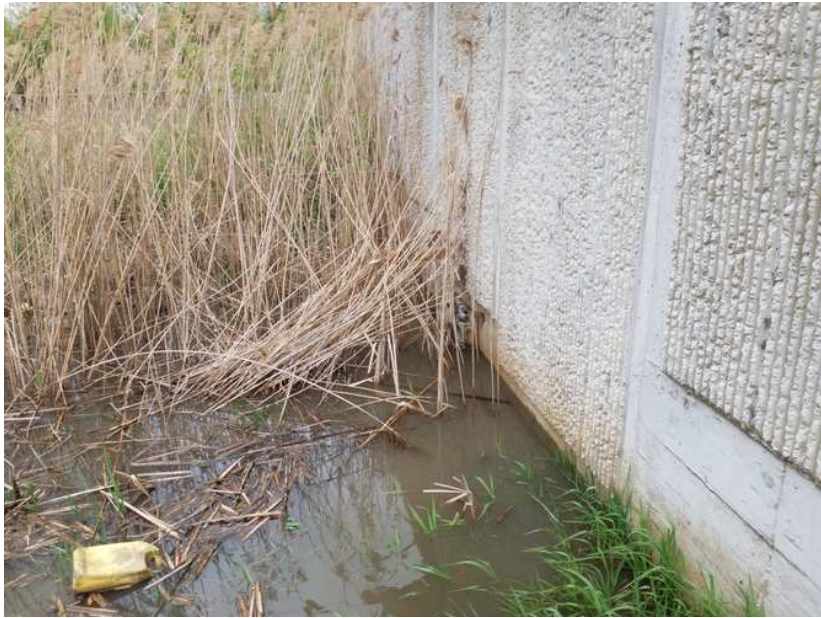
No User Rating (Site Visit) - HA-27: Debris at outlet

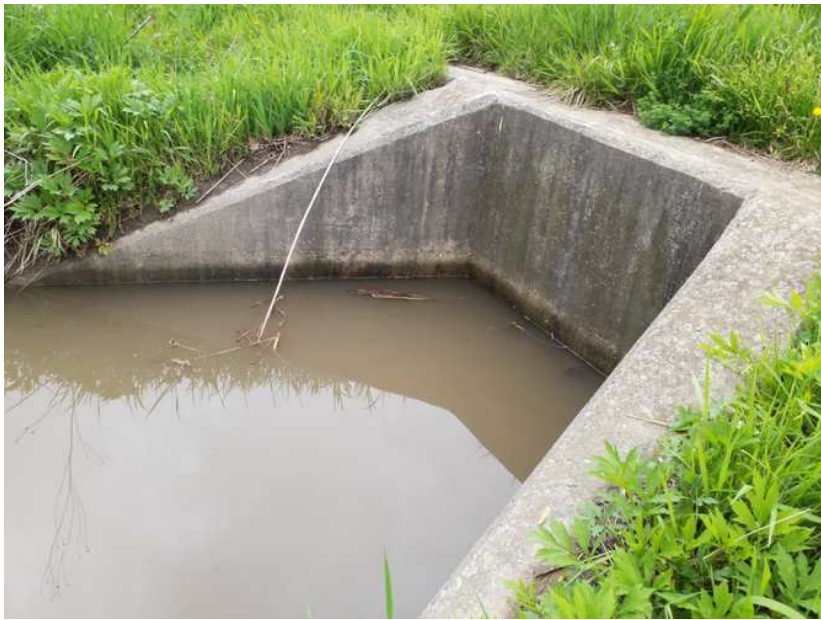
No User Rating (Site Visit) - HA-24: Vegetation blocking view of flapgate

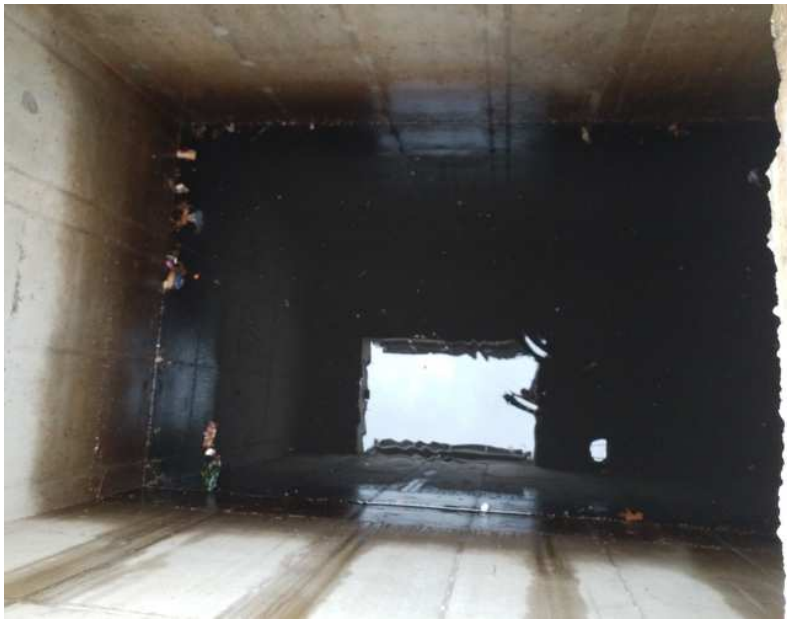
No User Rating (Site Visit) -HA-23: Water level too high to see flap gate

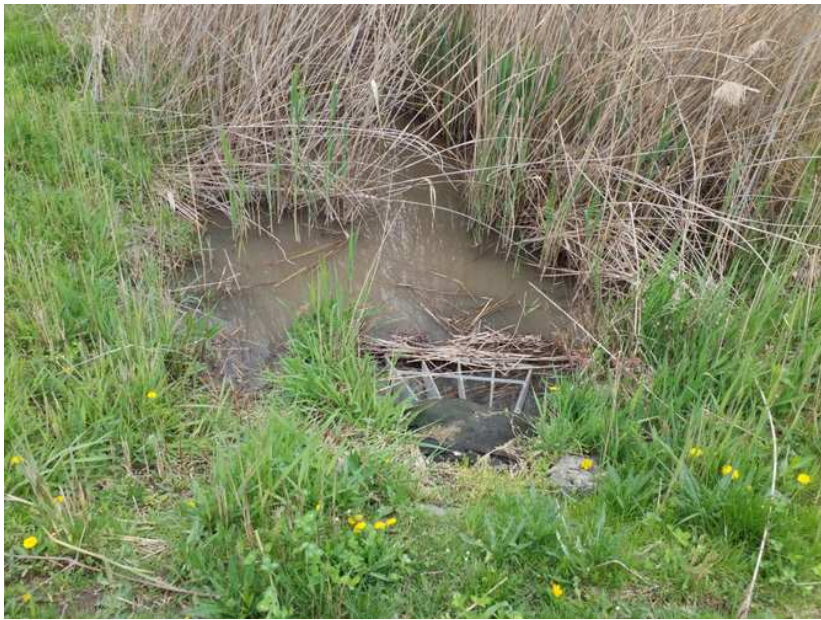
No User Rating (Site Visit) - HA-21: Water in chamber too high to see flap gates consistent across all three gates.

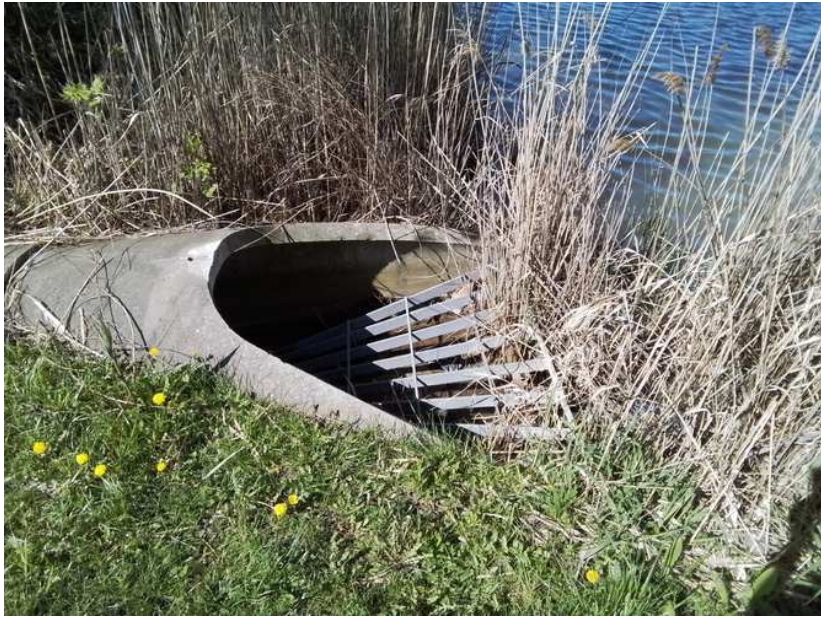
No User Rating (Site Visit) - HA-23: Debris on trash rack

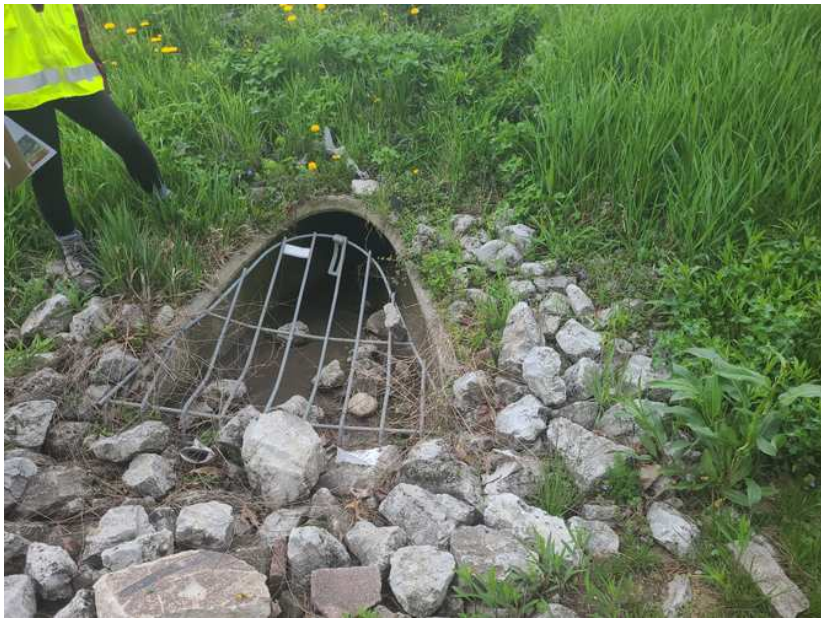
No User Rating (Site Visit) - HA-17: Displaced trash rack. Near pump station PS-CA.

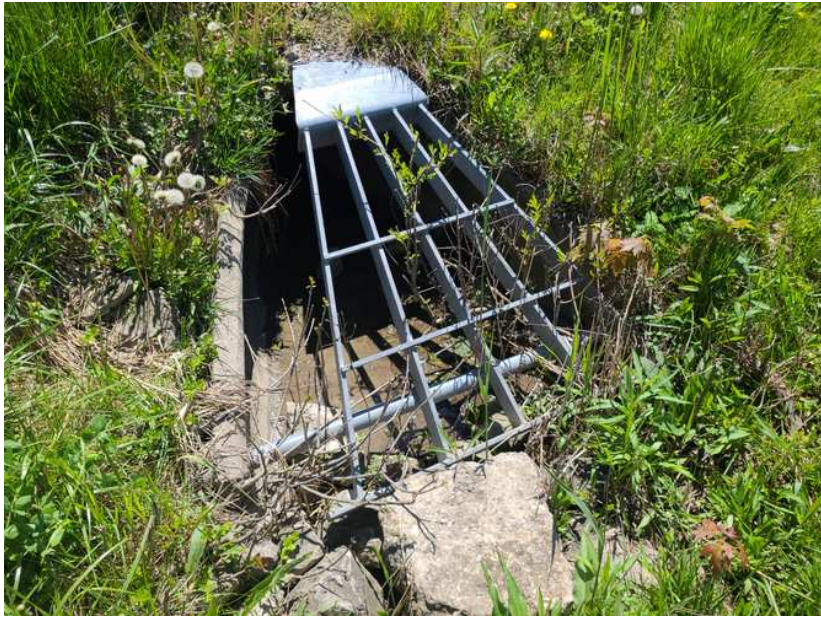
No User Rating (Site Visit) - HA-09: Intake grate is loose, stone getting past grate

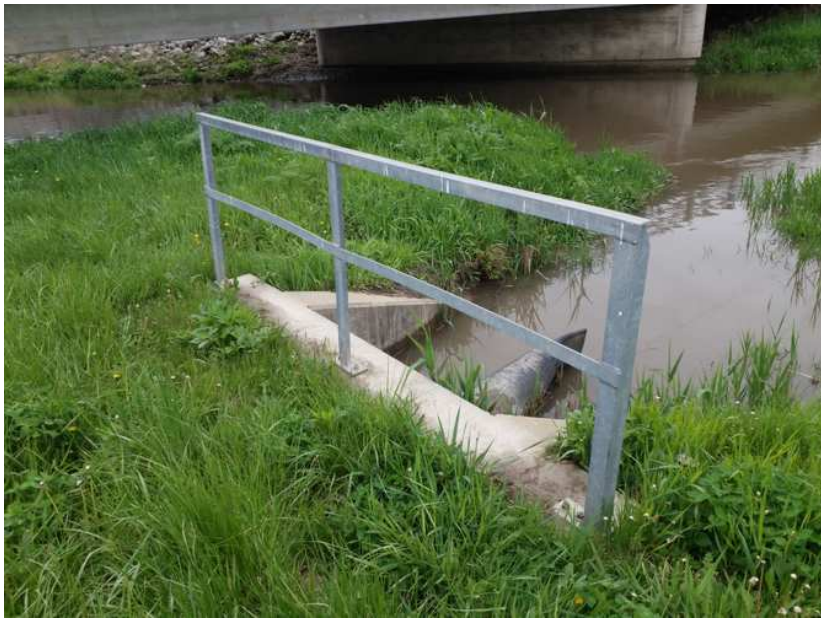
No User Rating (Site Visit) - HA-05: Offset and midsized trash rack is allowing riprap into inlet

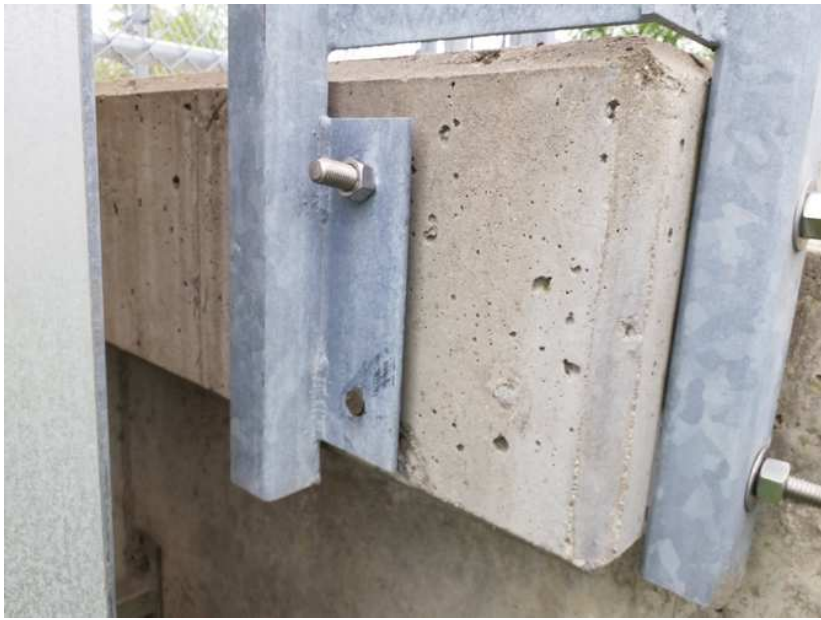
No User Rating (Site Visit) - HA-13: Wobbly guardrail

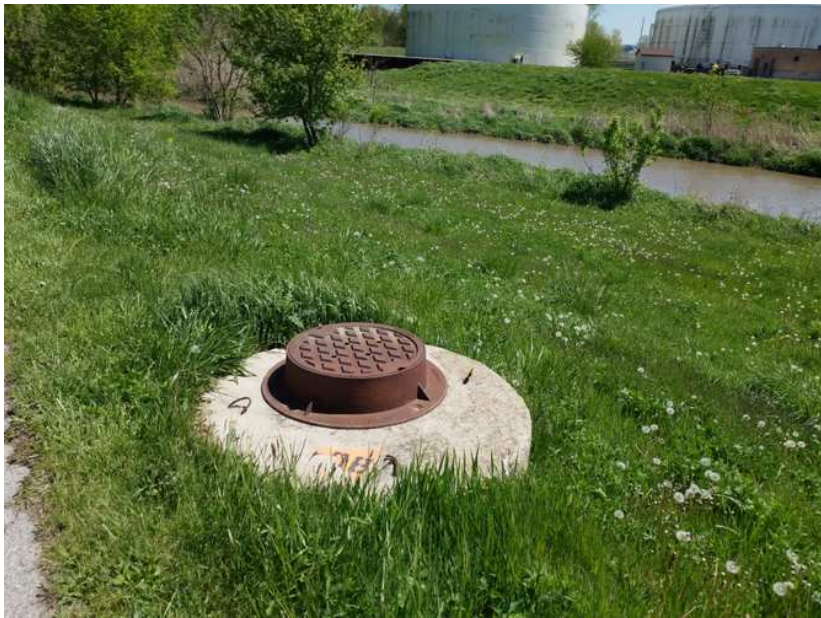
No User Rating (Site Visit) - HA-2: Manhole

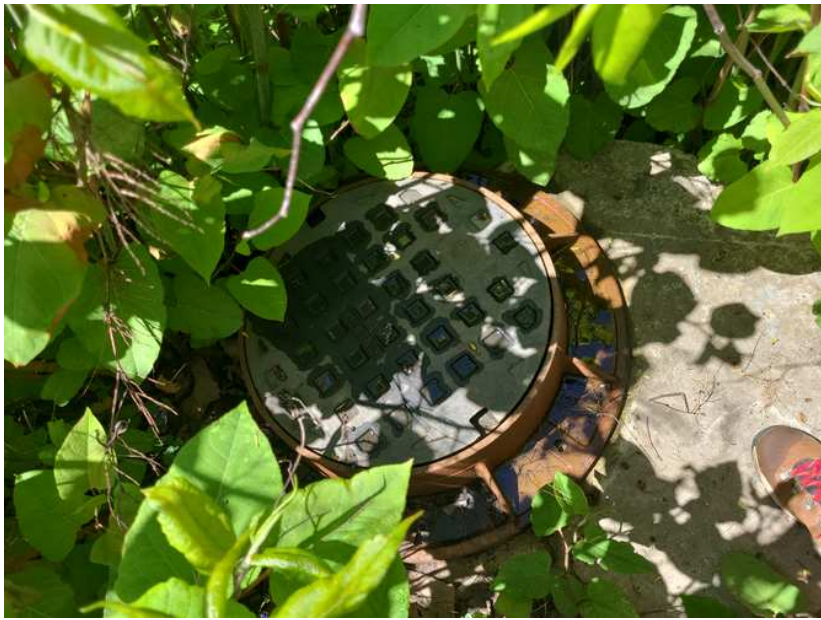
No User Rating (Site Visit) - HA-11: Lid has moved.

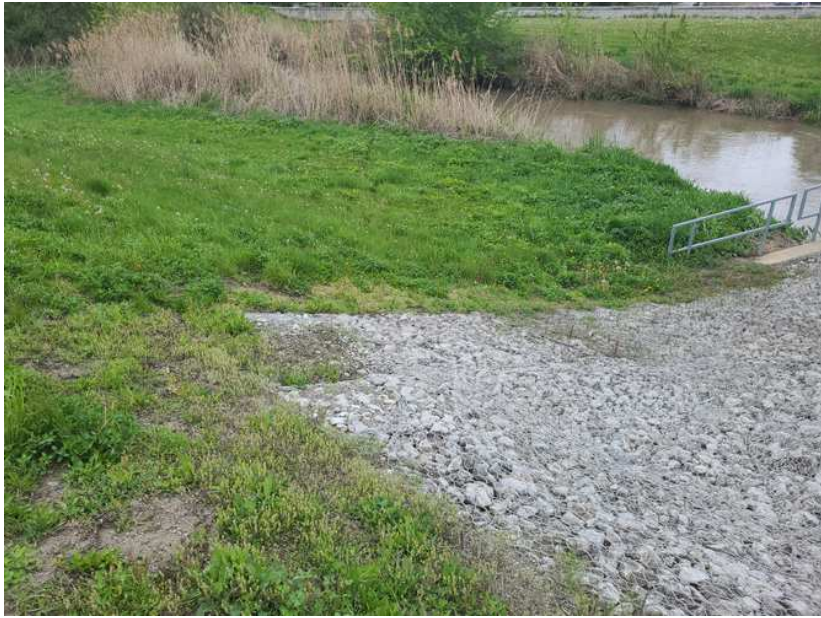
No User Rating (Site Visit) - Geosynthetic exposed

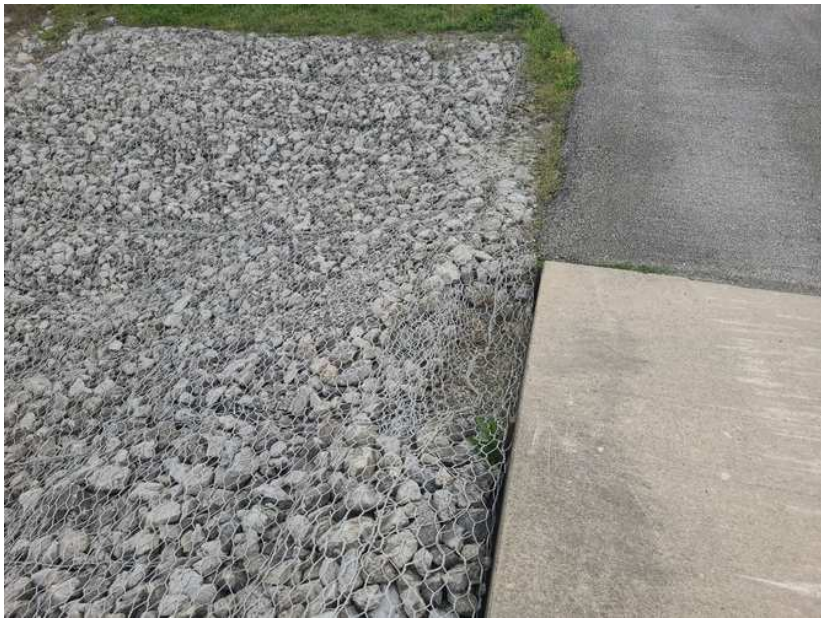
No User Rating (Site Visit) - Damaged and missing gabions on east side of restrictor.

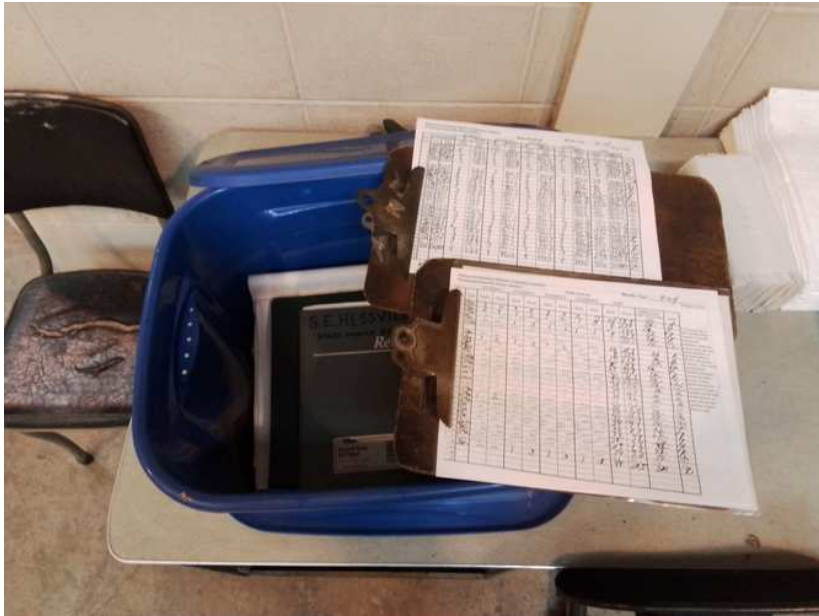
No User Rating (Site Visit) - PS-SK: Good maintenance record keeping

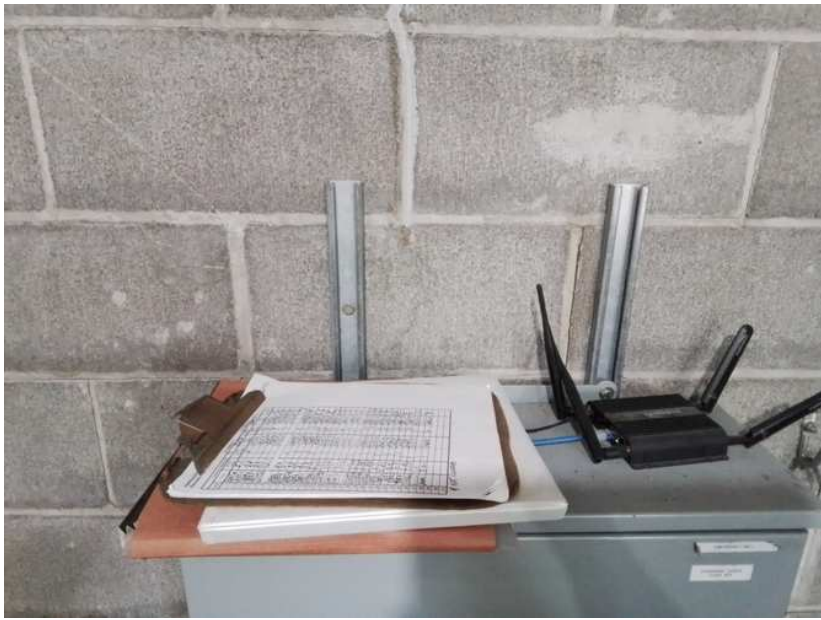
0596 - No User Rating (Site Visit) - PS-HV: Good maintenance record keeping

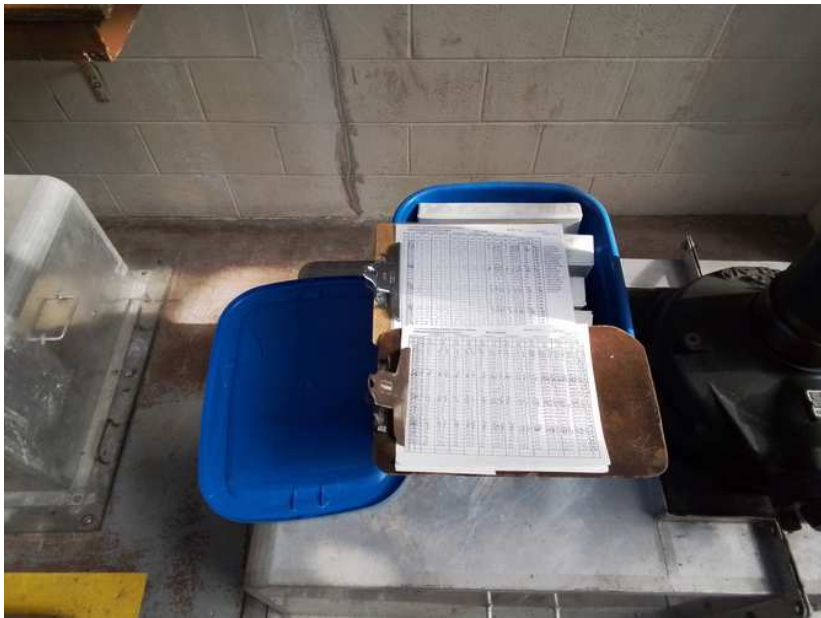
0597 - No User Rating (Site Visit) - PS-KA: Good maintenance record keeping

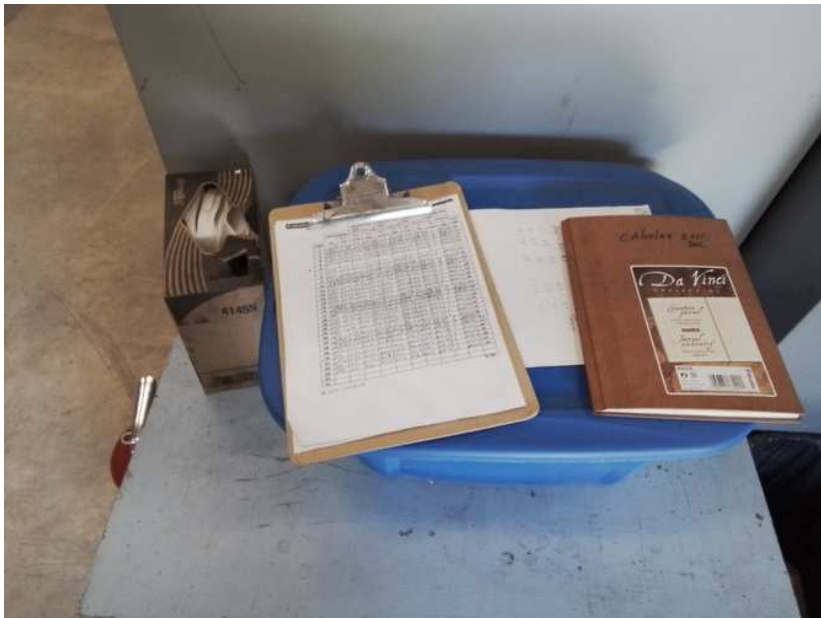
0598 - No User Rating (Site Visit) - PS-IN: Good maintenance record keeping

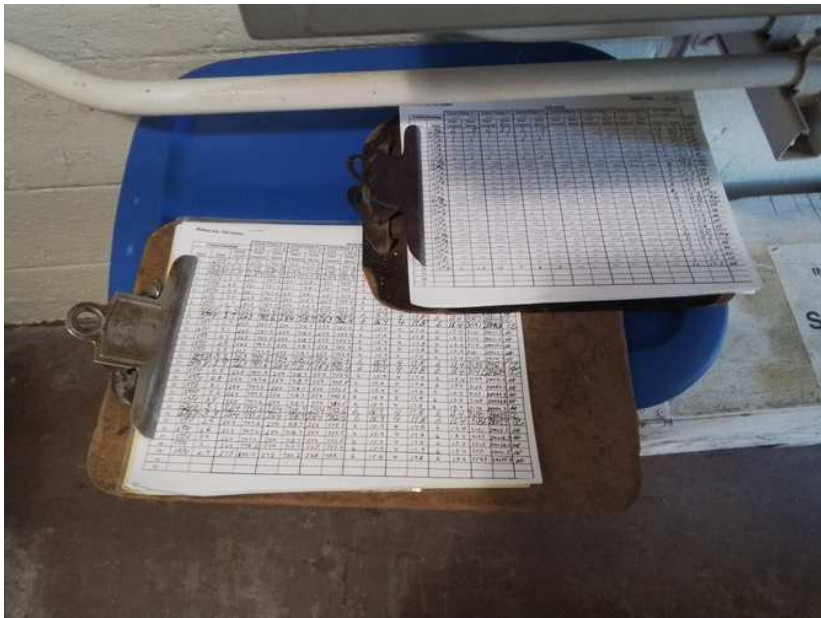
0599 - No User Rating (Site Visit) - PS-CA: Good maintenance record keeping

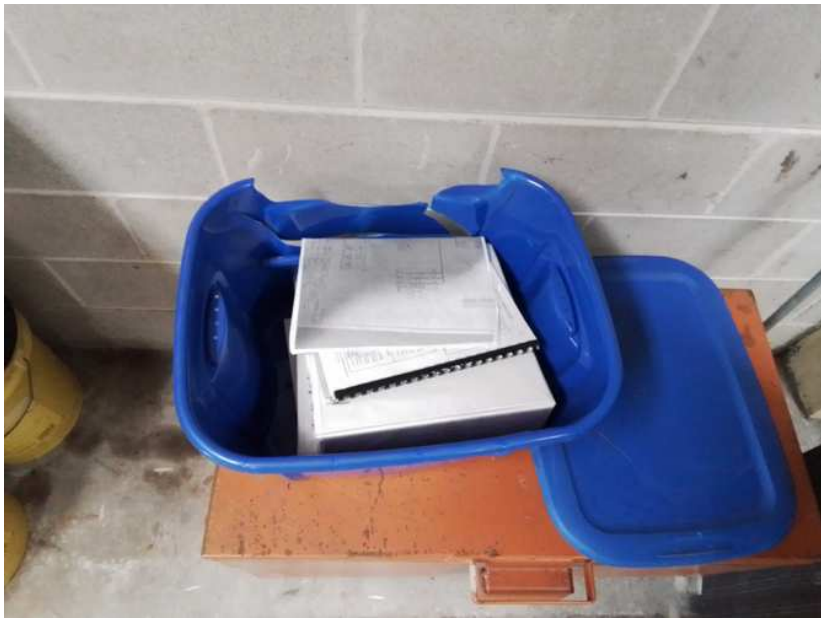
0601 - No User Rating (Site Visit) - PS-JA: Good maintenance record keeping

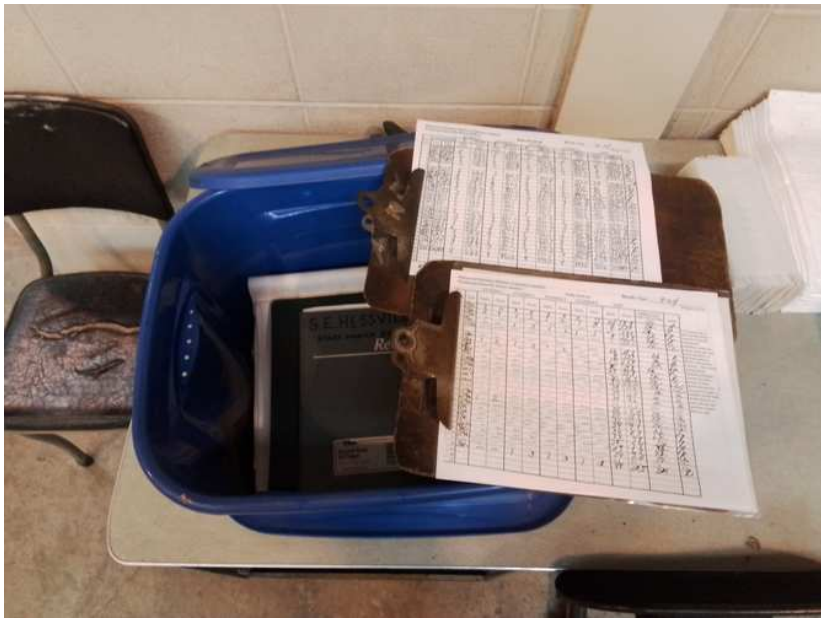
No User Rating (Site Visit) - PS-SK: Manuals kept onsite

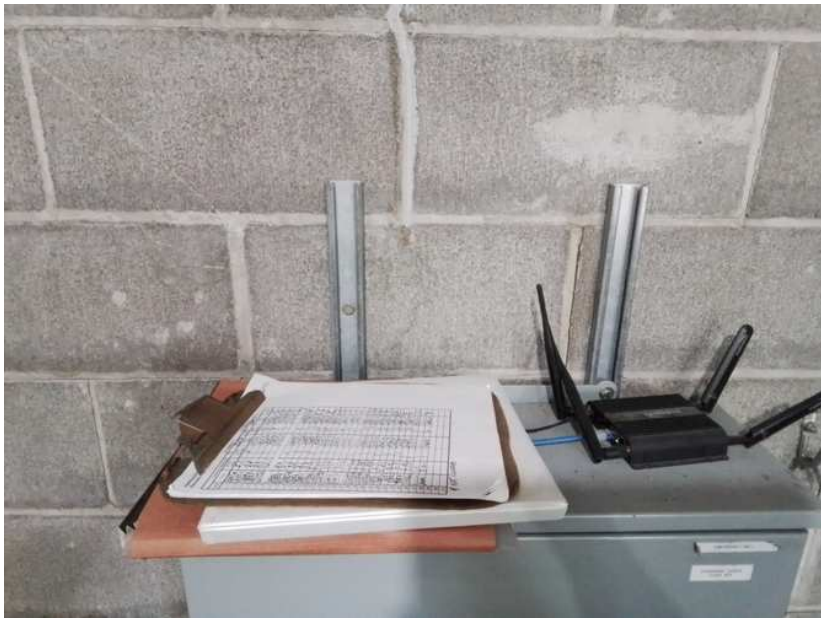
No User Rating (Site Visit) - PS-HV: Manuals kept onsite

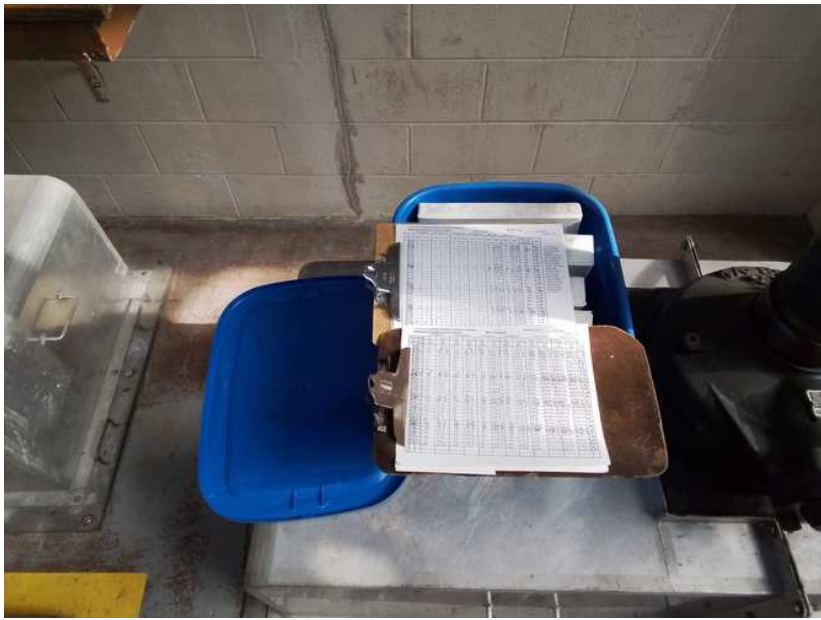
No User Rating (Site Visit) - PS-KA: Manuals kept onsite

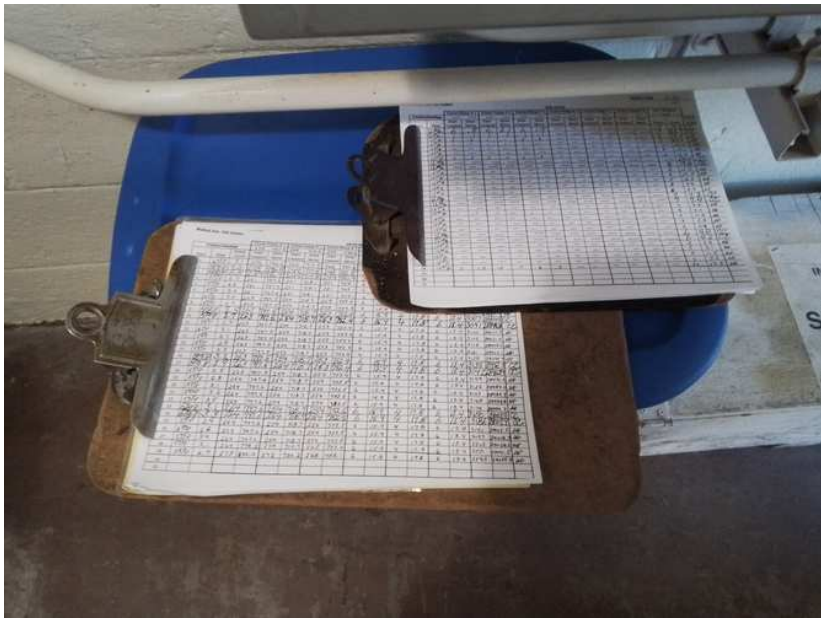
No User Rating (Site Visit) - PS-CA: Manuals kept onsite

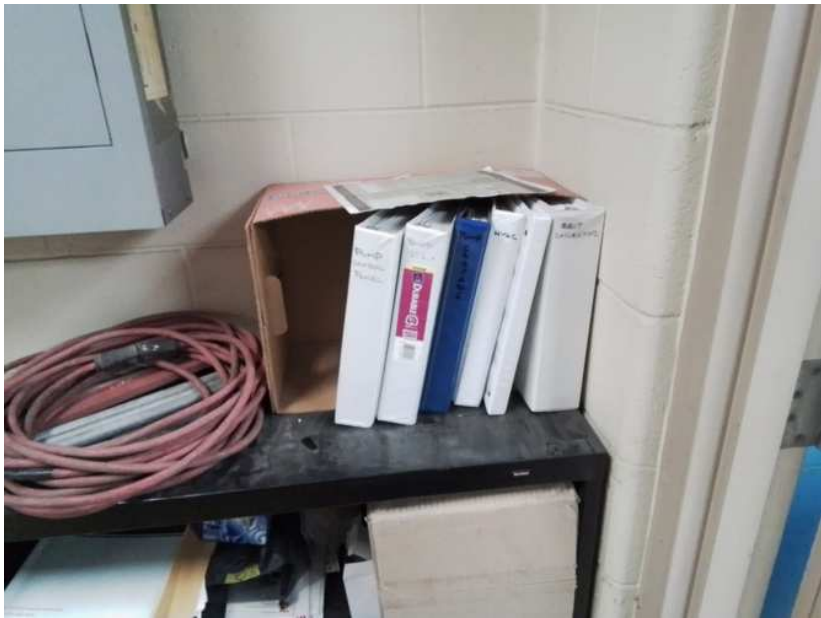
No User Rating (Site Visit) - PS-WA: Manuals kept onsite

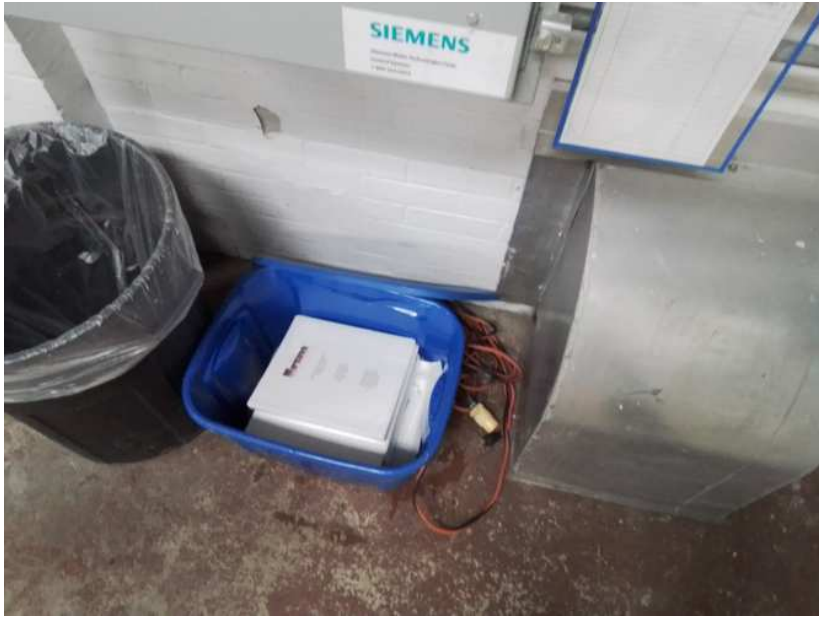
No User Rating (Site Visit) - PS-SS: Manuals kept onsite

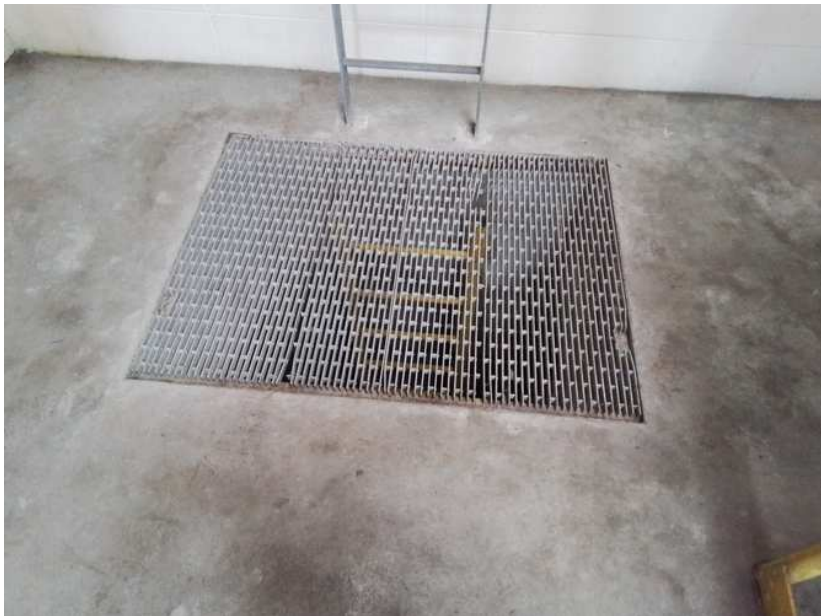
No User Rating (Site Visit) - PS-SK: Missing confined space label

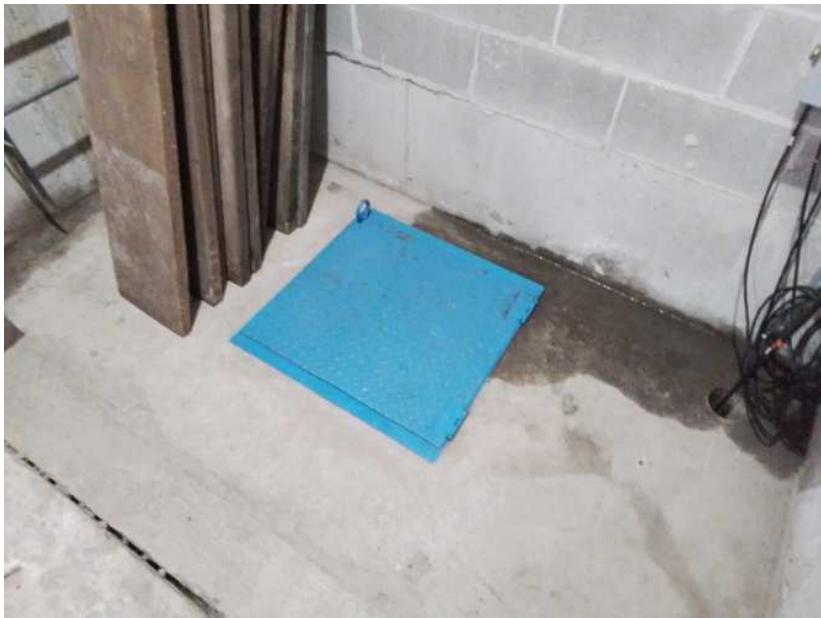
No User Rating (Site Visit) - PS-HV: Missing confined space label

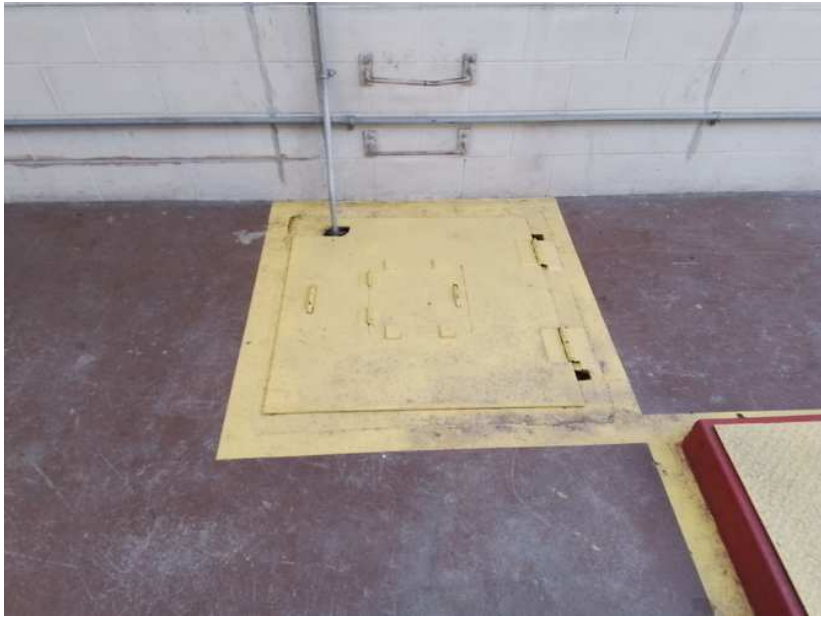
No User Rating (Site Visit) - PS-KA: Missing confined space label

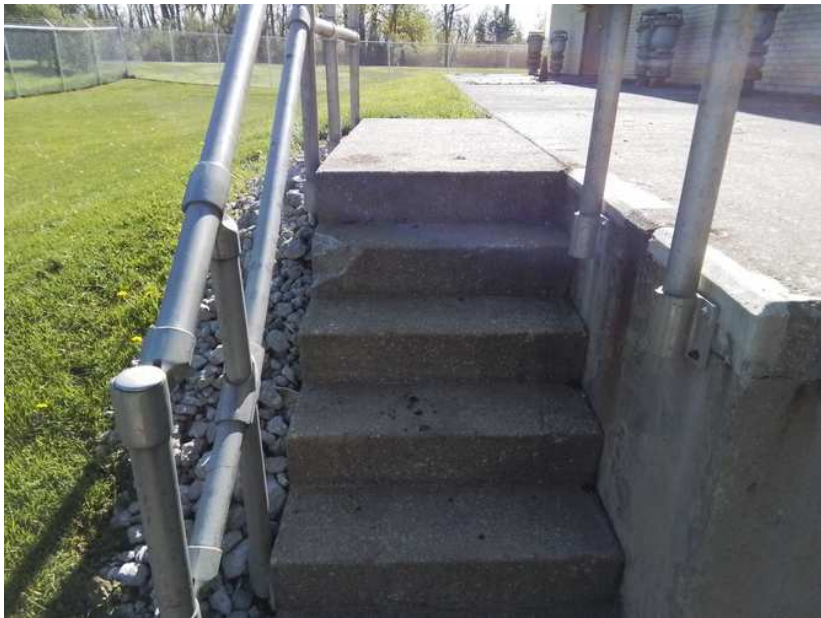
No User Rating (Site Visit) - PS-IN: Missing confined space label
