US Army Corps
of Engineers ®

Site Visit Summary

Name of System: Hammond

Date of Site Visit: 04/29/2024 - 04/30/2024

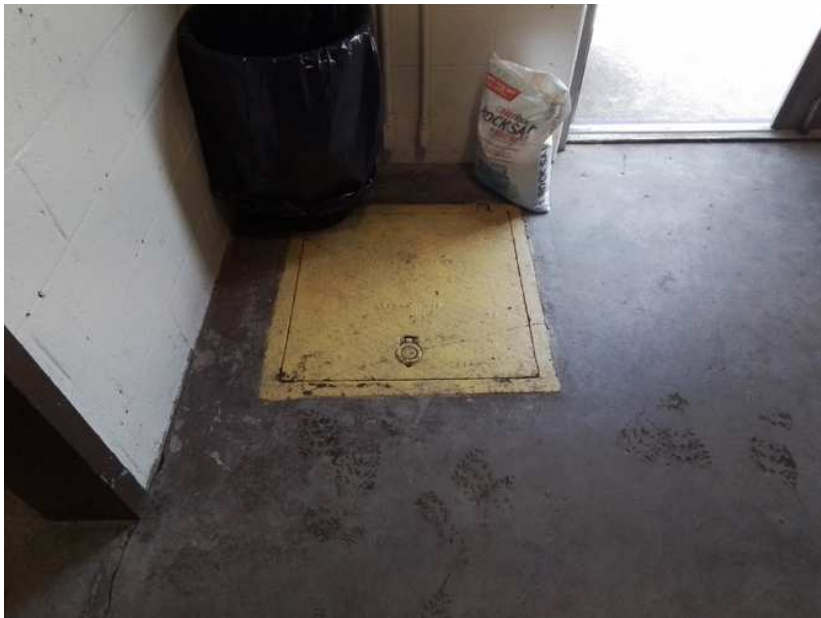
No User Rating (Site Visit) - PS-CA: Missing confined space labels

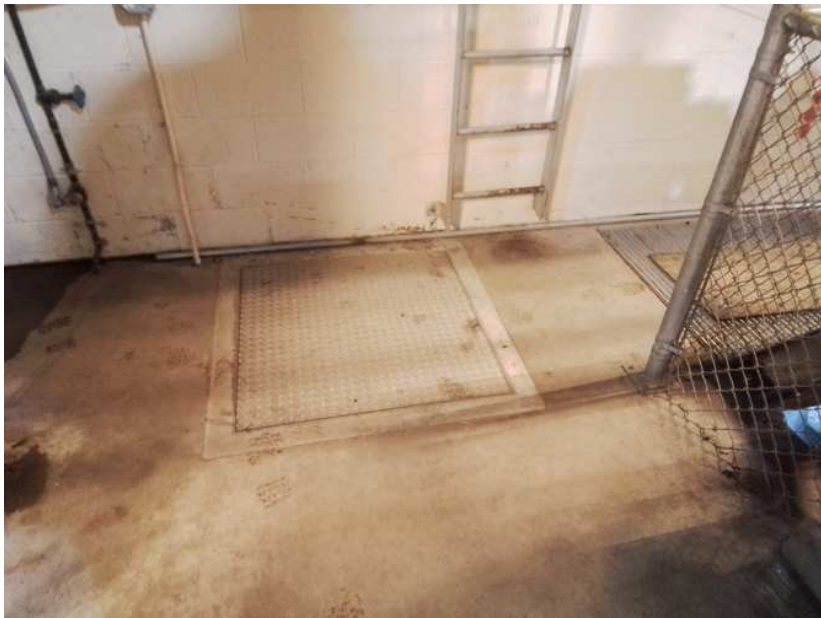
No User Rating (Site Visit) - PS-WA: Missing confined space label

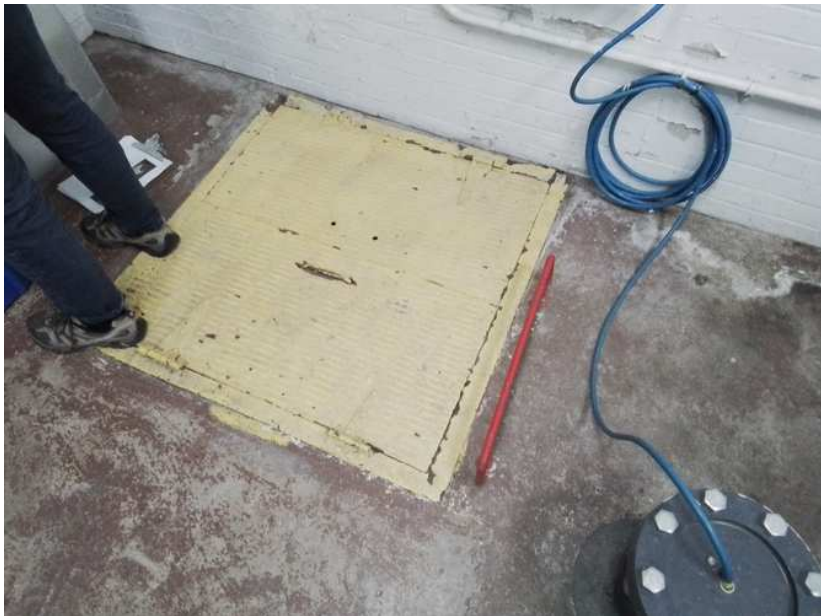
No User Rating (Site Visit) - PS-SS: Missing confined space label

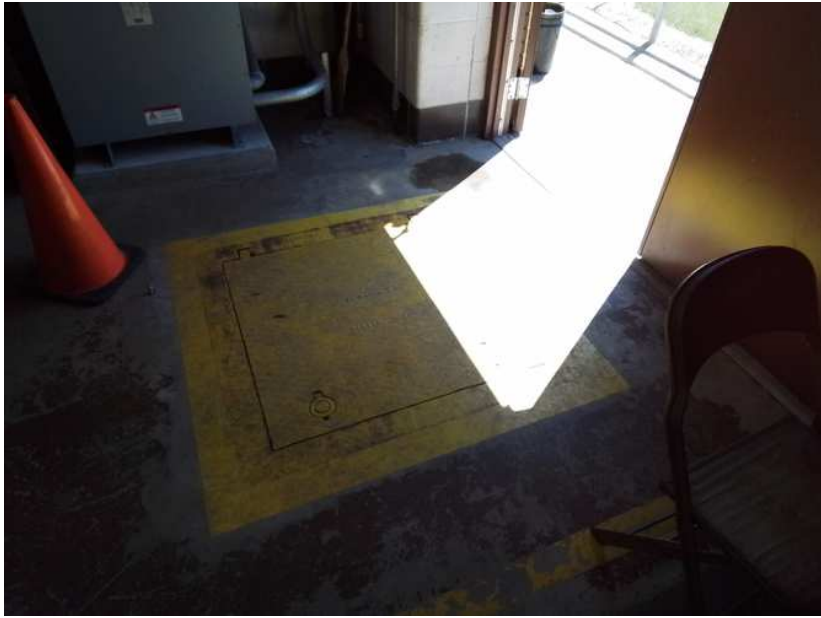
No User Rating (Site Visit) - PS-TA: Missing confined space label

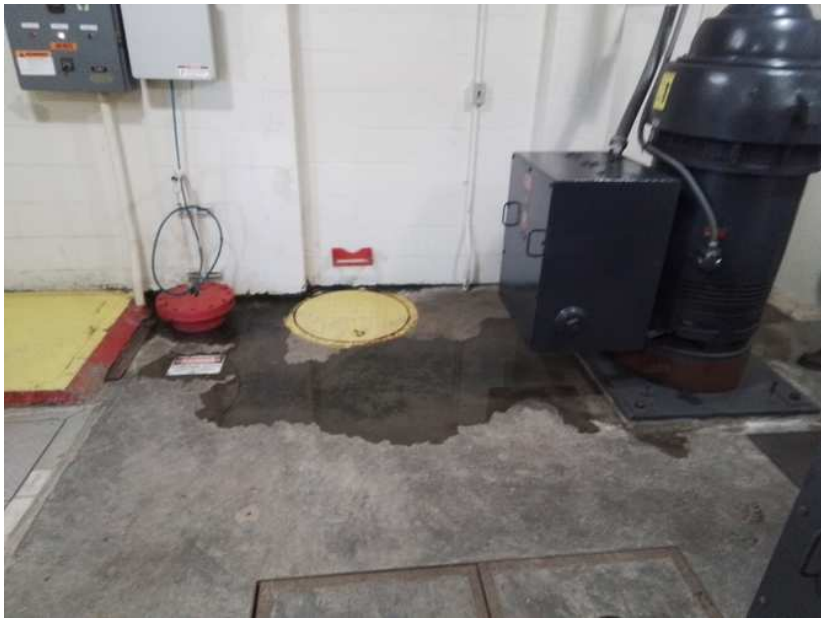
No User Rating (Site Visit) - PS-WA: Leak in building

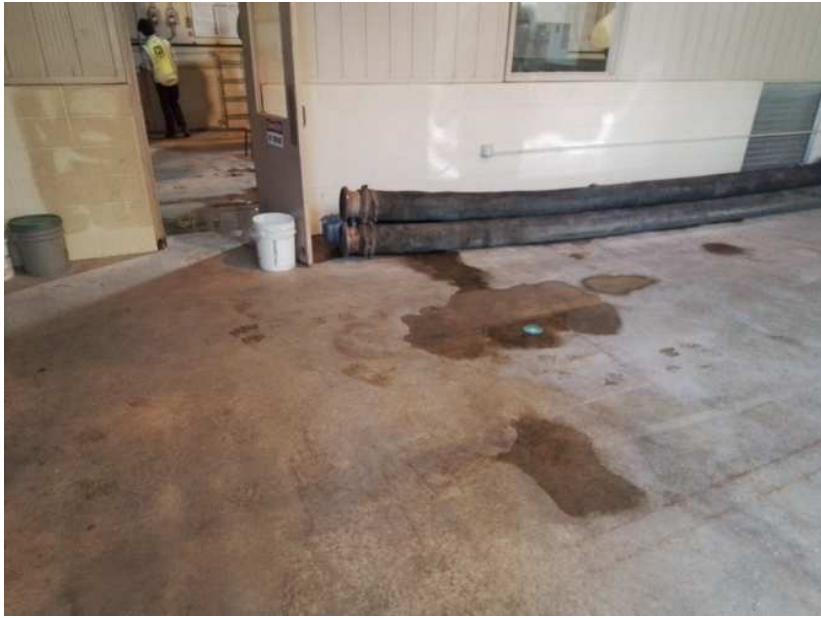
No User Rating (Site Visit) - PS-WA: Leak in building

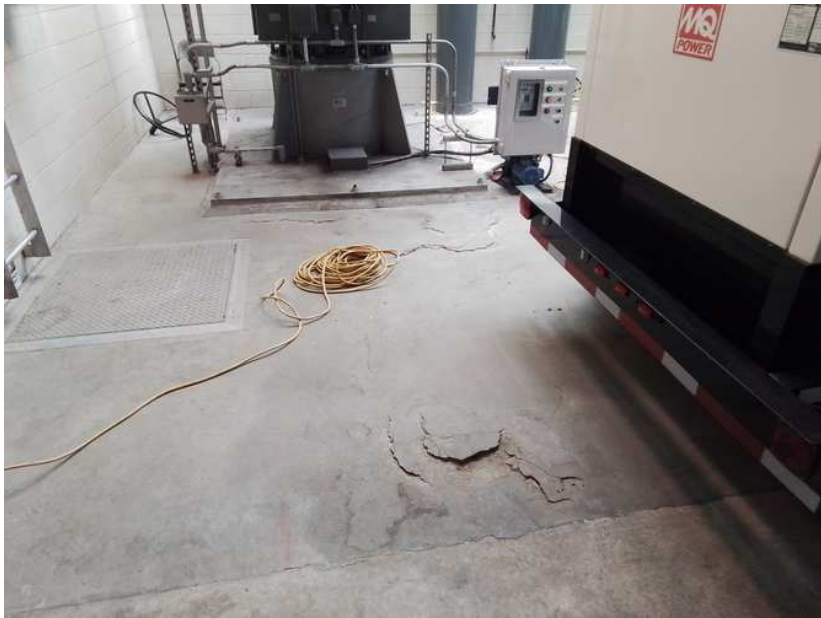
No User Rating (Site Visit) - PS-SS: Leak in building

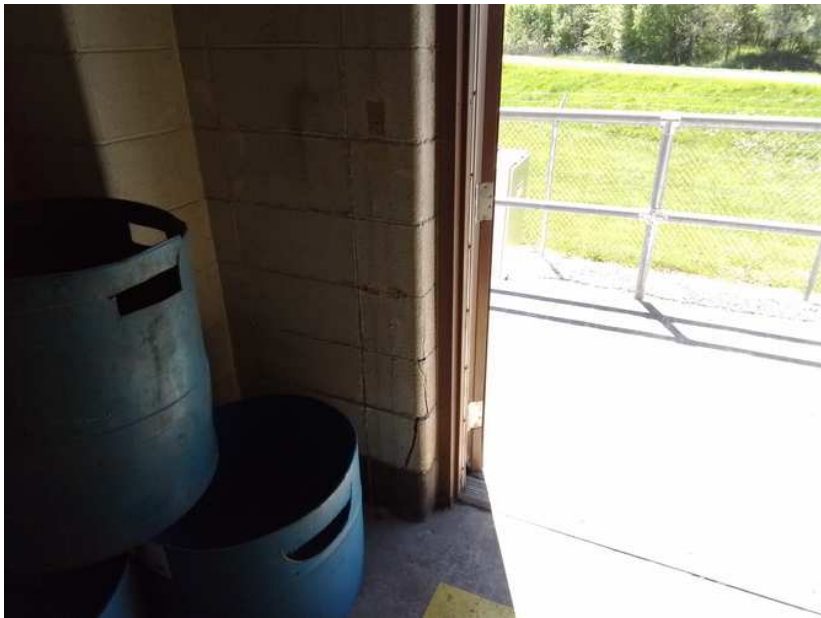
No User Rating (Site Visit) - PS-JA: Spalling near stairs

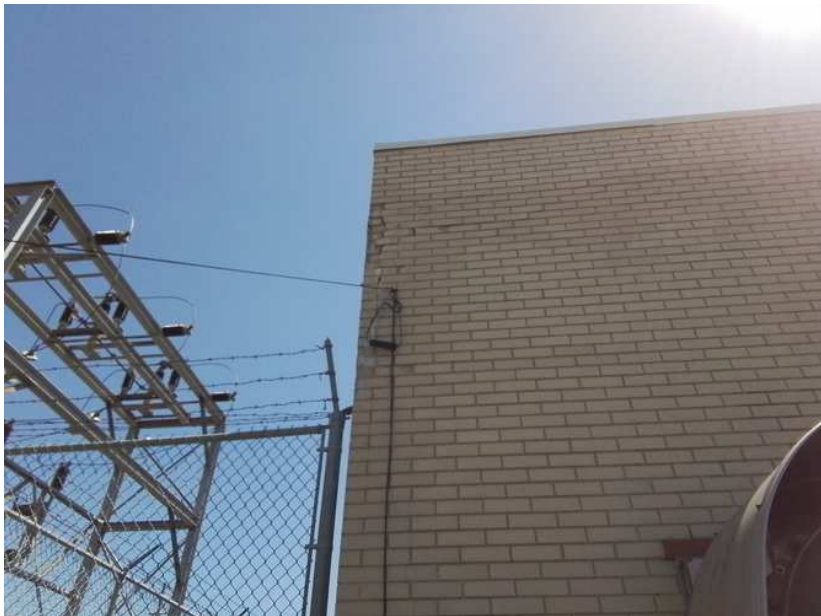
No User Rating (Site Visit) - PS-JA: Roof drip edge is pulling away from building

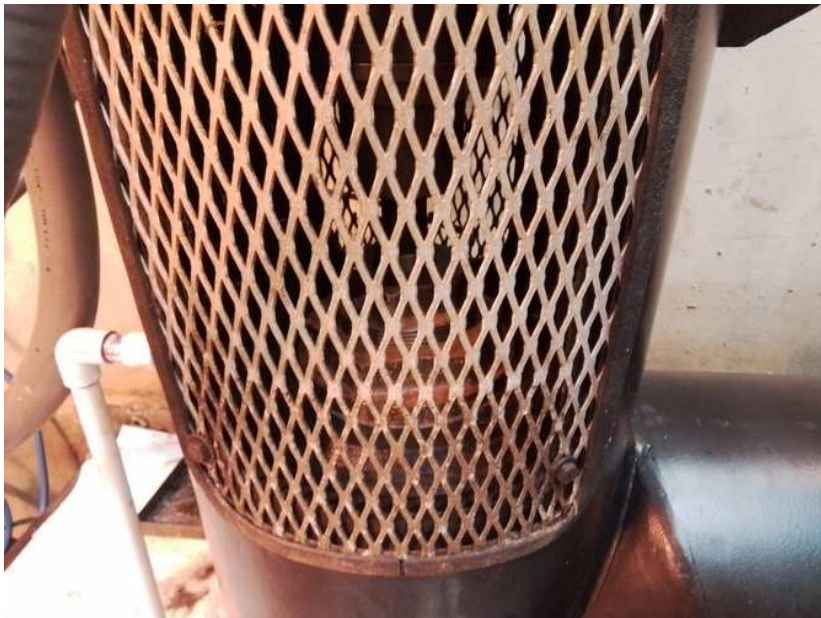
No User Rating (Site Visit) - PS-HV: Heavy corrosion on valve connected to discharge piping of DWP - noted during previous inspections

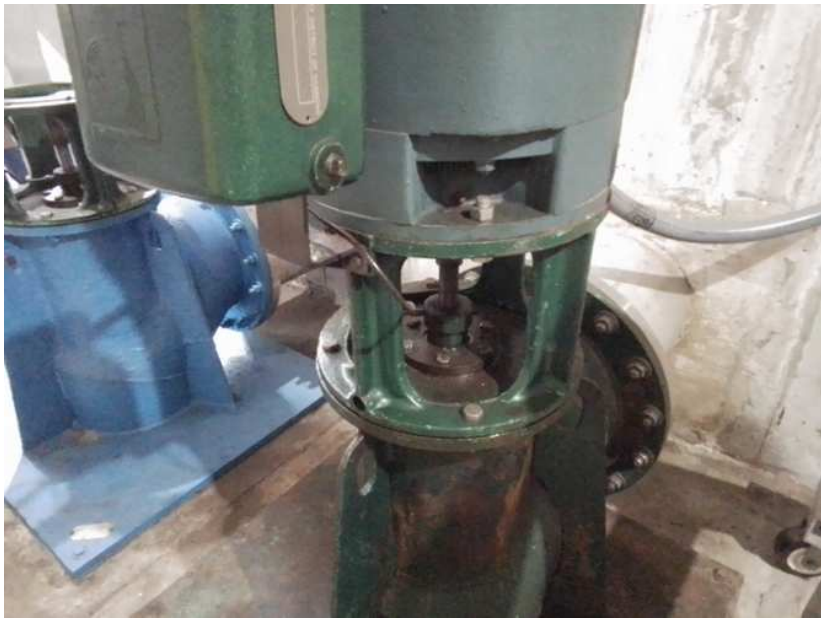
No User Rating (Site Visit) - PS-KA: Pump 1 out of service for maintenance

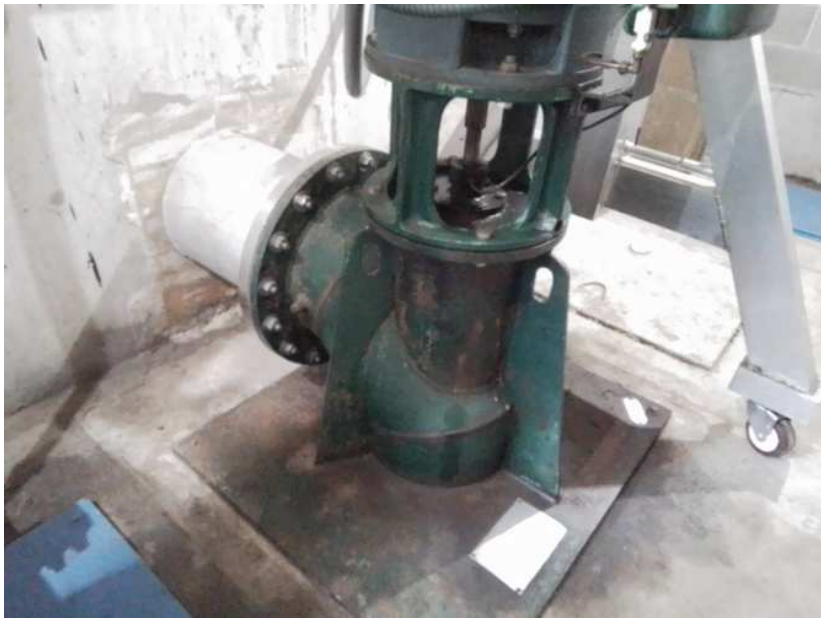
No User Rating (Site Visit) - PS-KA: Evidence of oil leak at elbow of the supply lubricating line

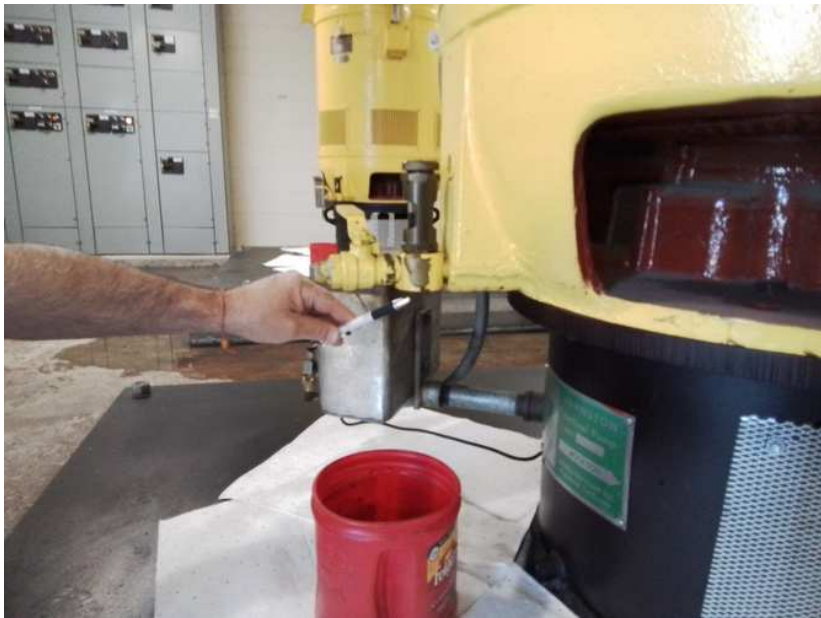
No User Rating (Site Visit) - PS-IN: Excessive lubricant on the exposed connection shaft of SWP-2 - noted during last inspection

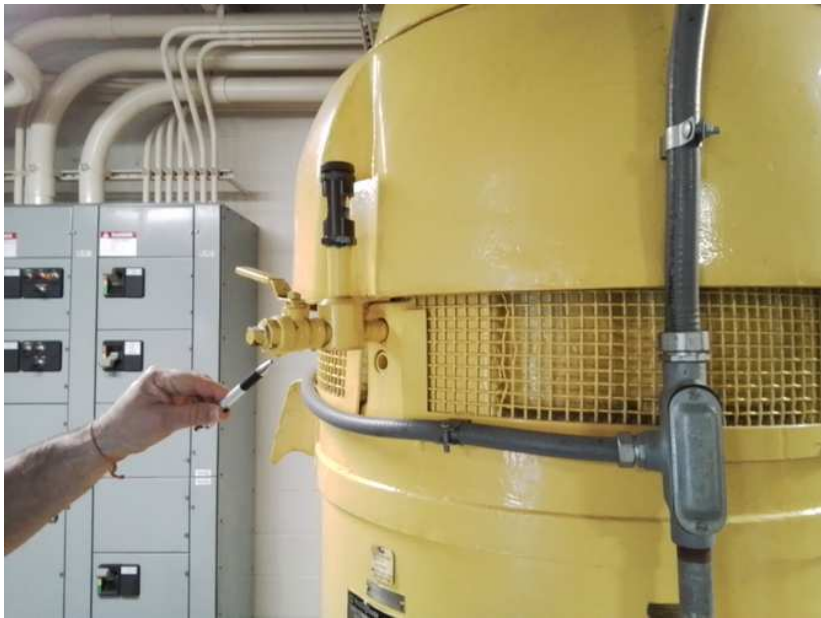
No User Rating (Site Visit) - PS-WA: Leak at drain valve for lubricating system on SWP-5

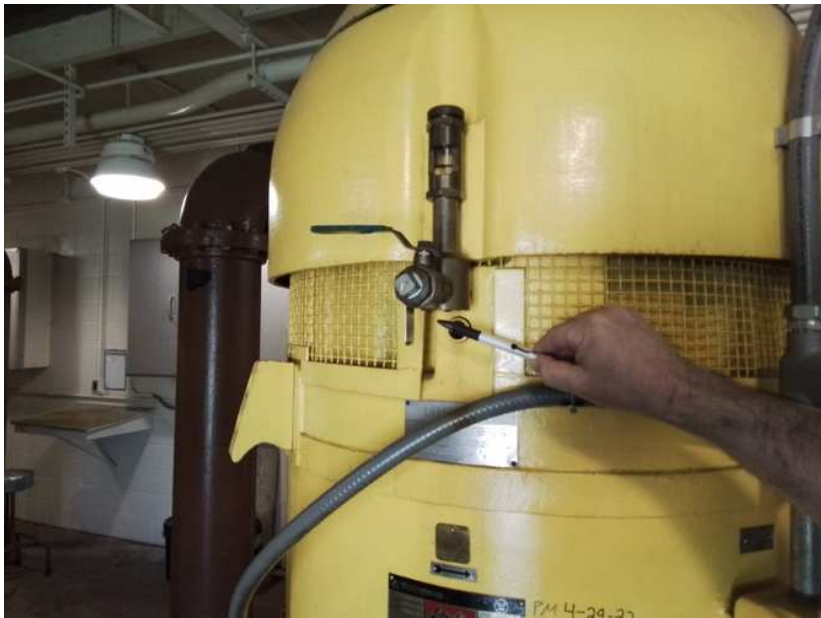
No User Rating (Site Visit) - PS-WA: Leak at electric motor lubricating system on SWP-6

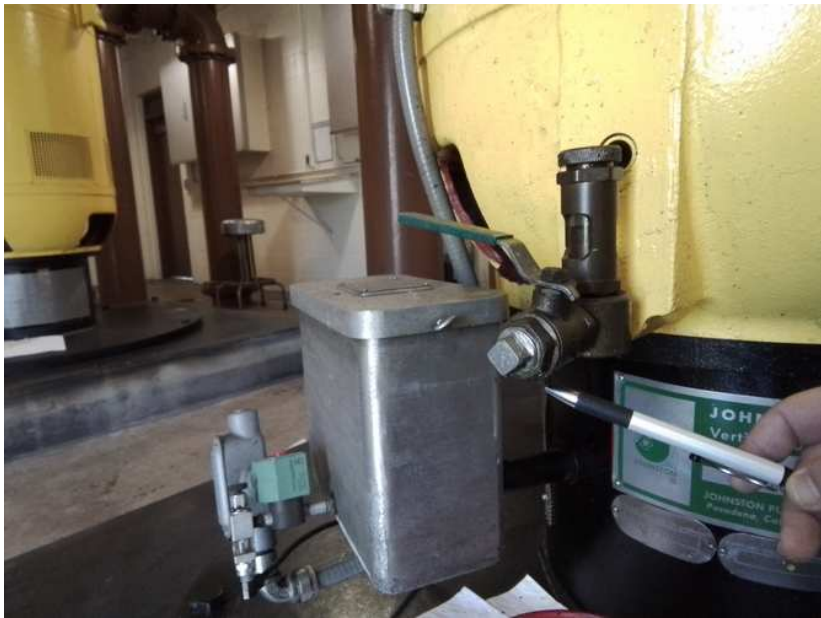
No User Rating (Site Visit) - PS-WA: Oil may be low on SWP-4

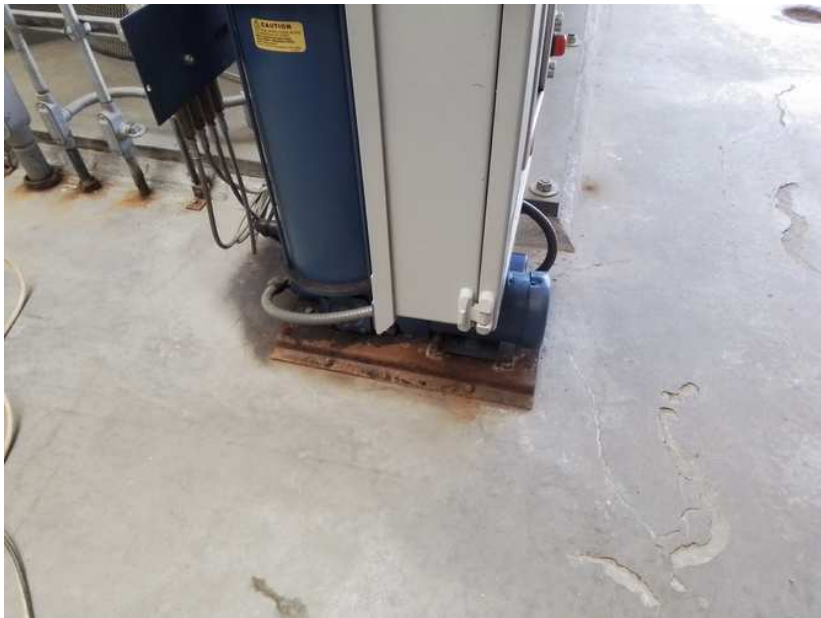
No User Rating (Site Visit) - PS-WA: Oil leak at drain valve for lubricating system on SWP-4

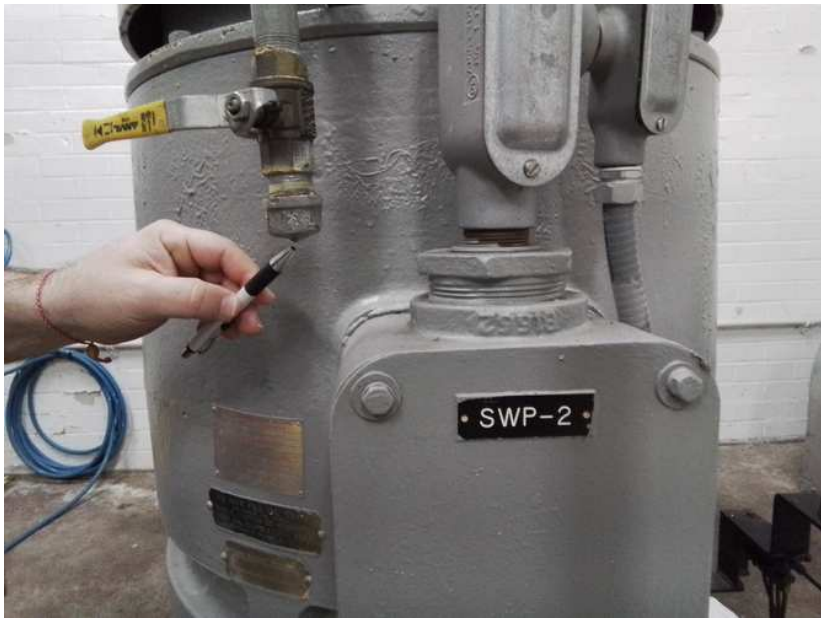
No User Rating (Site Visit) - PS-SS: Oil residue around bases of all pump lubricating systems (SWP-2 shown)

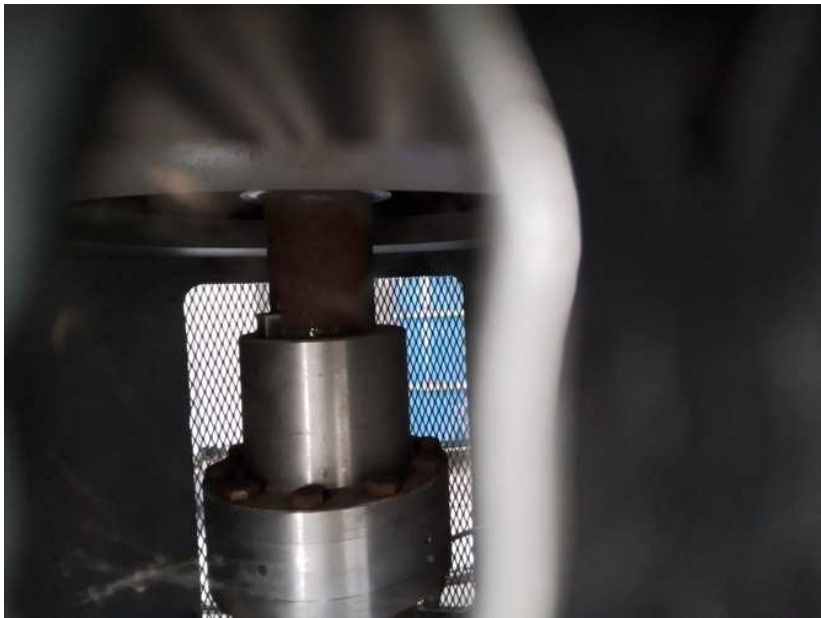
No User Rating (Site Visit) - PS-TA: Leak at lubricating drain on SWP-2

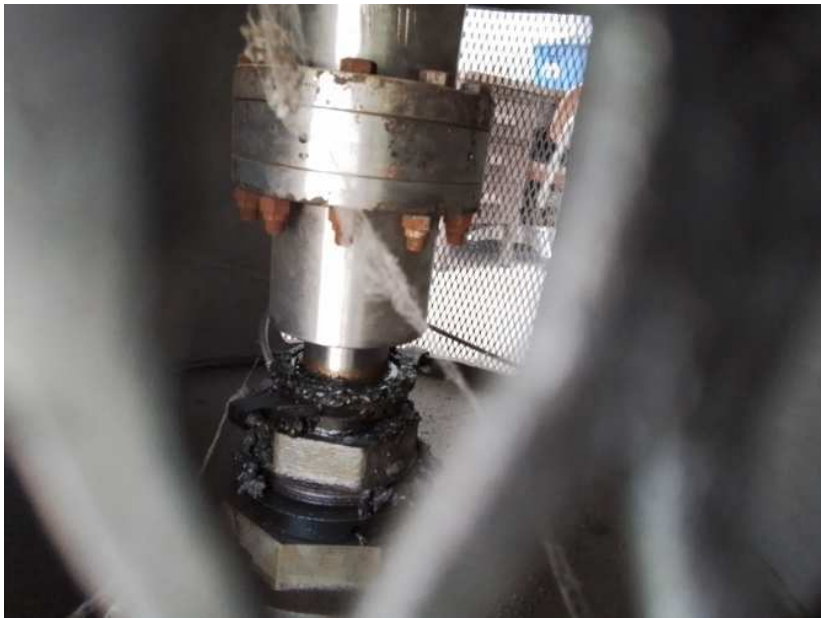
No User Rating (Site Visit) - PS-JA: Exposed key shaft at top of exposed connection is corroded for pumps 1 and 2 (pump 1 pictured) - noted during previous inspection

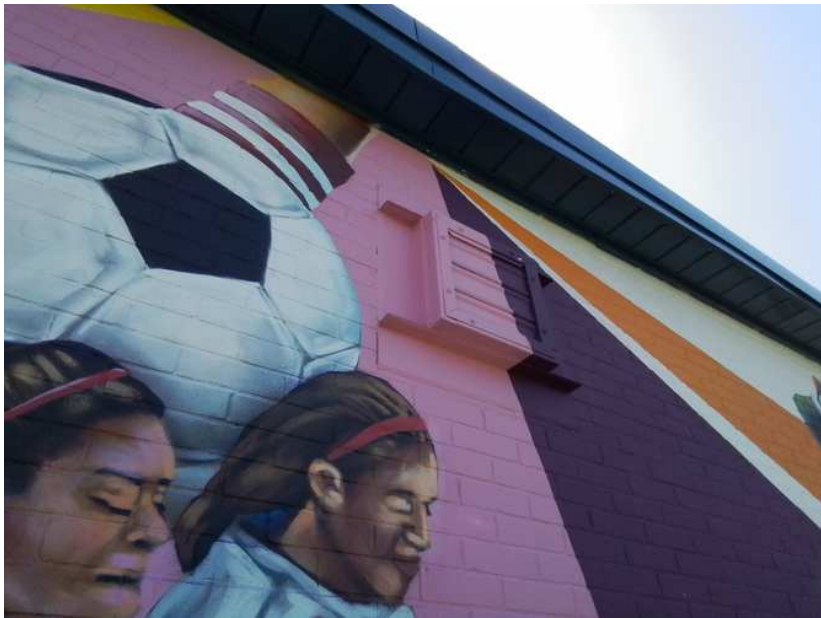
No User Rating (Site Visit) - PS-SK: During the last inspection, there was housing around the exhaust fan that was almost disconnected - the housing is now gone

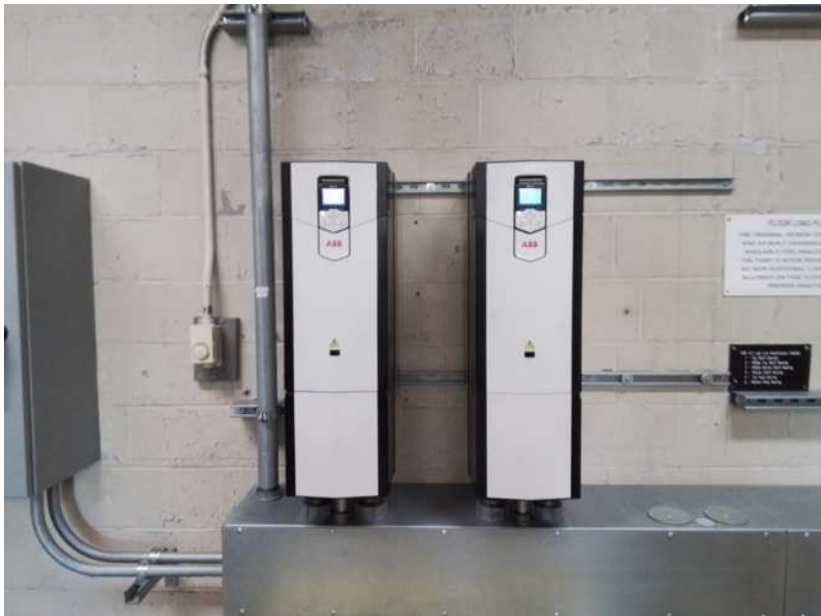
No User Rating (Site Visit) - PS-SK: Outdated arc flash labels

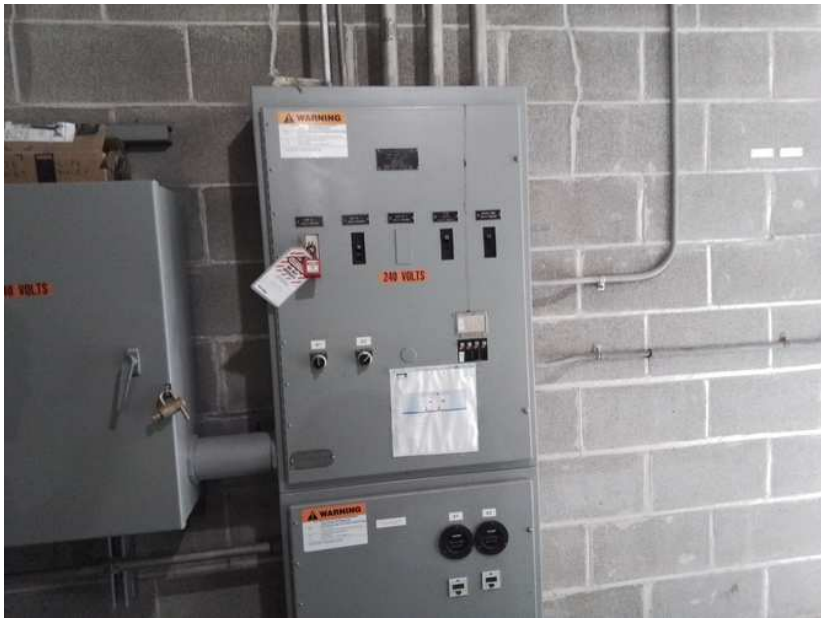
No User Rating (Site Visit) - PS-HV: Outdated arc flash labels

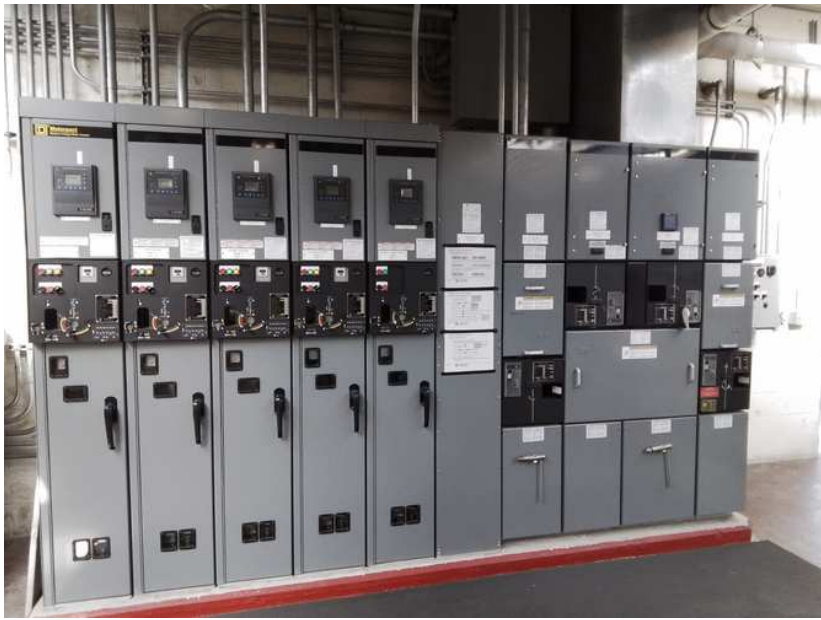
No User Rating (Site Visit) - PS-KA: Outdated arc flash labels

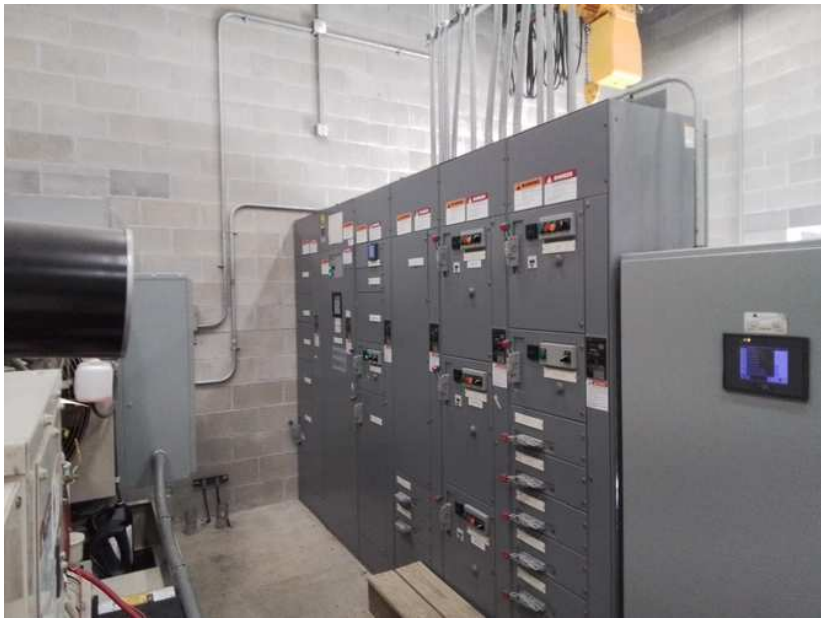
No User Rating (Site Visit) - PS-IN: Outdated arc flash labels

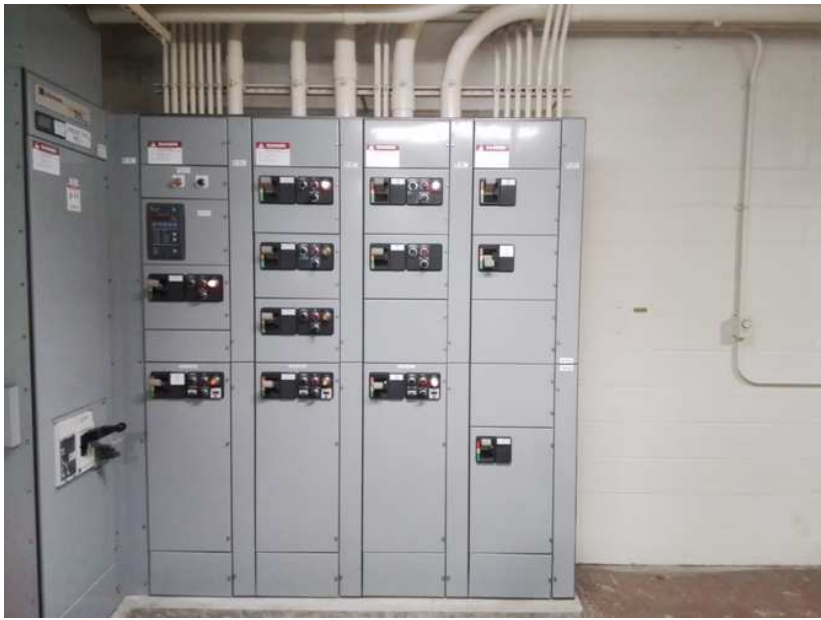
No User Rating (Site Visit) - PS-CA: Outdated arc flash labels

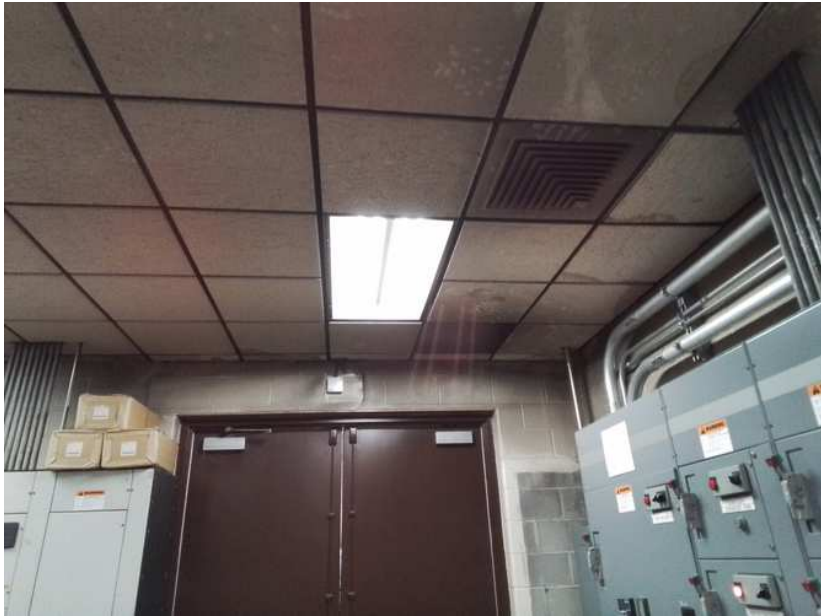
No User Rating (Site Visit) - PS-SS: Outdated arc flash labels

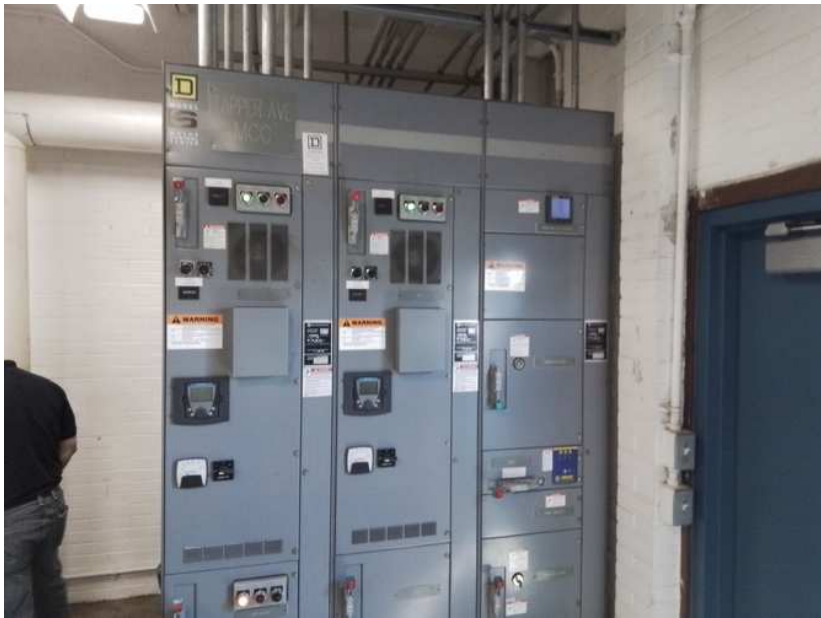
No User Rating (Site Visit) - PS-SS: Heater is not operational

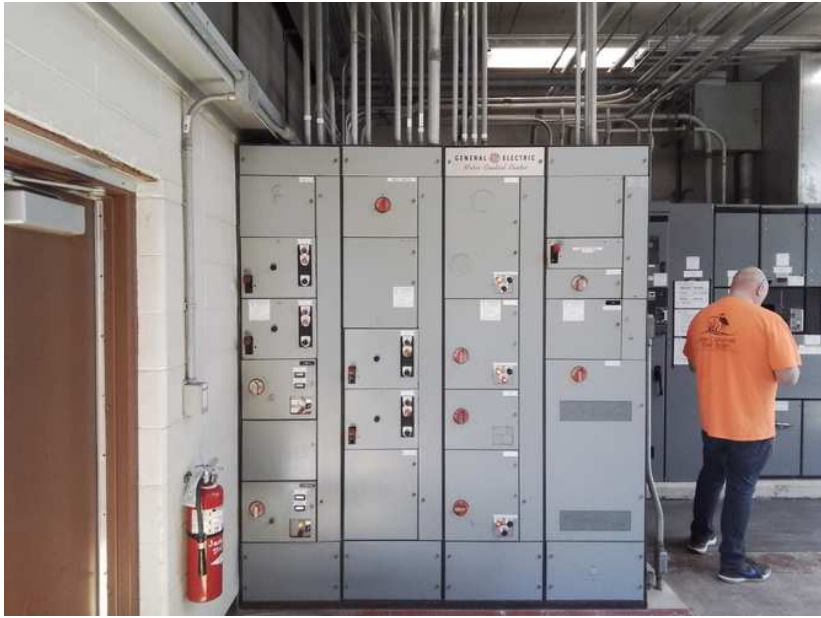
No User Rating (Site Visit) - PS-TA: Outdated arc flash labels

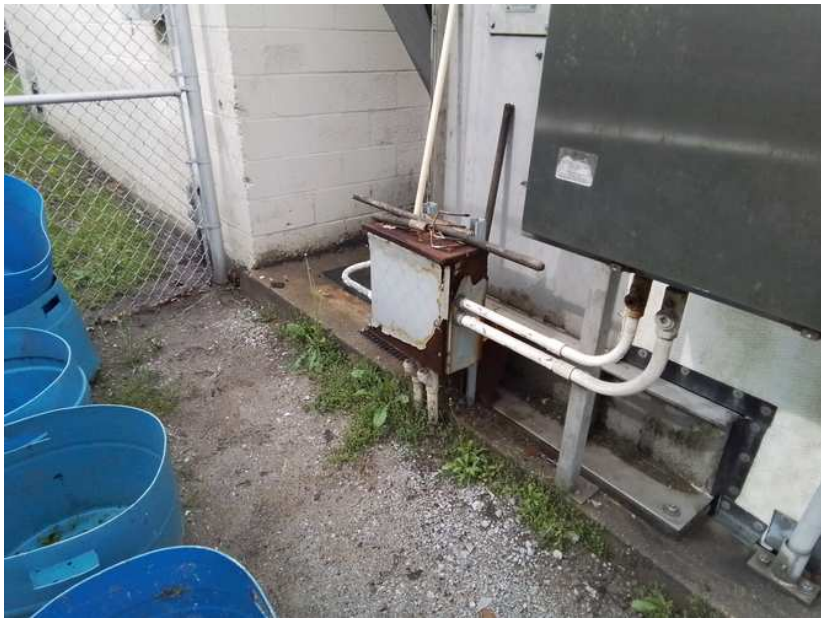
No User Rating (Site Visit) - PS-JA: Outdated arc flash labels

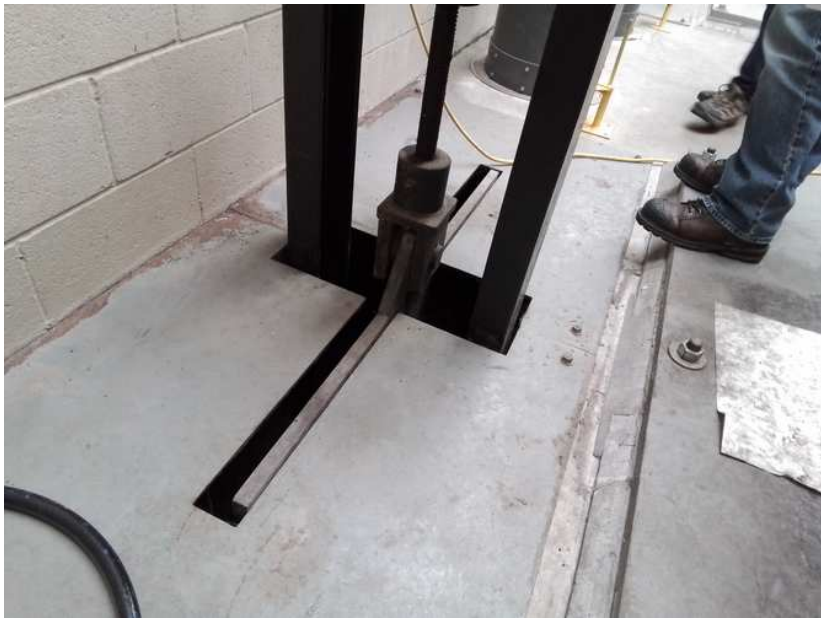
No User Rating (Site Visit) - PS-HV: During the last inspection, the influent sluice gate vibrated during closing- it did not vibrate during the current inspection

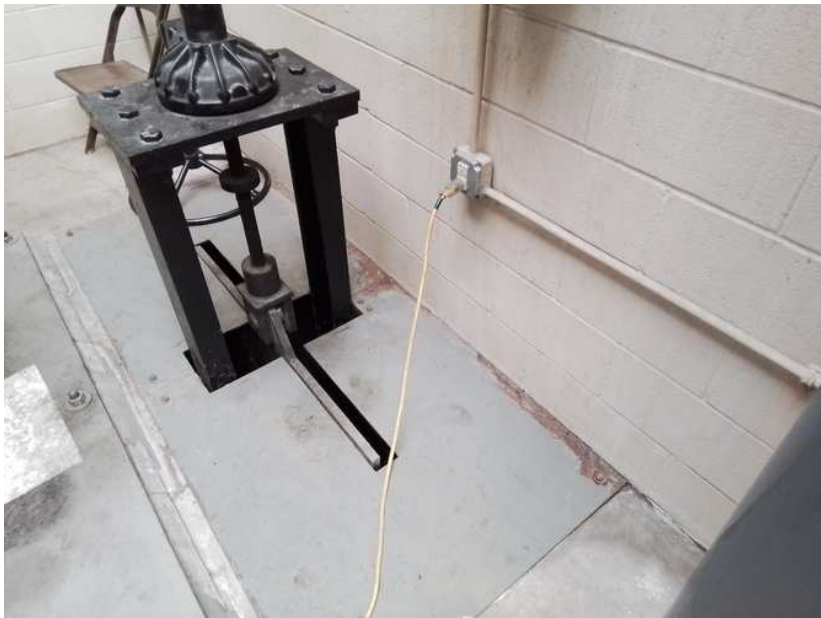
No User Rating (Site Visit) - PS-SS: Tight clearance between gate and cover for sluice gates on SWP-1 and SWP-2 (SWP-1 pictured) - noted during last inspection
